Torrens Road Housing Complex Detailed Engineering Evaluation BU 0480 - 001EQ2 - Block A BU 0480 - 002 EQ2 - Block B Quantitative Report

17 April 2013

Detailed Engineering Evaluation Quantitative Report – SUMMARY

53 Torrens Road
Middleton
Christchurch

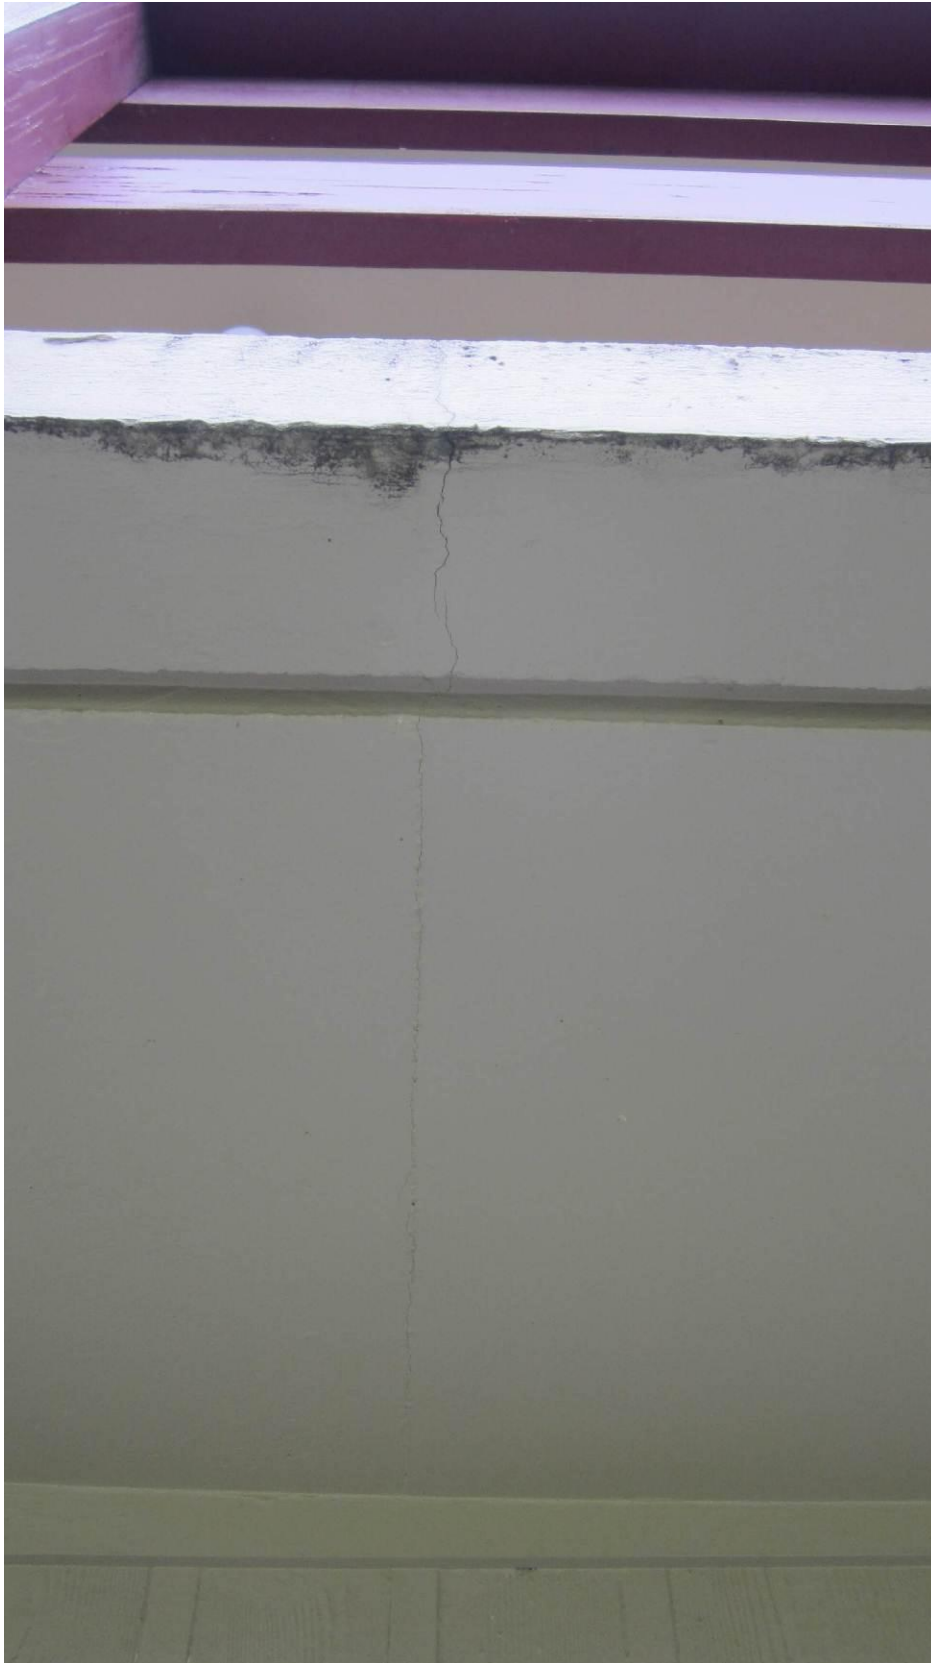
Photo 7: Underside of typical first floor concrete balcony

Damage Description: Cracking of concrete balcony.

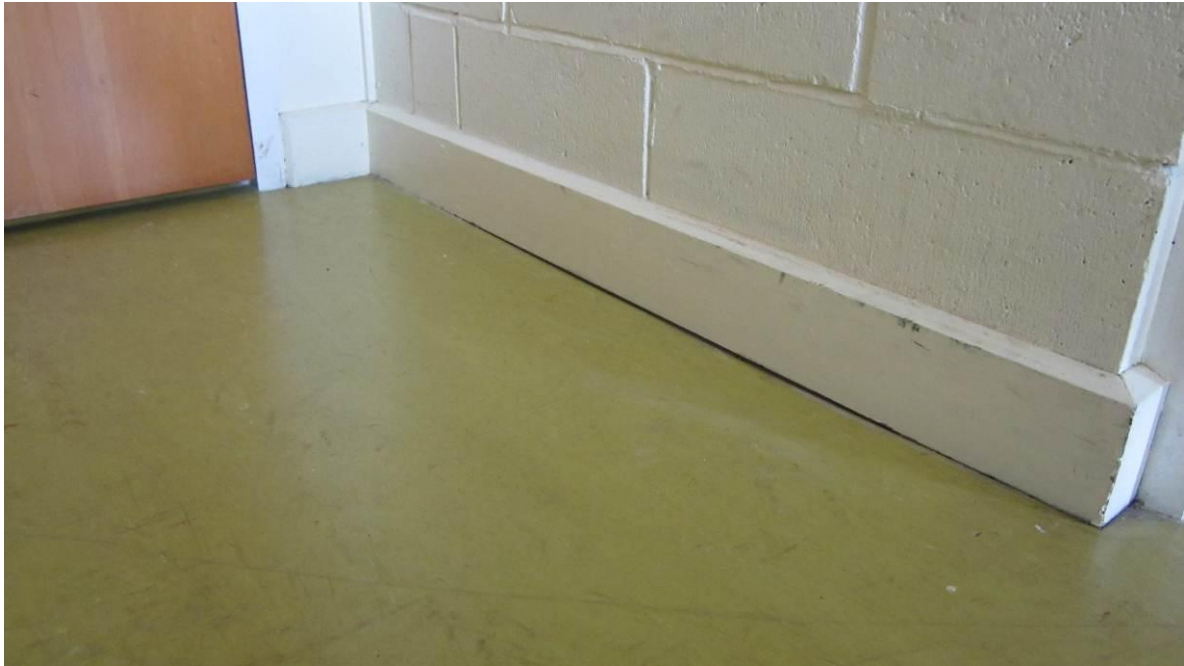
Photo 8: Landing at top of stairway

Damage Description: potential movement between wall and floor.

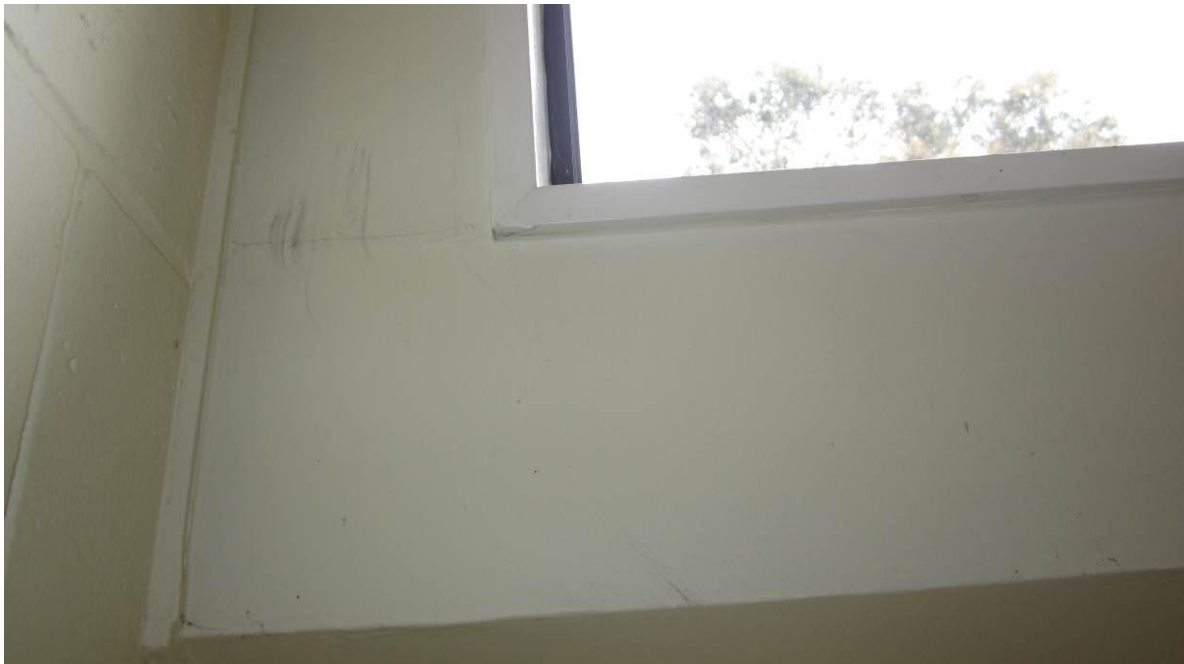
Photo 9: Window in stairway.

Damage Description: Cracking of internal wall linings (typical).

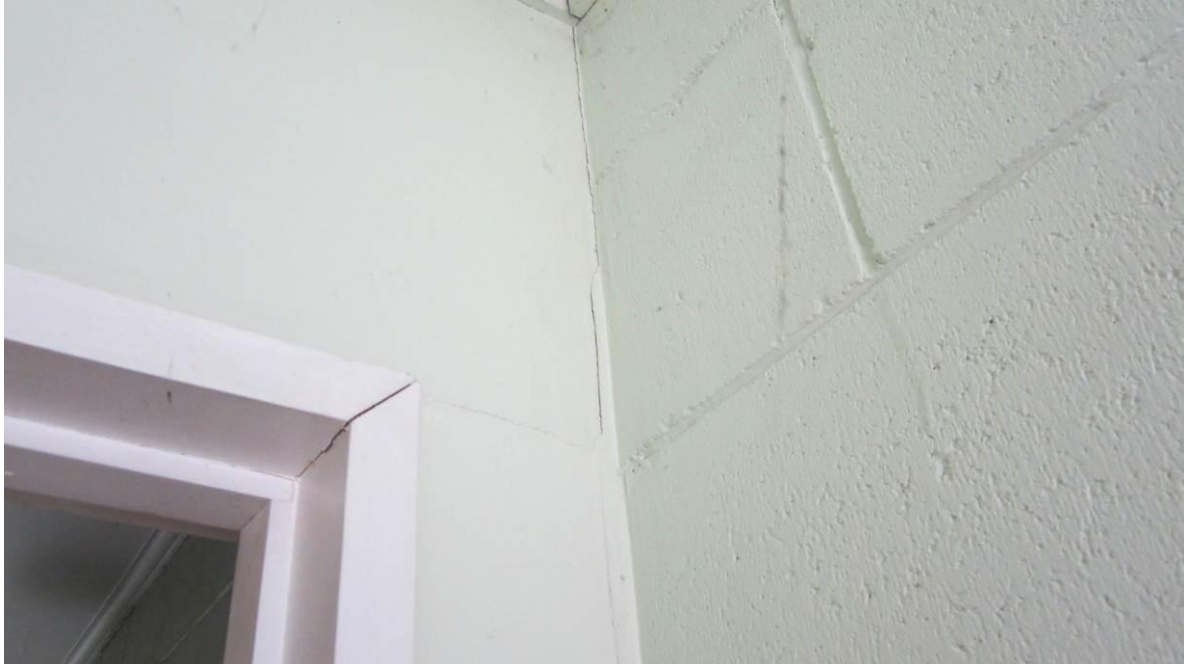
Photo 10: Storage room at top of stairs.

Damage Description: Cracking of wall linings (typical).

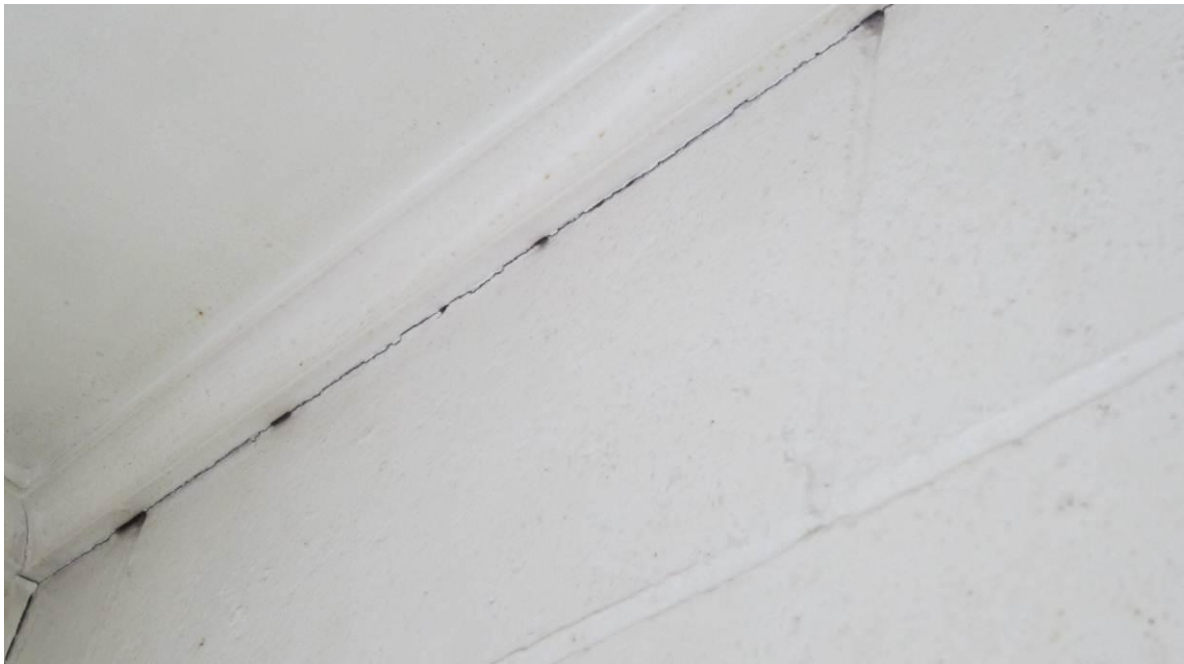
Photo 11: Typical cornice detail.

Damage Description: Separation of wall and ceiling linings (typical).

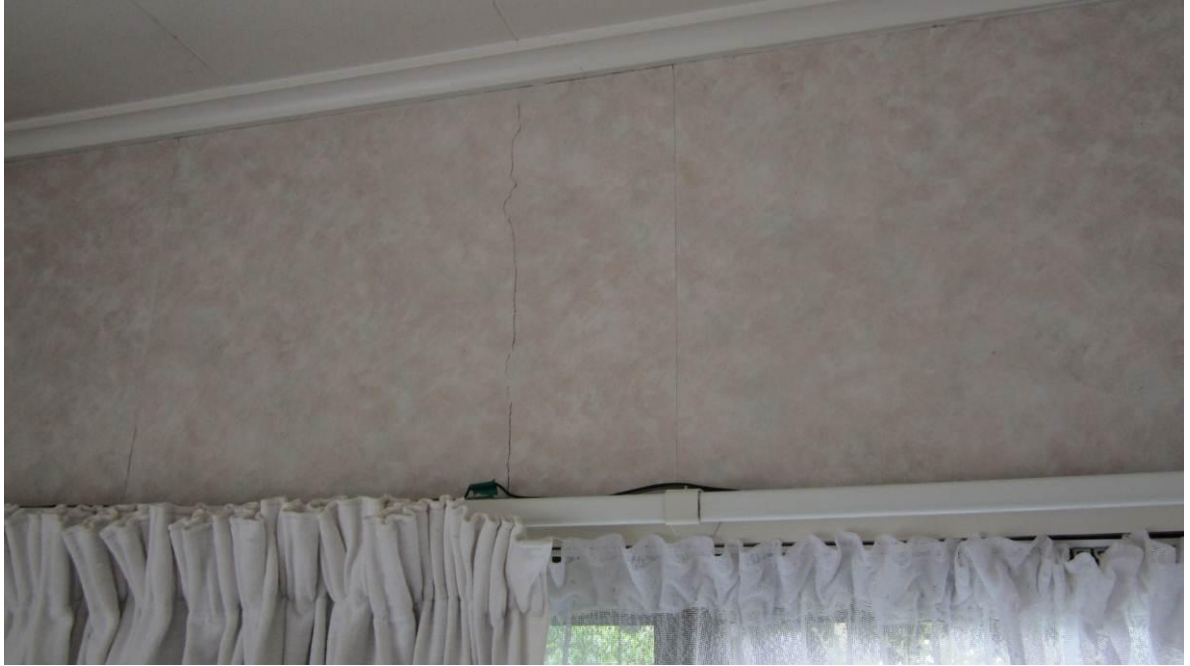
Photo 12: Wall lining above entrance doorway.

Damage Description: Cracking of internal wall linings (typical).

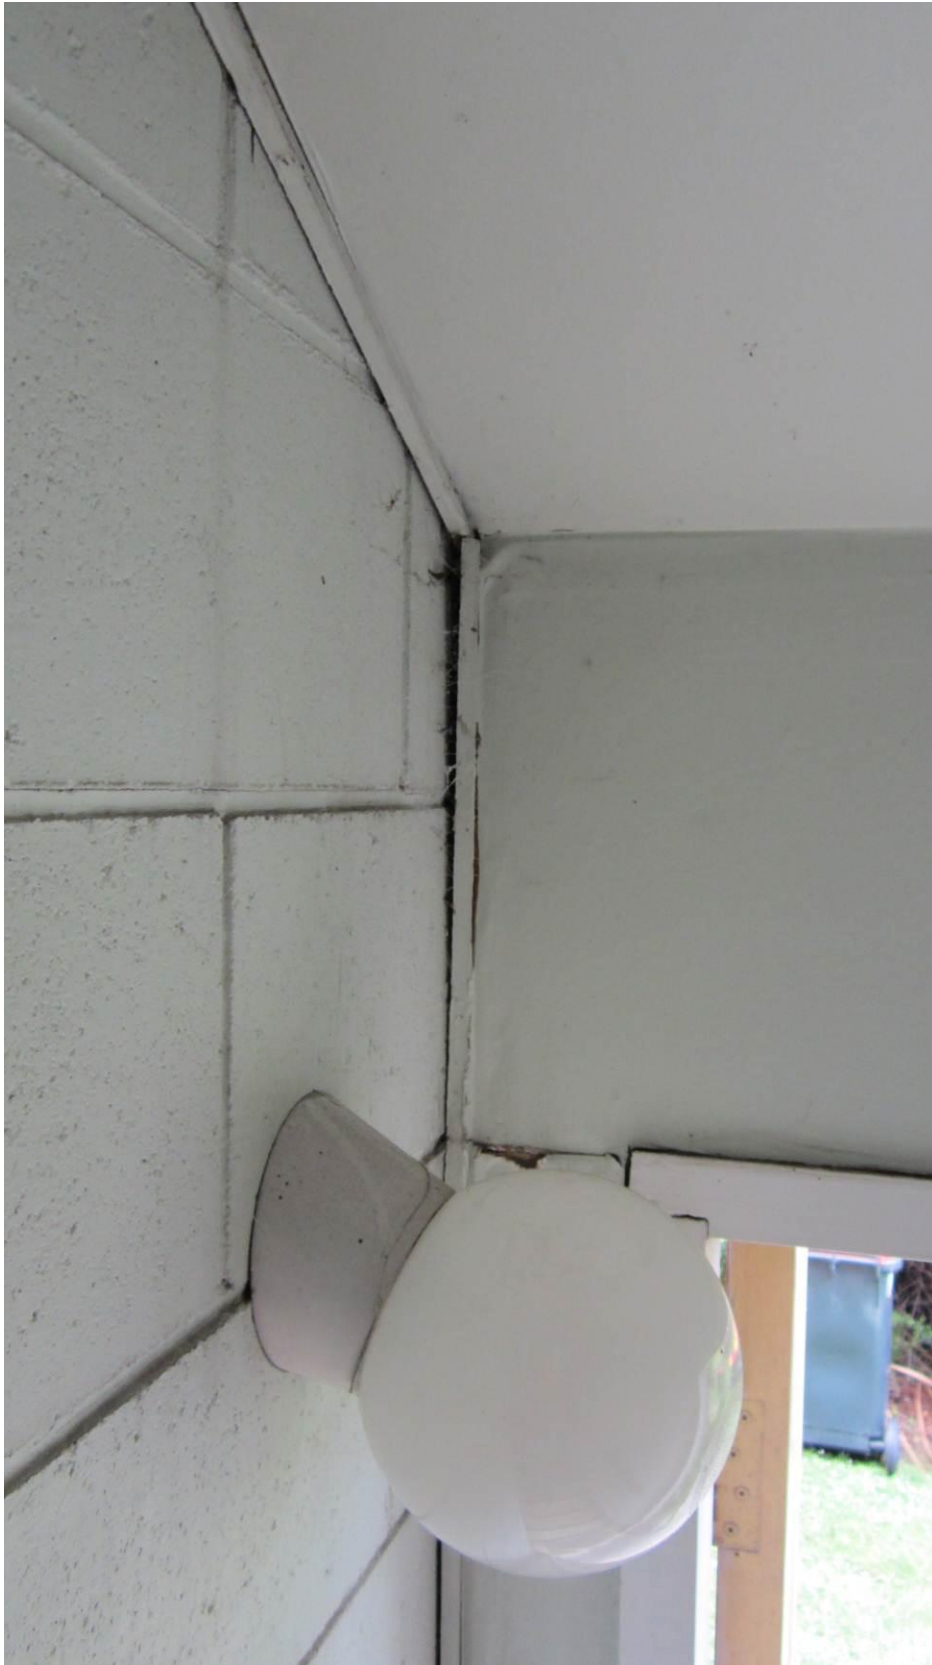
Photo 13: Typical wall junction in stairwell.

Damage Description: Separation of wall and ceiling linings (typical).

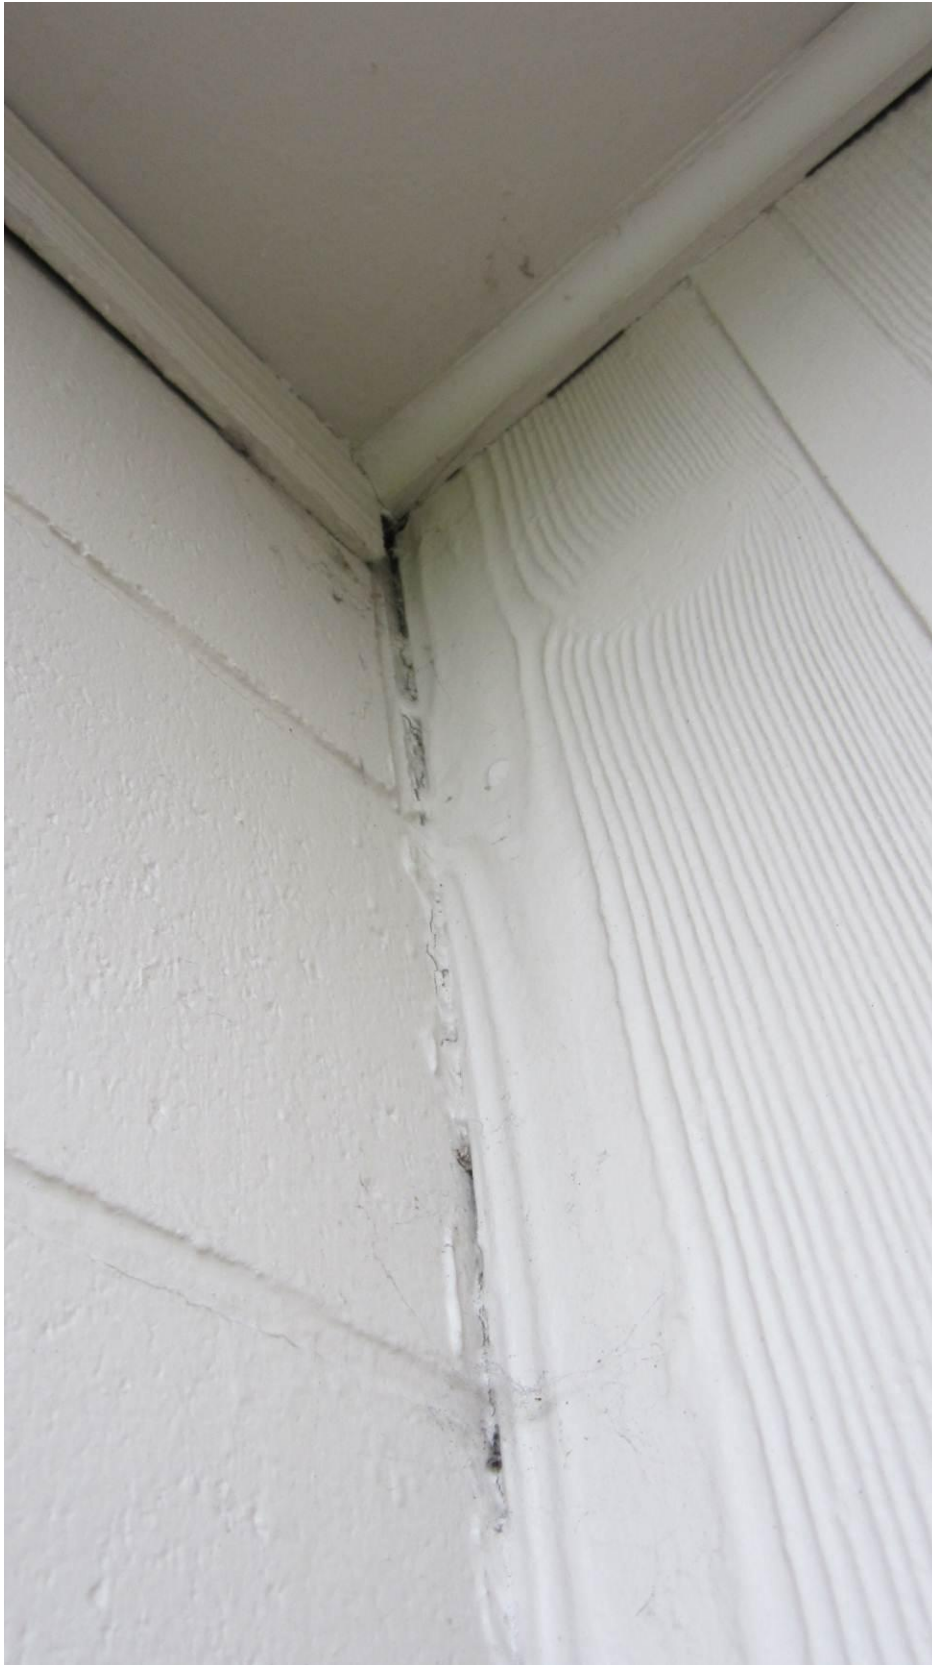
Photo 14: Typical junction of transverse concrete masonry block wall and longitudinal timber framed wall with weatherboard cladding.

Damage Description: Separation of wall and ceiling linings (typical).

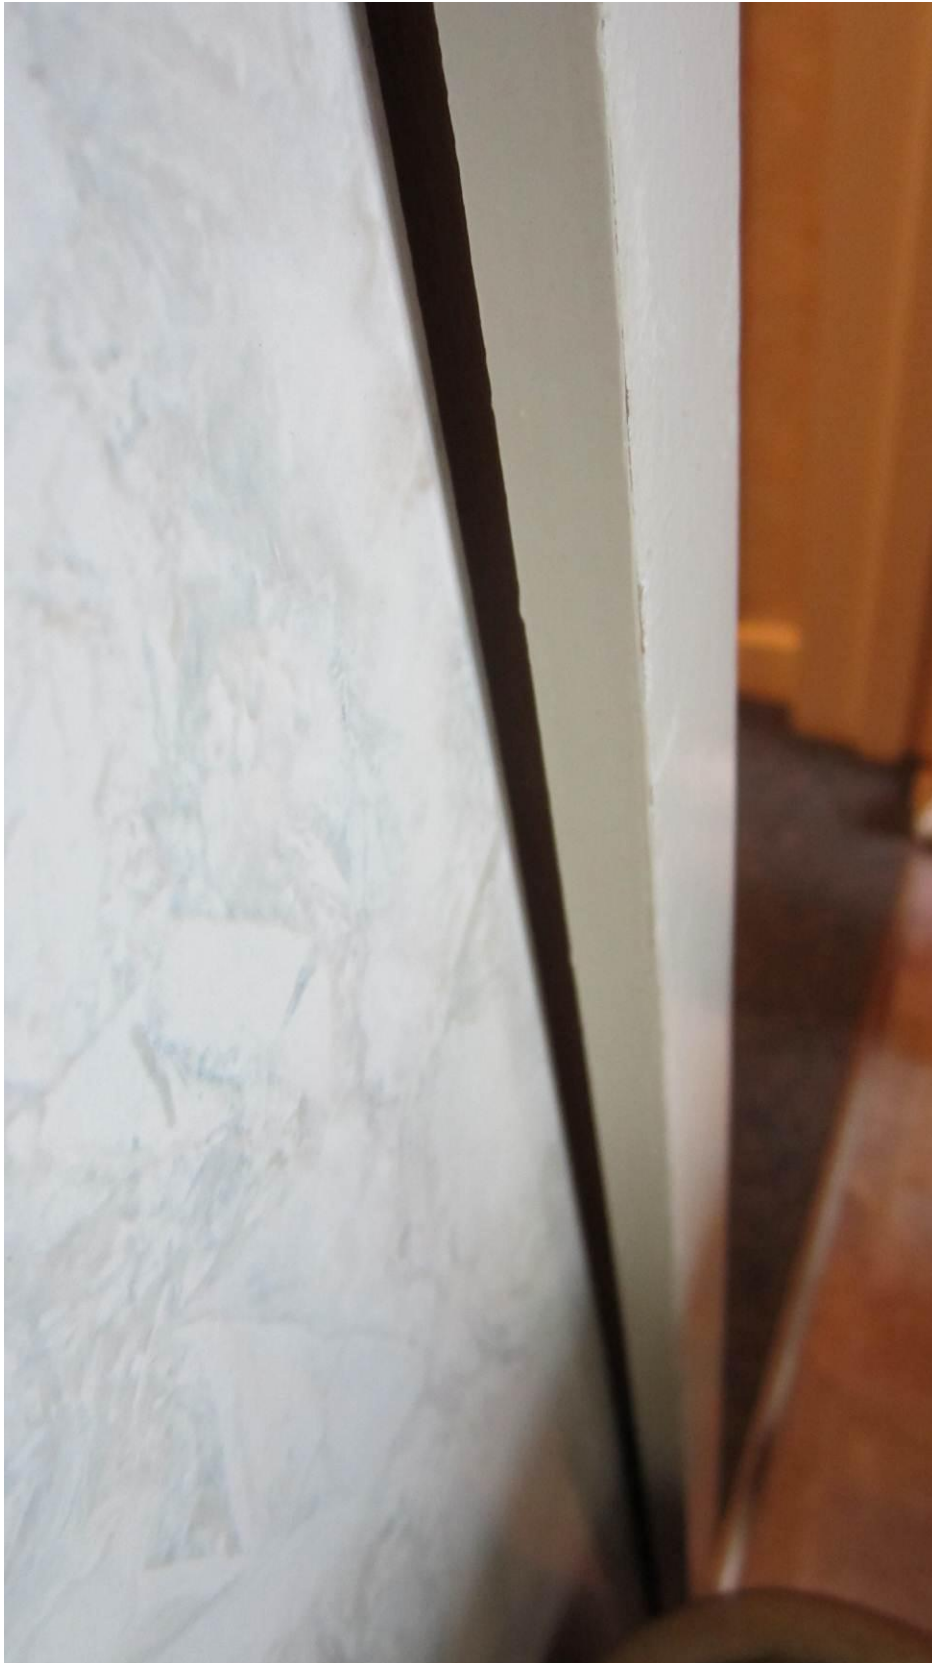
Photo 15: Separation of wall lining and architrave.

Damage Description: Evidence of building movement – gap between lining and architrave. (dark shadow is the opening/gap – finger width 10-15mm)

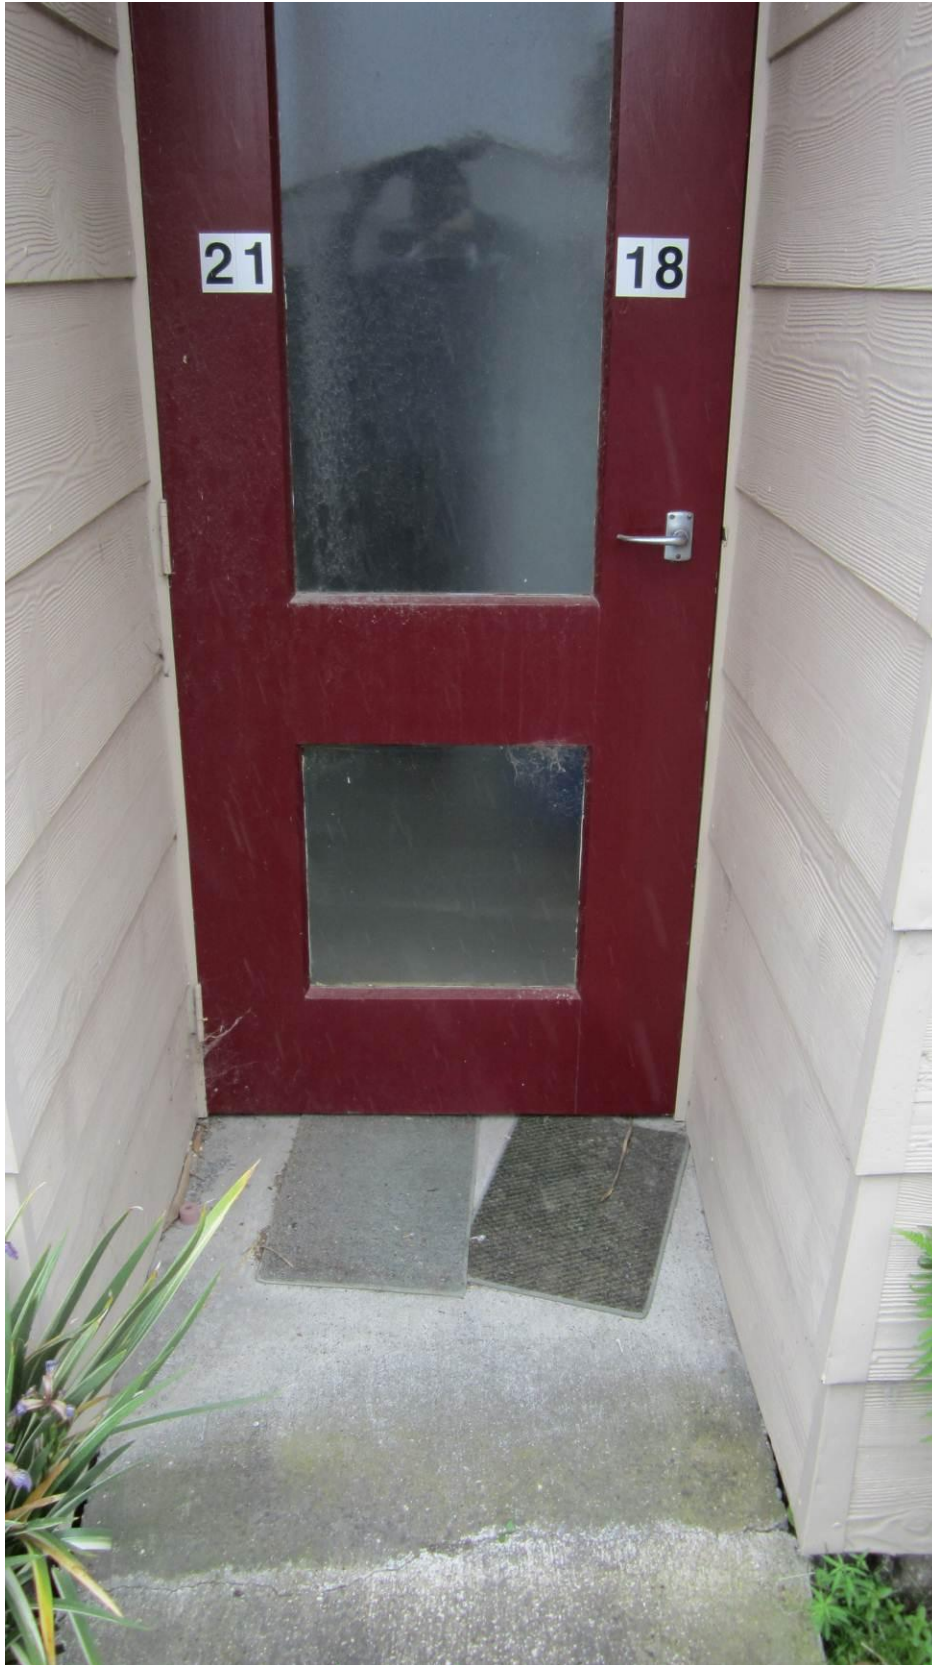
Photo 16: External pavement at entrance of under-stair storage area at rear of Block B.

Damage Description: Cracking of concrete. This cracking was typical for all entrances to under-stair storage.

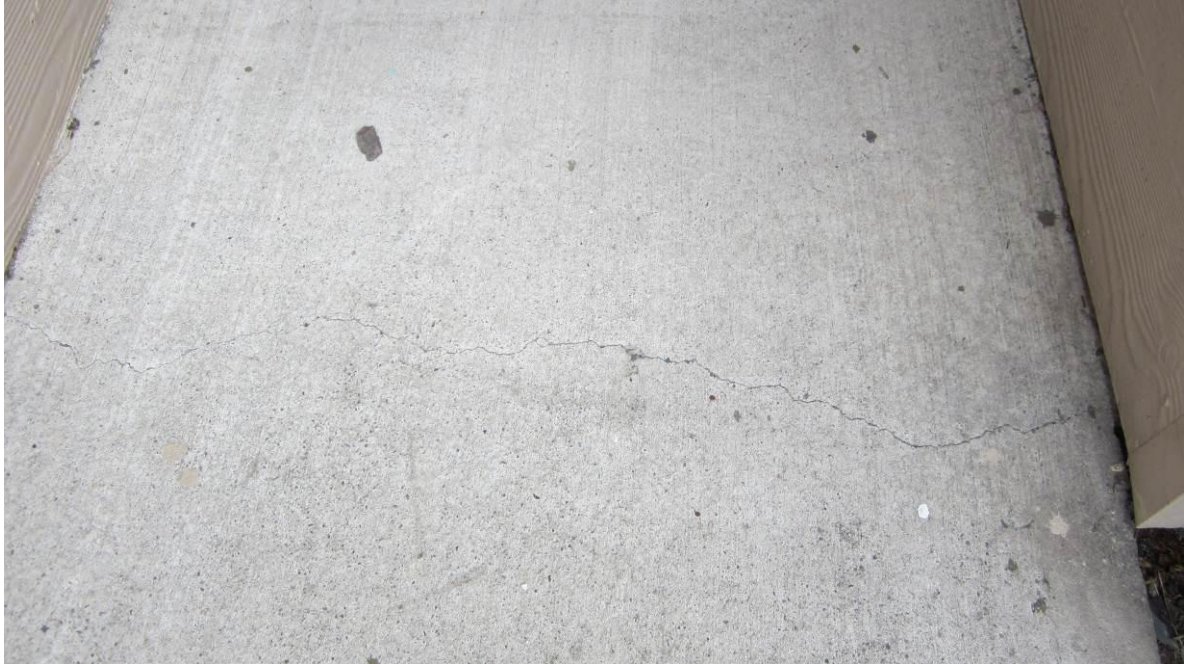
Photo 17: External pavement at entrance of under-stair storage area at rear of Block B (see Photo 16).

Damage Description: Cracking of concrete. This cracking was typical for all entrances to under-stair storage.

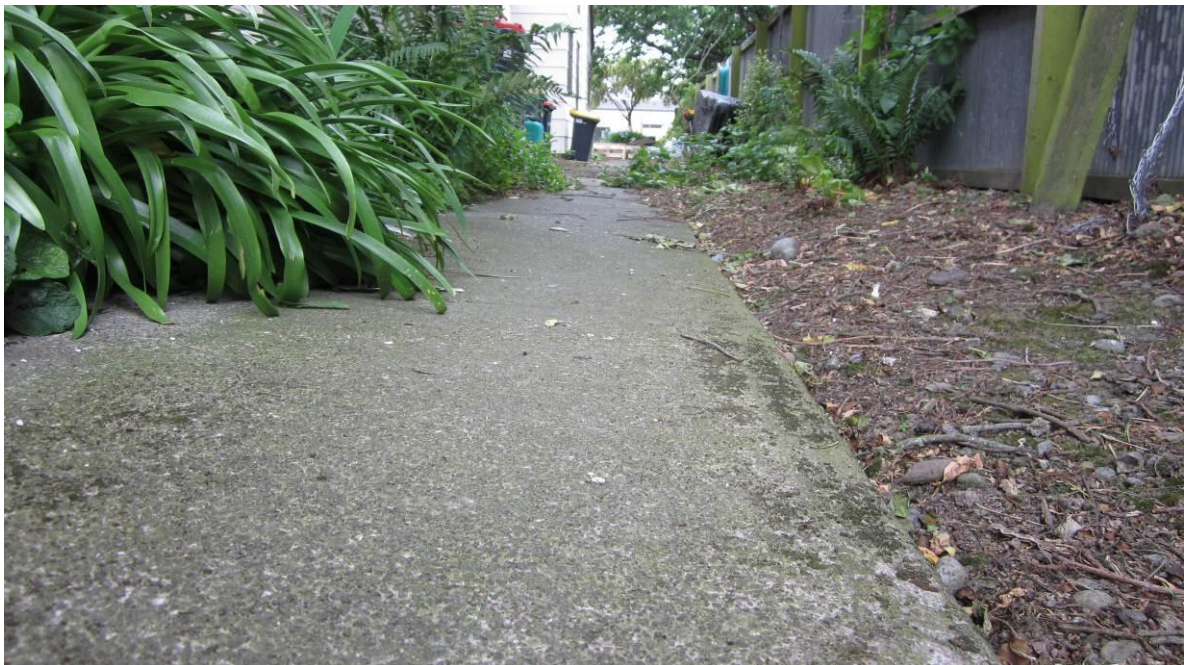
Photo 18: Sloping of external pavement at rear of Block A.

Damage Description: Differential settlement of external ground.

- A full damage assessment on both buildings is carried out for insurance purposes.
- A verticality and level survey could be carried out to determine the extent of settlement of the buildings for insurance purposes.

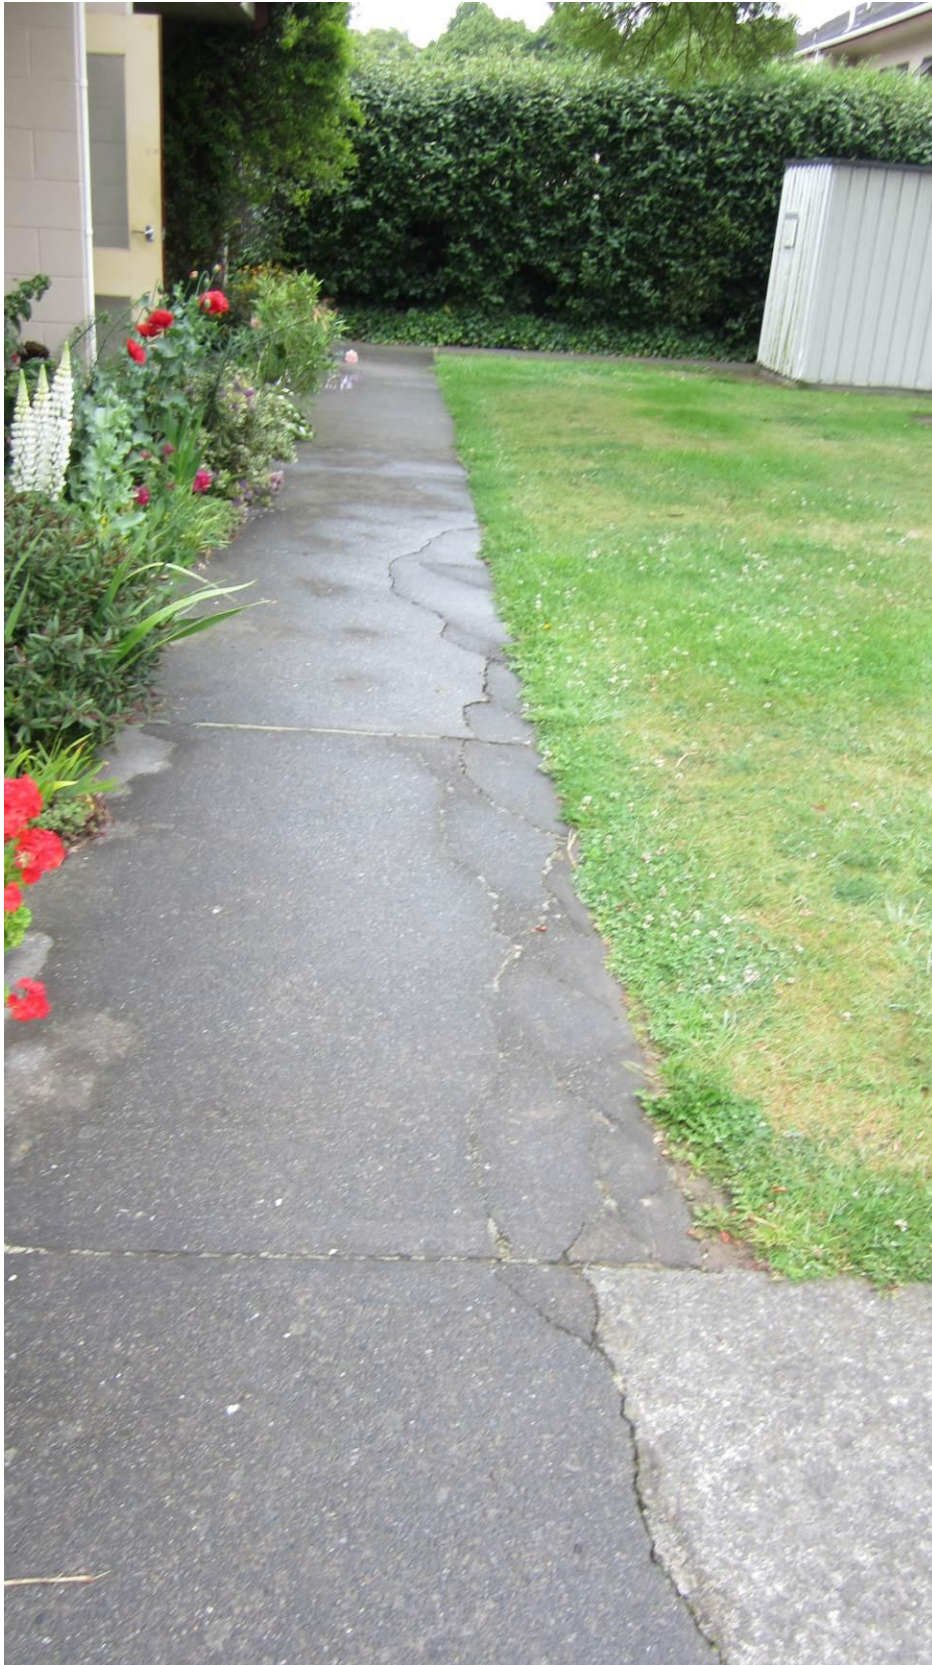
Photo 19: External pavement at front of Block A.

Damage Description: Cracking of concrete and local subsidence of ground.
