Tram Barn

BU 1221-001 EQ2

Detailed Engineering Evaluation
Quantitative Assessment Report

Date: February 2013
Reference: 6-QUCCC.64
Status: Final

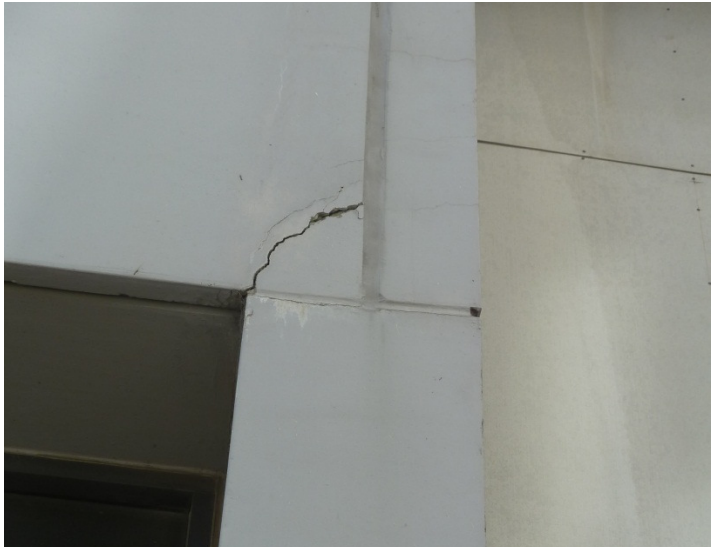
- f. The spandrels along the east face have moderate cracks up to 3 mm wide in the lower corners.
- g. Cracks between the columns and window frames along the east elevation indicate differential movement.

3.	Damage to spandrels (north east column in photo)

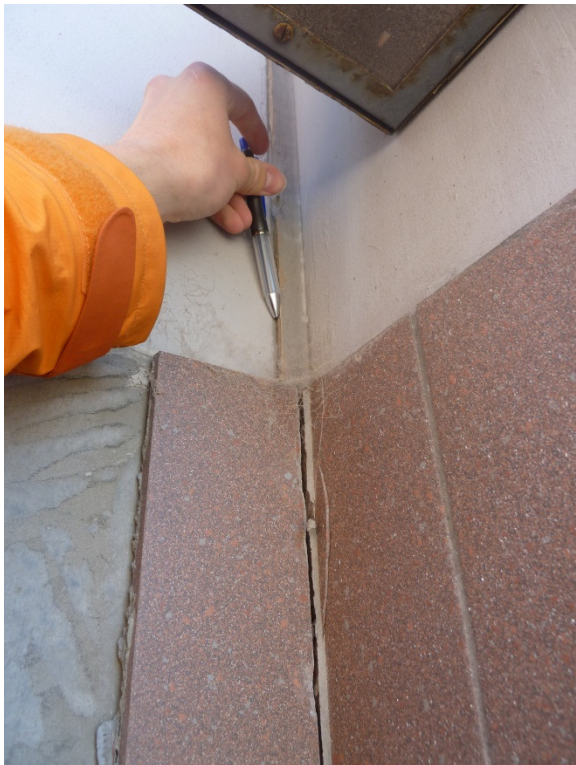
A photograph showing a vertical crack in a light-colored spandrel panel, located near the intersection of a window frame and a column.
4.	Separation of window frames from columns on east boundary

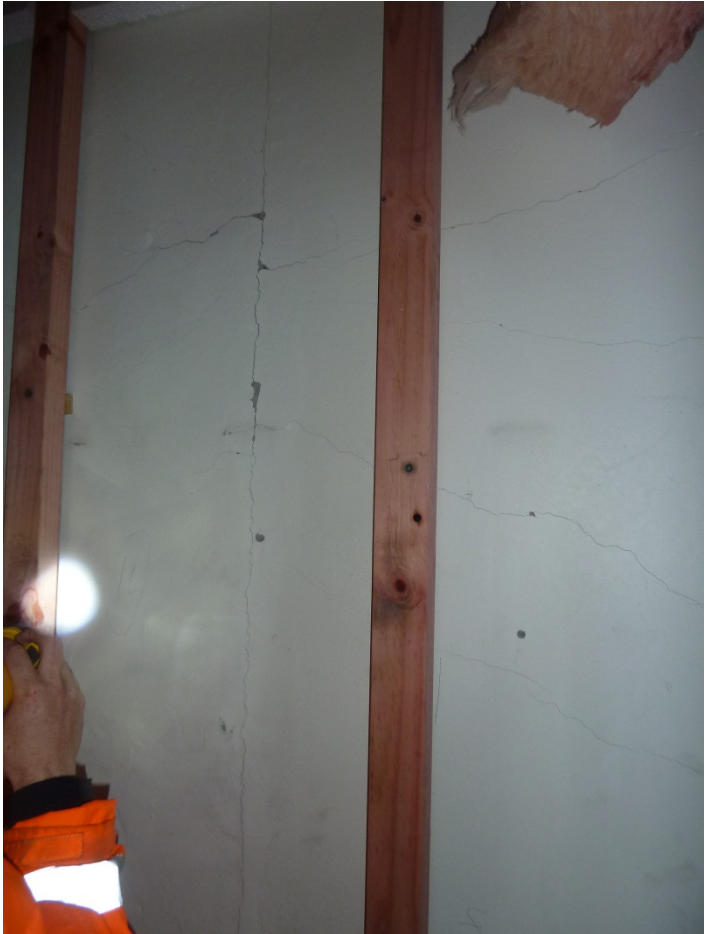
- h. Minor cracking visible in precast concrete panels along south and west boundaries.
- i. Minor horizontal cracking visible in the south-east corner column.

6.	Horizontal cracks in panels extending out from panel connection

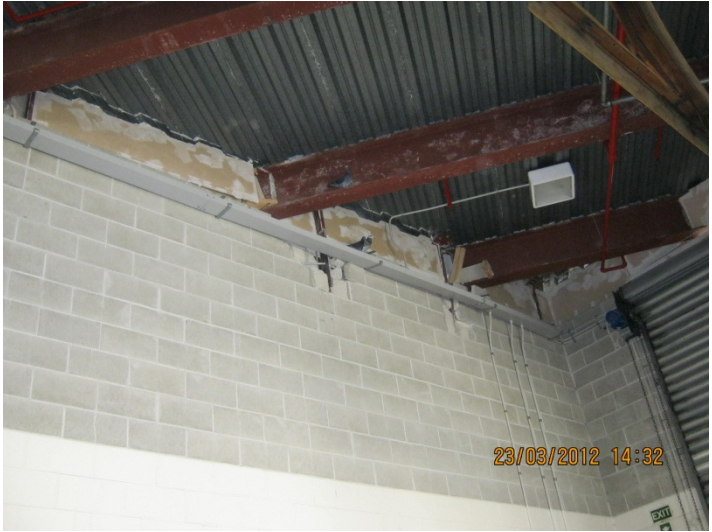
- a. The reinforced masonry wall along the north-western boundary has settled by around 50mm and has pulled the restraint fixings out of the roof level slab soffit, resulting in the wall now cantilevering from ground level. This has resulted in damage to the wall. The wall also has a number of diagonal shear cracks through it, indicative of ground movement. This masonry wall is directly behind the retaining wall forming the basement in the northern building.

The quantitative assessment results show that the primary structure has a seismic capacity of approximately 84%NBS. Building elements with a seismic capacity less than 100% NBS include the connection of the roof diaphragm to the walls, the foundation beam under the north-east wall, and the reinforced masonry wall at ground floor level along the north-west elevation. In an undamaged state the masonry wall has a capacity of 70% NBS, however the settlement of this wall relative to the piled structure has resulted in it no longer being restrained at roof level, thereby causing it to cantilever from ground level. In this condition the wall has a seismic capacity of 18% NBS.

8.	Reinforced masonry wall along the north-western boundary

Due to damage sustained to the wall it is recommended that this wall is replaced with a new wall complying with the New Building Standard. This will result in the building having a seismic capacity of 84% NBS.

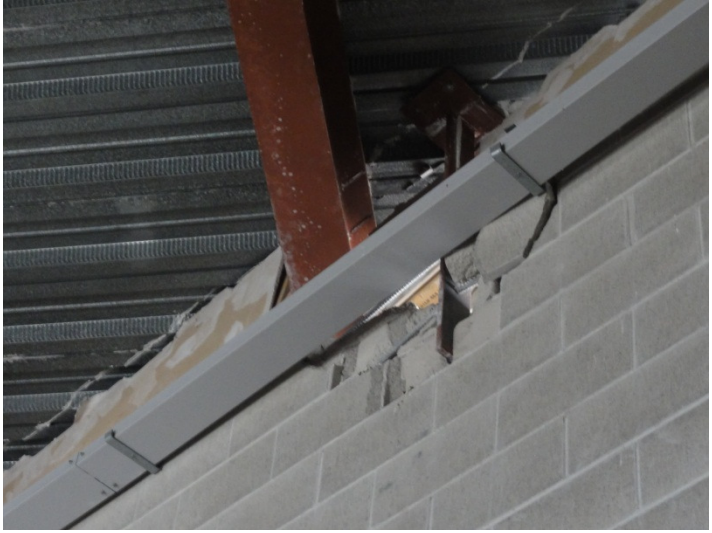
9.	Failed masonry wall restraint to roof slab

- a) The masonry wall on the north-west boundary could be propped as an interim measure. Once this wall has been propped full occupancy of the building is expected to resume subject to CERA approval.
- b) A remedial solution is investigated for the masonry wall on the north-west boundary. Once the wall is removed and replaced with a new element complying with the New Building Standard the Tram Barn will have a seismic capacity of 84% NBS.

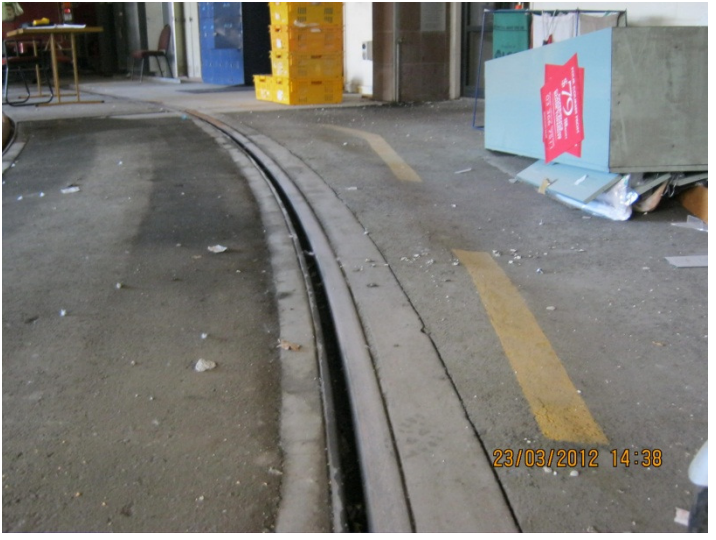
Uniform settlement has occurred to the northern masonry wall. Observations from the shallow investigations have not identified any damage to the shallow foundations. A number of remedial options may be undertaken based on whether the wall is to remain or be rebuilt. Options may include restraining the wall in its current position, re-levelling the wall, or replacing the wall.

<p>10.</p>	<p>Visible settlement adjacent to the north-western boundary wall</p>

- The selection of the most appropriate foundation option for the wall should consider the susceptibility of soils at the site to liquefy in future seismic events, occupant's safety and the economics of undertaking such remedial solution.
- Specific analysis of the foundations would be required in the detailed design phase. A dependable bearing capacity of 90 kPa is indicated for surficial soils at the site and needs to be addressed in the design of shallow foundations (if adopted), or a shallow foundation ground treatment should be considered.

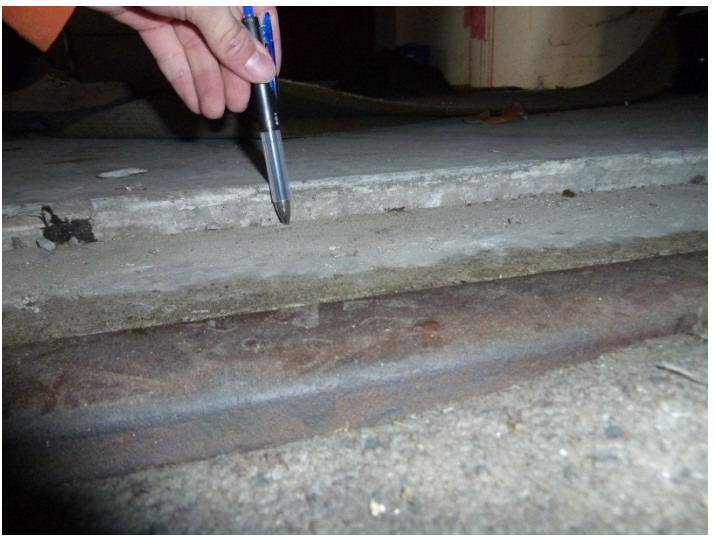
<p>11.</p>	<p>Differential settlement of slab next to service pit</p>

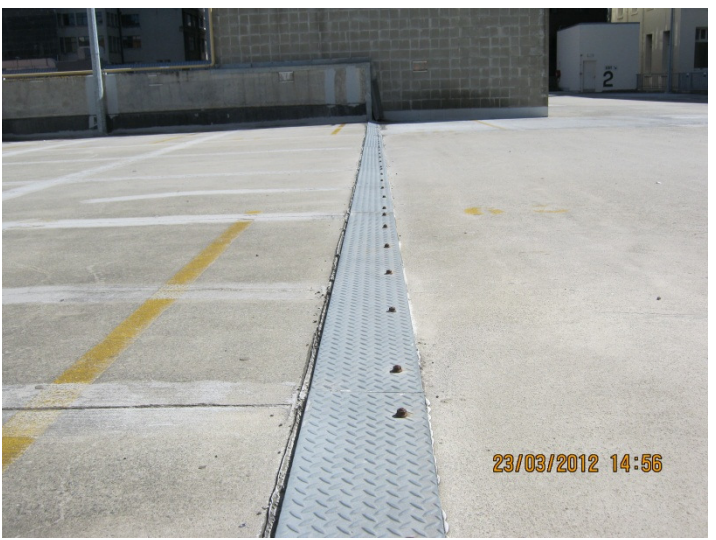
<p>12.</p>	<p>Differential settlement along the length of the seismic joint at roof level</p>

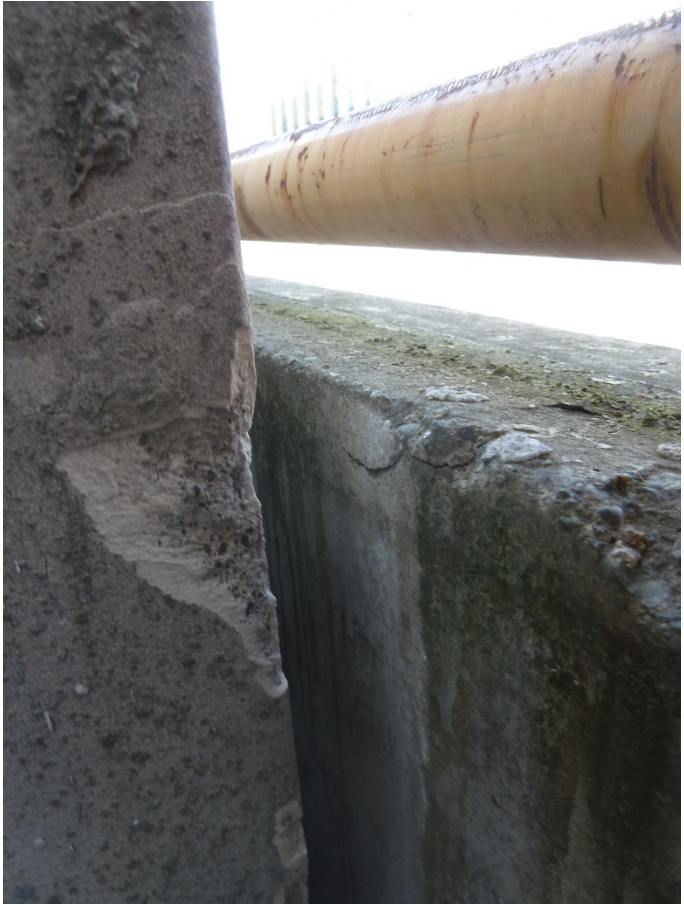
- a. There is a 50mm separation between the Tram Barn building and the six storey building to the west. There is evidence of pounding having occurred between the adjacent building and the roof parapet on the Tram Barn building.
- b. The carpark building immediately to the north has settled around 40mm relative to the southern building, and has also moved slightly towards the north. This movement has opened up the seismic joint, which is now leaking some water into the ground floor area below.
- c. Some water appears to be leaking through the roof slab and onto the precast beams, however the extent of this prior to the earthquakes is unknown.

- Guidance from NZSEE 2006 suggests that for buildings of similar height where floor levels are aligned, pounding effects are considered to be insignificant, and will generally result in some local damage, mostly non-structural and nominal structural. Local damage to the floor slabs could adversely affect floor slab performance if it results in damage or loss of post tensioning anchorage. This effect can be addressed during the strengthening phase.

14.	Pounding damage between the roof parapet and the building to the west

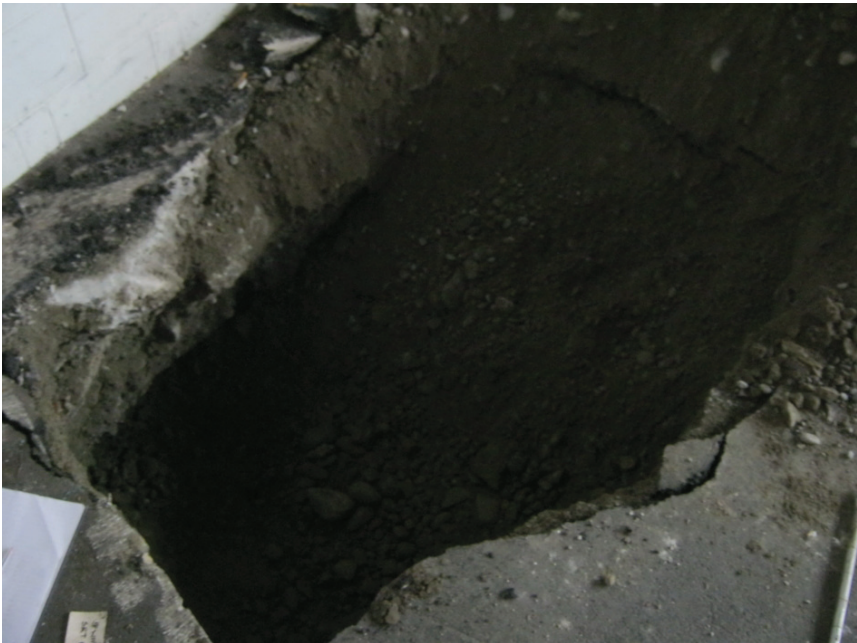
NOTES No oserved damage to the foundations.	LOGGED B.Barnett	DATE EXCAVATED 27/07/2012	
	OPERATOR N/A	EXCAVATOR 6 Tonne	
	CLIENT Chrstchurch City Council	JOB No. 6-QUCCC.64	TP1
	Guideline for the field classification of soil and rock for engineering purposes: NZ Geotechnical Society (2005) Determination of penetration resistance of a soil, NZS 4402 : 1988, Test 6.5.2 Shear strength using a hand held shear vane: NZ Geotechnical Society (8/2001)

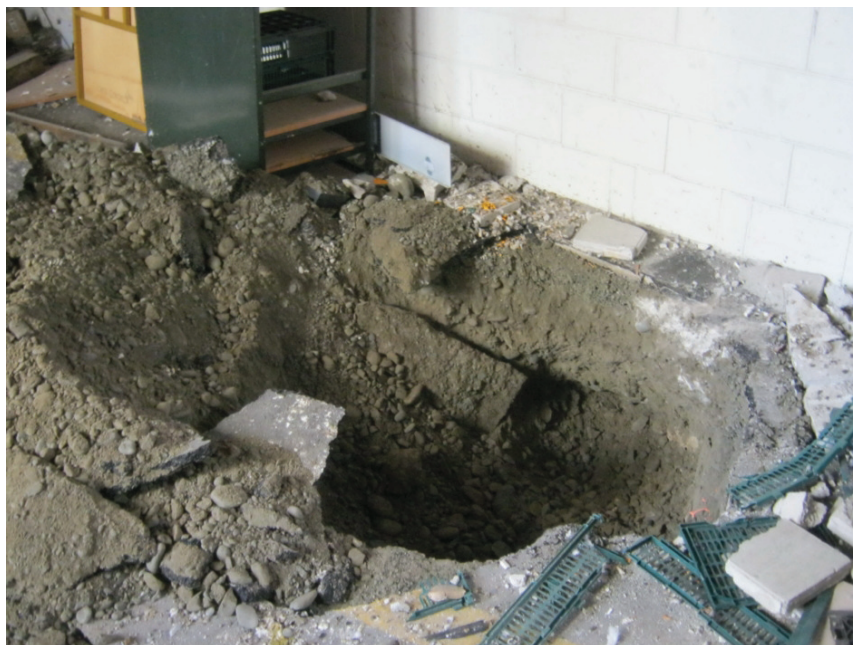
No observed damage to the foundations.
