CHRISTCHURCH CITY COUNCIL
PRK_2347_BLDG_002 EQ2
Travis Wetland Barn & Dairy Unit
280 Beach Road, Burwood

QUALITATIVE ASSESSMENT REPORT

- Rev B
- 24 September 2013

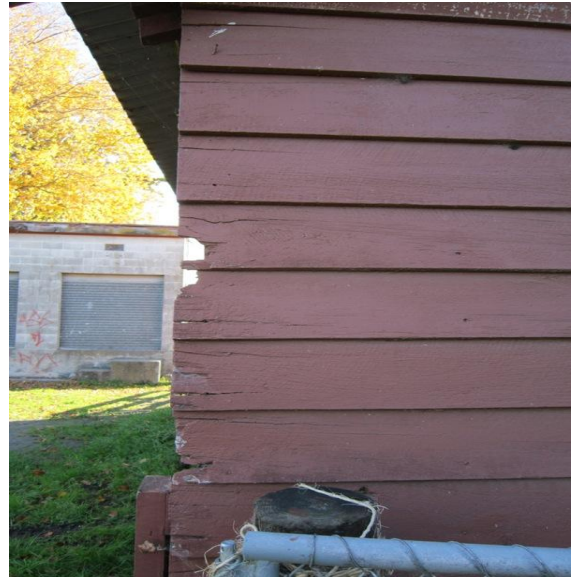
Photo 14: Existing impact damage to timber weatherboards on southeast corner.

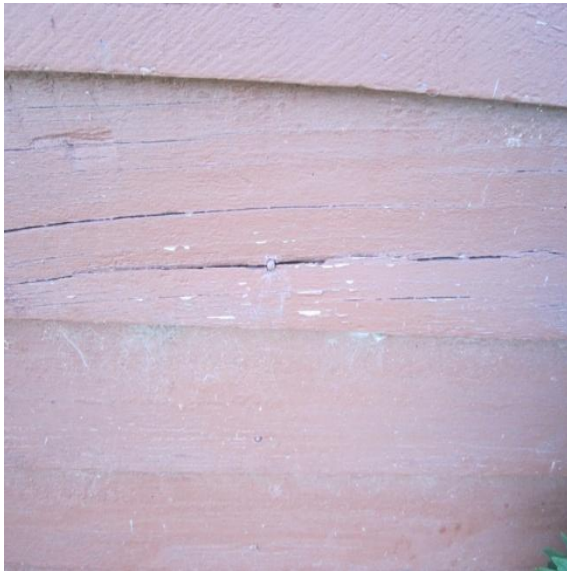
Photo 15: Cracking to timber weatherboards on east wall.

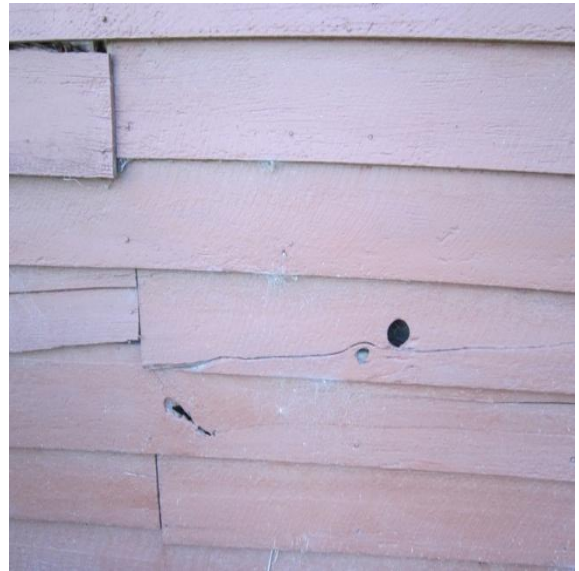
Photo 16: Cracking to timber weatherboards on east wall.

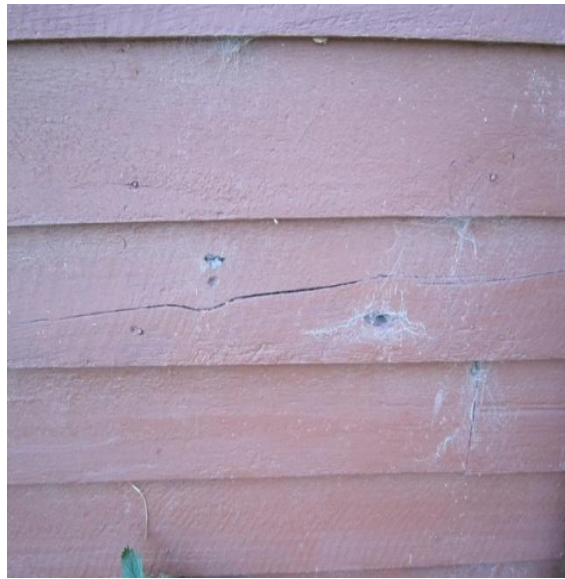
Photo 17: Cracking to timber weatherboards on east wall.

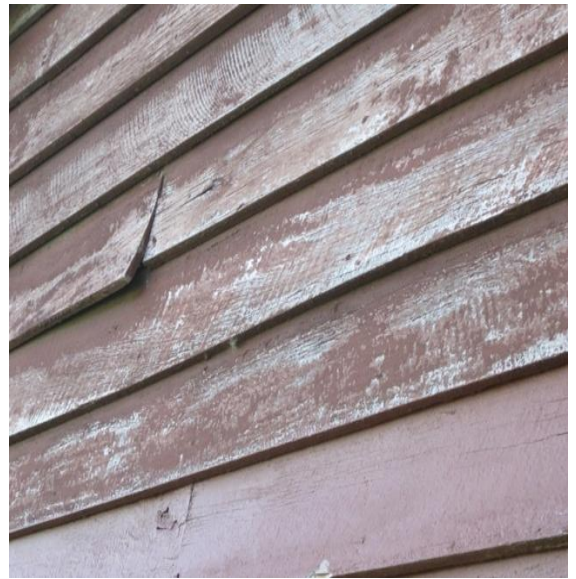
Photo 18: Bowed weatherboards on east timber wall.

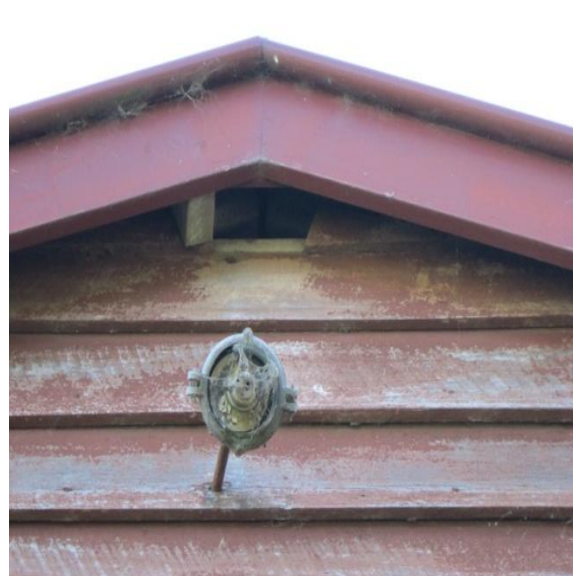
Photo 20: Missing weatherboards at roof apex on east wall.

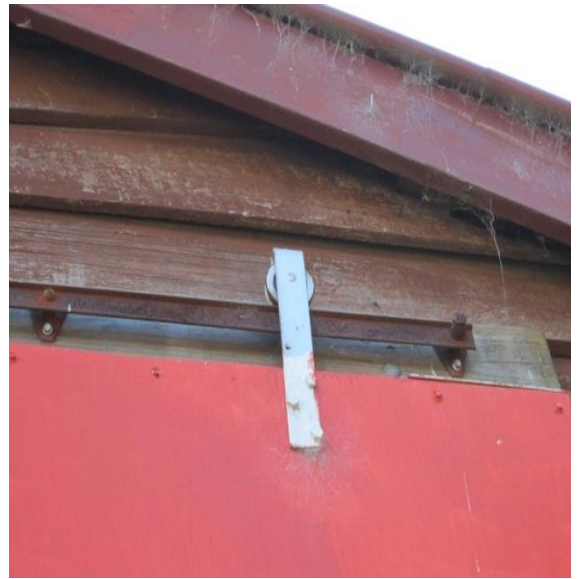
Photo 22: Rusted steel elements of building.

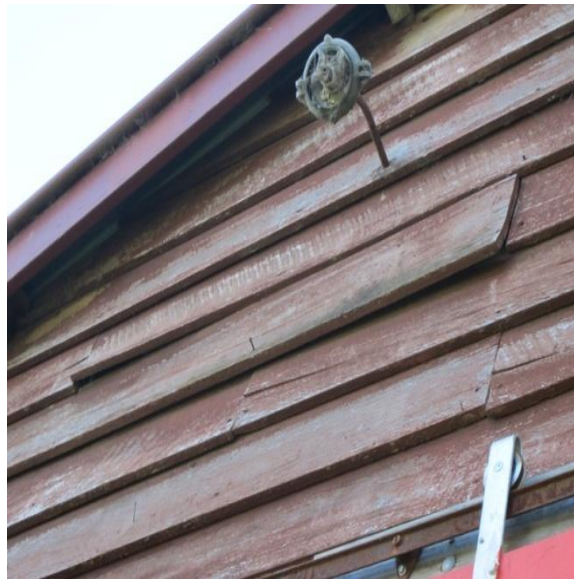
Photo 23: Bowed weatherboards on east timber wall.

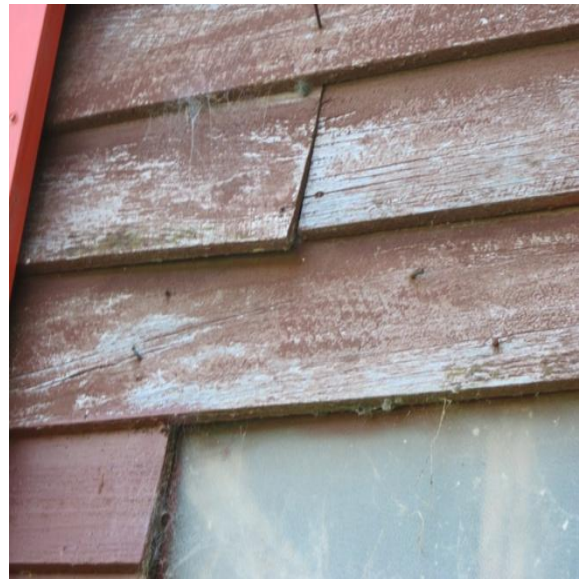
Photo 24: Bowed weatherboards on east timber wall.

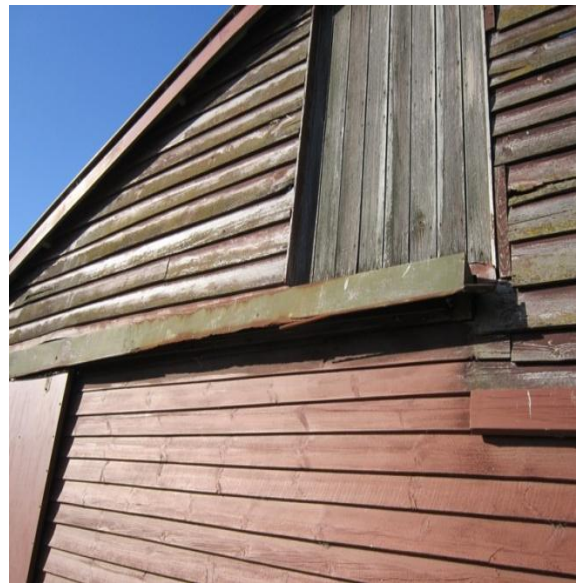
Photo 36: Rusted roller door elements on west wall.

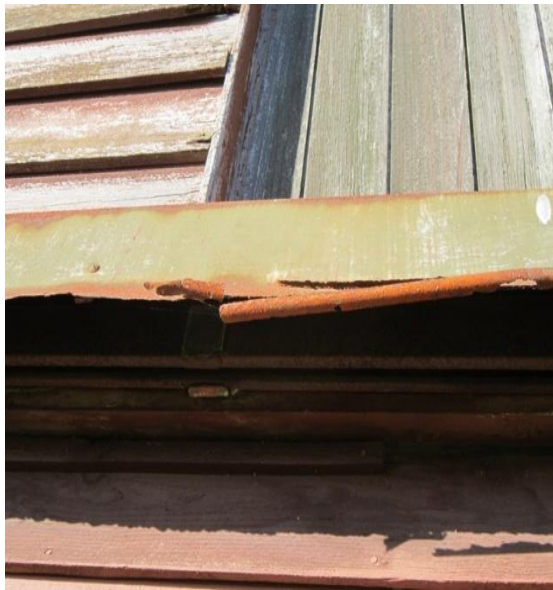
Photo 37: Rusted roller door elements on west wall.

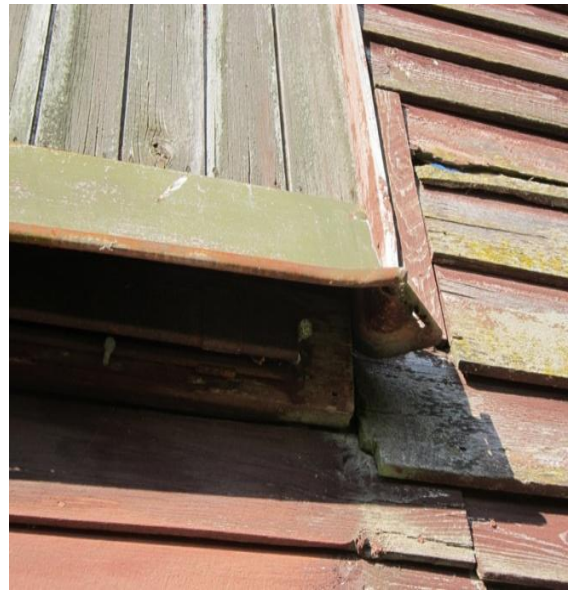
Photo 38: Rusted roller door elements on west wall.

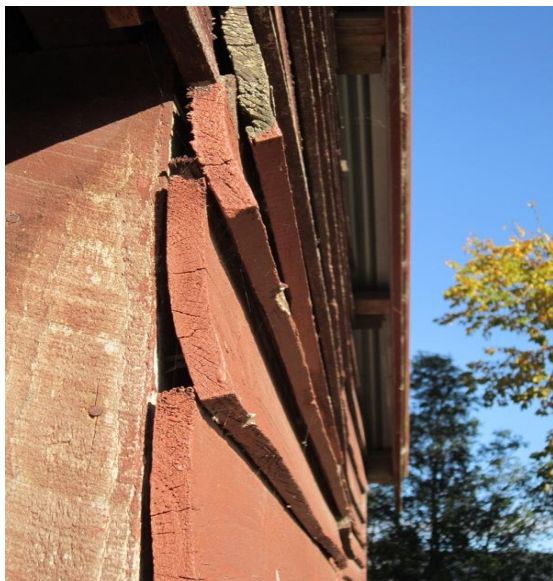
Photo 39: Bowed weatherboards on west wall.

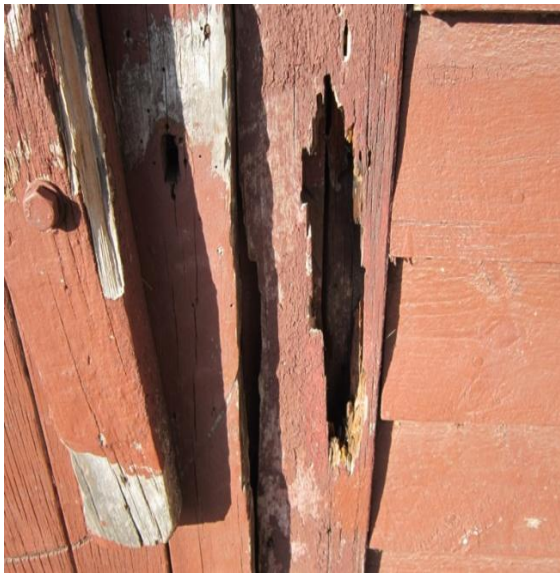
Photo 43: Existing damage to timber members on west wall.

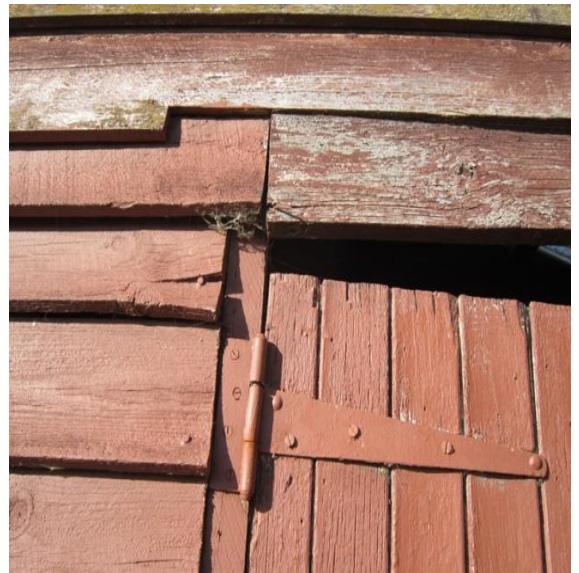
Photo 44: Cracking of timber weatherboards on west wall by door.

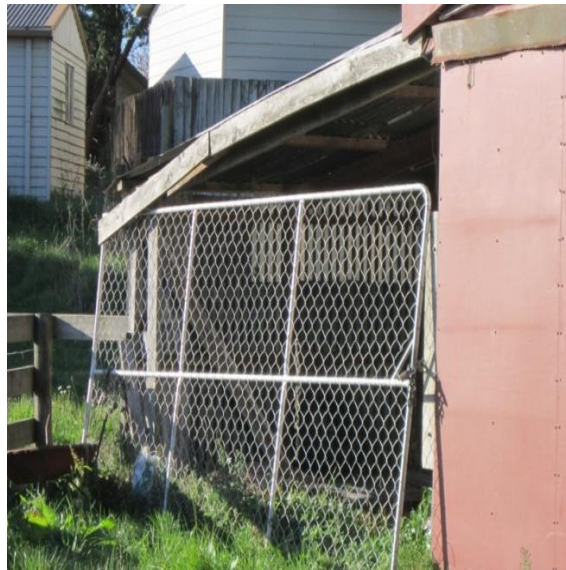
Photo 45: Displaced timber roof beam over west entrance to northern extension.

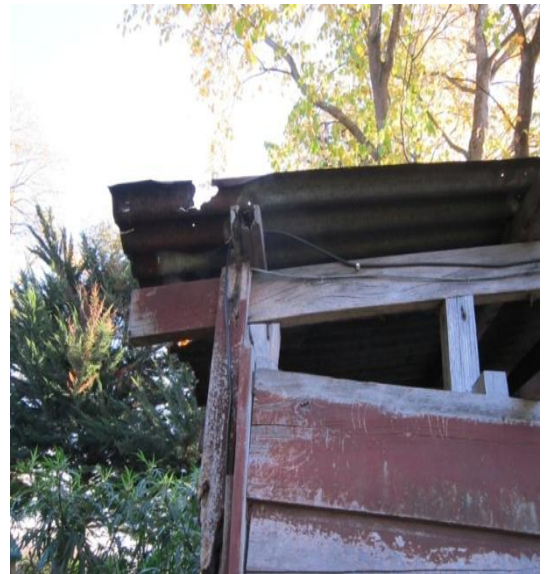
Photo 12: Lean-to on the south of the building with corroded metal roof sheeting.

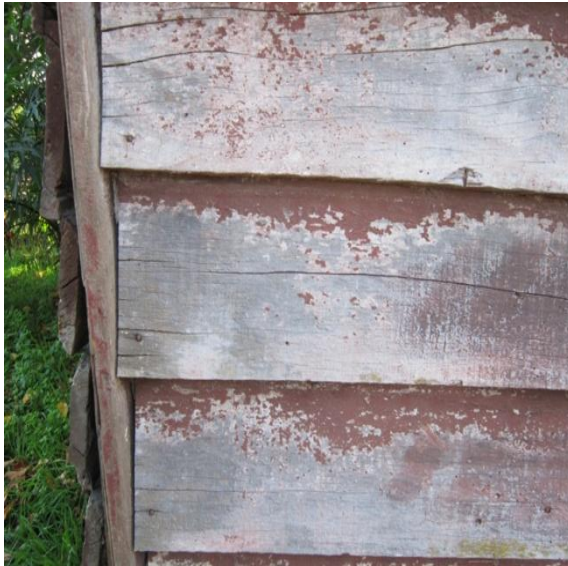
Photo 13: Cracking in timber weatherboards on south lean-to.

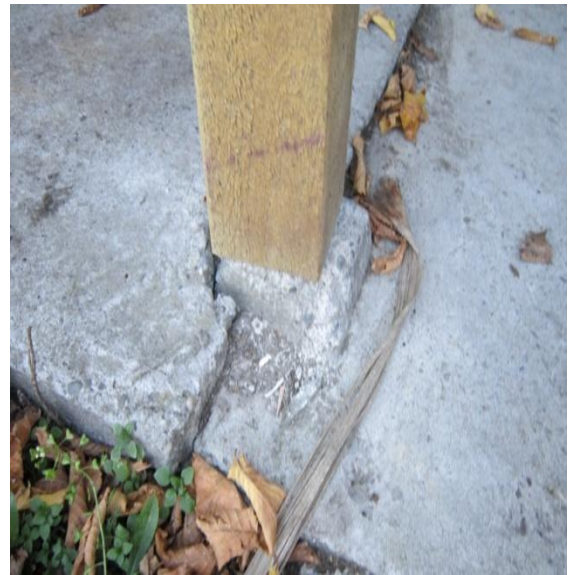
Photo 16: Base of timber column on east side appears to have no fixed shear connection to the concrete ground slab.

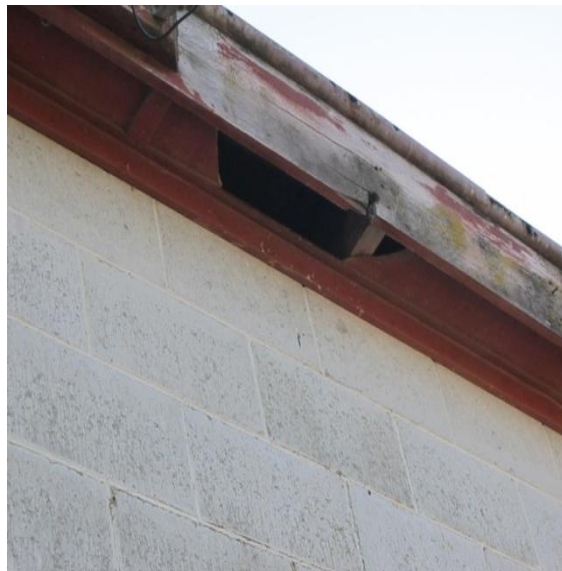
Photo 27: Soffit element missing on north side.

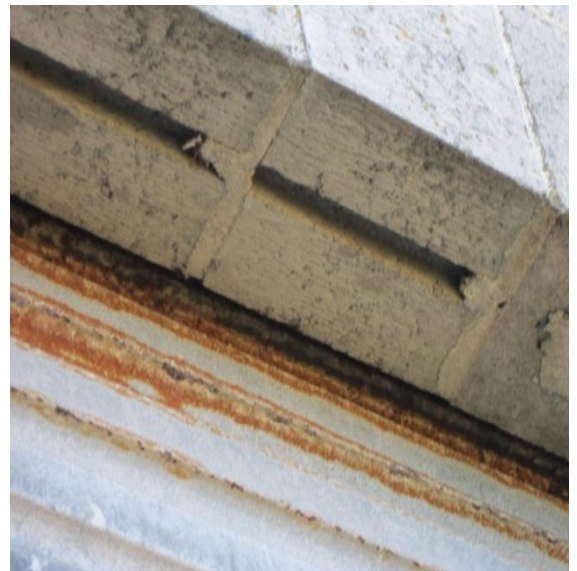
Photo 28: Roller door on east side has rusted.

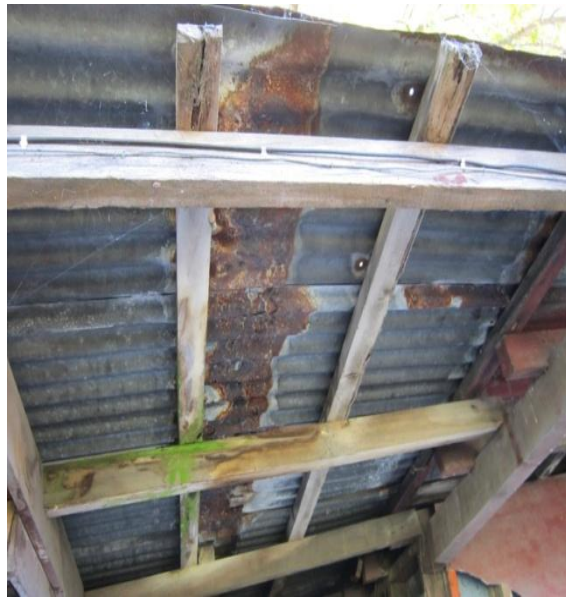
Photo 29: Rusted corrugated roof sheeting on south lean-to.

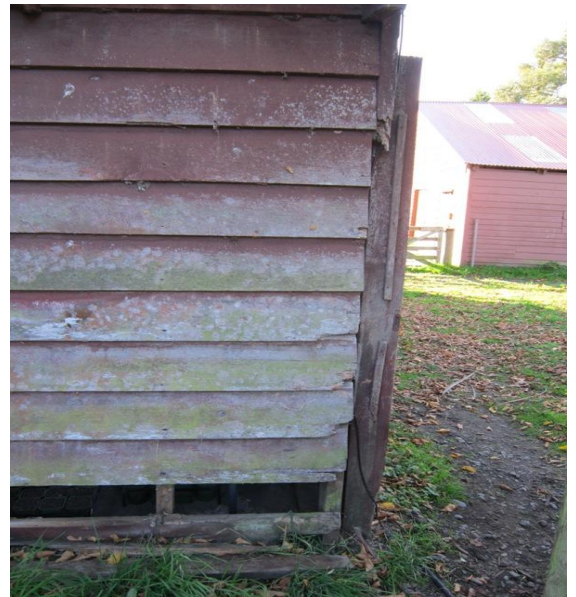
Photo 30: Missing weatherboard on south side of south lean-to.

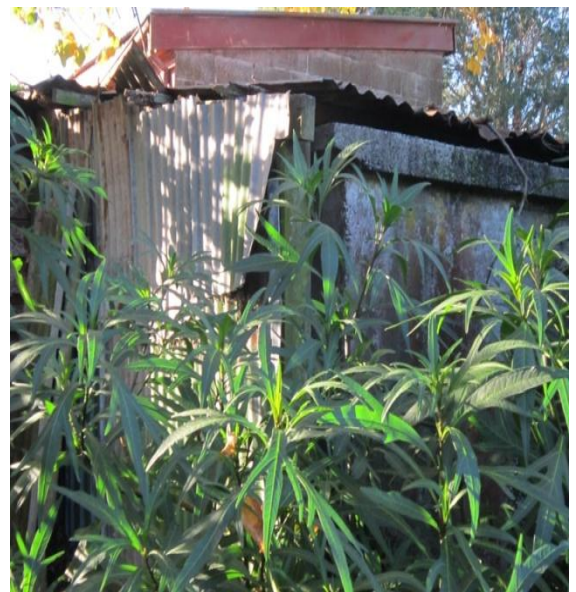
Photo 32: Deflected corrugated wall sheeting on south lean-to.

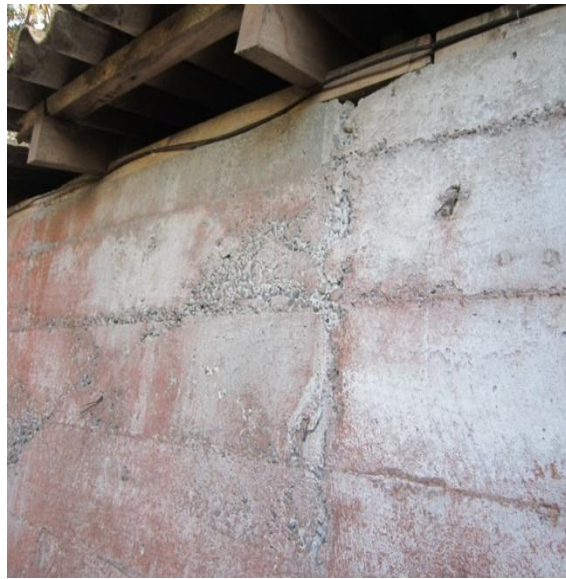
Photo 37: Spalling of south concrete wall due to large aggregate sizes. Timber roof elements also shown.

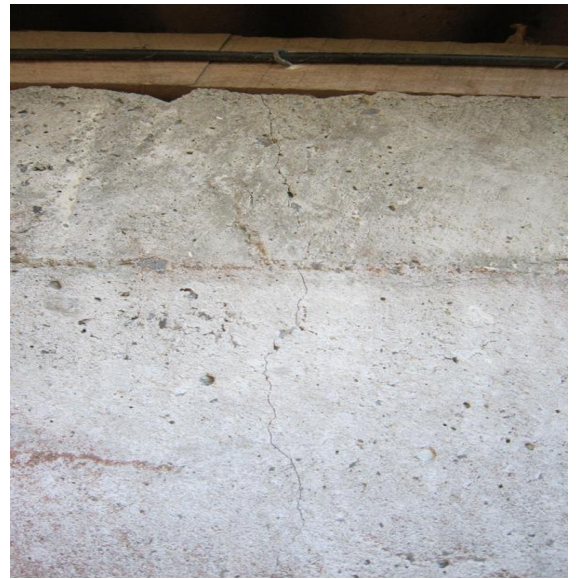
- 1) Hairline crack in the south concrete wall.
- 2) Corroded roof sheeting was noted on the southeast side of the building, but this is not earthquake-related damage.
- 3) Missing soffit elements on the north side was noted, but this is not believed to be earthquake-related damage.
- 4) Spalling from the concrete wall on the south and west of the building was noted, but this is due to the large aggregate size in the concrete and is not earthquake-related damage.

Photo 38: Vertical hairline crack on south concrete wall.

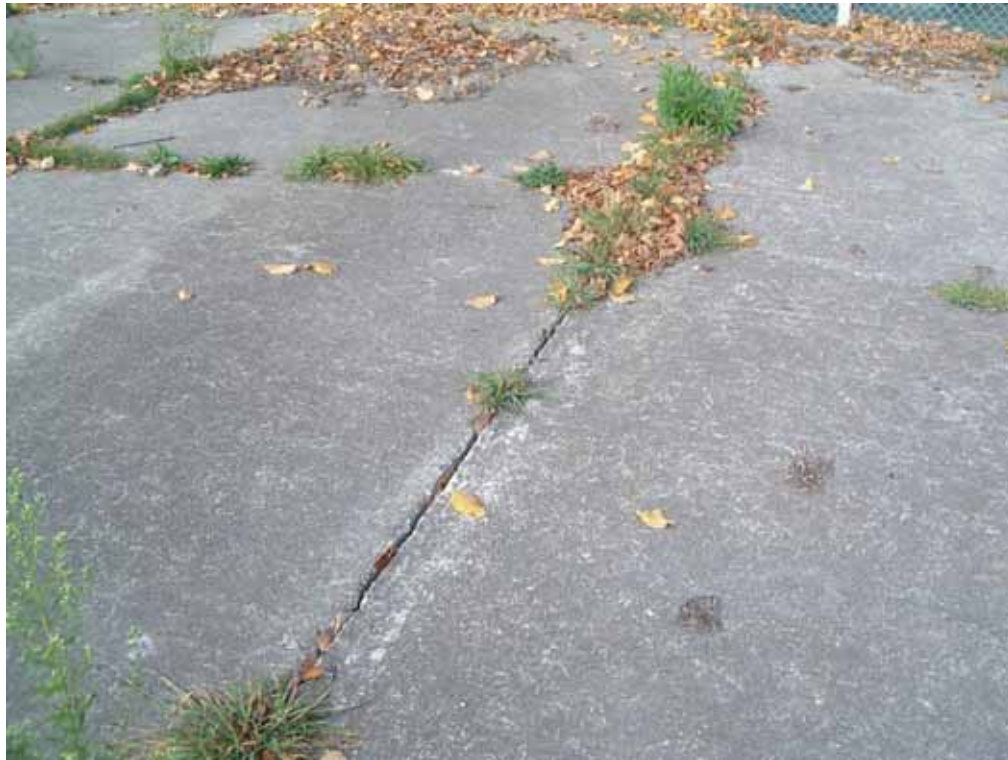
■ **Figure 16 - Noted damage to the concrete paving**

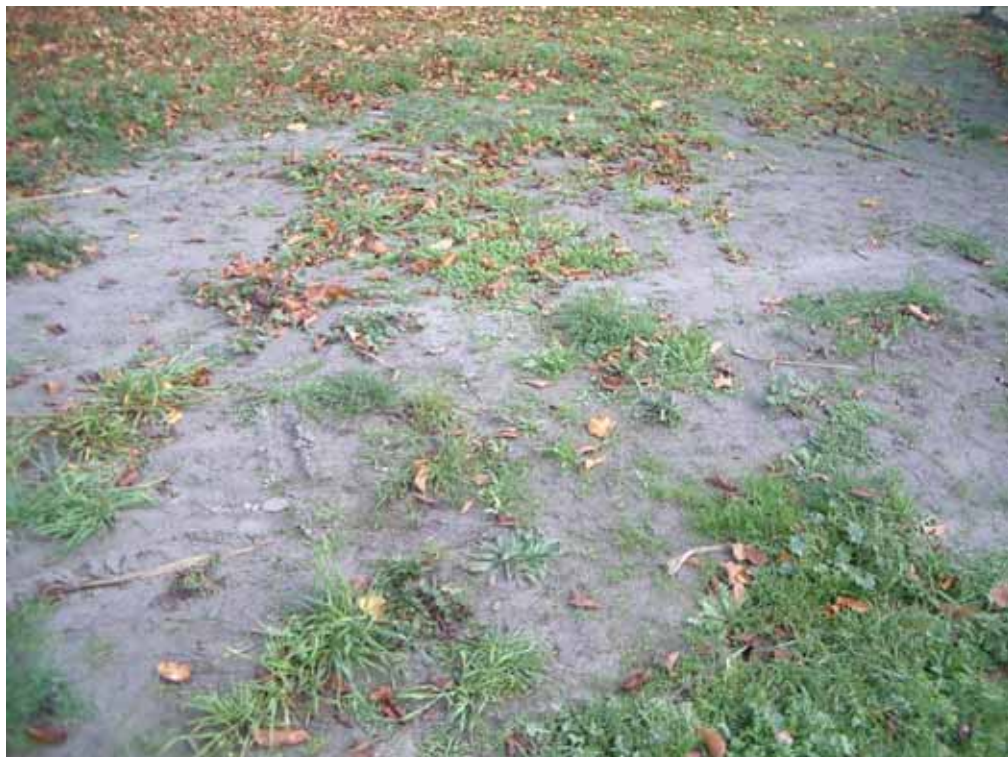
■ **Figure 17 - Ejected sand**
