CHRISTCHURCH CITY COUNCIL

PRK_2347_BLDG_005 EQ2

Travis Wetlands – Bird Hide

QUALITATIVE ASSESSMENT REPORT

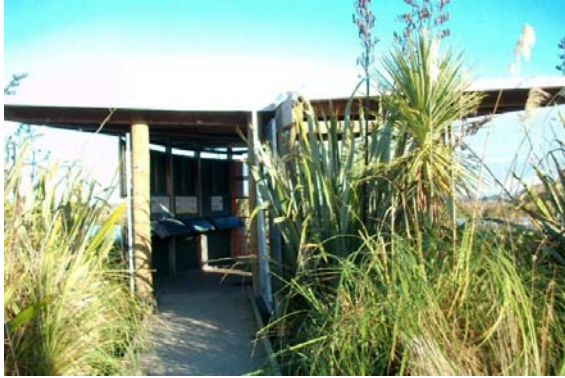
Photo 1: Bird Hide – Eastern Elevation

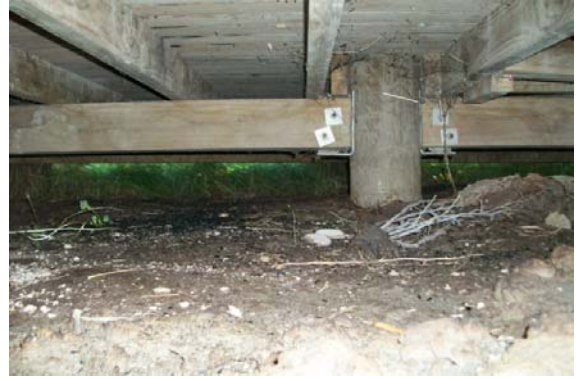
Photo 2: Foundation Details

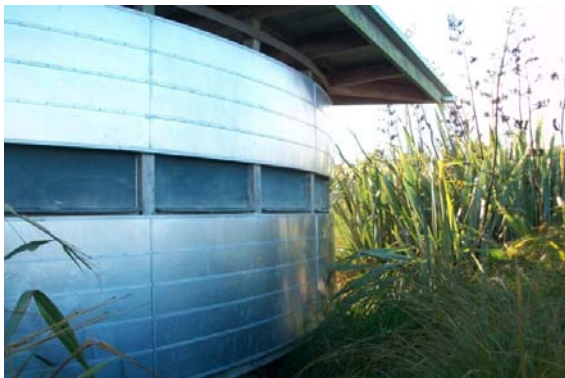
Photo 3: Typical Wall Cladding

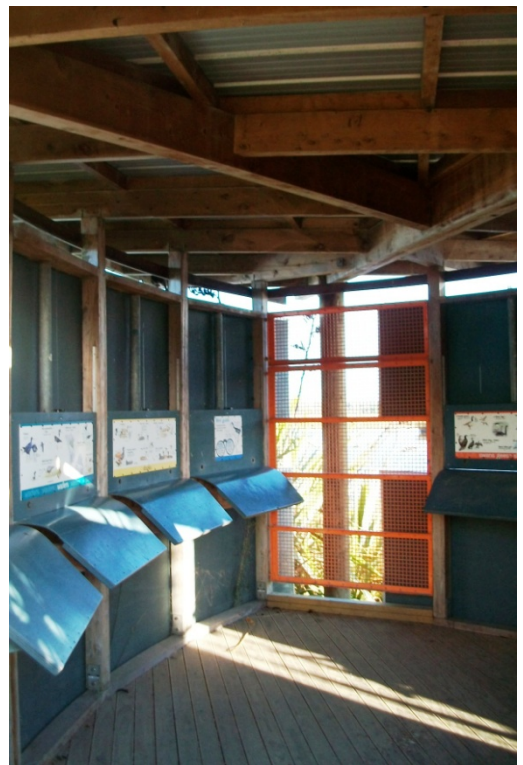
Photo 4: Internal View

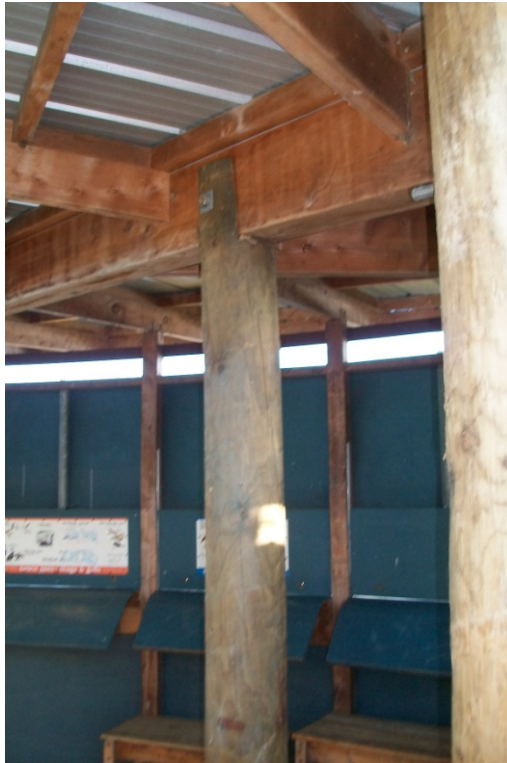
Photo 5: Internal Column

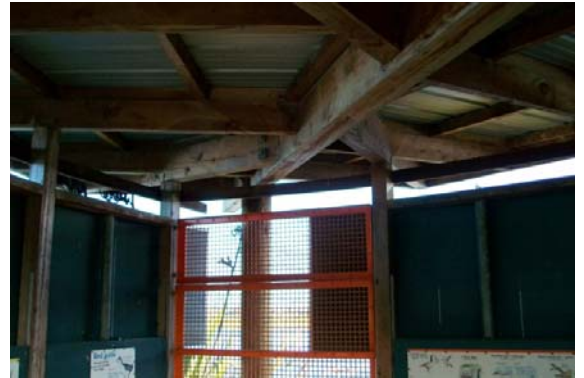
Photo 6: Roof Structure

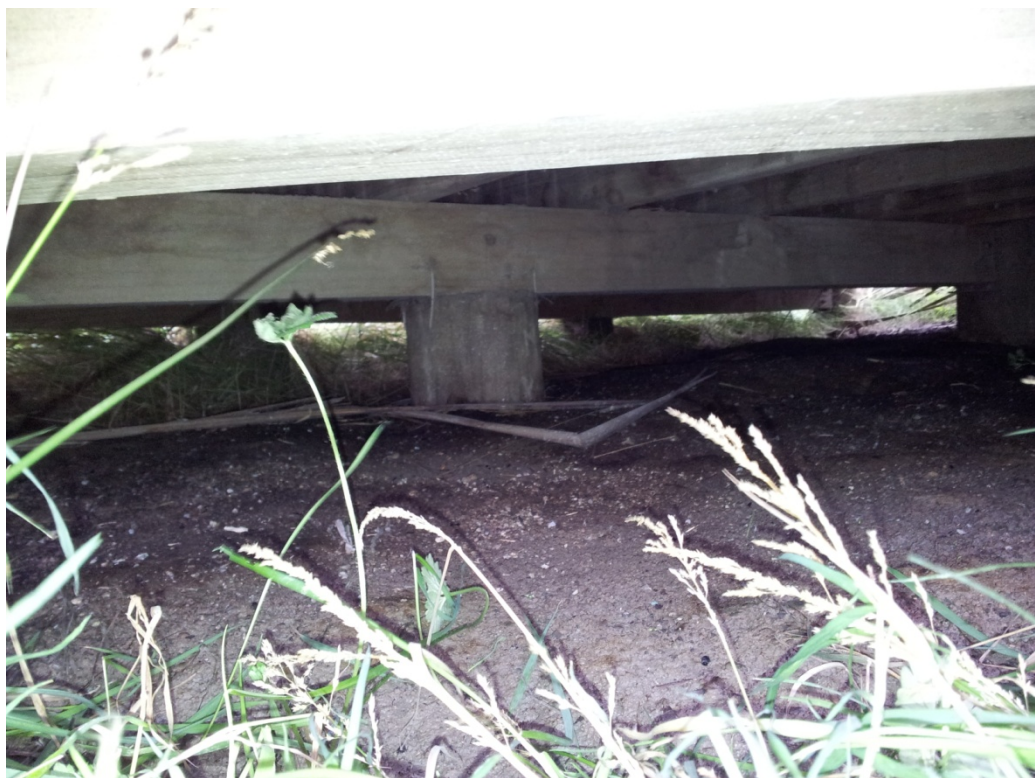
■ **Figure 13 – Foundation details of the bird hide**
