Tulett Park Toilet
Qualitative Engineering Evaluation

Functional Location ID: PRK 0394 BLDG 001

Address: 99 Claridges Road

Date: 4 July 2013

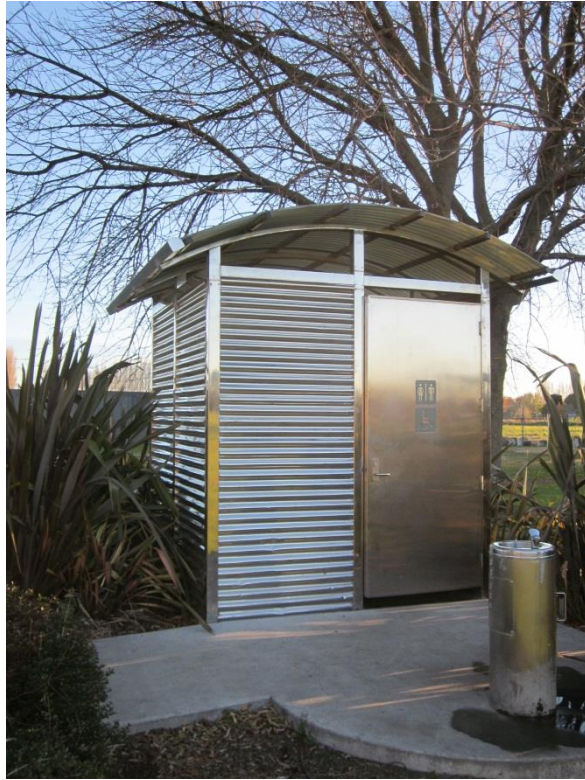
Northern elevation of the Tulett Park Toilet.

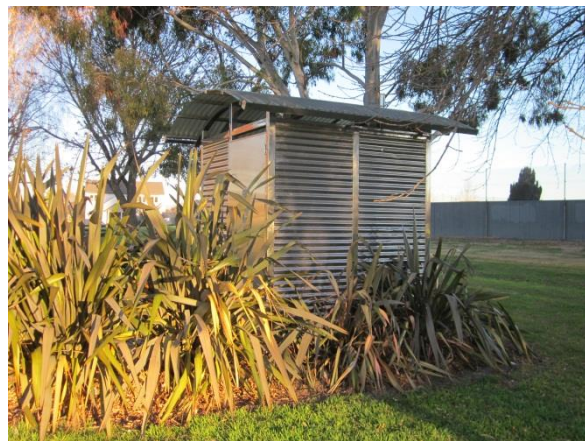
Western elevation of the Tulett Park Toilet.

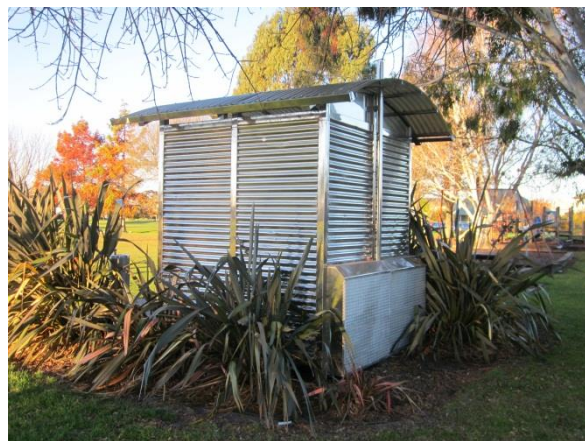
Southern elevation of the Tulett Park Toilet.

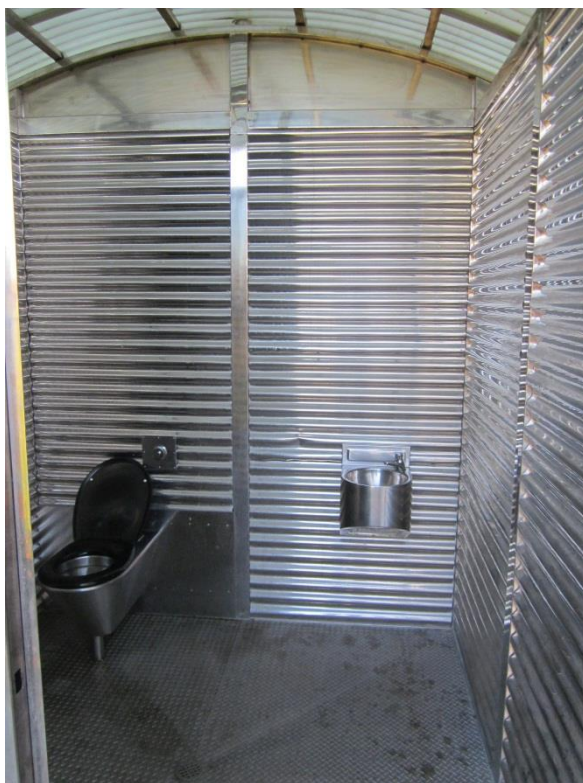
Internal view of the Tulett Park Toilet.

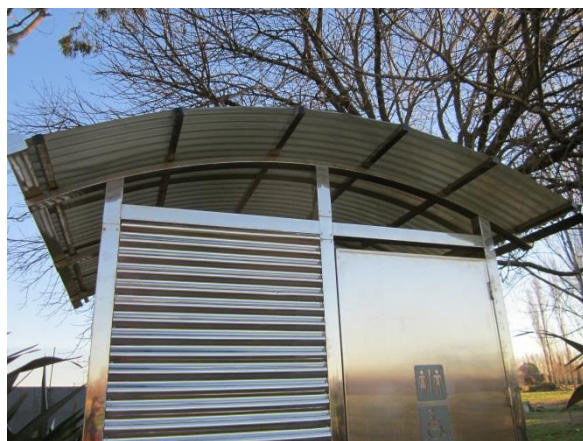
Detail of wall and roof.

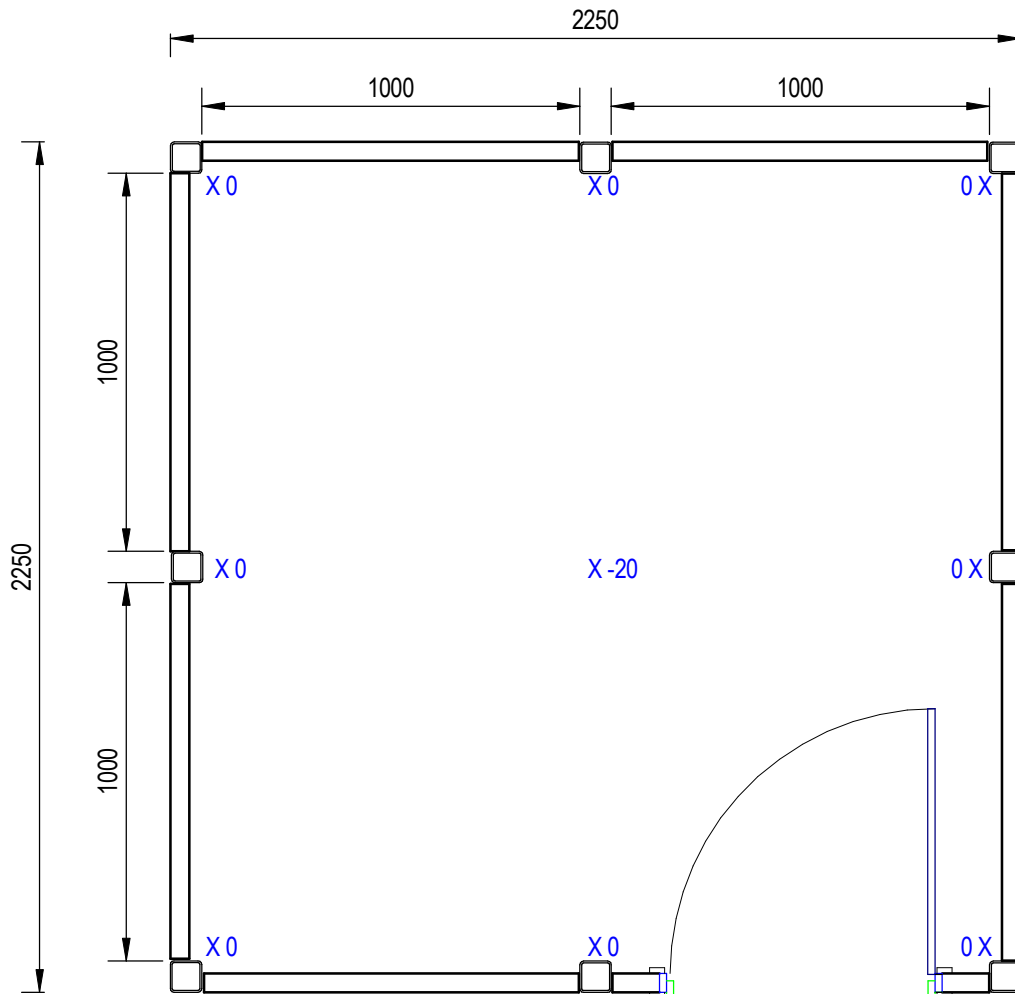
PROJECT
TULETT PARK TOILETS
TITLE
LEVEL SURVEY

A floor level survey was undertaken to establish the level of unevenness across the floors. The results of the survey are presented on the attached sketch in Appendix A. All of the levels were taken on top of the existing floor coverings which may have introduced some margin of error.

The floor levels for the Tulett Park Toilet were found to be within the recommended tolerances with the only slope in the floor being for drainage purposes.
