Toilets Upper Riccarton Domain
PRK 0236 BLDG 005 EQ2
Detailed Engineering Evaluation
Quantitative Report
Version FINAL

92 Yaldhurst Road, Upper Riccarton

Christchurch City Council

Date
15 March 2013

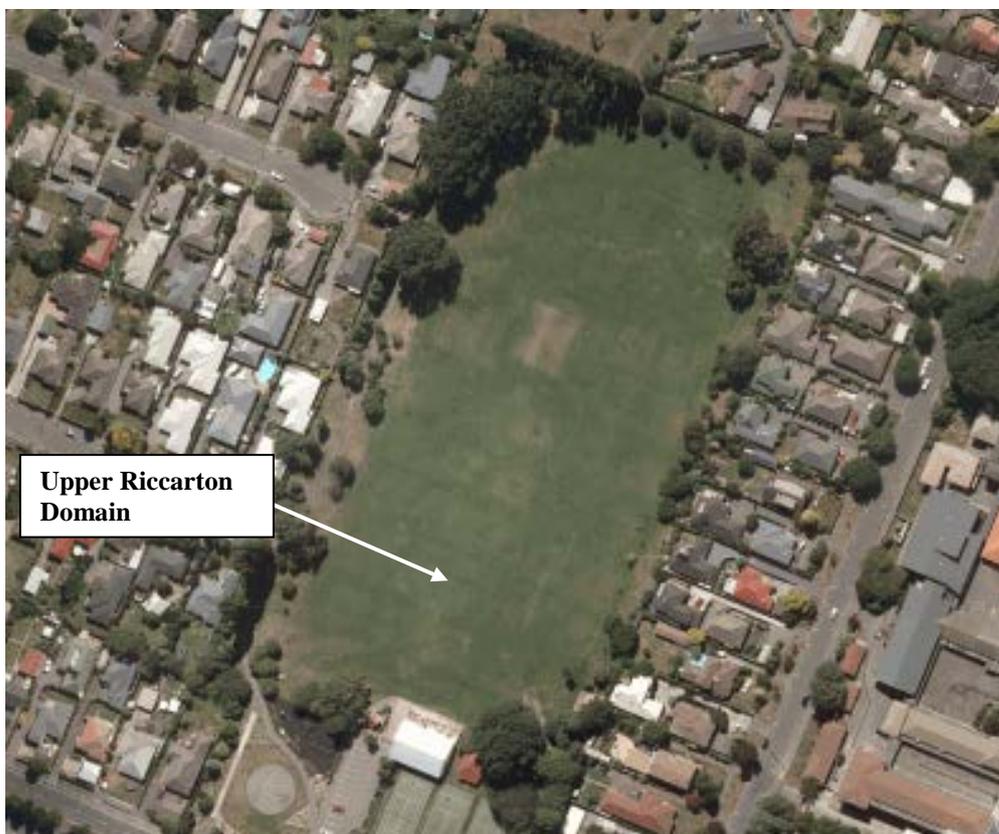
Figure 5 Post February 2011 Earthquake Aerial Photography³

Aerial photography taken following the 22 February 2011 earthquake shows no signs of liquefaction outside the building footprint or adjacent to the site, as shown in Figure 5

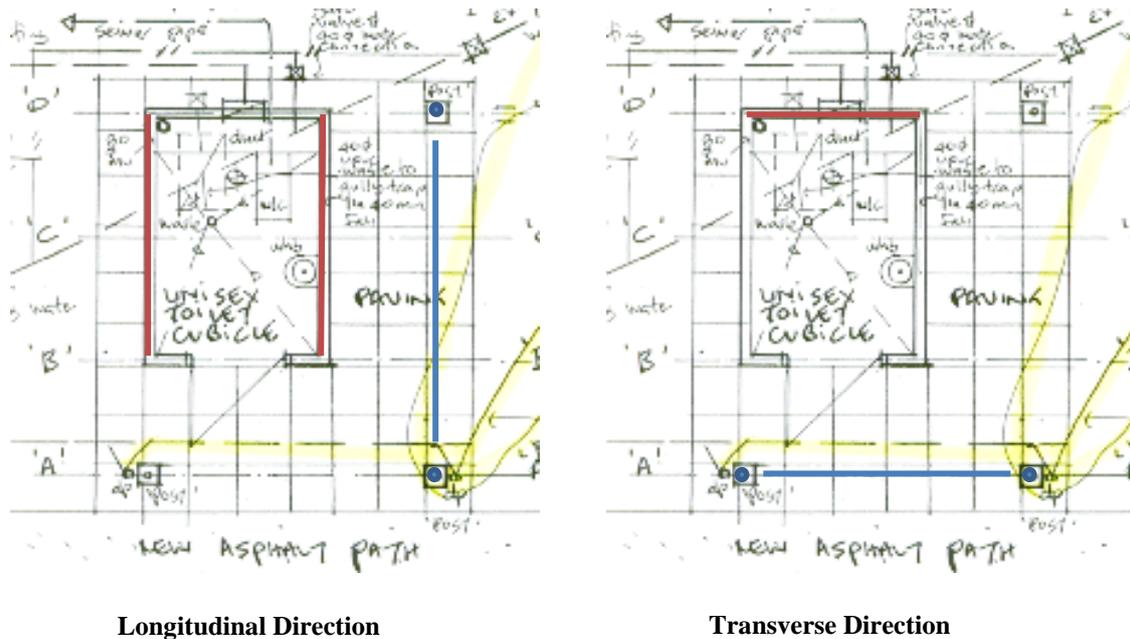
Figure 6 Bracing Elements as considered for both directions

The longitudinal and transverse directions were considered separately. The Bracing Elements providing lateral restraint in each direction are shown below in Figure 6. The **timber frame wall panels** are shown in red, and the **steel tube portal frames** are shown in blue.

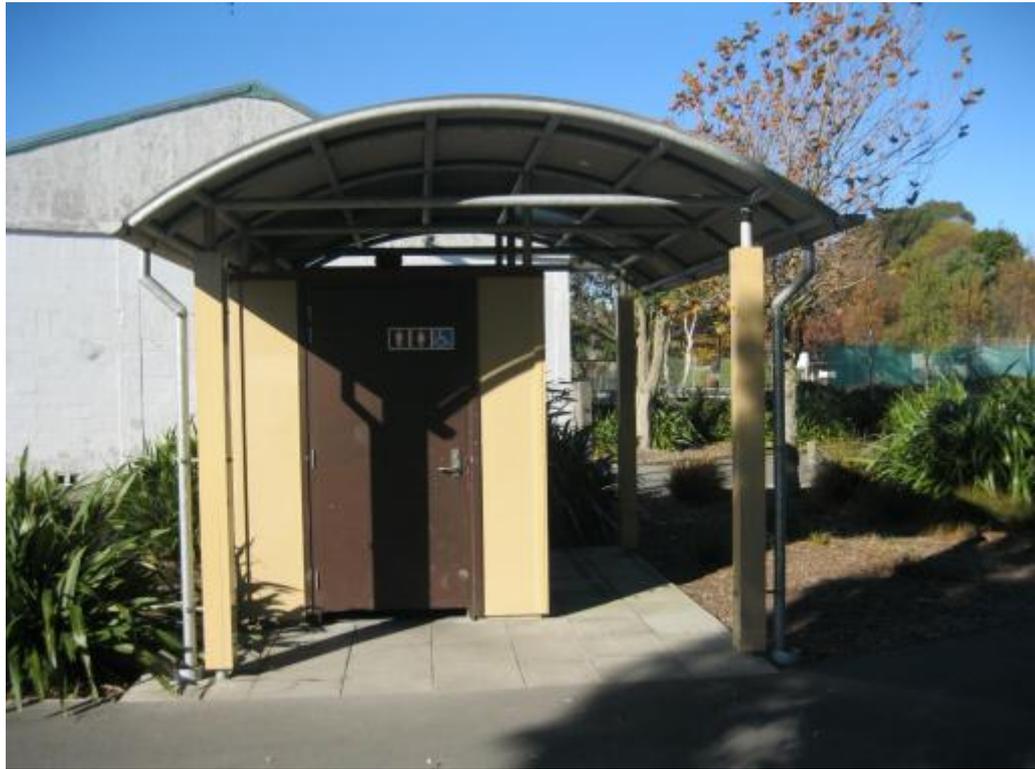
Photo 1. View of toilets from the northwest.

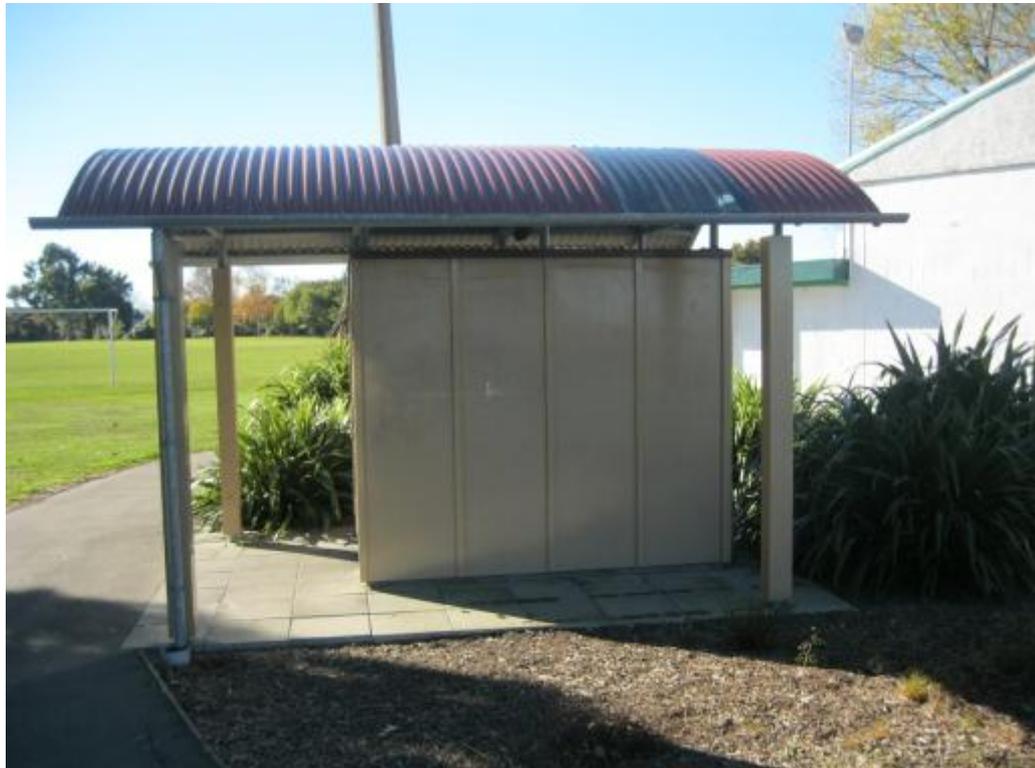
Photo 2. View of toilets from the southwest.

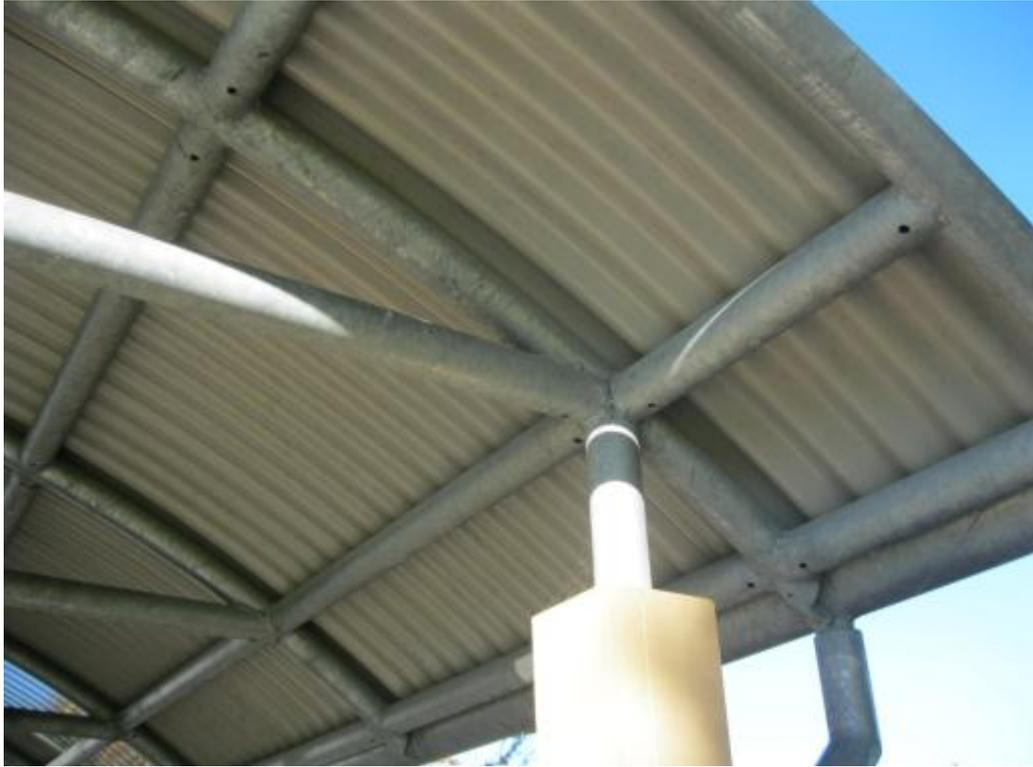
Photo 3. Rigid frame formed from fixed connections of steel tubes.

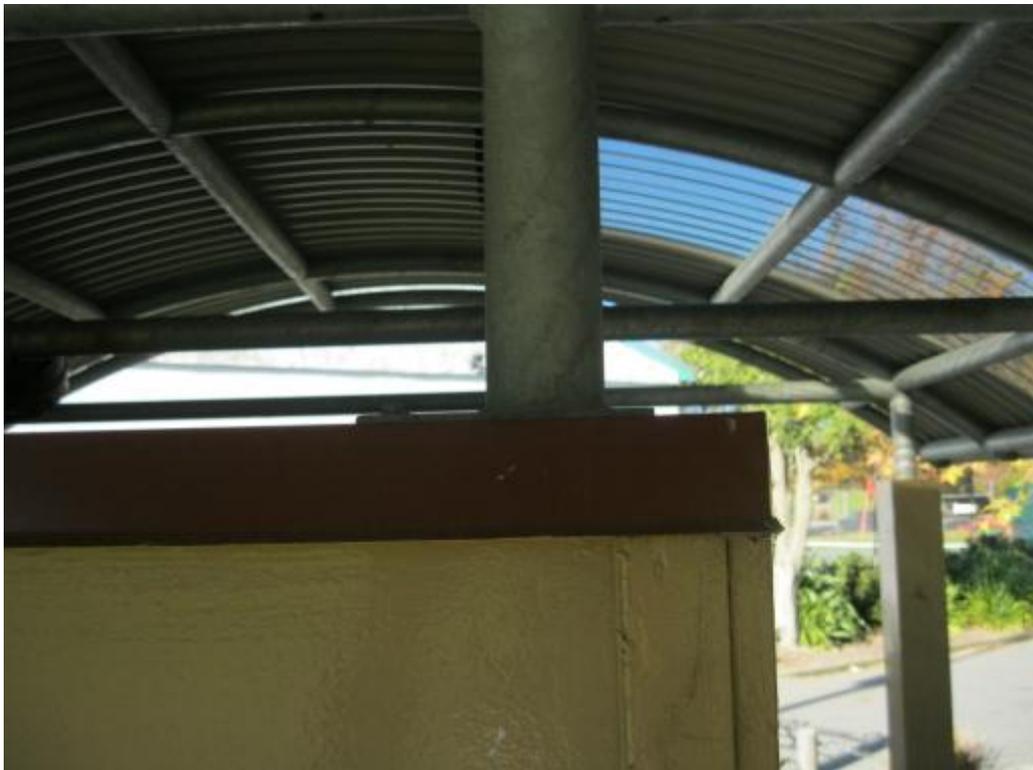
Photo 4. Steel tube post supported on load bearing timber frame wall.

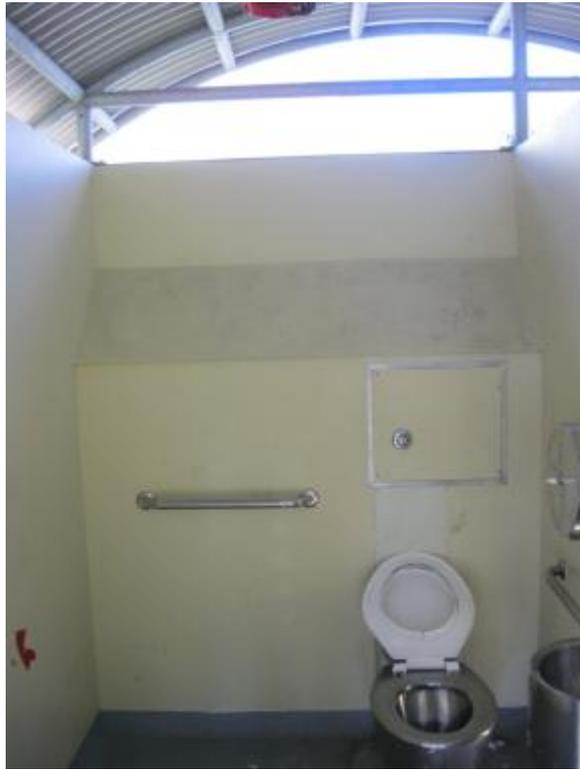
Photo 5. Toilet interior.
