Victoria Park –Fuels Shed
Qualitative Engineering Evaluation

Reference: 228901

Functional Location ID: PRK 1829 BLDG 014

Date: 4 April 2014

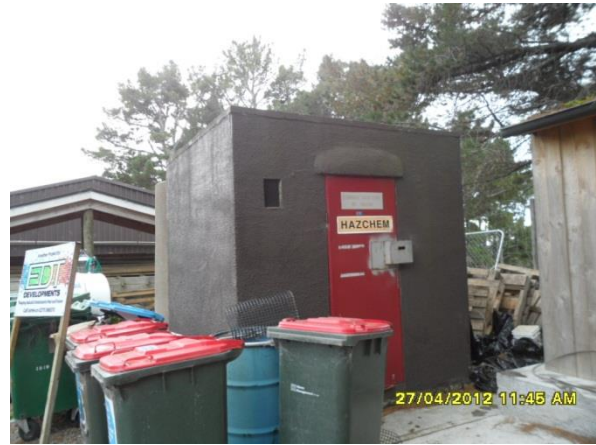
South end view of the structure.

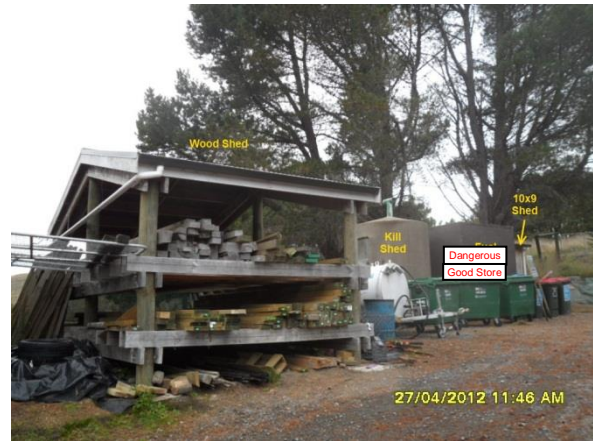
Northwest corner view of the structure.

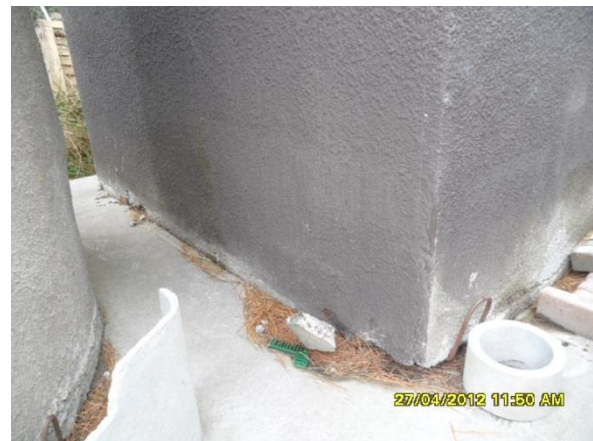
View of the structure on top of concrete slab.
