Victoria Park – Shed for Fire Appliances  
Qualitative Engineering Evaluation

**Reference:** 228664

**Prepared for:**  
Christchurch City Council

**Date:** 11 October 2013

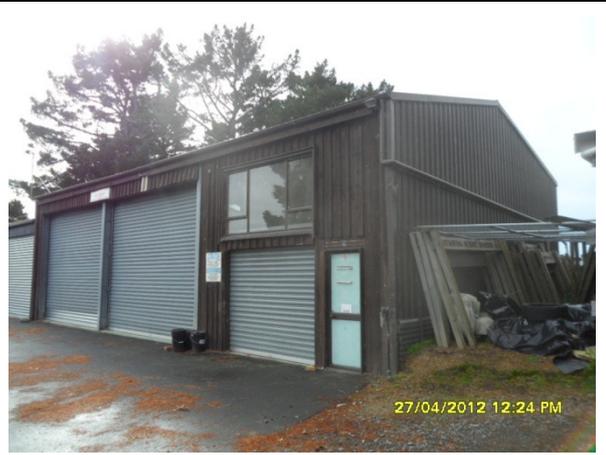
West view of the building.

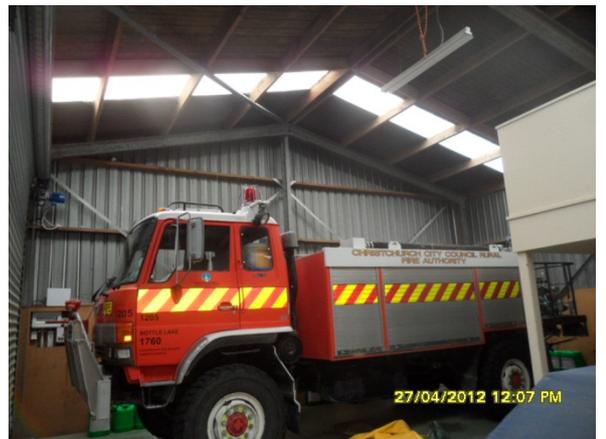
Internal south side of the building.

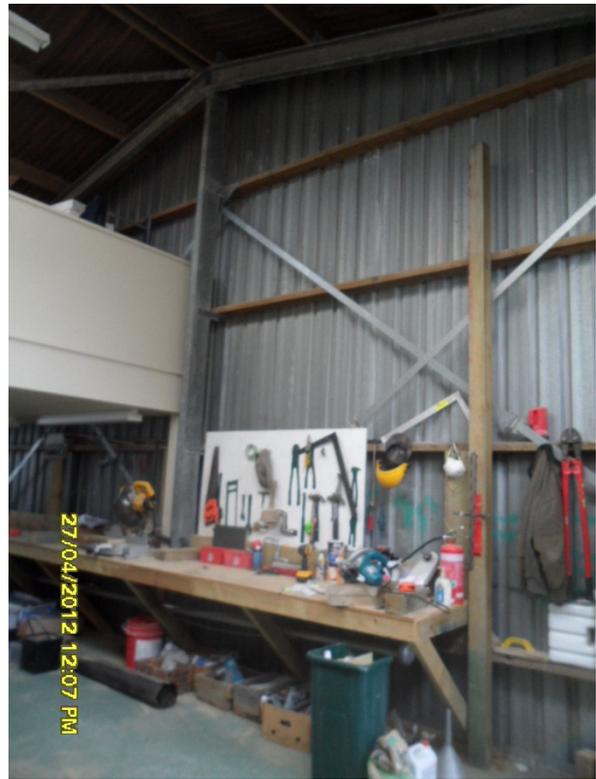
View of the mezzanine on the south end of the building from the ground floor.

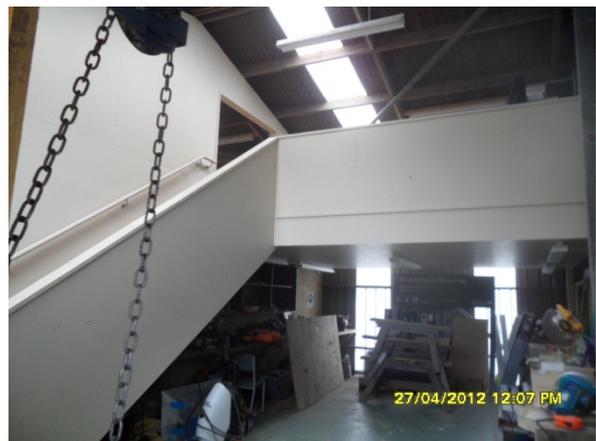
View of the mezzanine on the north end of the building from the ground floor.

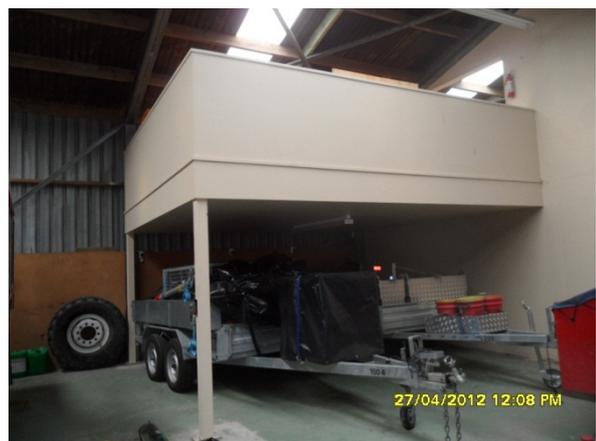
View of the mezzanine looking towards the northwest corner of the building.

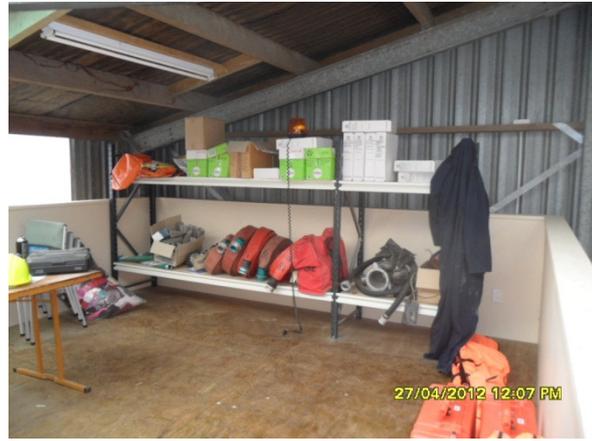
View of the mezzanine looking towards the northeast corner of the building.

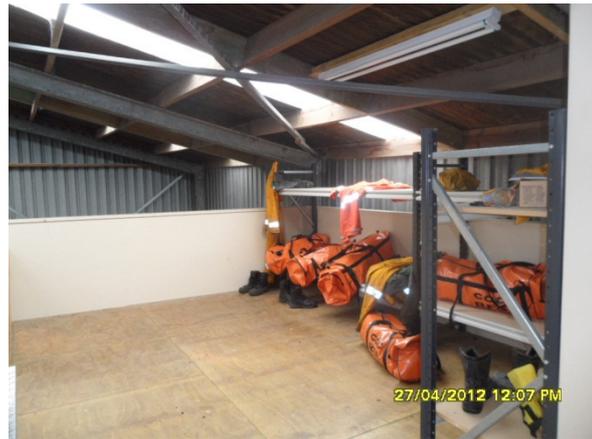
View of the north end side of the building from the mezzanine.

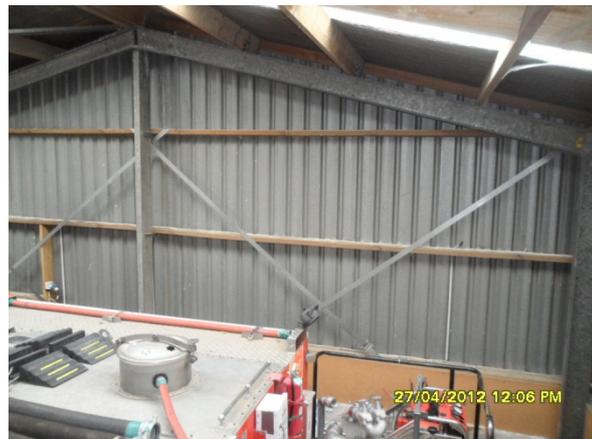
Typical connection detail at ridge.

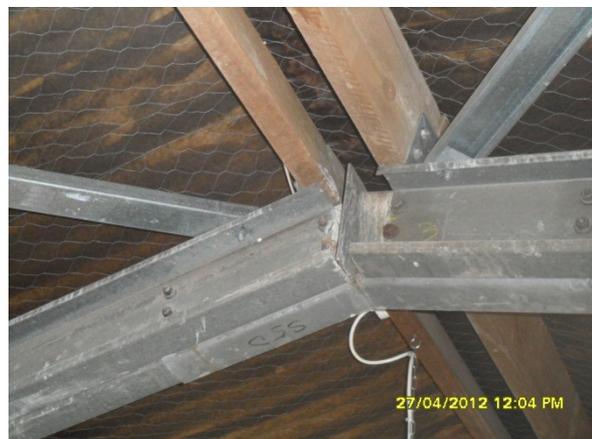
Typical connection details at knee.

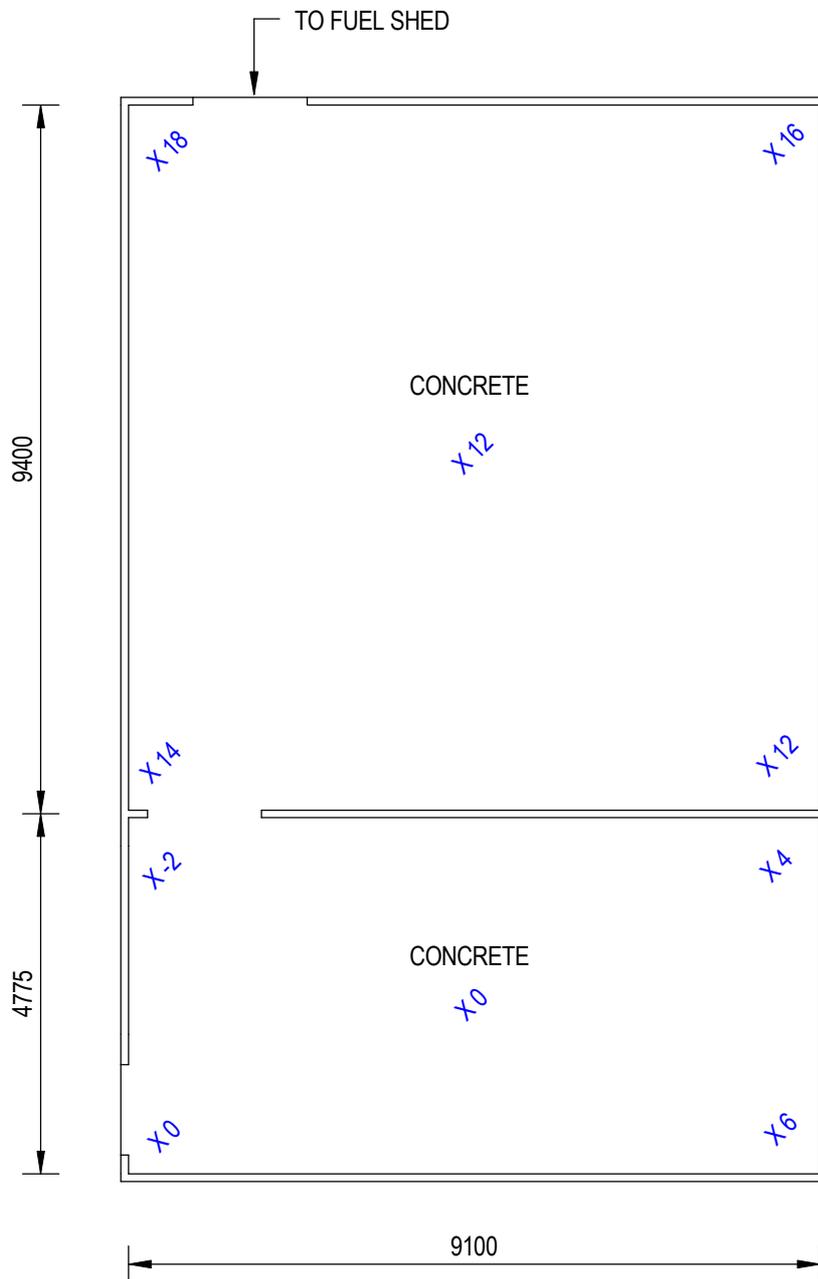
PROJECT
VICTORIA PARK SHED FOR FIRE APPLIANCES
TITLE
LEVEL SURVEY

Floor level survey has been undertaken and the result shows minimal settlement. No further investigation is required as part of the DEE process.
