# **Vincent Courts Housing Complex PRO 1012**

**Detailed Engineering Evaluation  
Quantitative Assessment Report**

**60 Vincent Place, Opawa,**

Date: March 2014  
Reference: 6-QC412.00  
Status: Final

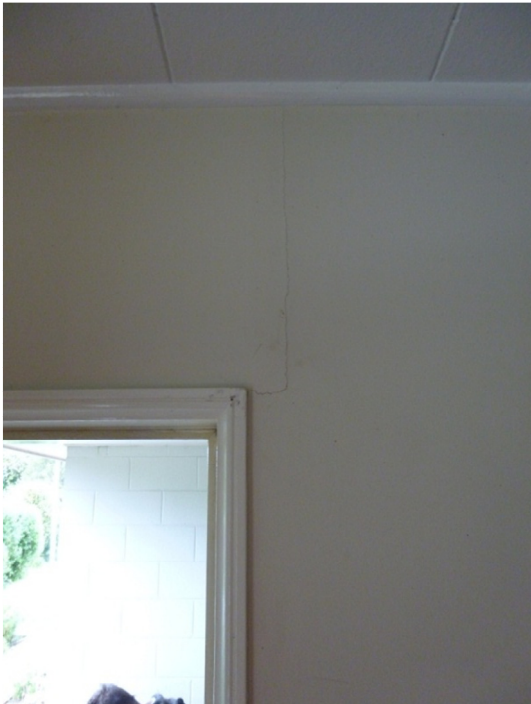
Minor plasterboard cracking was observed in all units, typically observed above doorways, windows and at the roofline (photos 29-31). Minor cracking was observed in the ceiling diaphragms in most units. This damage is deemed minor and not to affect the lateral resistance structure.

Damage		
29.	Typical plasterboard cracking above doorways

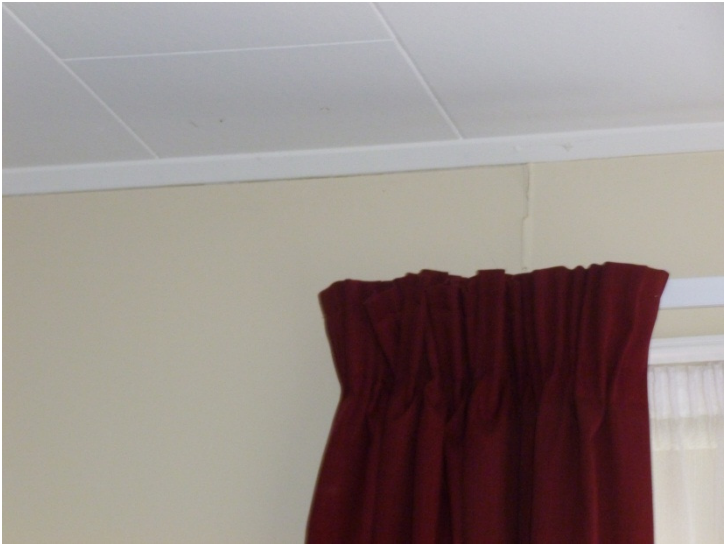
30.	Typical plasterboard cracking above windows

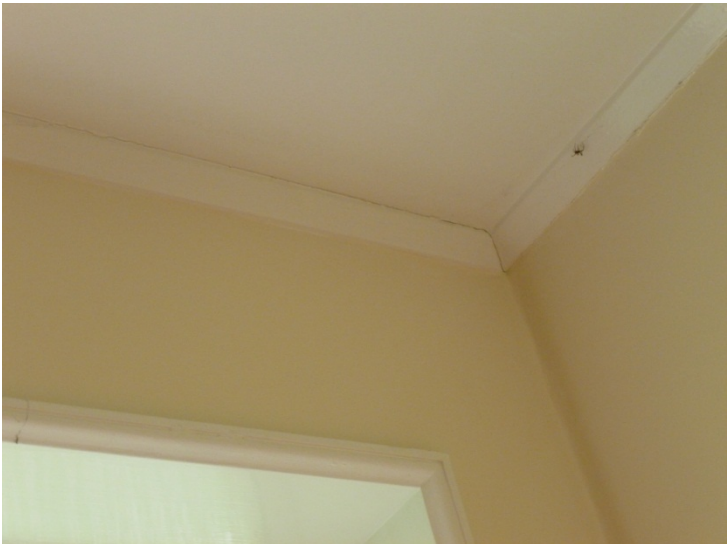
31.	Typical plasterboard cracking at the roofline

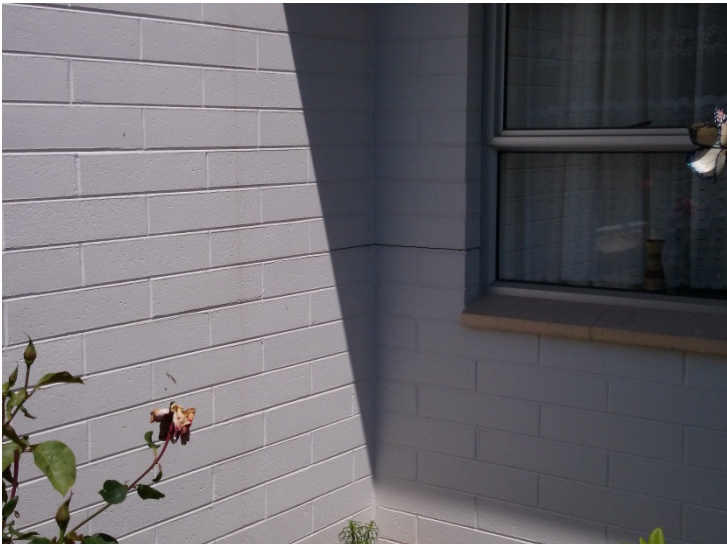
Stepped cracking in the brick veneer was observed in Blocks A and B, where a crack was observed between the brick veneers of Units 5 and 4 (photo 32). Cracking was observed through the brick under windows down to the foundations at the back of Blocks A and B (photo 34). Slight separation of the veneer from the firewall was observed in Block A. Cracking between the entrance ramp and patio was observed in Block A.

32.	Cracking between the veneers of Units 5 and 4

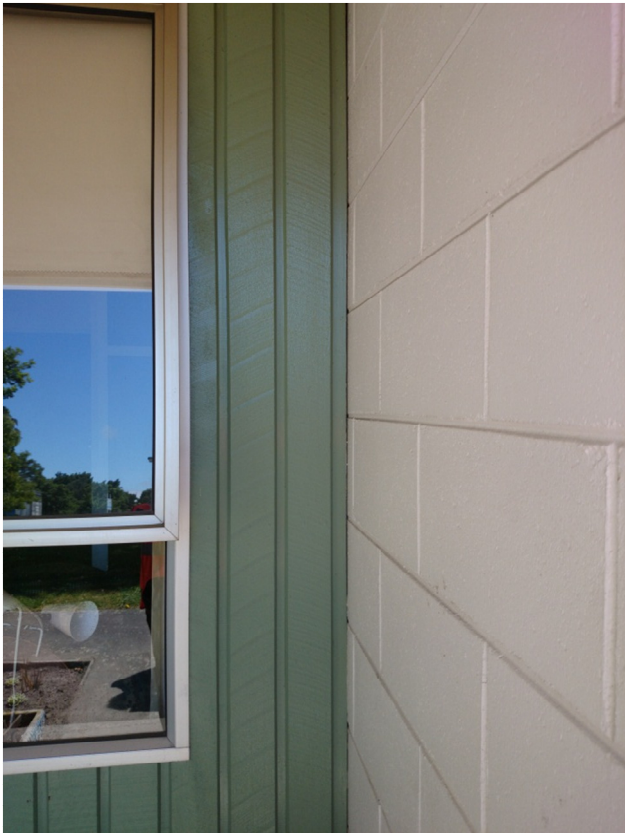
33.	Splitting between the veneer and firewall

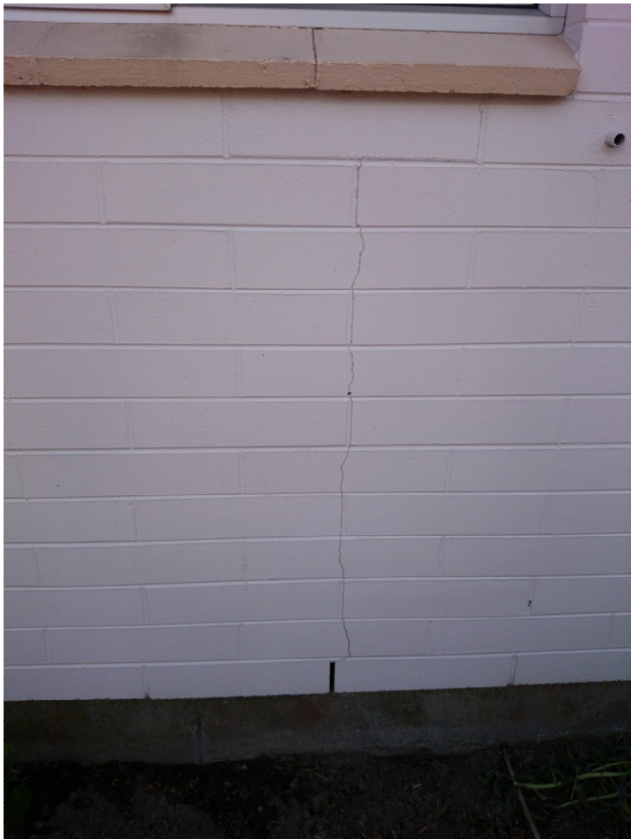
34.	Cracking through the brick at rear of Block A

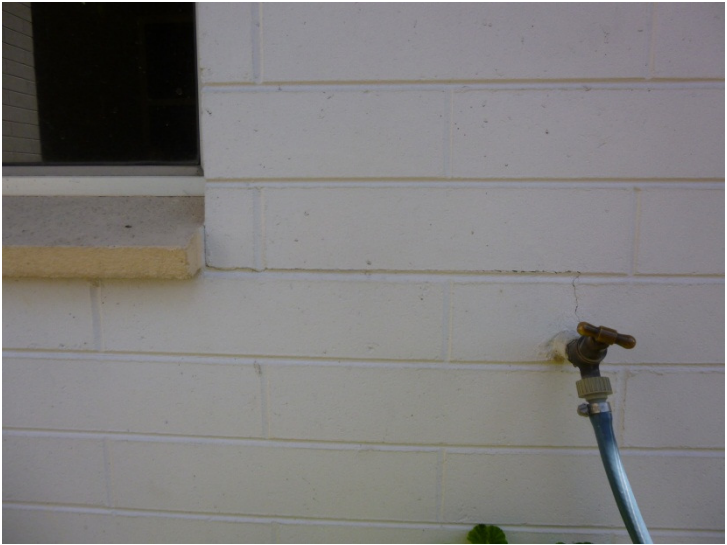
35.	Cracking in veneer around windows

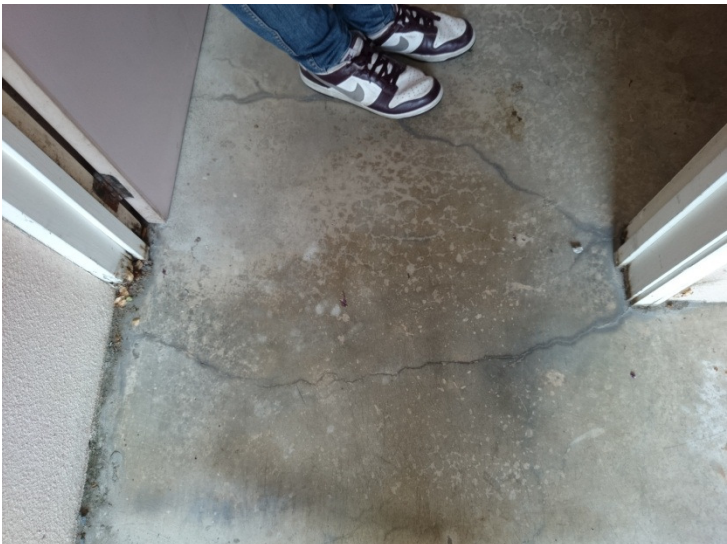
Minor foundation cracks were observed on Blocks A and B. Cracking was observed in the concrete slab under the stairs in Block C (photo 37). Cracking was also observed in the second storey precast floor slab originating from the firewall toward the balcony free edge (photos 38-40).

A photograph of a rear entrance step. The step is made of concrete and has a green plastic curb. A black mat is placed on the step. A broom is leaning against the wall to the left of the step.
37.	Cracking in the floor slab between stairwells in Block C

- Veneer at height (gable ends) have the veneer ties checked (Residents Lounge).
- Cracking of the concrete pad be repaired where significant cracking has occurred.
- Strengthening schemes be developed to increase seismic capacity of Blocks A - C to at least 67%NBS.
- Cosmetic repairs be undertaken as required.

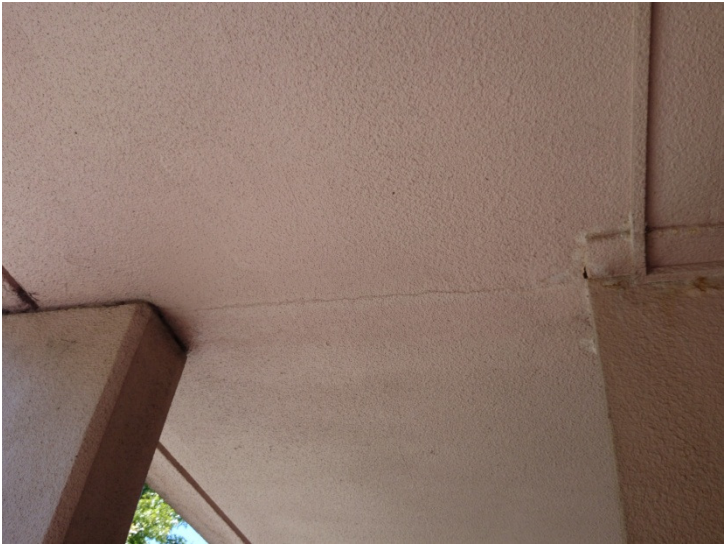
38.	Cracking under entrance balcony in Block C

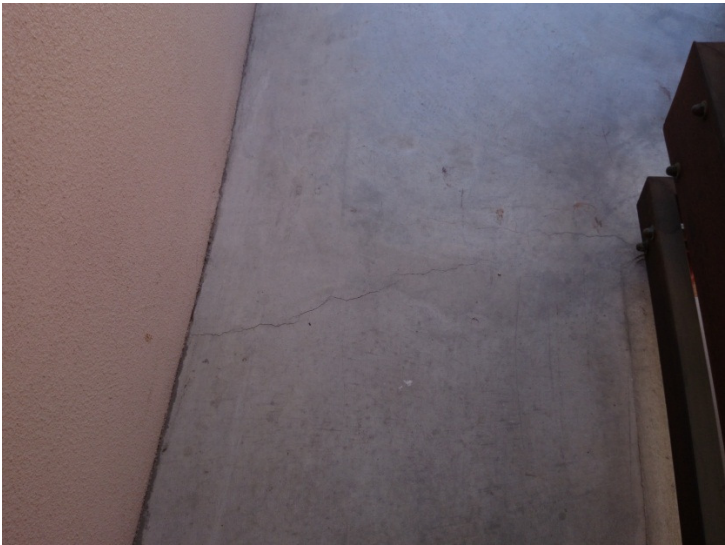
39.	Cracking of the second floor slab by the stairwell

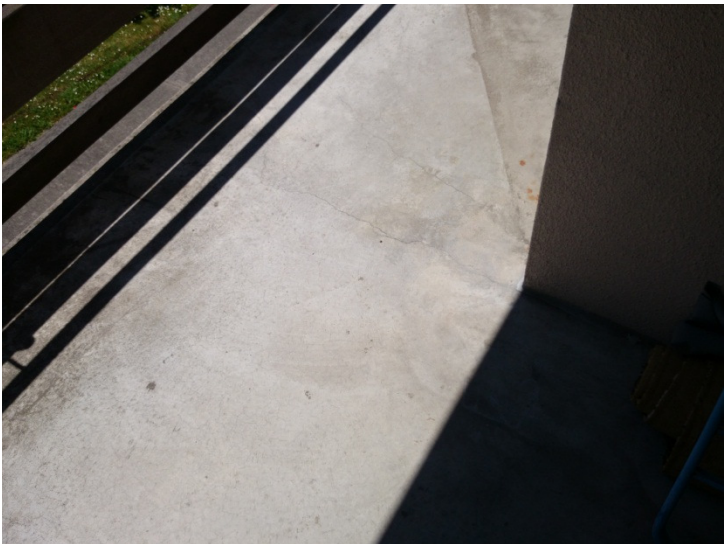
40.	Cracking of the second floor slab around firewall

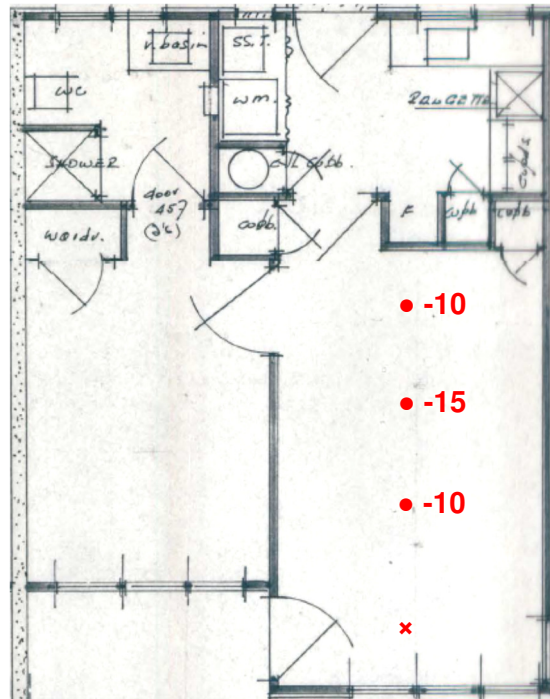
### Unit 5

Block	Unit No.	Comment	Maximum Fall*
A	1	Pass	-
	2	Pass	-
	3	Pass	-
	4	Pass	-
	5	Fail	6mm/m
	6	Pass	-
B	7	Pass	-
	8	Fail	8mm/m
	9	Fail	9mm/m
	10	Pass	-
C	11	Pass	-
	12	Pass	-
	13	Pass	-
	14	Pass	-
	15	Fail	7mm/m
	16	Fail	5mm/m
	17	Pass	-
	18	Pass	-
Residents Lounge		Pass	-

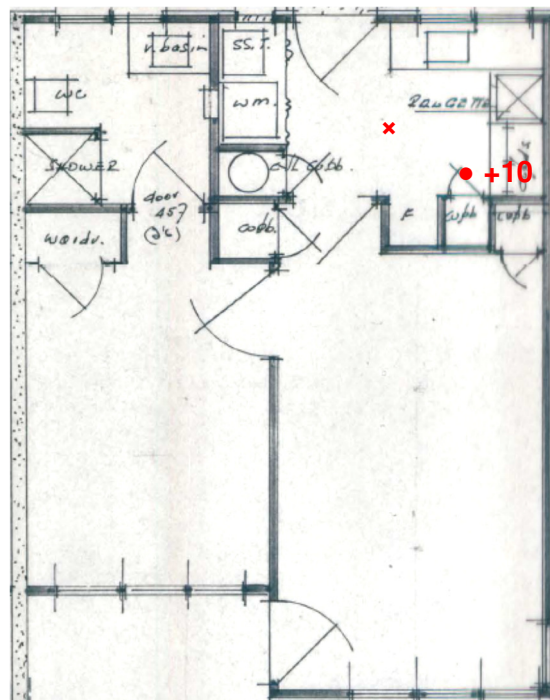
### Unit 8

Residual displacements were observed to exceed MBIE guidelines in Units 6, 8, 9, 15 and 16. Displacements in Units 8 and 9 were more severe than other residual displacements observed and both occurred in the kitchen-living room-firewall corner.
