**Wainoni Park Youth Activity Centre**  
BU 1264-002 EQ2  
**Detailed Engineering Evaluation**  
**Quantitative Report**

# **Wainoni Park Youth Activity Centre**

## **Detailed Engineering Evaluation Quantitative Report**

Date: November 2012  
Reference: 6-QUCCC.66  
Status: Final

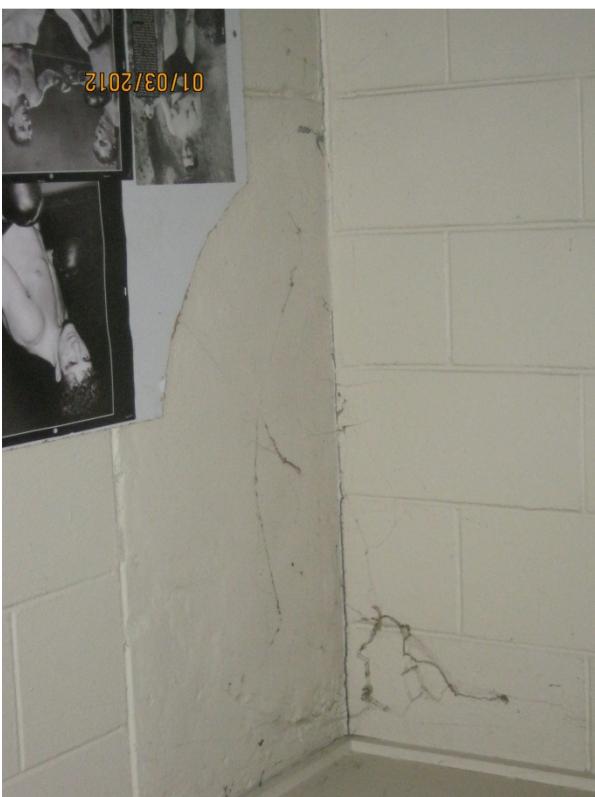
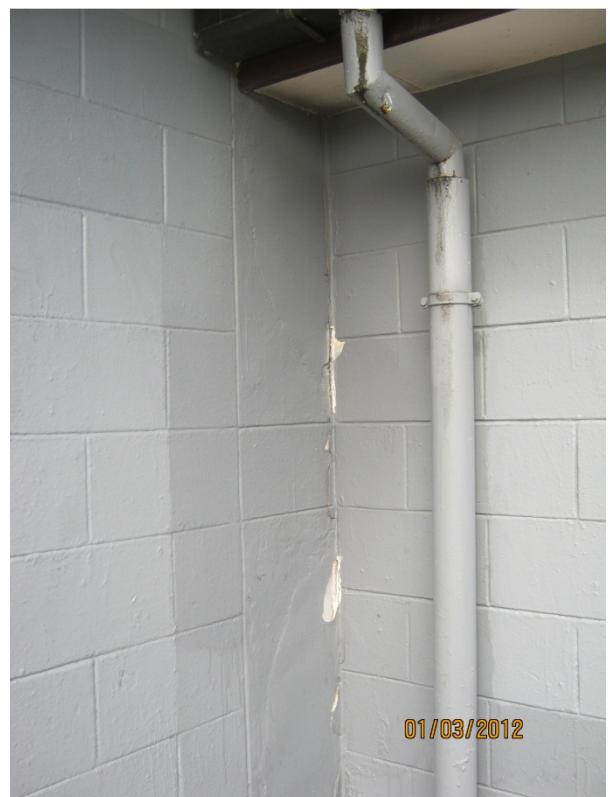
- Minor vertical hairline cracks at the junction of the Western addition and the flank wall of the main octagonal room.

Some vertical hairline cracking was noted at the junction between original building and the later Western extension but in general the building appears to be in good condition.

**Photos 7&8: Cracking Between Original Building & Main Addition**

- a) In order to minimise further cracking at the junction between the main building and the Western addition during future seismic events consideration should be given to raking out the existing vertical joints between the two areas and installing a flexible sealant.

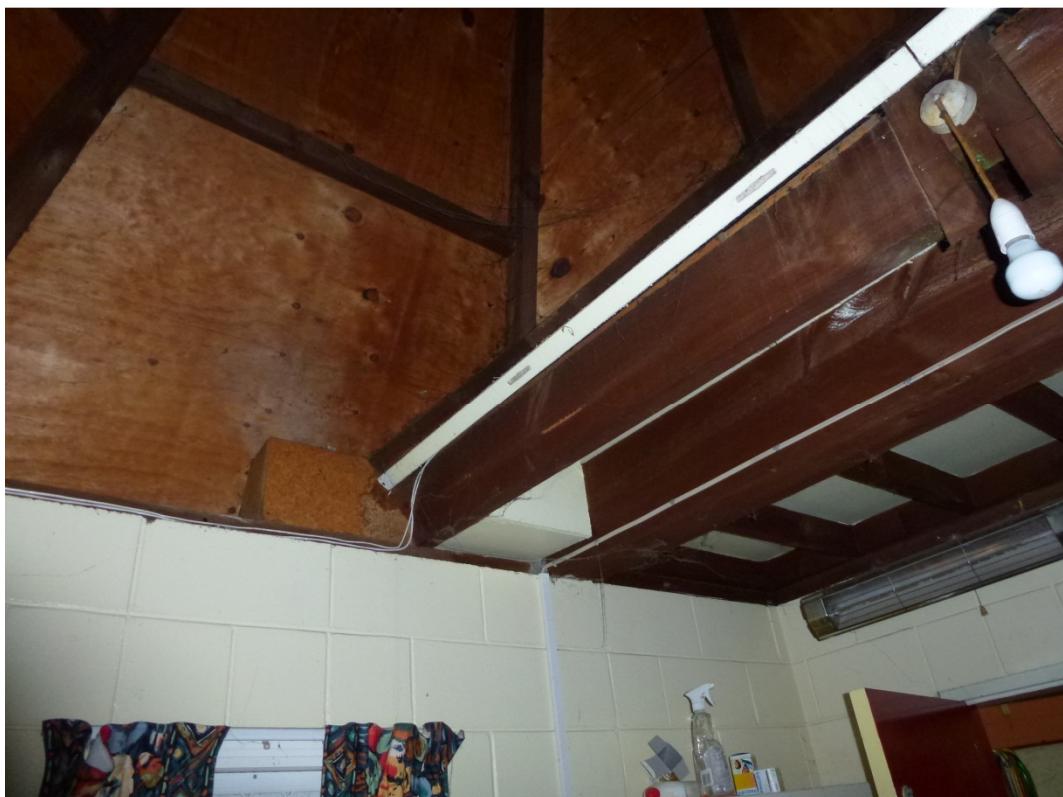
**Photo 22: Junction between Kitchen Addition & Main Building**

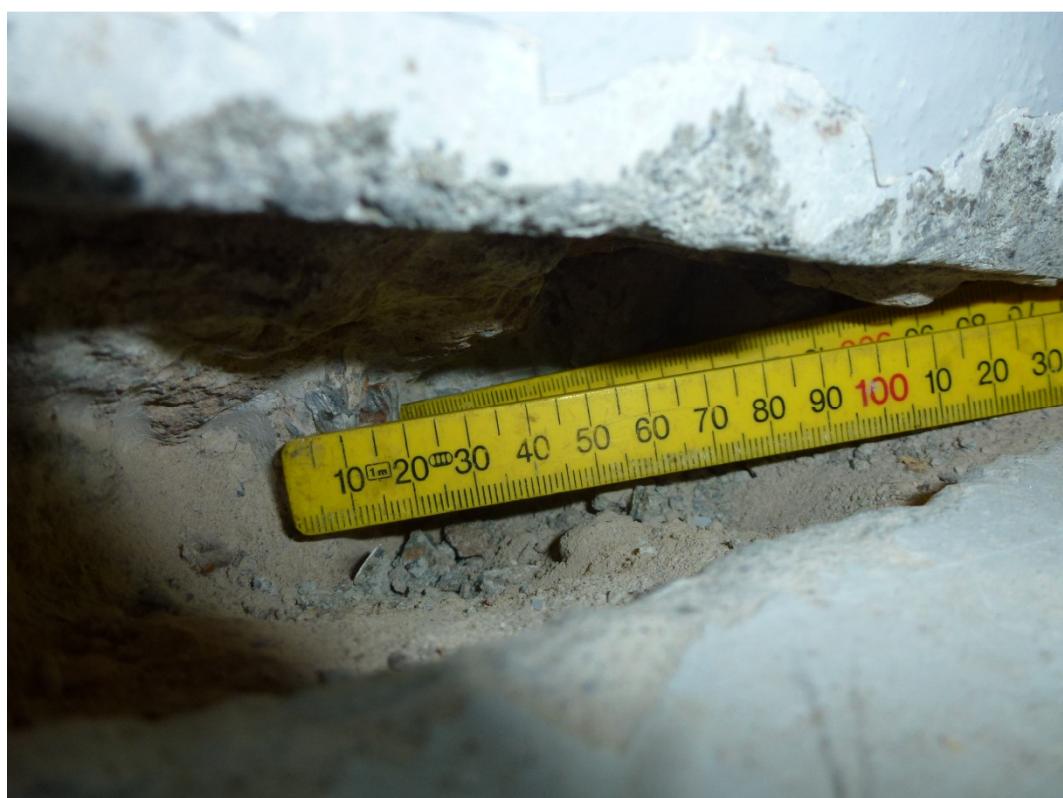
Opening up works were undertaken at one location to expose a vertical reinforcement bar contained within the walls. At this location it was found that a deformed bar, 12mm in diameter had been used. It has been assumed that a similar bar size has been used in the remainder of the building.

**Photo 23: Confirmation of Main Vertical Reinforcement**

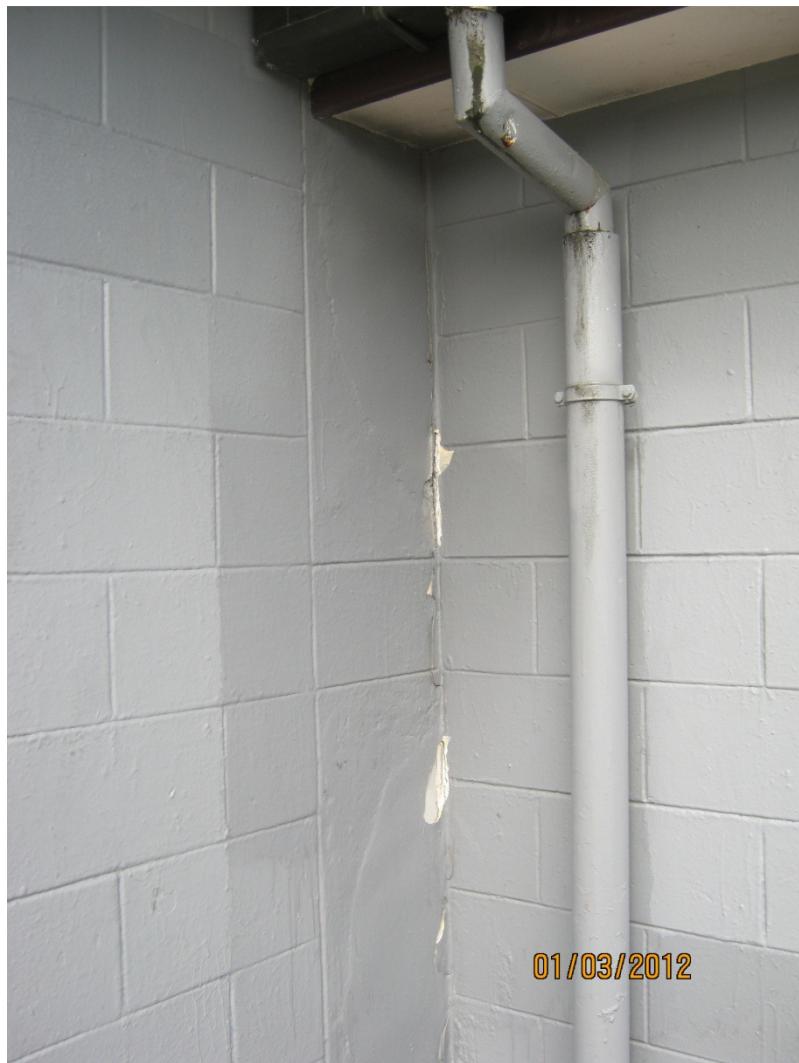
Photograph 3. Hairline crack in brick wall (does not extend into foundation)

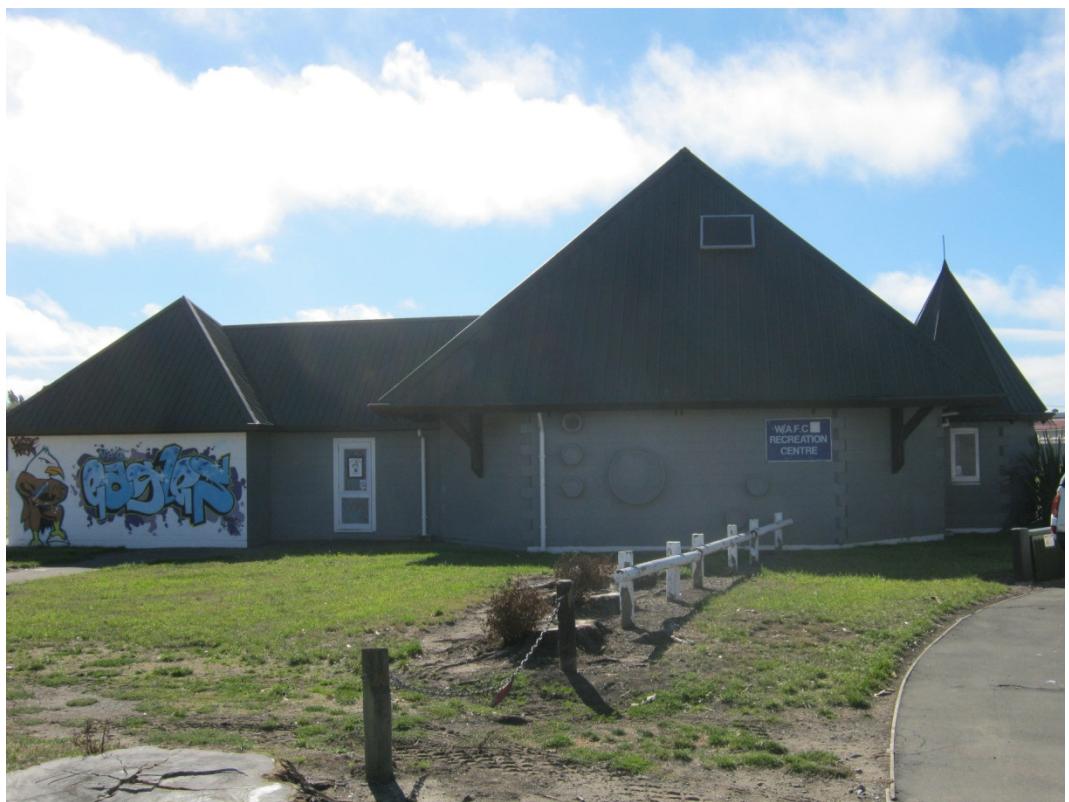
- Confirmed evidence of ejected liquefied sand on Hampshire Street and in the park;
- Hairline cracks at some of the corners of the building. Possibly due to seismic shaking (Refer Photograph 5 and 6);

Photograph 5. Southern side of the building

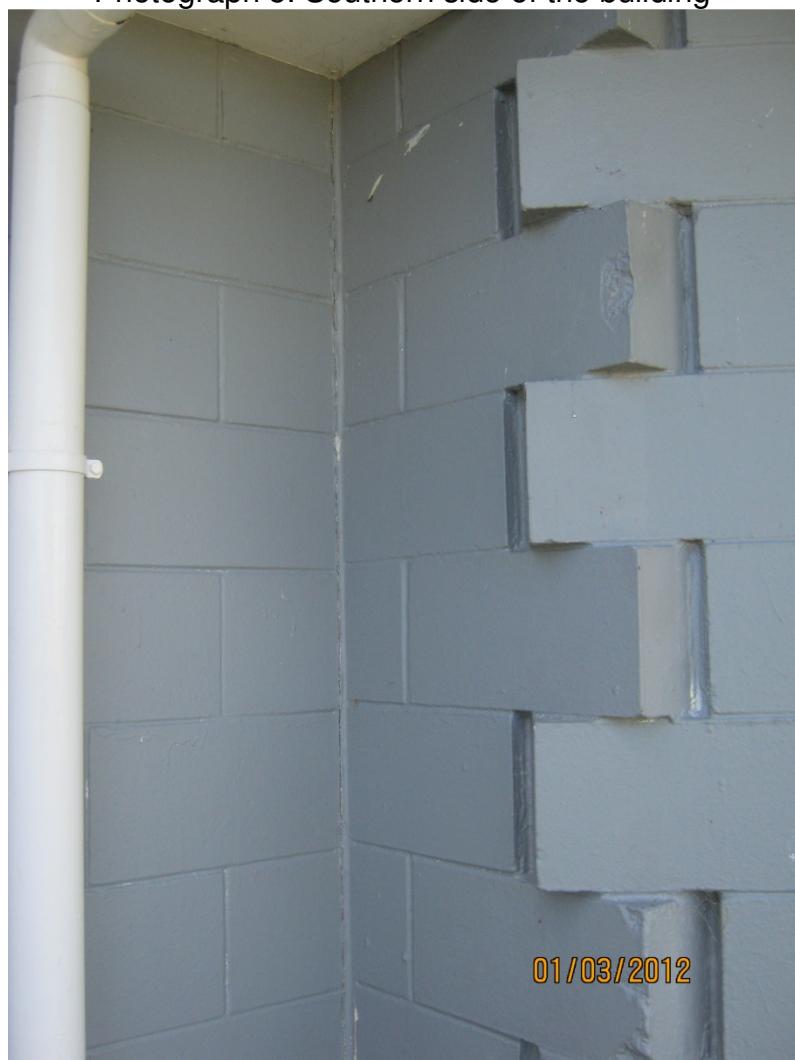
Photograph 6. Hairline cracking in brick wall (does not extend into foundation)
