Wainui Community Hall Toilets

BU 3675 002 EQ2

Detailed Engineering Evaluation

Quantitative Assessment Report

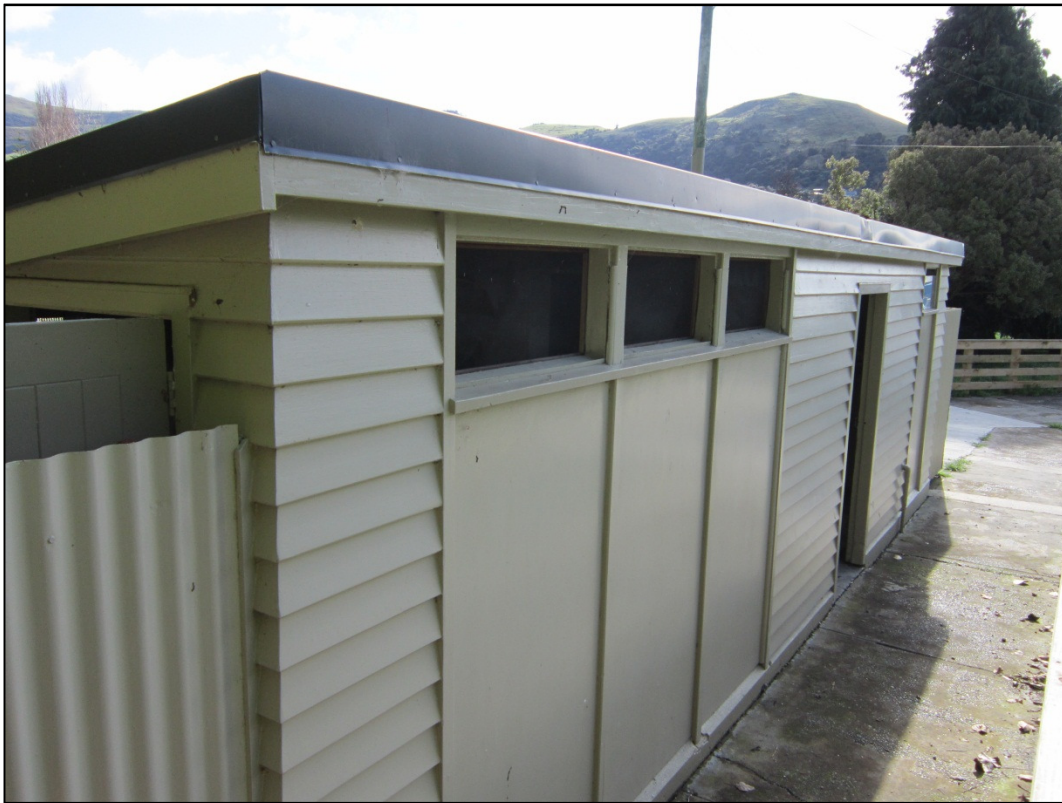
Photo 1: View of the eastern elevation of the toilet block

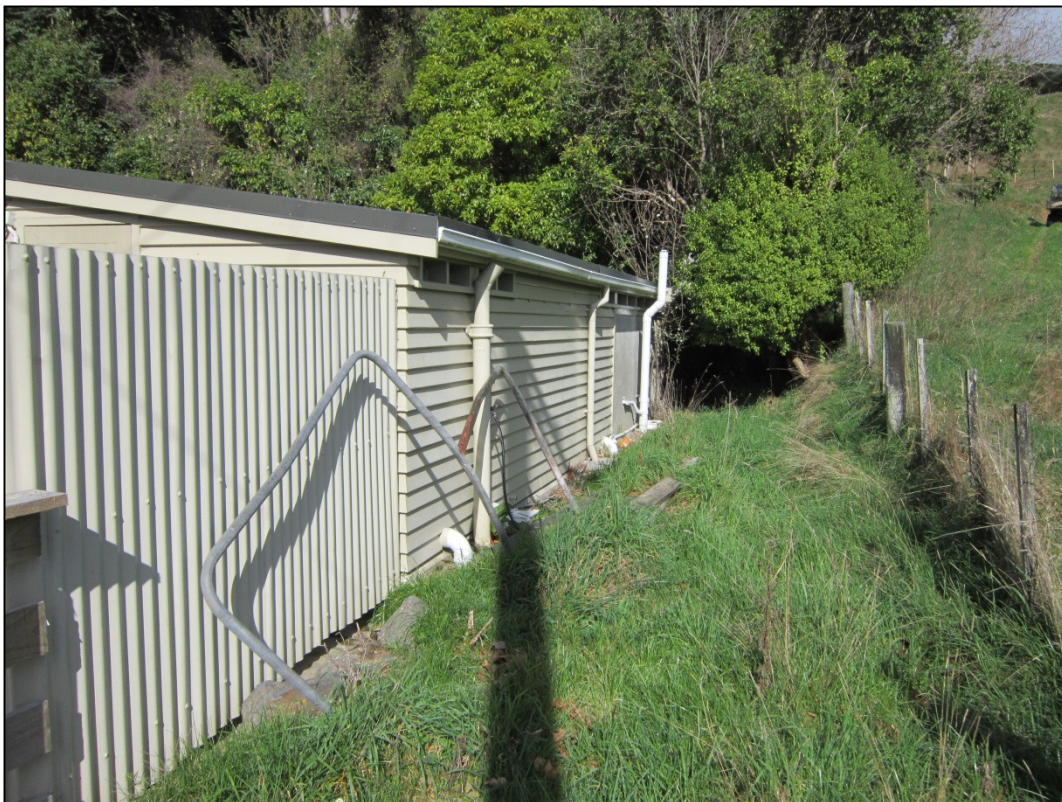
Photo 2: View of the western elevation of the toilet block

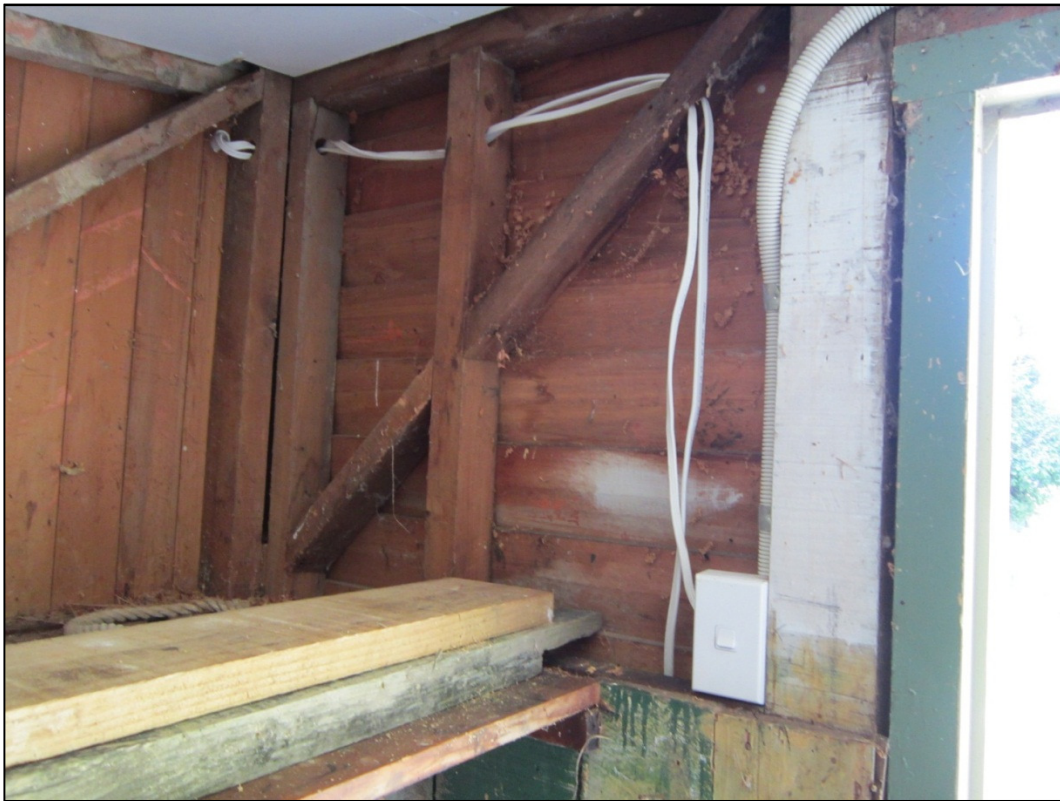
Photo 3: View of a let-in timber brace in the storage room

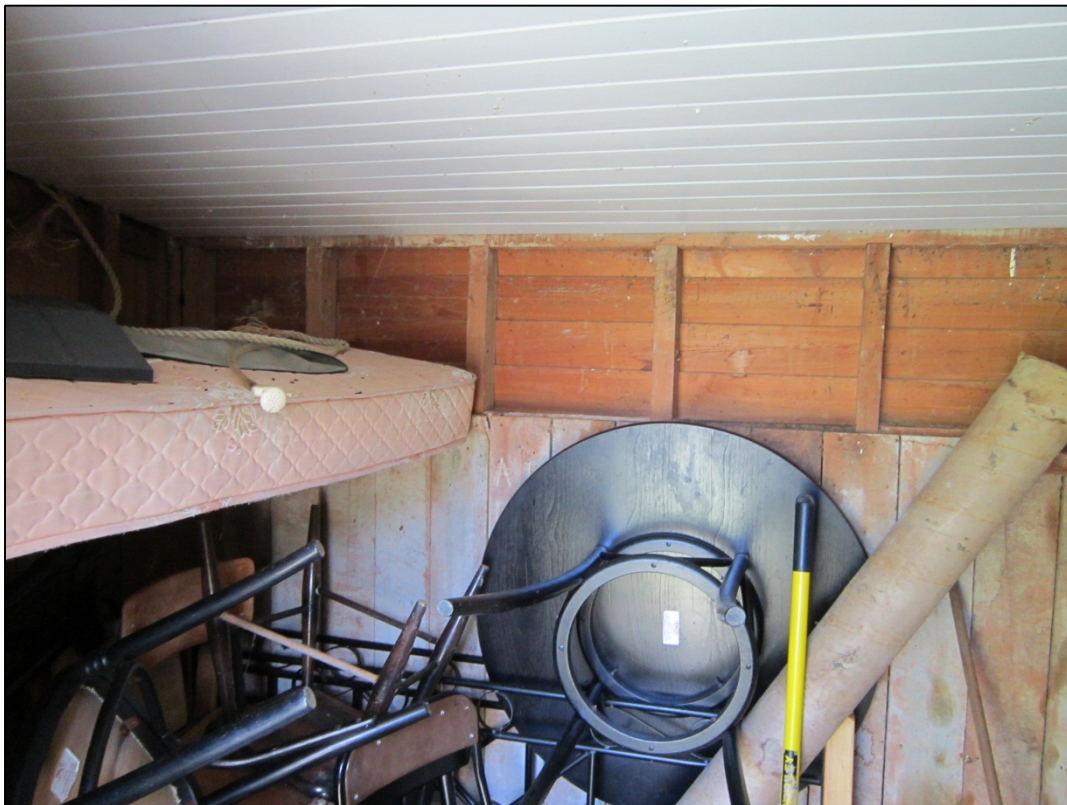
Photo 4: View western wall in the storage room

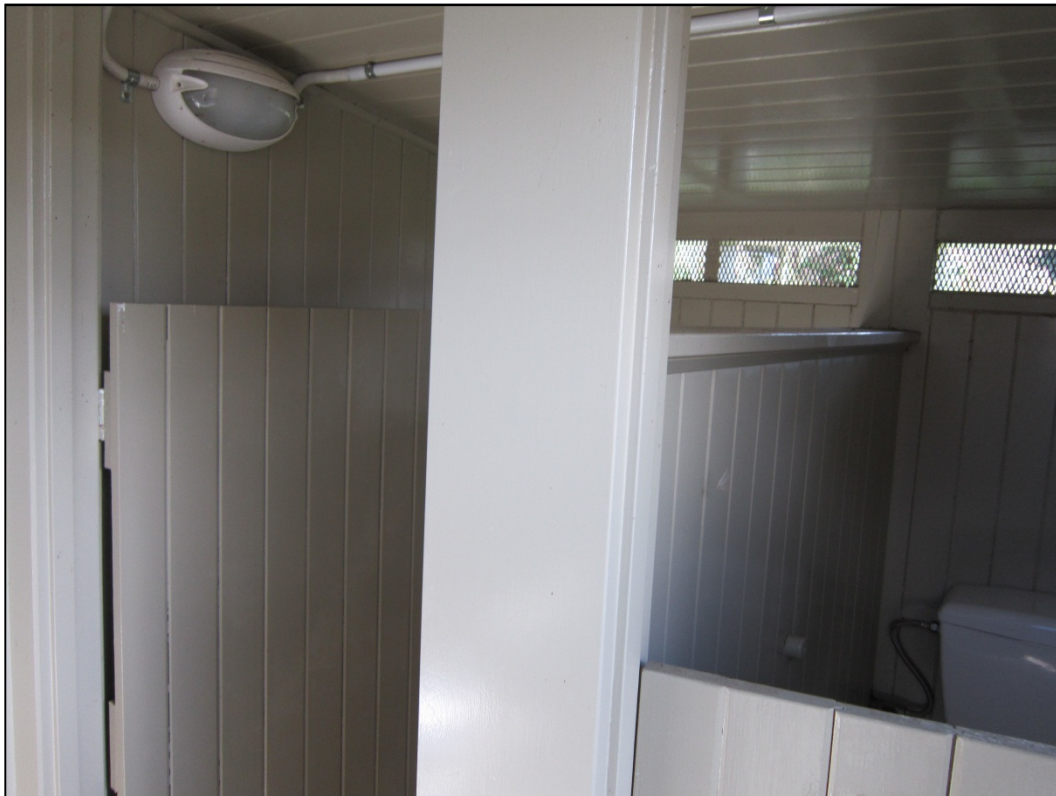
Photo 5: View of the wall and ceiling linings in the female toilets

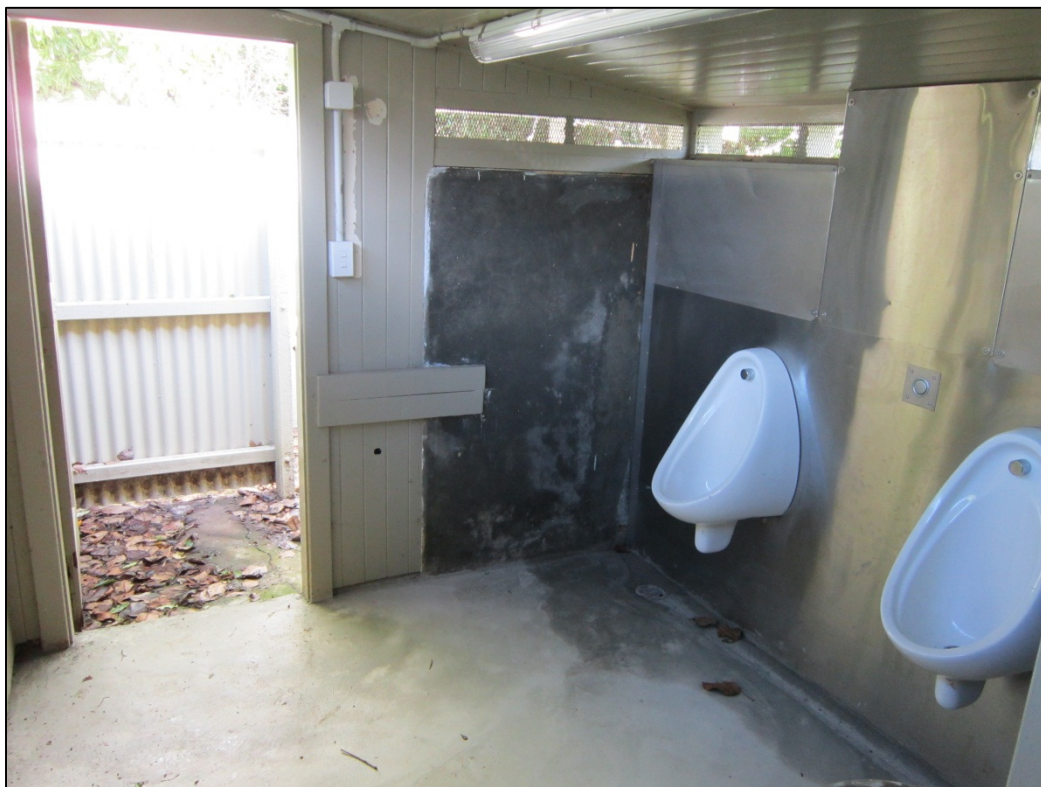
The walls are timber framed with a stud height of approximately 2.2m. A section of wall in the male toilets at the south west corner is constructed of reinforced concrete.

Photo 6: View of the south west corner in the male toilets

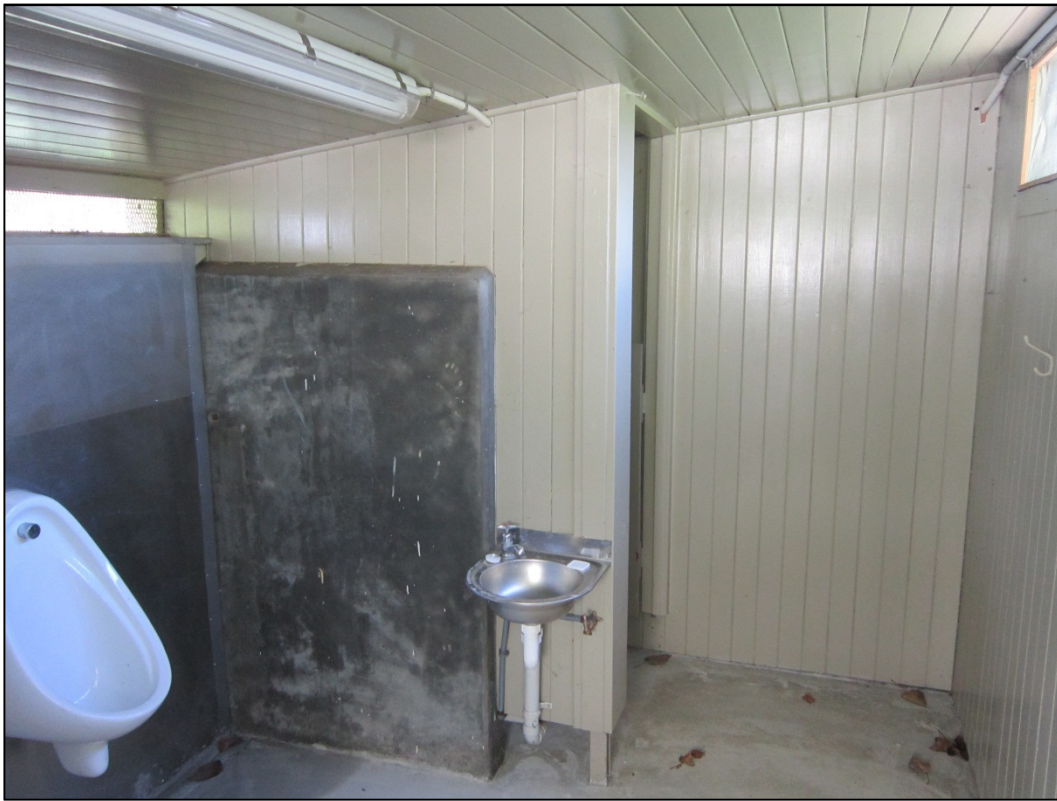
Photo 7: View of northern wall in the male toilets
