Walsall Courts Housing Complex

Qualitative Engineering Evaluation

Functional Location ID: BE 0488 EQ2

**Date:** 1 May 2013

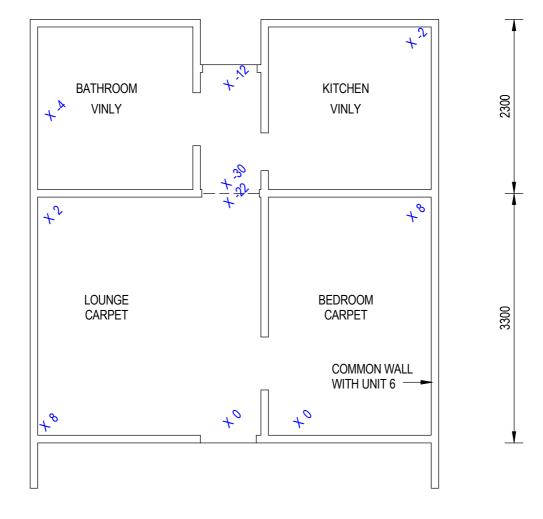
WALSALL COURTS HOUSING COMPLEX
CHRISTCHURCH
TITLE
LEVEL SURVEY
UNIT 5

A level survey was undertaken on the floor coverings of the building to quantify the level of unevenness. The survey was undertaken on top of existing floor finishes which may have influenced the results of the survey. The table below shows a summary of the areas and units where the slope recorded exceeds the DHB guideline of 0.5%.

Room	Unit	Maximum slope (%)
Lounge	5	0.58
	8	0.55
	20	1.1
	21	0.7
Bedroom	4	0.7
	9	1.4
	10	0.52
	15	1.3
	18	1.1
	21	1.0
Kitchen	5	1.1
	10	0.9
	14	0.7
	16	0.5
	18	0.63
	20	0.62
	21	0.69
Back entrance	3	0.75
	5	2.3
	6	1.25
	9	1.2
	16	1.3

Due to the low level of damage observed to the structural components and the high %NBS values calculated for the units, it is considered that the units in the Walsall Courts Housing Complex are **suitable for continued use**. However, due to large floor level variations in certain units, it is recommended that re-levelling of the floors is undertaken.
