Walter Park Pavilion Toilets  
Qualitative Engineering Evaluation

**Reference:** 229183  
**Prepared for:**  
Christchurch City Council

Address: 91 Kellys Road, Christchurch

**Date:** 16 October 2012

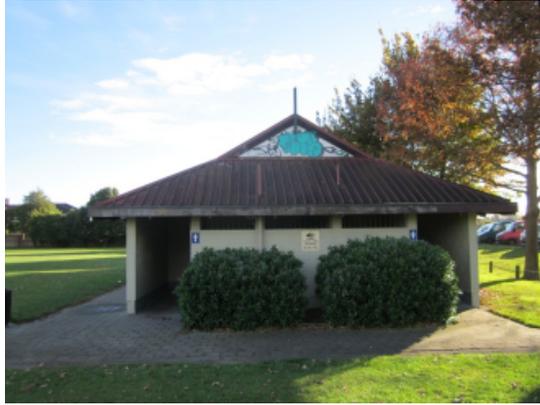
Southern view of the building.

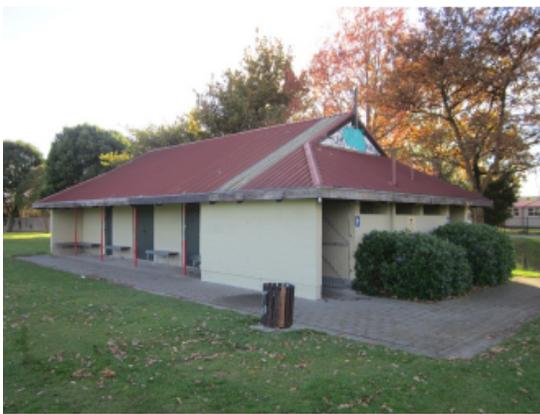
Southwest view of the building.

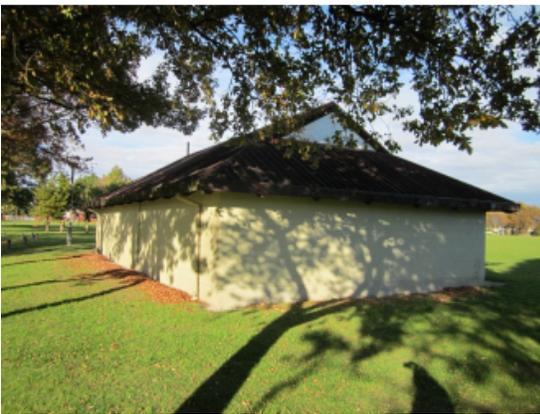
Northeast view of the building.

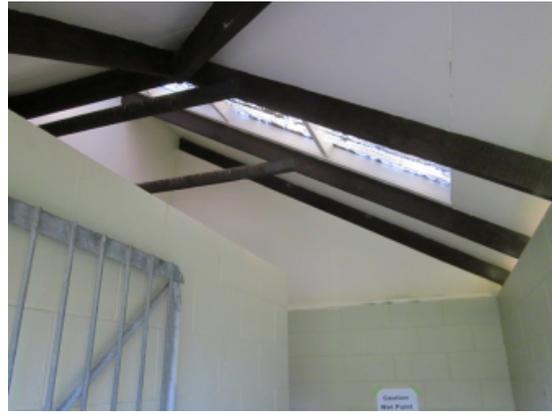
Typical timber truss detail.

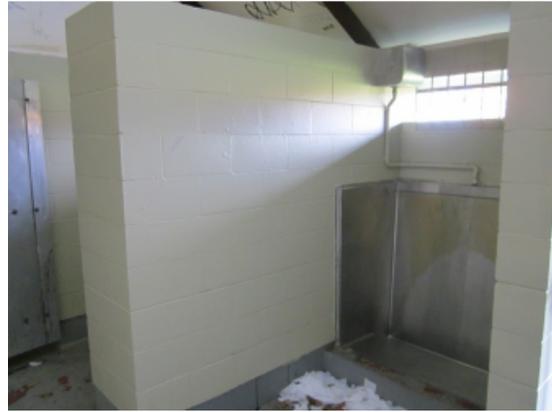
Internal view of the toilets.

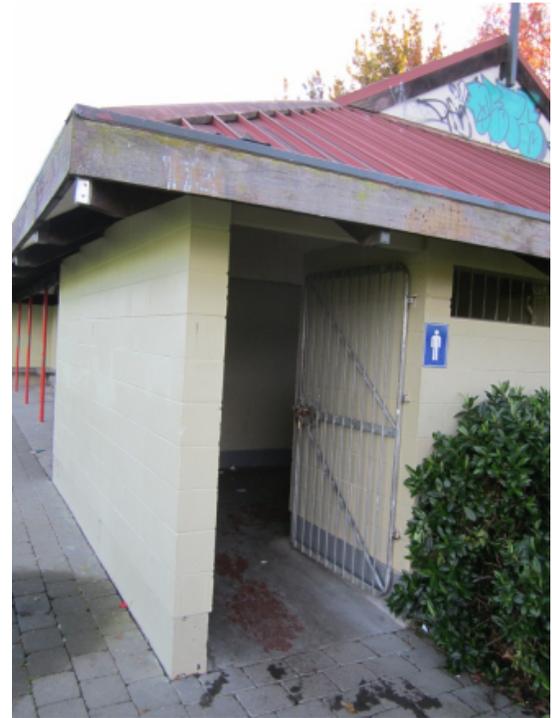
Typical view of the entrance to the toilet.
