Waltham Park Pavilion
PRK 1044 BLDG 005 EQ2
Detailed Engineering Evaluation
Quantitative Report
Version FINAL

30 Waltham Road, Waltham

Christchurch City Council

Date
16th September 2013

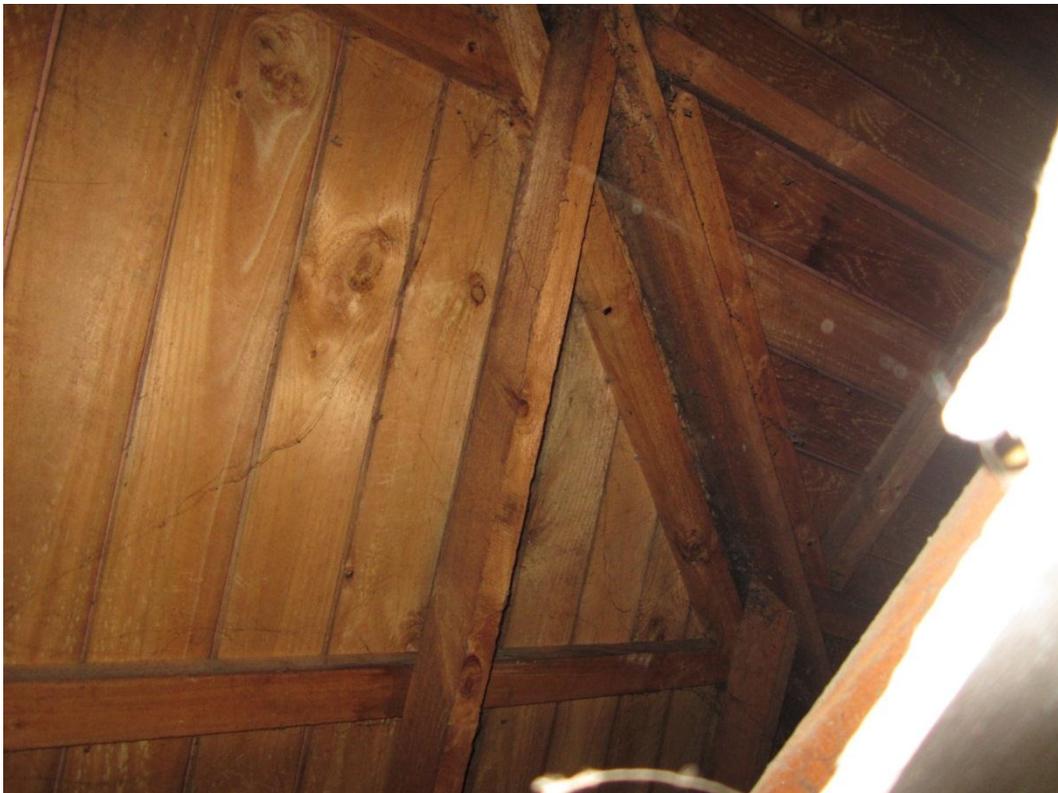
Photograph 6 Timber sarking supporting the profiled sheet metal roof cladding

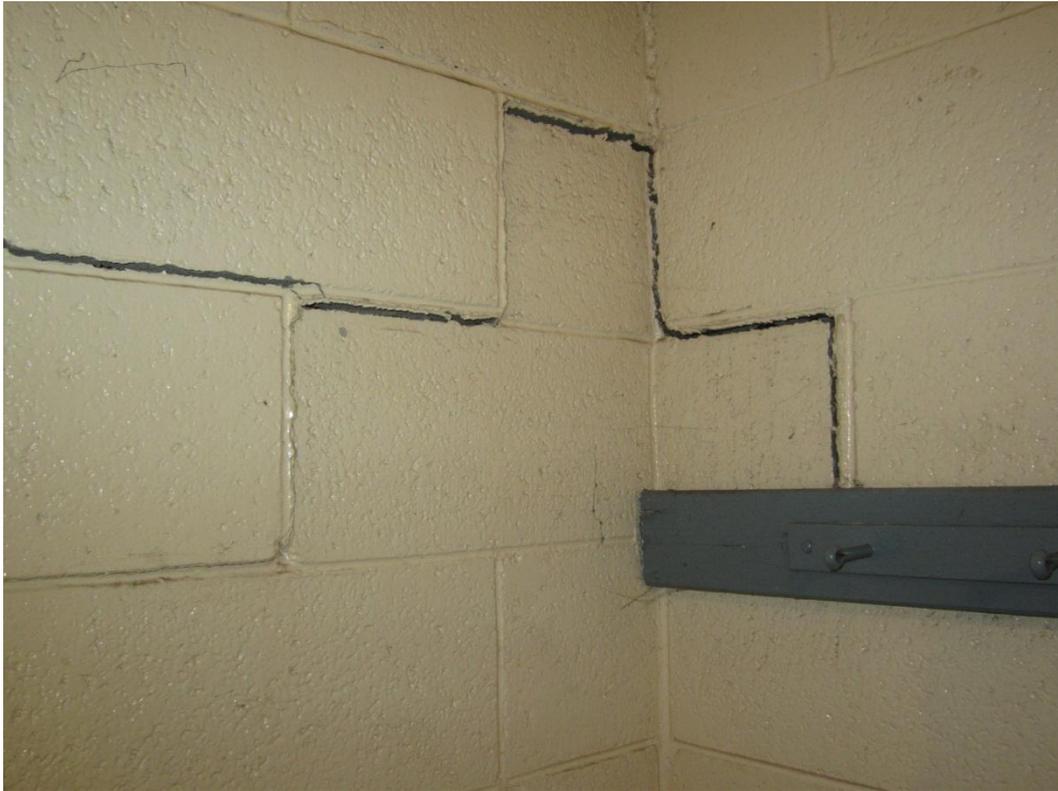
Cracking in the mortar between the concrete masonry units was observed in the north-western end of the original building.

Cracking in the mortar between the concrete masonry units was observed in the north-western end of the original building. The observed damage is shown in Photographs 7 and 8. The location of the cracking observed in Walls 3 and 4 is shown in Figure 4.1 and Appendix B. The calculated load resisting capacity of Walls 3 and 4 has been reduced by 25% to account for the damage observed. These reduced wall capacities were not found to be the critical %NBS for the structure.

Photograph 7 Cracking along the mortar lines in the concrete masonry walls

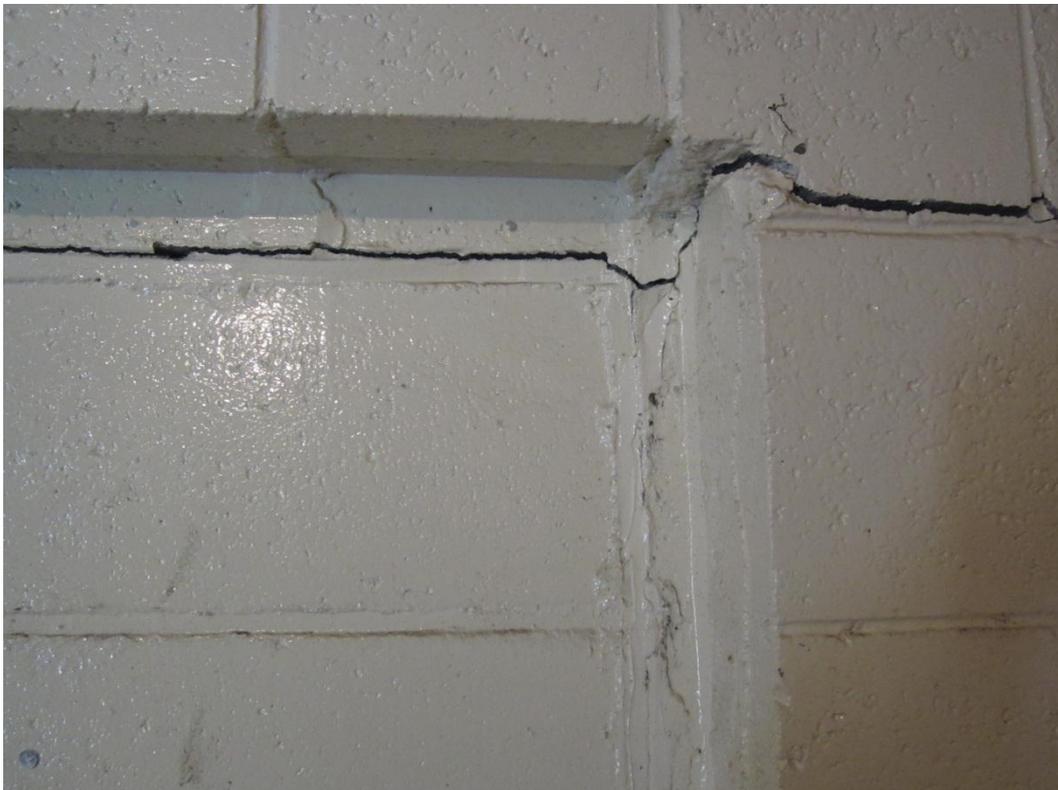
Photograph 8 Cracking occurring at the corner of a filled in opening in a concrete masonry wall
