Waltham Pool
Main Building Complex
PRO 1044-001
Detailed Engineering Evaluation
Qualitative Report
Final

30 – 40 Waltham Road, Waltham

Christchurch City Council

Date
27 May 2013

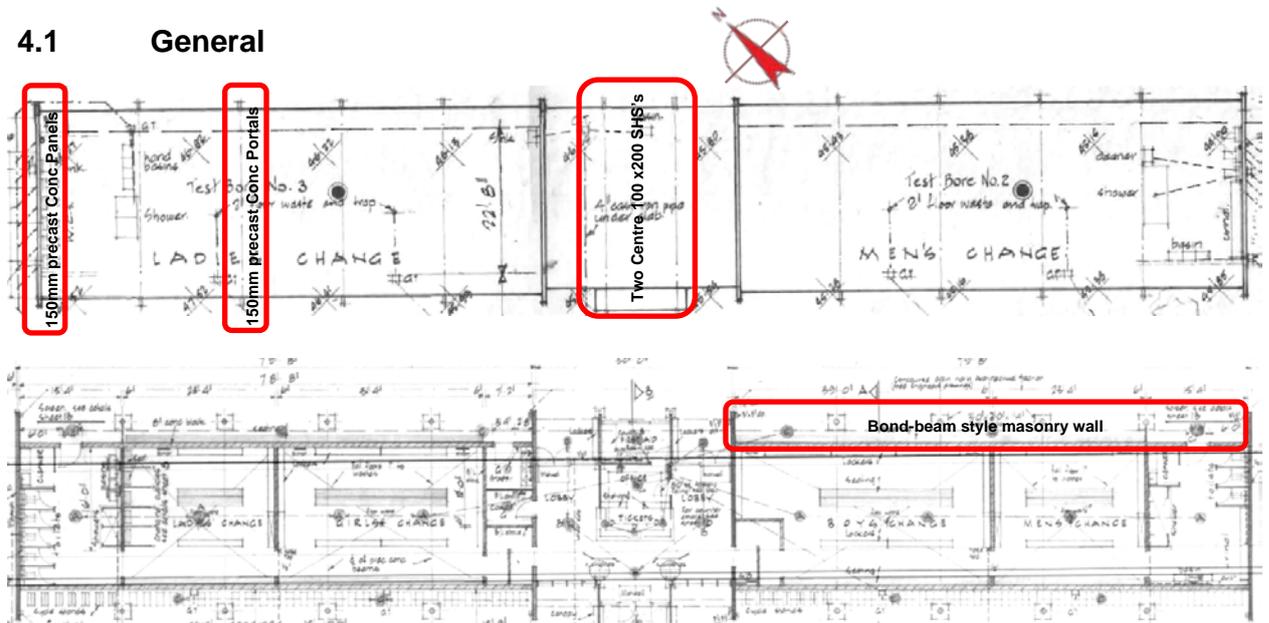
Figure 2 Plan Sketch Showing Key Structural Elements

The building is constructed of 20 series equivalent masonry bond-beam style walls primarily running in the longitudinal direction, with mostly concrete portals and precast concrete panels running in the transverse direction. The roof is a light steel sheet profile on timber purlins. Foundations are concrete pads for the portals connected to strip footings for the masonry walls. The floor is a 100mm slab poured to compacted hardfill.

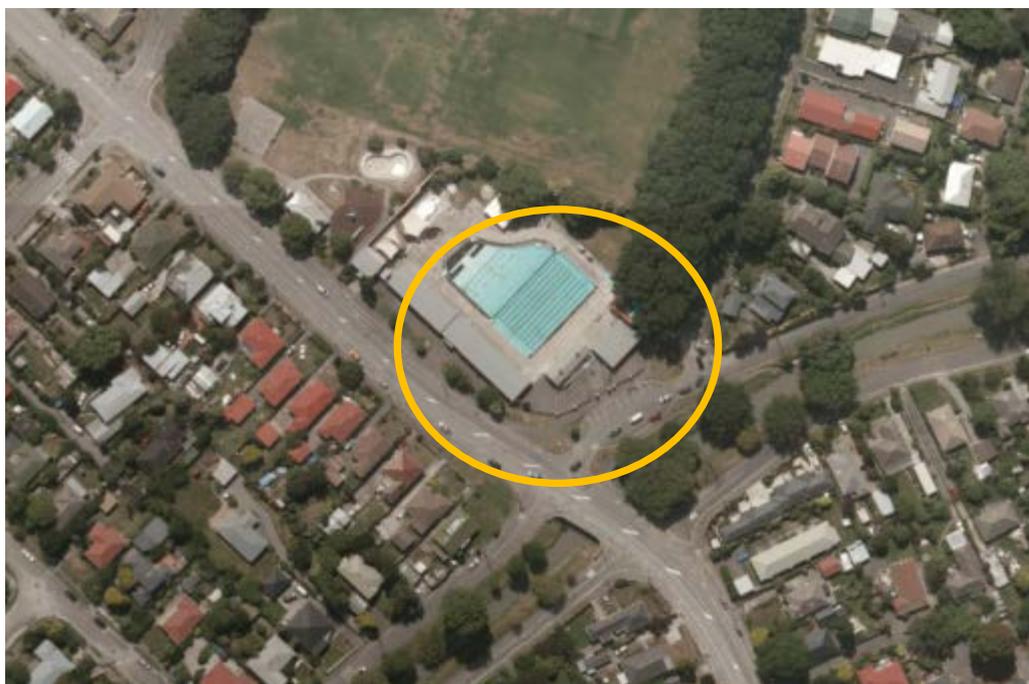
Figure 3 Post February 2011 Earthquake Aerial Photography¹

Aerial photography taken following the 22 February 2011 earthquake shows no signs of liquefaction outside the building footprint or adjacent to the site.

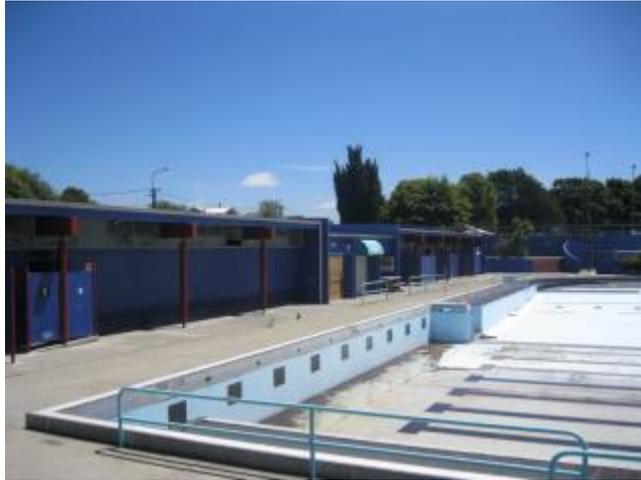
Minor residual displacements of the structure were observed in some of the external masonry walls on the pool side of the building. These were apparent in an outward top of wall displacement of 3-5mm.

Photograph 1 Pool side elevation of the main complex.

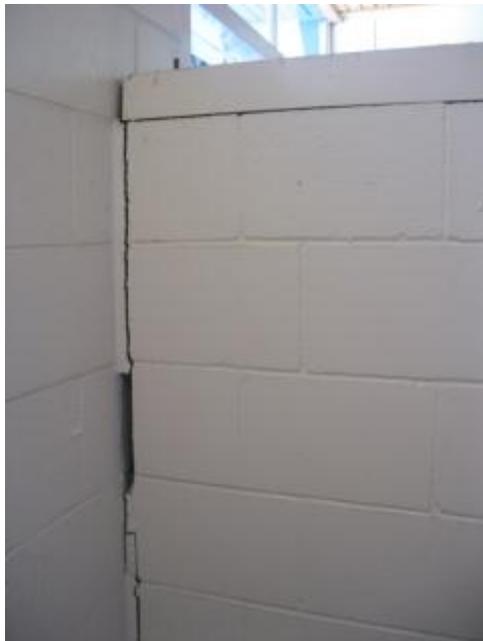
Most structural damage occurred during differential seismic movement of masonry walls forming 90 degree internal corners. These walls now have visible separation cracks at the corners, an indication of sparse or absent steel reinforcement continuity where the masonry meets at the corners.

Photograph 2 Typical masonry wall separation.

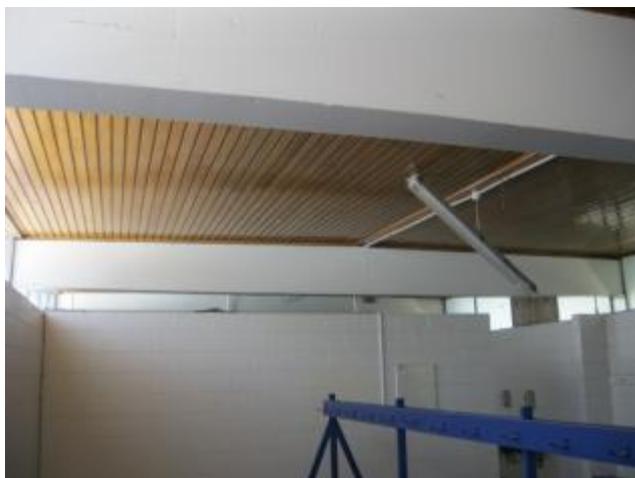
Possible bracing could not be observed in the roof of this building due to the presence of a ceiling lining. Bracing across relies on concrete portals at regular centres so in plane roof bracing could not be considered essential. However, the structure would benefit from roof braces if present to distribute more load to the end concrete panels, stiffening the structure. Opening the ceiling would be beneficial to prove or disprove the existence of roof plane bracing.

Photograph 3 Ceiling showing lining and concrete portal support.

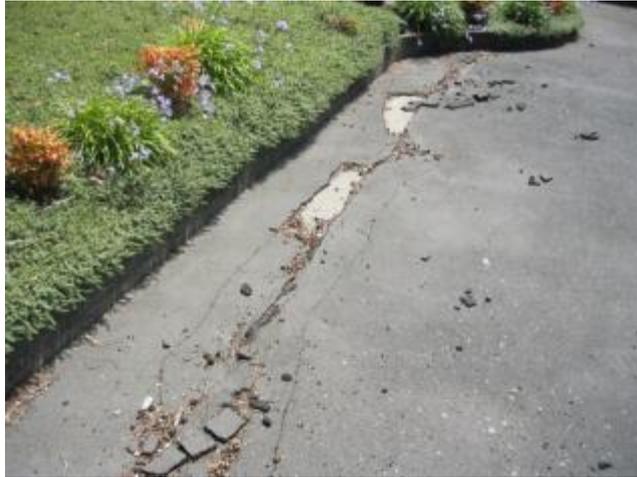
Paving at the building front shows damage that may be caused by minor lateral spread movement of the raised garden. Though geotechnical desktop study confirms there is significant potential for liquefaction, there was no evidence of liquefaction occurrence in this seismic event.

Photograph 7 Cracking in asphalt paving roadside, possible lateral spread.

Should a more comprehensive liquefaction and/or ground condition assessment be required, it is recommended that an intrusive investigation comprising of one piezocone CPT be conducted. From this, a numerical liquefaction analysis may be undertaken.
