**Warren Park Toilets**  
**PRK 1567 BLDG 002 EQ2**

**Detailed Engineering Evaluation**

**Quantitative Assessment Report**

### **29 Oakley Crescent**

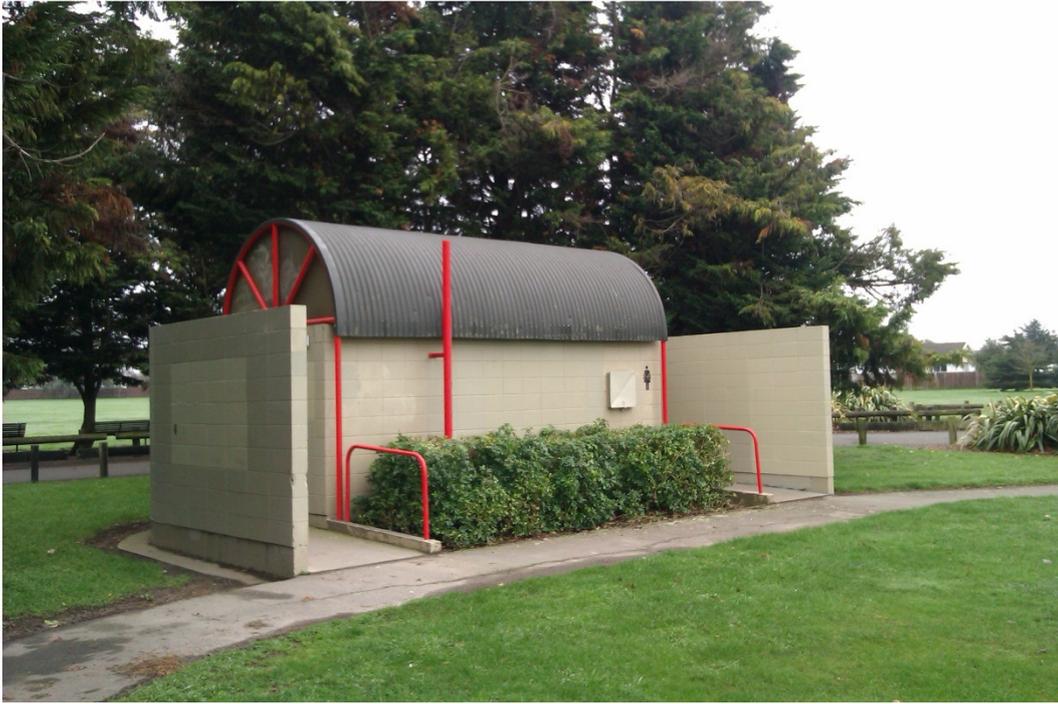
**Photo 1: Front View**

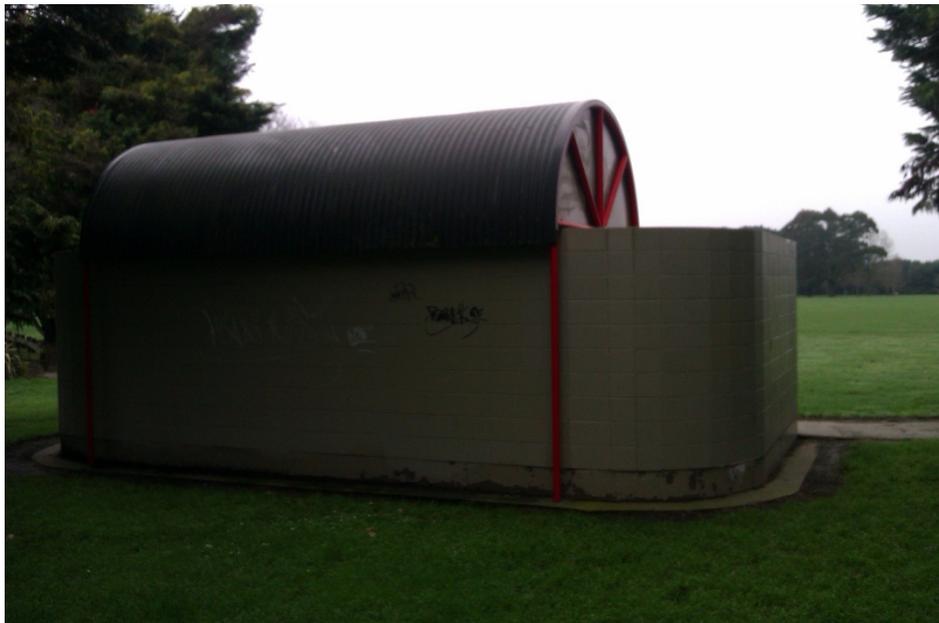
**Photo 2: Rear View**

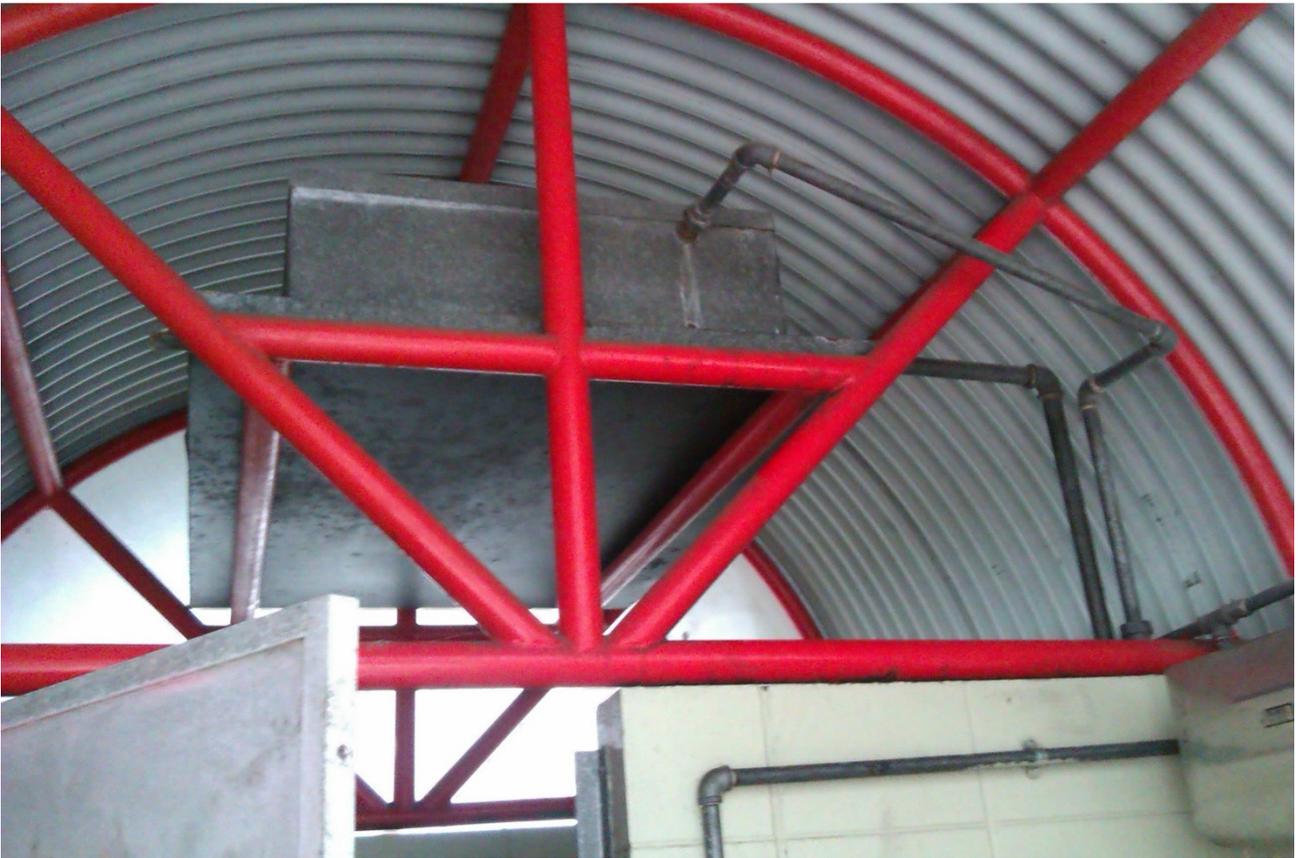
**Photo 3: Internal View of Roof**
