**Waterworks MPS Workshop  
Detailed Engineering Evaluation  
Quantitative Report**

Opus International Consultants Ltd

Date: 8 February 2013

54 Colombo St, Christchurch

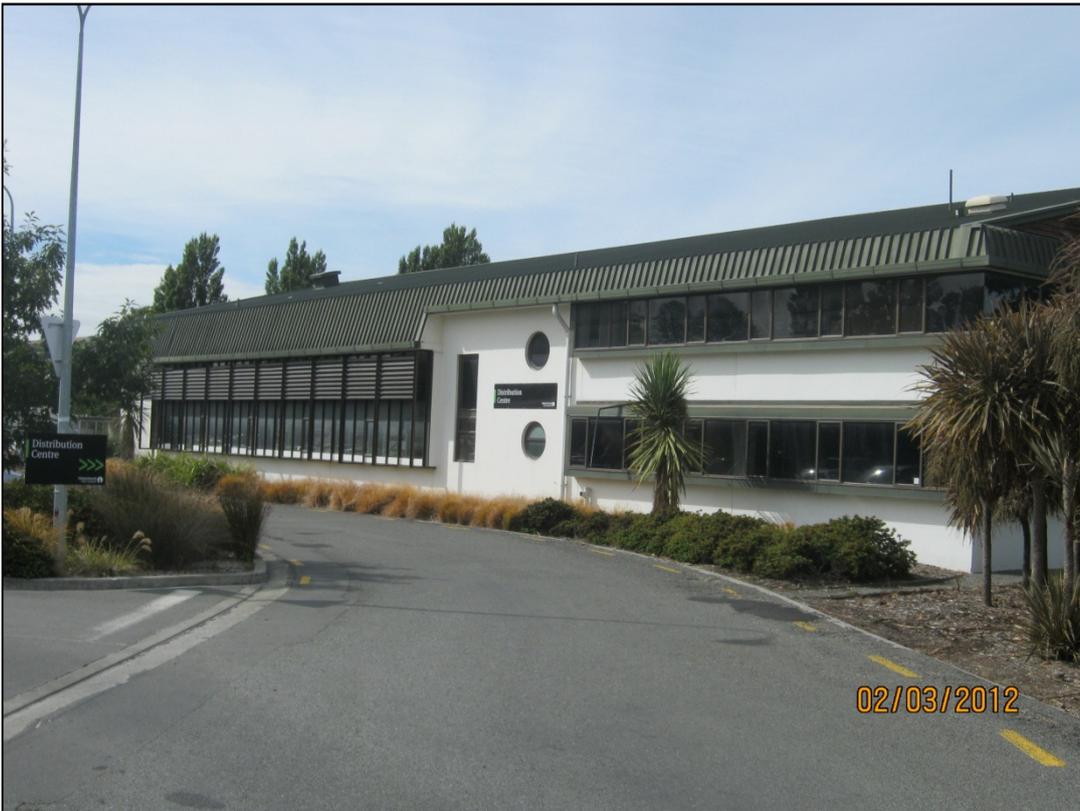
Photo 1: North facing wall

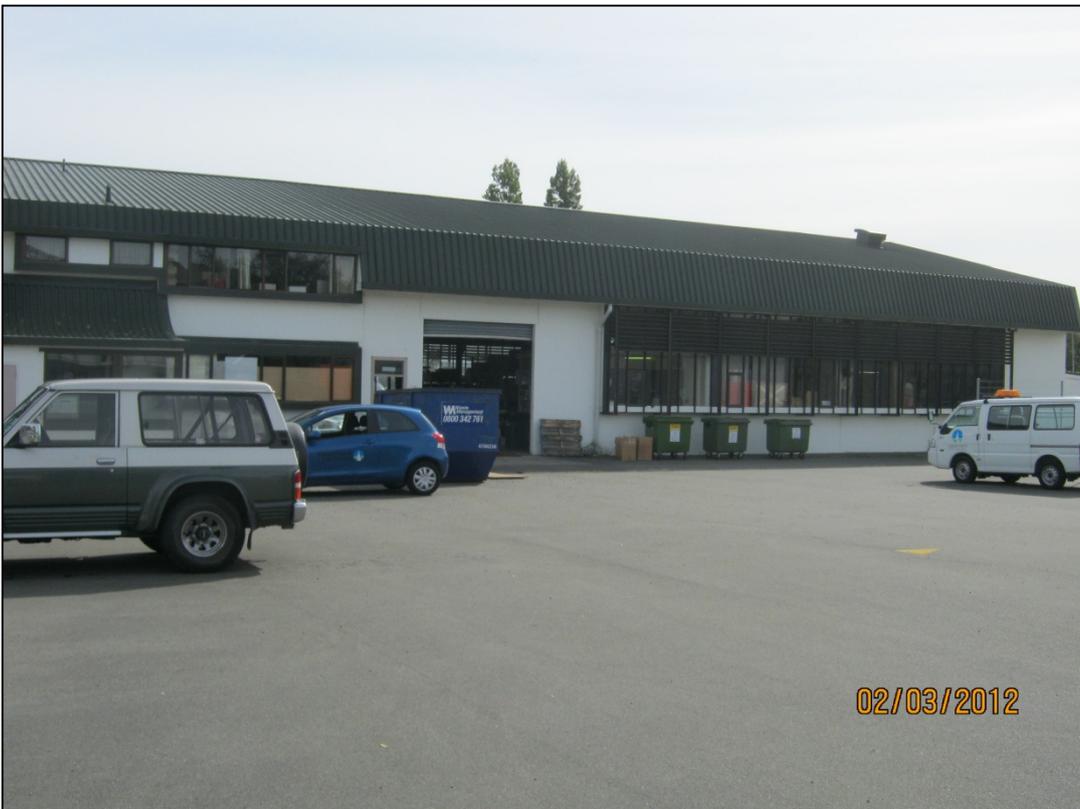
Photo 2: South facing wall

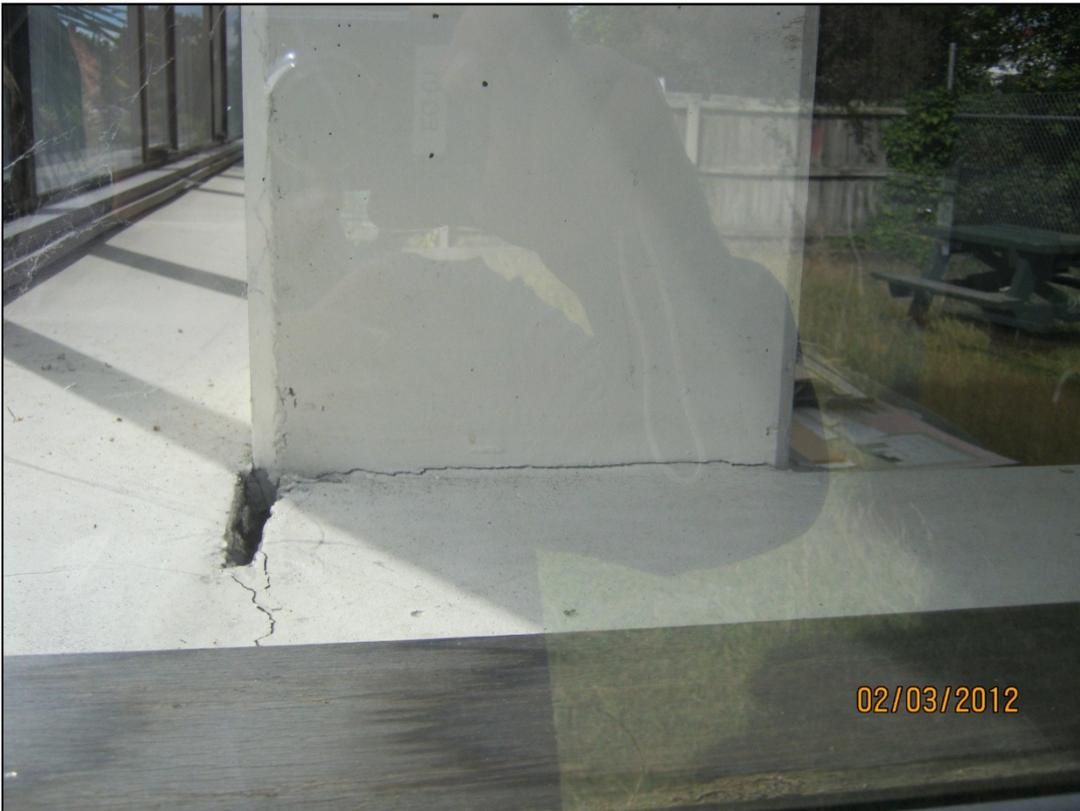
**Photo 3: Misalignment of wall panel at western end**

- (a) Carry out repair of the concrete slab
- (b) Carry out repair to the precast wall panel at the western end which has misaligned.
- (c) Carry out repair on the separation of panels around openings.
- (d) Strengthen the building to at least 67% NBS.

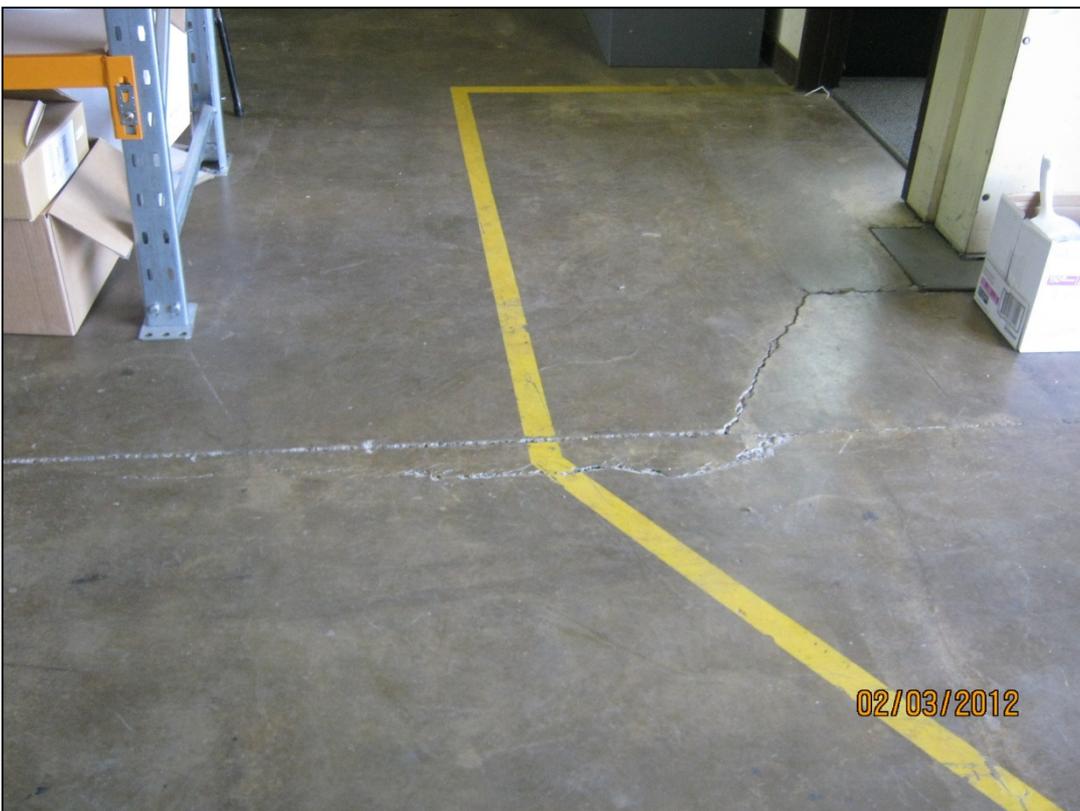
We observed cracks on the concrete slab on grade. These cracks were around and adjacent to several column locations.

**Photo 4: Cracking of floor slab**

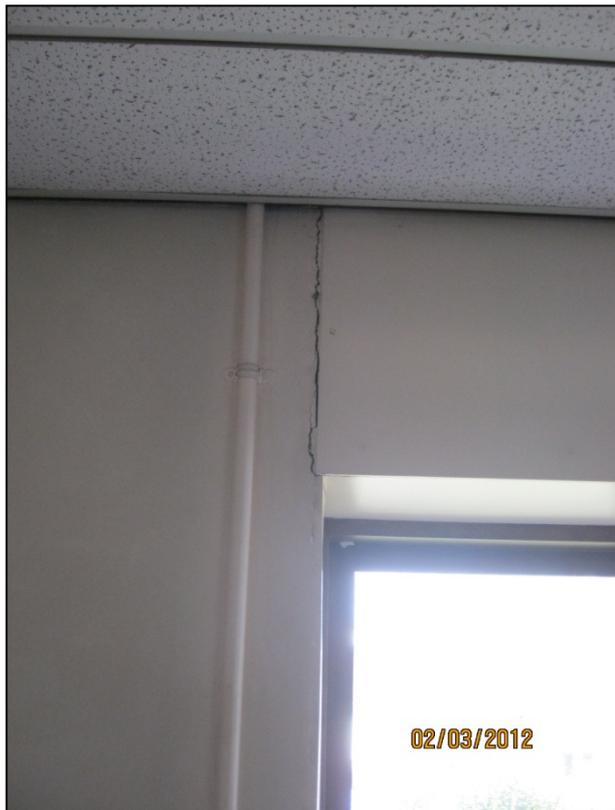
There is some minor cracking in the panels and separation of joints around window openings and panel joints.

**Photo 5: Cracks between panel joints**

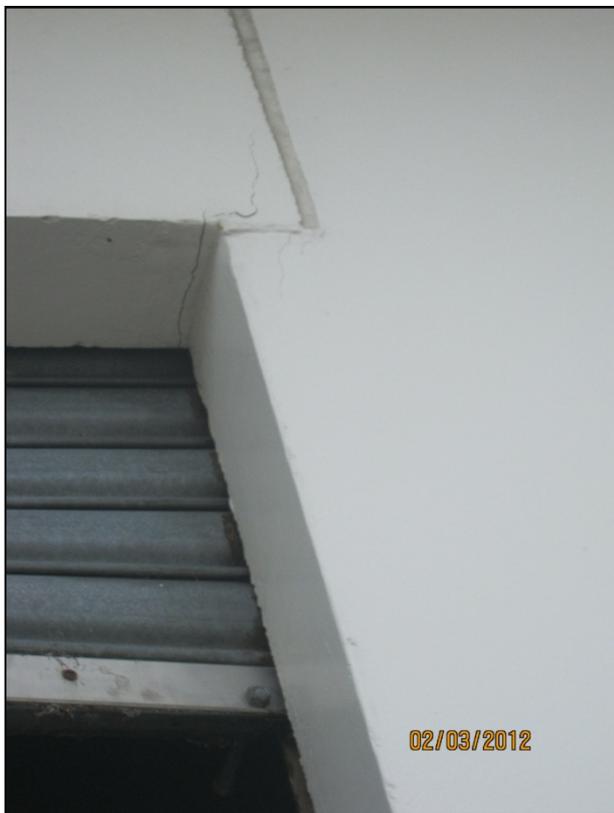
**Photo 6: Crack at panel seating**

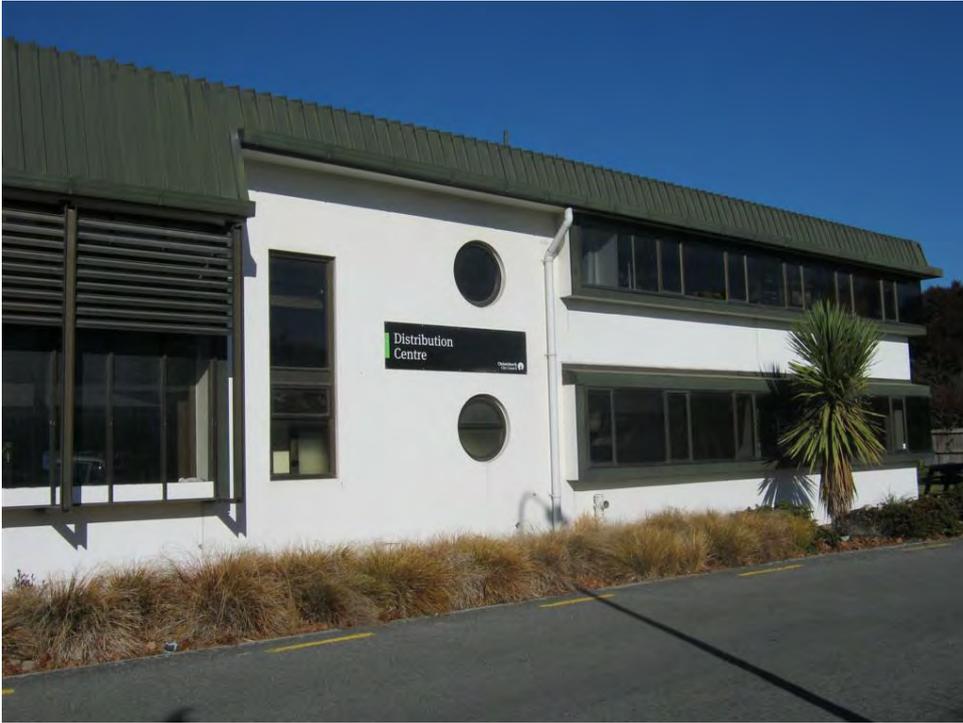
**Photo 1: Northern elevation, Waterworks MPS - Workshop, 54 Colombo Street.**

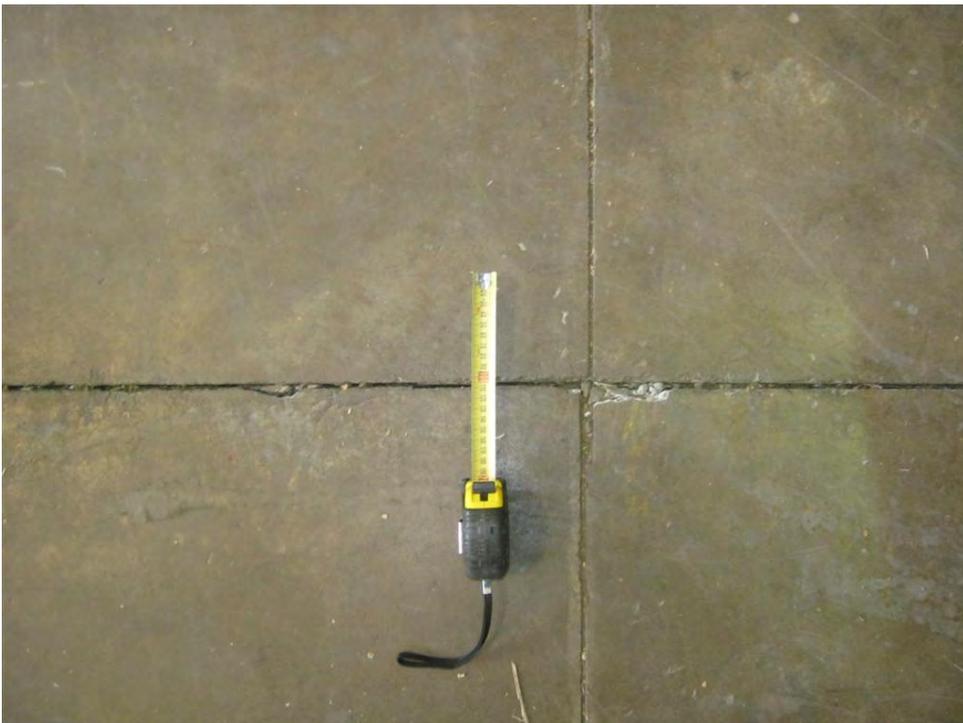
- Minor gaps have opened up between some floor slabs, maximum width of 10mm. Refer to Photos 2 and 3.
- Minor cracks have been observed within some floor slabs, the majority of these cracks are closed; however some have maximum widths of between 1mm to 2mm. Refer to Photo 4.

**Photo 2: Gaps opened up between floor slabs, maximum 10mm wide.**

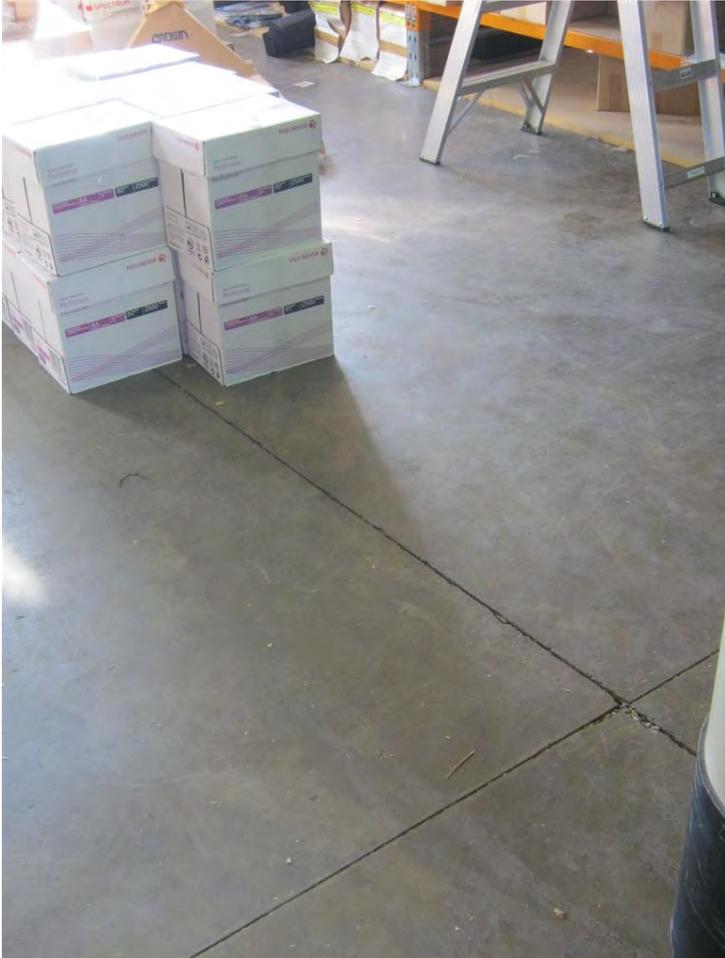
**Photo 3: Gaps opened up between floor slabs, maximum 10mm wide.**

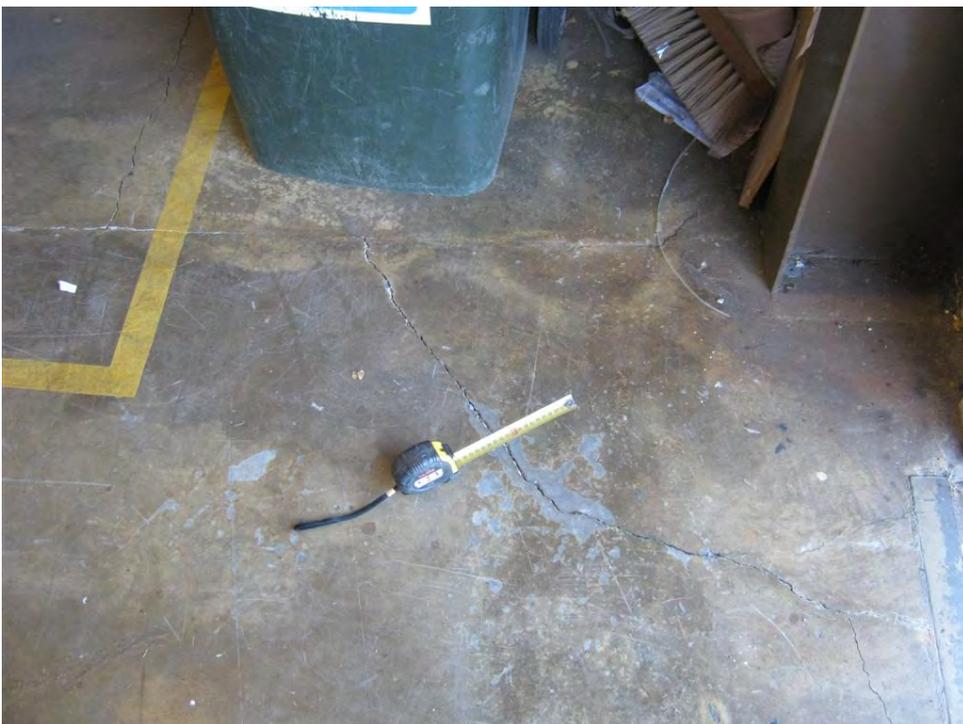
**Photo 4: Cracks observed within floor slab, 1mm to 2mm wide.**

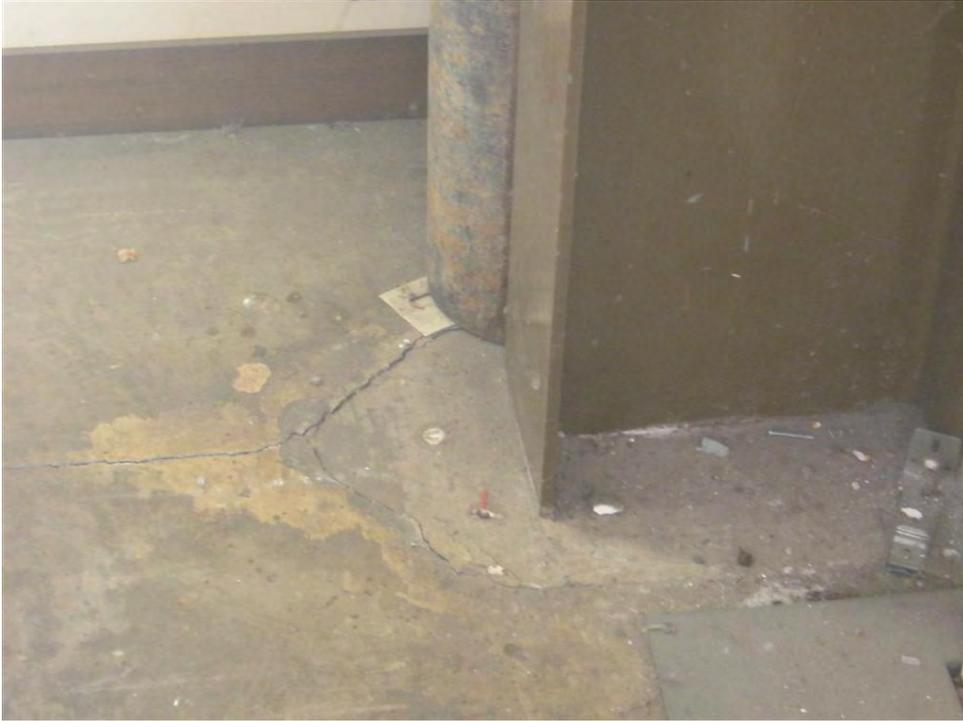
- Minor cracking has been noted around the base of some of the columns on the northern side of the building, maximum width of 5mm. Refer to Photo 5.
- A gap has opened up between the roller door on the eastern wall of the building and the floor slab with a maximum width of 10mm. Refer to Photo 6.

**Photo 5: Cracks observed at the base of column, 1mm to 2mm wide.**

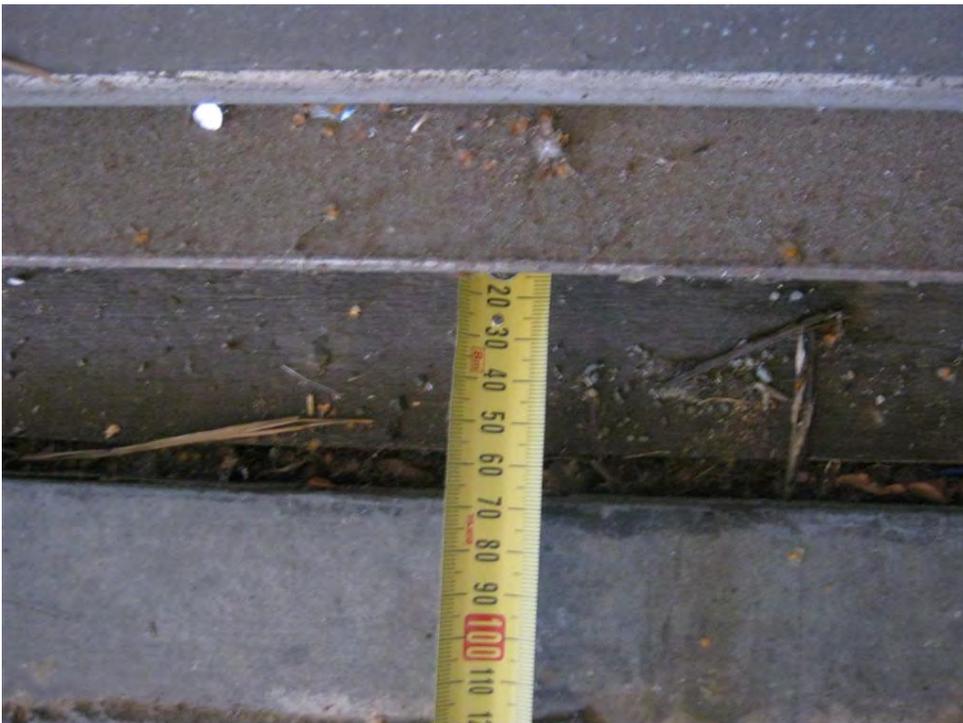
**Photo 6: Gap opened up between the base of the roller door on the eastern side of the building and the floor slab.**

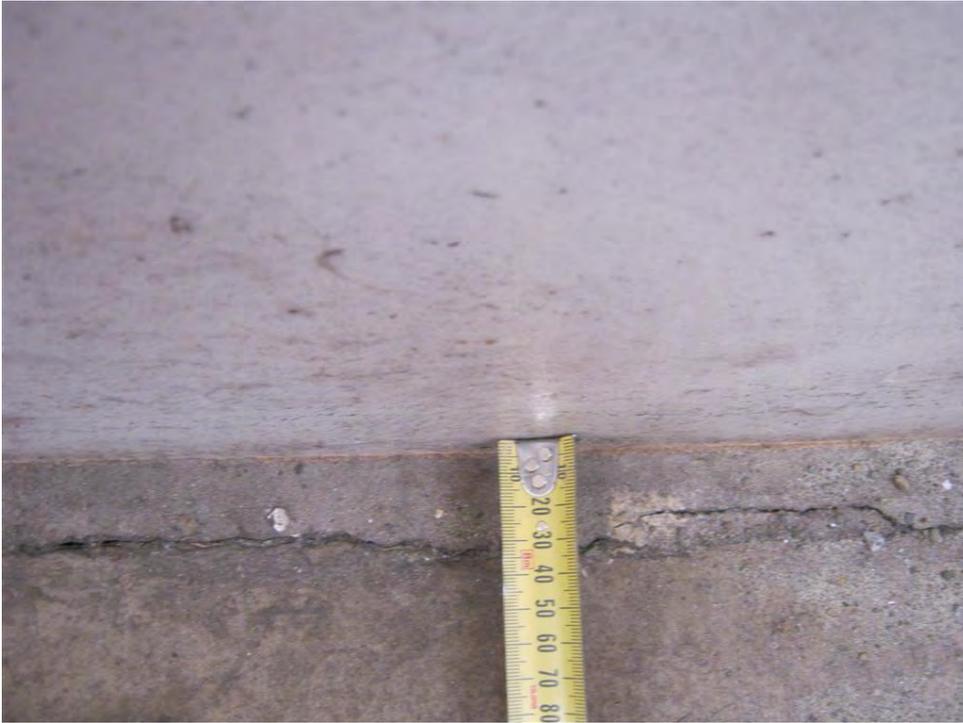
- Minor gaps have been observed between the base of some walls and the floor slabs. Refer to Photo 7.
- Minor differential settlement of approximately 5mm has been observed over some cracks in the floor. Refer to Photo 8 and 9.

**Photo 7: Crack at the base of the wall, 1mm to 2mm wide.**

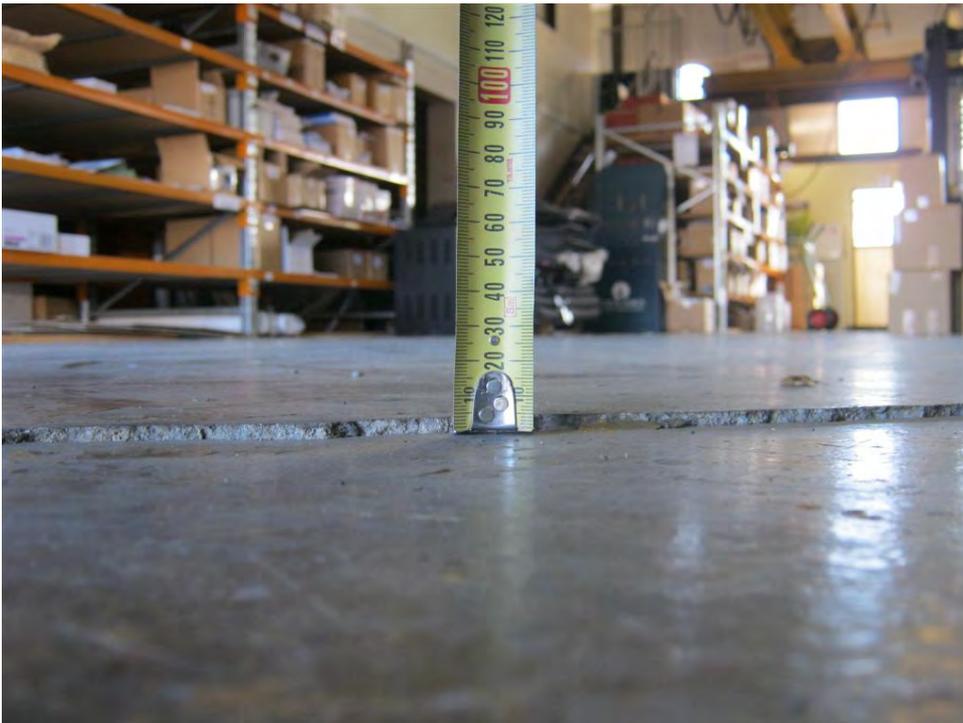
**Photo 8: Differential Settlement of 5mm across a crack within the floor slab.**

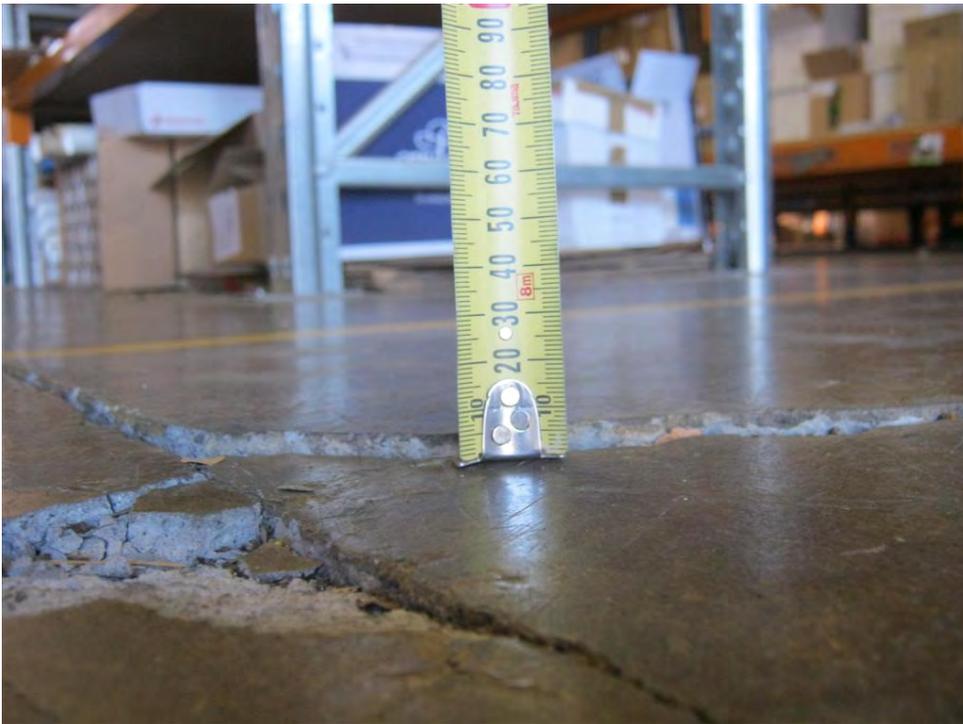
**Photo 9: Differential Settlement of 5mm across a crack within the floor slab.**

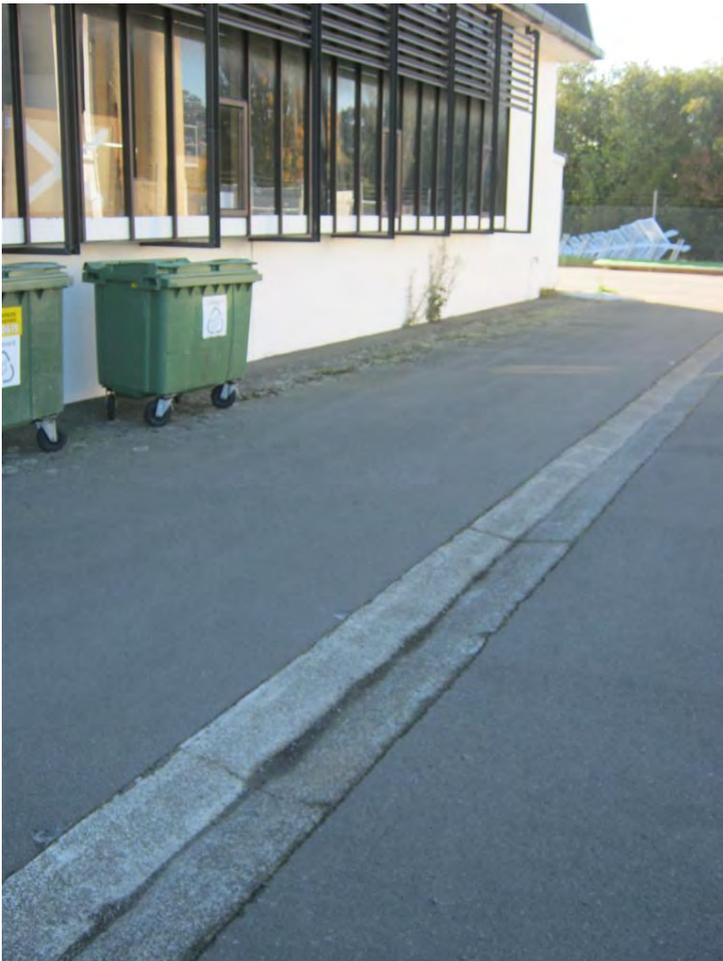
**Photo 10: Raised drainage channel by approximately 1mm to 2mm.**

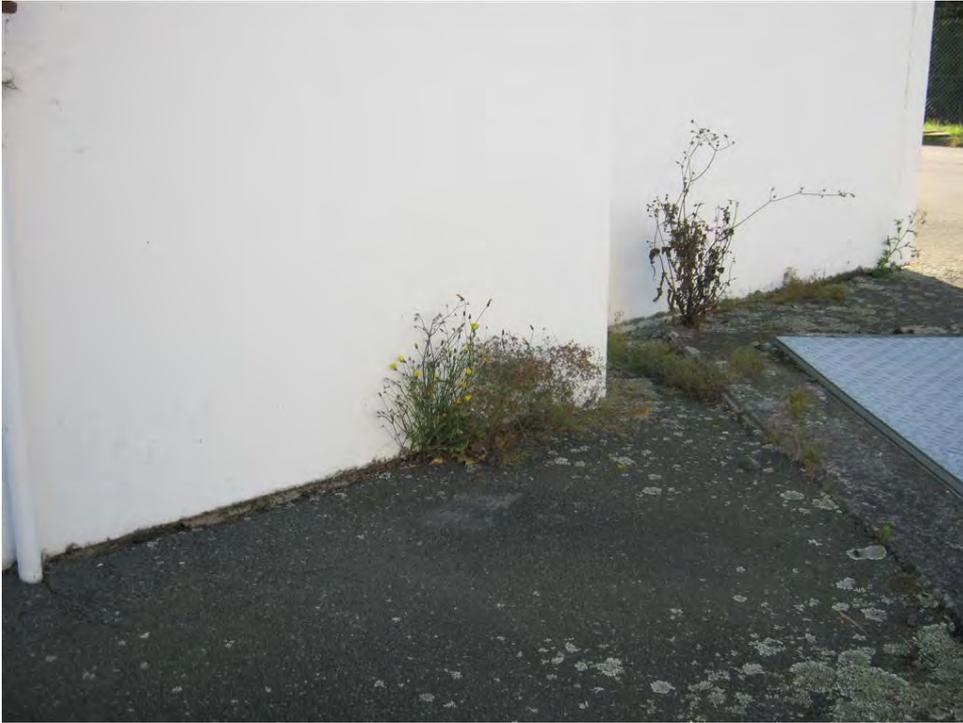
**Photo 11: Land settlement around manhole and south-eastern corner of building, maximum settlement 30mm.**

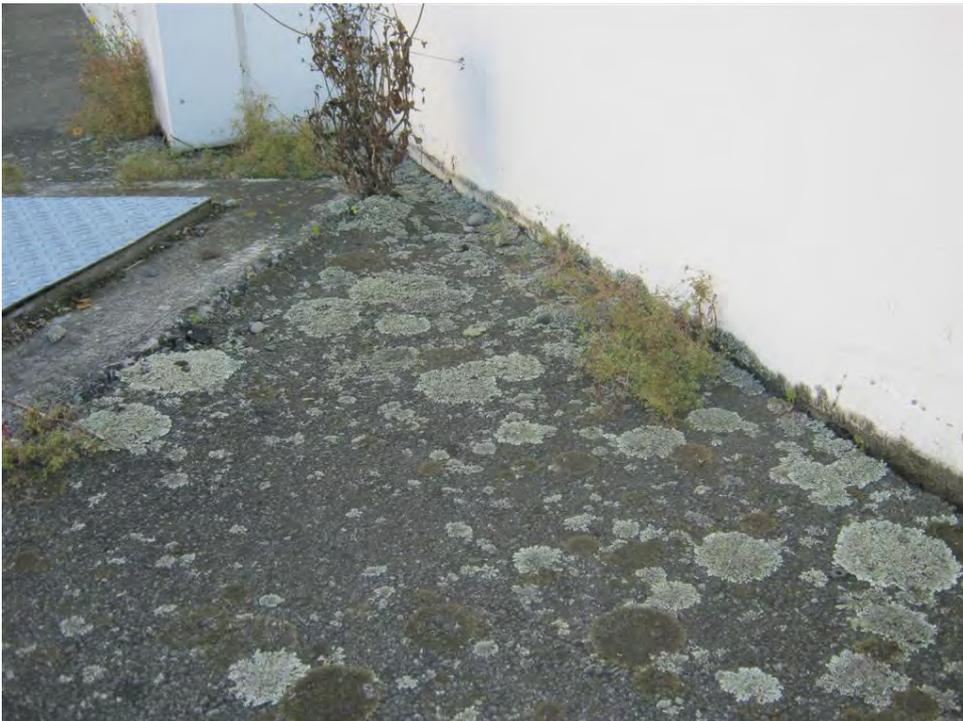
**Photo 12: Land settlement around manhole and south-eastern corner of building, maximum settlement 30mm.**

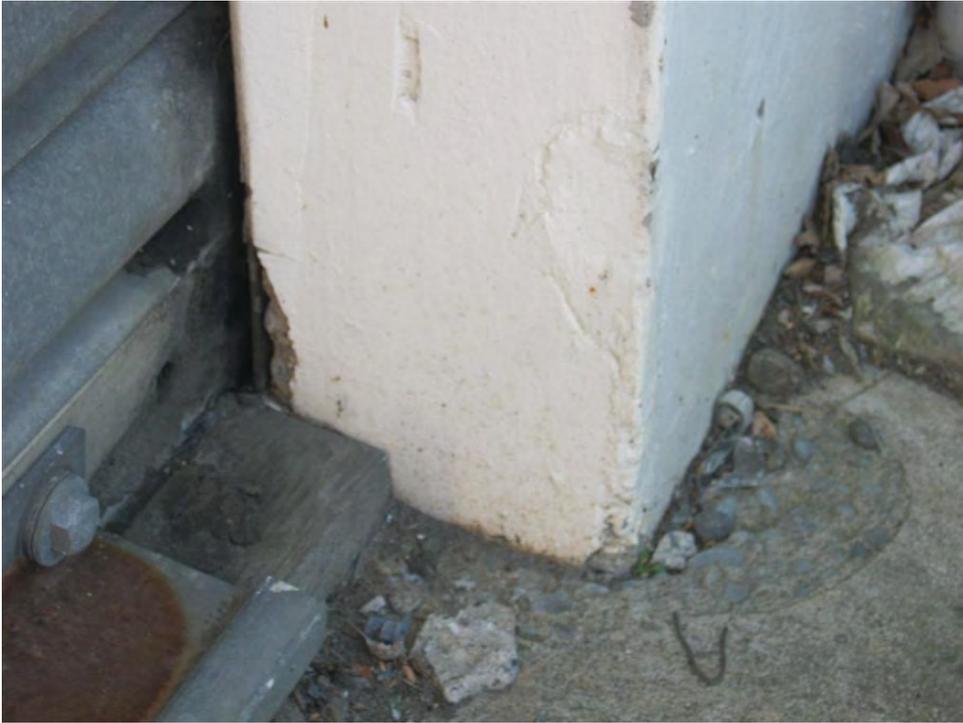
**Photo 13: Minor spalling of concrete at the eastern roller door.**

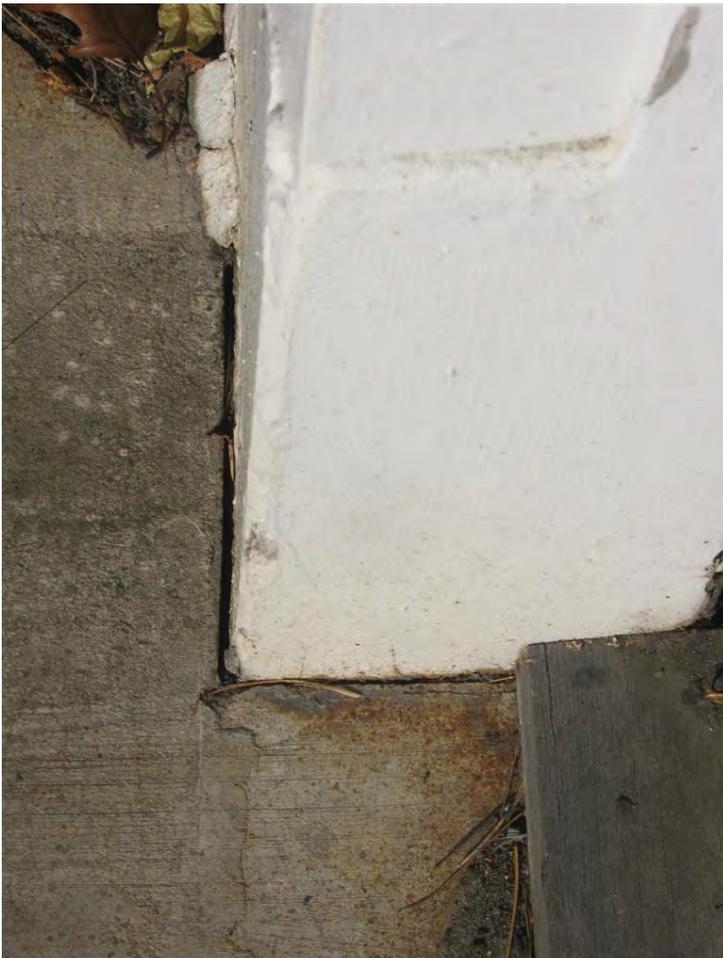
**Photo 14: Minor gap opened up between eastern side of the building and the asphalt carpark.**

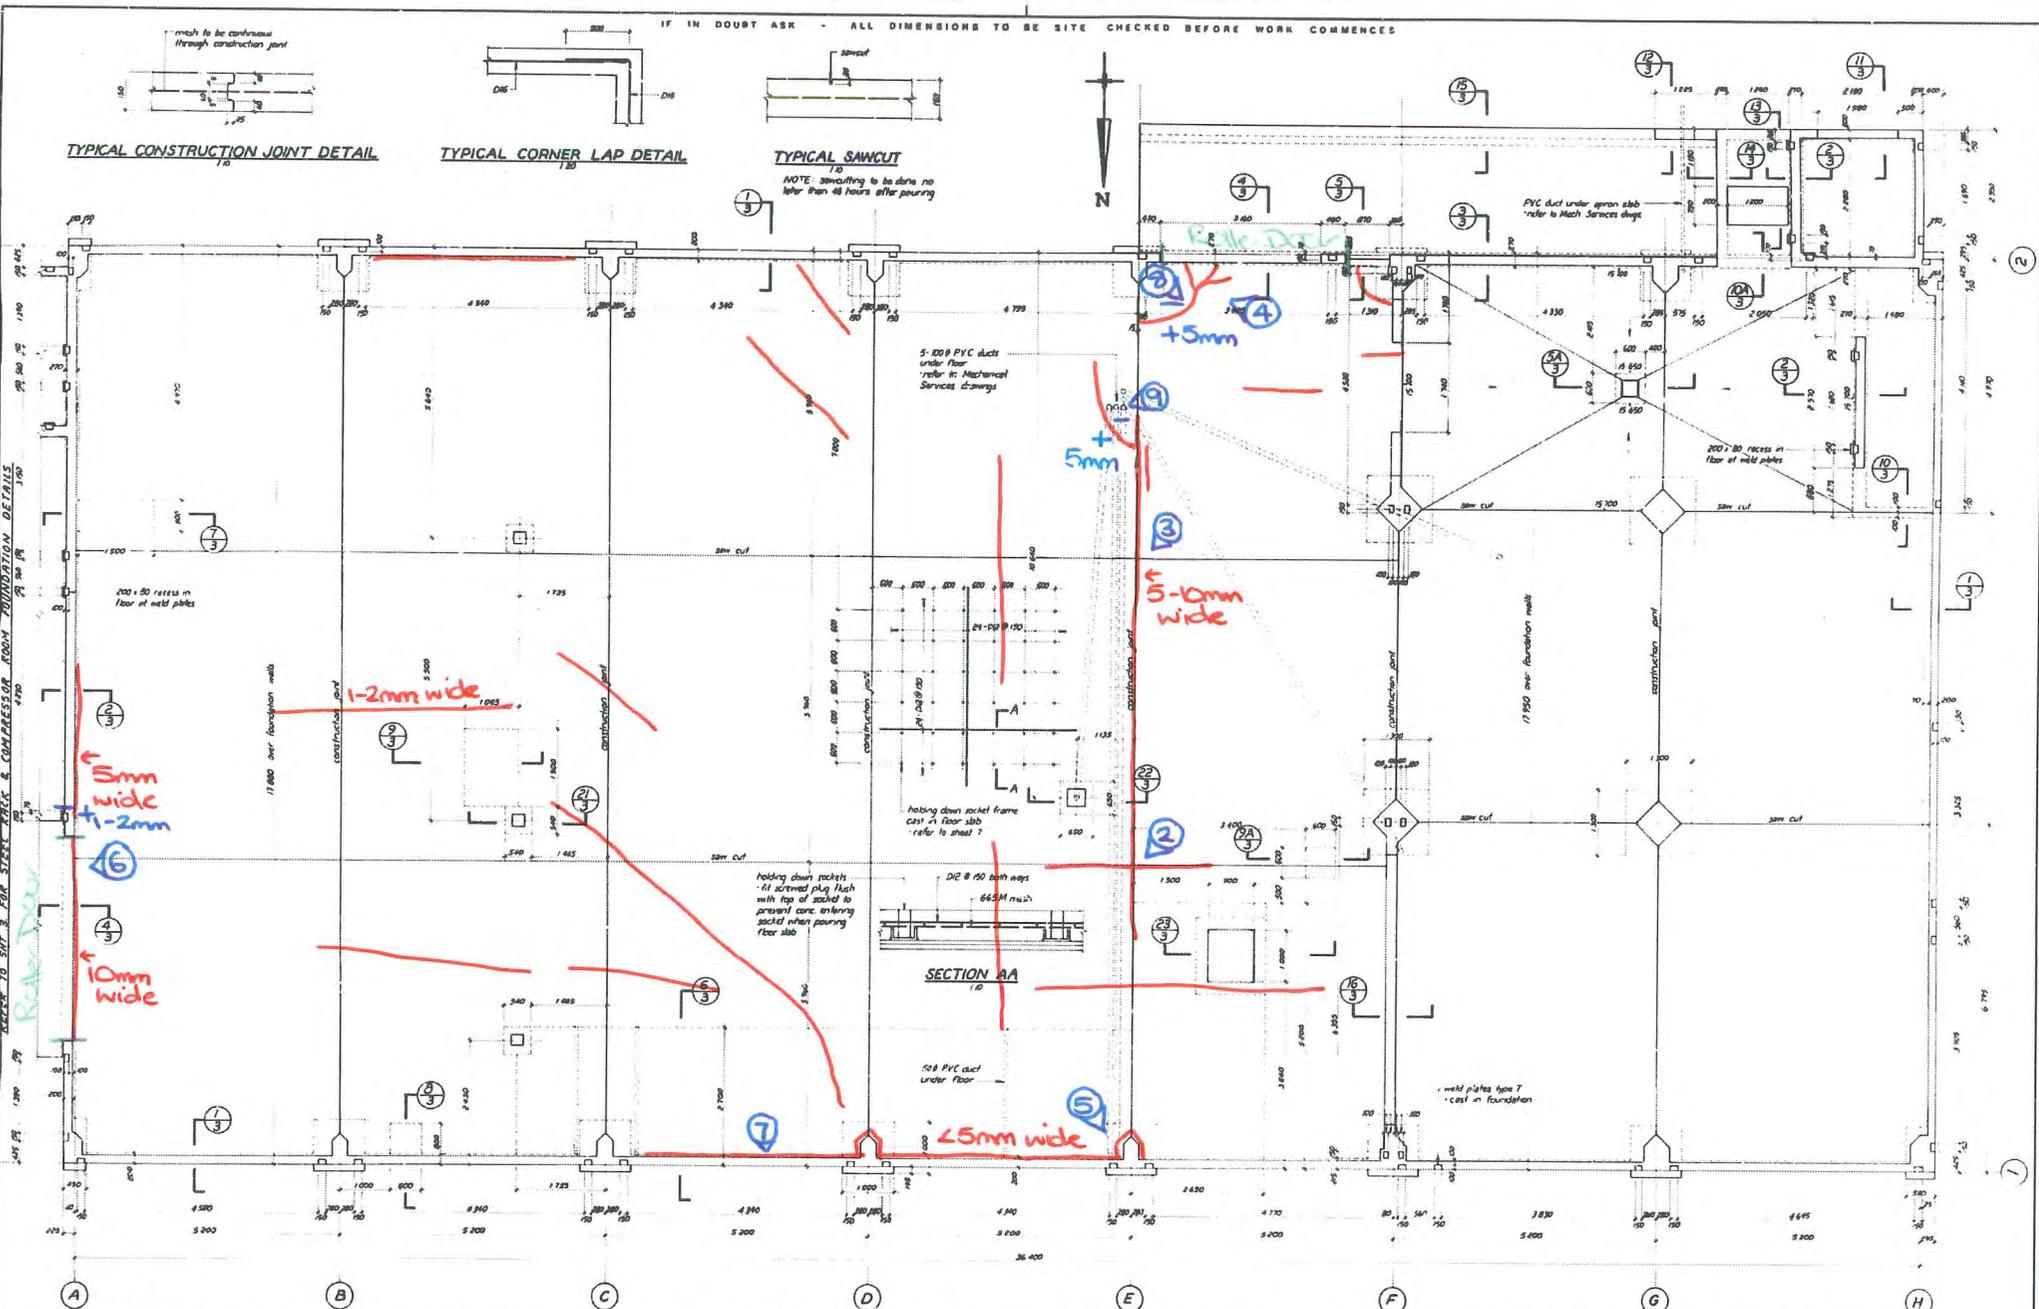
/ Cracks (closed unless stated).    
 + Differential settlement over a crack.    
 ⊙ Numbered Photos from Appendix A.
