**Westburn Reserve Toilets
PRK 0273 BLDG 001 EQ2**

Detailed Engineering Evaluation

Quantitative Assessment Report

32 Westburn Terrace, Burnside

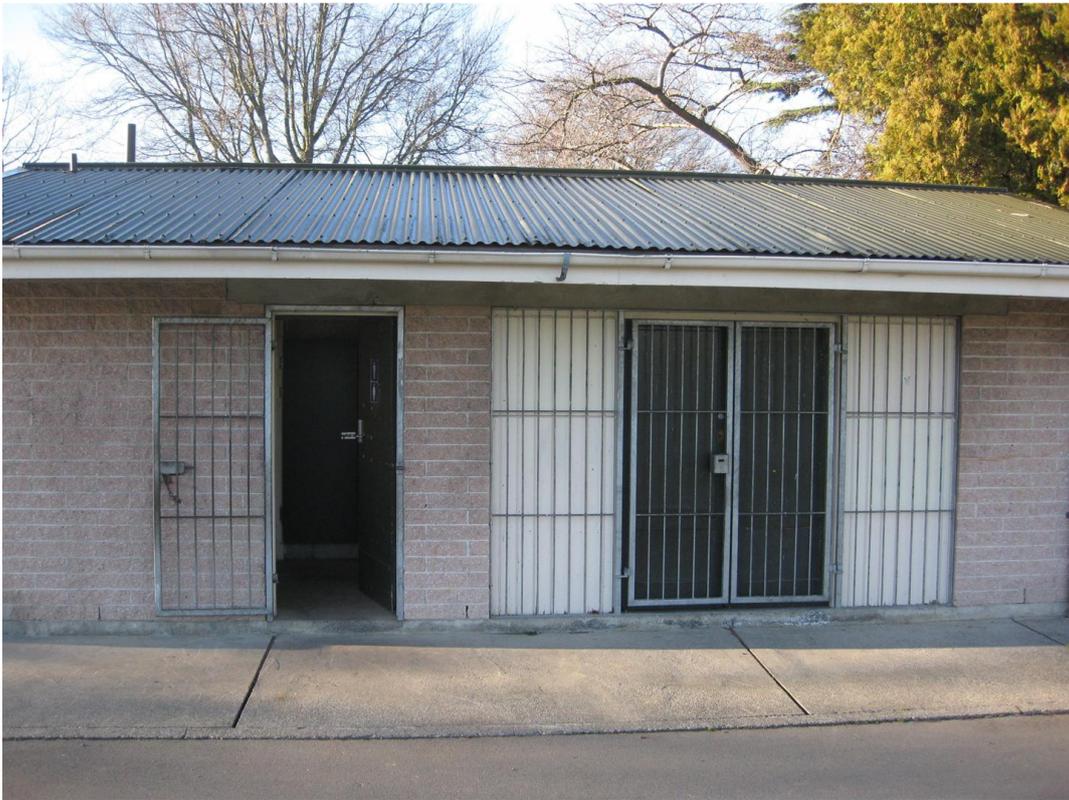
Photo 1: View of the building from the street

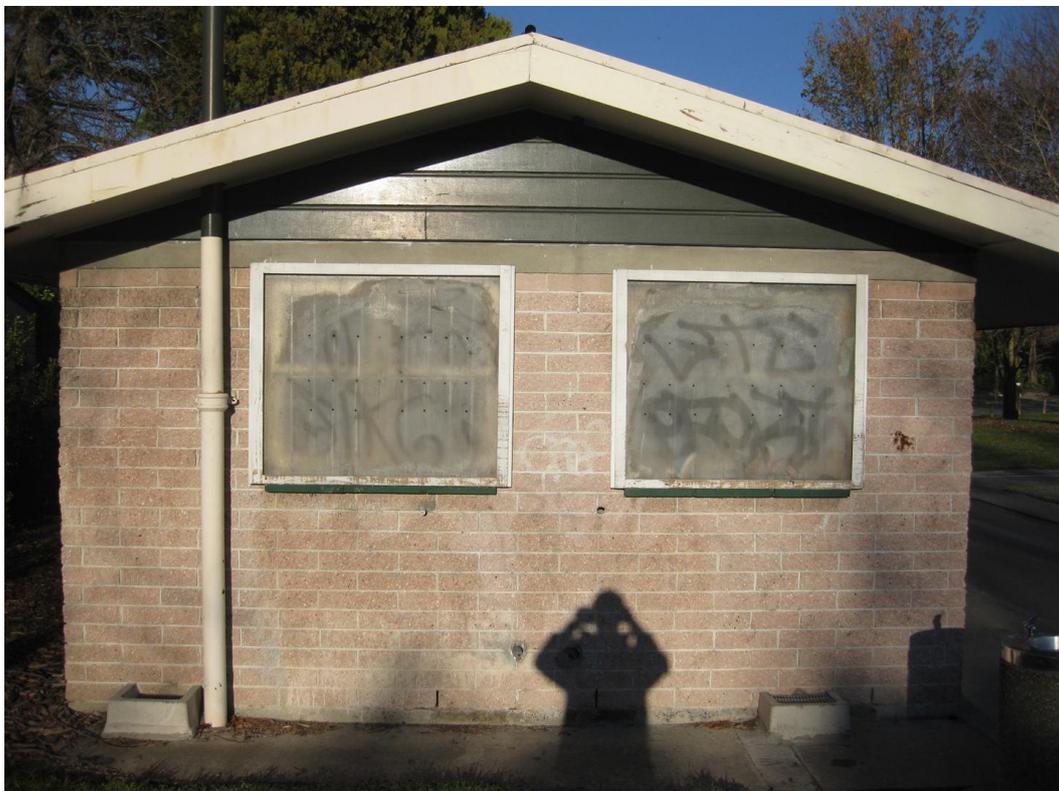
Photo 2: View of the building from left side

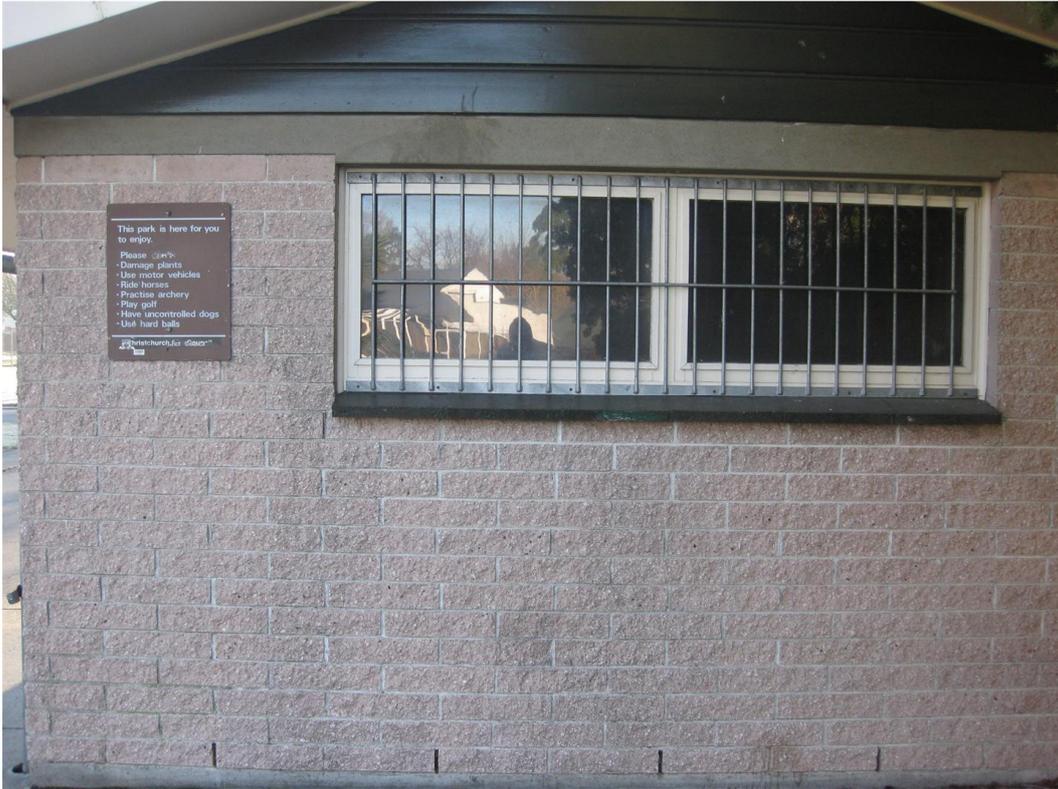
Photo 3: Right side wall

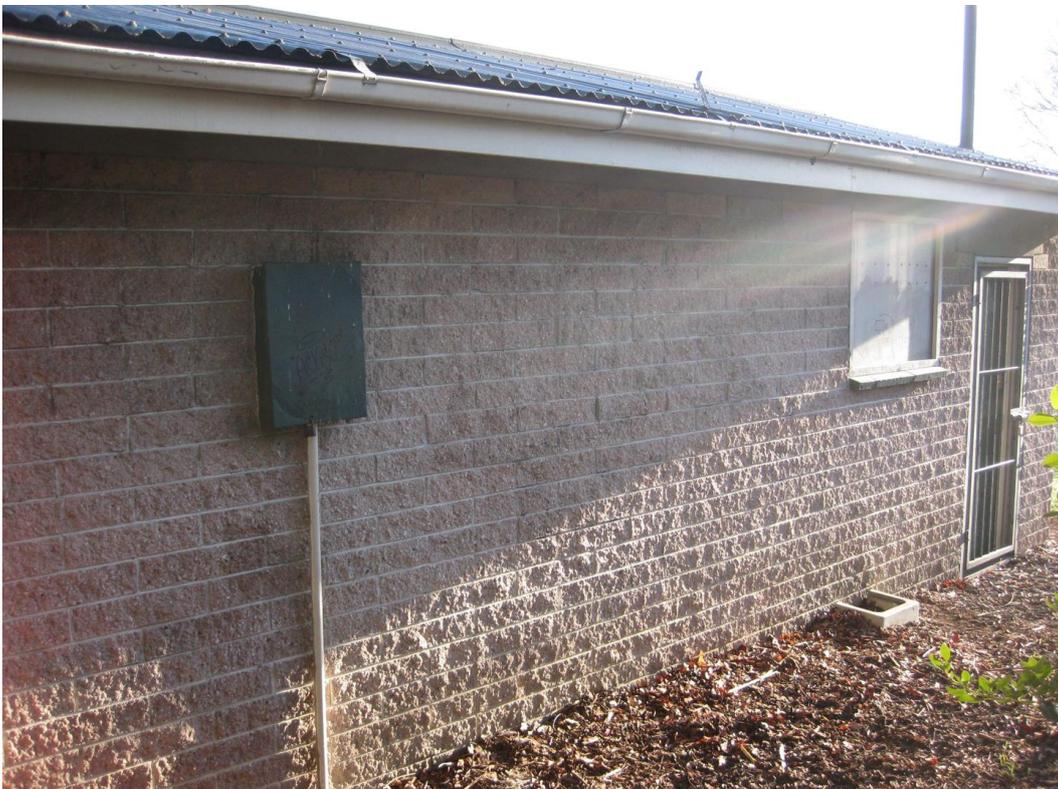
Photo 4: Rear wall

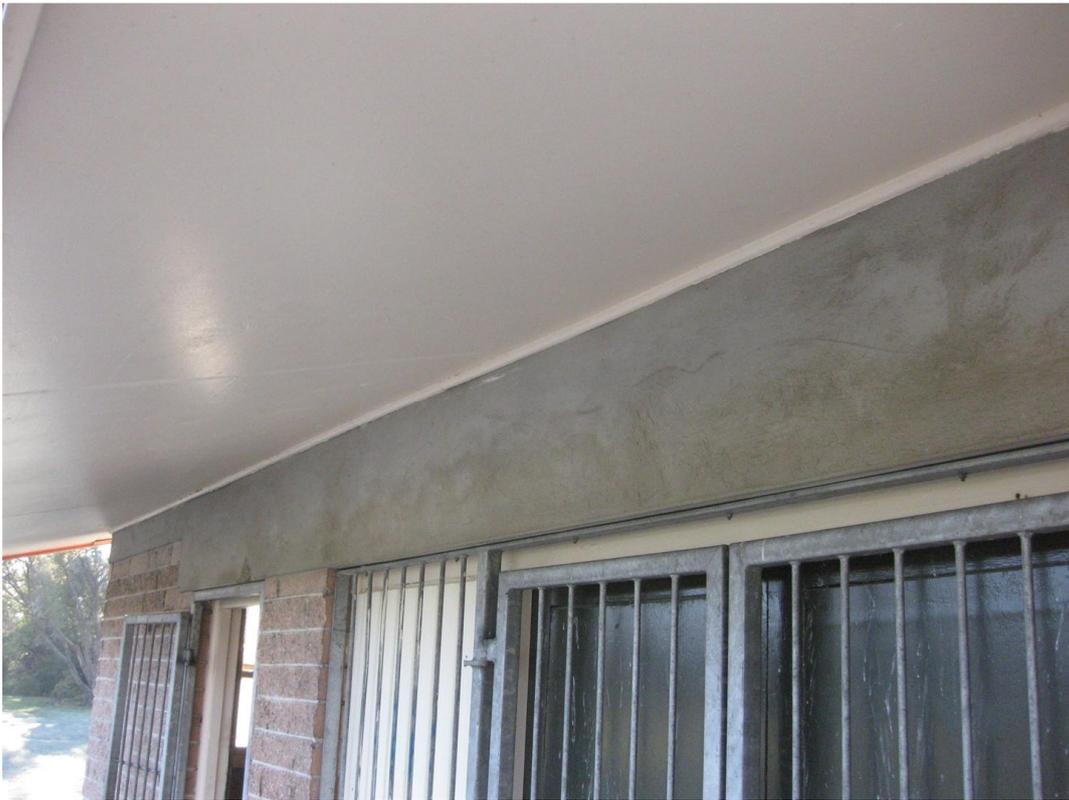
Photo 5: Front wall lintel

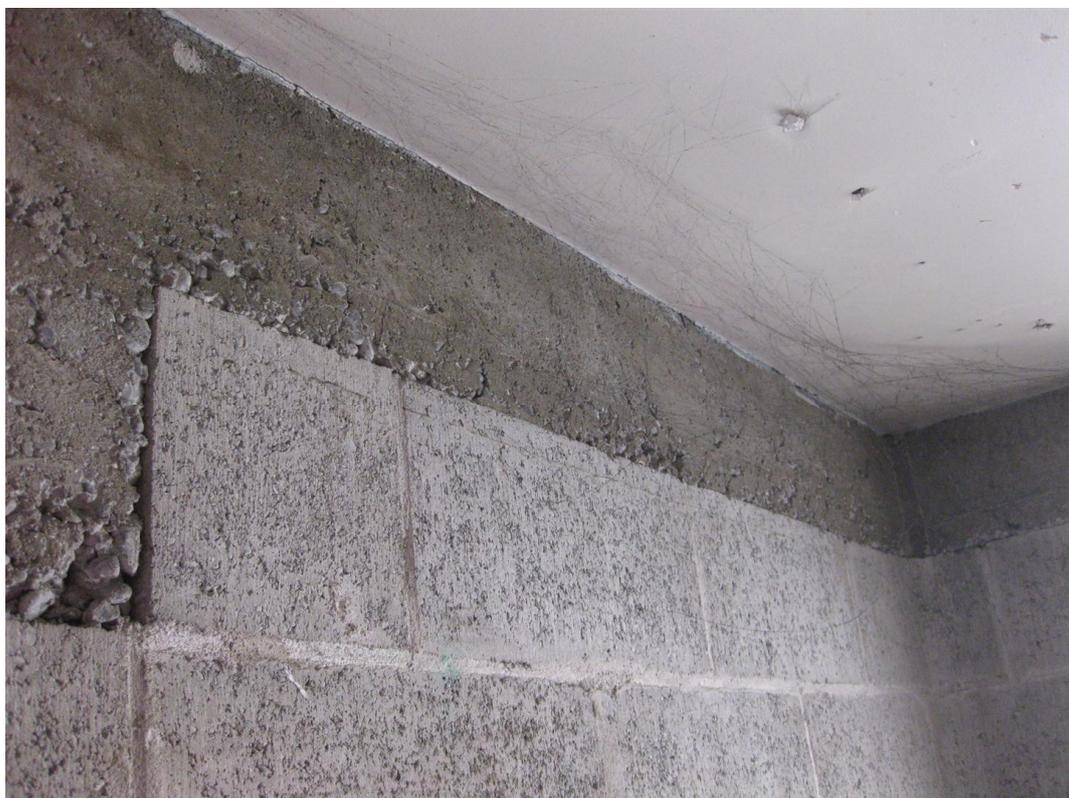
Photo 6: Internal wall, bond beam and ceiling

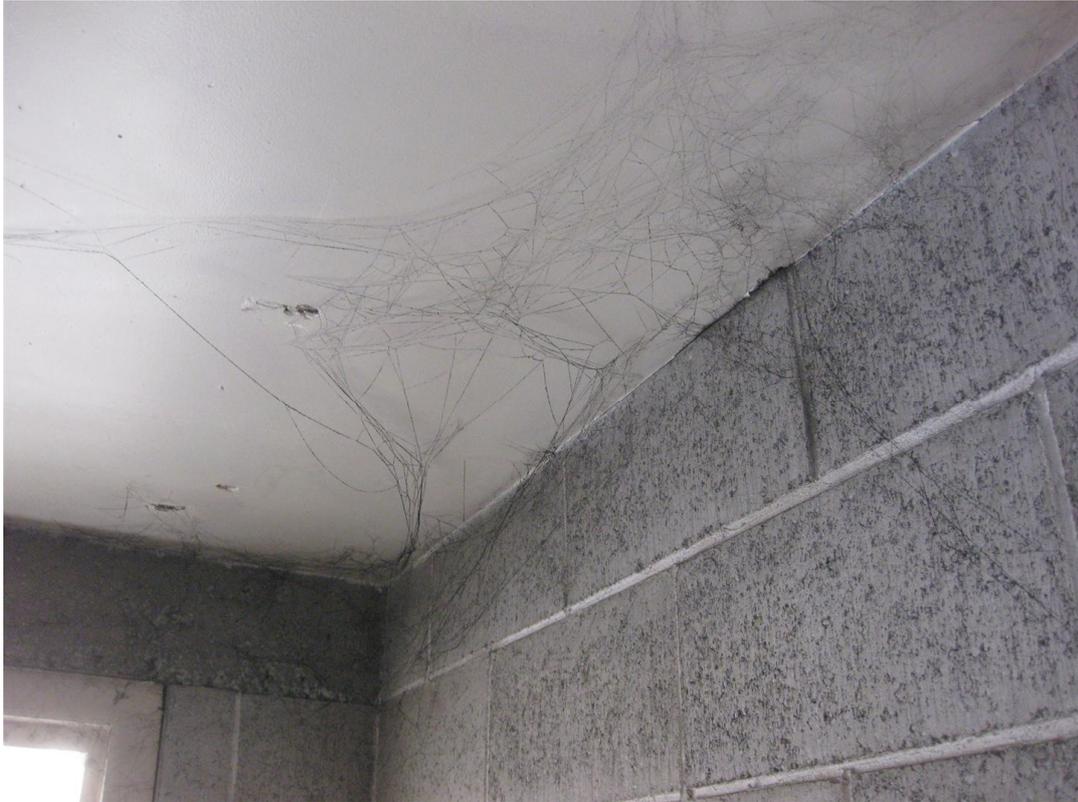
Photo 7: Internal wall, bond beam and ceiling

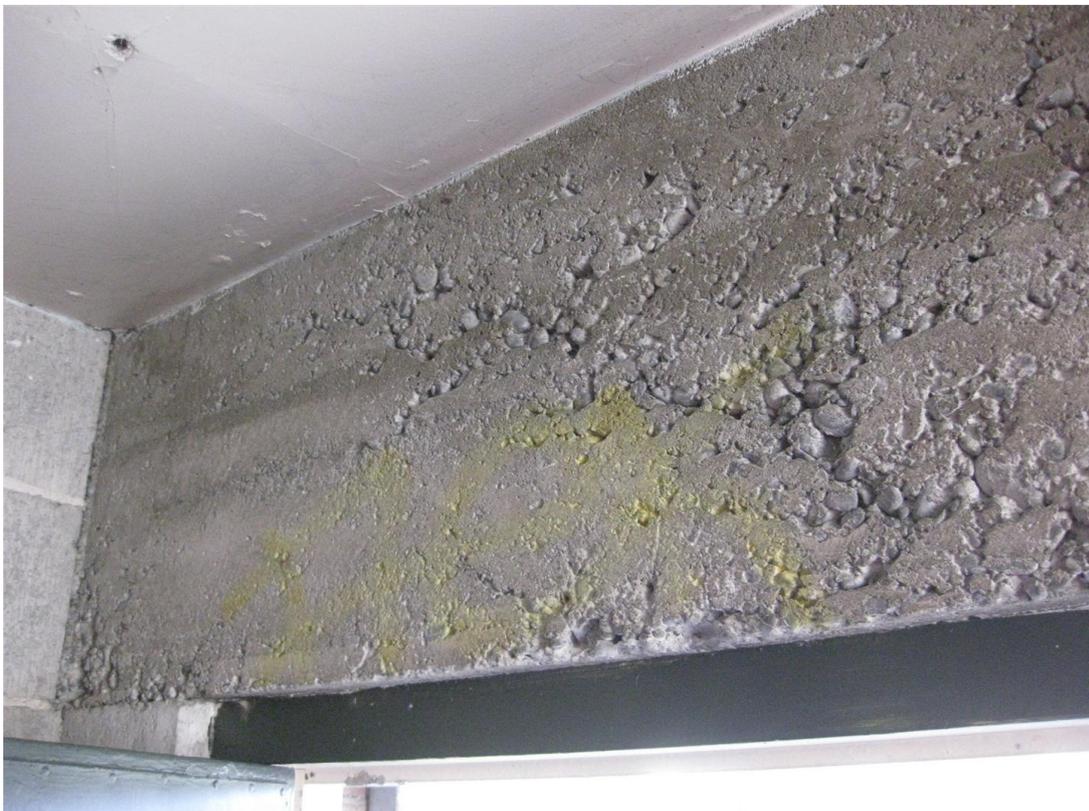
Photo 8: Front wall lintel

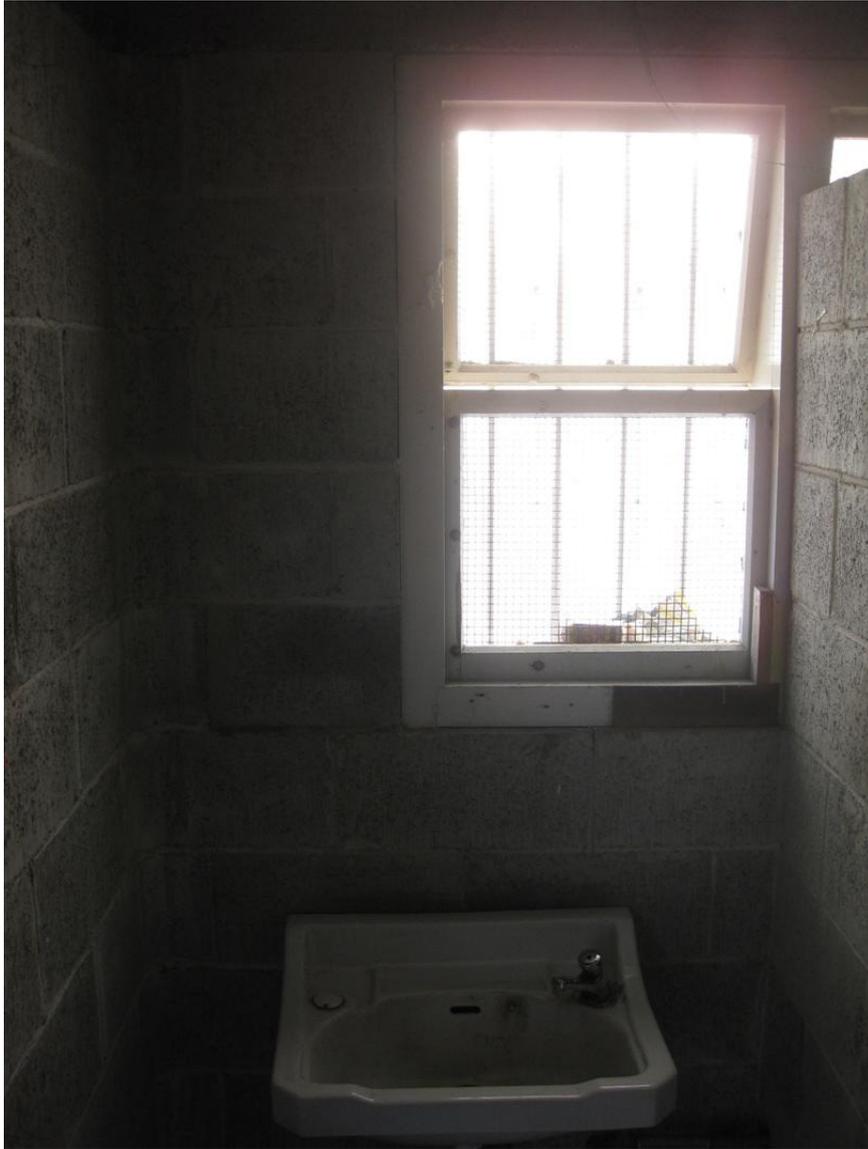
Photo 9: Partition wall at Toilet
