**Wharenui Recreation Centre Sports Hall**

***Detailed Engineering Evaluation***  
**Quantitative Assessment Report**

Christchurch City Council

Date: September 2012  
Reference: 6-QUCCC.41  
Status: Final

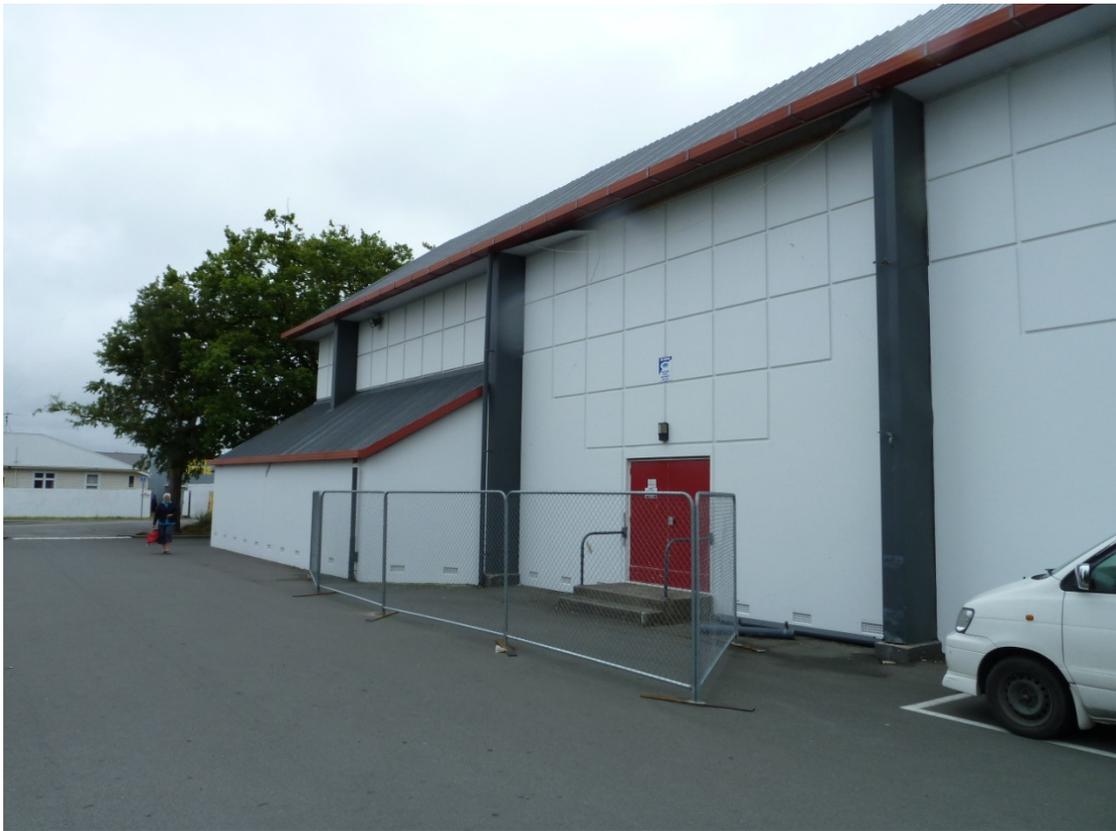
1. The damage sustained to the external precast panels appears to be a combination of both shear cracking and out of plane failure. Some spalling/crushing of concrete was also noted near one of the ventilation grills, and internally at the top of one of the precast panel joints. Damage was observed primarily along the west and south walls, with cracks located in panels with access way cut-outs.
  - a) We will first consider the damage observed along the west wall of the building, see over page:

**Photo 1 - West wall elevation**

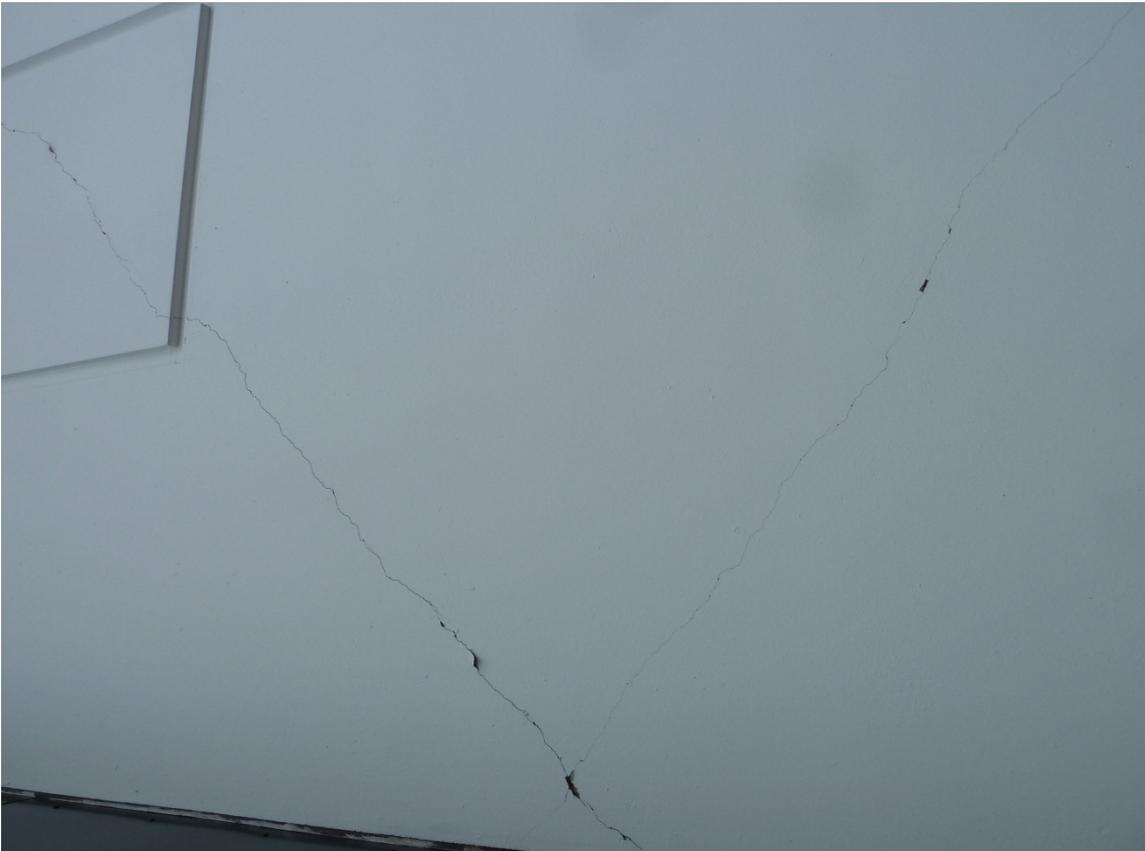
**Photo 2 – Diagonal cracks in the west wall precast panel**

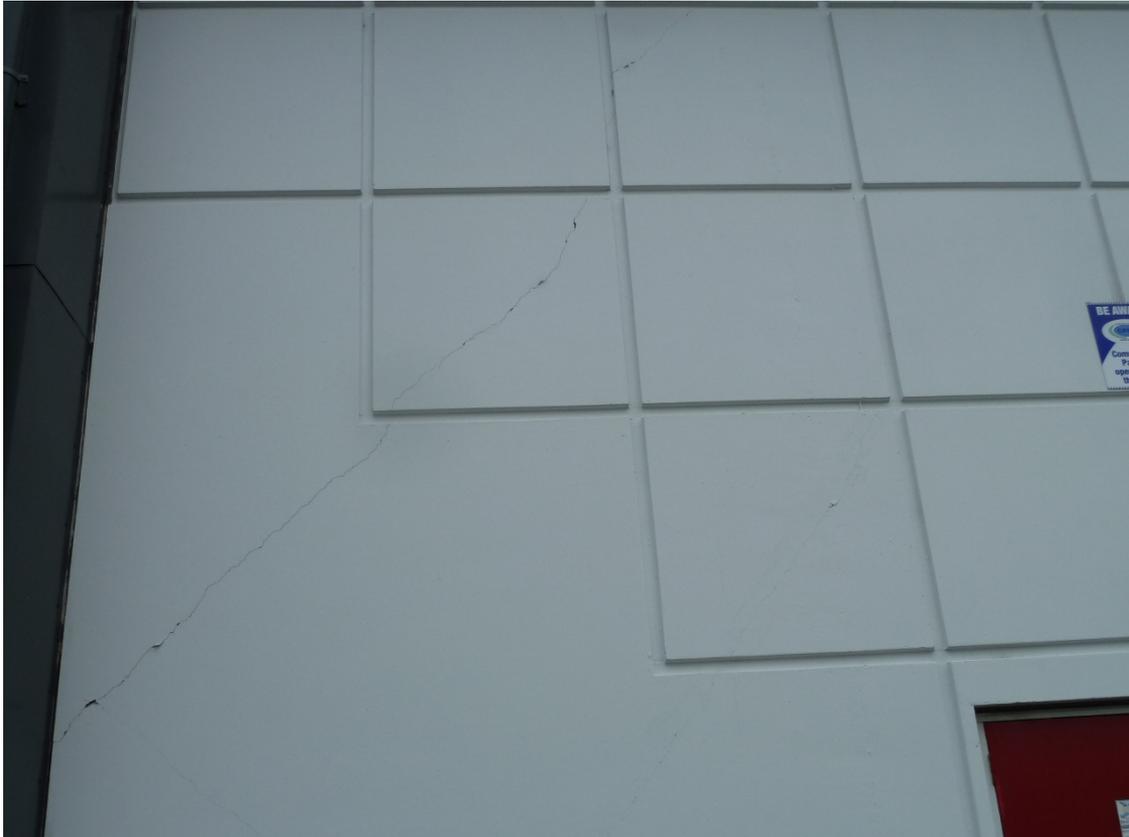
**Photo 3 - Shear crack in west wall panel**

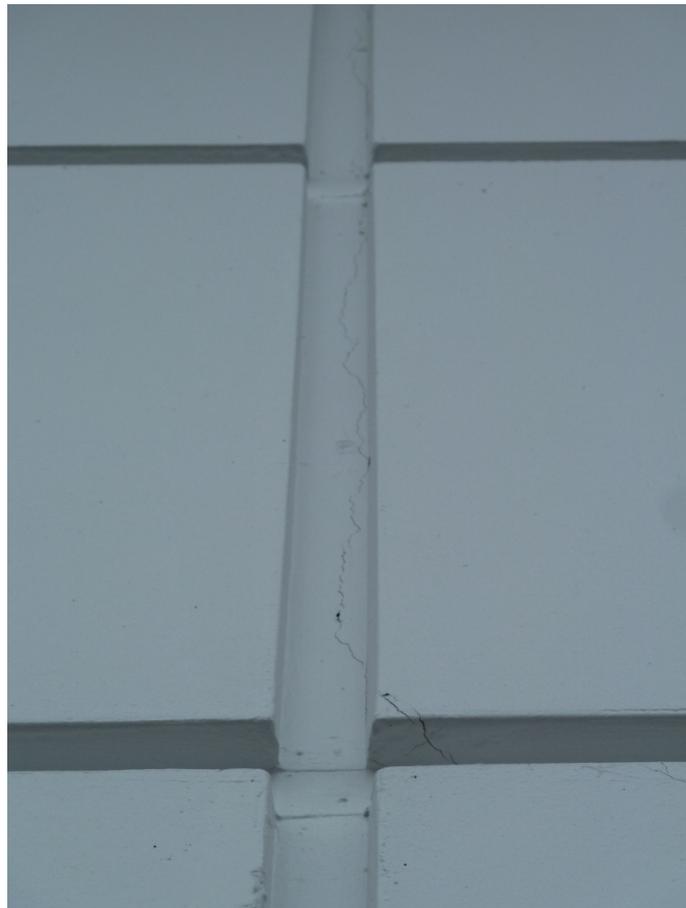
**Photo 4 - Vertical crack in west wall panel**

Note the vertical crack in the west wall is located in the panel with diagonal steel ties shown above. With the diagonal ties acting in tension, and without tie beams between portals, the precast panel will need to carry the resultant axial compression. The compression forces in the panel could contribute to the out of plane failure of the panel.

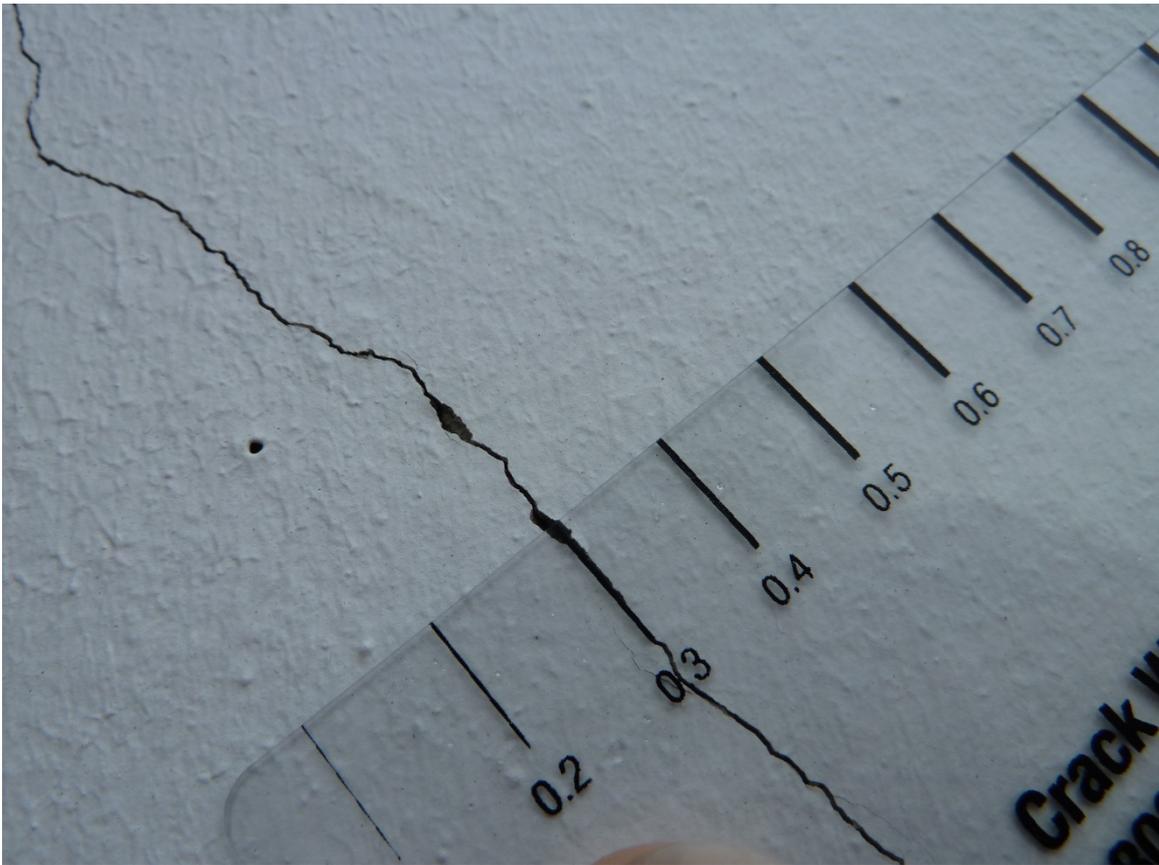
**Photo 5 - Diagonal crack approximately 0.3mm wide on the west exterior panel**

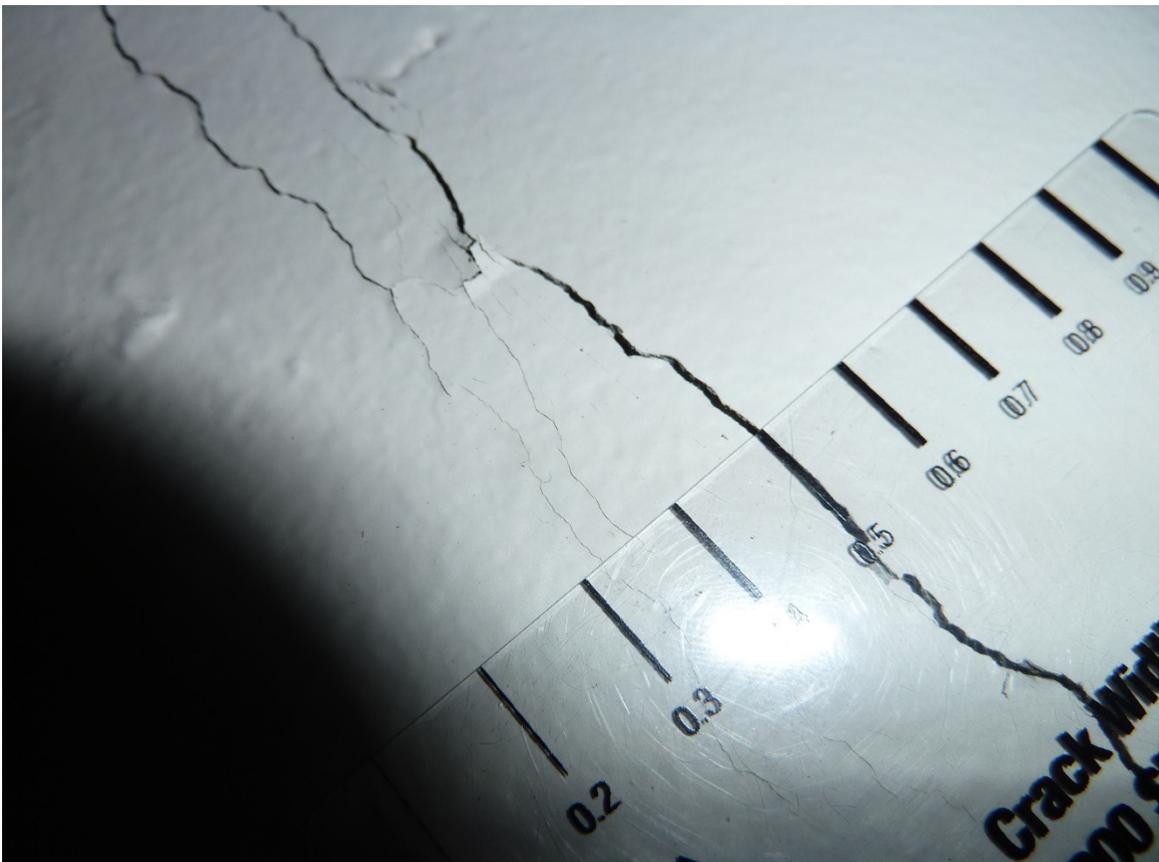
**Photo 6 - Diagonal crack approximately 0.5mm wide on the west wall interior**

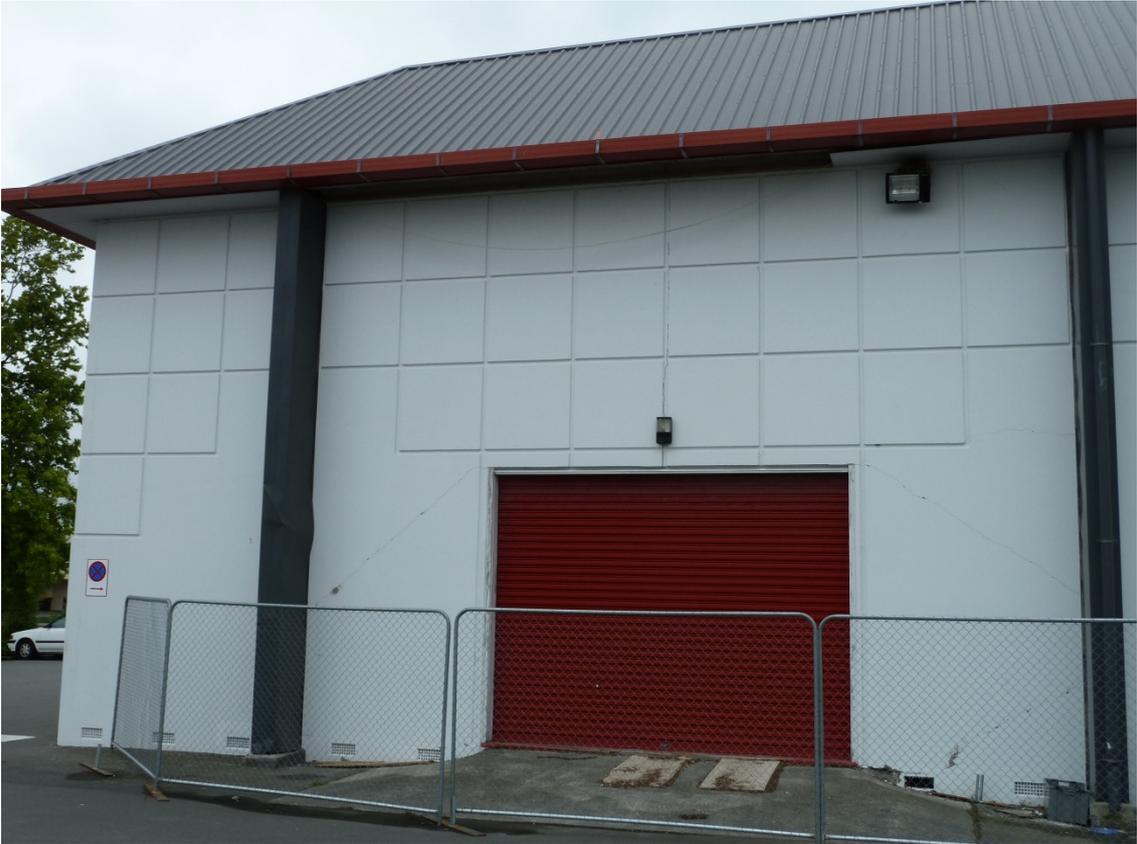
**Photo 7 - South wall elevation**

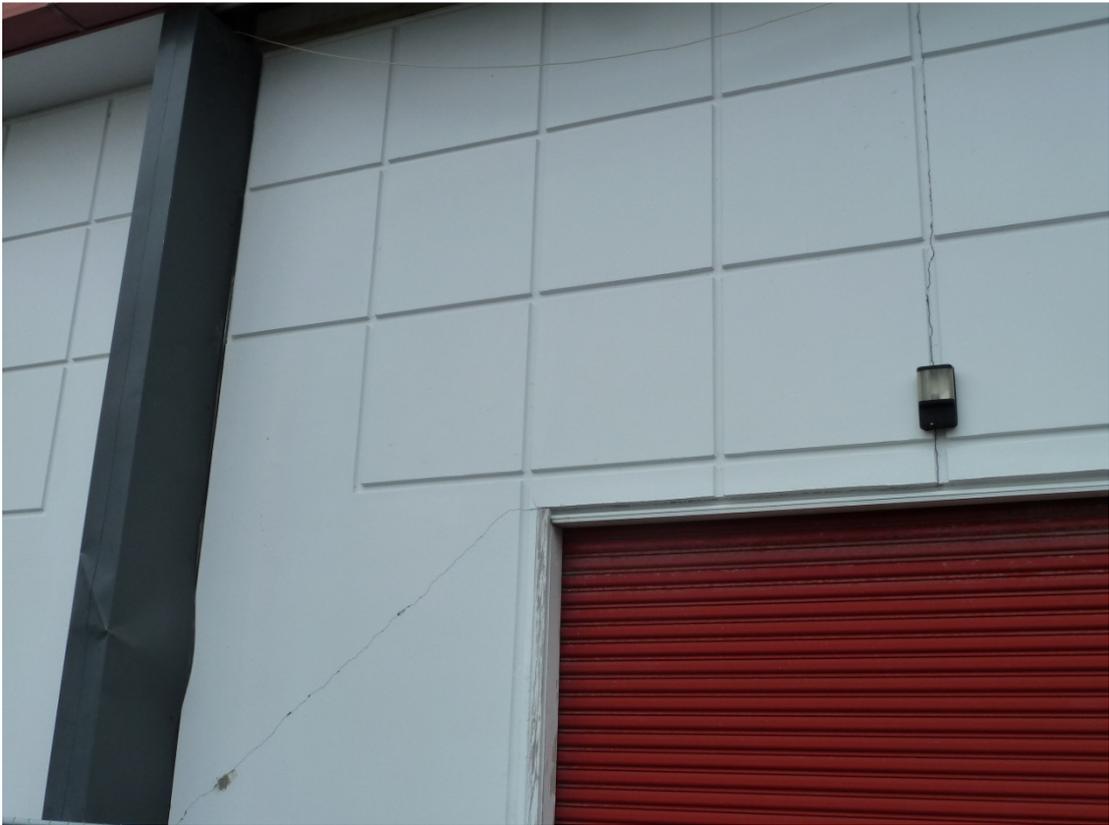
**Photo 8 - Cracks located around the large access opening**

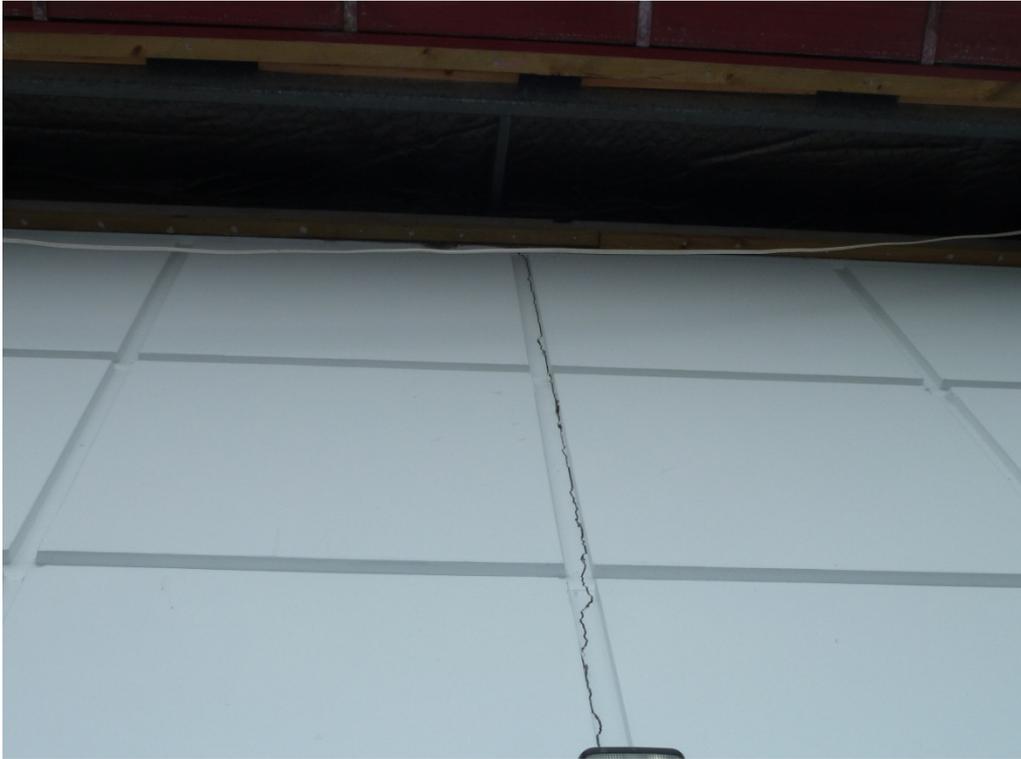
**Photo 9 - Vertical crack propagating from the access way in the south wall panel approximately 5mm width**

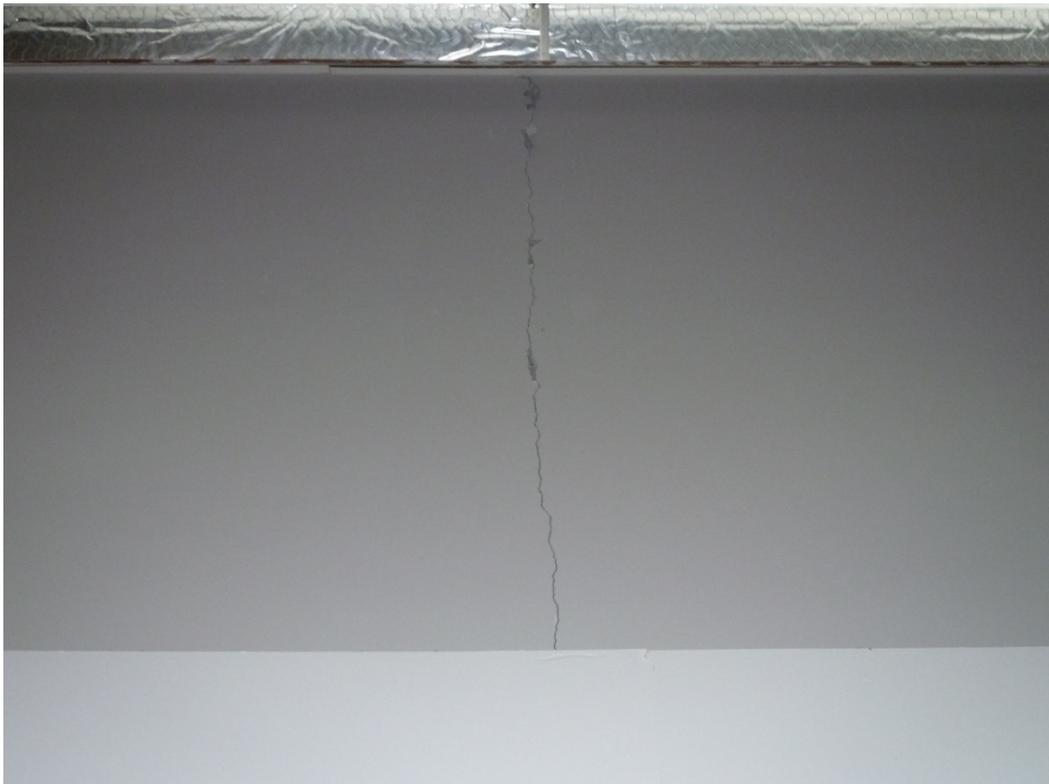
**Photo 10 - Interior view of vertical crack on the south wall panel**

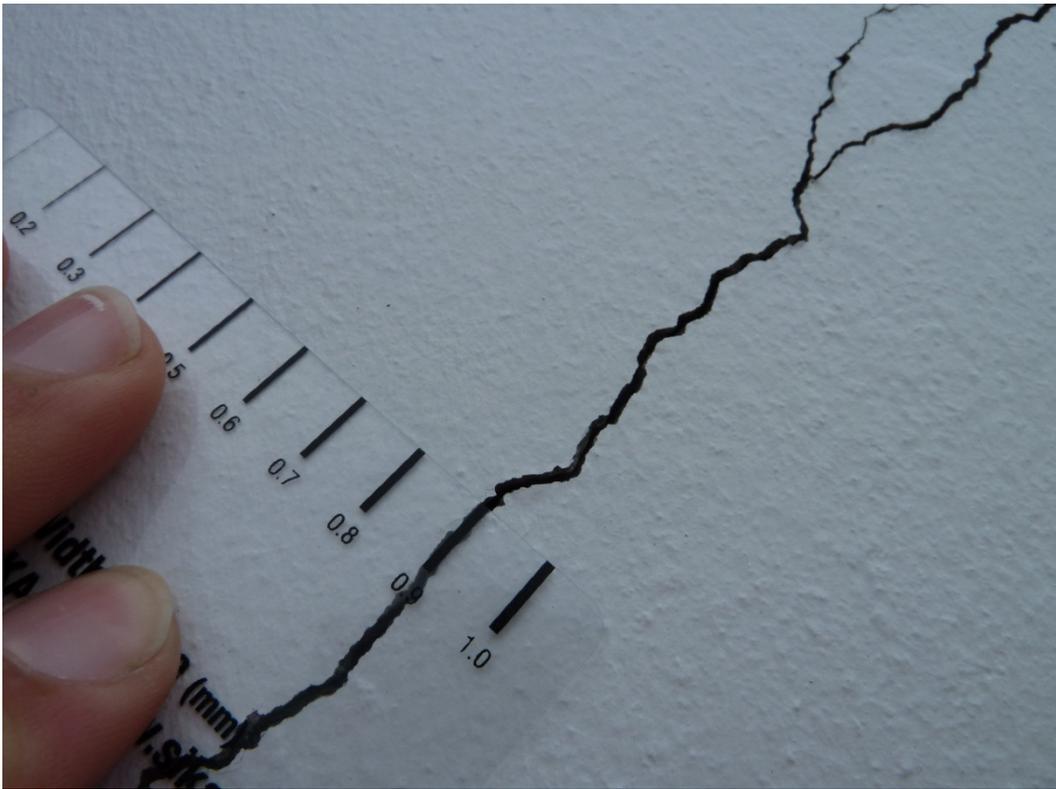
**Photo 11 - Diagonal crack along the south wall exterior approximately 0.9mm**

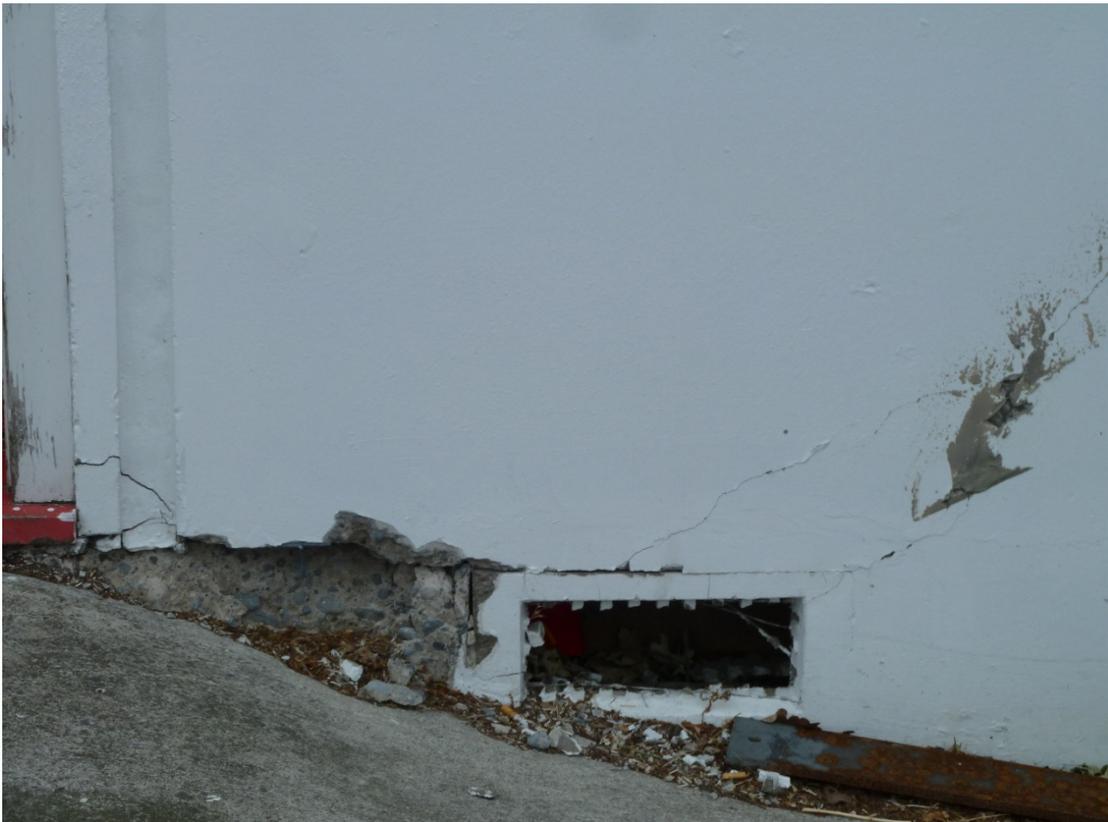
**Photo 12 - Cracking/Spalling at the base of the south wall**

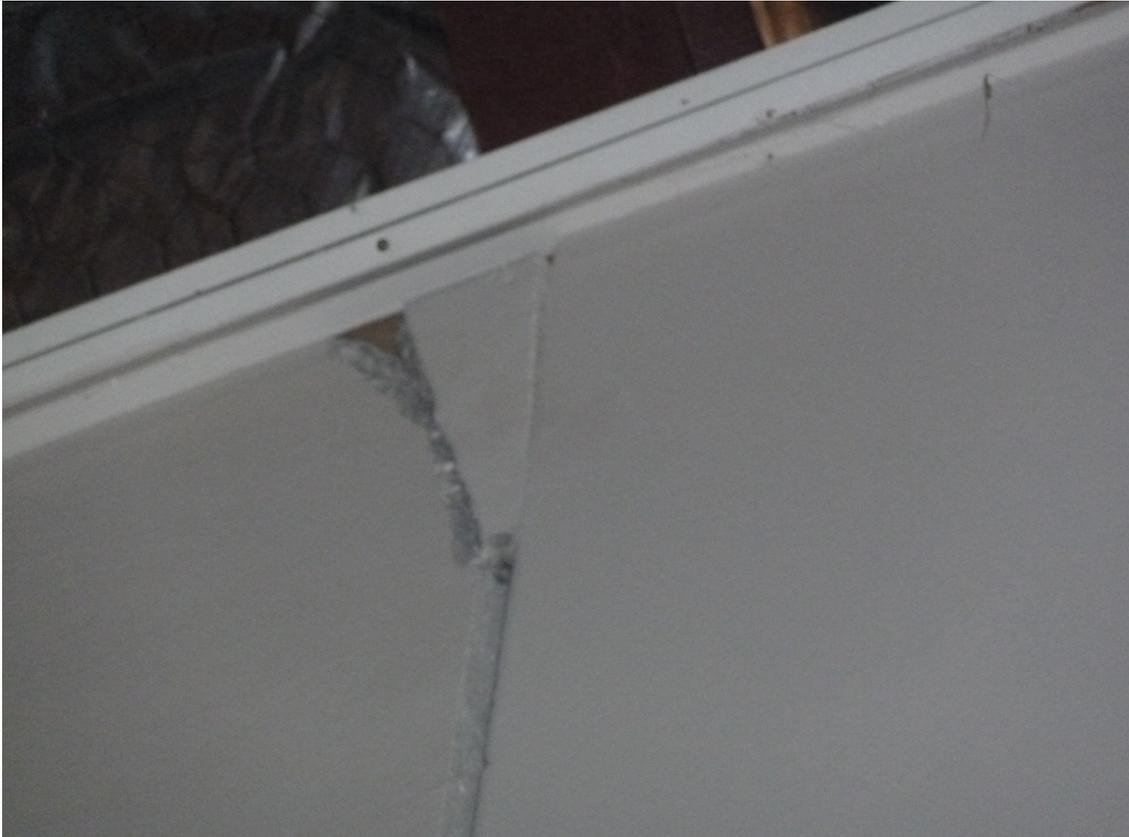
**Photo 13: Cracking/Spalling at the top of the precast panel south wall, viewed internally to the east of the damaged panel shown previous**

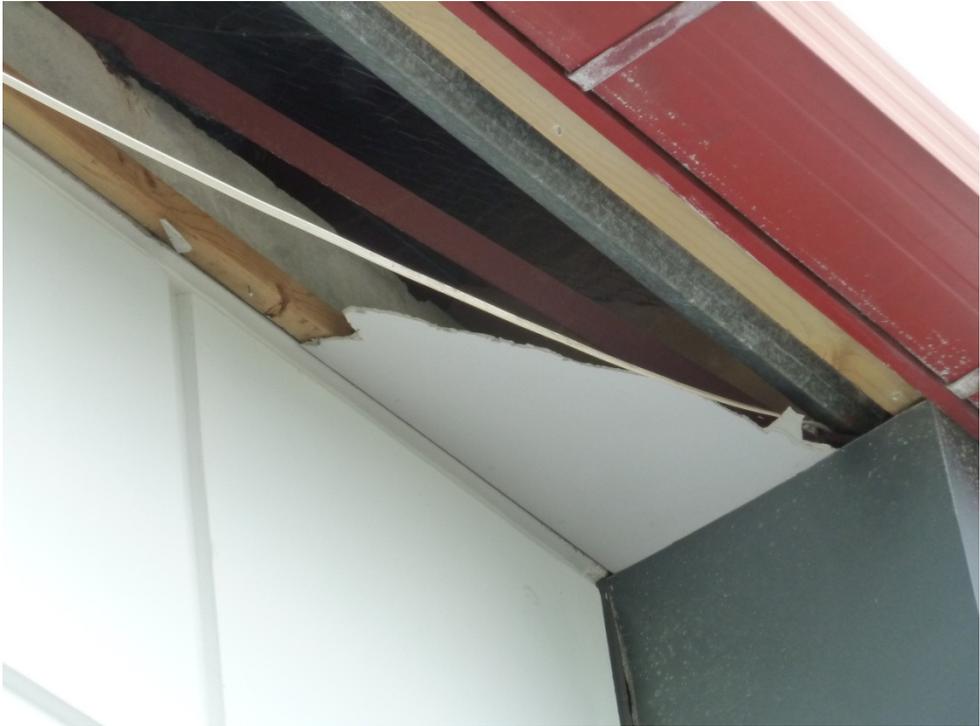
3. Tie beams between frames in the north-south direction were not visible from both an exterior and interior view of the precast panels. We can therefore assume these are not present in the structure. See figures below:

**Photo 14 - External view of west wall precast panel**

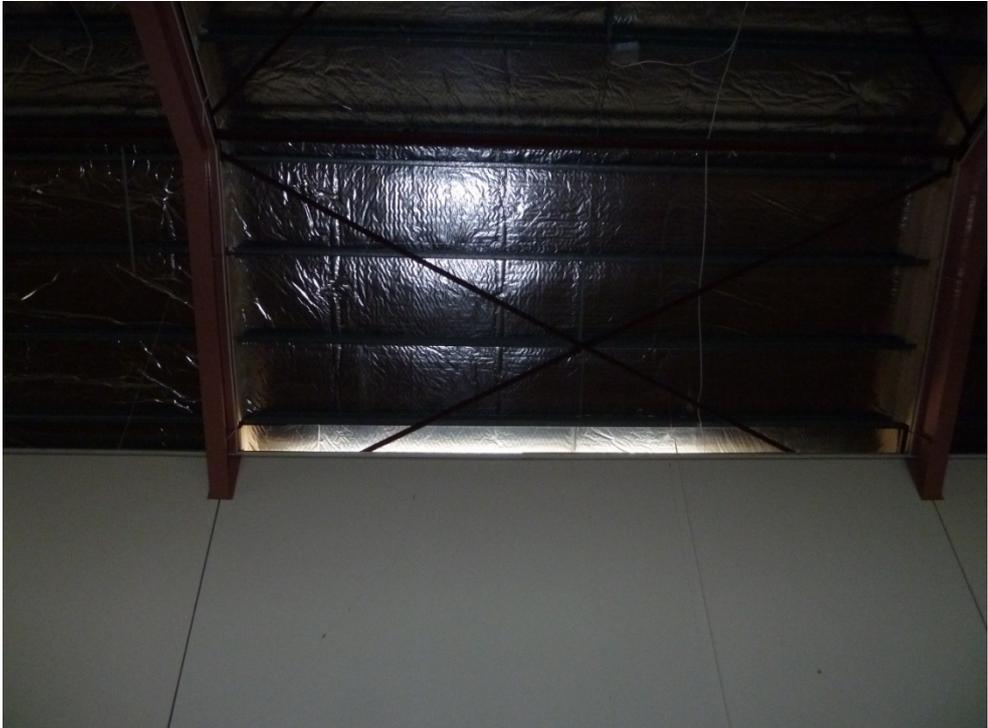
**Photo 15 - Interior view of west wall precast panel**

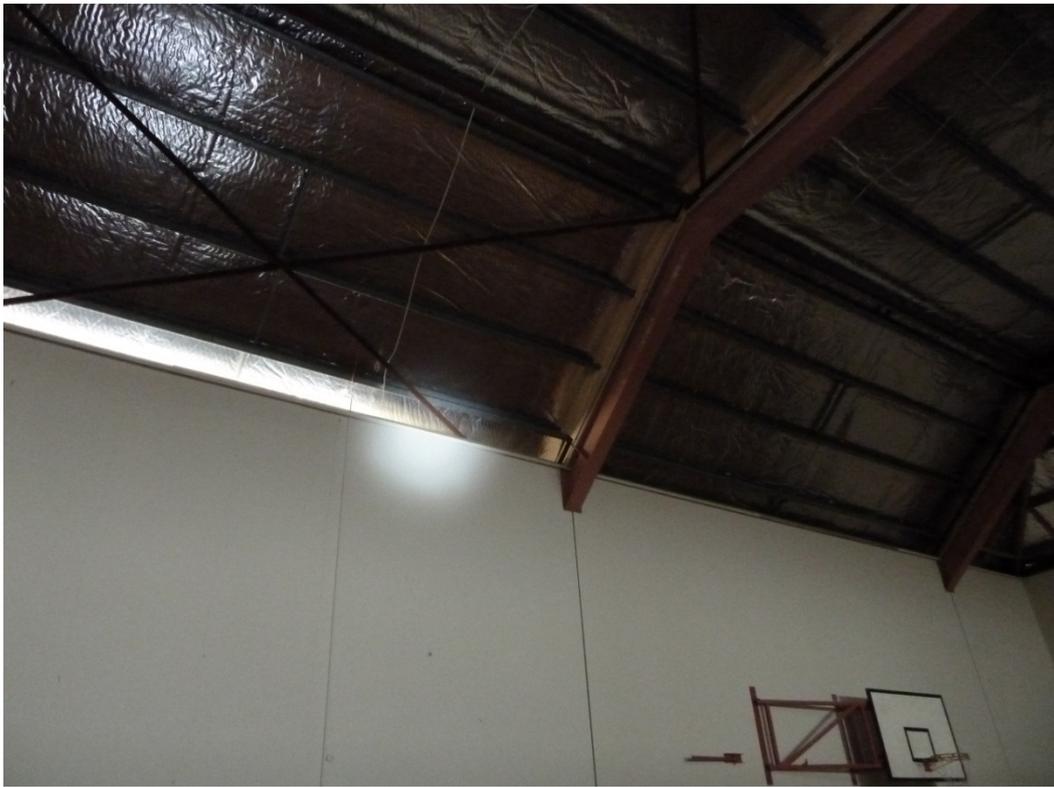
**Photo 16 - Diagonal ties above west wall panel**
