**Willard Street
Housing Complex
PRO 1112**

**Detailed Engineering Evaluation
Quantitative Assessment Report**

Willard Street Housing Complex Quantitative Assessment Report

21-71 Willard Street, Spreydon,

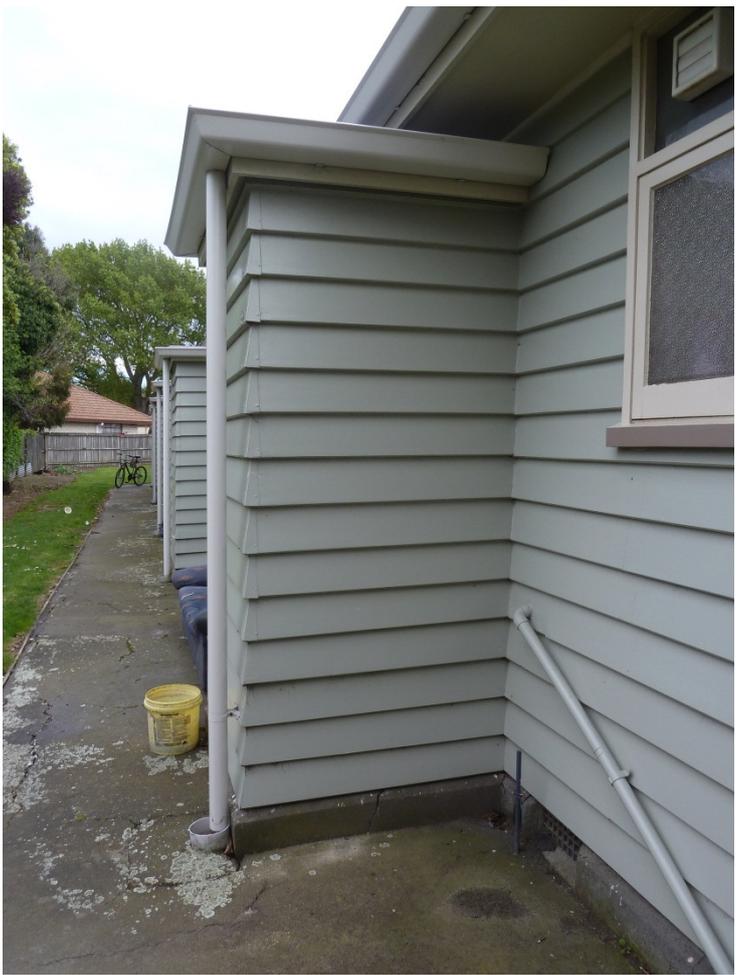
It was observed on site that the concrete foundation pads, supporting the back door 'lean-to' of Block D have suffered some damage due to the earthquakes. A severe crack is located through the slab where residual displacement appears to have occurred and has caused the pad to move relative to the rest of the structure. This occurs along the back elevation of all units in Block D and is consistent with level survey data (Photos 9-12).

<p>9.</p>	<p>Typical exterior back door 'lean-to' for Units 45-55 where the foundation pad has suffered damage</p>

- The concrete perimeter footings be repaired on blocks where severe cracking occurs.
- A site specific geotechnical site investigation be carried out (because the site is located adjacent to a TC3 area) to determine the liquefaction potential of the site and the shallow bearing capacities of the soils if this information is required for future construction on the site.
- Cosmetic repairs be undertaken as required.
- All buildings be strengthened to at least 67% NBS.

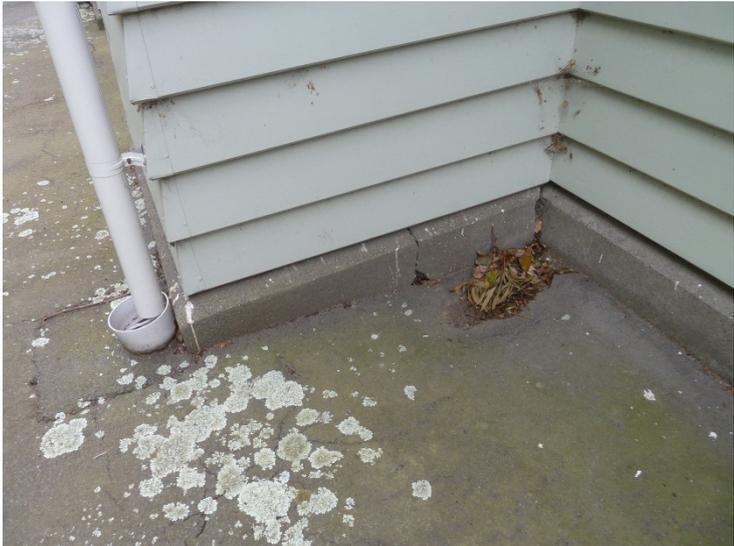
<p>11.</p>	<p>Cracking of back door 'lean-to' foundation pad for Units 45-55</p>

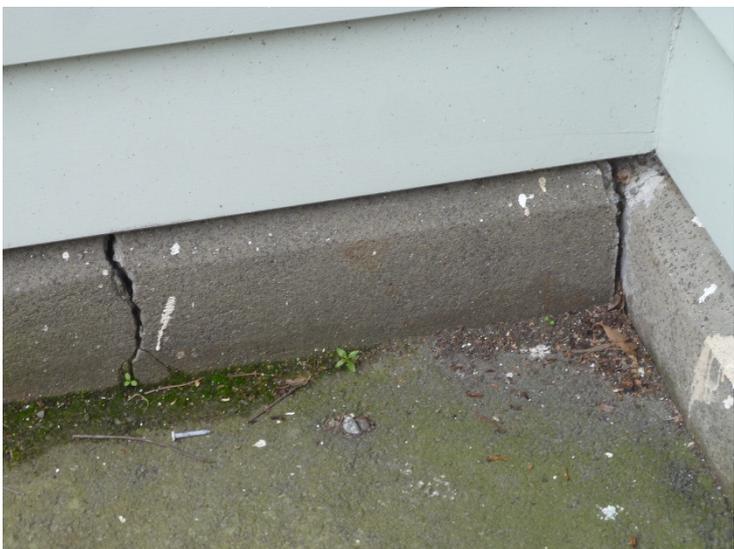
<p>12.</p>	<p>Cracking of back door 'lean-to' foundation pad for Units 45-55</p>

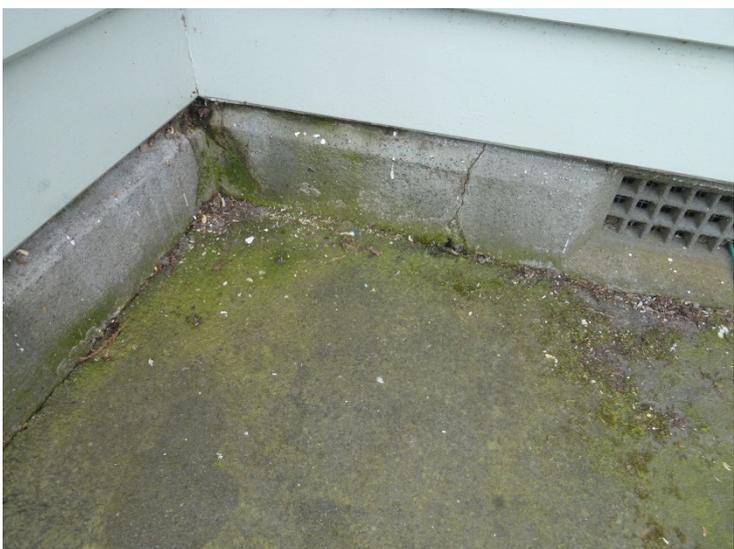
Minor hairline cracking of the concrete perimeter foundation footing was observed in some of the buildings (Photo 13).

<p>13.</p>	<p>Typical cracking of concrete perimeter foundation footing</p>

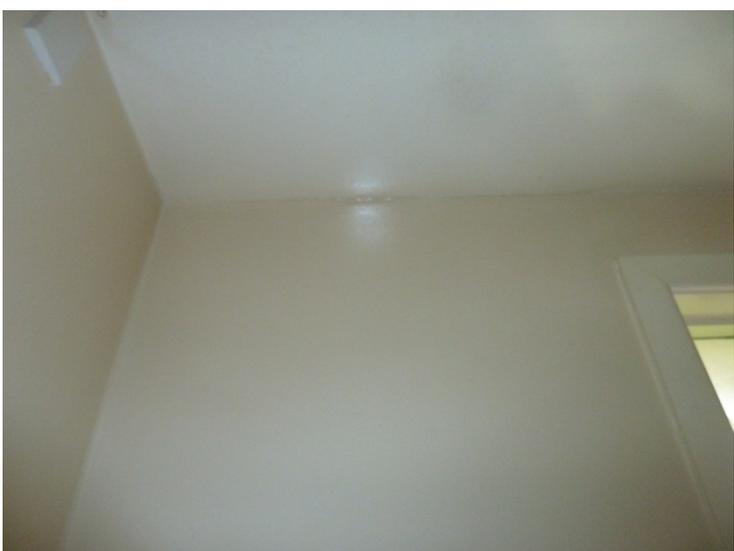
Minimal cracking of ceiling and wall linings was observed in the units. This form of damage was not common throughout the units.

16.	Typical minor cracking of interior linings

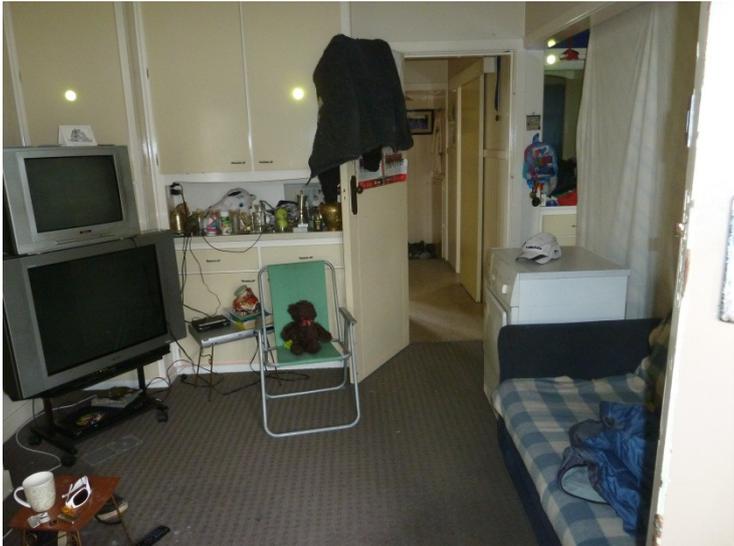
<p>17.</p>	<p>Typical living area where the floor slopes from front-to-back</p>

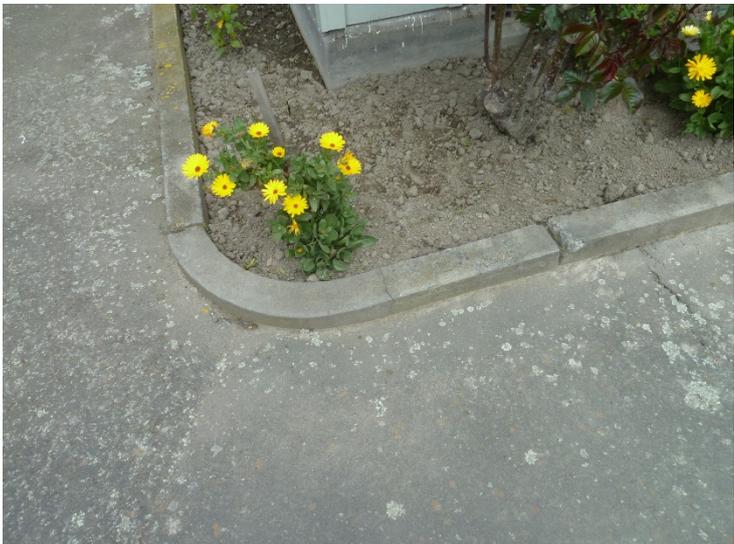
The external footpaths and kerbing has suffered varying amounts of damage throughout the site.

<p>18.</p>	<p>Kerb damage</p>

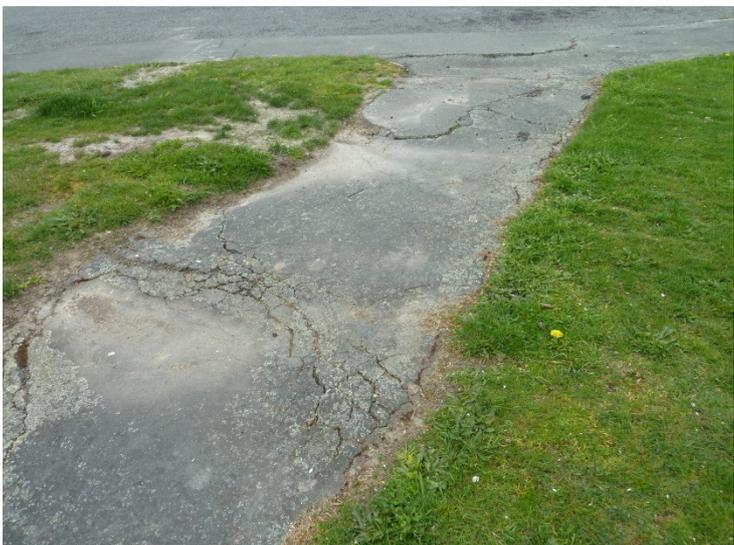
<p>19.</p>	<p>Cracking of footpaths & uneven surfaces</p>
