Woolston Crèche BU 1985-002 EQ2

Detailed Engineering Evaluation Quantitative Report

Version FINAL
52 Glenroy Street, Woolston

Prepared By
Shashank Kumar

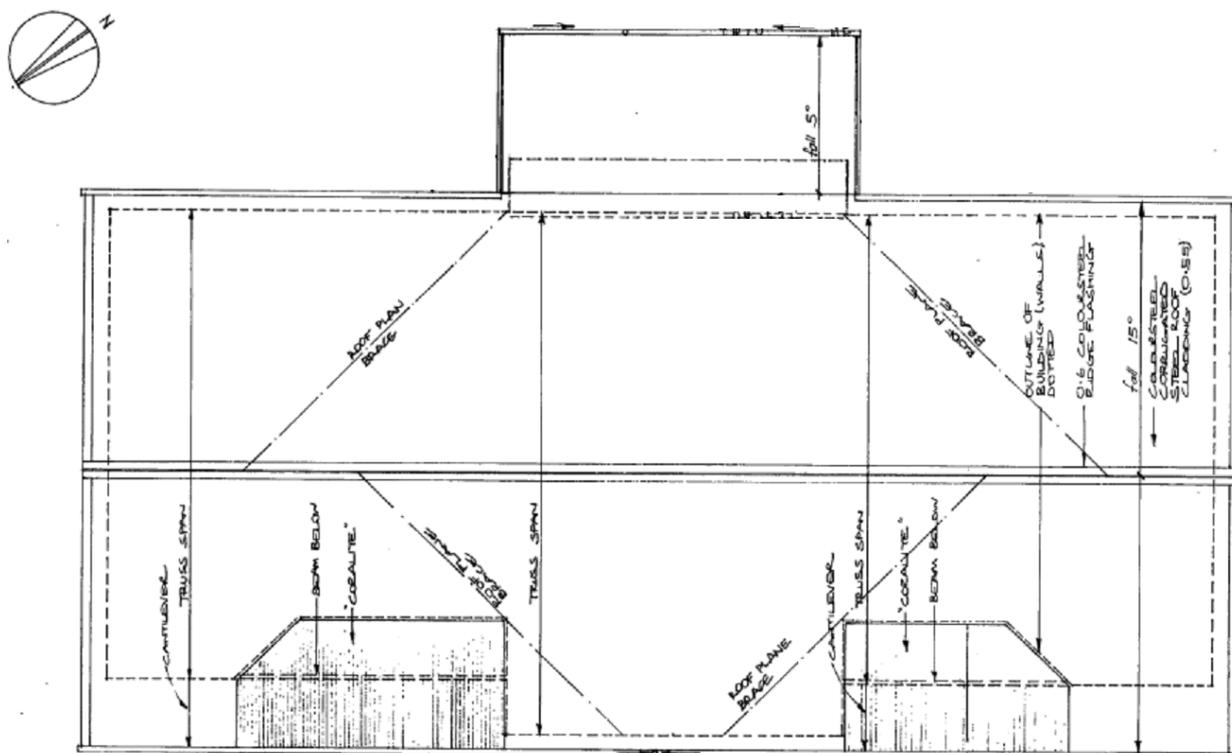
Figure 2 Plan sketch of building showing key structural elements

Lateral loads acting on the structure are resisted by the plasterboard lined timber framed walls. Lateral loads are transferred from the roof through the purlins and rafters to the internal and external plasterboard lined timber framed walls. The walls then transfer the load into the concrete strip foundations.

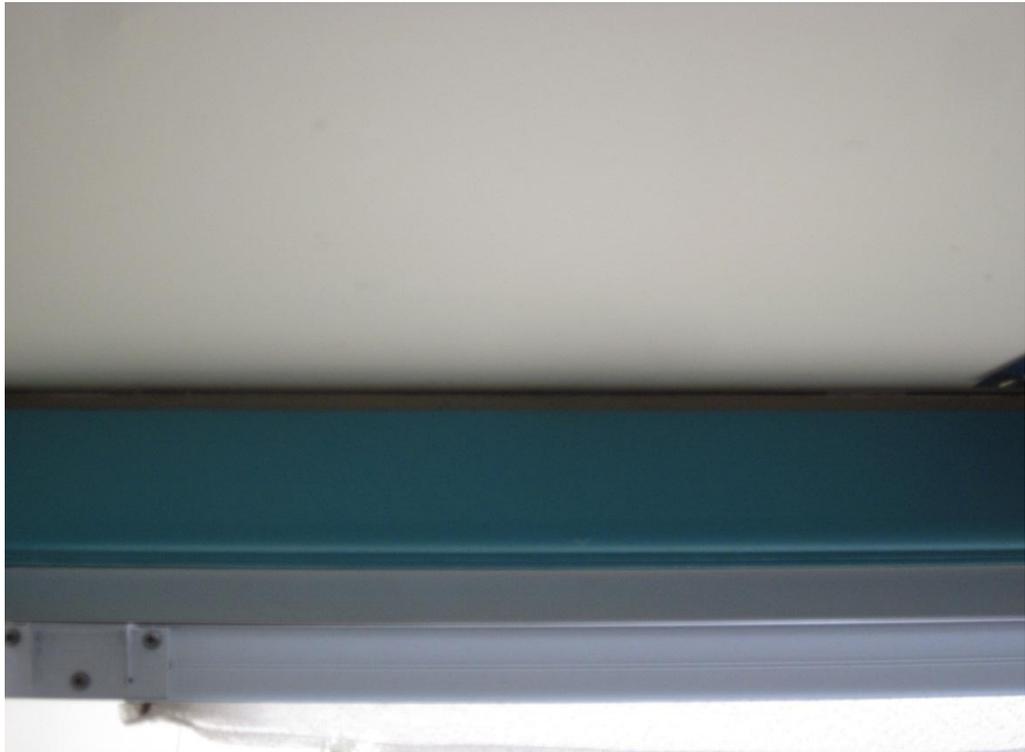
Minor cracking was noted to the internal plasterboard lining in several locations throughout the building, primarily above windows and doors. These cracks are not considered significant and have now been repaired.

Photograph 3 Cracking at door frame of staff room

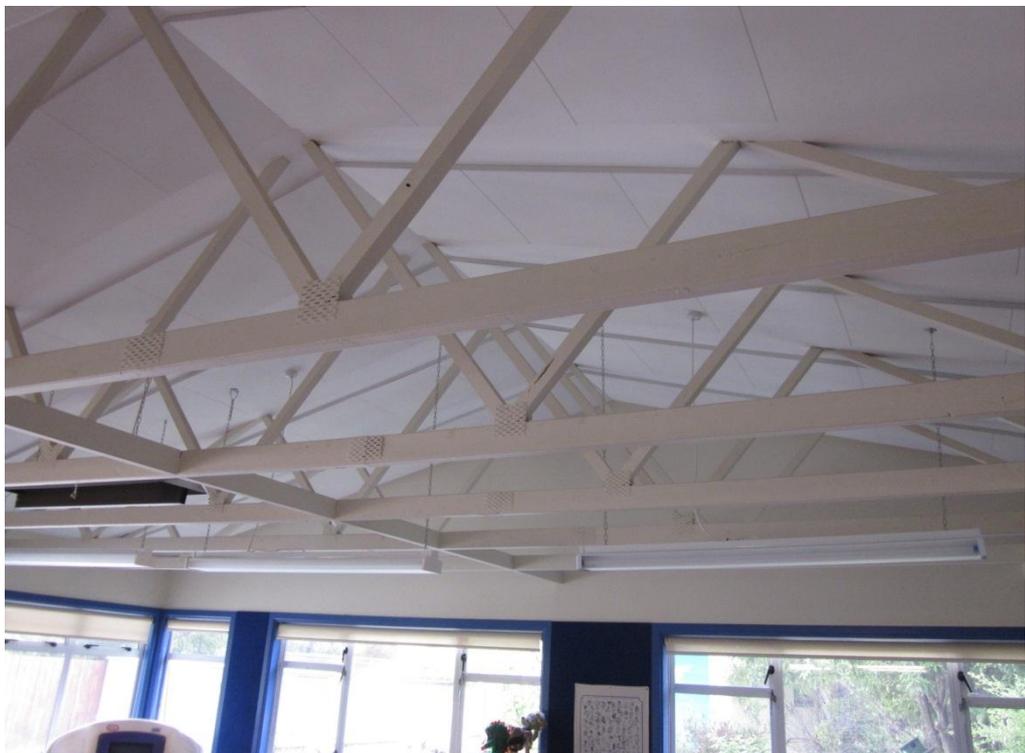
Photograph 4 Exposed timber roof trusses at eastern end of building.

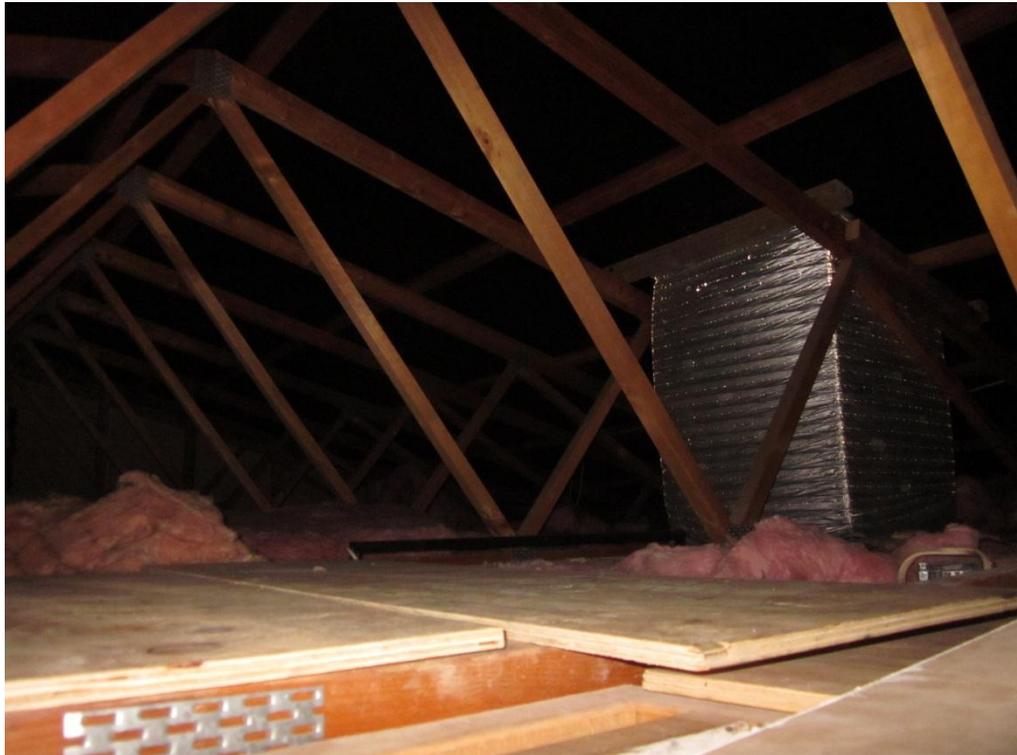
Photograph 5 View of roof structure concealed by ceiling.

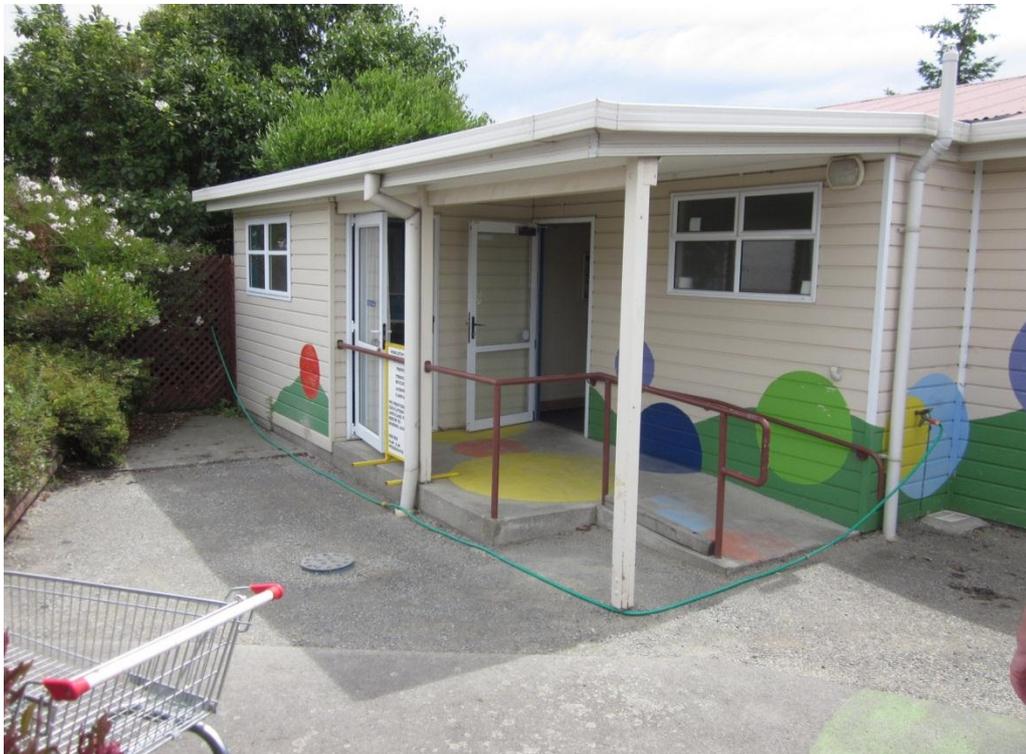
There was no evidence of ground damage on the property, however the tenants indicated that ground damage in the form of destruction of external concrete paving slabs had occurred but had been remediated. It was noted that concrete slabs on the crèche property had been damaged and been replaced prior to inspection. Discussions with the tenants indicated that no liquefaction occurred on the crèche property during the recent seismic events. Liquefaction on the adjacent water tank property to the east had seeped through the boundary fence onto the crèche property but this had been removed prior to inspection. Evidence of liquefaction on the water tank property was noted.

Photograph 6 Area of paving being replaced at south side of building.
