# Wycola Park Shed PRK 1557 BLDG 004 EQ2

## **Detailed Engineering Evaluation**

**Quantitative Assessment Report**

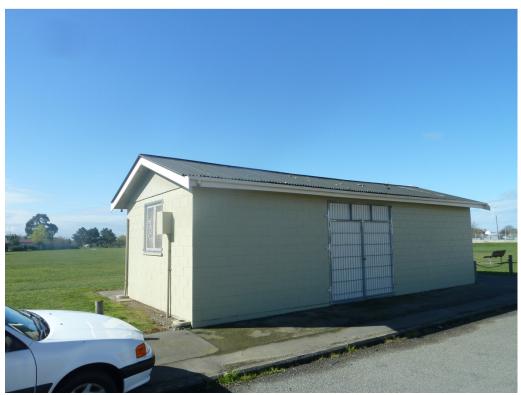
Photo 1: View of Exterior

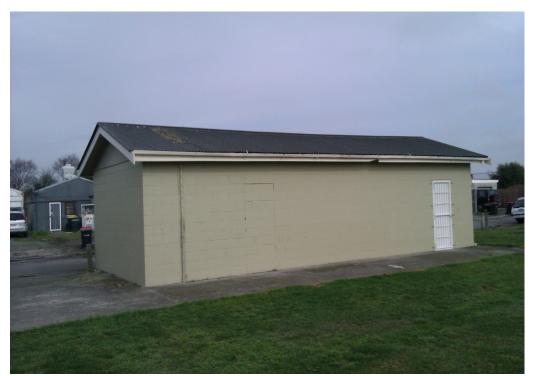
Photo 2: View of Exterior
