YWCA Units 1-4 BU 2311-001 EQ2 YWCA Units 5-9 BU 2311-002 EQ2 Detailed Engineering Evaluation Quantitative Report

Prepared for Christchurch City Council (Client)

By Beca Carter Hollings & Ferner Ltd (Beca)

4 July 2013

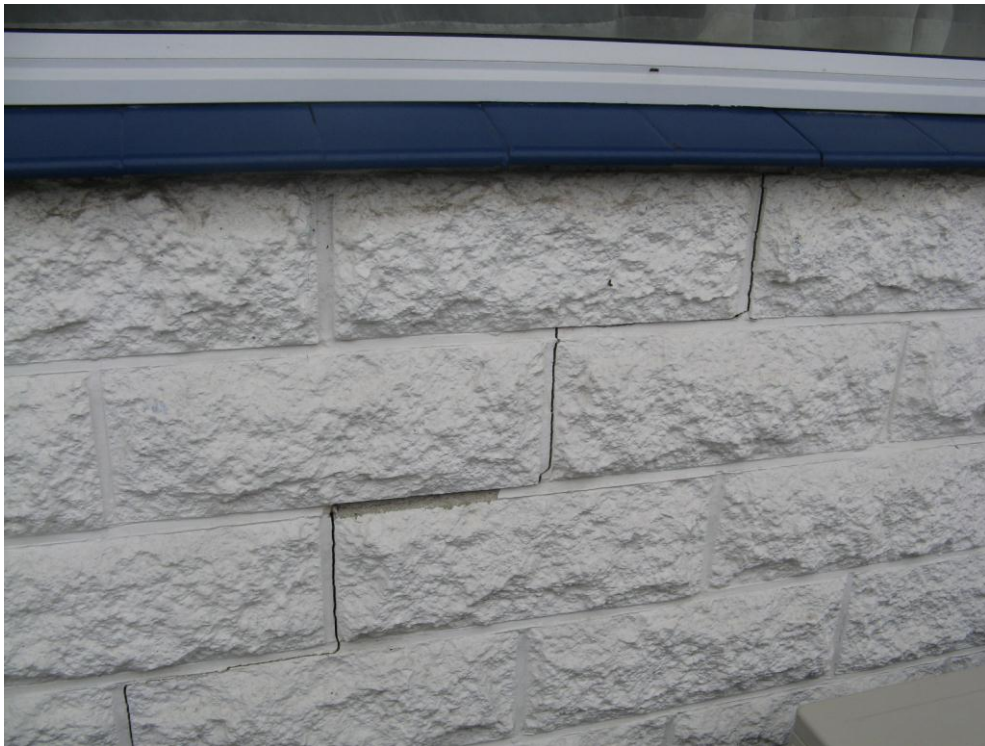
Photo 2: Damage to 90 block wall cladding

Damage: Stepped cracking in block wall (crack width up to 5mm)

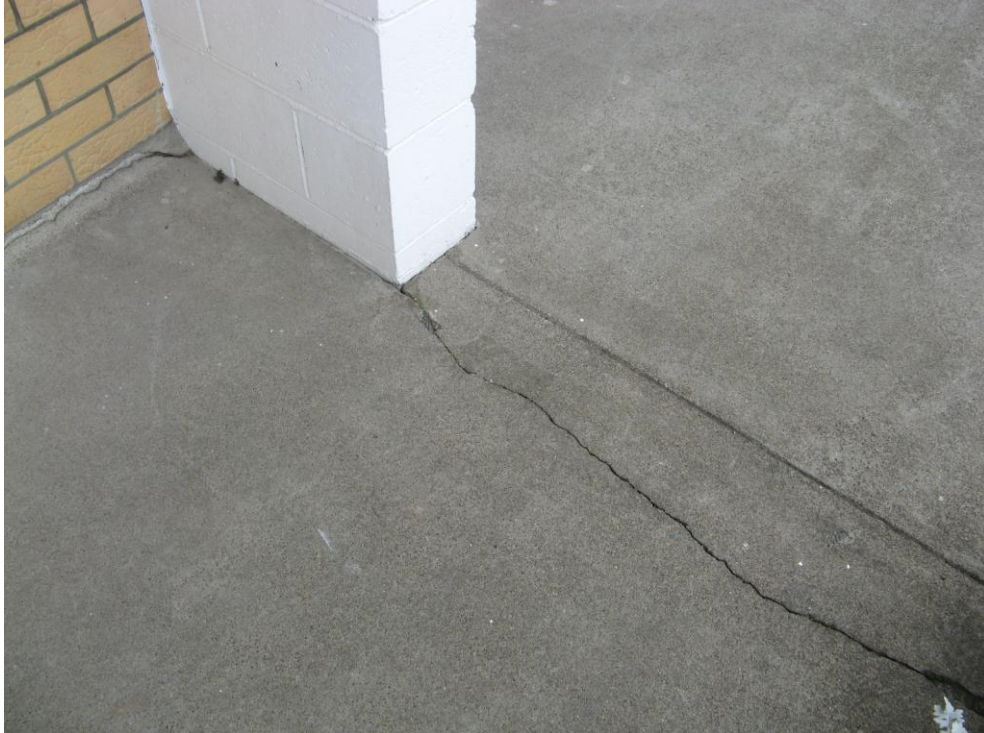
Photo 3: Damage to external raised slab.

Damage: Cracking to concrete slab and minor spalling.

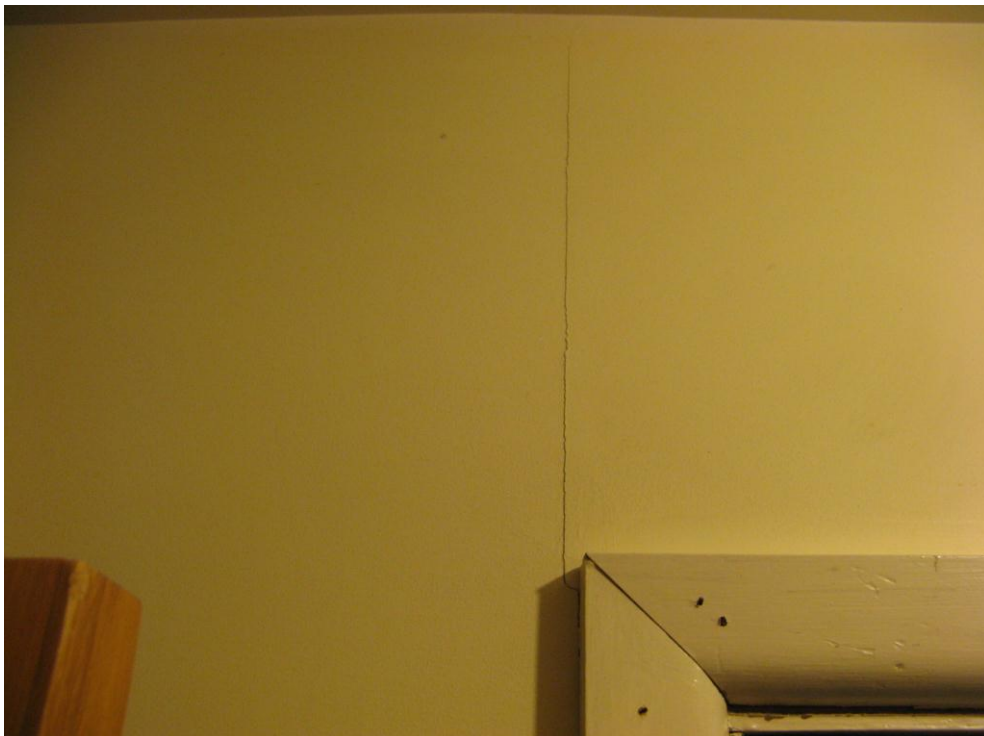
Photo 4: Damage to plasterboard wall lining.

Damage: Cracking to plasterboard due to seismic displacement.

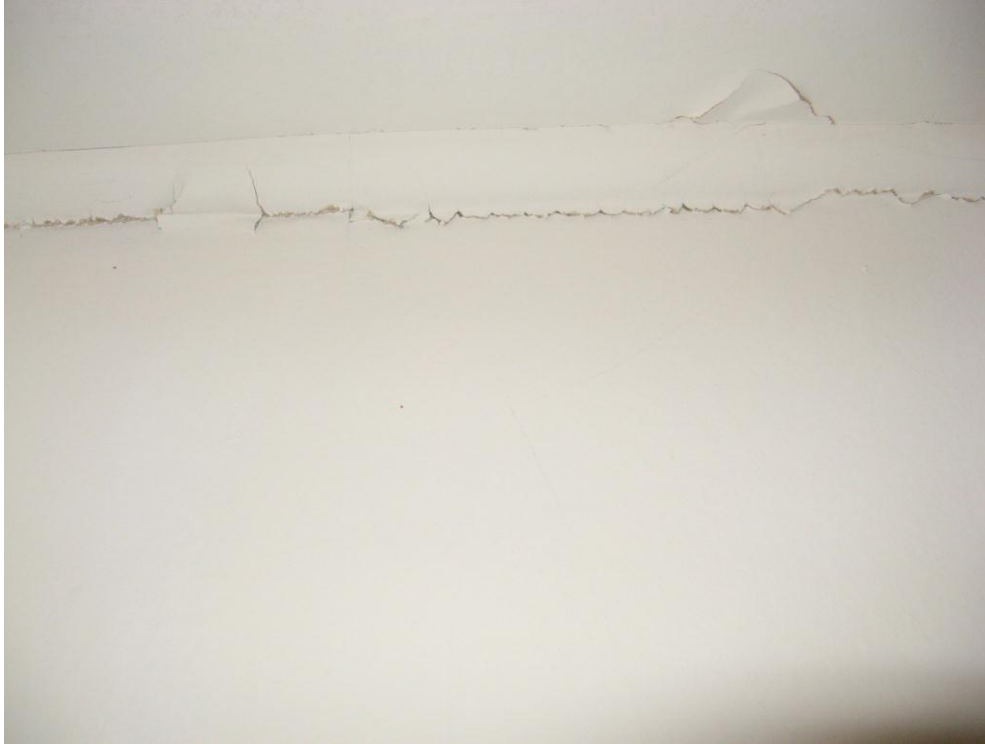
Photo 5: Typical damage at plasterboard ceiling connection to masonry walls.

Damage: Cracking to plasterboard due to relative movement between ceiling and concrete masonry wall.

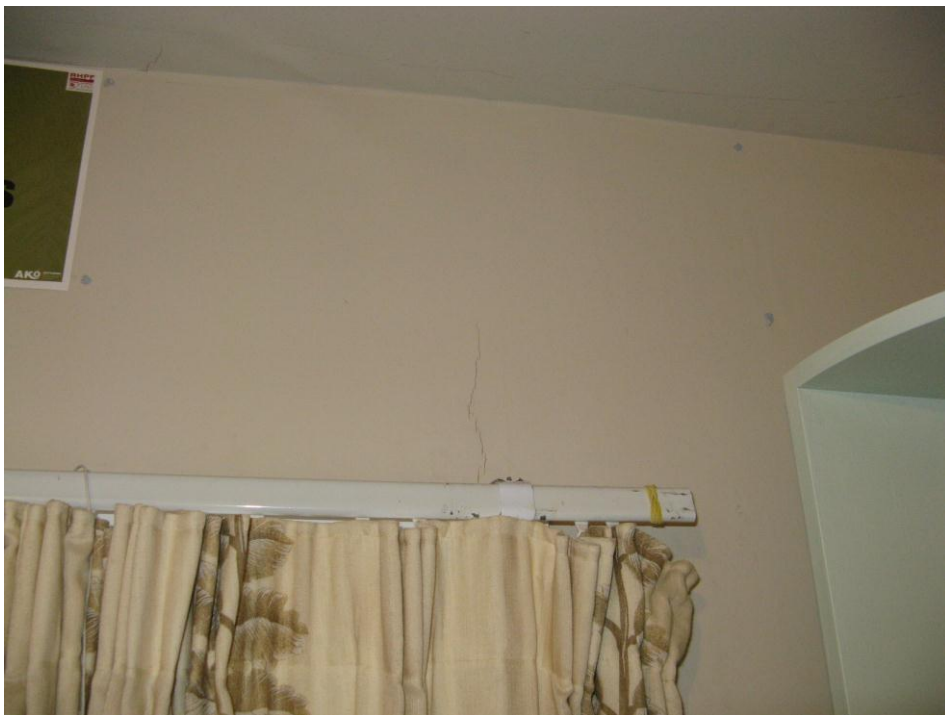
Photo 6: Damage to plasterboard wall lining.

Damage: Cracking to plasterboard due to seismic displacement.

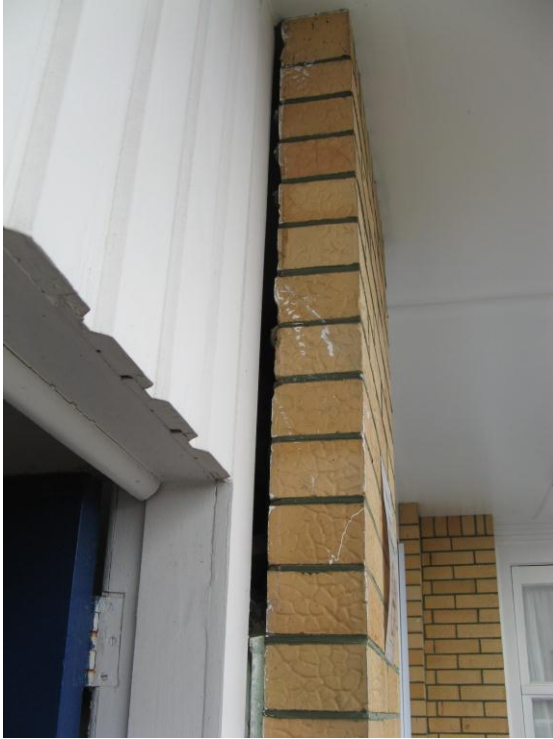
Photo 7: Separation of brick veneer cladding from timber framed wall.

Damage: Movement of brick veneer cladding due to damage to ties.

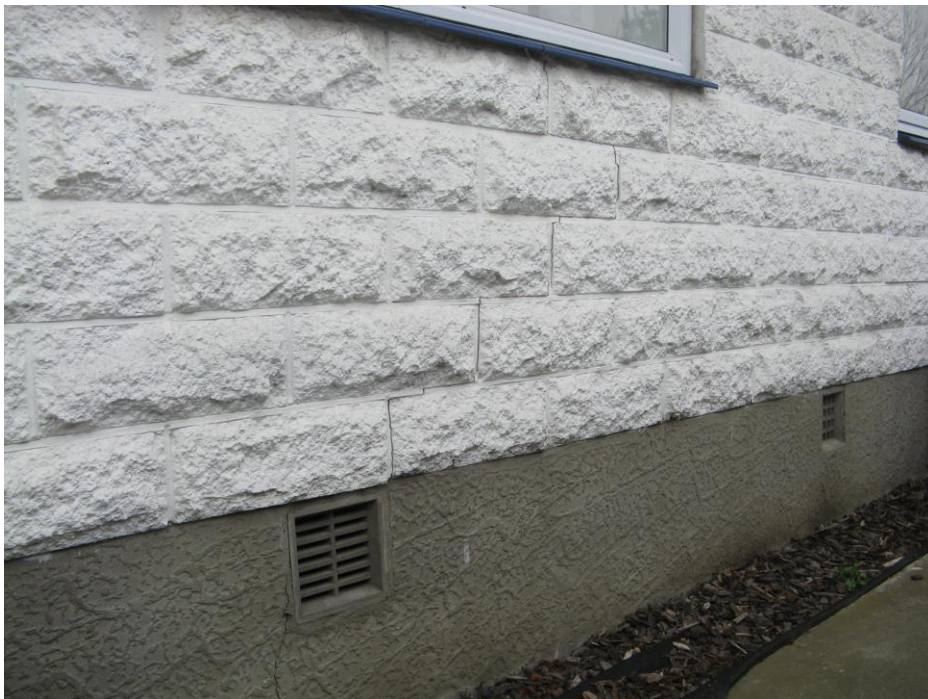
Photo 8: Damage to block wall and foundation wall.

Damage: Stepped cracking through mortar joints in block wall and cracking through foundation wall.

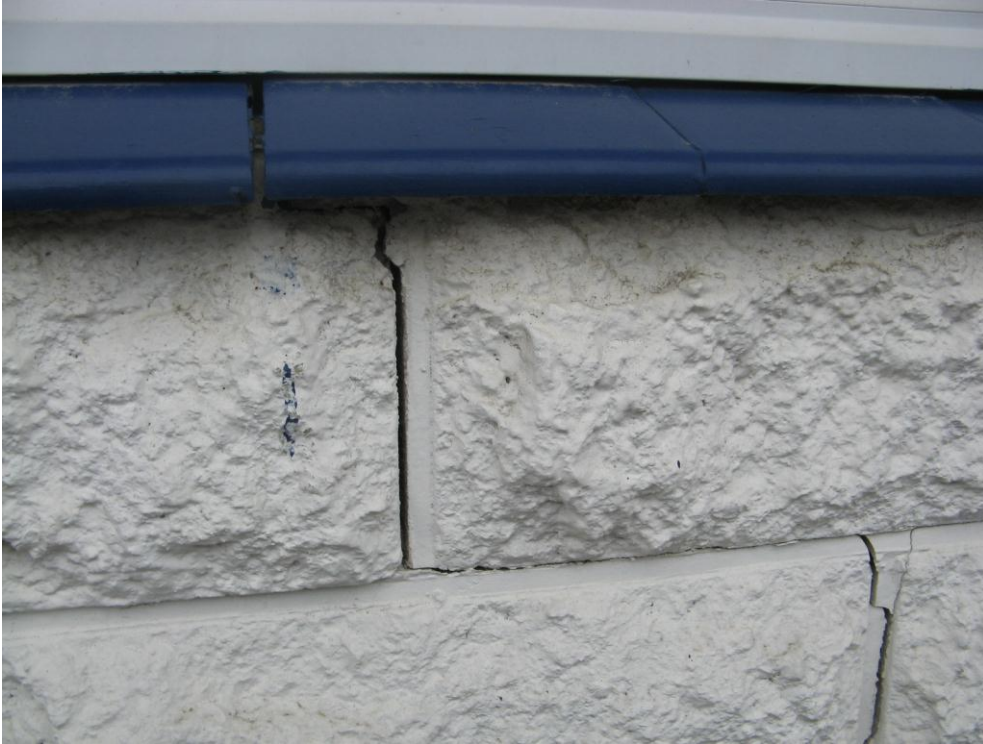
Photo 9: Damage to block wall cladding.

Damage: Stepped cracking in block wall (width of up to 5mm) and cracking to sill tiles.

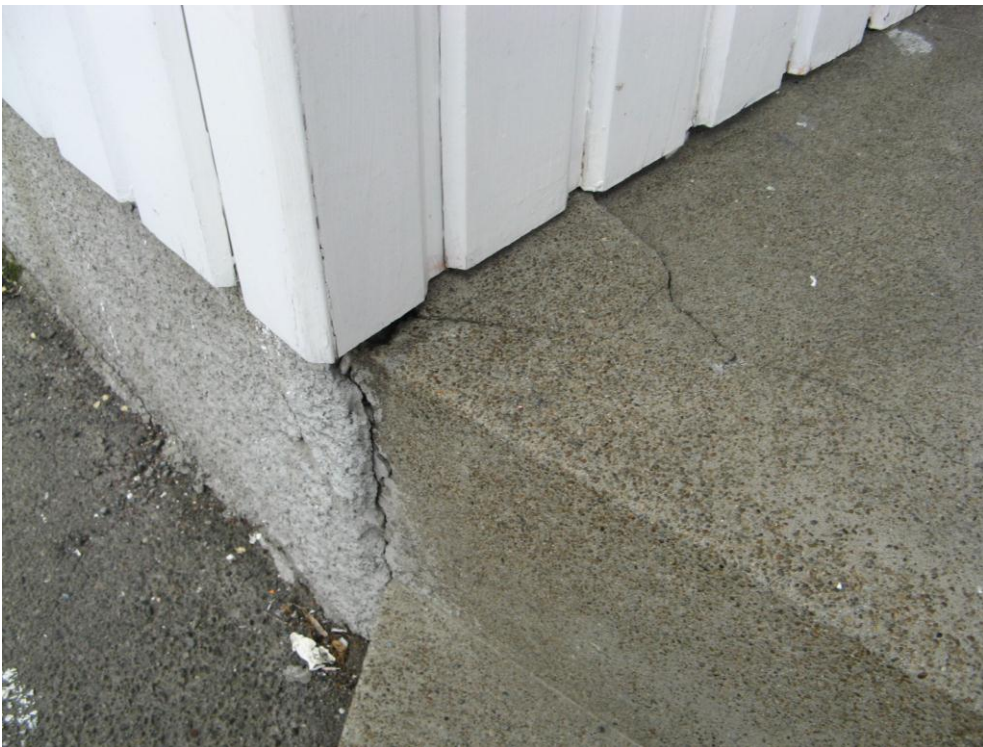
Photo 10: Damage to raised concrete slab.

Damage: Cracking to concrete slab.

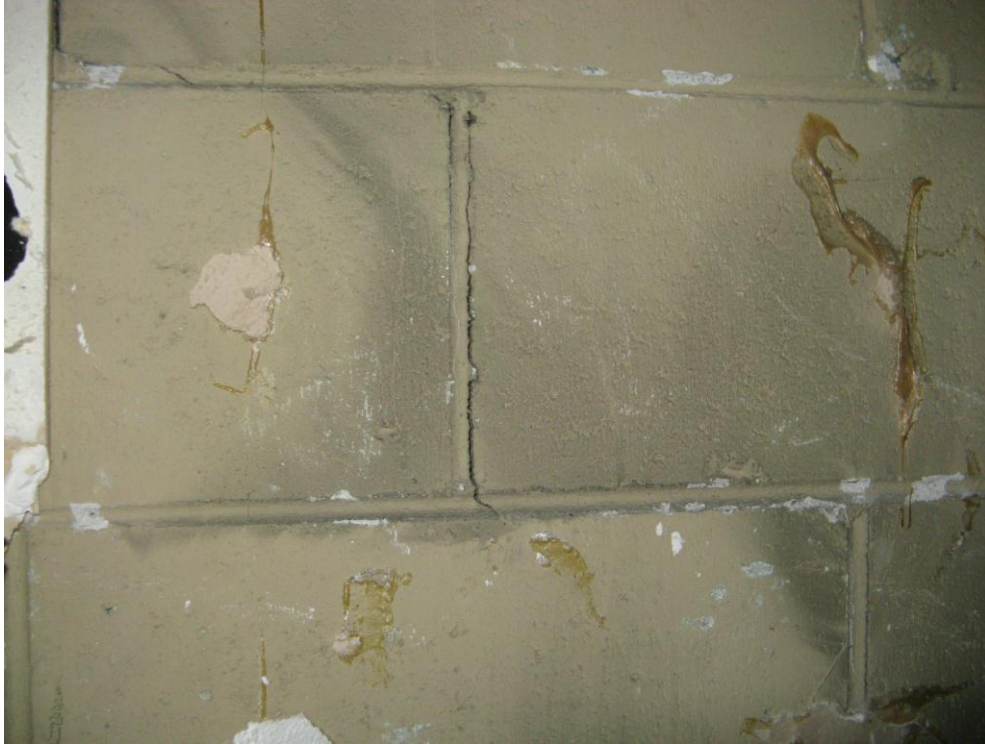
Photo 11: Damage to concrete masonry walls between units 2 and 3.

Damage: Stepped cracking through concrete masonry mortar joints.

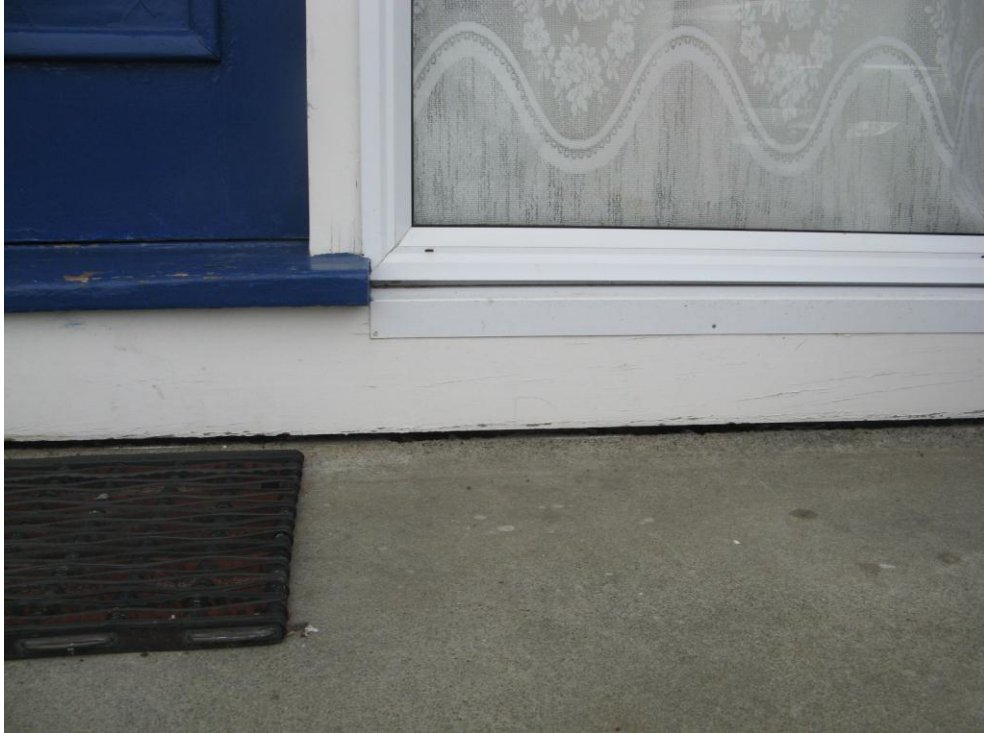
Photo 14: Separation of wall from ground slab at the entrance to unit 6. Shows differential settlement may have occurred.

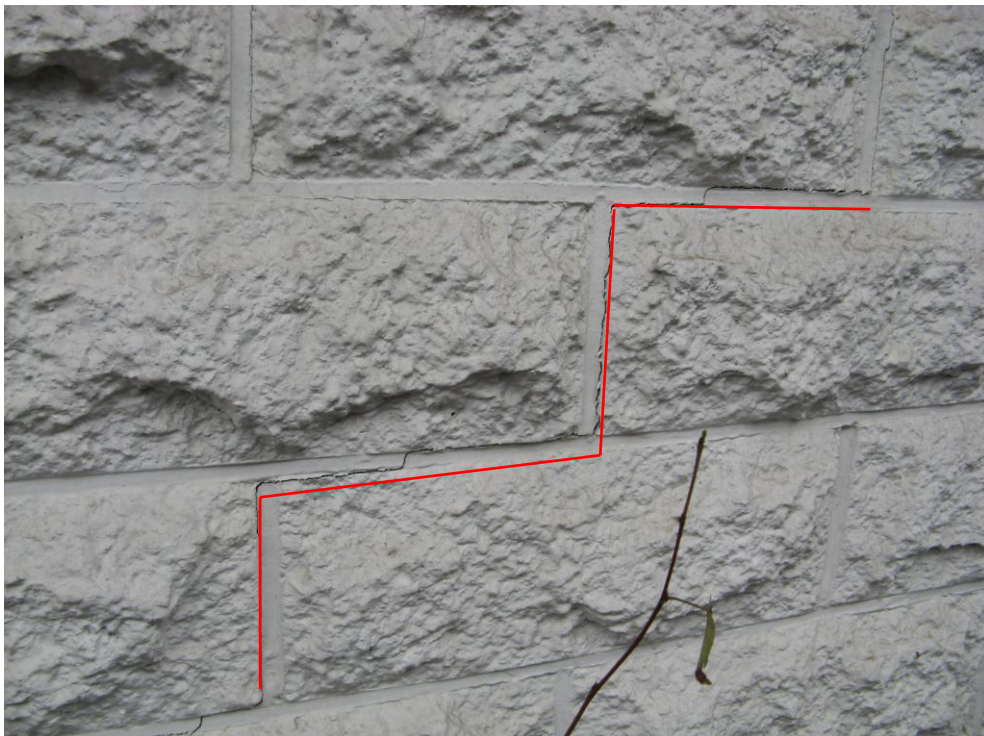
Photo 15: Damage to block wall

Damage: Stepped cracking in brick veneer.

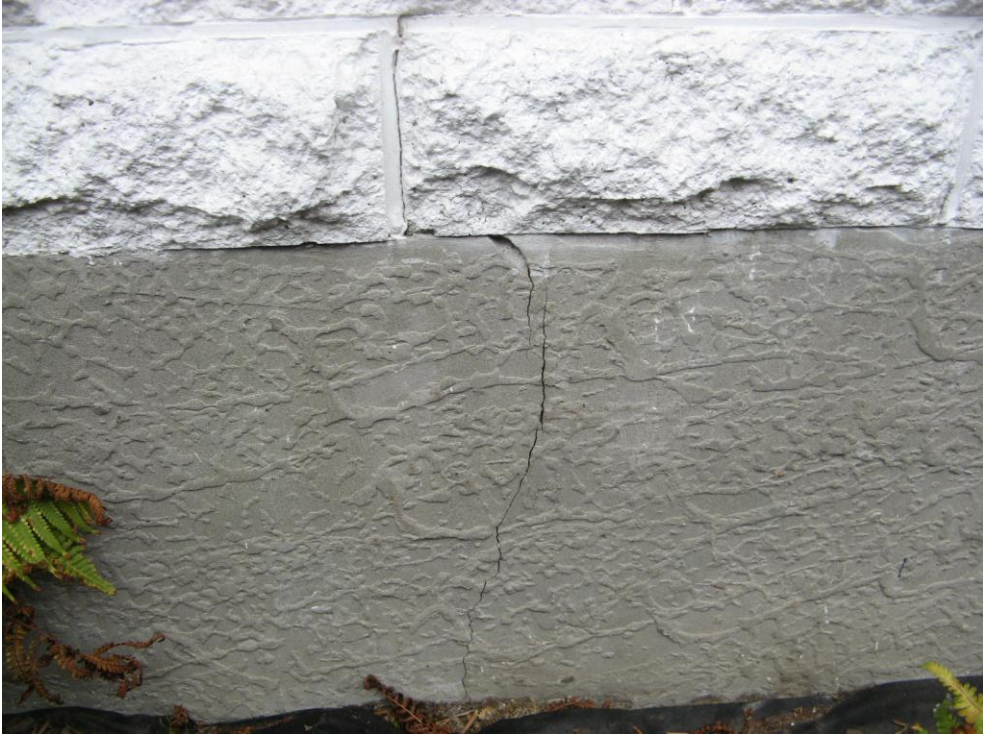
Photo 16: Damage to perimeter foundation.

Damage: Cracking to concrete perimeter strip foundation.

- Foundations are exposed to confirm suitability of assumptions and damage as part of a subsequent Damage Assessment reporting.

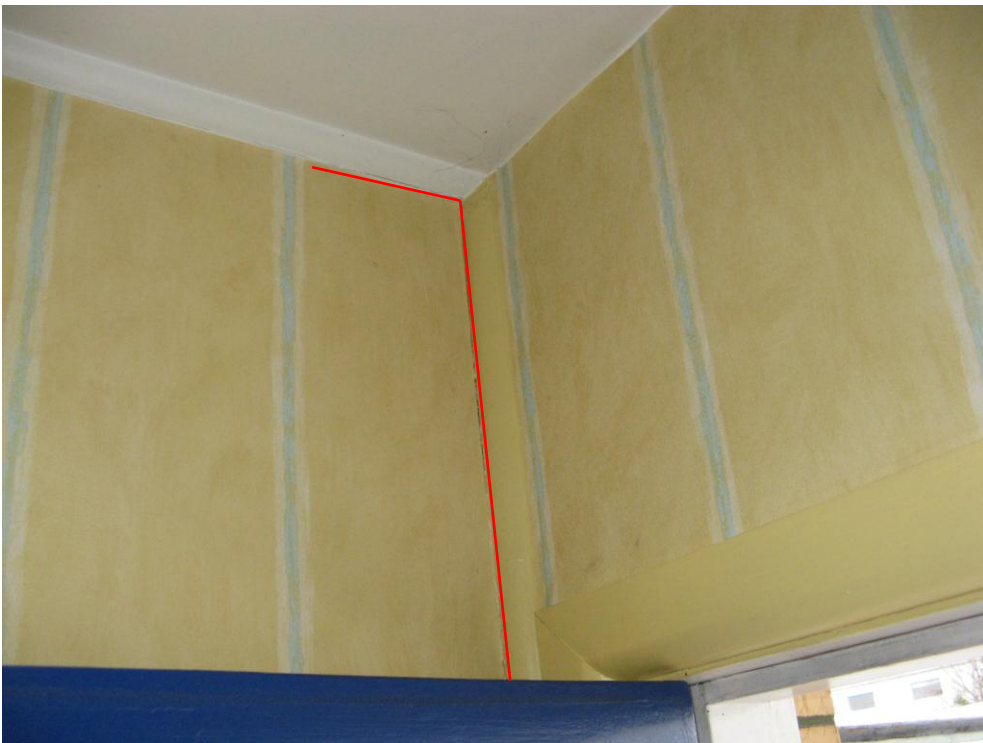
Photo 17: Damage to internal fit out.

Damage: Cracking of plasterboard lining at joint due to movement.

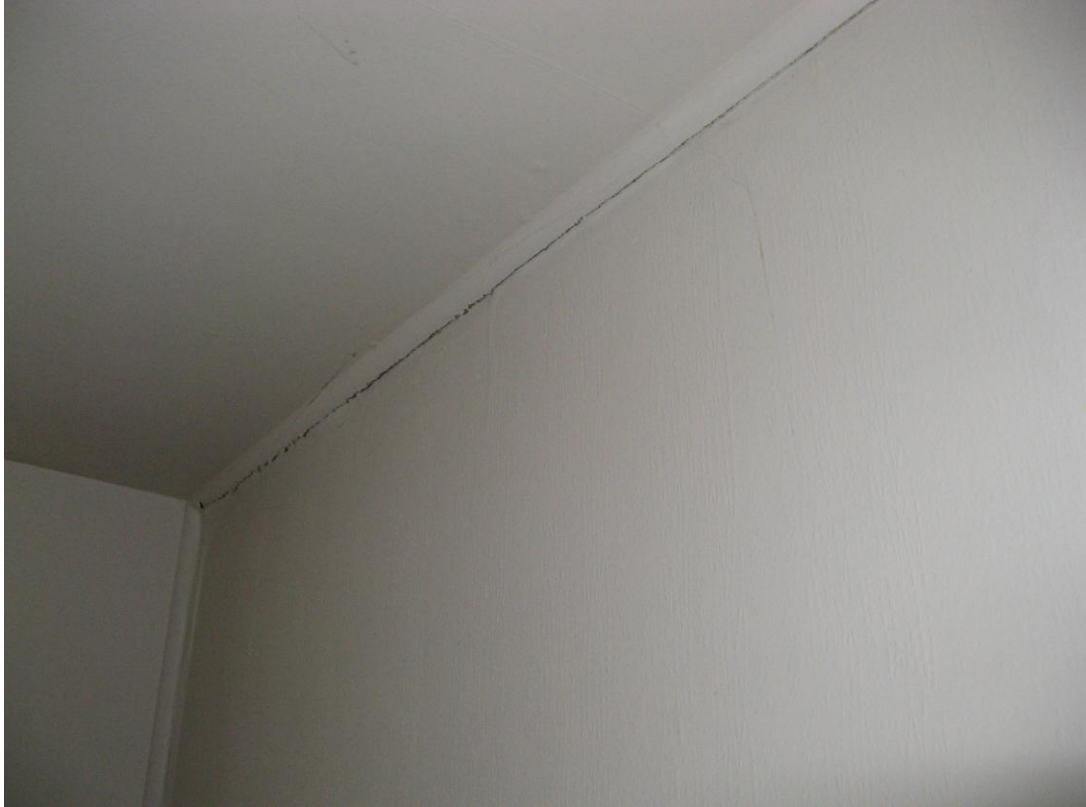
Photo 18: Typical damage at plasterboard ceiling connection to masonry walls.

Damage: Opening of joint due to relative movement between ceiling and concrete masonry.
