**Project Number 28912.000.001**

**Geotechnical Assessment**

Lighthouse Road Landslide, Akaroa,

Submitted to:  
Christchurch City Council  
PO Box 73016  
Christchurch 8154

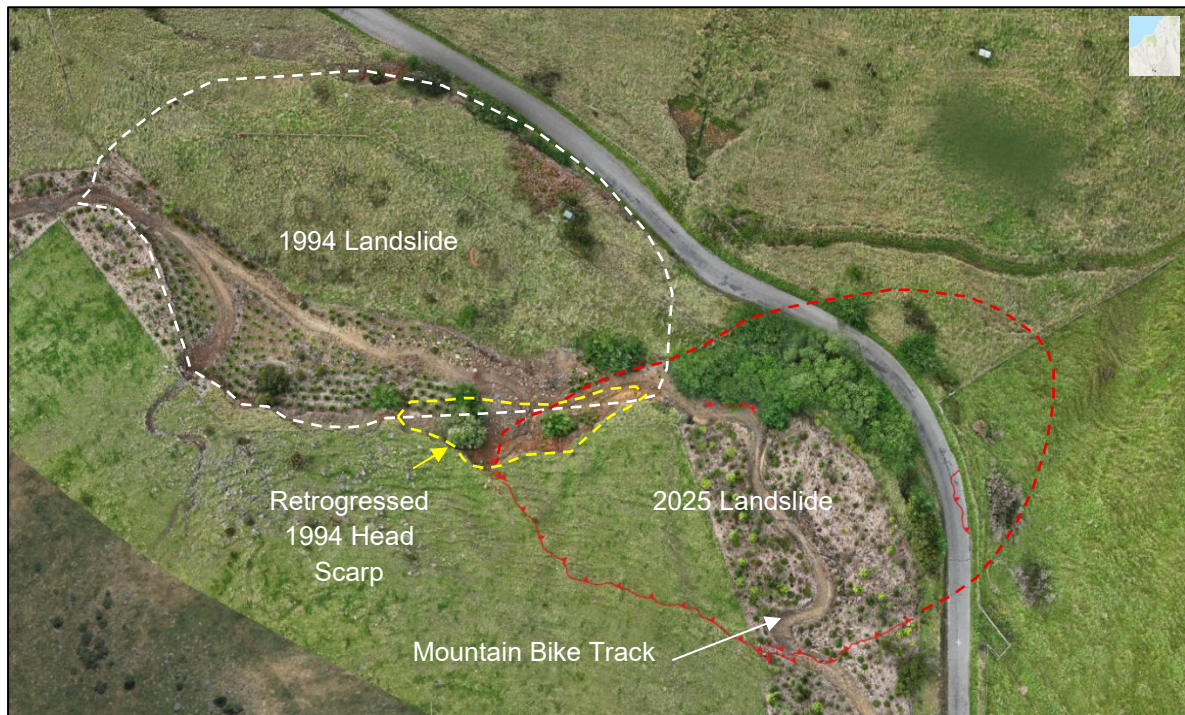
**Figure 3: 2025 Imagery with the Recent 2025 Landslide and 1994 Landslides Locations Annotated**

Christchurch City and Banks Peninsula experienced prolonged, intense rainfall between 30 April and 2 May 2025, resulting in flooding and multiple landslides across the region. On 1 May, cracks appeared along Lighthouse Road at the base of the landslide, prompting closure of the road. Evacuation of downslope residents occurred on the morning of Friday 2 May, when aerial reconnaissance revealed the extent of the cracking on the hillside. Following closer observation, tension cracks were observed extending from the crest of the historic landslide southeast for approximately 70 m, then east down to the road for approximately 35 m (Figure 3).

The 1994 landslide scarp is clearly visible, along with a more recent retrogressive failure within the eastern portion of the original scarp (Figure 3).

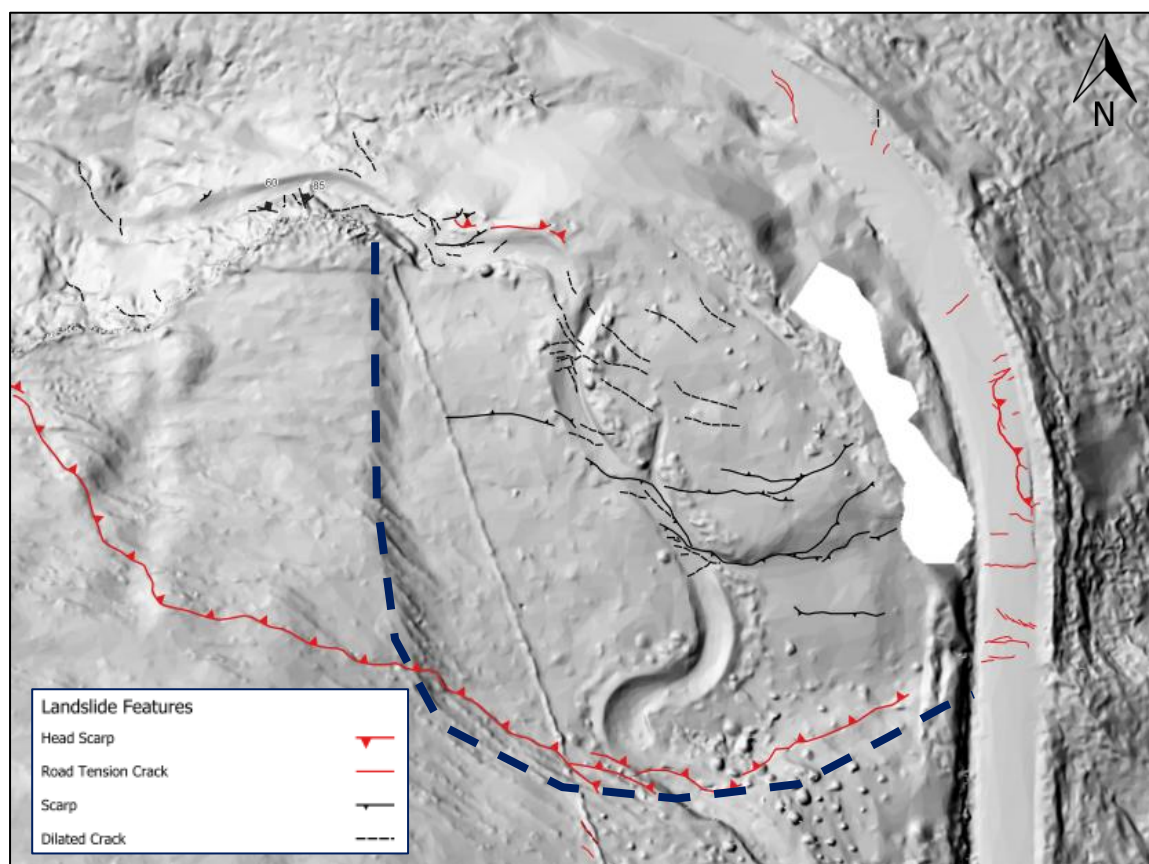
**Figure 5: Geomorphology Overlain on Hillshade Image**

Geomorphic evidence suggests that the landslide has been present in the landscape for some time prior to the recent reactivation. An arcuate feature is apparent in the LiDAR hillshade DEM as shown on Figure 5, which is interpreted to represent the headscarp of the landslide. During our field reconnaissance, this feature was noted to be rounded and subdued, suggesting that the landslide was inactive for many years to decades prior to movement in May.

Note: Inferred headscarp of previous landslide shown by blue dashed line.

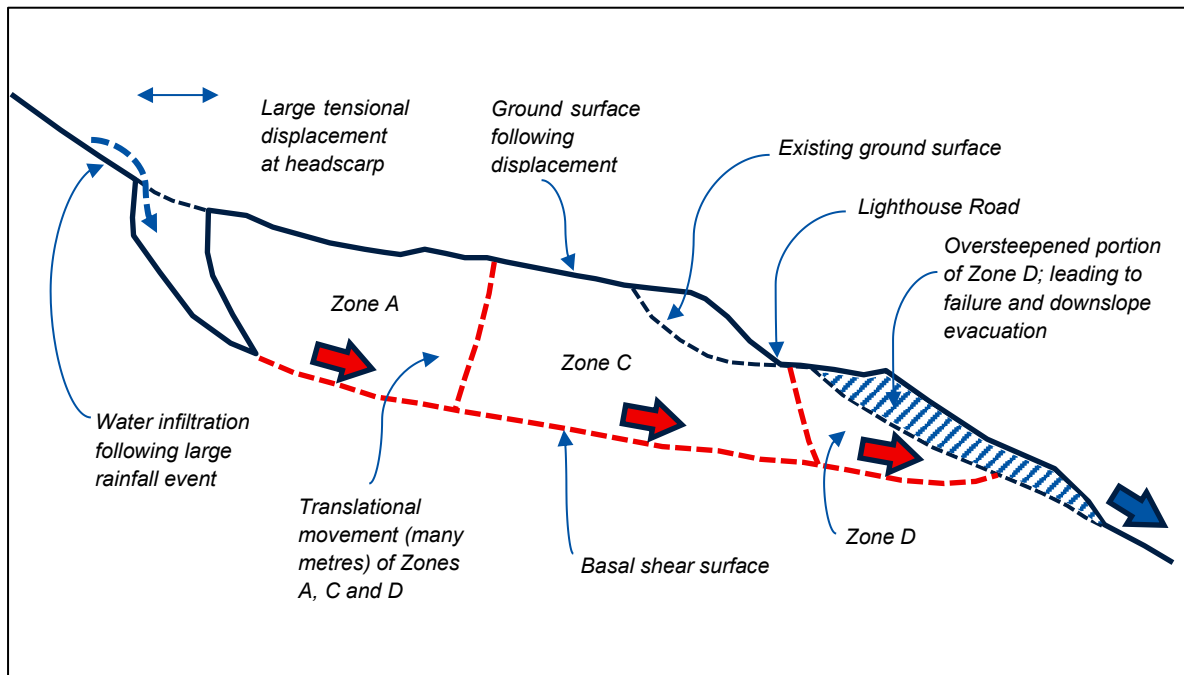
**Figure 6: Inferred Mechanism for Debris Flow Initiation**

For debris flow failure to occur, we consider that several precursor events would need to happen in sequence, as shown in Figure 6 and described below.

Conservatively assuming that all of the length of the toe were to fail, a solid failure volume of 3,000 m<sup>3</sup> is inferred, with a more likely event being on the order of 1,000 m<sup>3</sup>. The distance that these volumes of material could move downslope is assessed in Section 6.2 following.

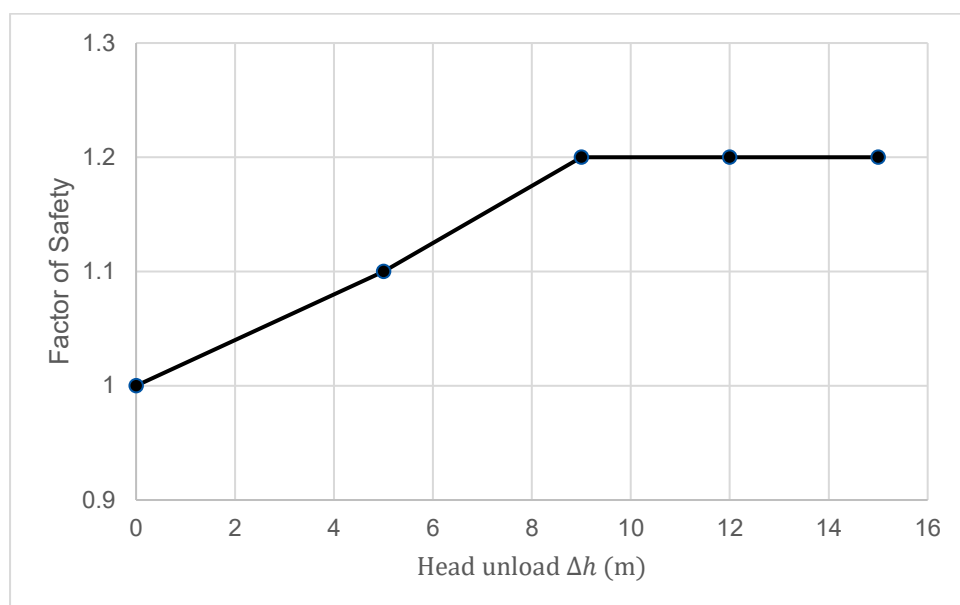
**Figure 8: Results of Slope Stability Analysis - Head unloading (Refer text for additional description)**

Head unloading slope stability outputs are included in Appendix 10.

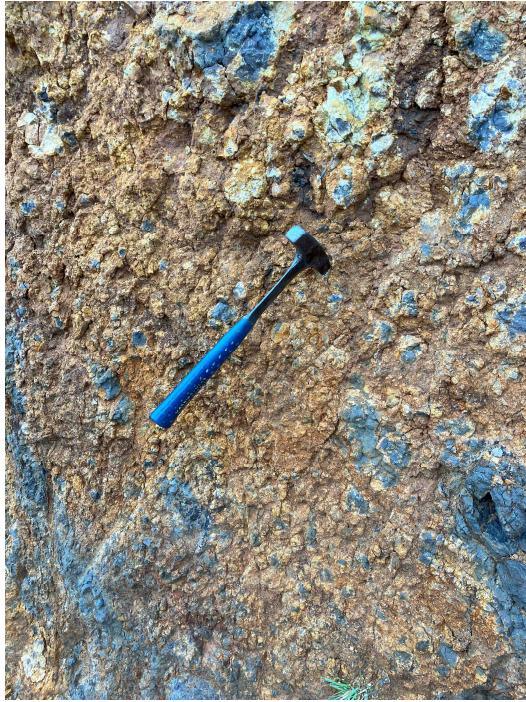
**Figure 1** Highly weathered pyroclastic layer visible in the road cut. Basalt clasts are visible in the deposit, presenting as the obvious grey areas, within the browner matrix material

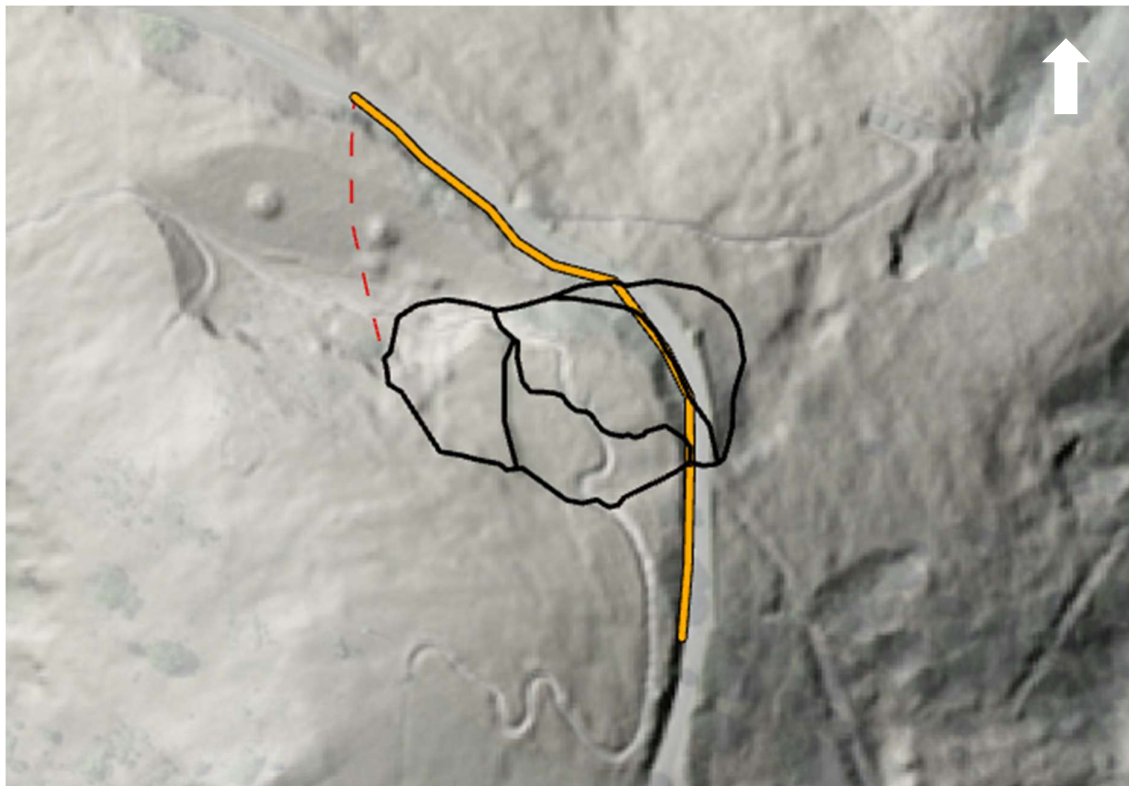
**Figure 2** Mapped extent of landslide from Engeo study (black lines). The site slopes generally from SW to NE. The approximate extent of the weathered material is illustrated on the west side of the mapped landslide by the red dashed line. The observed extent of the weathered material in the road cut is indicated by the orange line. It may extend past this to the south but was not investigated in detail during the brief site inspection.

It is clear that the landslide has occurred in the highly weathered rock material. There is no sign of movement in the less weathered material to the west (though previous landslides have occurred near here – possibly also in highly weathered rock units). Mapping of the landslide extent is based on areas that moved this year, all of which are located within the observed extent of the highly weathered material. There is little observed (mapped) movement in the area previously unloaded, however the preliminary cross section from Engeo implies that that area still has several metres of material remaining above the inferred failure plane. As such it may be prudent to regard the extent of weathered material as the possible landslide extent – even if outside of the currently active lobe. Further site investigation could confirm the distribution of the highly weathered rock. The failure plane of the landslide is likely a defect or transition between a pyroclastic and a basaltic (lava flow) layer, with residual weathered clays along this horizon facilitating movement of the slide.

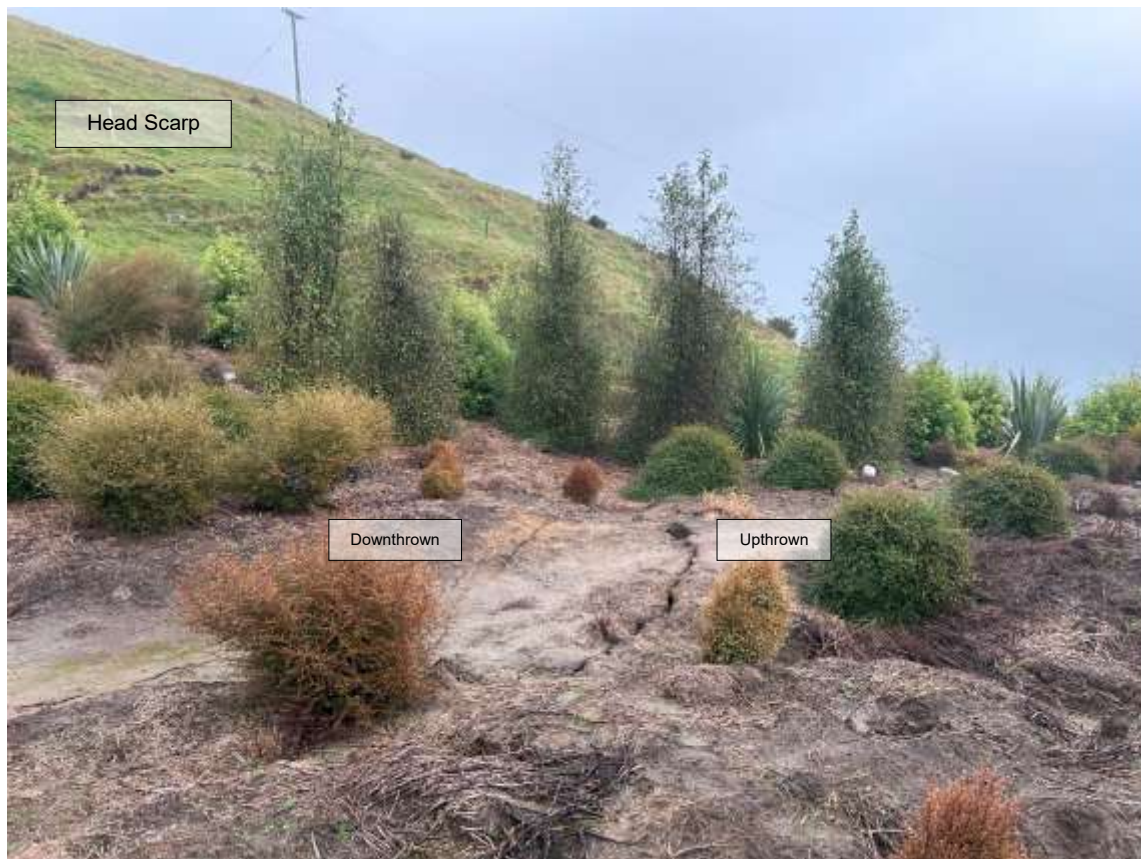
Photo 1. Landslide head morphology. Photo taken looking west from within the mountain bike area.

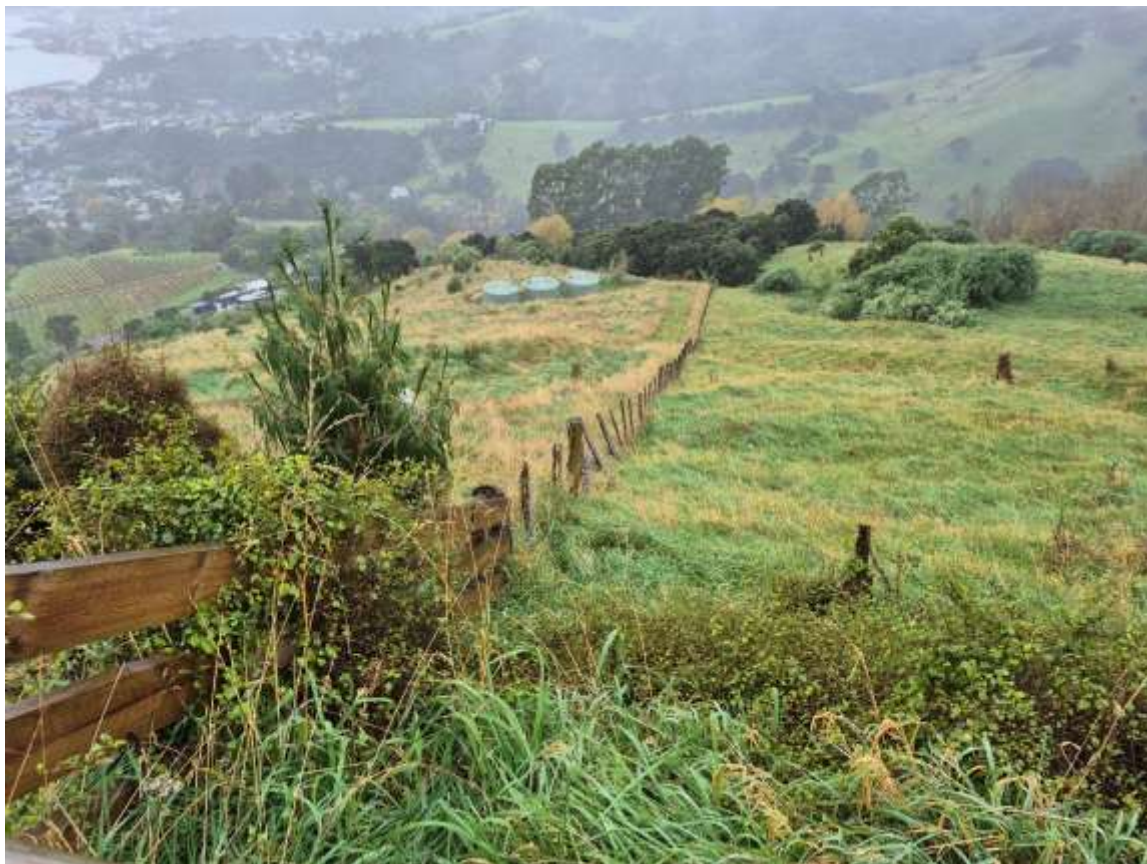
- **Fence Line Distortion:** The fence line along the downslope side of Lighthouse Road was noted to be taut and straight. In contrast, the fence line running perpendicular to the road is buckled and slackened downslope to approximately 233 m asl, indicating differential ground movement. A fence line intersecting the head scarp was observed to be taut with a post pulled up out of the ground by approximately 300 mm.
- **Internal Deformation:** Within the landslide mass between the head scarp and Lighthouse Road a cluster of small scarps and tension cracks indicates ongoing ground movement. These features undulate with the landscaped bike track and show vertical offsets dipping both to the south / southwest and north / northeast. A small upthrown graben feature is visible in the central eastern portion of the landslide mass.

Photo 2. Slacked fence line below Lighthouse Road.

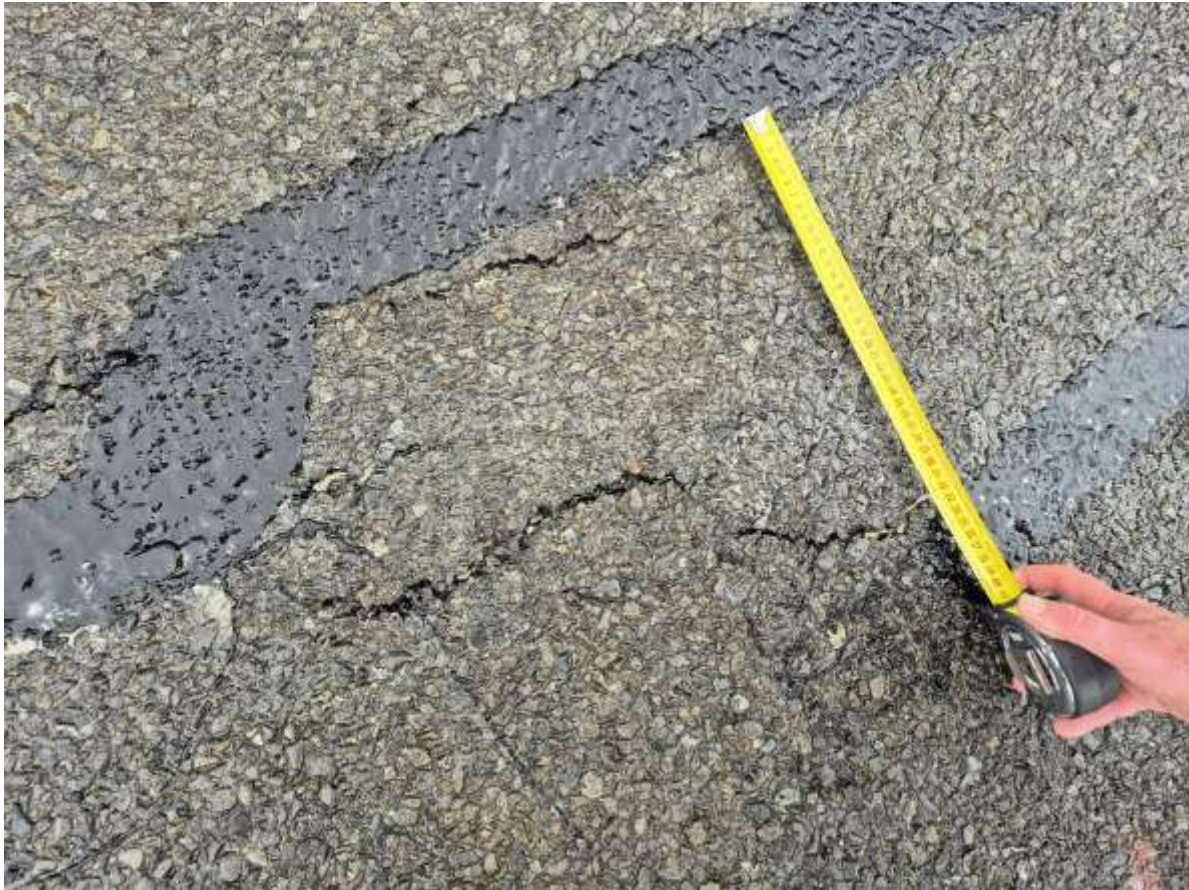
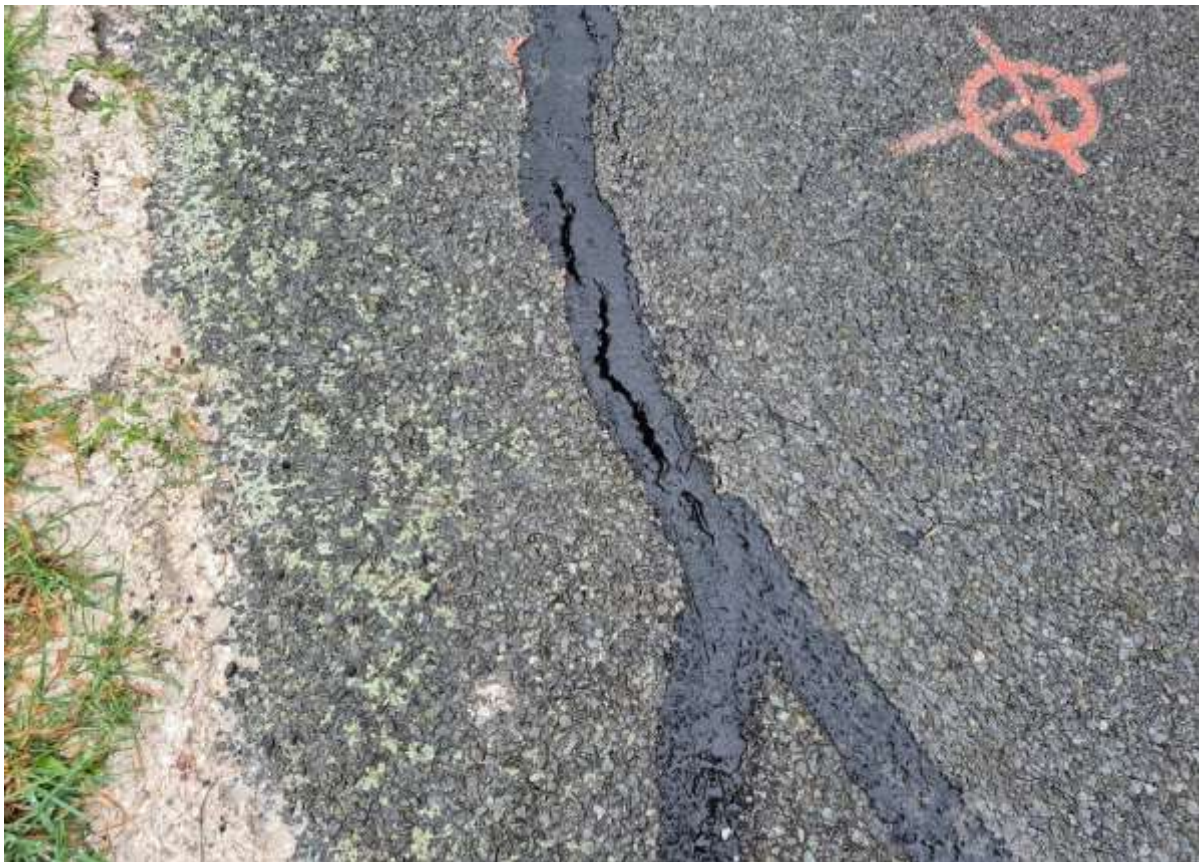
- Road Deformation:** Tension cracks were observed within Lighthouse Road. These had recently been infilled with road seal, but some appear to have since re-opened, with dilated cracks up to 10 mm wide visible within the infill material. The road surface which rises from 240 and 250 m asl shows slight bulging on the upslope side in two locations. On the downslope side, cracks up to 30 mm wide run sub-parallel to the road seal.
- Head Scarp and Surface Expression:** A prominent head scarp extends from the centre of the retrogressed 1994 scarp westward through the grassed farmland, intersecting the mountain bike track and landscaped area. It becomes indistinct on the vegetated slope above the road to the east, with only minor tension cracks continuing down the 1994 scarp to the west.

Photo 3 & 4. Evidence of continued movement in tension cracks within Lighthouse Road.

Targeted pavement investigations are advised to inform pavement design. Damaged road sections should be reconstructed using geogrid-reinforced engineered fill to improve stability and load distribution. Surface water controls, including roadside swales and stormwater outfalls, should be enhanced to prevent infiltration and erosion.

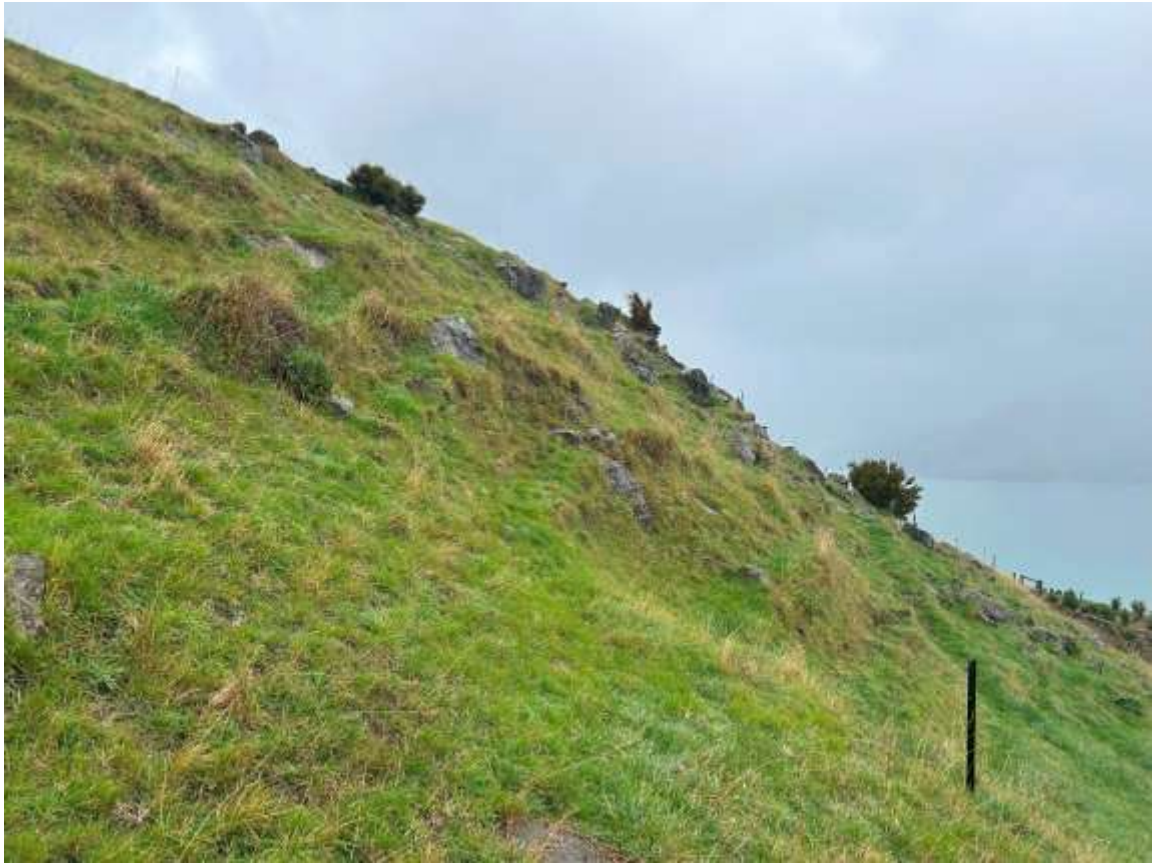
We observed weathered basalt outcrops near the crest of the spur, above the landslide head scarp. Additionally, basalt outcrops are apparent within the road cuttings downslope of the landslide on Lighthouse Road. According to Geotech (1994), a competent basalt flow is located below Lighthouse Road, dipping into the slope.

Photo 5. Basalt sub-crops above head scarp.

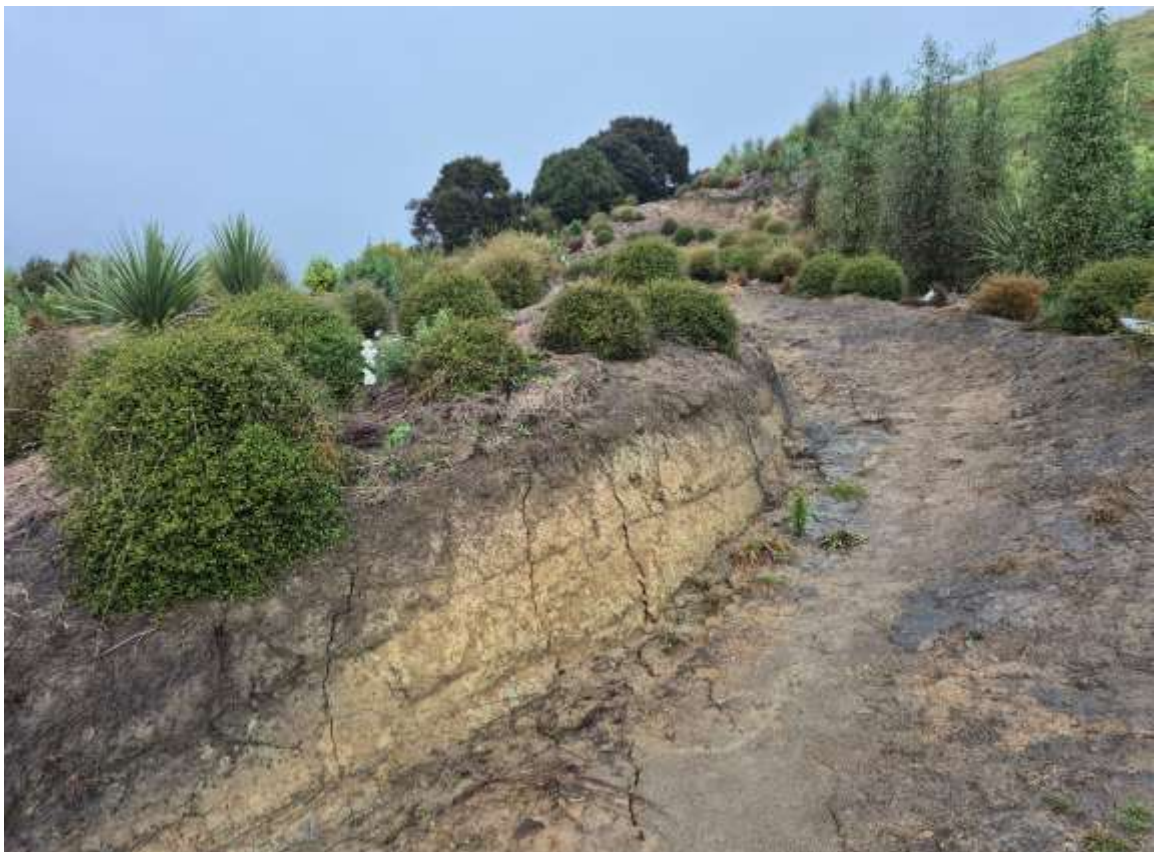
**Zone C** denotes a displaced extensional area where back scarps form slight upthrown graben features typical of extensional settings. This zone has a high concentration of tension cracks aligned subparallel to the main head scarp and to the orientation of the defects measured in outcrop (as described in Section 4.1).

Photo 6. Tension cracks within Zone C.

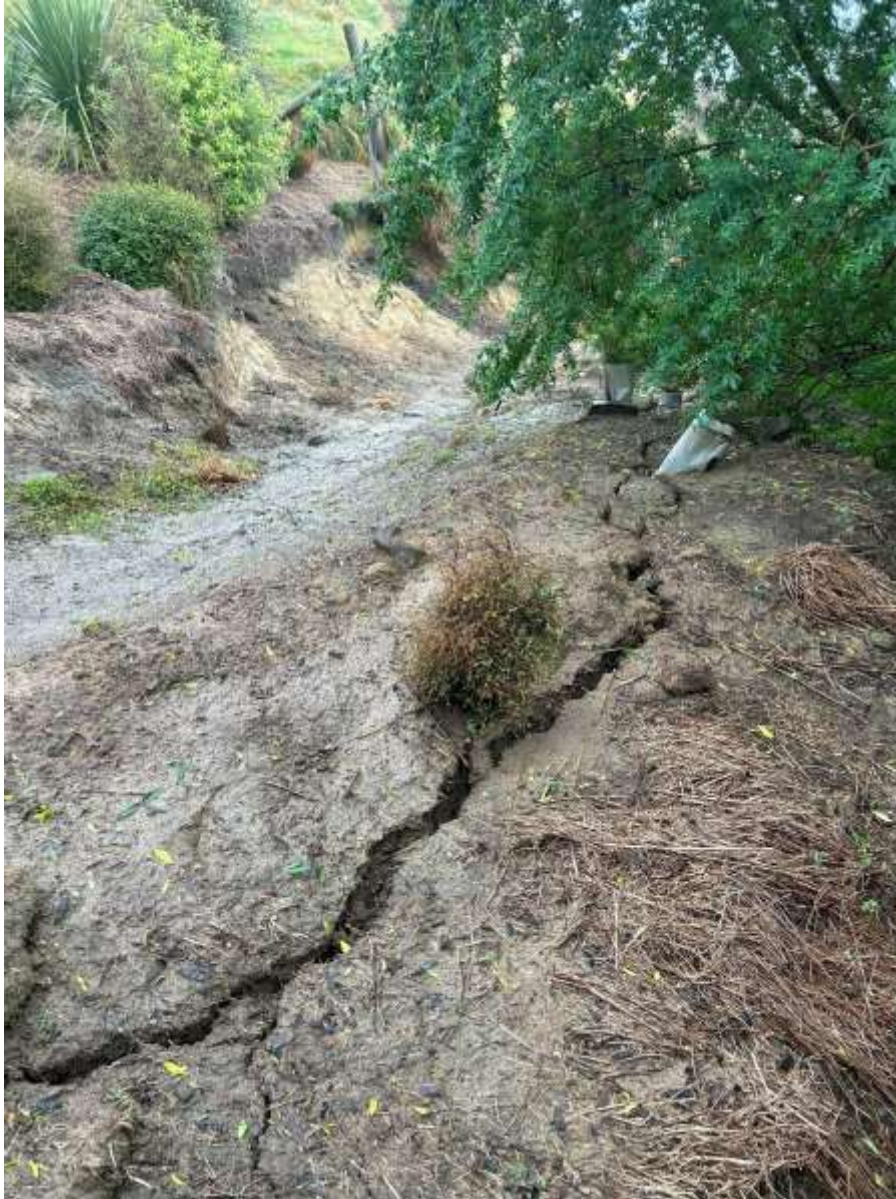
Photo 7. Tension Cracks within Zone D2.

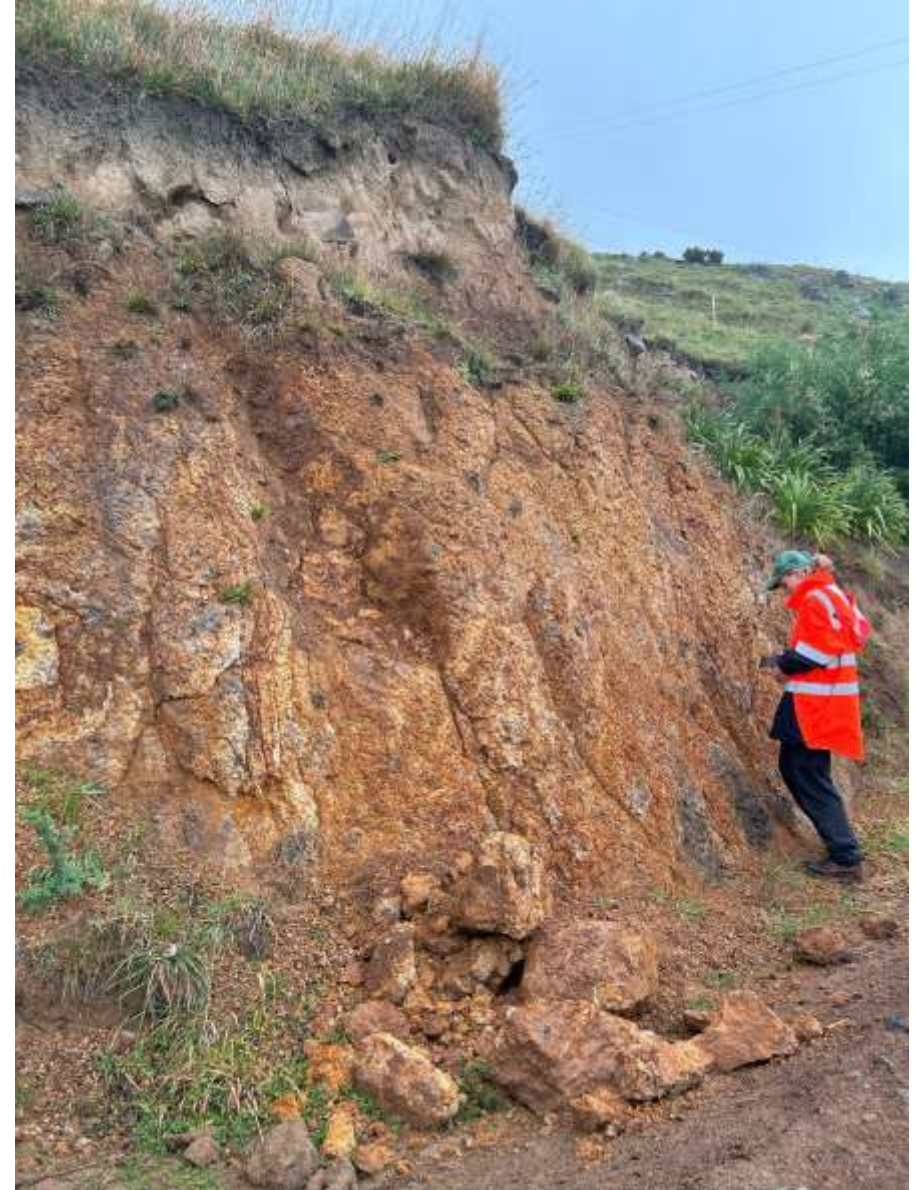
We took structural measurements on two defect sets within the pyroclastic material, with one set measuring subvertical / 072°<sup>7</sup> and the other measuring 60° / 014°. Both defects showed evidence of movement, and were dilated to between 30 and 40 mm.

Photo 8. Volcanic Tuff material with open defects (Dip/Dip Direction Measured).

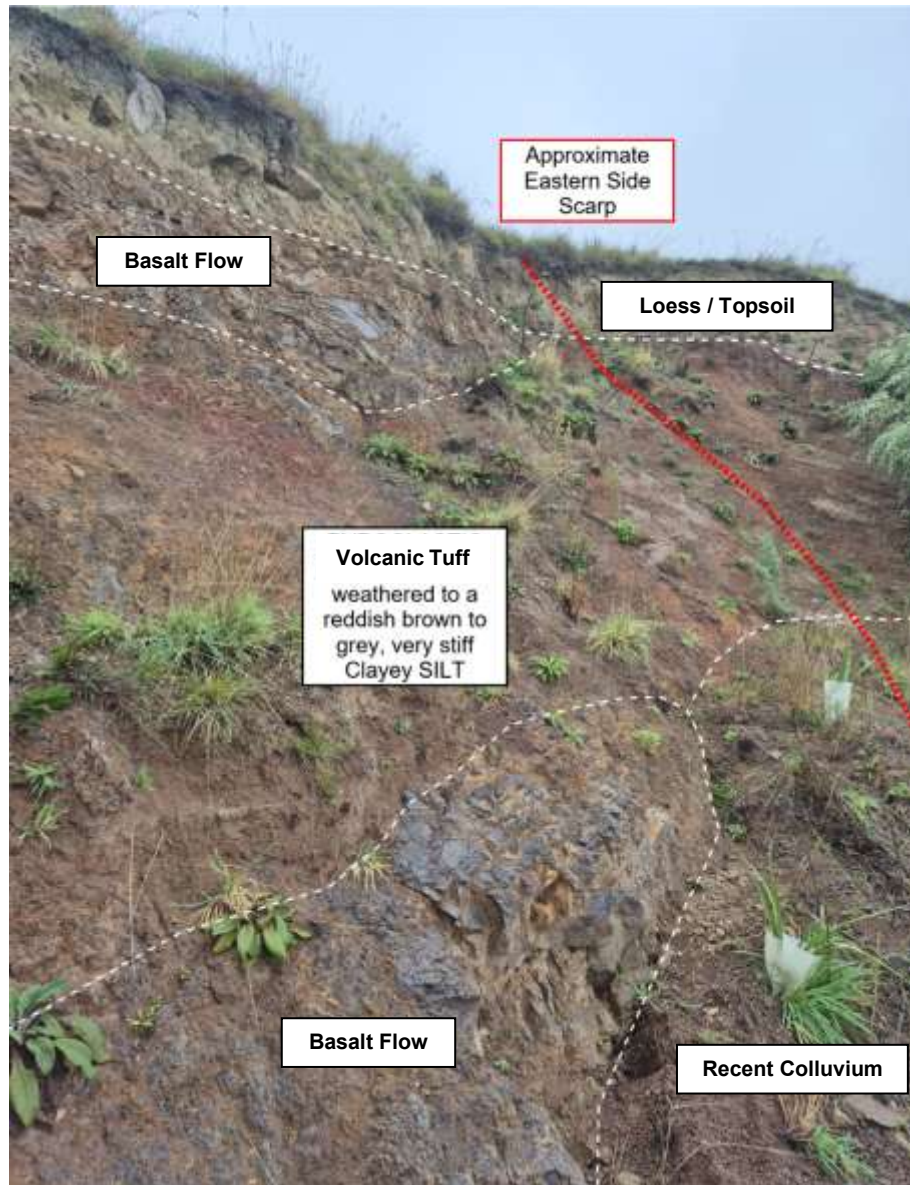
Pyroclastic material was found within the retrogressed 1994 landslide scarp. The surface of this pyroclastic material was weathered to a reddish-brown colour, while the unweathered material appeared light grey. The weathered material was a clayey silt with an estimated strength of very stiff. Isolated metre-scale basalt flows are present within the pyroclastic material, forming more competent beds within the rock mass. Two defect sets were also identified and may be exerting some structural control within the rock mass.

Photo 9. Cross-sectional geology of the landslide, shown as a representative face within the regressed 1994 landslide.
