Dudley Creek Flood Remediation
Downstream Options Report
Rev 2, 12/6/15
Appendix B

Dudley Creek Flood Remediation Downstream Options Report Tree Survey Summary

Dudley Creek Flood Remediation: ECOLOGICAL CONDITION OF LOWER DUDLEY CREEK

EOS Ecology Report No: BEC01-15015-01 | June 2015
Prepared for: BECA
Prepared by: EOS Ecology
Shelley McMurtrie & Alex James

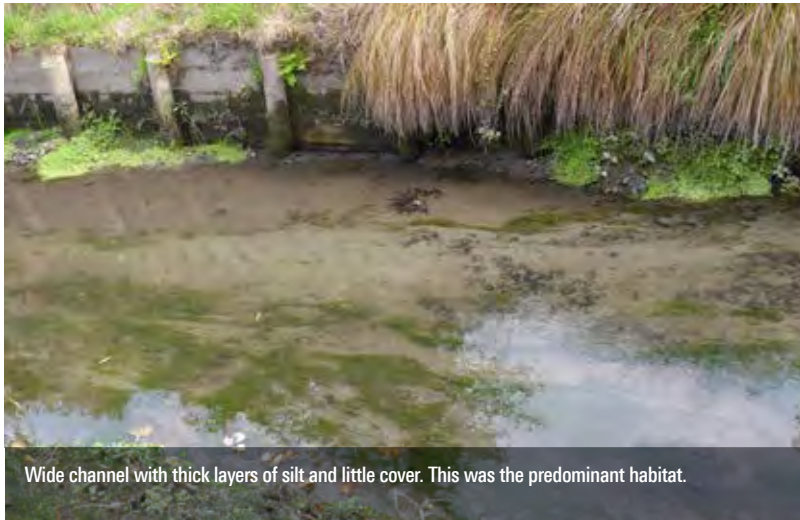
Wide channel with thick layers of silt and little cover. This was the predominant habitat.

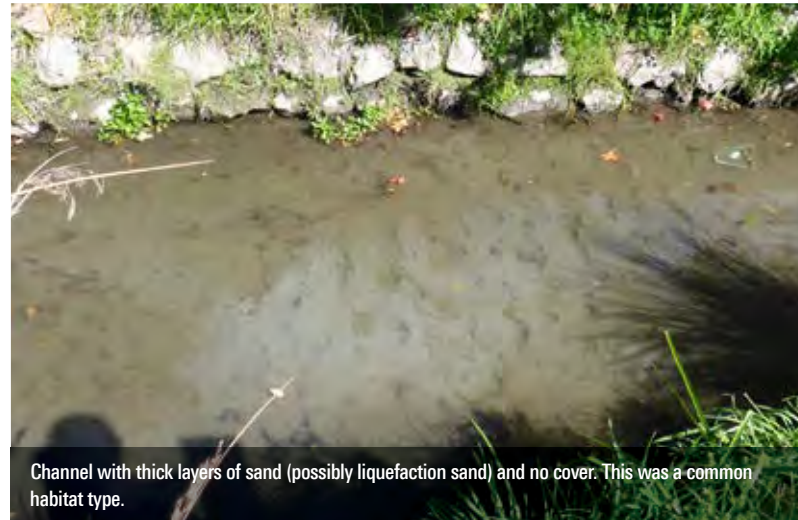
Channel with thick layers of sand (possibly liquefaction sand) and no cover. This was a common habitat type.

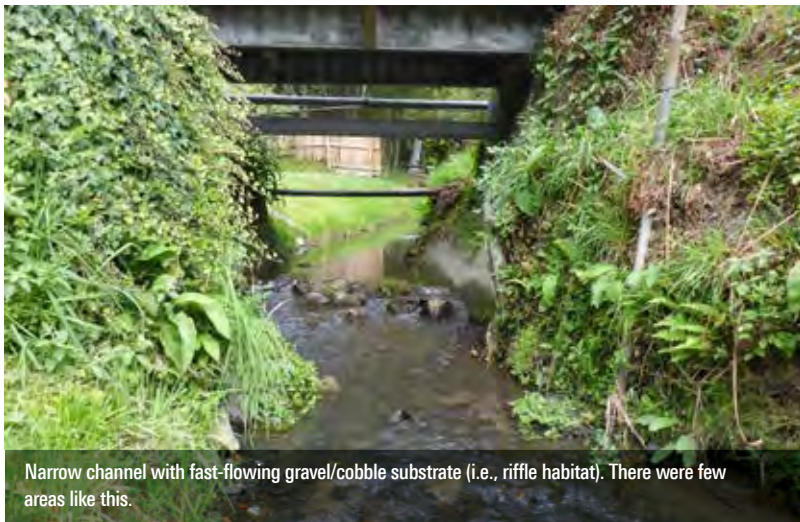
Narrow channel with fast-flowing gravel/cobble substrate (i.e., riffle habitat). There were few areas like this.

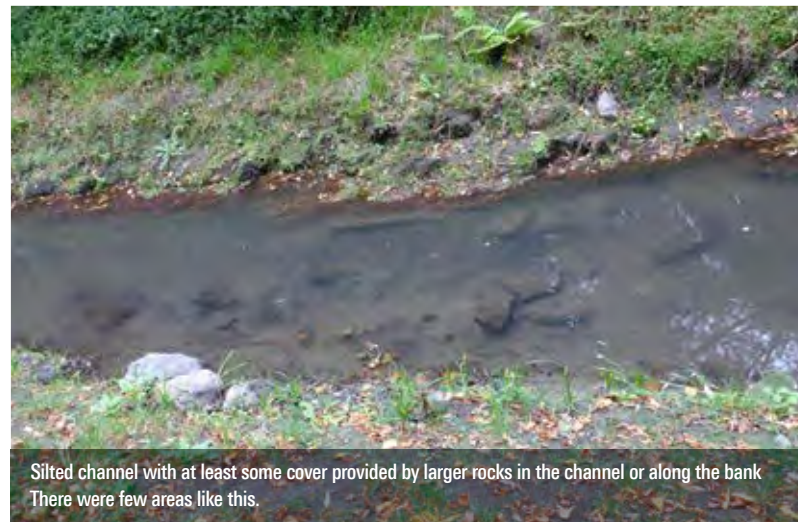
Silted channel with at least some cover provided by larger rocks in the channel or along the bank. There were few areas like this.

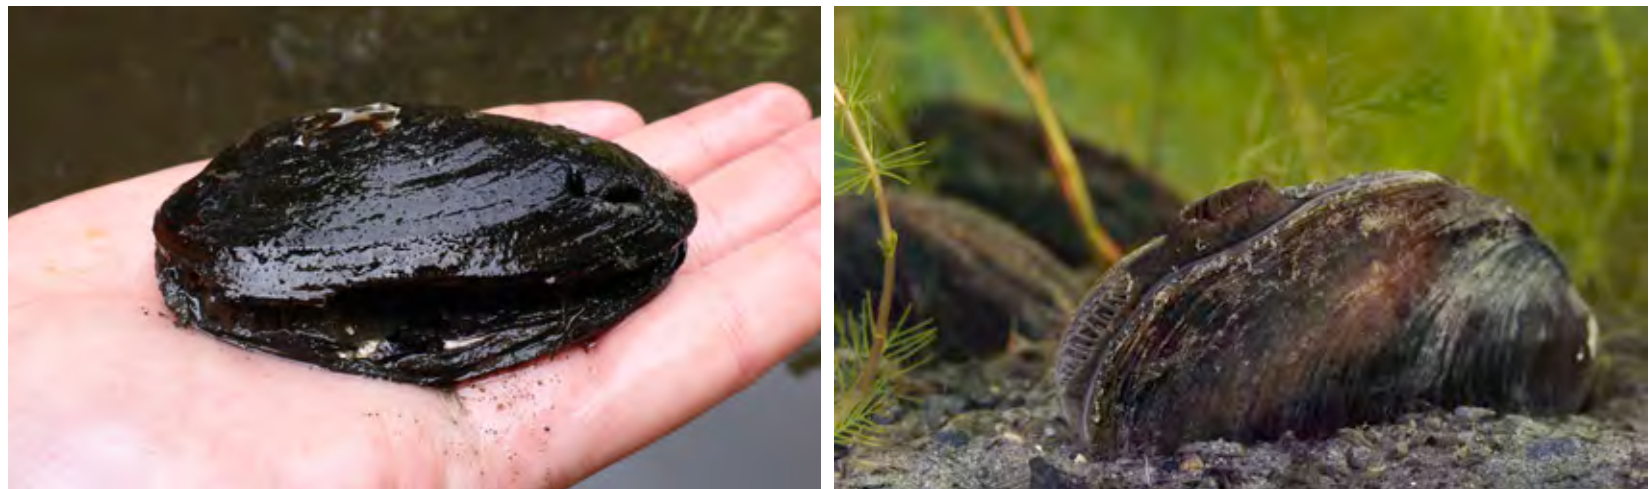
FIGURE 9
Empty freshwater mussel/kakahi shells (left) were found in Dudley Creek along Banks Avenue. No live specimens (right) were found although a specific search for them was not undertaken.

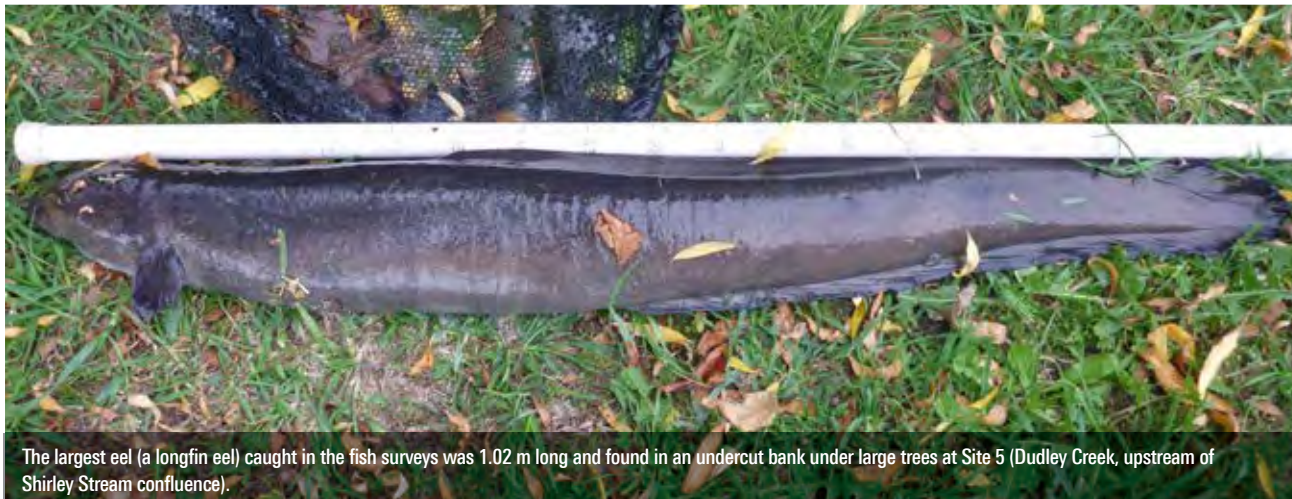
The largest eel (a longfin eel) caught in the fish surveys was 1.02 m long and found in an undercut bank under large trees at Site 5 (Dudley Creek, upstream of Shirley Stream confluence).

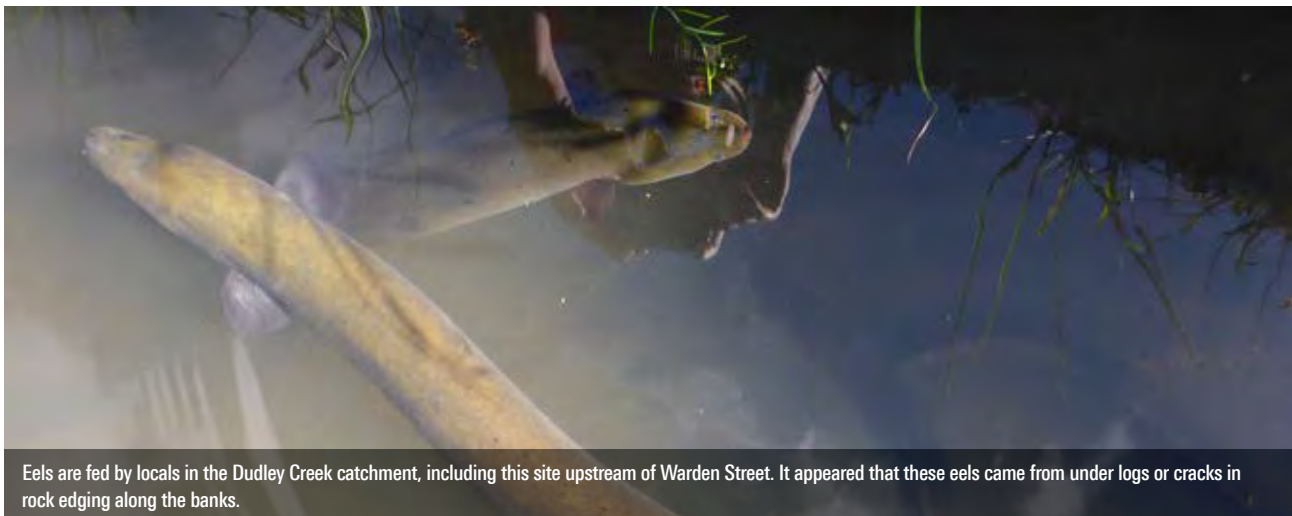
Eels are fed by locals in the Dudley Creek catchment, including this site upstream of Warden Street. It appeared that these eels came from under logs or cracks in rock edging along the banks.
