Akaroa Wastewater Irrigation to Land Investigations

Akaroa Wastewater Irrigation Preliminary Geotechnical Assessment (CH2M Beca Ltd)

Prepared by CH2M Beca Ltd

13 June 2016

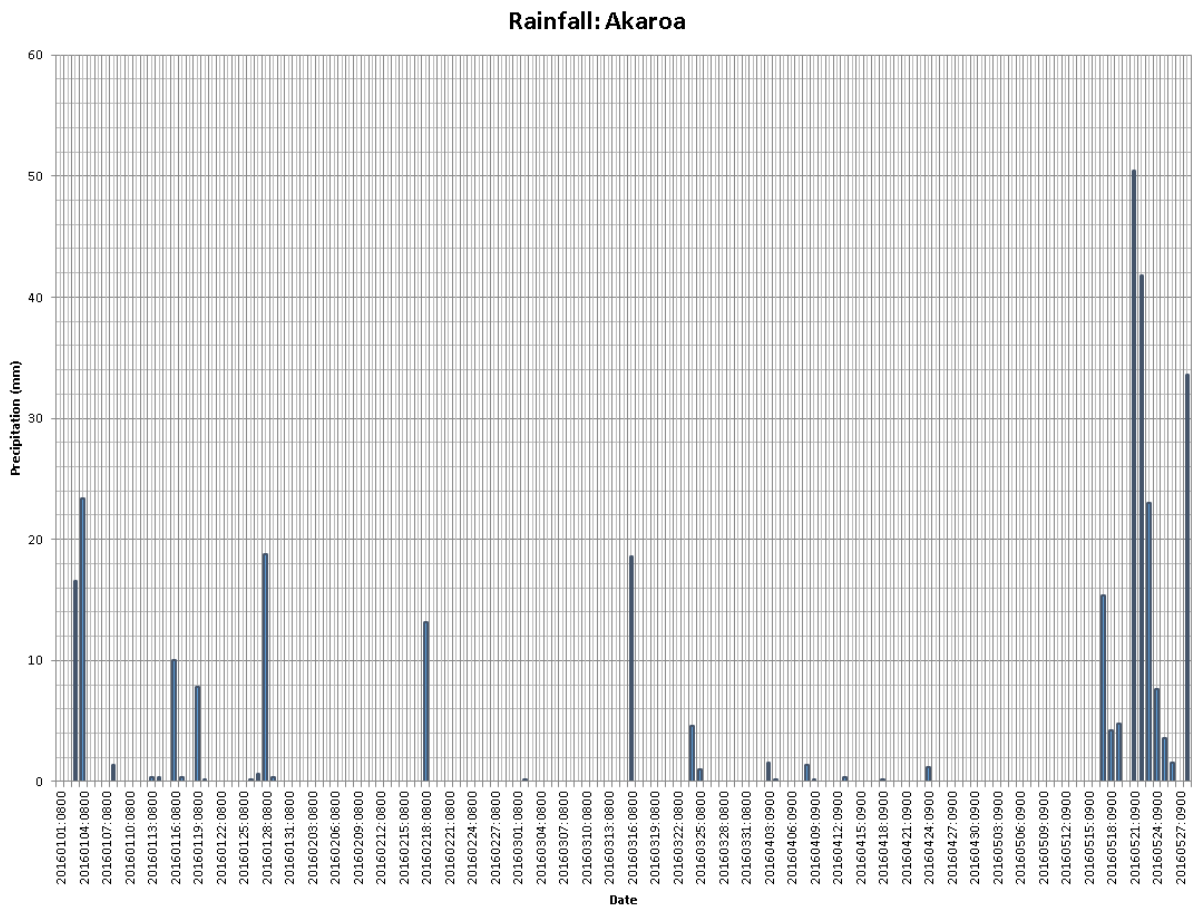
Daily rainfall data for Akaroa was sourced from the NIWA National Climate Database for 1 January 2016 to 29 May 2016 (Figure 2-1). The data indicates that the period between 1 January 2016 and 16 May 2016 was relatively dry with the approximate cumulative rainfall over the five months amounting to 125 mm. In the 12 days leading up to the investigation (17 May 2016 to 29 May 2016) rainfall increased and the cumulative amount for the 12 day period was approximately 190 mm.

Figure 2-1 Rainfall Data for Akaroa (Station No. 36593) from 1 January 2016 to 29 May 2016. Data sourced from Cliflo: NIWA's National Climate Database on the Web, <http://cliflo.niwa.co.nz>, Data retrieved 13 June 2016

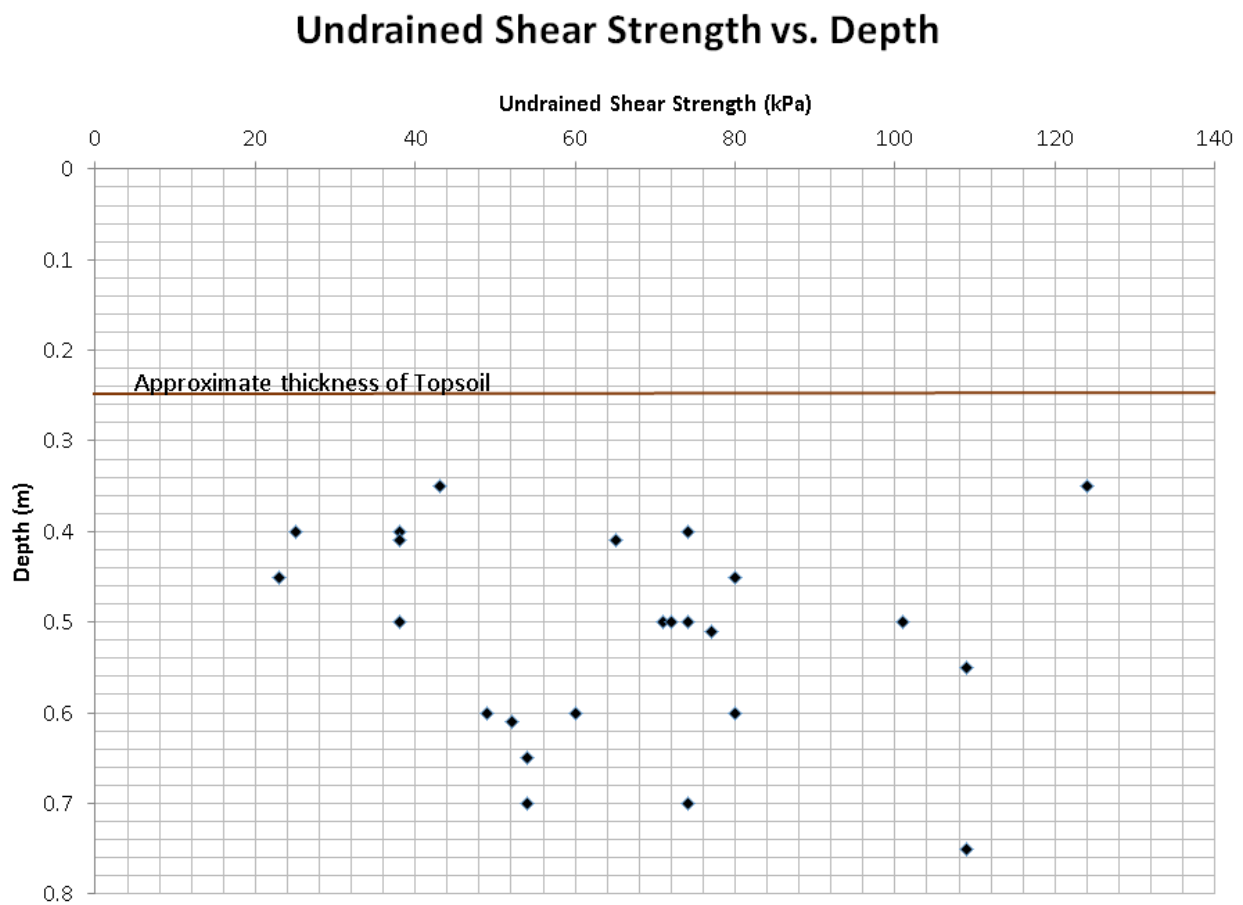
Figure 4-1 presents the peak undrained shear strength values from hand held shear vane testing in the loess in the test pits plotted against depth. This demonstrates the wide range in recorded undrained shear strength and suggests a loose trend of increasing strength with depth. The 20kPa to 40kPa undrained shear strengths recorded in some of the shallow tests may reflect a higher moisture content resulting from the recent rainfall.

Figure 4-1: Undrained Shear Strength (kPa) vs. Depth (m) data from geotechnical investigation (May, 2016)

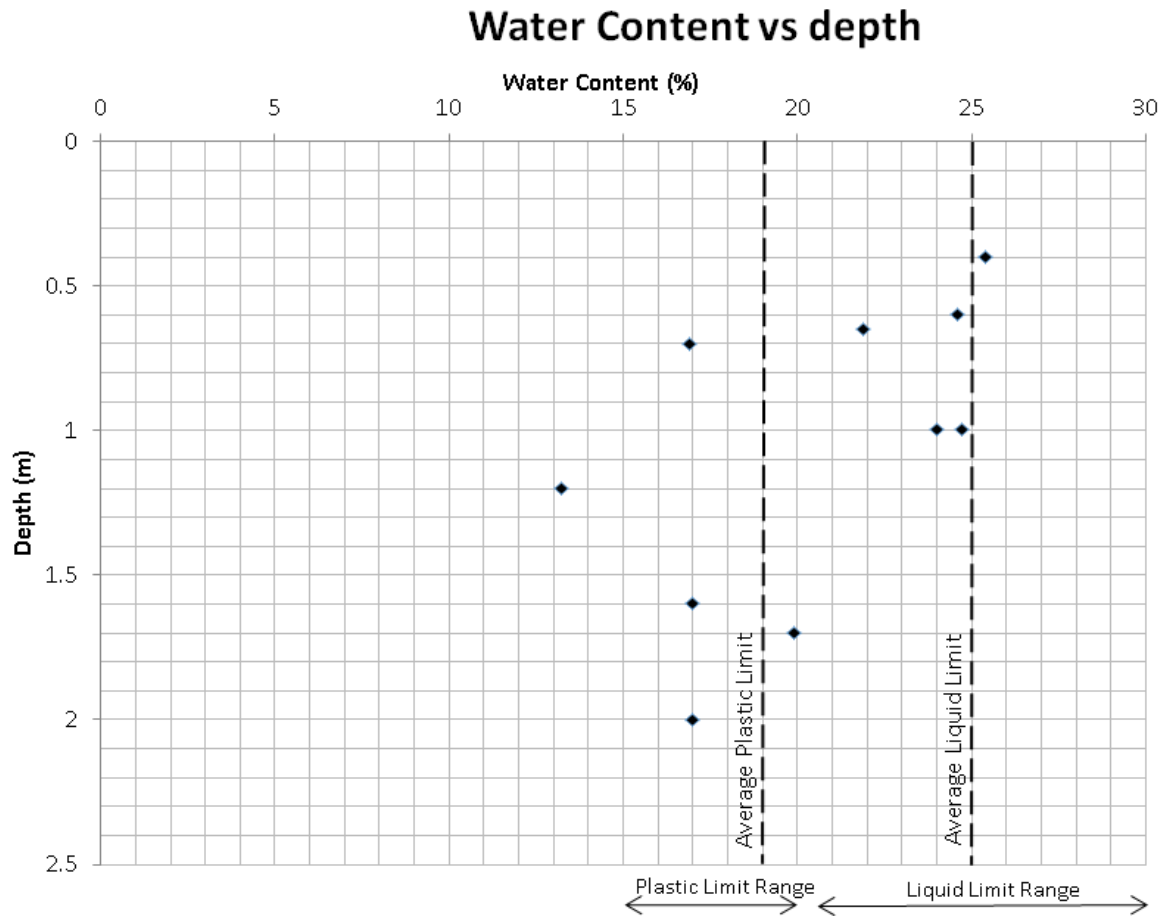
Figure 4-2 presents the results from the laboratory water content tests plotted against the depth of samples. The liquid limit and plastic limit average lines and ranges have been sourced from information reviewed in unpublished University of Canterbury theses on loess from Banks Peninsula.

Figure 4-2: Water content test results vs. depth (m). Water content data from Beca Laboratory test results (May, 2016).

The laboratory tests indicated that the water content in the loess ranges from 13 % to 25 %, with an average water content from the tested samples of 20 %. Generally the laboratory test results indicated a decrease in water content with depth.

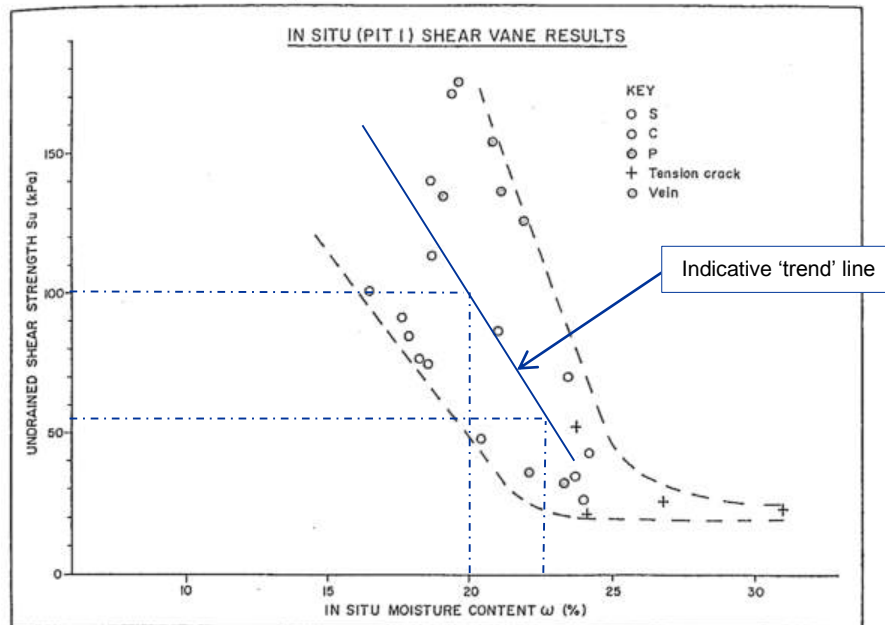
The undrained shear strength of loess is sensitive to changes in moisture content. Figure 4-3 has been taken from a University of Canterbury thesis and shows the effect of changing moisture content on the shear strength of loess. The figure suggests that when the moisture content increases by 2.5 % (from 20 % to 22.5 %) the undrained shear strength of loess is approximately halved from 100 kPa to 55 kPa.

Figure 4-3 Undrained shear strength (S_u) measured with hand held shear vane compared with in-situ moisture contents (%). Sourced from Unpublished MSc thesis by Goldwater (1990)

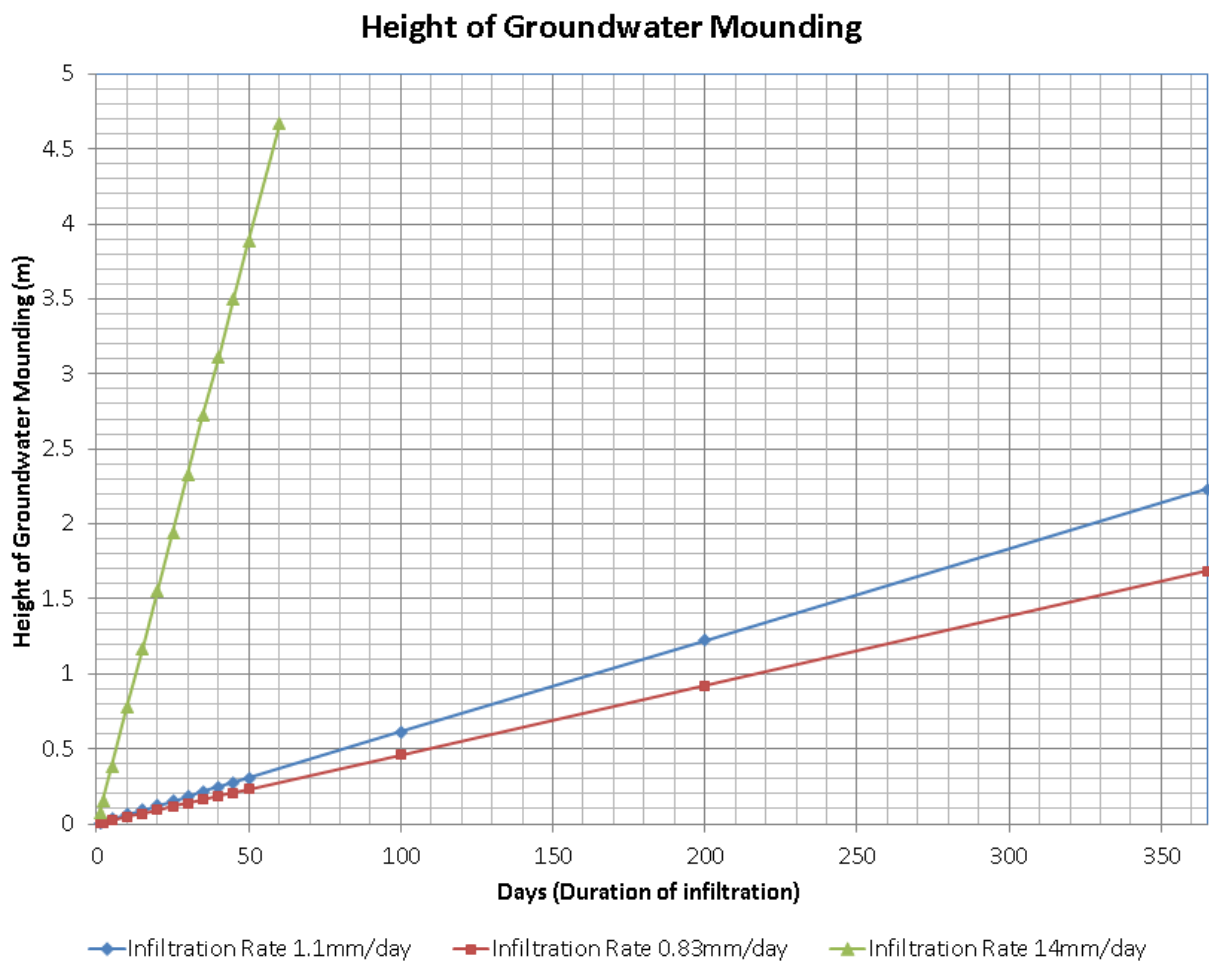
The groundwater mounding calculations indicated the degree of groundwater mounding was affected primarily by the duration which the wastewater was applied. The longer the wastewater was applied the higher the groundwater mounding. Figure 5-1 presents the height of groundwater mounding against duration of loading application for Blocks E and G based on the average net infiltration rates. This indicates that groundwater may mound to 2m over a one year period based on a number of simplifying assumptions.

Figure 5-1: Groundwater mounding compared with duration of irrigation (days)

However, this assessment is based on average annual figures and if there were to be a prolonged wet period during the year, the mounding would increase. For example if the net infiltration rate increased to a level equal to the application rate, after 60 days the height of groundwater mounding is calculated to be greater than 4.5 m. If the thickness of loess is between 4 m – 5 m thick the groundwater will be above or within 1 m of the surface layer. The width of the groundwater mounding has not been calculated as part of this assessment.

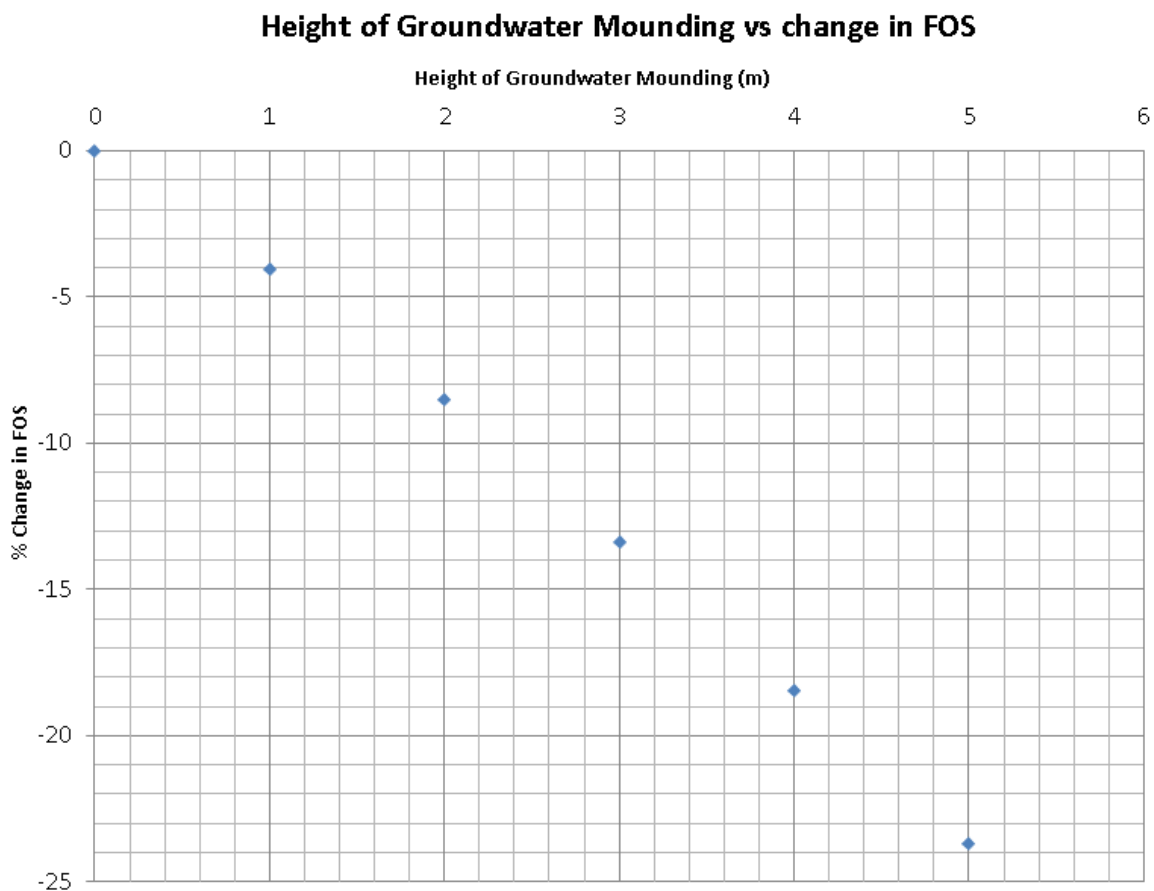
Figure 6-1 shows the height of groundwater mound compared with relative change in Factor of Safety (FOS).

Figure 6-1: Height of groundwater mound compared with relative change in Factor of Safety (FOS)

The analyses showed that if the application of irrigation water results in a 4 m to 5 m high groundwater mound, the FoS is expected to reduce by approximately 20%. If the mound is lesser (say 2 m after 1 year as indicated by analyses using average net infiltration rates reported by PDP (2016)), then a reduction in FoS of about 10% might be anticipated. This means that if a slope currently has marginal stability then the addition of wastewater might result in instability, in particular when combined with a period of rainfall.

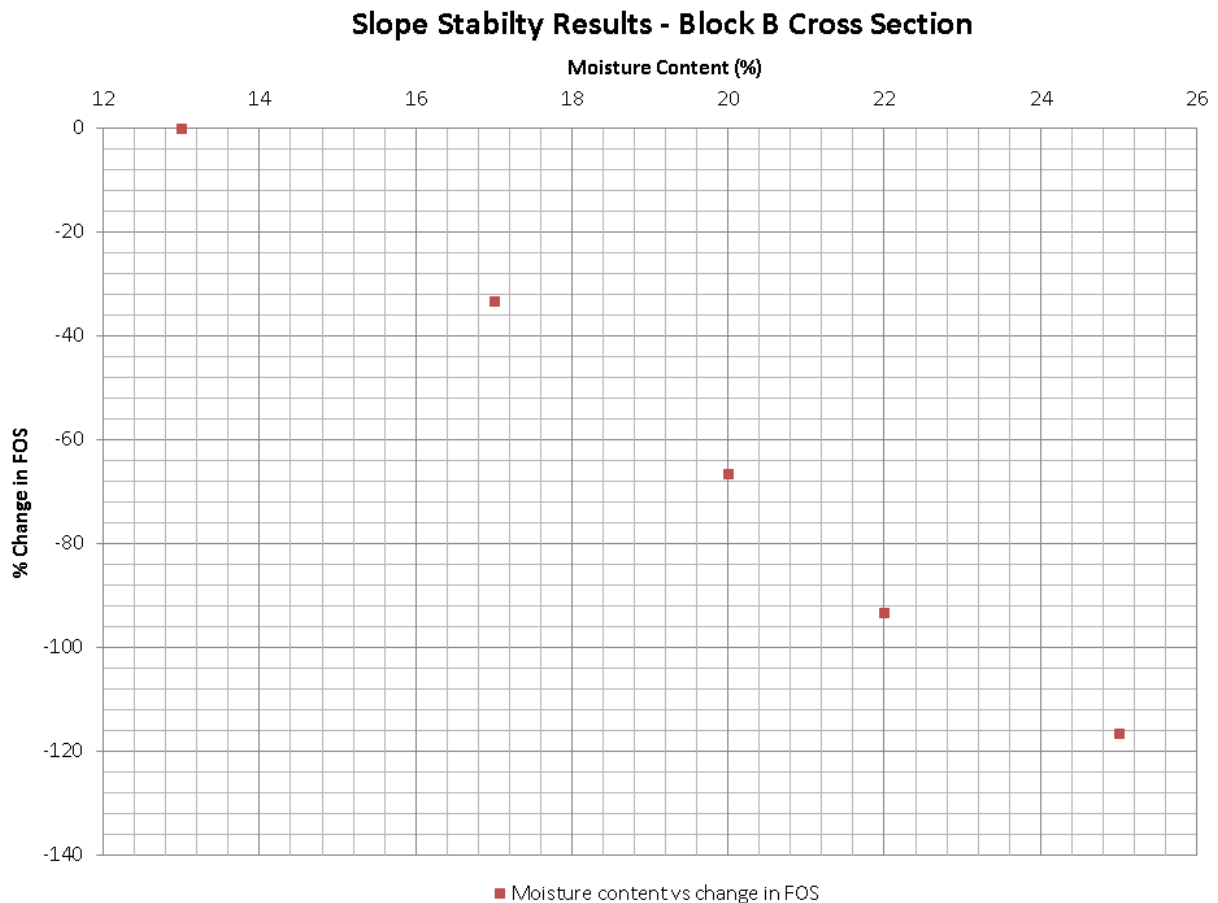
Figure 6-2 shows the inferred effect of a change in moisture content with FoS for undrained loading, based on the moisture content versus undrained shear strength relationship given in Figure 4-3.

Figure 6-2 Moisture content vs. relative change in Factor of Safety (FOS)

The undrained analyses showed that an increase of moisture content between 2 % and 4 % can reduce the FoS by approximately 30 % and 40 %. This reduction in FoS would apply under seismic loading and is independent of the reduction shown in Figure 6-1.

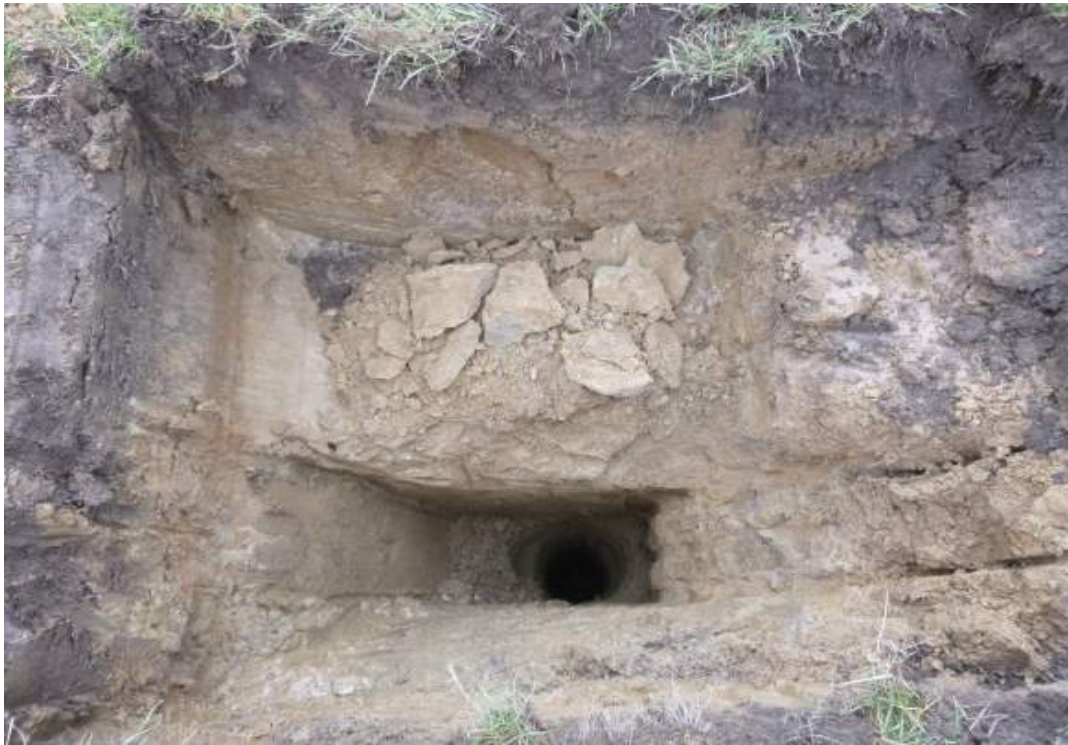
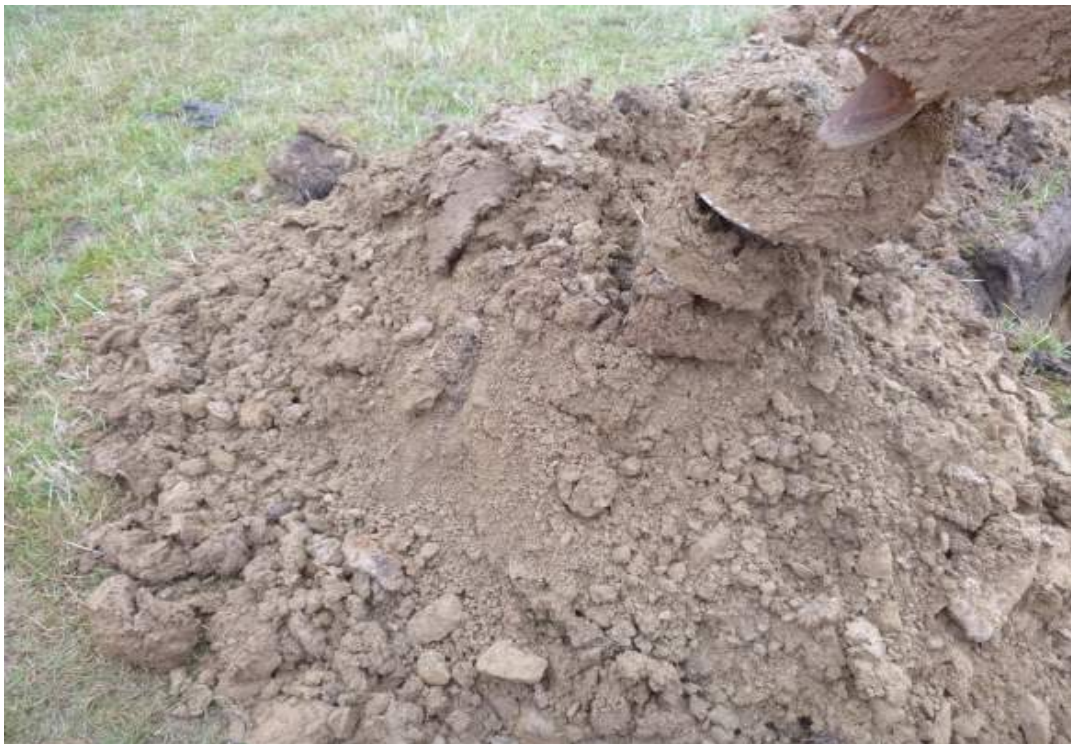
TP1

0.5		x x x x x					1				
		x x x x x					0	90/12	124/16		
		x x x x x					1	74/18	101/23		142.5
		x x x x x			From 0.6m to 1.4m: vertical and horizontal veining infilled with soft, SILT, trace clay; grey; moist; low plasticity. Orange staining surrounding grey veins. Vein aperture approximately 1-3cm.		2	60/14	80/18	B
