# Spring identification and groundwater management for potential rezoning at the Grassmere Block

Prepared for Christchurch City Council

Prepared by (Beca)

22 December 2016

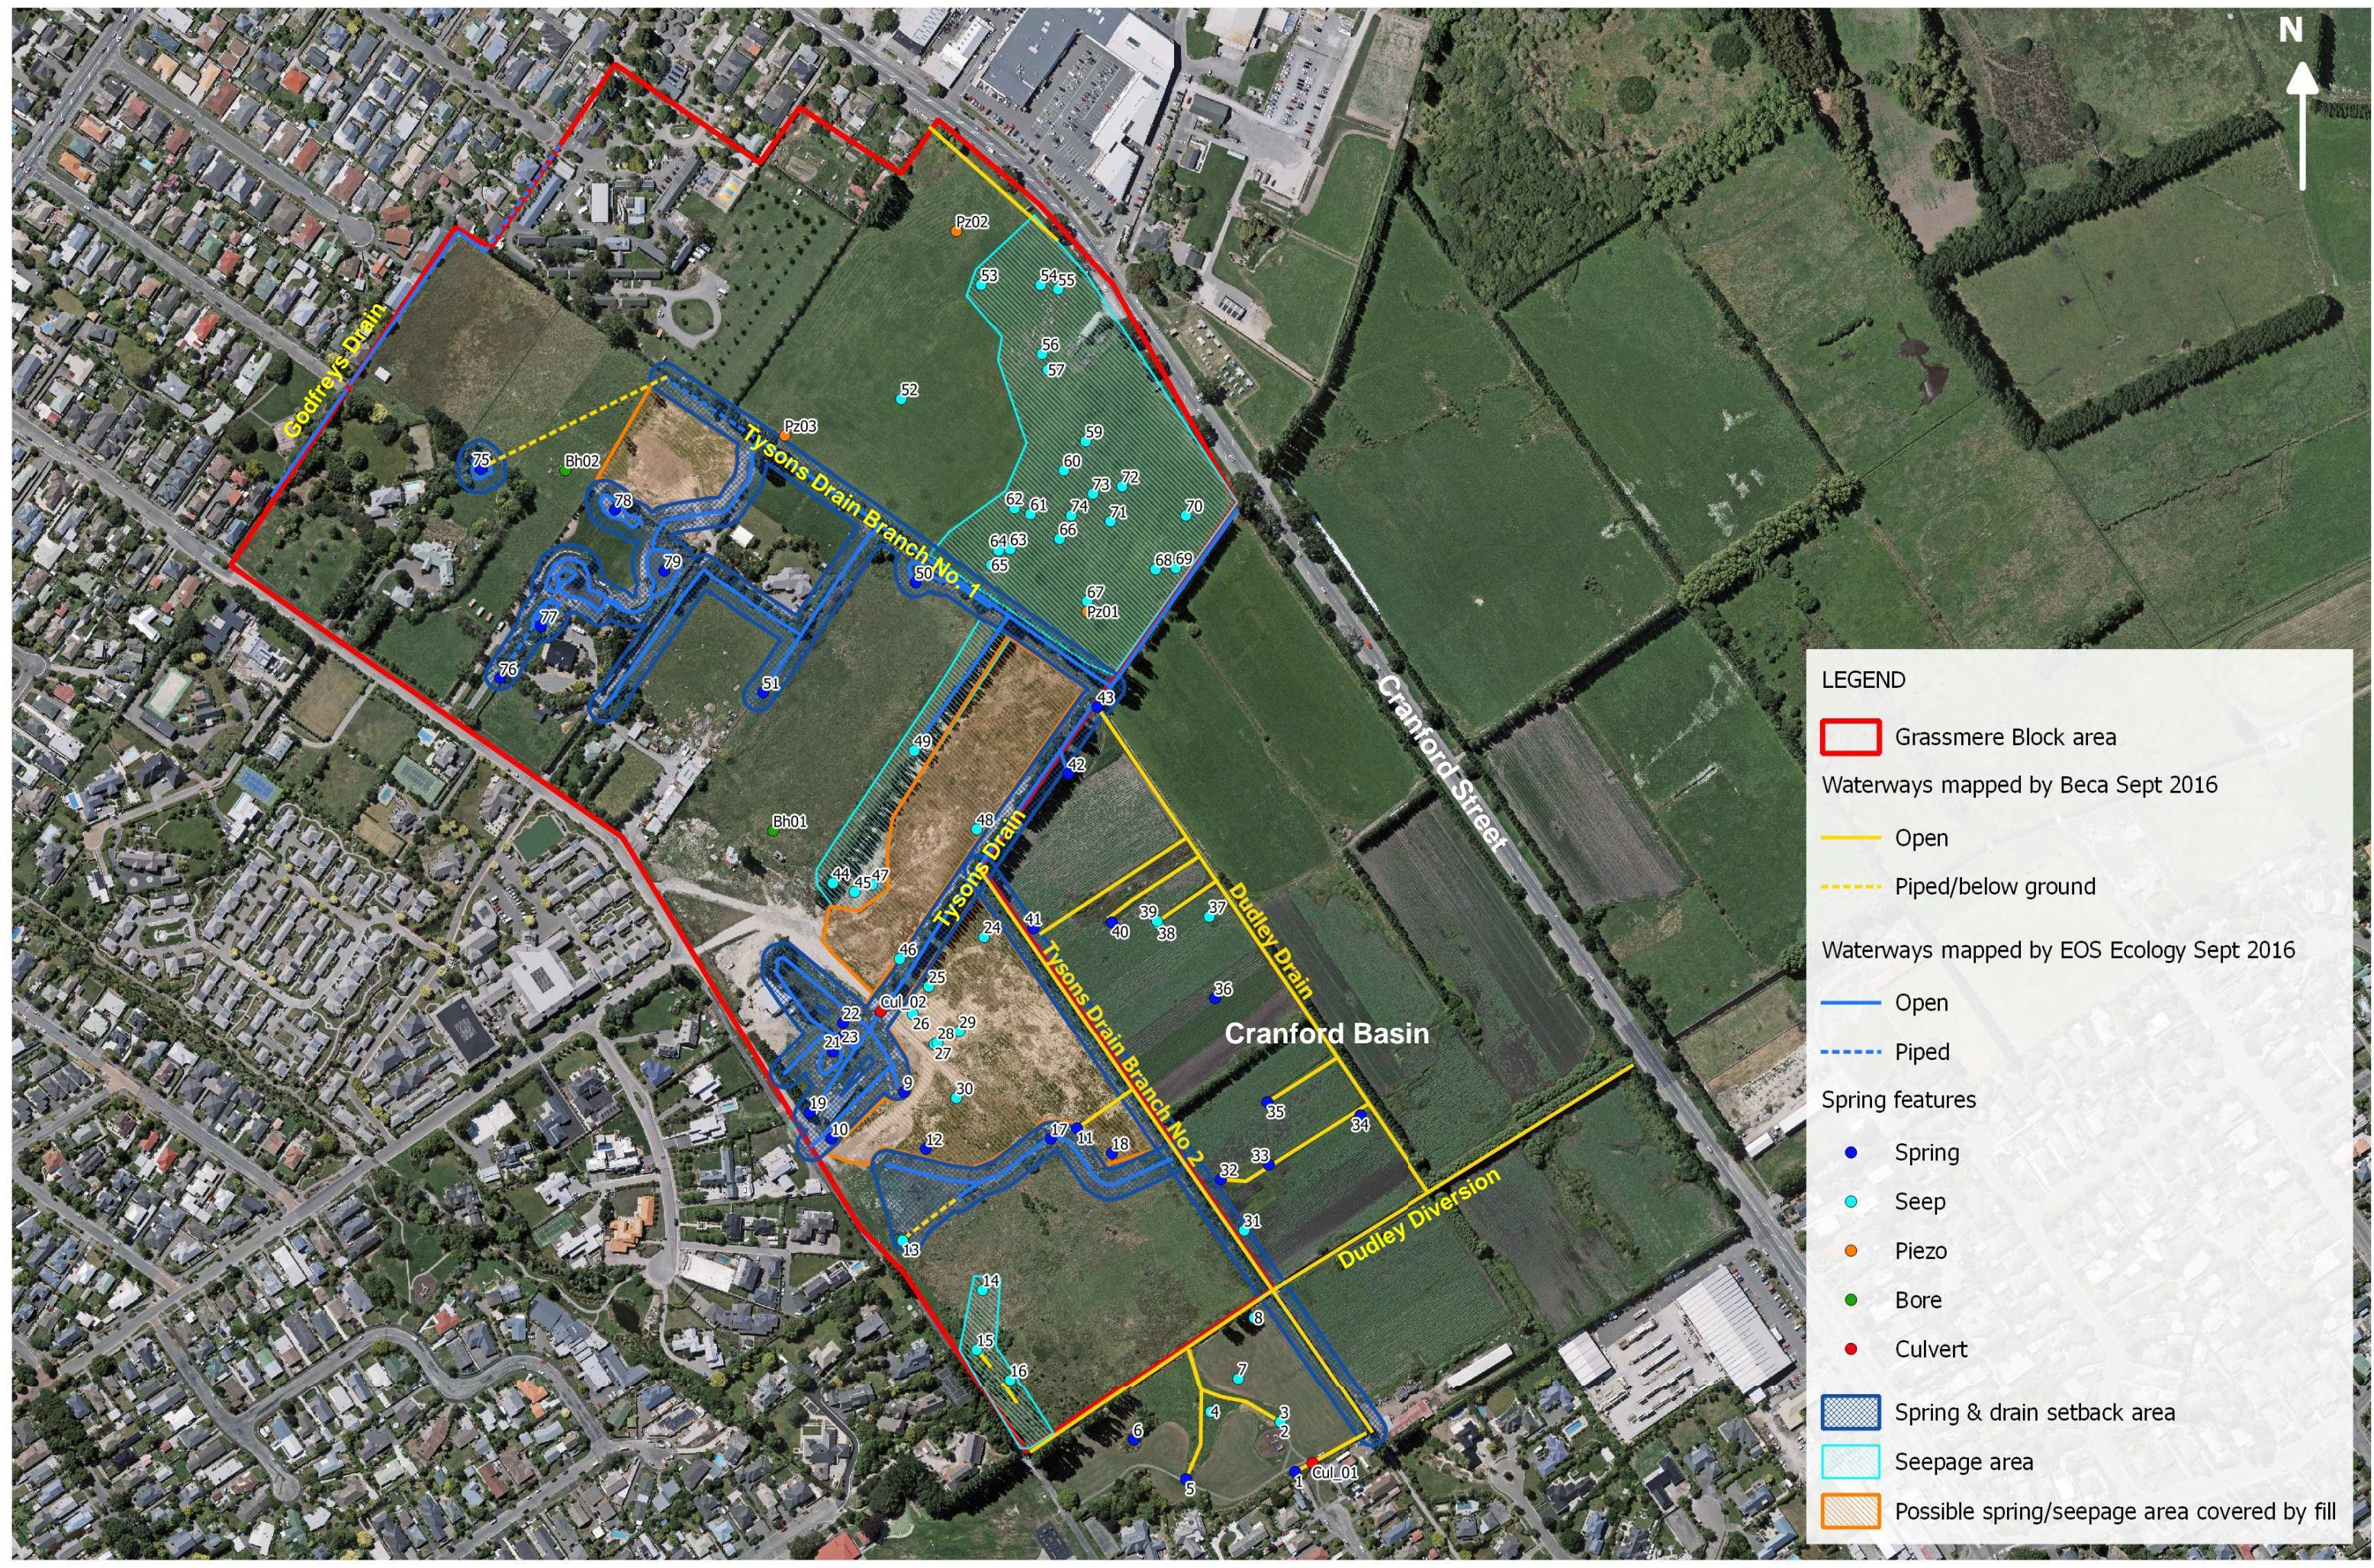
Plan 1: Grassmere Block Spring Mapping September 2016

- Approximately 32 artesian springs flowing into the headwaters of Tysons Drain from 3 main areas:
  - Tysons Drain Branch No.1
  - Tysons Drain Branch No.2
  - Upper Tysons Drain
- Approximately 46 seeps ponding in shallow depressions most of which many may be intermittent or ephemeral in three main areas:
  - Southern half of the block adjacent to Cranford St
  - South western end of the block adjacent to the Papanui Parallel Cycleway
  - The blocks surrounding upper Tysons Drain and Tysons Drain Branch No.2

Three main spring discharge corridors exist across the Grassmere Block area. Consideration should be given to retaining these in order to allow springs to continue to flow into the upper reaches of Tysons Drain, including branches No.1 and No.2. Plan 1 (Appendix A) shows the general spring and seepage discharge areas and those areas where filling is known to have occurred and where springs or seepage may have been covered. The mapped extents are largely based on a site visit in September 2016 and data collected by EOS Ecology<sup>4</sup>. Therefore spring and seepage flows and extents may vary from these one-off observations and inferences drawn.

We recommend that a "blue network" of naturalised channels and restored spring vents are established along the spring discharge areas marked in Plan 1, Appendix A. We understand this could be used as part of the Outline Development Plan process which is likely to be required for residential development. We have applied a default 10 m setback around these features although in some cases it may be appropriate to encroach within ~10 m of a spring vent or modify existing springs or channels to form an efficient drainage network. We recommend minimising any such modification. The set-back of 10 m for springs and waterways would allow conveyance paths to be 20 m wide (10 m each side), and could form stormwater drainage / flood flow corridors as well as spring flow conveyance.

Observations of springs, seepage and topography suggest that medium density residential housing is more likely to be viable in the northern part of the area (Plan 1, Appendix A). The southern and eastern parts of the site are low lying and contain numerous springs and seepage features which may be more suited to very low density housing or reverting to wetlands or stormwater treatment.
