# HORNBY LIBRARY, SERVICE CENTRE AND SW LEISURE CENTRE KYLE PARK

## Preliminary CPTED Review

Christchurch City Council

6 March 2019

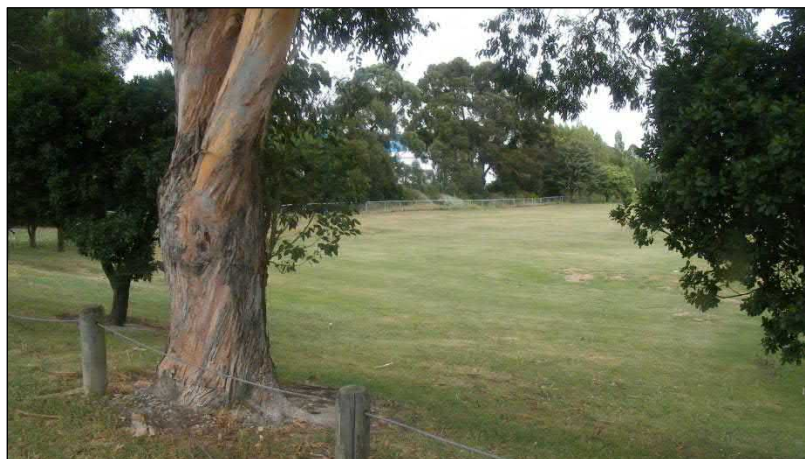
- f. There is low fencing enclosing an area on the southern boundary. It is possible that this fencing contains an area of contaminated fill.

Kyle Park view from eastern boundary.

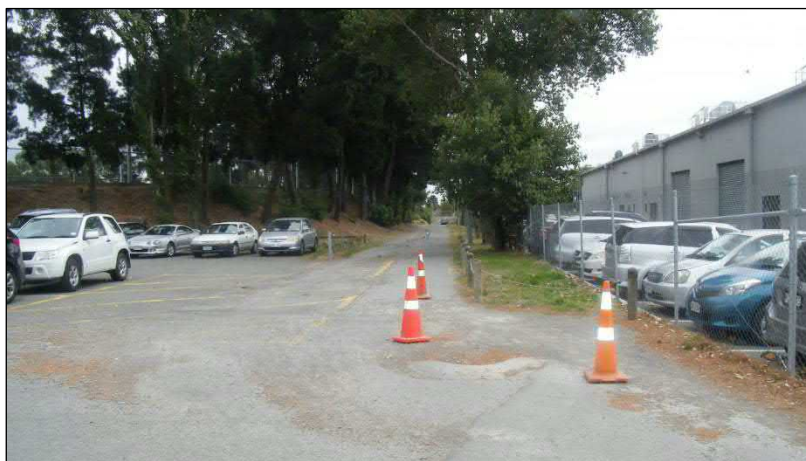
- i. Difficulty in locating the southern approach without local knowledge. This is due to lack of signage, the length of the approach, and the tunnel entrance being obscured.
- ii. Sub-standard quality of the sealed area leading to the tunnel entrance.
- iii. Possibly sub-standard level of lighting on the approach and within the tunnel.
- iv. Complete absence of wayfinding signage.
- v. Security fence at car park on eastern boundary which reduces escape opportunities. This has presumably been constructed as a deterrent to illegitimate use of the car park area to the rear of the new adjacent commercial building.
- vi. Escape opportunities unclear to the west of the approach, behind the velodrome.

Railway underpass – southern approach.

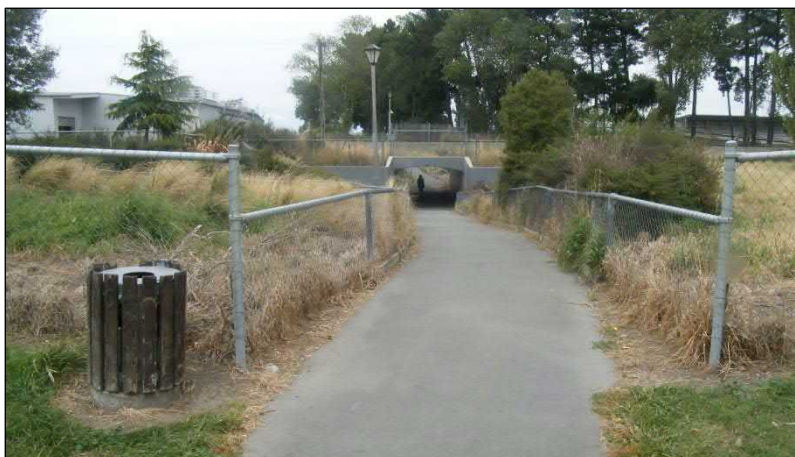
- c. Northern approach;
  - i. Sightlines restricted by topography.
  - ii. Low wire netting fencing completely enclosing areas of grass and shrubs. I understand this was a measure taken to exclude public from contaminated areas. The maintenance of vegetation has since become severely restricted.
  - iii. Evidence of arson.
  - iv. Complete absence of way-finding signage.

Railway underpass – northern approach.

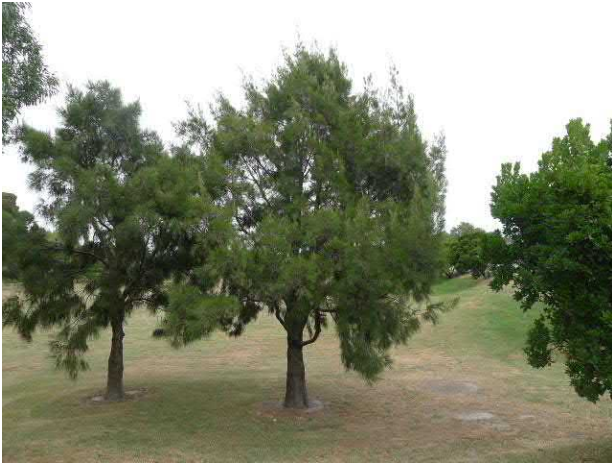
**06 - 93359**

6	93359	Arbutus unedo	Irish Strawberry Tree	4.0	3.0	0.3	3	3	3	Areas of isolated dieback, with less than 30% foliage density loss overall. Previous branch failures on the south-western side.
7	93365	Casuarina cunninghamiana	She Oak	9.0	9.0	0.35	3	3	3	Slightly sparse crown density, and previous branch failures.
8	93368	Casuarina cunninghamiana	She Oak	8.0	9.0	0.3	3	3	3	Slightly sparse crown density, and previous branch failures.
9	93364	Arbutus unedo	Irish Strawberry Tree	4.0	4.0	0.18	3	4	4	Slightly sparse foliage density, less than 30% foliage density loss overall. Included unions and previous structural failures. Further structural failures likely.

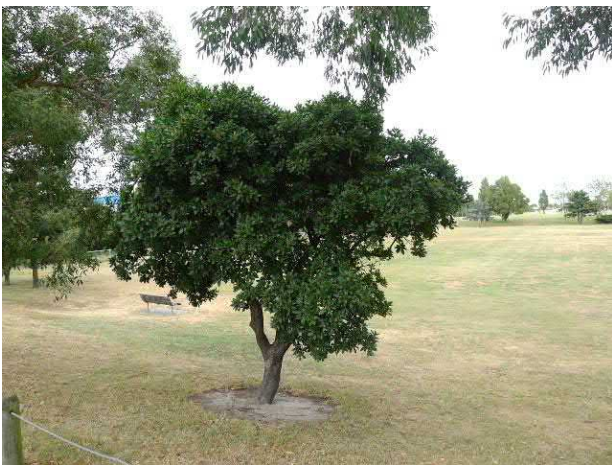
**10 - 93367**

Survey Number	Tree ID	Species	Common Name	Height	Canopy Spread	DBH	Tree Health	Tree Form	Overall Condition	Comments
10	93367	Eucalyptus gunnii	Cider Gum	10.0	14.0	0.8	2	3	3	Reasonably good foliage density, no significant structural defects. One dead branch over footpath.
11	93369	Arbutus unedo	Irish Strawberry Tree	3.5	4.0	0.2	3	3	3	Slightly sparse crown density, and previous branch failures.
12	93371	Eucalyptus gunnii	Cider Gum	7.0	8.0	0.4	2	3	3	Reasonably good foliage density, and minor deadwood. No significant structural defects.
13	93375	Arbutus unedo	Irish Strawberry Tree	3.0	4.0	0.2	2	3	3	Reasonably good foliage density. Previous branch failures on the south-western side.
14	93376	Quercus cerris	Turkey Oak	5.0	5.0	0.18	2	3	3	Reasonably good foliage density. Previous branch failures on the eastern side. Squat form due to crown suppression.
15	93377	Eucalyptus delegatensis	Alpine Ash	12.0	12.0	0.9	2	4	4	Three stems originating from the tree base with included unions. Decay present within the main stems. Multiple previous branch failures, further structural failures likely.

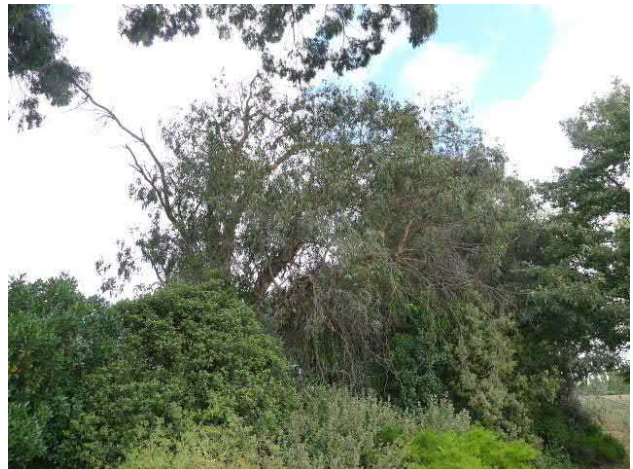
**36 - 93427**

36	93427	Eucalyptus	Gum	9.0	8.0	0.6	4	4	4	More than 30% decline. Multiple stems from 1m.
37	93428	Eucalyptus	Gum	10.0	11.0	0.7	4	3	4	Canopy becoming sparse, with possibly more than 30% foliage density loss. No significant structural defects.
38	93429	Quercus cerris	Turkey Oak	10.0	11.0	0.45	2	3	3	Reasonably good foliage density, included branch unions.
39	93430	Fraxinus americana	White Ash	6.5	9.0	0.2	2	3	3	Reasonably good foliage density. Multiple stems from 1.0m. Minor bark wound at the base and on one stem. No significant structural defects.

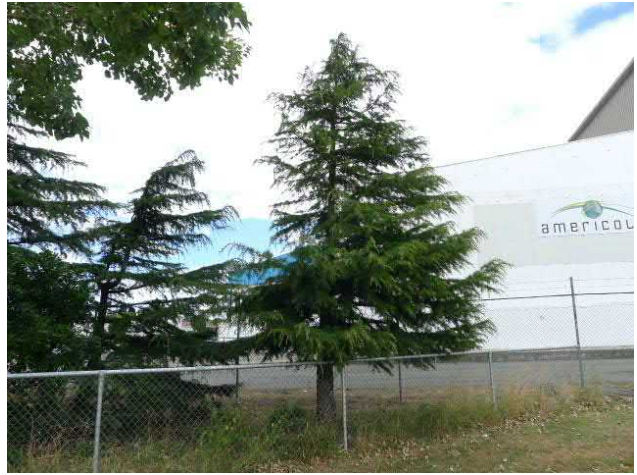
50 - 93448

Survey Number	Tree ID	Species	Common Name	Height	Canopy Spread	DBH	Tree Health	Tree Form	Overall Condition	Comments
50	93448	Cedrus deodara	Deodar Cedar	8.0	5.0	0.25	2	3	3	Some suppression on the north-western side of the canopy. No significant structural defects.
51	93444	Populus nigra	Black Poplar	14.5	11.0	0.45	3	3	3	Slightly sparse foliage density, currently less than 30% foliage density loss. Minor deadwood. Previous branch failures.
52	93443	Populus yunnanensis	Chinese Poplar	14.5	9.0	0.4	2	3	3	Reasonably good foliage density. Co-dominant from 2.0m with included unions.
53	93441	Cedrus Glauca atlantica	Blue Atlas Cedar	2.0	2.5	0.08	5	4	5	Small, stunted tree in very poor condition due to lack of live growth, a large bark wound at the trunk base, and multiple previous branch failures.
54	93439	Populus Italica nigra	Lombardy Poplar	13.0	2.0	0.18	3	3	3	Reasonably good foliage density, slight yellowing of leaves. No significant structural defects.
