Cashmere Stream Baseline Aquatic Ecology Survey

August 2021

Prepared for:
Christchurch City Council

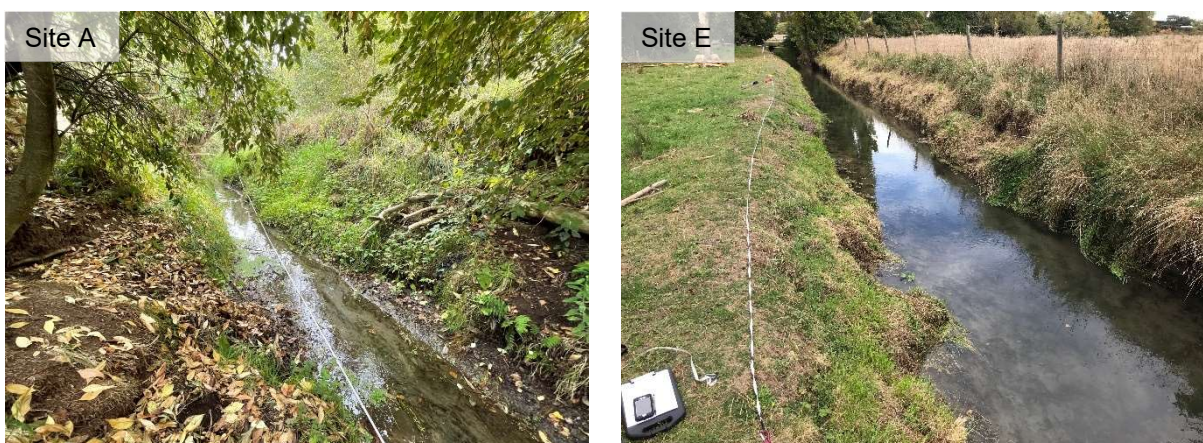
Riparian vegetation throughout the length of the waterways sampled was dominated by long pasture grass and pasture weeds. Consequently, most sites were poorly shaded, with an average of 32% shade across Sites A to H. Sites with greater levels of shading included Site A (64% shade), which was bordered by a mix of tall native and exotic trees along half the sampling reach, and Site C (77% shade), which was bordered by tall exotic trees (Table 3). Bank cover with low “ground cover” vegetation was on average 86% across all sites. This high level of cover with ground vegetation would both help prevent bank erosion and intercept overland flow. The average riparian buffer width was 4.3 m across all sites sampled.

Figure 2: Representative photographs of Cashmere Stream sampling sites.

Waterway banks were mainly comprised of natural earth, but they were steep and bank erosion was widespread, with an average of 42% bank erosion across the sites. Mean channel width ranged from a minimum of 0.59 m at Site G on Quarry Road Drain up to 4.83 m at Site C on Cashmere Stream (Table 3). Mean water depth ranged from 0.08 m at Site A on Cashmere Stream to 0.48 m at Site D on Cashmere Stream. Mean water velocity ranged from 0 m/s at Site H on Farm Drain to 0.14 m/s at Site E in Cashmere Stream. Mean values for the six Cashmere Stream sites were 3.0 m for wetted width, 0.32 m for water depth, and 0.11 m/s for velocity.

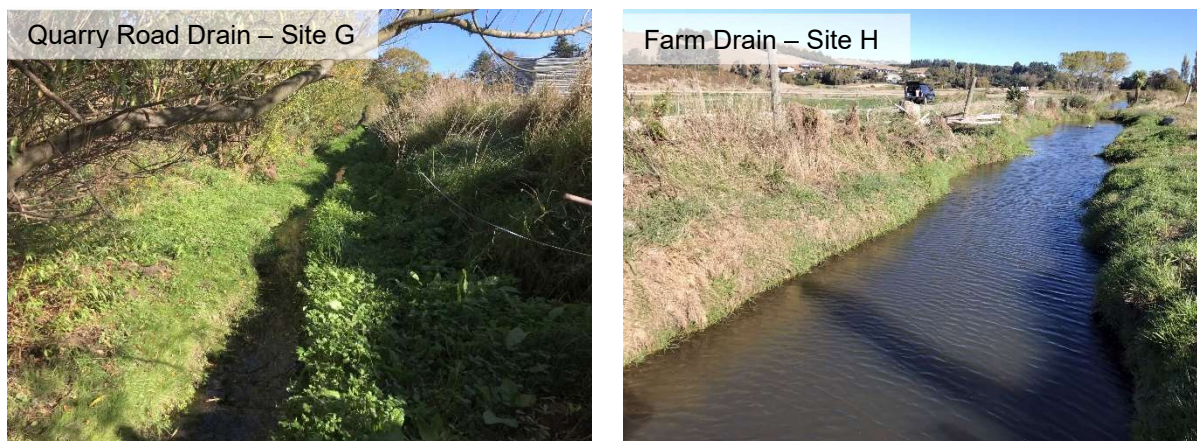
Figure 3: Tributary sampling sites.

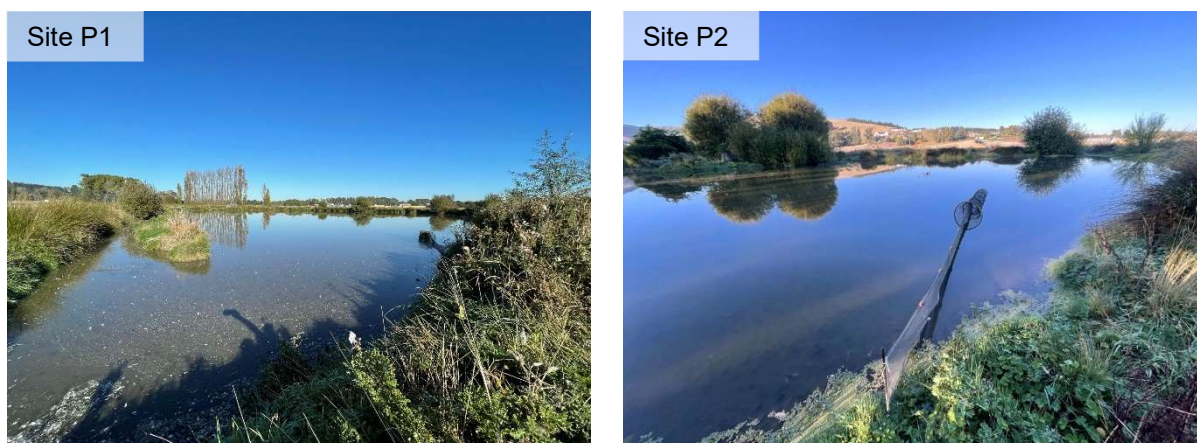
Figure 4: Pond sampling sites.

The two ponds were shallow, with average water depths of approximately 0.15 m for P1 and 0.25 m for P2. There was a narrow, deeper section at the northern end of P1, where the water depth was approximately 0.5 m. The beds of both ponds were comprised of fine sediment (<2 mm diameter) that varied from a hard pan to deeper deposits.

- **Pond habitats – retain equivalent or better.** The two ponds sampled covered a large area, but they were dominated by shallow water and lacked good quality fish habitat. Creating a greater variety of depths, as well as the addition of habitat features (e.g., logs and boulders), and riparian planting, would greatly enhance fish habitat.

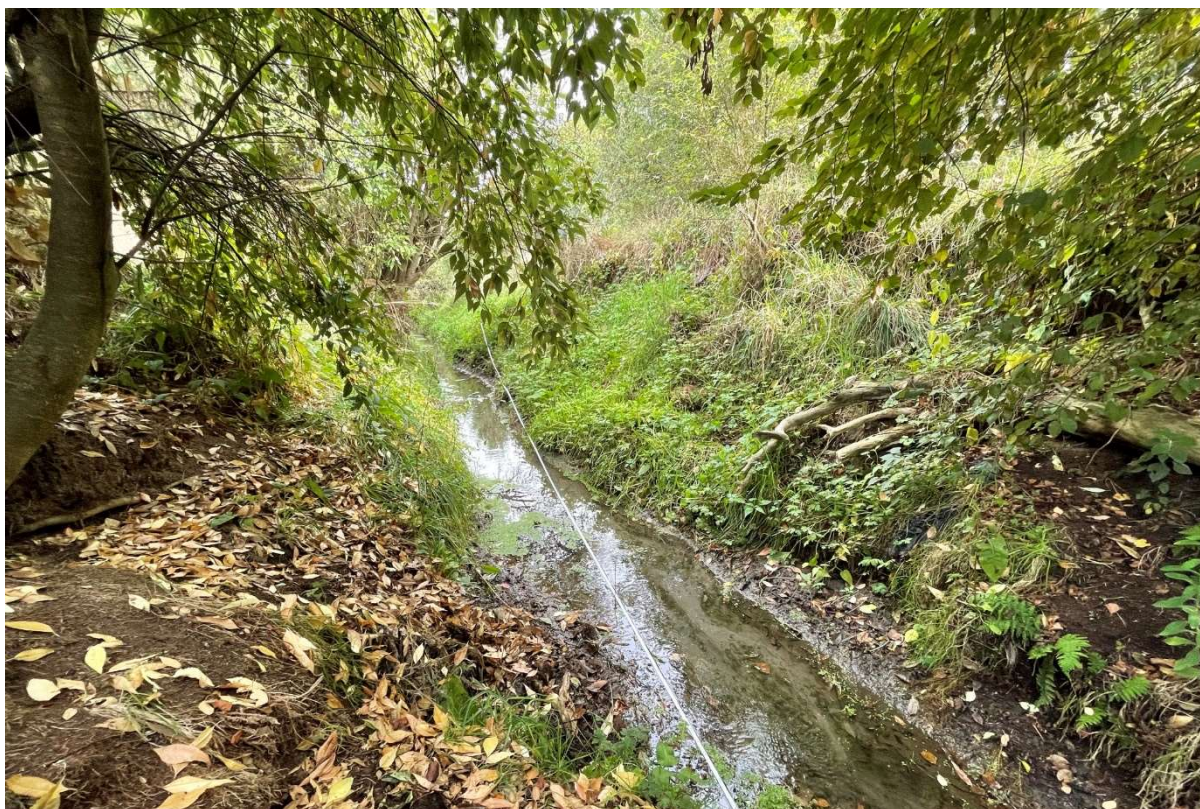
Figure 1: Site A – downstream looking upstream.

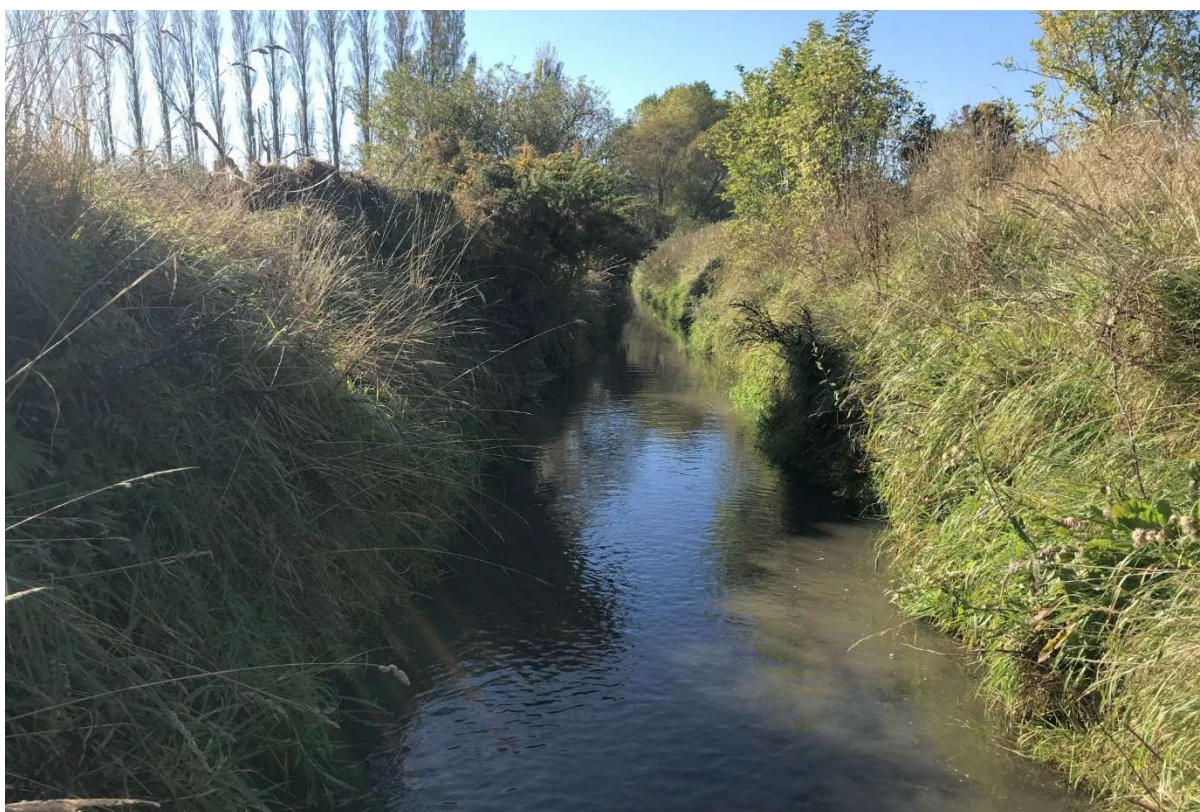
Figure 2: Site B – upstream looking downstream.

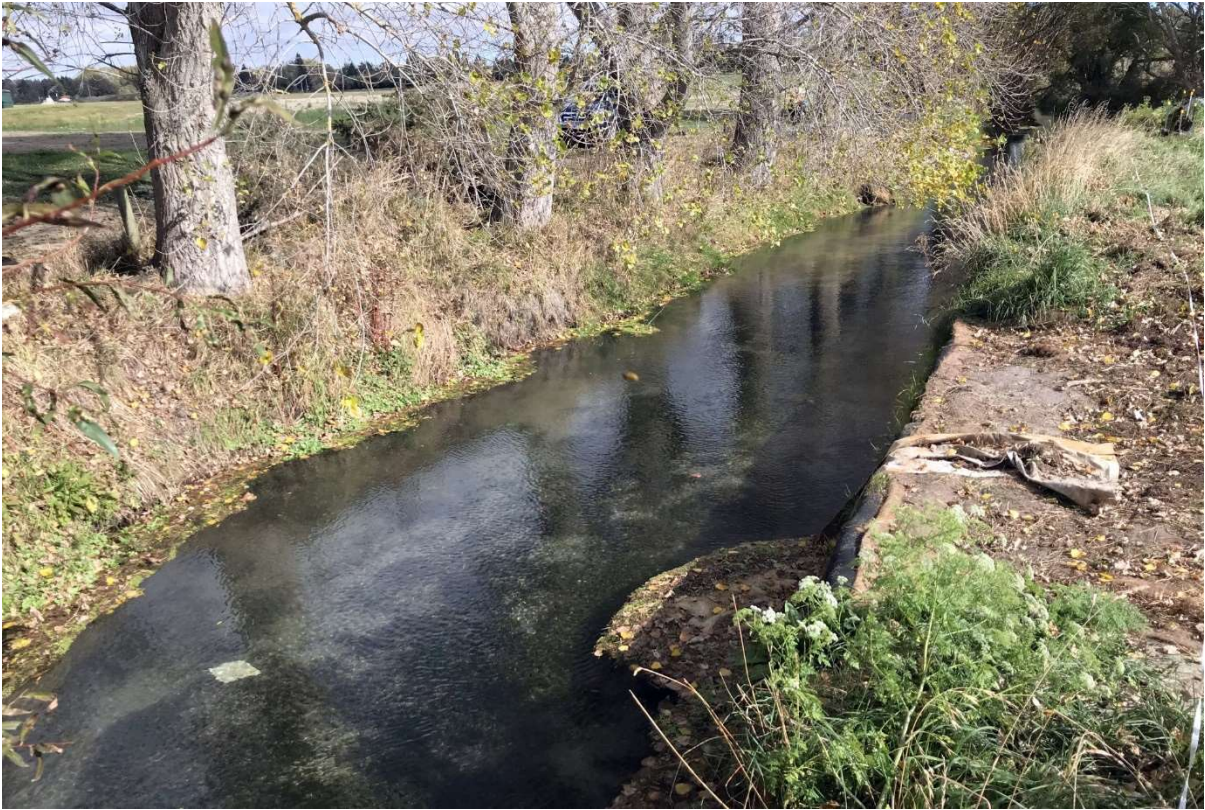
Figure 3: Site C – downstream looking upstream.

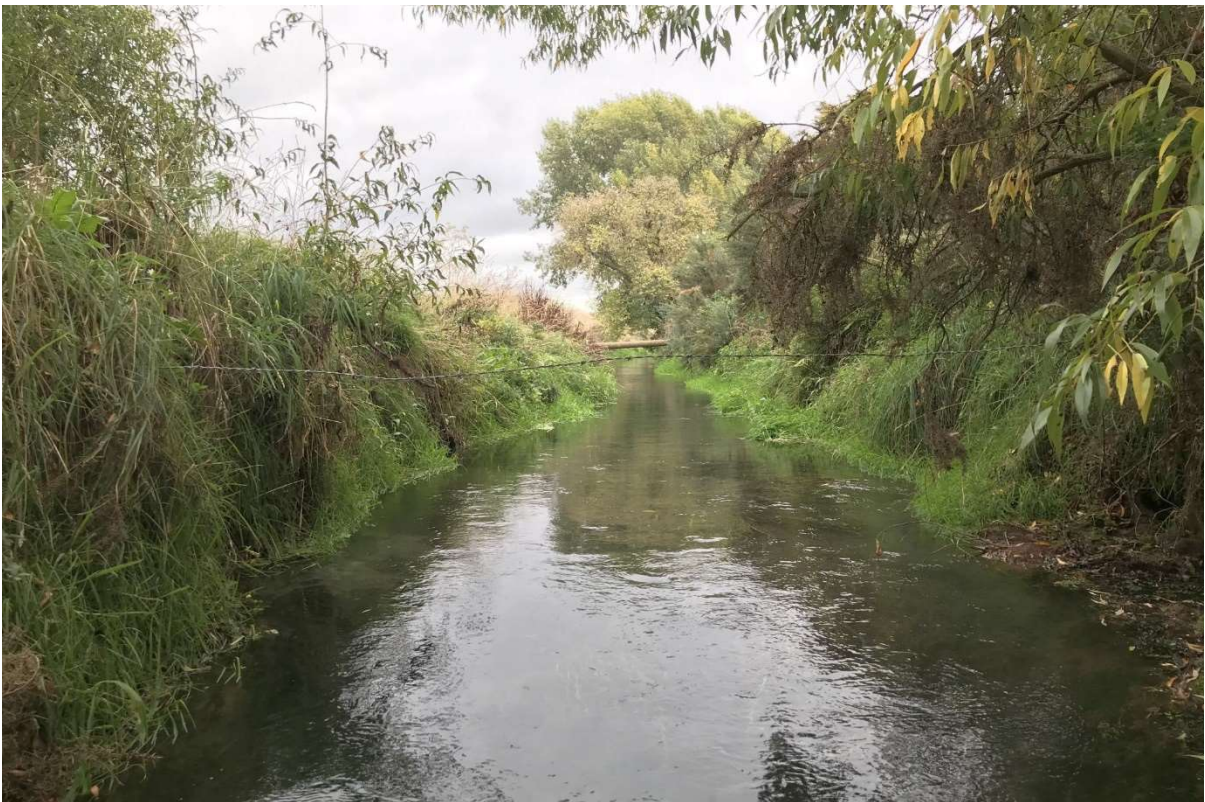
Figure 4: Site D – downstream looking upstream.

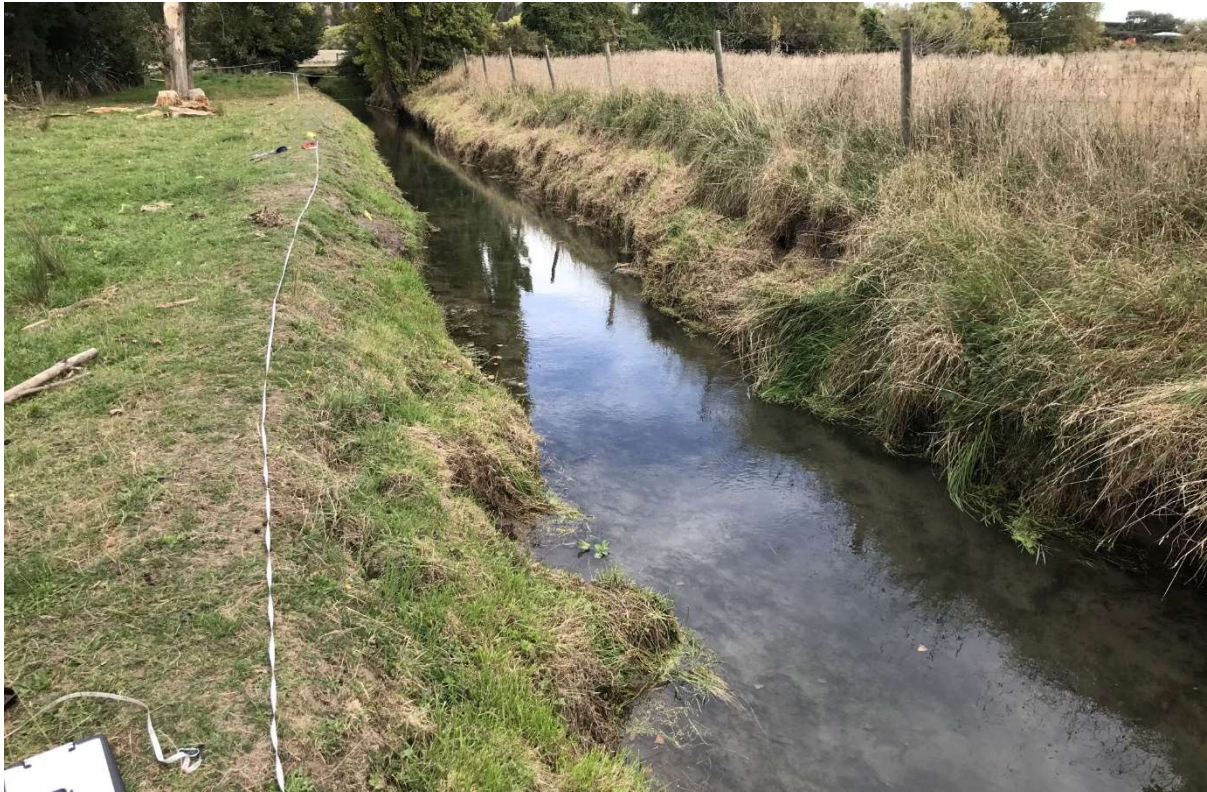
Figure 5: Site E – downstream looking upstream.

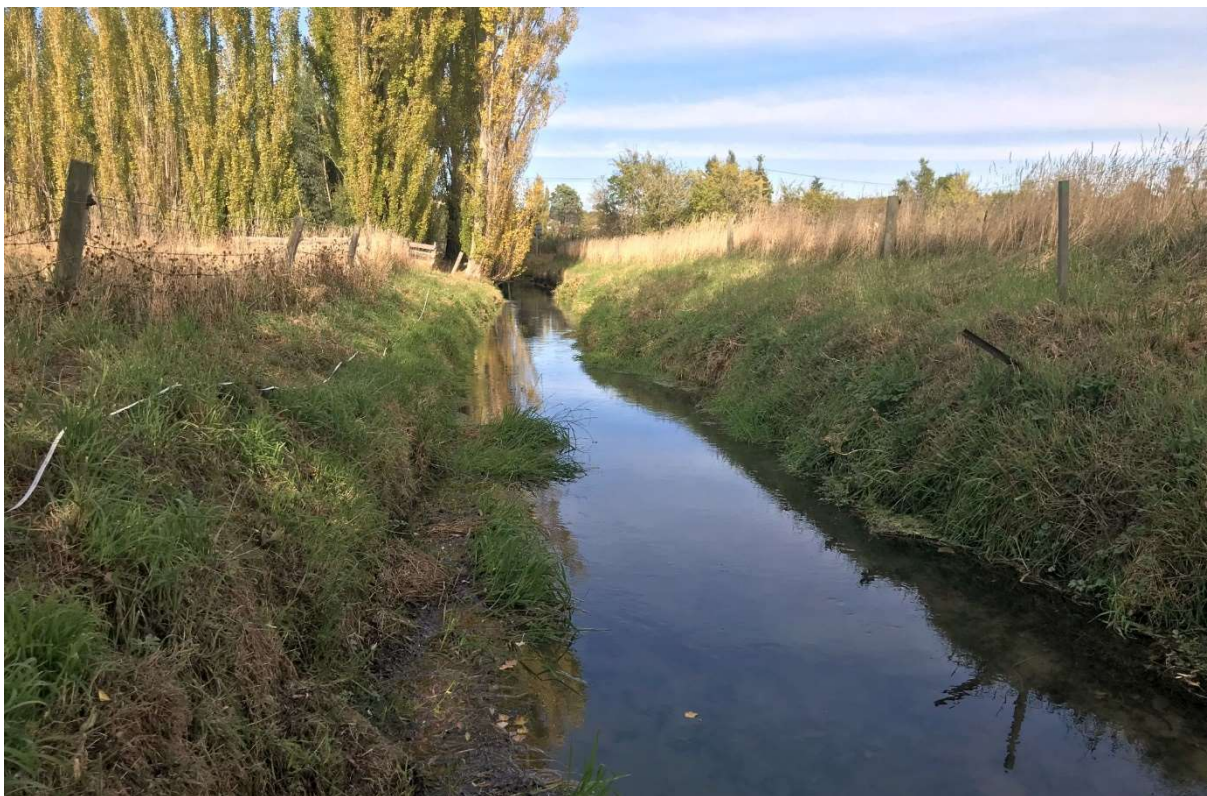
Figure 6: Site F – downstream looking upstream.

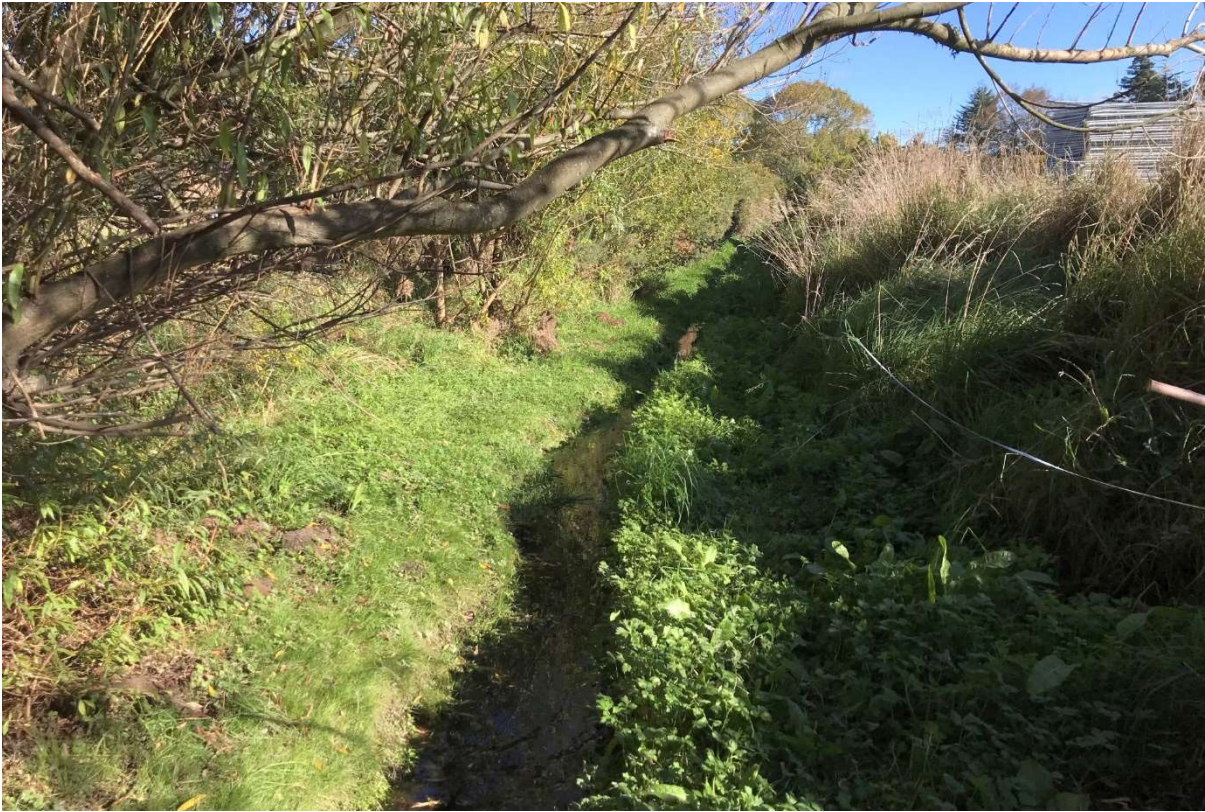
Figure 7: Site G – downstream looking upstream.

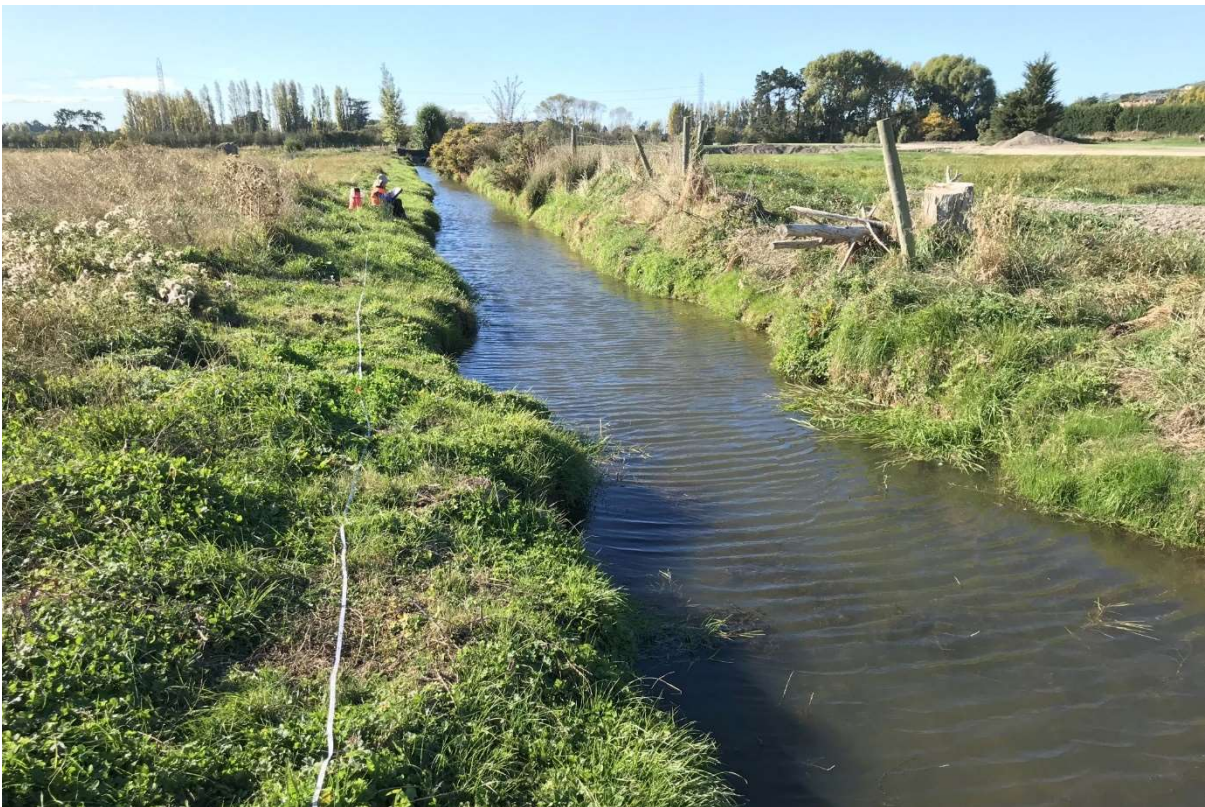
Water clarity was high at all sites, except for Farm Drain (Site H), which was slightly turbid and had a brown, tannin-stained appearance.

Figure 8: Site H – upstream looking downstream.

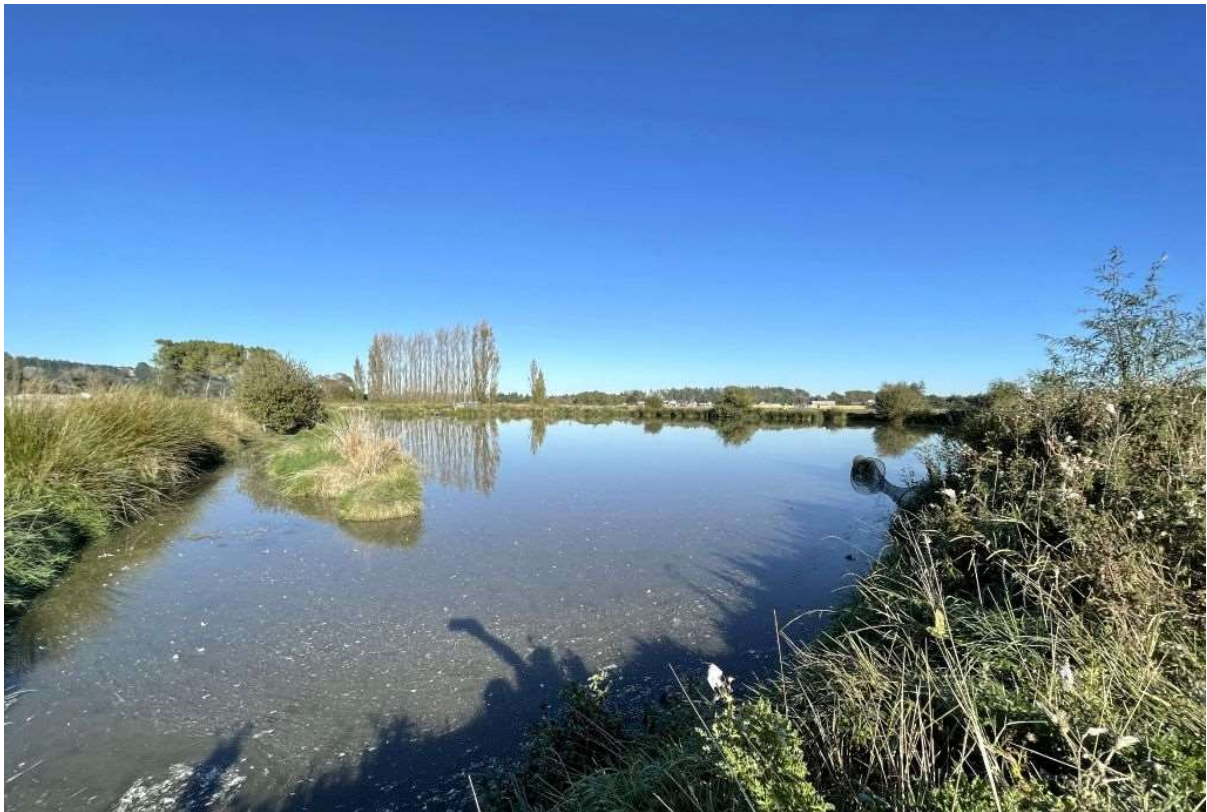
Figure 9: Site P1 – looking south from the northern bank.

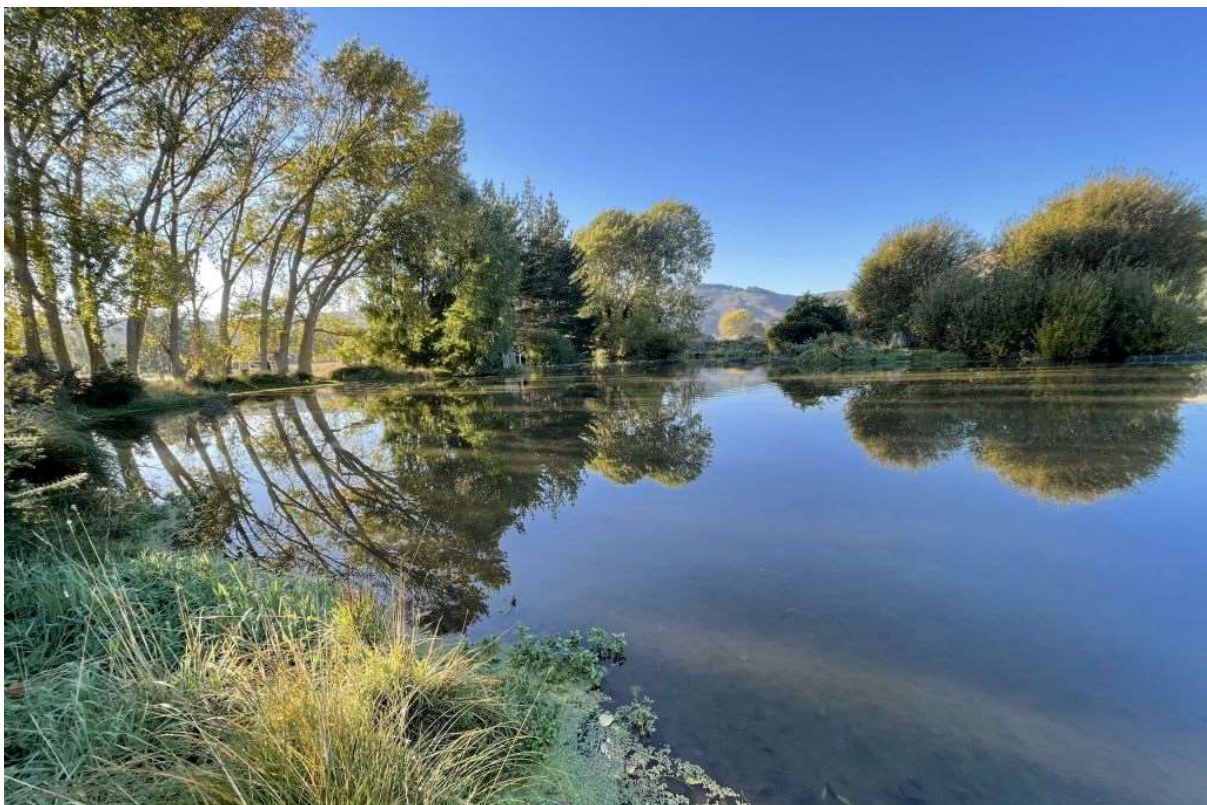
Figure 10: Site P2 – looking east, across the northern bank.
