CRC204086

Akaroa Wastewater Treatment Plant

Condition 19 – Annual Report

1 July 2022 – 30 June 2023

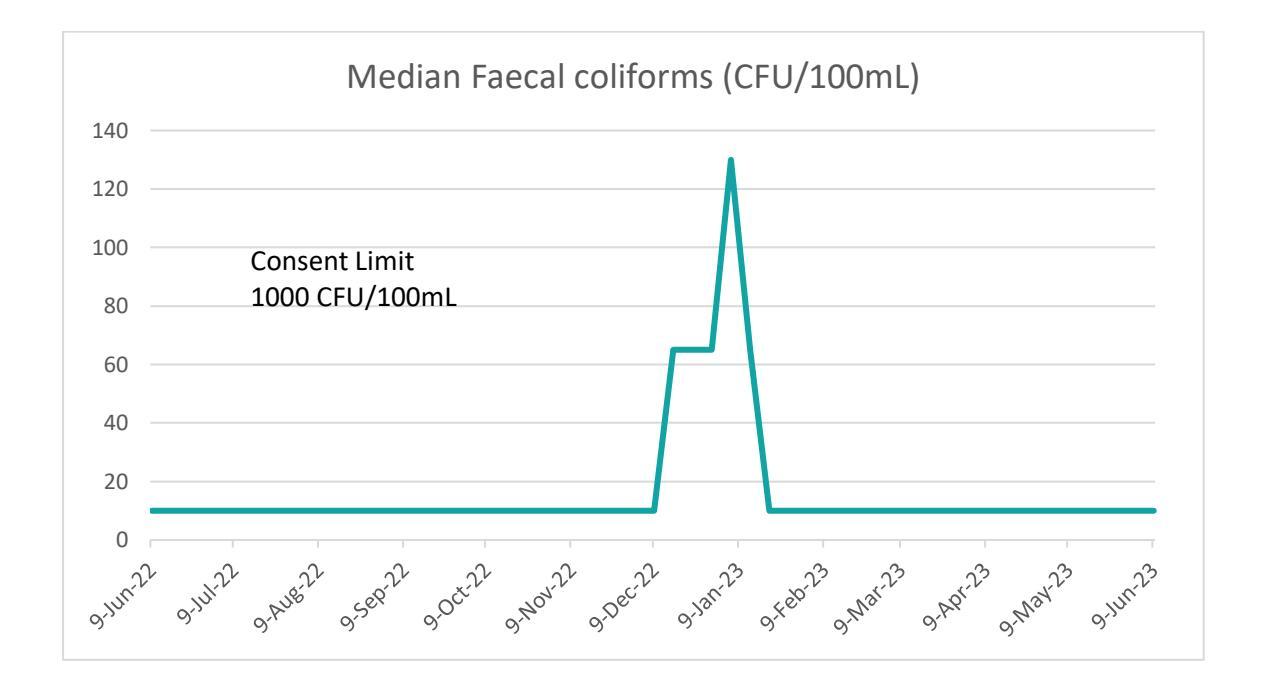
The median Faecal coliforms sampled after wastewater treatment and prior to discharge into Akaroa Harbour via the outfall did not exceed the consent limit of 1000 CFU/100mL.

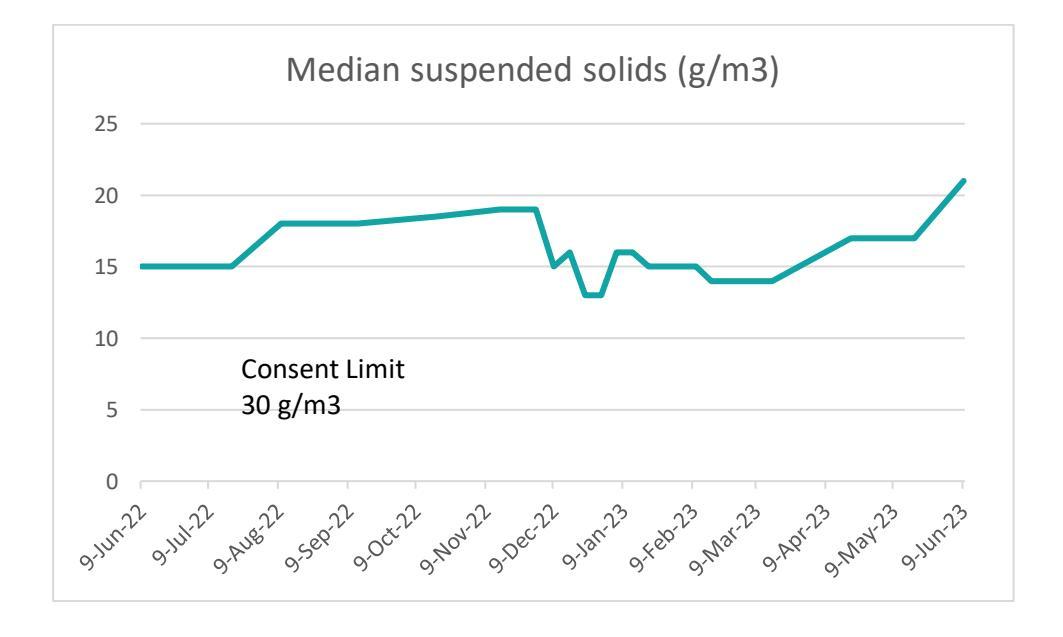
The median Total Suspended Solids sampled after wastewater treatment and prior to discharge into Akaroa Harbour via the outfall did not exceed the consent limit of 30 g/m3.

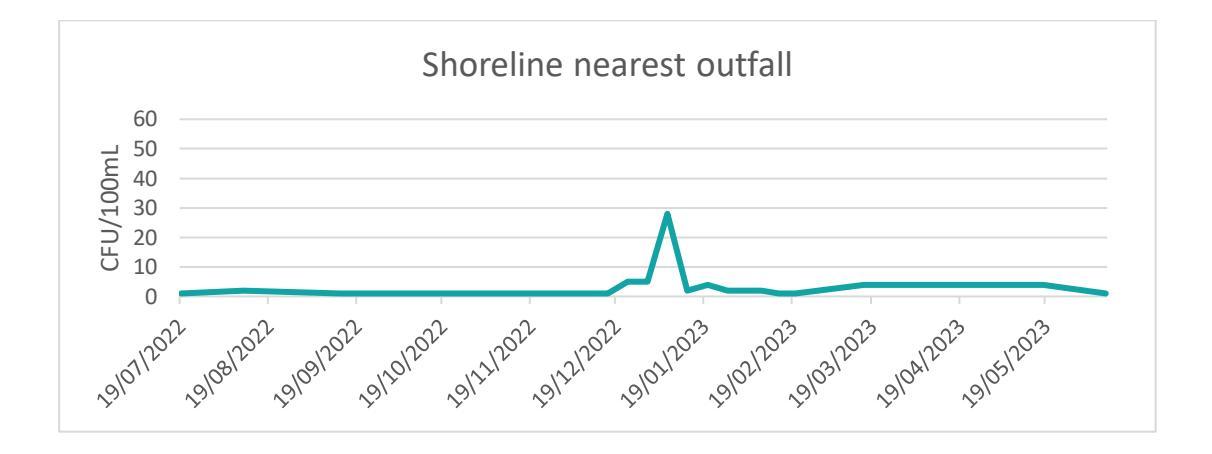
There was one exceedance of the rolling median of 14 faecal coliforms per 100 millilitres from the previous five samples collected at the shoreline nearest the outfall of 28 on 6/1/2023.

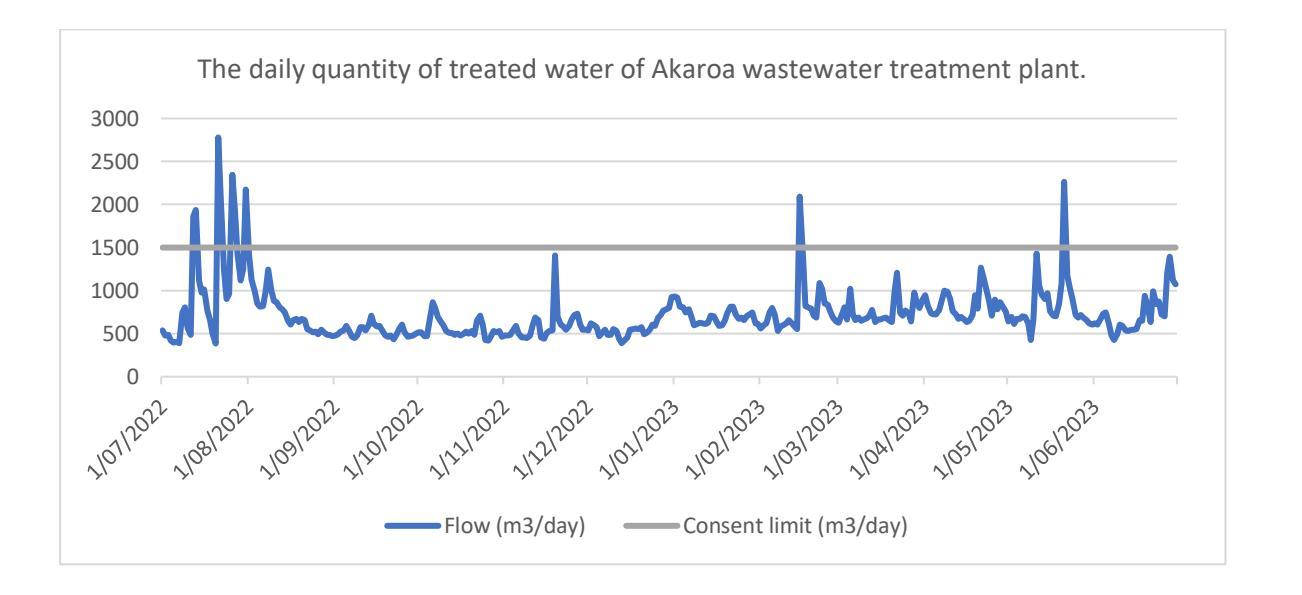
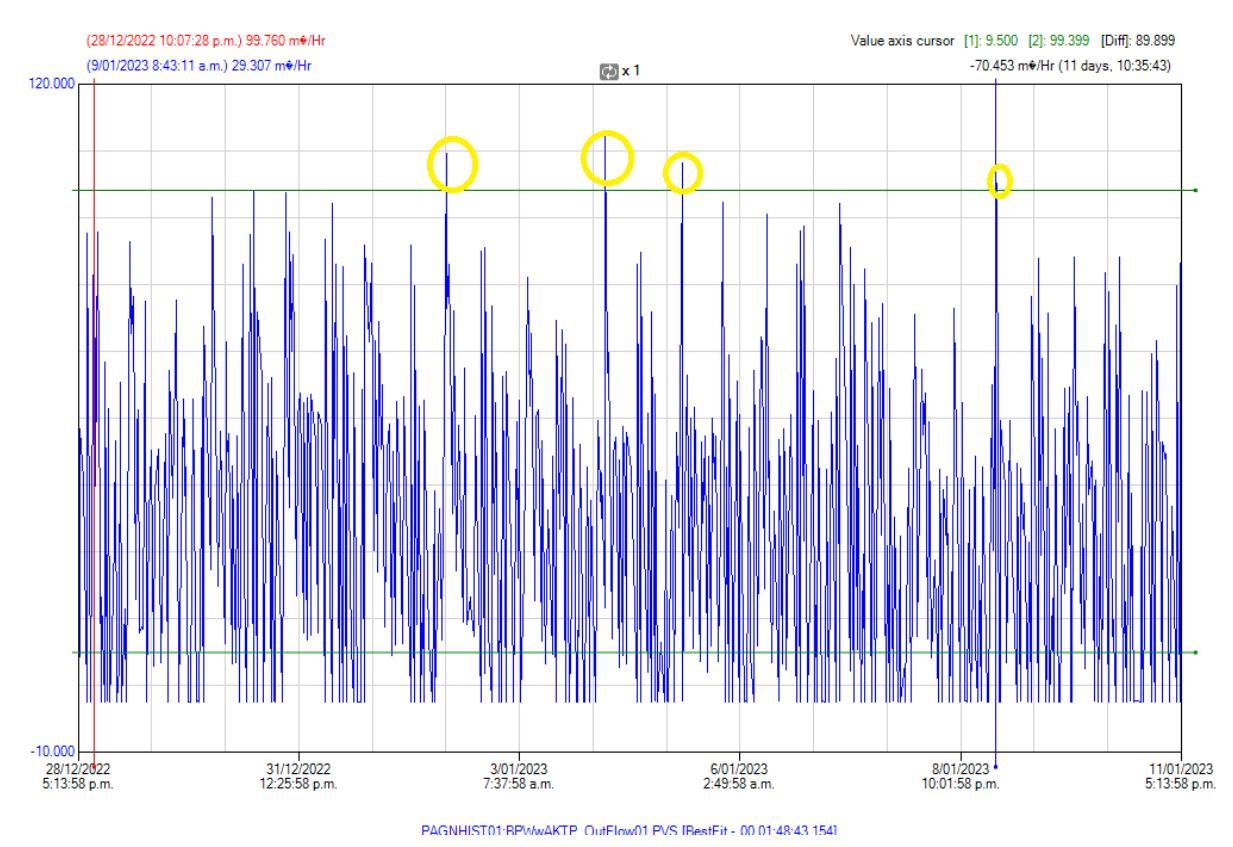
In addition, during the year there were cases in which the discharge in the treatment plant exceeded the maximum hourly flow rate of 99 m3/h designed for the plant. These events occurred outside of rainfall events and were related to abrupt increases in flow attributed to increased population levels during holiday periods, especially during the month of January.

In response to this, a continuing effort is being made to formulate a contingency plan. This strategy implies the possible activation of the bypass (valve 225.0 OV001) from the UV channel to the chlorine contact tank during times of high flow or festive periods.
