REPORT **ST ASAPH STREET** POST CONSTRUCTION ROAD SAFETY AUDIT

Prepared for Christchurch City Council 13 March 2017

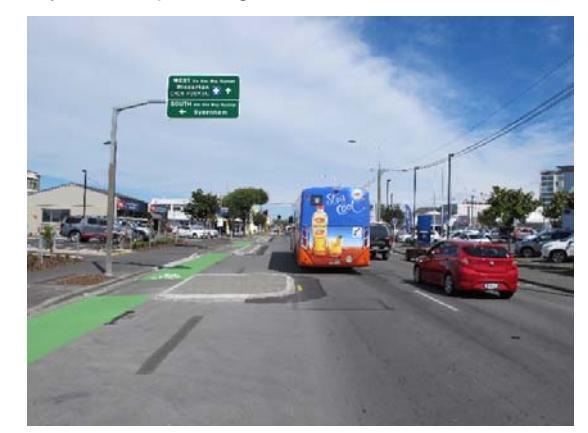
Photo 1: Example of new constrained road environment. Note low conspicuity of kerb.

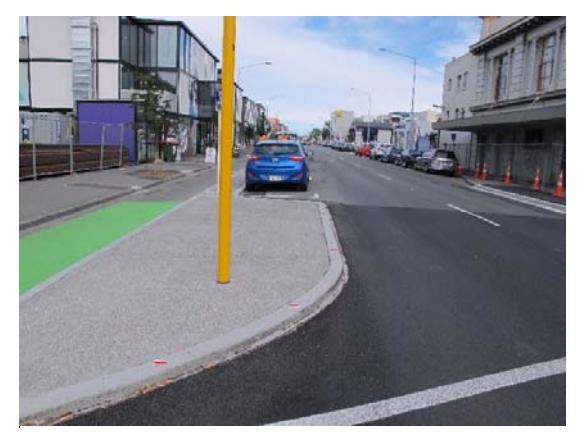
Photo 2: Example of kerb build outs to achieve protection for parked vehicles, and correct placement of traffic signals.

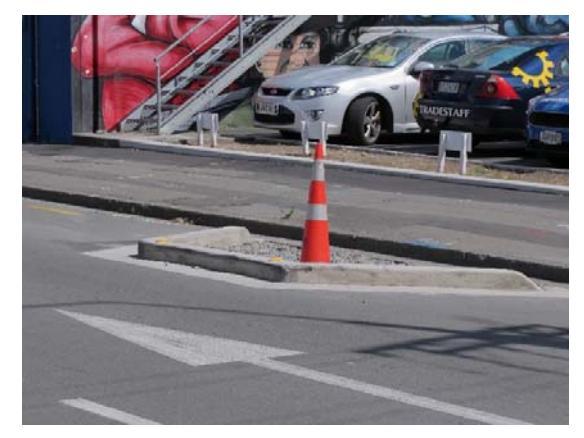
Photo 3: Example of new planter – north side. Note lack of plants installed to define vertical element.

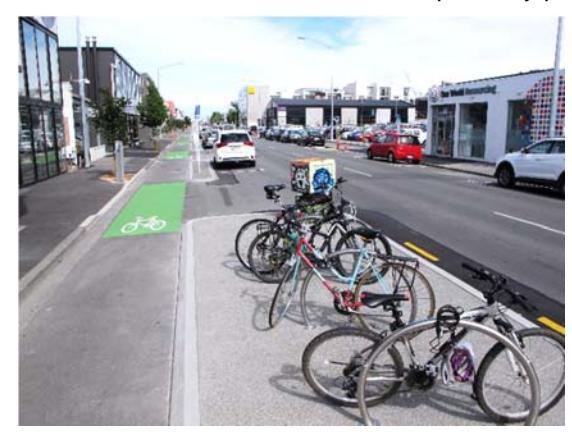
Photo 5: Example of left turn in protection offered by kerb build out. Note utilisation of this space for cycle parking and street art (installed by local business)

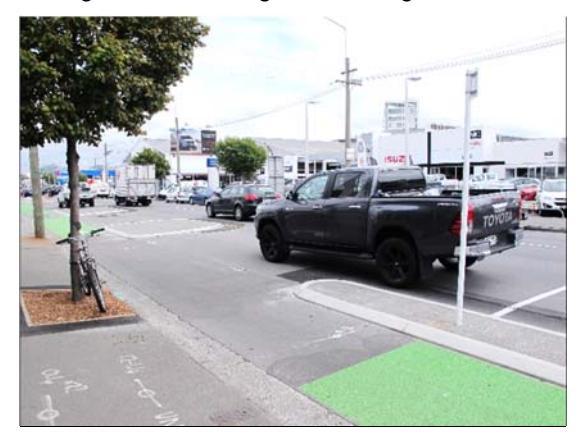
Photo 6: Example of unprotected left turn in. Driver is positioned such that they cannot see back down cycle facility.

As discussed, this left turn will be required to be undertaken from the through lane, and the driver will be subject to pressure to depart the traffic lane from traffic formed behind.

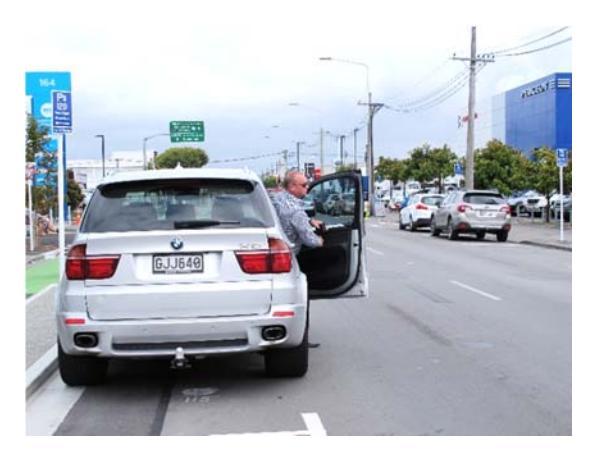
Of note was observations of large vehicles parking in the shoulder parking spaces, with a portion of the vehicle overhanging the through traffic lane. In addition, the SAT observed on numerous occasions where large and small vehicles (typically delivery vehicles) were parked within the through lane, blocking traffic. This action contravenes the traffic regulations (unless for an emergency situation), and causes significant safety risks to users of the street.

Photo 9: Example of larger SUV overhanging parking space. Note door into edge of traffic lane.

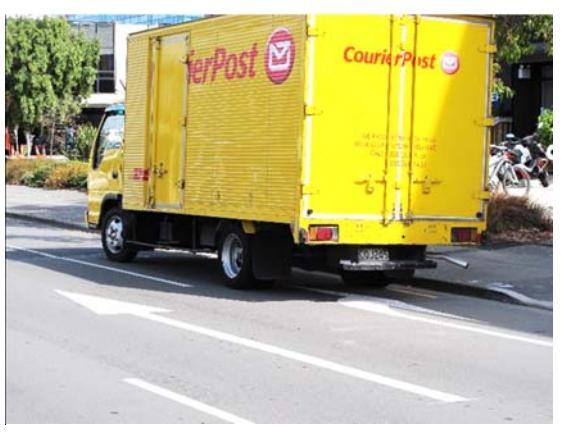
Photo 10: Example of illegal parking by delivery vehicles

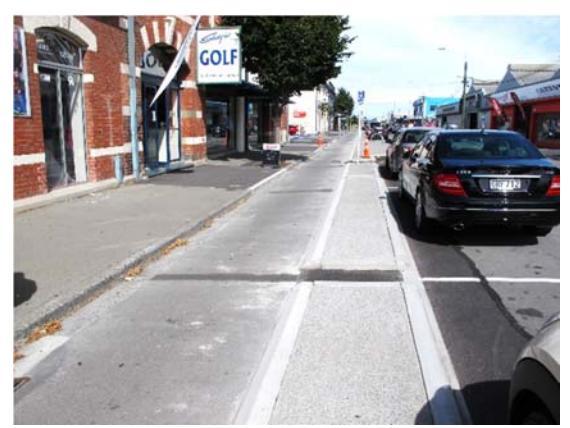
The SAT noted that at a number of locations the new formation offered poor visual contrast to these changes in height. With the new formation, it may be difficult for elderly and visually impaired users to define the edges due to the lack of tonal contrast this instance.

Photo 11: Example of typical separator formation.

- 1. Education of the public of the new facilities, and behaviours expected
- 2. placement of an appropriate contrast tonal marking in high pedestrian use zones,
- 3. Better enhancement of the kerb build outs through the use of items such as planters and possible signage.

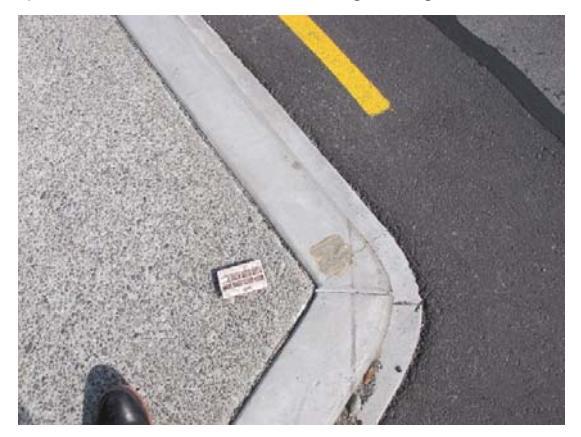
Of concern to the SAT was the high proportion of RRPM's that were absent – evident by the adhesion marks on the kerb top. This would indicate that the attachment adhesive utilised has failed under general use, and the effect of vehicles running over the low profile kerb to access car parks or driving into access ways. This overrun gets worse as more units are knocked off, resulting in a higher level of impacts onto the units, resulting in a greater level of loss.

Photo 13: Example of RRPM loss

2. Undertake immediate remedial repairs of installed red RRPM's

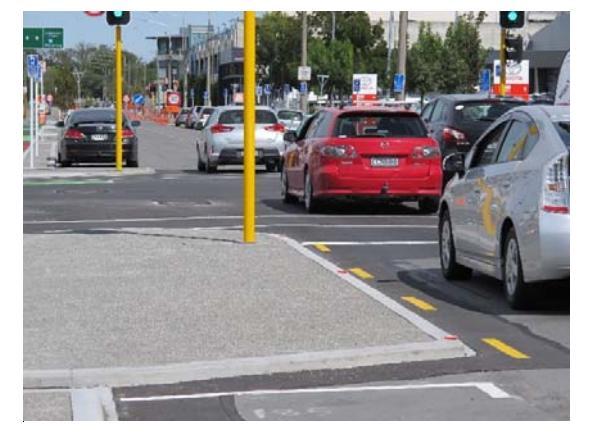
It was noted that the new kerb formation produced a grey on grey tone, offering poor contrast to highlight the kerb units. To counter this, the project has installed red kerb top RRPM markers on the faces that are visible to the approaching driver. This delineation is at approximately 100 mm above the road surface.

Photo 14: Example of Red RRPM installed on kerb top.

1. Install appropriate delineation devices to highlight the kerb edges, especially during night time off-peak and weekend use.

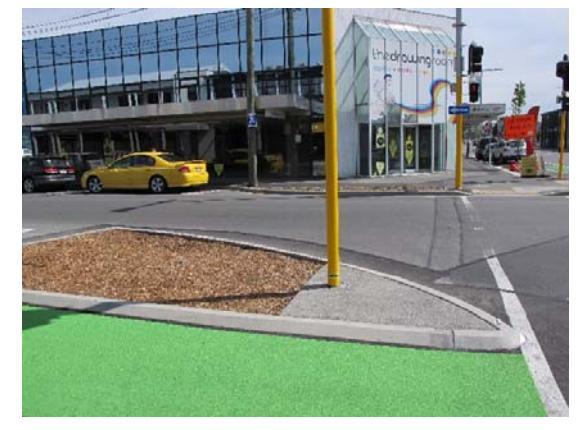
Delineation can also take the form of road markings, where reflectorized road markings provide the level of channelization required for general night operations. It was observed that there was a very high level of poor road markings, resulting in an inconsistent and inappropriate level of guidance. This was found to be accentuated at night, especially during wet road conditions, where the old road markings (ones not refreshed) disappeared from view due to the wet surface and poor retro reflectivity. This will result in poor lane discipline for drivers as they will be unable to judge where the actual lane is.

Photo 15: Example of old and ineffective pavement markings – Manchester St / St Asaph St.

- 1. That the project length is remarked utilising an appropriate high profiled pavement marking system that performs well in wet and / or dark conditions.
- 2. That all ghost markings be eliminated as much as possible noting the guidelines outlined by the Road Markers Federation, and that clear specifications be inserted into all future contracts of a similar nature.
- 3. Consider the use of temporary taped lane markings for future temporary works, or delay placing the final asphalt surfacing to minimise ghost markings.
- 4. Undertake a review of the specifications for all future major central city projects to ensure that an appropriate level or remark of all pavement markings is incorporated.

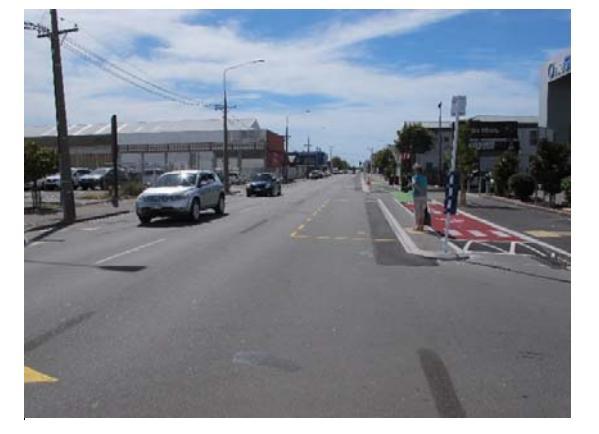
Photo 16: Example of conflicting markings (including "ghost" markings from old road layout)

In many instances the new road alignment has required the removal of the old road lane lines. These have been removed by abrasion, and have resulted in "ghost" markings that become more apparent during wet weather. This creates confusion as often two line systems will be visible.

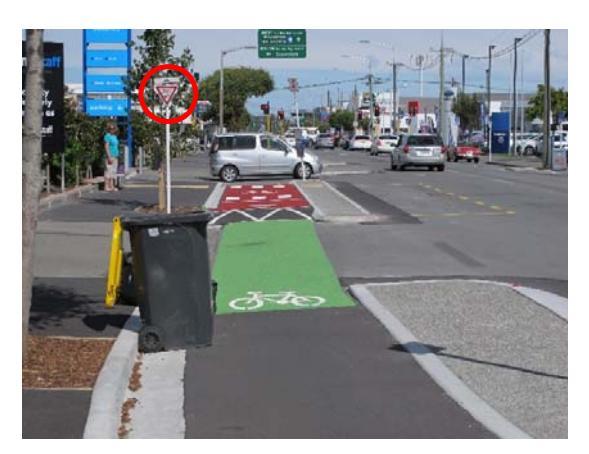
Photo 17: Cyclists view on approach to bus stop. Note Give Way sign (circled) is lost in street furniture, and rubbish bin placed in the cycle facility.

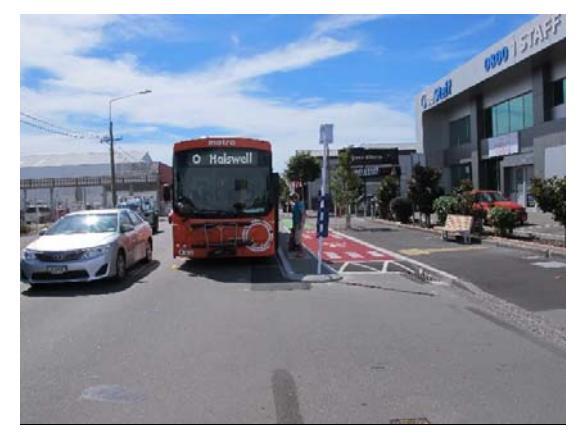
The current design has the bus timetable information installed on the pole immediately adjacent to the traffic lane side of the separator. This requires the pedestrian to cross over the cycle facility, read the information, and then cross back to the seating. This exposes the pedestrian to multiple opportunities for impact with a cyclist. The placement of the bus timetable on the footpath side of the cycle facility would minimise these conflicts.

Photo 18: Bus patron utilising new facility. Note that they are in the shade of the bus and may not be clearly visible to cyclists using the system.

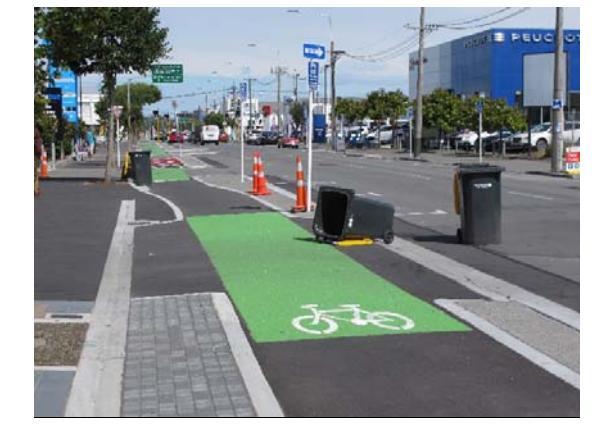
Photo 20: Rubbish bins placed in the parking shoulder. Note bins topple into cycle lane and block entrance.

This will result in cyclist's travel being compromised, with the risk of impact with a rubbish bin being high on collection day. The presence of vertical kerbs either side of the cycle facility restricts the cyclist's ability to safely take evasive action.

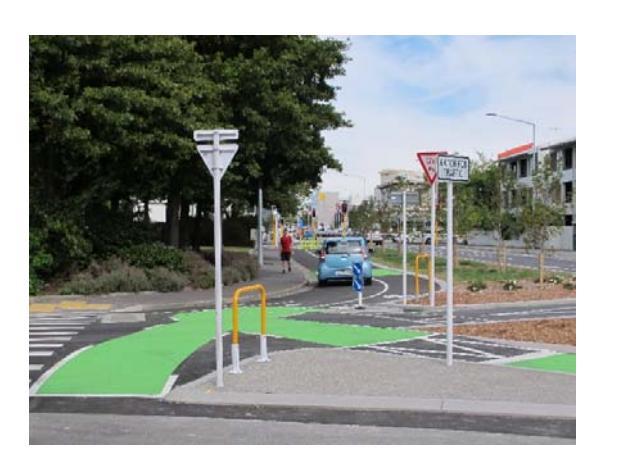
At the time of undertaking the site inspection, the SAT observed 3 vehicles drive down the separated cycleway within 30 minutes during the morning off peak travel time. All three vehicles had to reverse or turn and drive the wrong way out. These vehicles would have been blind to a cyclist entering from the Ferry Road (westbound) lane.

Photo 21: The blue car "comfortably" driving along

flagged down the car and got the driver to reverse

the 2 way cycle path. The man in the red top

Improve the delineation and channelisation of Ferry Road traffic approaching the St Asaph Street intersection. While a wider review of the intersection layout and operation is recommended (discussed below in further detail), in the interim it is strongly recommended the use of bollards to prohibit motorists from accidentally accessing the cycle path.

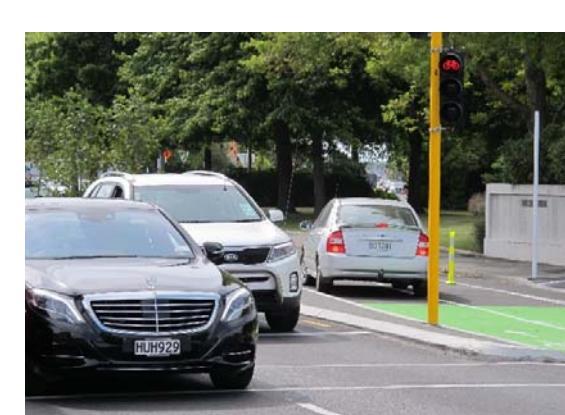
Photo 22: The silver car on the right has just

completed a 5 point turn at the Cashel Street end of

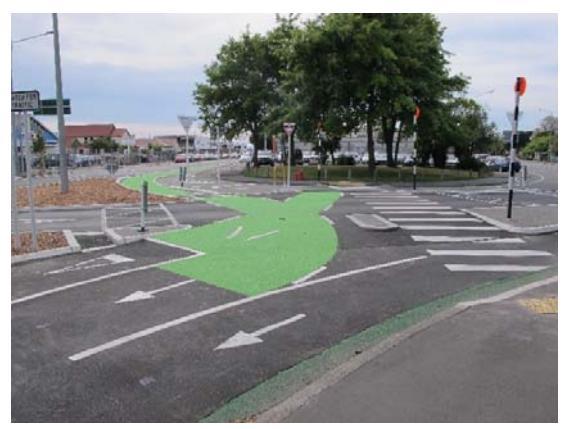
- The give way for the left turn movement (into Ferry Road) is positioned in such a location that it legally applies (placed on the left side of the cycle lane) to the westbound cycle movement. This conflicts with the priorities for the other approaches for the cycle lanes.
- Signs have been rotated to an incorrect direction
- Number of signs result in poor readability, blocked signs, conflicting / confusing layout. High number of signs causes confusion

Photo 23: Confusing markings and signs – Ferry Road / St Asaph Street intersection

- That the designers undertake a review of the current design, noting these conflicts and constraints, and undertake a remedial design to address the issues. The signage needs to be intuitive and easy to read – too much signage and the motorist/cyclists cannot absorb all the information in such a short decision time when entering the intersection.
- 2. It is strongly recommended that the design team observe driver behaviour on site to understand the conflicts and confusion that exist.

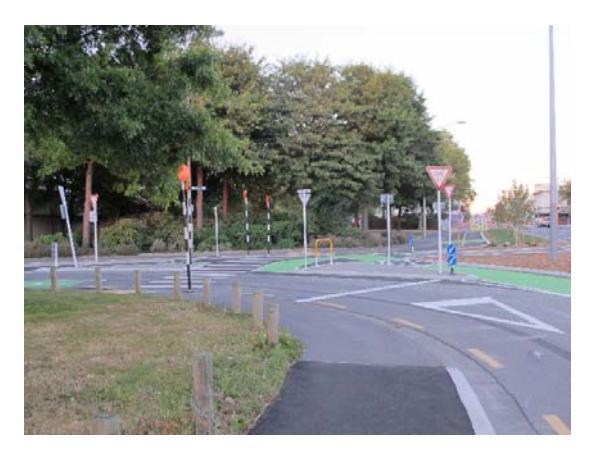
Photo 25: Confusing markings and signs – Ferry Road / St Asaph Street intersection

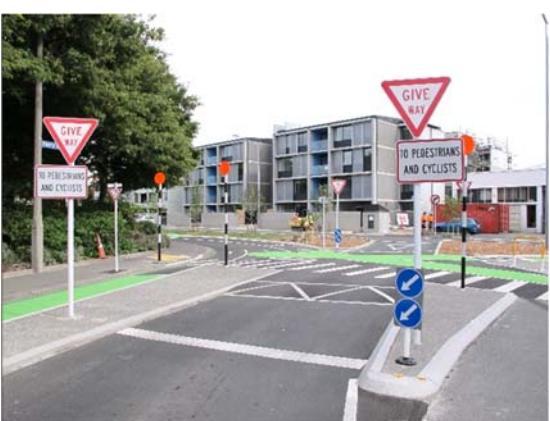
Photo 24: Confusing markings and signs – Ferry Road / St Asaph Street intersection

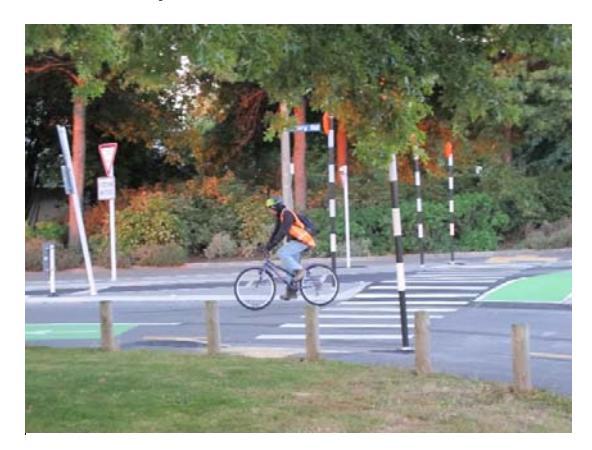
Photo 26: Example of cycle path exiting (eastbound) from the Ferry Road Intersection. Note pole damage to left.

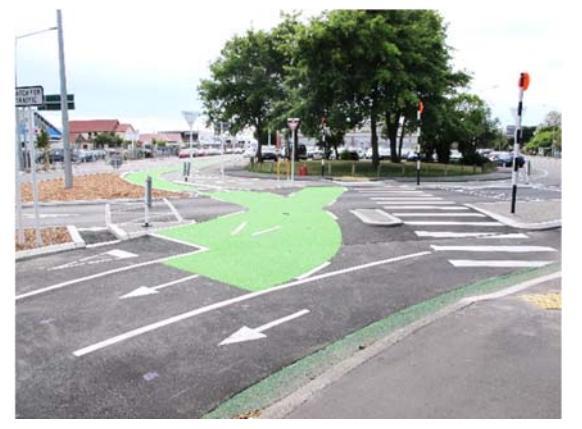
The cycle markings are confusing for the user. The green markings do not follow the path of the user as observed by the SAT. The ramp markings visually appear as a limit line – reinforcing the indication that the cyclist is required to give way for the westbound movement.

Figure 2-4: Actual controls and markings installed.

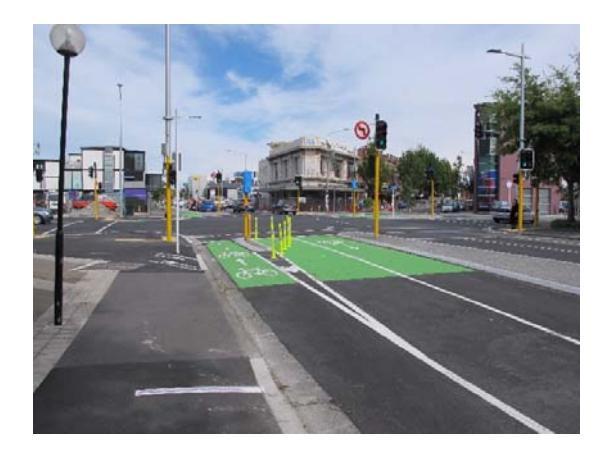
Photo 29: Madras Street / St Asaph Street. Note footpath markings marked for removal?

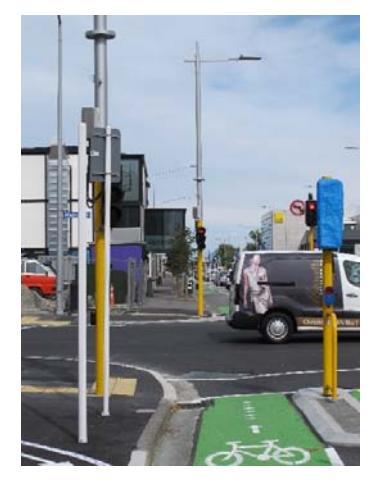
- The left hand traffic signal (westbound) for the cycle facility is partially masked by a preceding sign.
- The current dashed leader line between the St Asaph Street bi-directional facility, and the partially completed High Street facility. The current road markings do not give good guidance to the cyclists. The current line leads from the left hand side of the High street facility, onto the centre of the bi-directional facility. The use of a white line could miss-lead a driver. A change of colour to (say) green dashed would better represent the cycle path.

Photo 30: Sign masks primary traffic signal for cyclists.

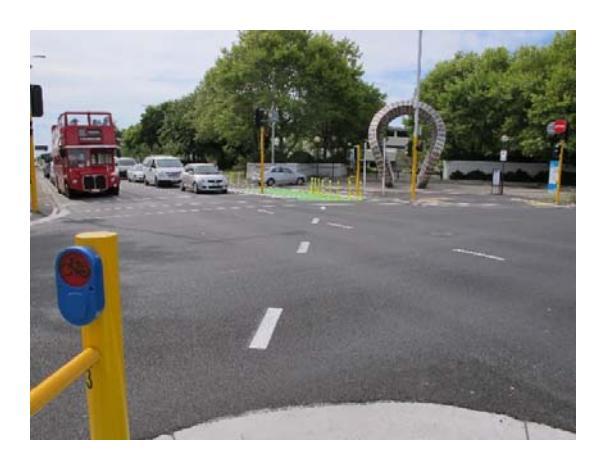
Photo 31: Miss-aligned pavement markings for cyclists. Note – this could be confused for conventional lane leader lines for drivers.

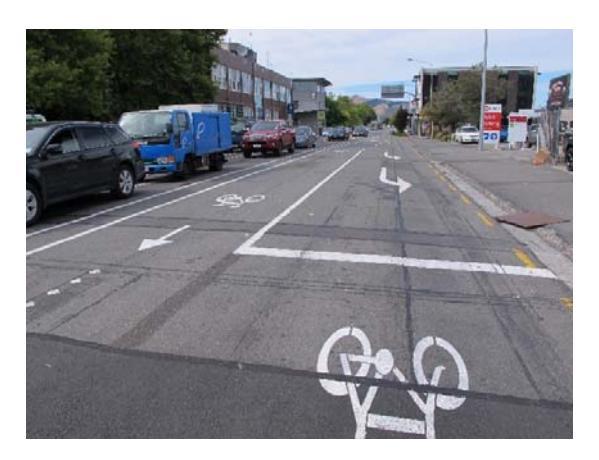
- The markings on Madras Street were incomplete, and resulted in what appeared to be an additional lane where cyclists were required to position for the northbound movement. Colouring of the road surface would be required to clearly define the cycle lanes to avoid motorists positioning themselves in the cycle lanes.

Photo 32: Lack of green markings – Madras Street.
