Christchurch City Council BE 1119 EQ2 Andrews Crescent

QUANTITATIVE ASSESSMENT REPORT FINAL

- Rev B
- 04 June 2013

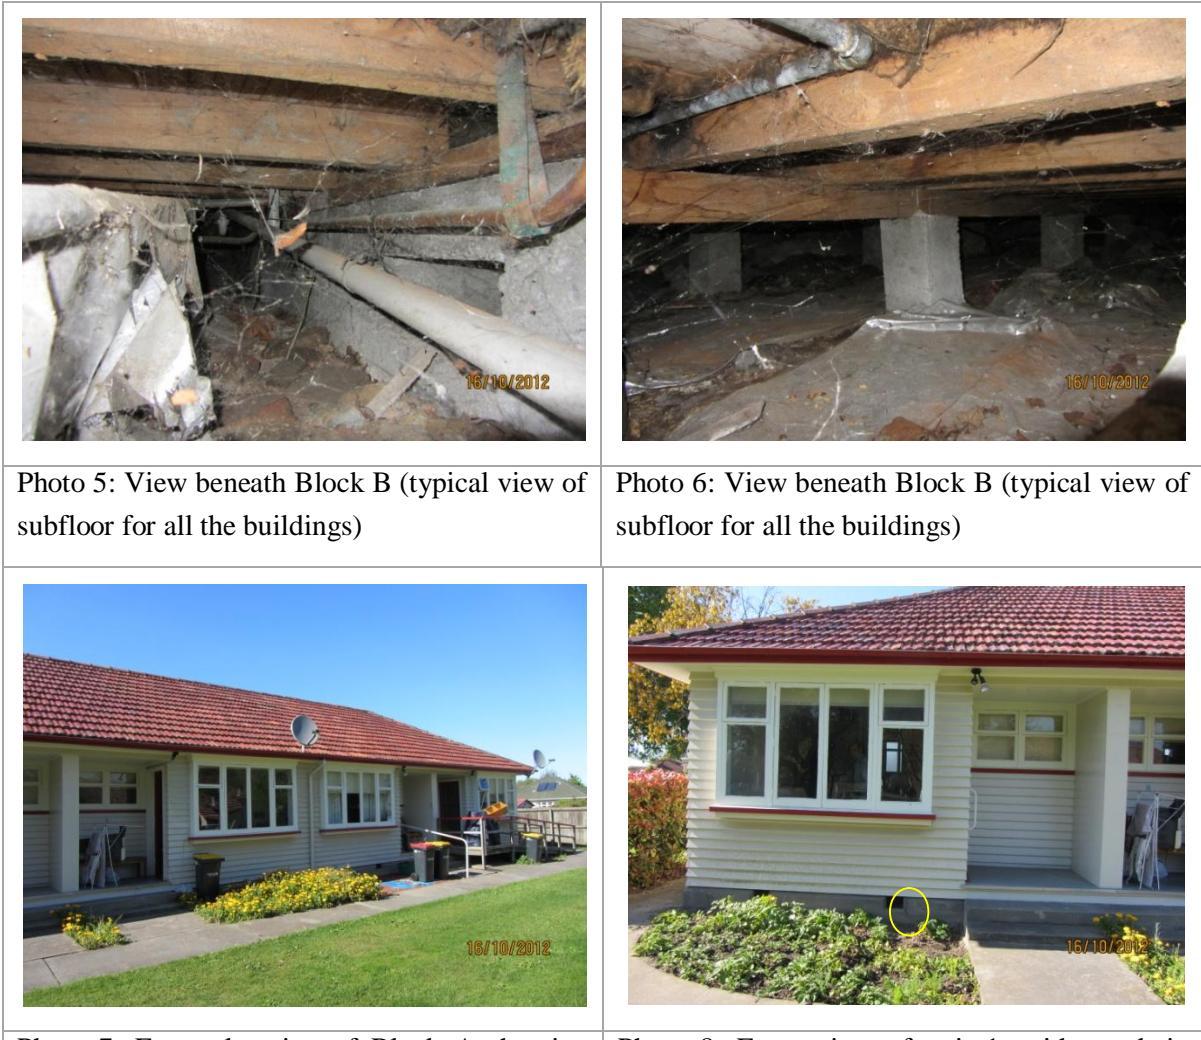
Photo 7: Front elevation of Block A showing
entrances to Units 1,3,5,7 respectivelyPhoto 8: Front view of unit 1, with crack in
foundation circled

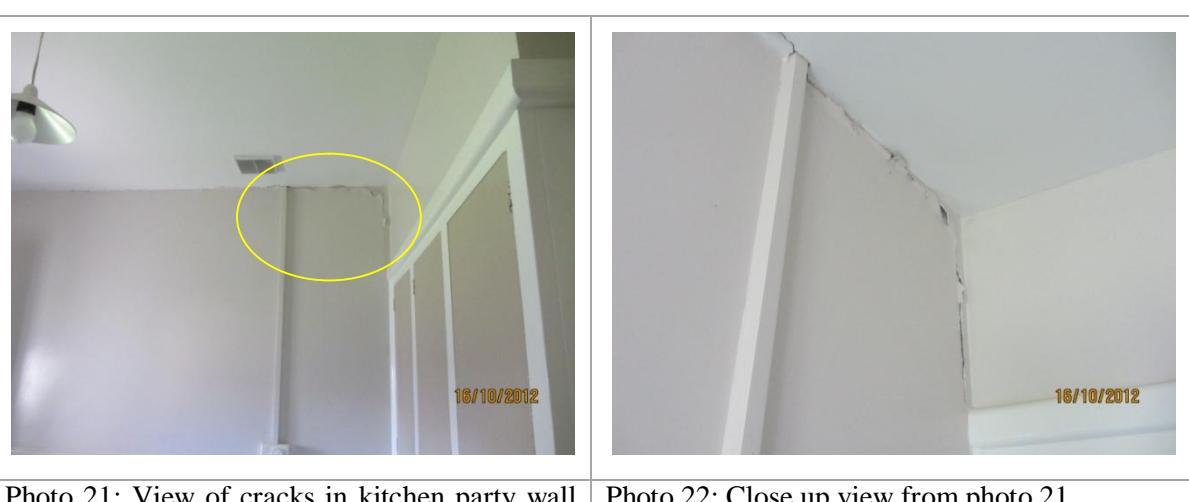
- Unit 5 has cracks in the bathroom ceiling (see photo 20)
- Unit 5 has cracks in the kitchen party wall (see photo 21)

Photo 21: View of cracks in kitchen party wall Photo 22: Close up view from photo 21 in unit 5

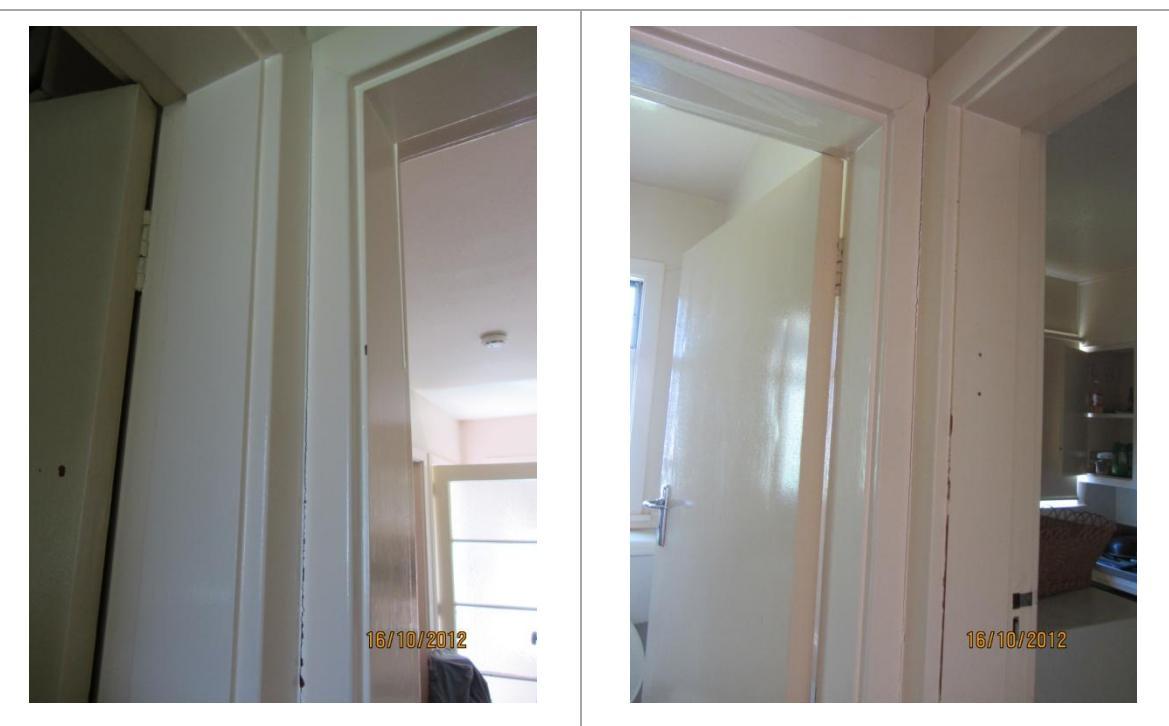
- Unit 9 has vertical cracks between the door frame junctions (see photo 62, 63)
- Unit 9 has diagonal crack beside the manhole in the hallway (see photo 65)
- Unit 11 has cracks in the lounge area above the doorway and also in the ceiling (see photo 67, 68)
- Unit 11 has a crack above the electrical meter box in the kitchen (see photo 70)
- Unit 11 has a crack above the back entrance doorway in the kitchen (see photo 71)
- Unit 15 has a crack above the doorway in the lounge area (see photo 76)
- Unit 15 has a diagonal crack beside the manhole in the hallway crack (see photo 78)

Photo 62: Kitchen and lounge doorway junctionPhoto 63: Bathroom and kitchen doorwayshowing crackjunction showing crack

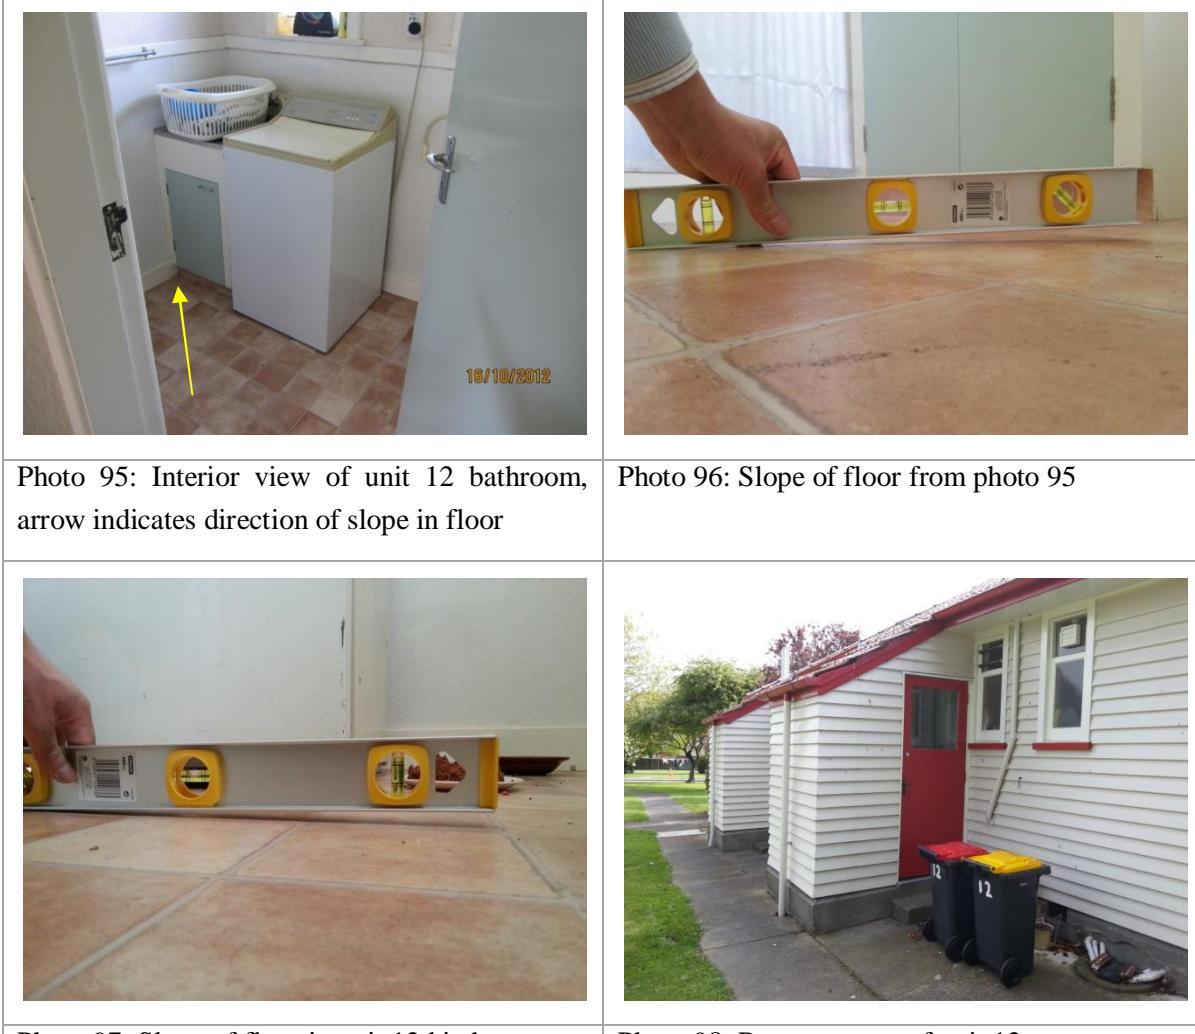
No internal damage was found during the inspection. The floor was seen to be severely out of level from initial inspections (see photo 97, 109). Refer to Section 6.2 Survey.

Photo 97: Slope of floor in unit 12 kitchen area

- a) There is no damage to any of the buildings that would cause it to be unsafe to occupy.
- b) We consider that barriers around the buildings are not necessary.
- c) The floors were found to be out of level and it is recommended the foundations be relevelled or rebuild, however the levelness of the foundation does not affect the %NBS of the buildings.

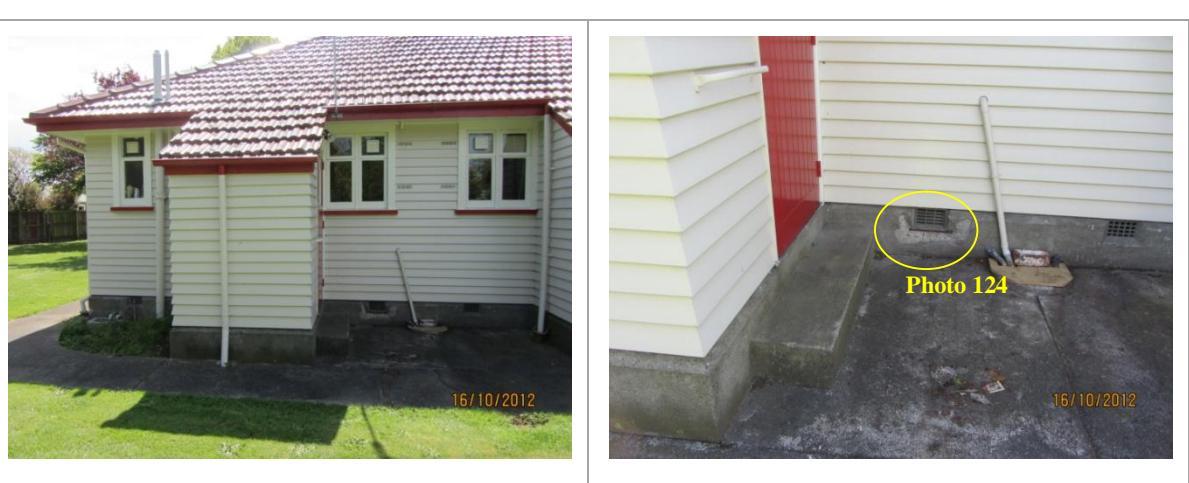
Photo 122: Rear entrance of unit 23

Photo 123: Perimeter foundation of unit 23 at rear entrance

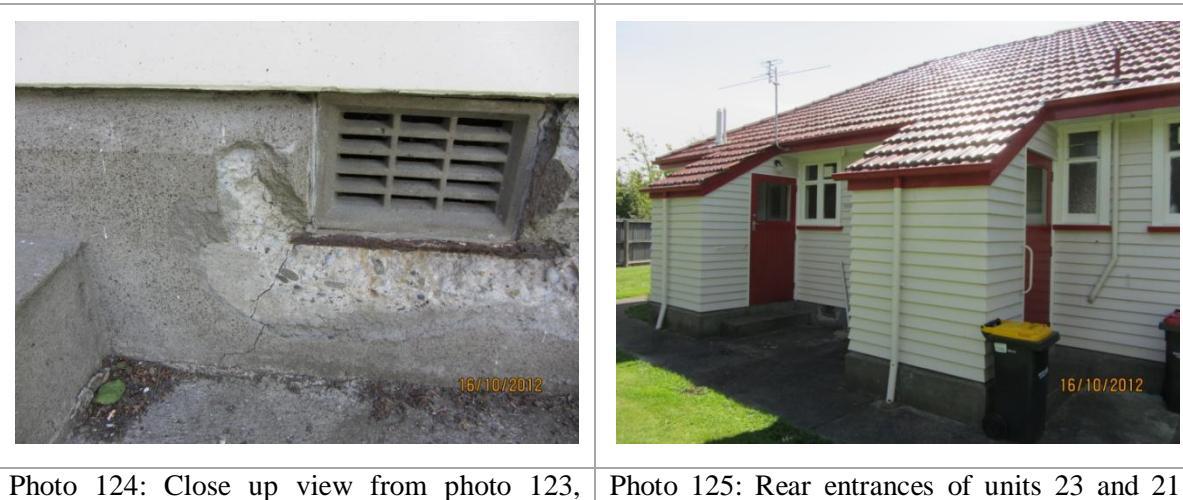
- Cracks were found around the perimeter foundation. (see photo 124, 127, 129, 132, 136)
- Concrete has spalled from the concrete perimeter foundation, exposing rusted reinforcing at the rear entrance of unit 23 (see photo 124). This damage does not appear to have come as a direct result of the earthquakes
- Concrete render has been displaced from the concrete perimeter foundation at the rear corner of unit 23 (see photo 119)
- Concrete steps leading up to the entrances of units 19 and 17 have cracked 2.5mm and 1mm respectively (see photo 121, 134)

Photo 124: Close up view from photo 123,
damage does not appear to be due to the
earthquakePhoto 125: Rear entrances of units 23 and 21
respectively

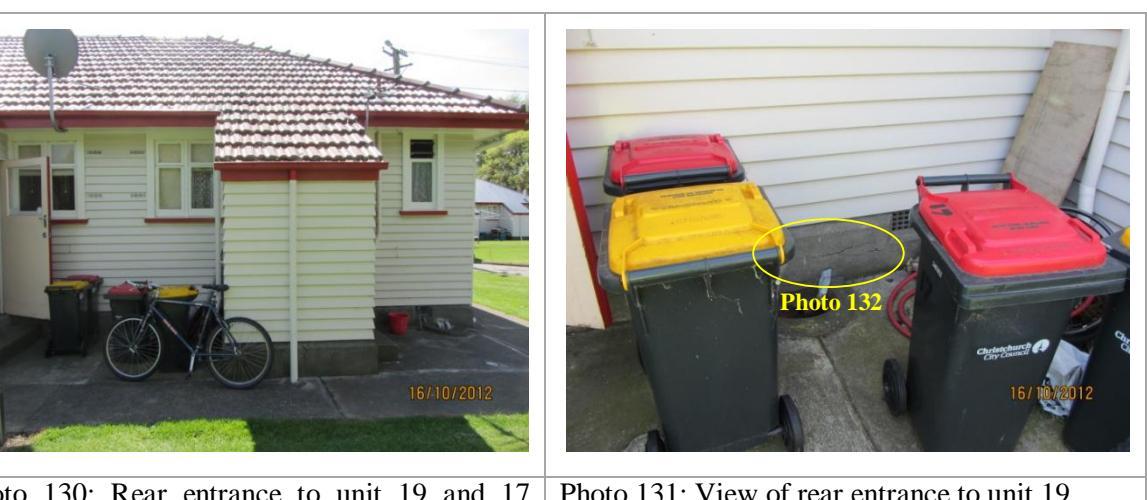
Photo 130: Rear entrance to unit 19 and 17 Photo 131: View of rear entrance to unit 19 respectively

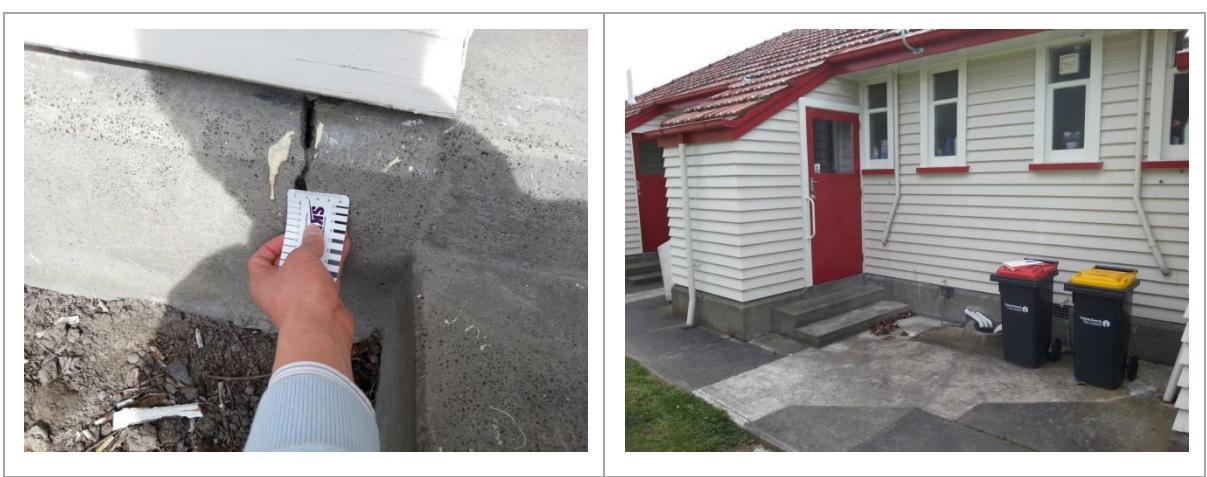
Cracks were found around the perimeter foundation. (see photo 138, 141, 142, 145, 148, 150, 152, 153, 154, 155). A maximum crack width was measured to be 11mm located outside the front entrance to unit 20.

Photo 145: close up view from photo 144Photo 146: Rear entrance for unit 20 (1)showing 11mm crack

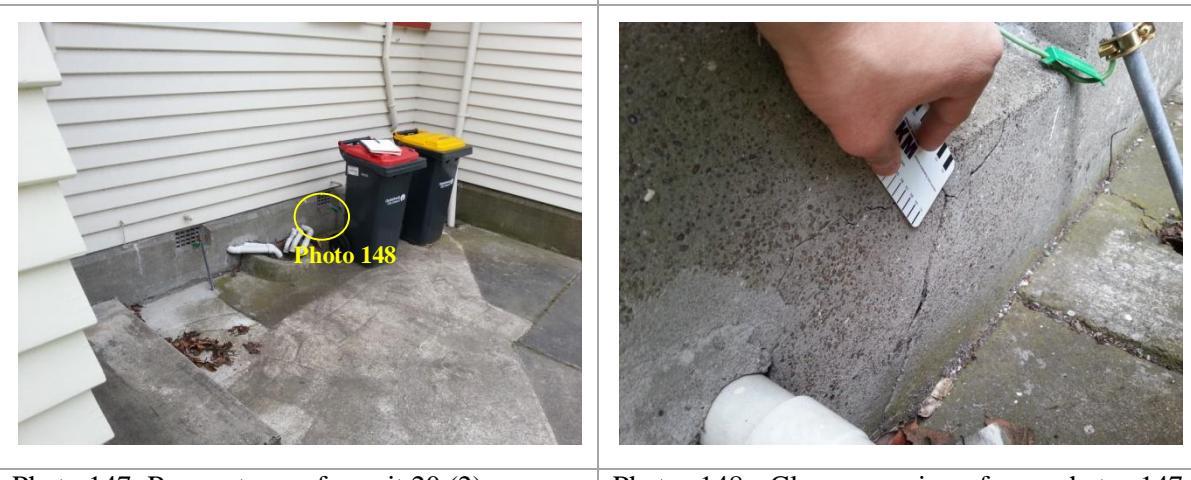
Photo 147: Rear entrance for unit 20 (2)Photo 148: Close up view from photo 147showing 0.7mm crack

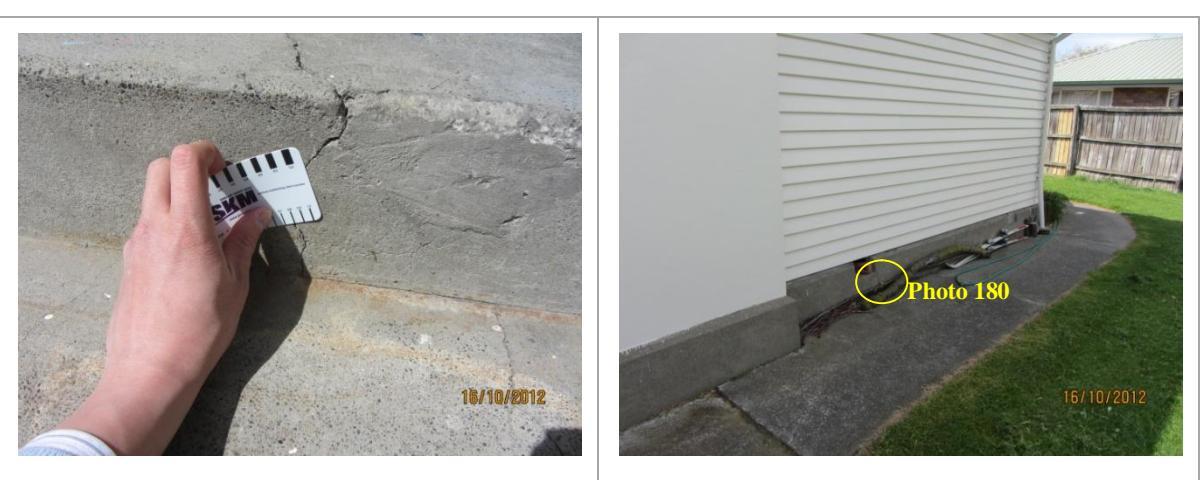
- Front entrance steps to unit 39 has 0.8mm cracks
- Cracks were found around the perimeter foundation. (see photo 173, 176, 180, 182, 184).

Photo 178: Close up view from photo 177Photo 179: Exterior side view of unit 39showing 0.8mm cracks

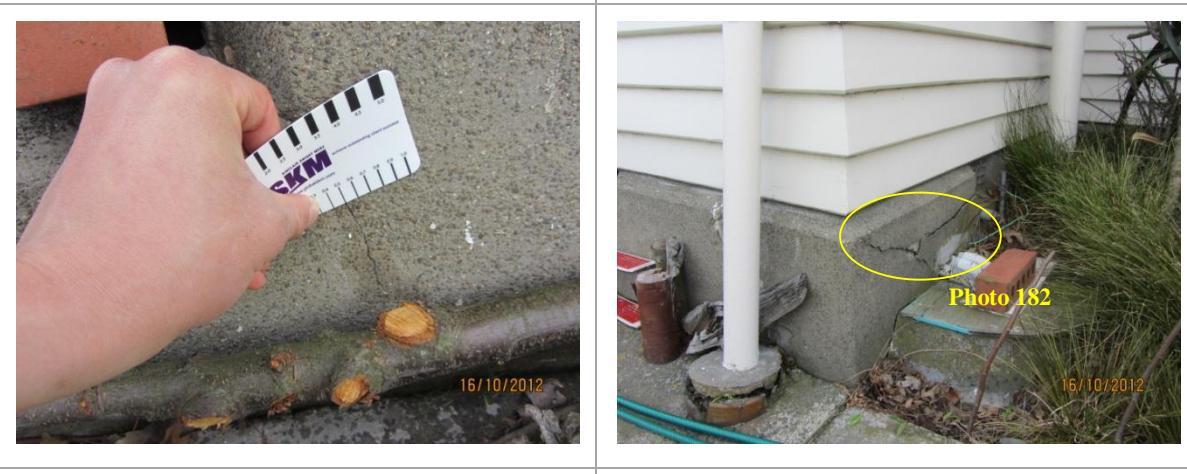
Photo 180: Close up view from photo 179Photo 181: Rear of unit 39showing 0.5mm crack in perimeter foundation
