Broad Park Toilets and Changing Rooms PRK 0121 BLDG 001 EQ2

Detailed Engineering Evaluation Quantitative Report Version FINAL Rev 1

7a Broadpark Road, Waimairi Beach

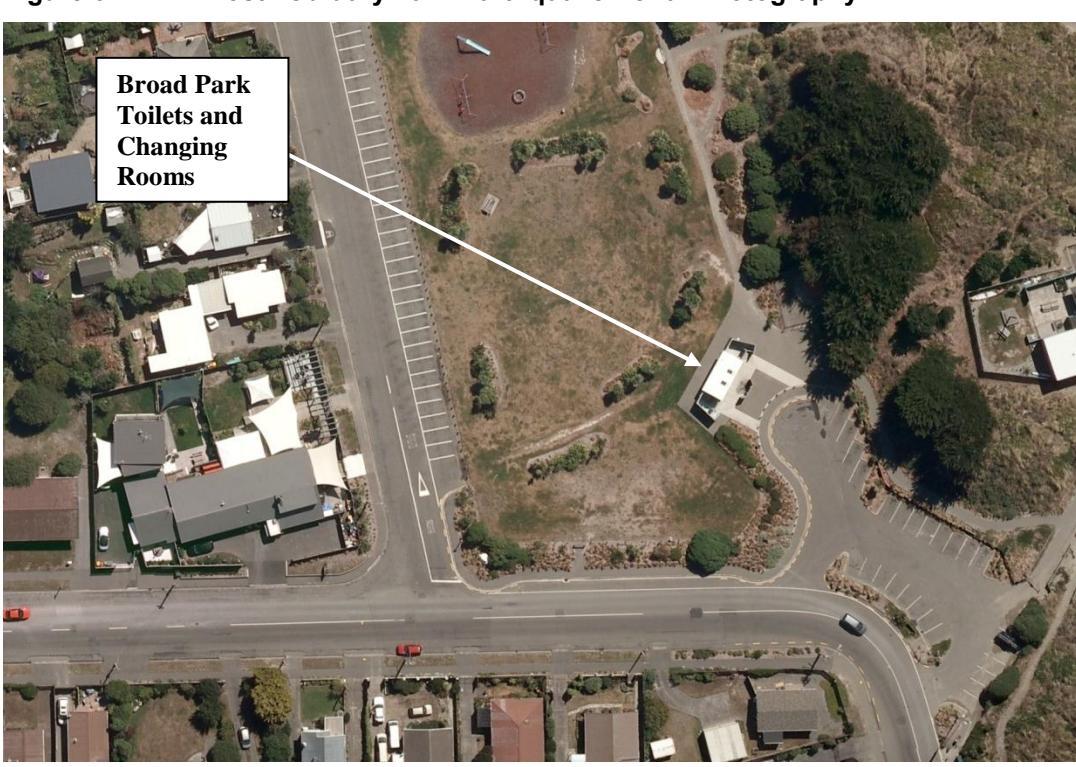
Figure 6.1 Post February 2011 Earthquake Aerial Photography²

Aerial photography taken following the 22 February 2011 earthquake shows no signs of liquefaction outside the building footprint or adjacent to the site, as shown in Figure 6.1. Due to the sites location near to the sea, the sand shown in the aerial photos is likely to be beach/dune sand and not liquefied material.

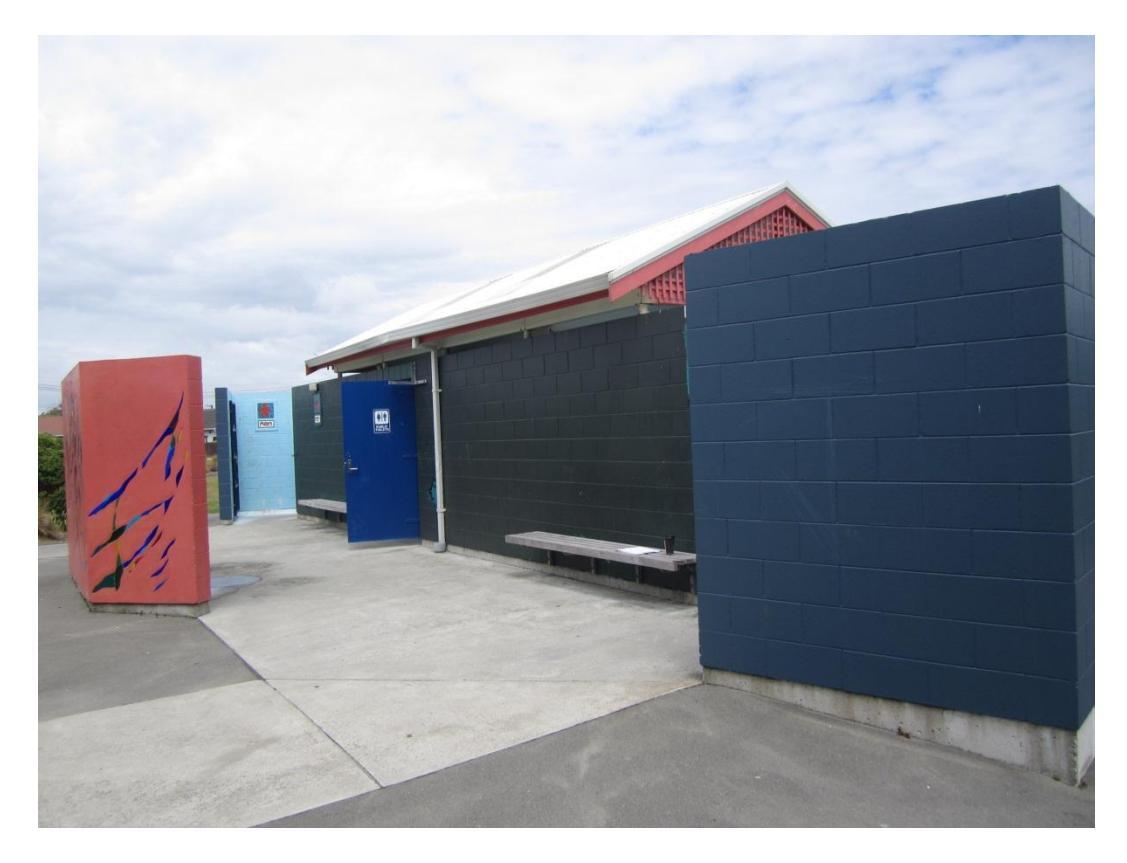
Photograph 3 View of concrete masonry wing walls and shower wall

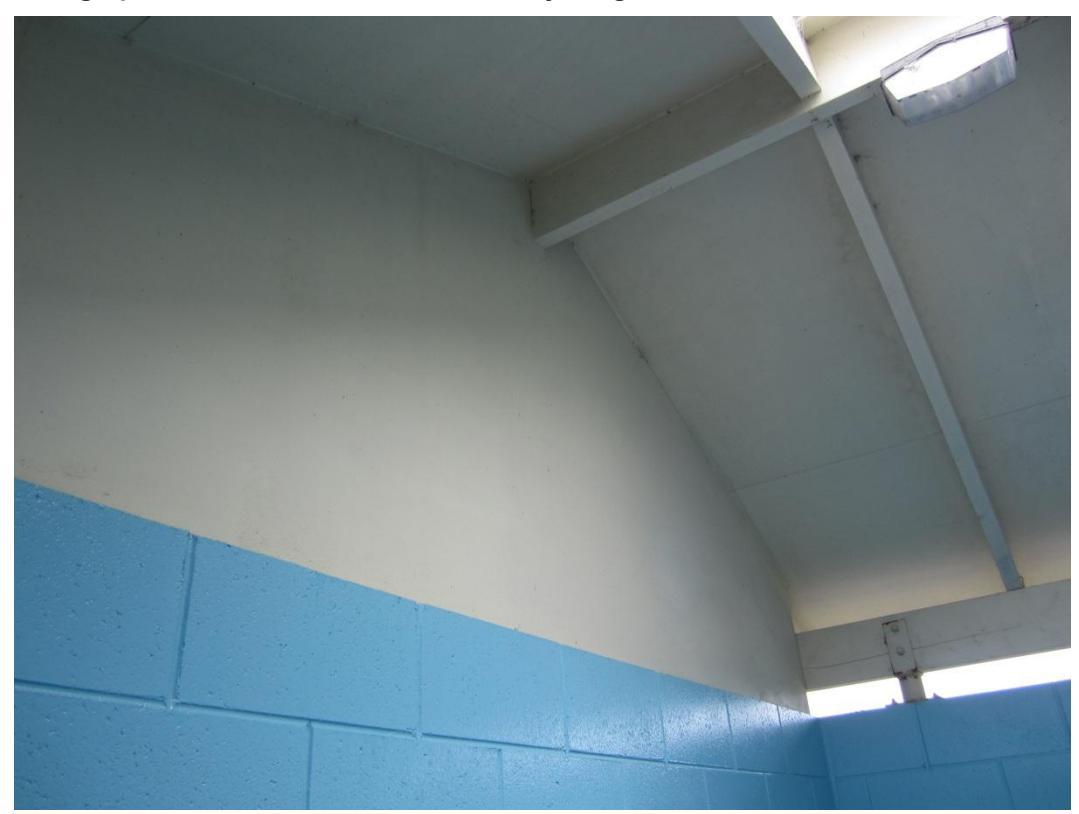
Photograph 4 View of internal ply lined timber framed gable walls

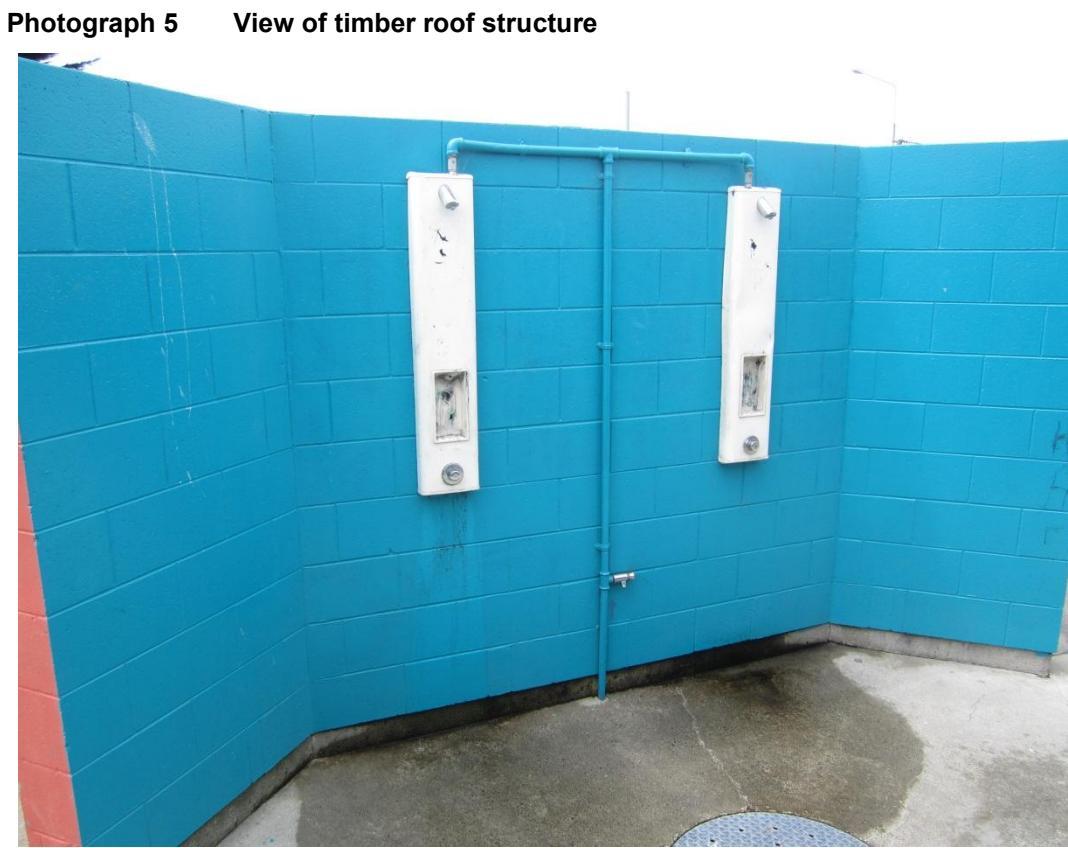
A number of concrete masonry panels with minimal lateral restraint at the top were noted in the structure. The shower area wall is one such panel and is shown in Photograph 6. These walls are restrained against lateral loading by their connection to the reinforced concrete floor slab.

Photograph 6 Unrestrained wall forming public showers

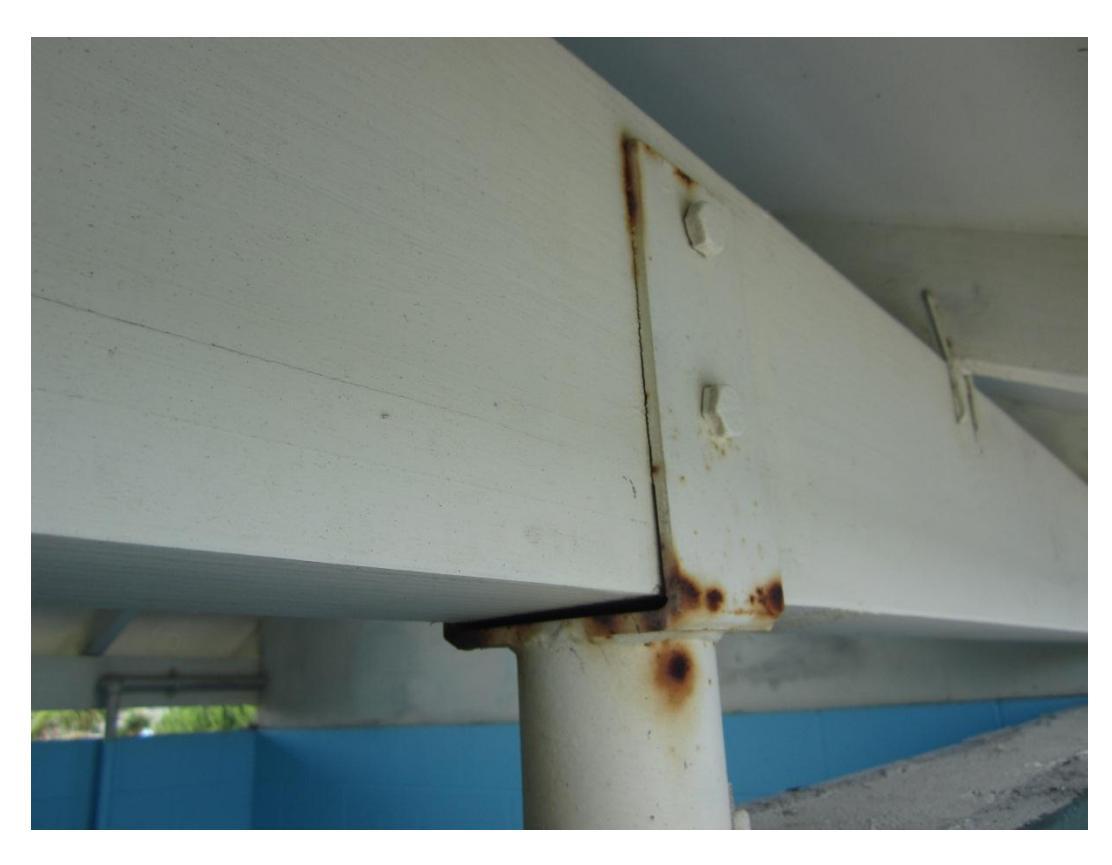
Photograph 7 Bracket fixing steel posts to the 200x90 timber beam

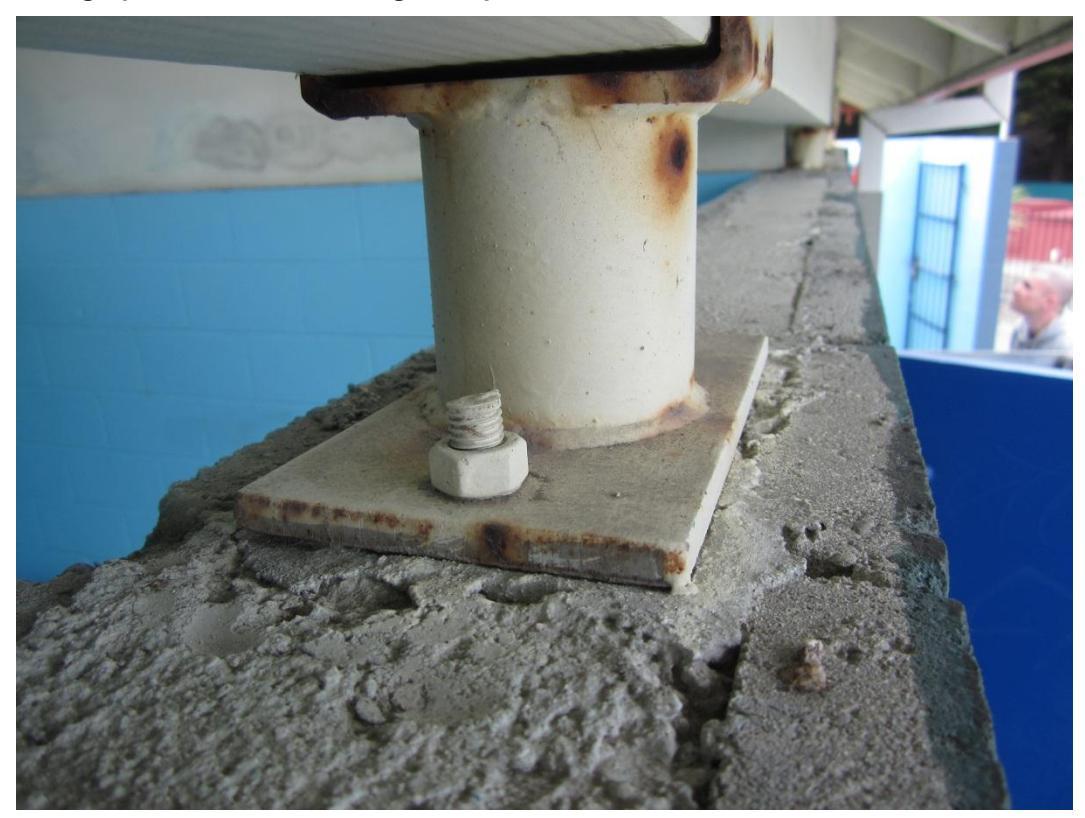
The critical consideration for the performance of the anchors in the concrete masonry walls is the failure of the concrete masonry under shear. The worst case occurs when the loading on the anchors is perpendicular to the direction the wall spans. The concrete masonry walls are 190mm thick and the anchors are centrally placed. As a result, the edge distances are within the required limits.

Photograph 8 2 No. M12 anchors fixing the steel end plate to the concrete masonry walls

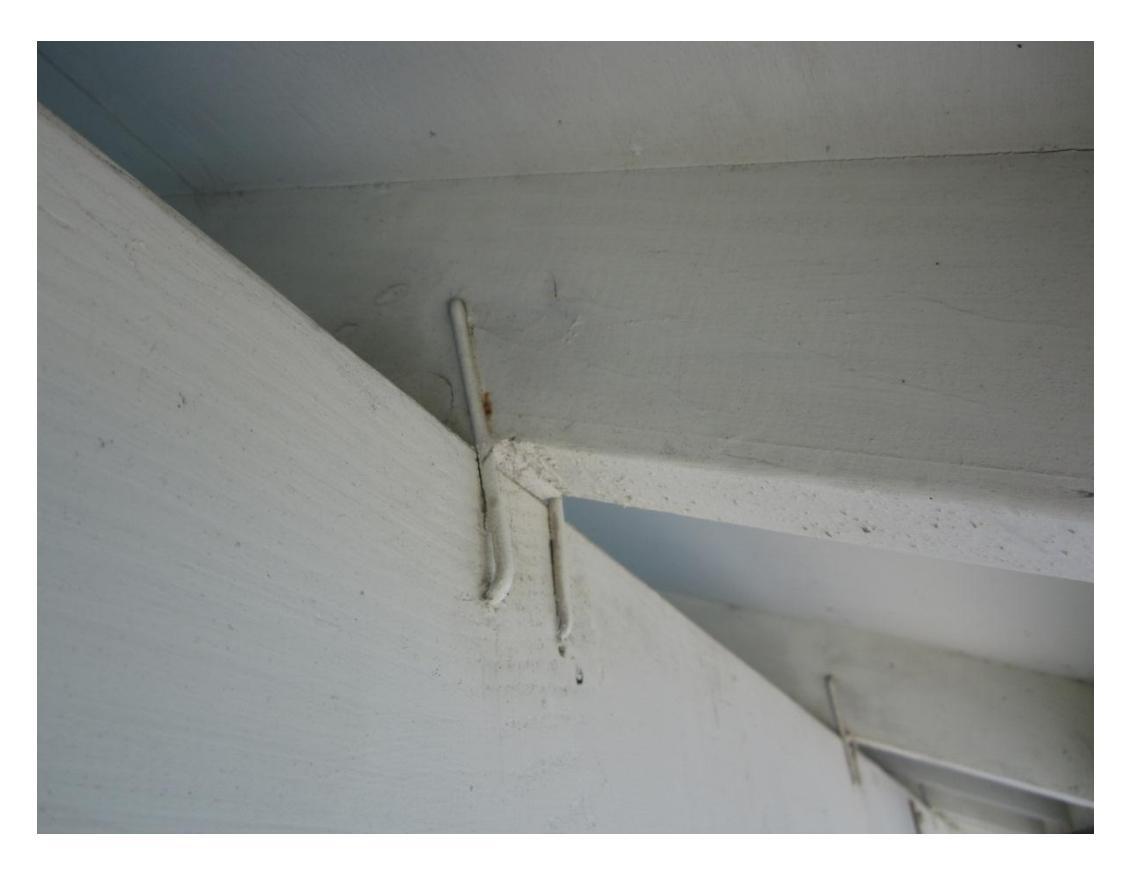
Photograph 9 Fixing between timber rafters and the supporting timber beam
