CHRISTCHURCH CITY COUNCIL PRO 0822 B002 EQ2 Linwood Library Support Services 180 Smith St, Linwood

QUANTITATIVE ASSESSMENT REPORT FINAL

- Rev C
- 13 January 2014

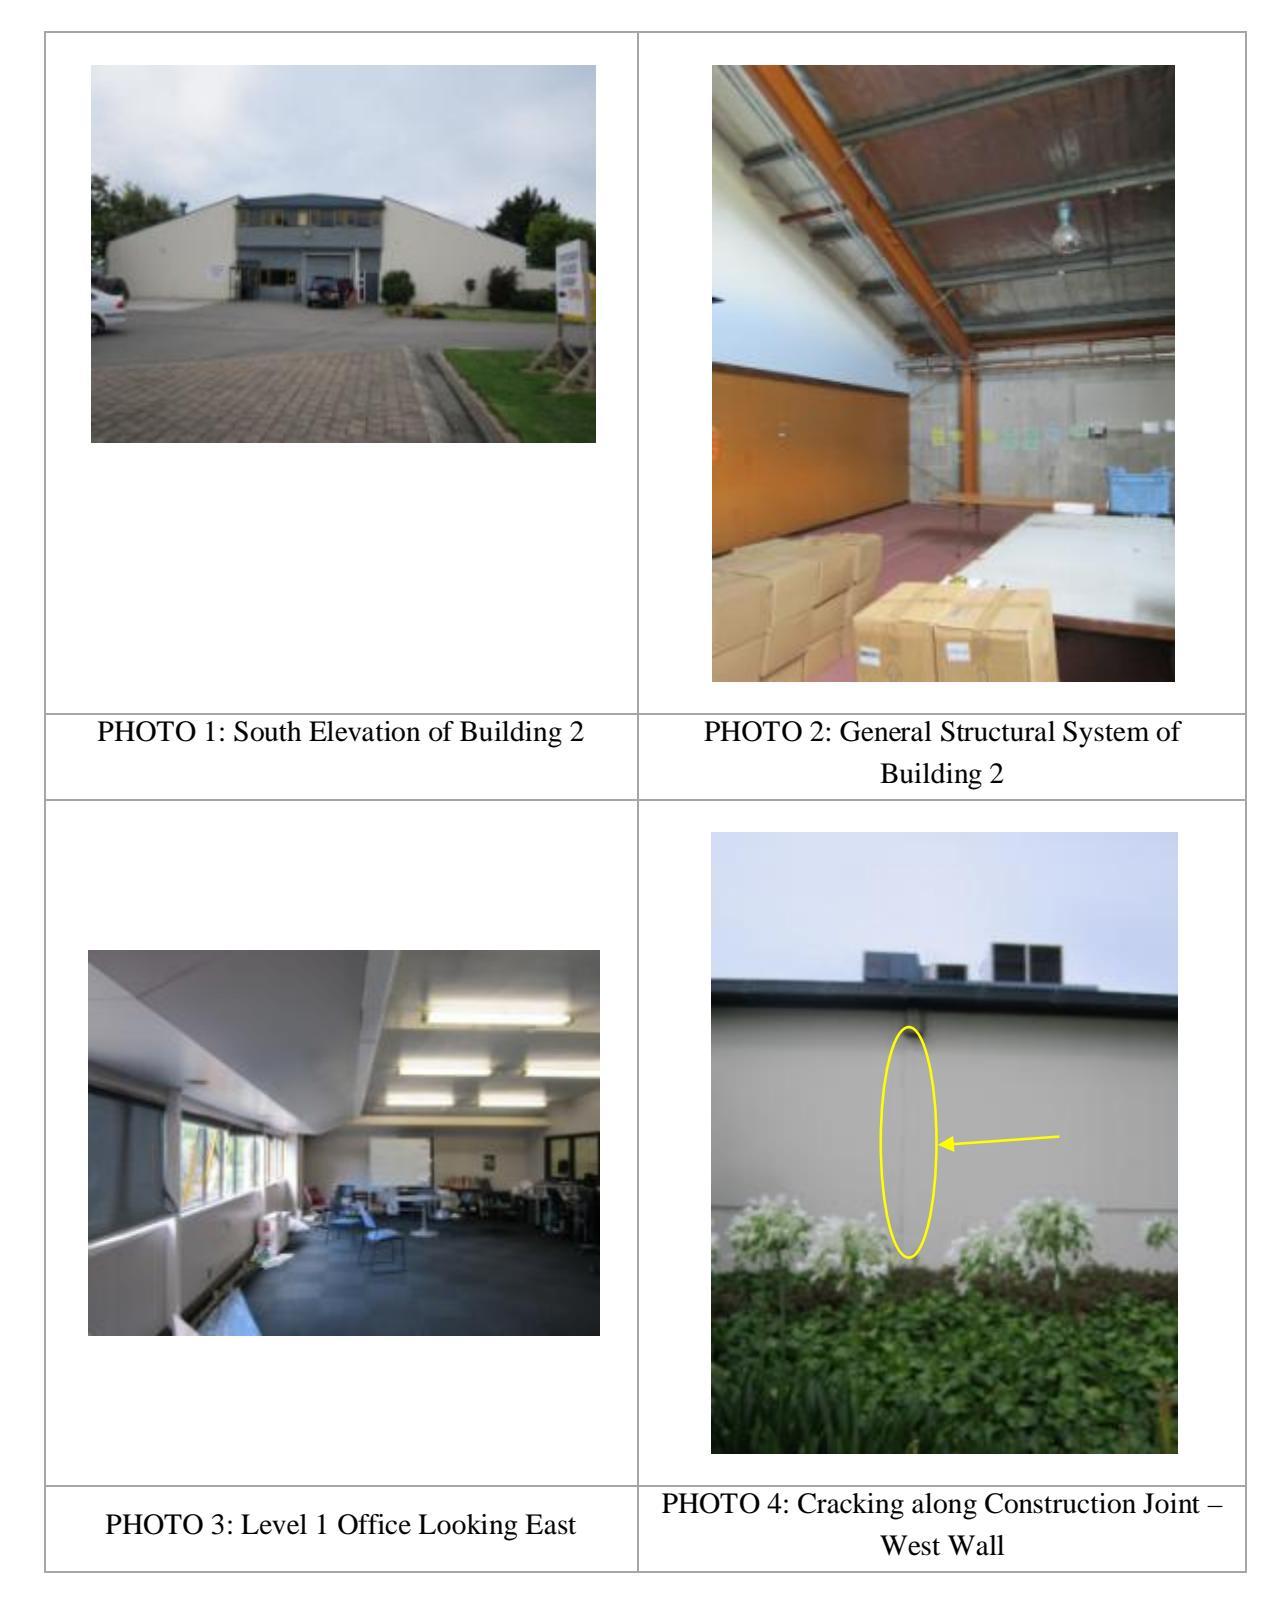
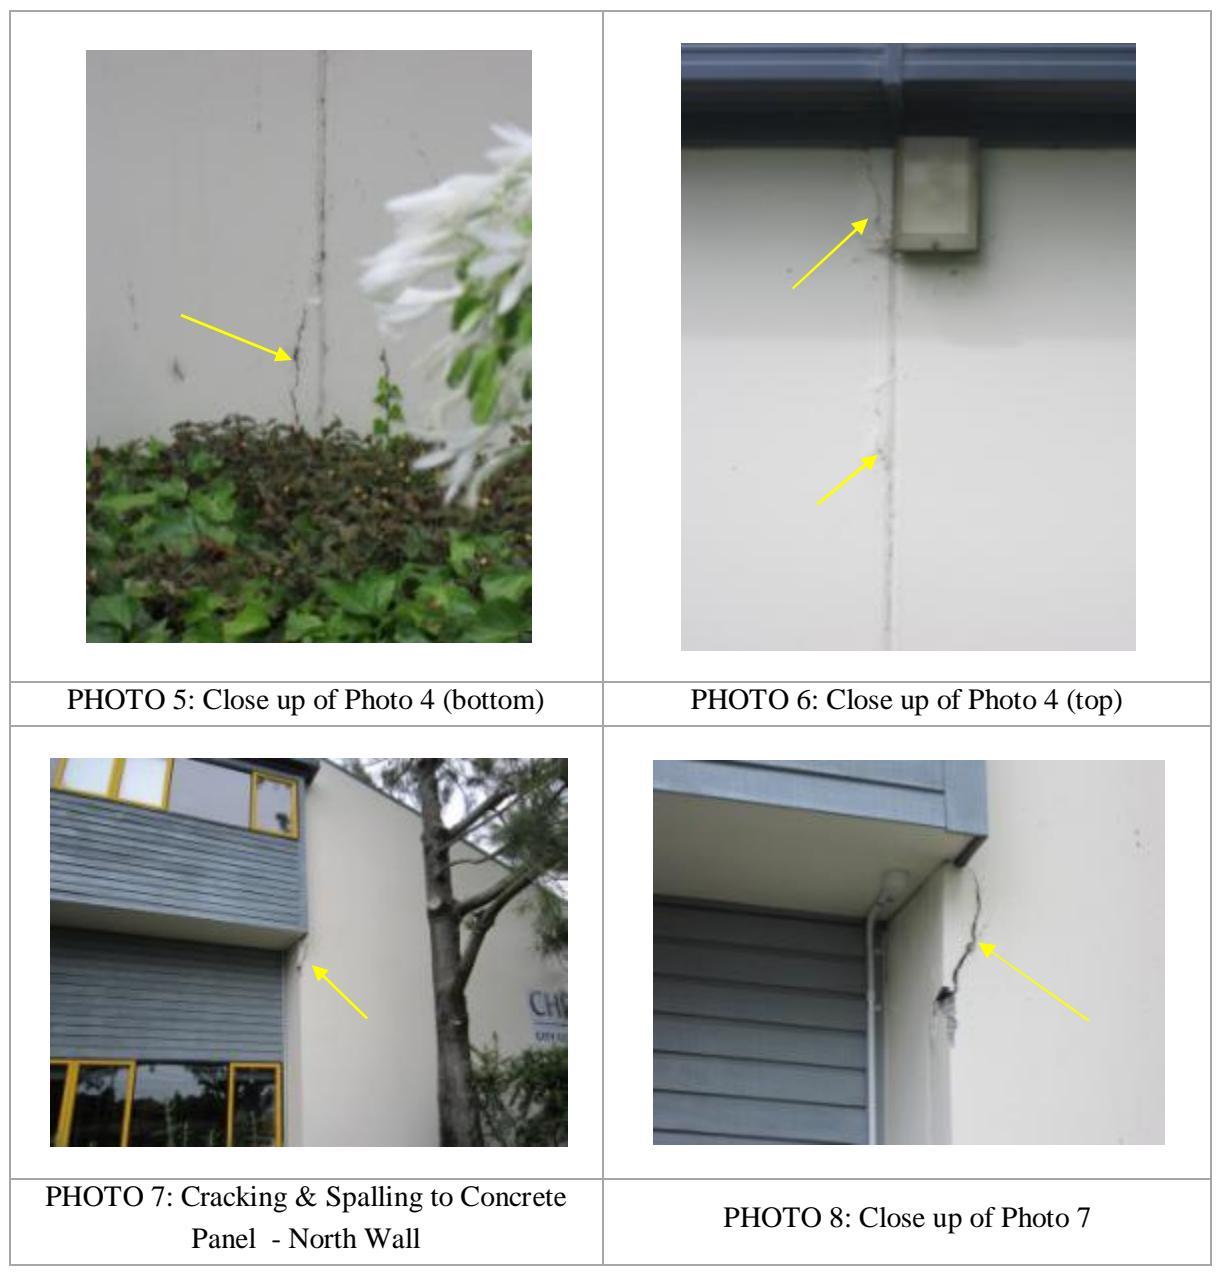
- Western Wall Cracking has occurred to the concrete panels along the construction joint near the centre of the wall. Concrete appears ready to spall off in some locations (PHOTO'S 4, 5 & 6).
- 2) North Wall Cracking and spalling of the concrete panel wall has occurred along the edge of the panel on the west side of the timber infill (PHOTO'S 7 & 8).
- 3) East Wall (garage) Hairline crack present along the joint between the timber rafter and the concrete column in the NE corner (PHOTO'S 9 & 10).
- 4) East Wall (garage) Vertical hairline crack present in the masonry mortar joint on the northern side of the office door lintel (PHOTO 11).
- 5) South Wall Gap present between the concrete wall and timber infill. Difficult to confirm if this is earthquake damage (PHOTO 12 & 13).

PHOTO 9: Hairline Cracking along Timber Rafter & Concrete Column Joint – East Wall	PHOTO 10: Close up of Photo 9
PHOTO 11: Hairline Cracking to Masonry Lintel above Office Entrance – East Wall	PHOTO 12: Gap between Concrete Panel and Timber Infill – South Wall

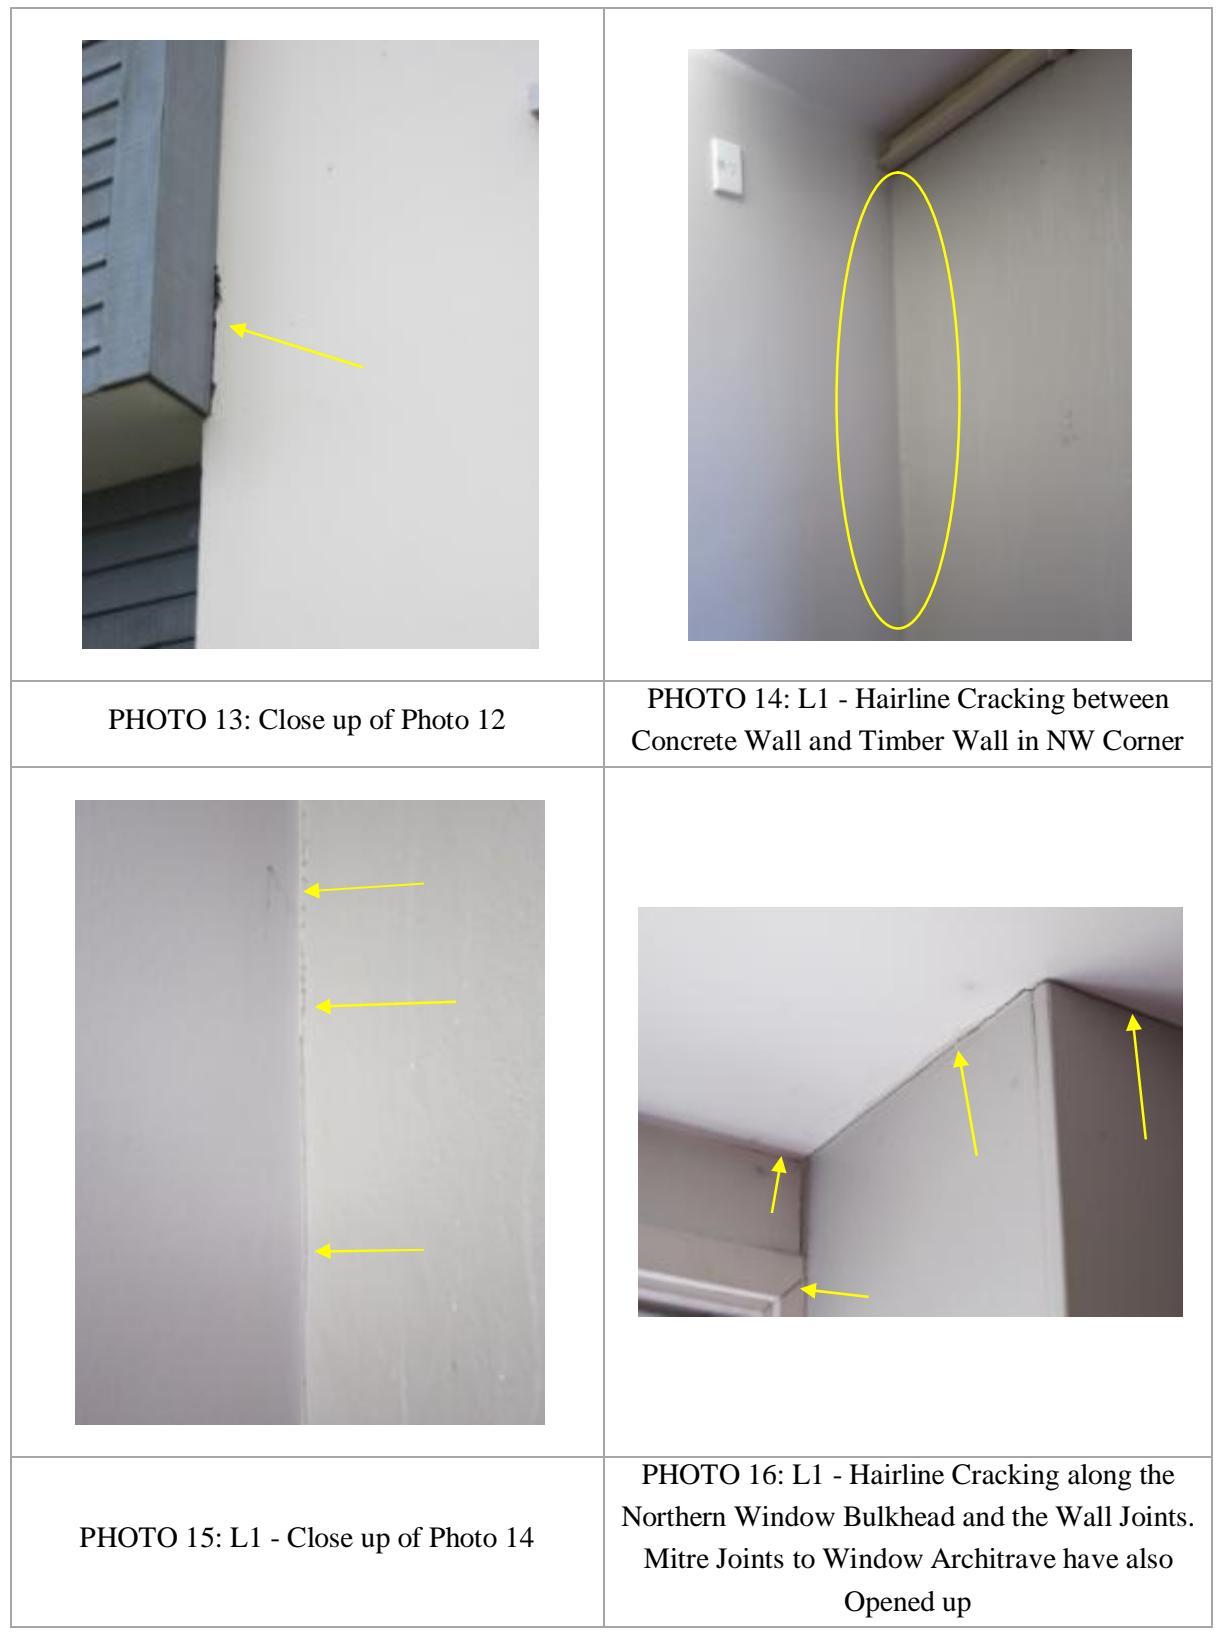
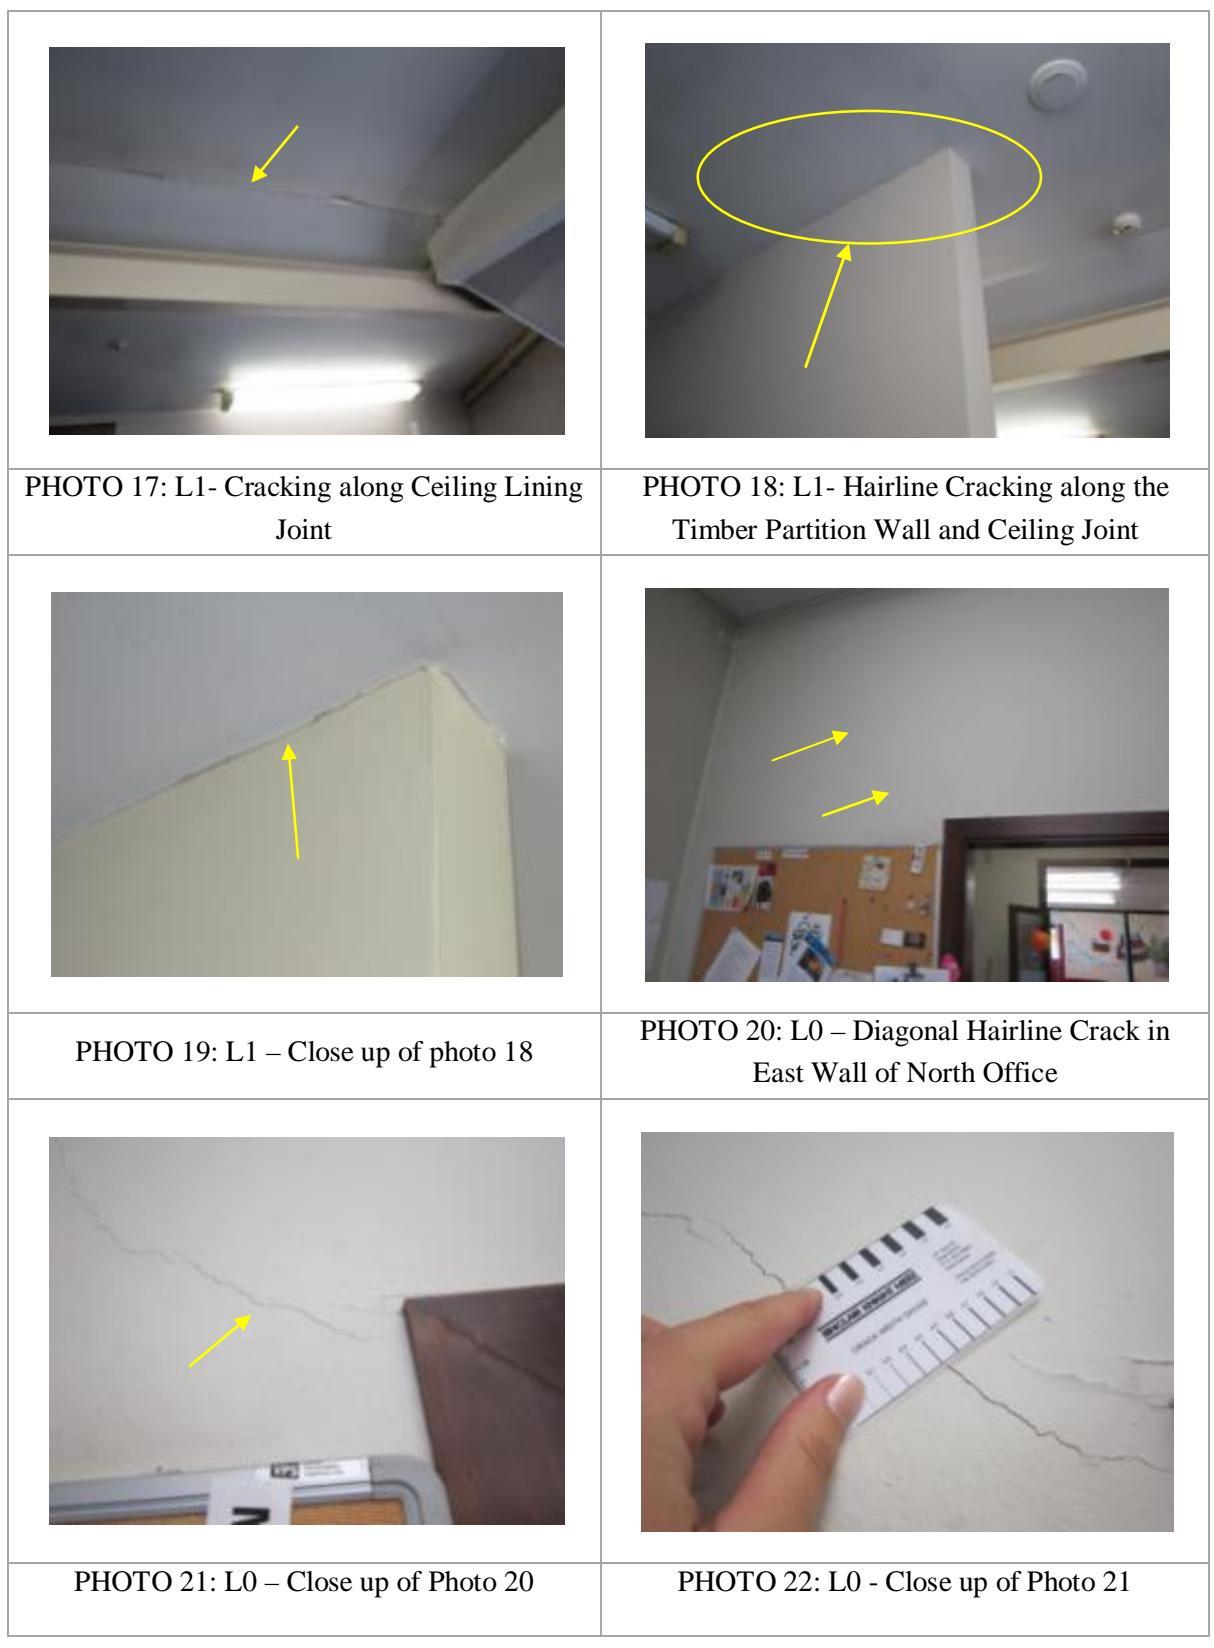
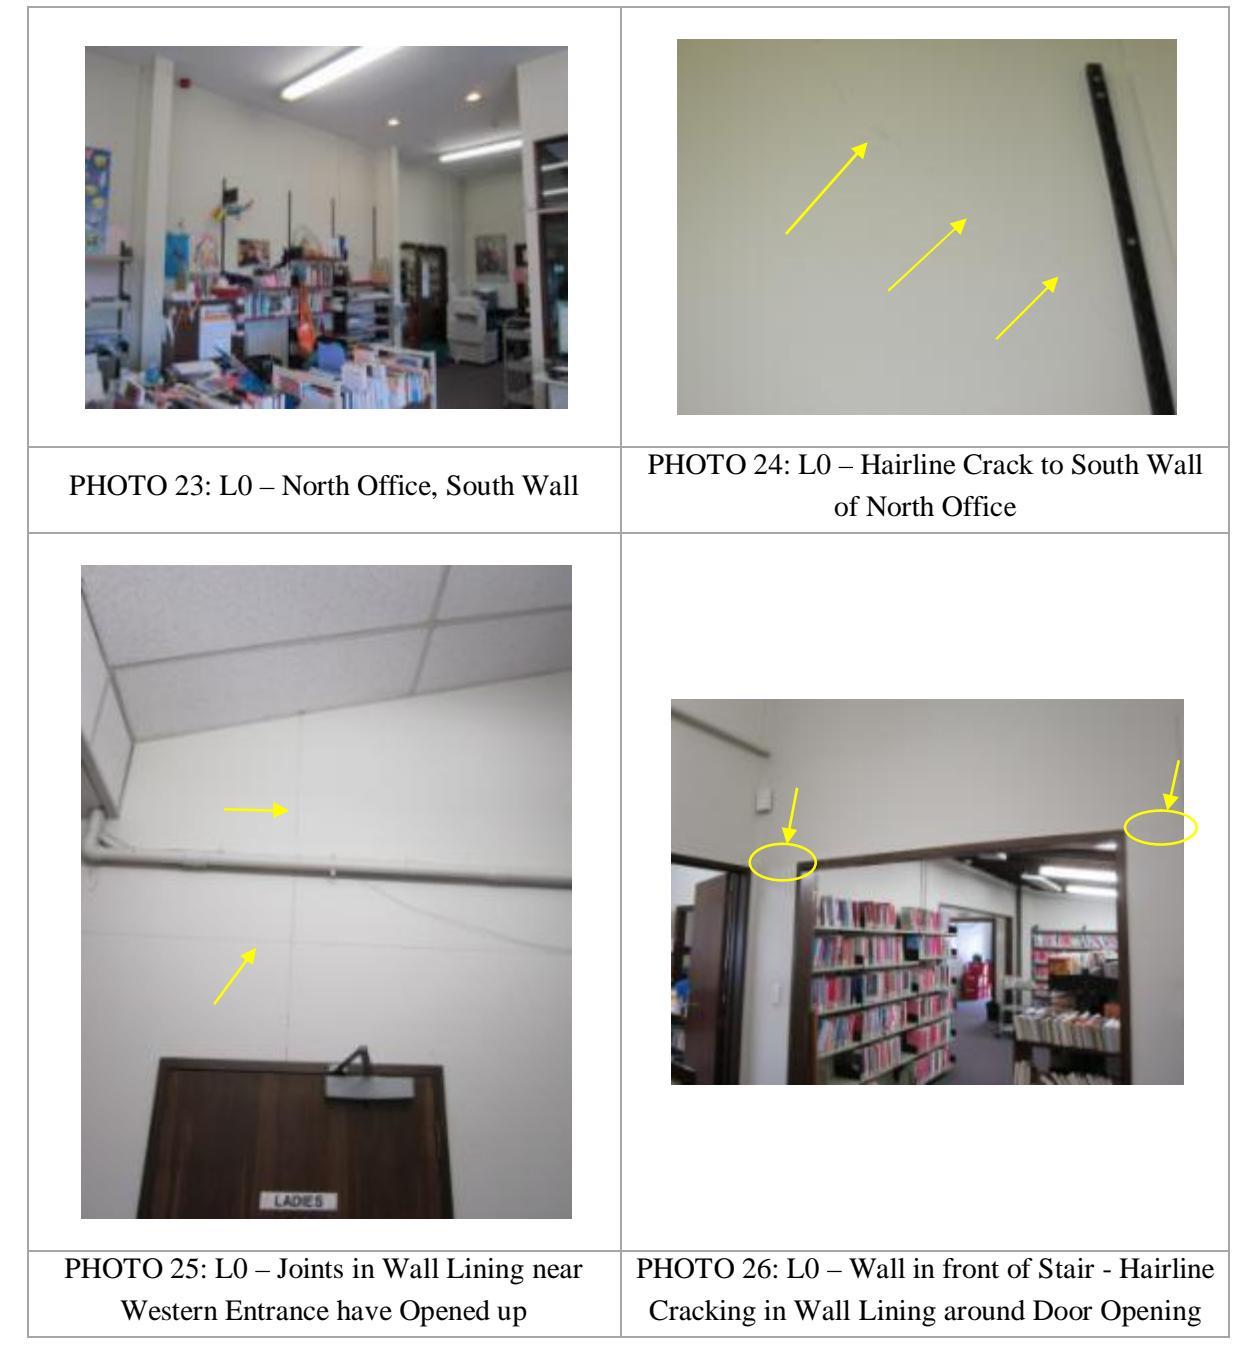
6) Hairline cracking present along the timber framed wall and concrete panel wall joint in the NW and NE corners (PHOTO'S 14 & 15).

- 7) Hairline cracks present along the joint between the northern window bulkhead and wall (PHOTO 16).
- 8) Mitre joints on the northern window architrave have opened up (PHOTO 16).

- 9) Cracking along ceiling joint on the western side where the ceiling changes slope. (PHOTO 17).
- Hairline cracking present around the top of the partition wall at the entrance to the L1 office. This crack occurs along the wall and ceiling joint and continues the full length of the partition wall (PHOTO'S 18 & 19).

- Ground Floor (L0)
- 11) North office, east wall: Diagonal hairline crack approximately 0.4mm wide present on the concrete wall radiating out from the top north corner of the opening (PHOTO'S 20, 21 & 22).

- 12) North office, south wall: Diagonal hairline crack approximately 0.2-0.3mm wide present in concrete wall located on the eastern side of the personnel door (PHOTO 24).

- 13) Joints in the timber wall linings near the western entrance have opened up (PHOTO 25).
- 14) Wall in front of stairs: Hairline cracking present in the timber wall linings around the wall opening (PHOTO'S 26, 27, 28 & 29).

PHOTO 27: L0 – Close up of Photo 26	PHOTO 28: L0 – Wall in front of Stair - Hairline Cracking in Wall Lining around Door Opening
PHOTO 29: L0 – Close up of Photo 28	PHOTO 30: L0 – Vertical Hairline Crack in Concrete Wall near Kitchen

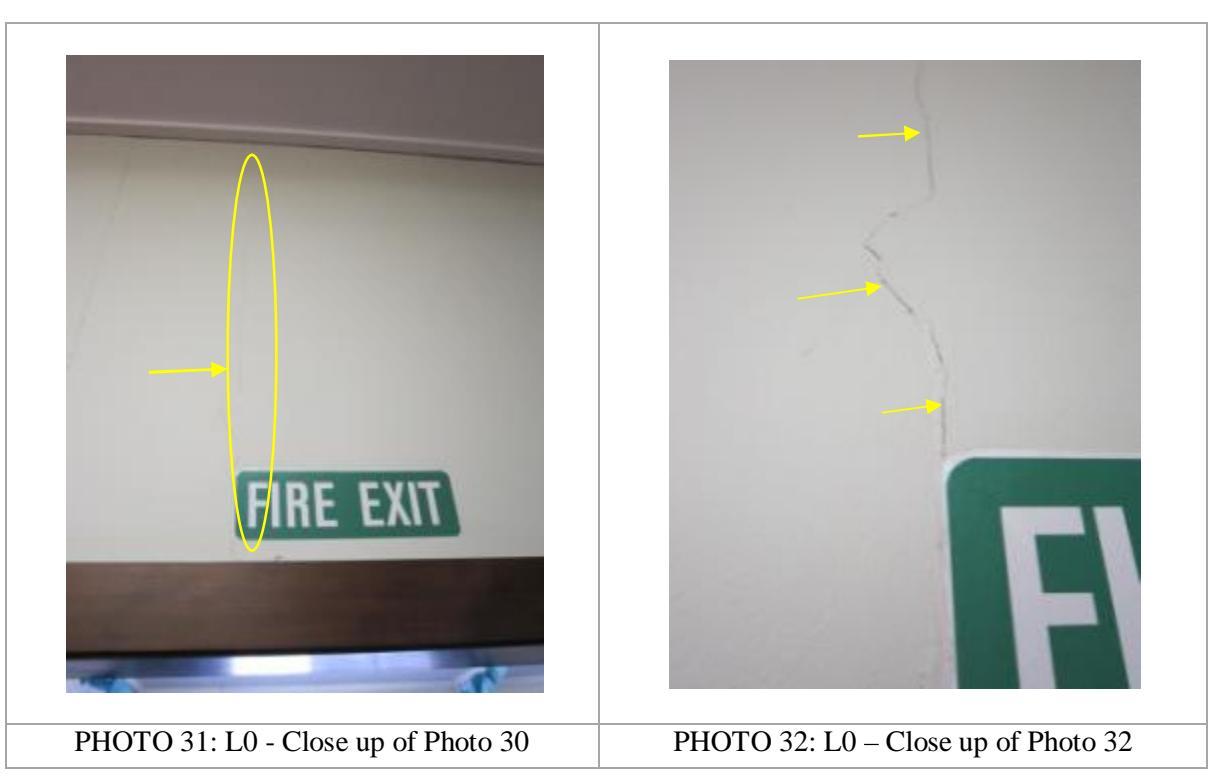
- 15) Concrete wall dividing the east office and the kitchen: Vertical hairline crack approximately 0.3mm wide above the opening in the concrete wall (PHOTO'S 30, 31 & 32).

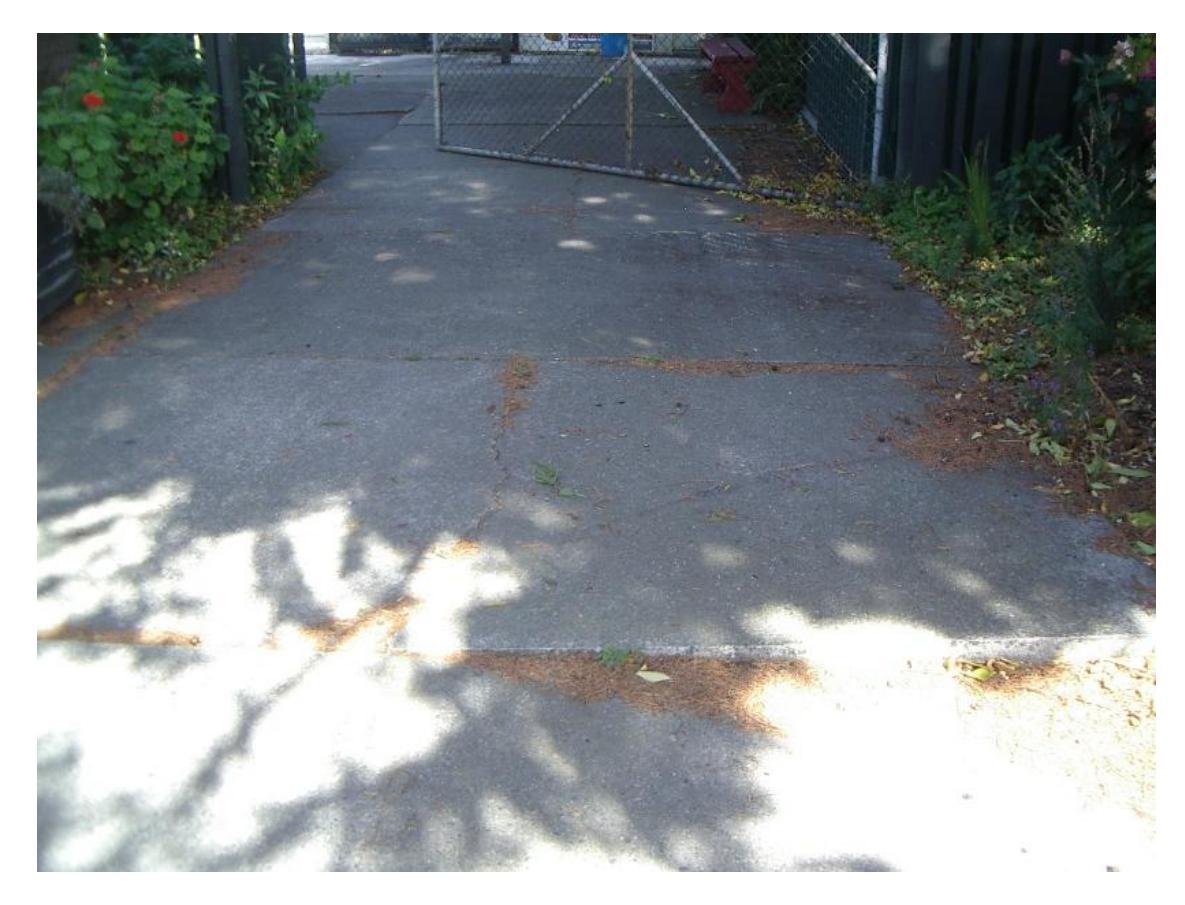
Residents report that the only damage occurred to the footpaths, with paving slabs being displaced, (Figure 8) and that no liquefaction occurred on the site.

Figure 8 Damaged paving slabs at Linwood Resource Centre
