# Rohit's Indian Restaurant Detailed Engineering Evaluation Quantitative Assessment Report

56 – 58 Lichfield Street, Christchurch Christchurch City Council

Date: Reference: Status: September 2012 6-QUCCC.55 Final

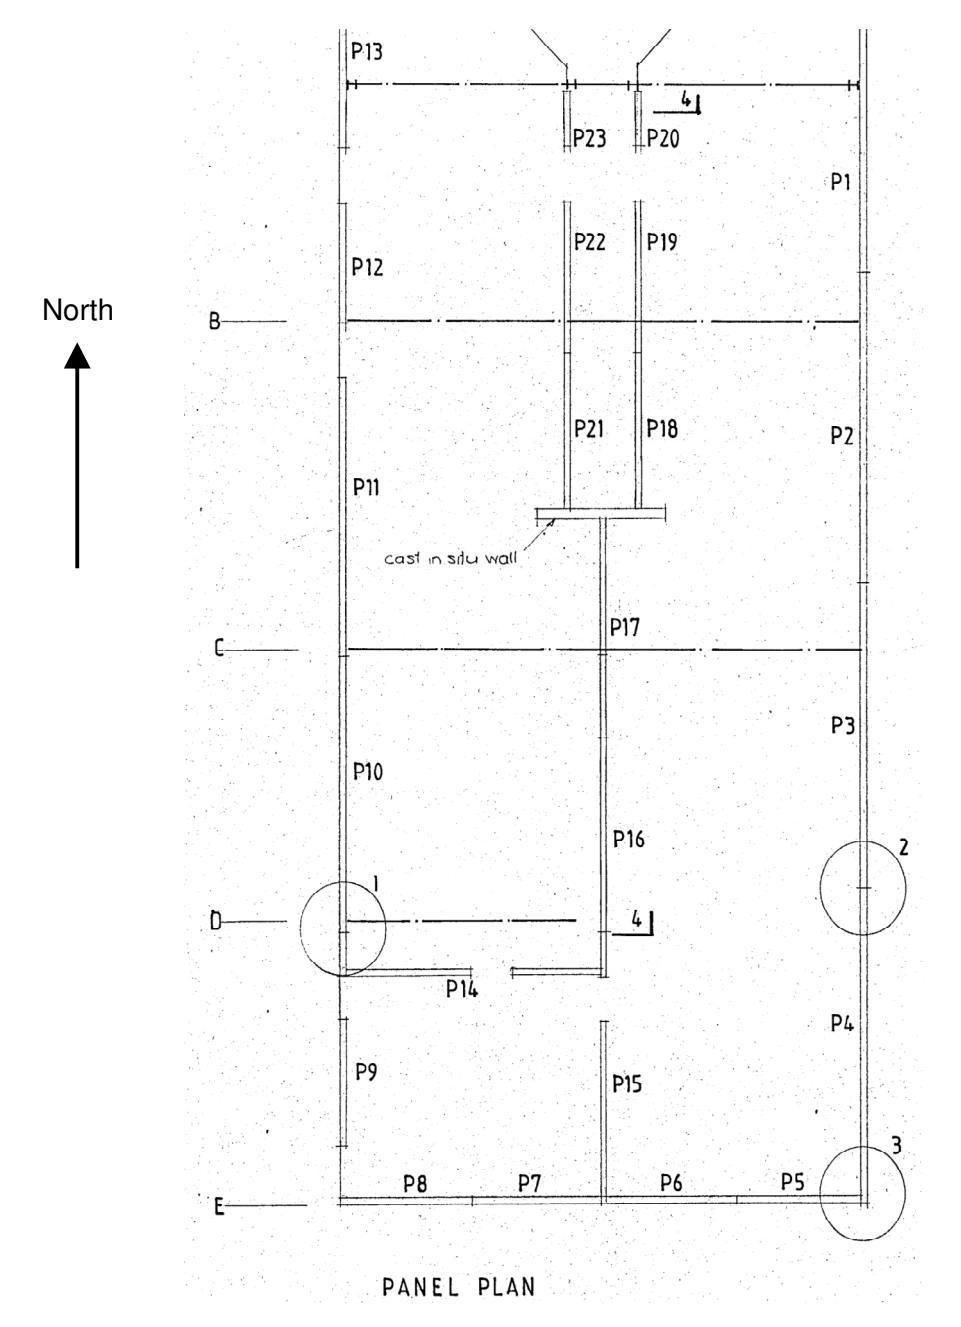
Figure 2: Panel Plan and Lateral Load System

East-west lateral loads at the first floor are resisted by the panels at the south elevation (panels 5, 6, 7 and 8), Panel 14 and the transverse insitu wall under the stairs. A steel moment frame is present along the northern end of the building below the first floor. However, it is extremely flexible relative to the pre-cast walls in the remainder of the building. As a result, it does not attract sufficient load to be considered as part of the lateral load resisting structure.

Because the remaining R&R Sport building abuts the eastern wall of Rohit's, it has not been possible to inspect this side of the building for pounding damage. It is possible that damage has occurred on the exterior of panels P1 - P4 (refer to Figure 2 for panel locations).

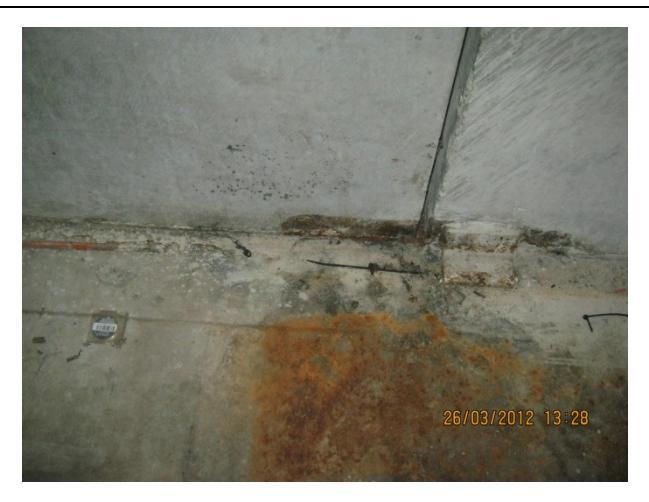
- e) Precast concrete walls are connected to the ground slab via single weld plates at each corner of the panel base. These plates are welded to embedded steel "fishtail" plates or angles fixed into the slab. In plane load capacity of the panels is limited by the shear capacity of the connections. The failure mode of these is brittle.

The seismic capacity of the building is governed by the capacity of the connection from the precast concrete walls to the foundations, with this connection having a capacity of 10-20% NBS. As highlighted in Table 2 above a number of other elements also have seismic capacities less than 34% NBS, and the building is therefore defined as being earthquake prone in accordance with the Building Act 2004.

Panel Connection to floor

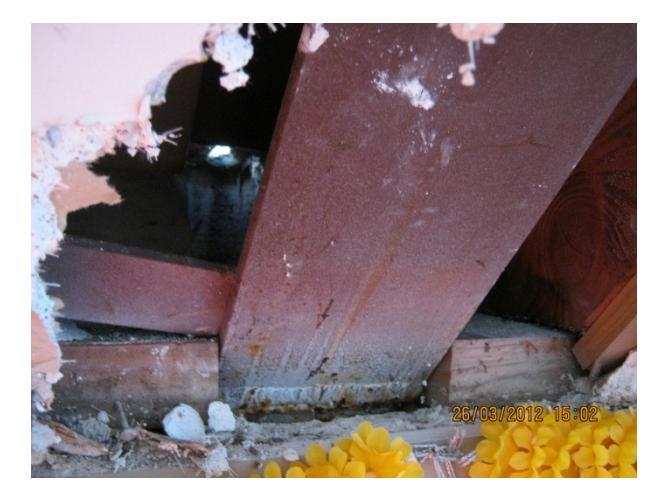
The connections of the steel roof frames to the top of the panels on the west wall pose a risk of brittle failure. These connections have a capacity of 40%NBS and damage to the panels immediately below the connections indicate that full capacity of the panel is unlikely to be able to develop before the connection fails. The potential for partial collapse of the building resulting from this type of failure is high. The relative risk to the public due to the current carpark access along this side of the building should be noted as being high.

Roof connection at top of panels

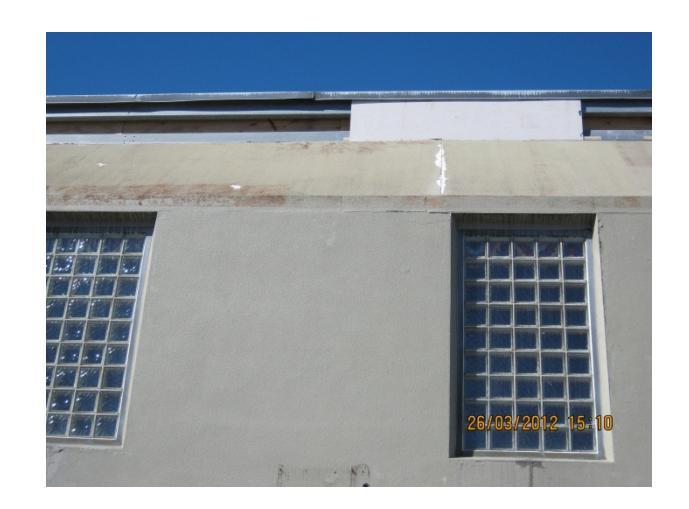
Cracking has been observed on the top of the western wall at the connections between the steel frames and panels P11 and P12. This is consistent with the lateral roof loads being transferred into the wall panels at the weld plate connections. Inspection of the eastern wall panels of the building has been limited to the interior walls due to proximity of the neighbouring building.

Damage noted at top of panel 12 (Western wall)

- Strengthen connection between existing UB beams and the top of the concrete wall.
- Provide supplemental support under UB beams.
- Strengthen foundation.
- Strengthening to address lateral forces in the east-west direction
- Repair of all current earthquake induced damage to the building.

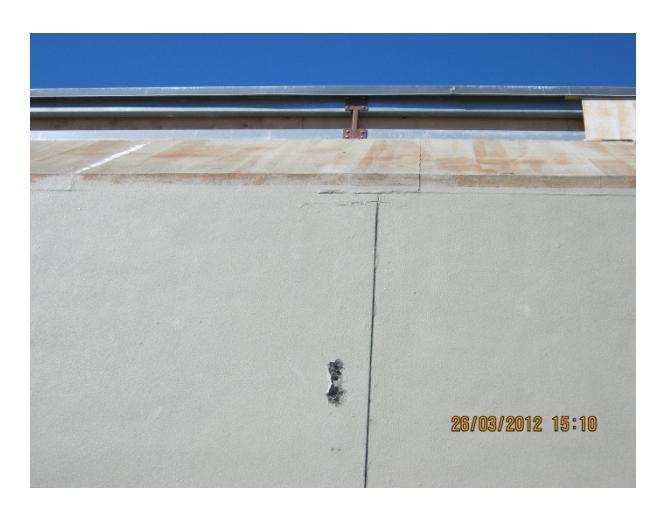
Damage noted at top of panels 11 (Eastern wall)

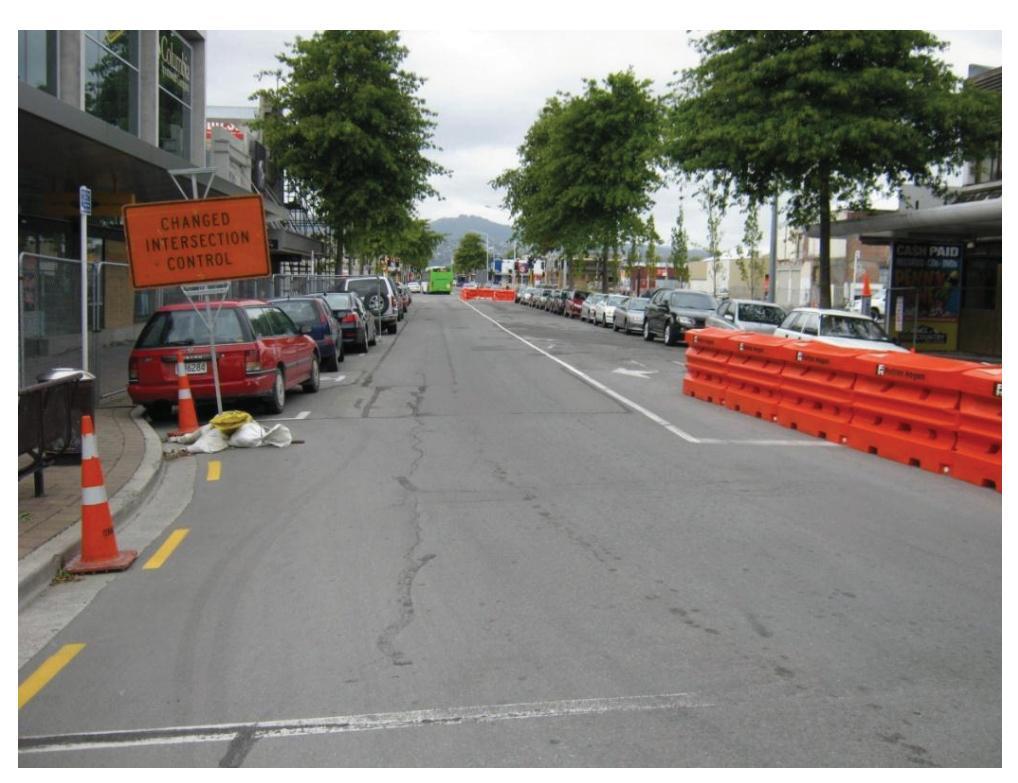
**Photograph 2 -** View south down Colombo from intersection with Lichfield; pavement cracking (24 January 2012).

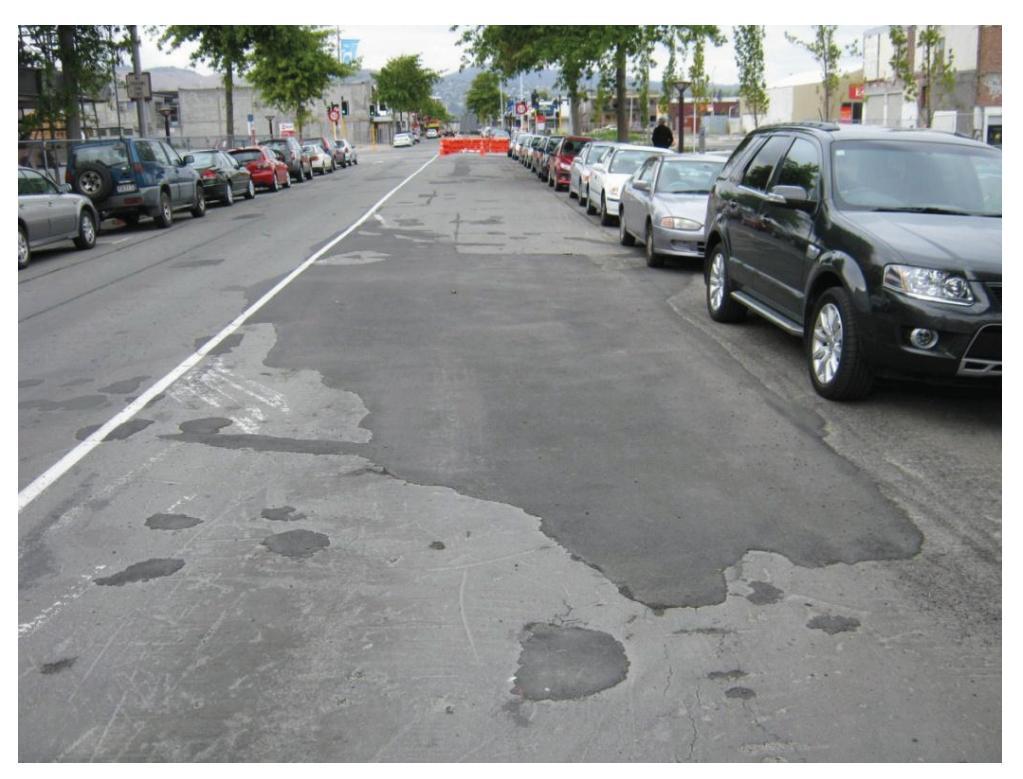
**Photograph 3 -** View south down Colombo from outside Penny Lane; pavement repair (24 January 2012).

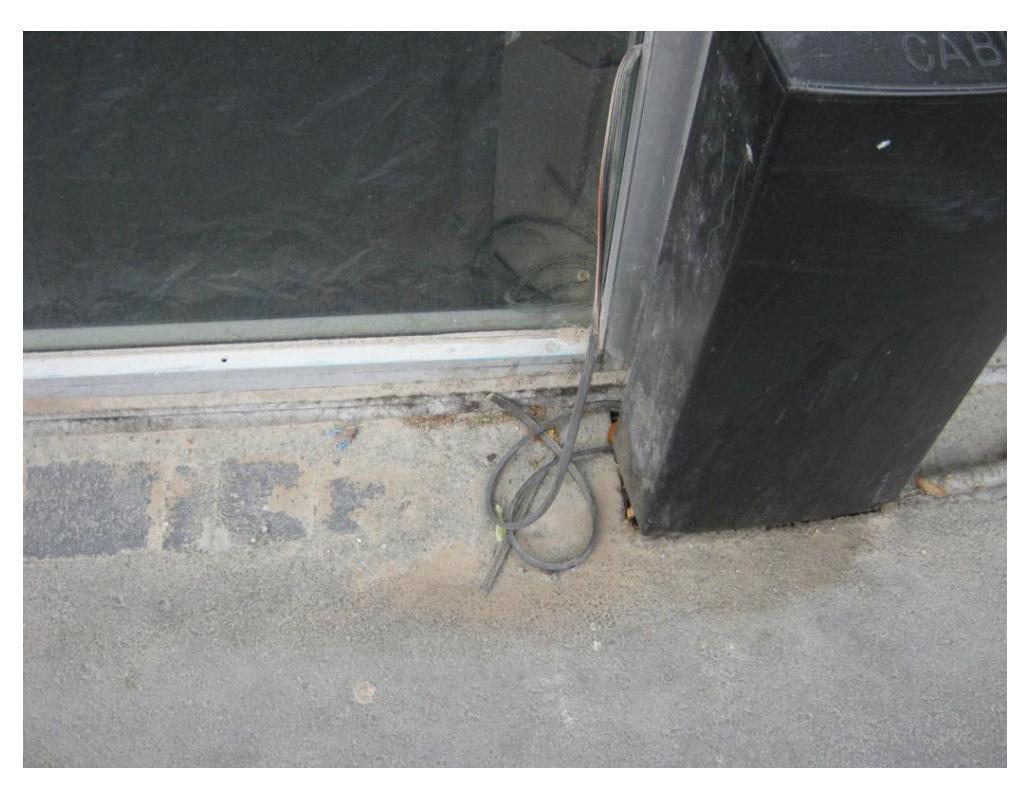
**Photograph 4** – Minor sand ejection around service duct; north side of R and R building (24 January 2012).

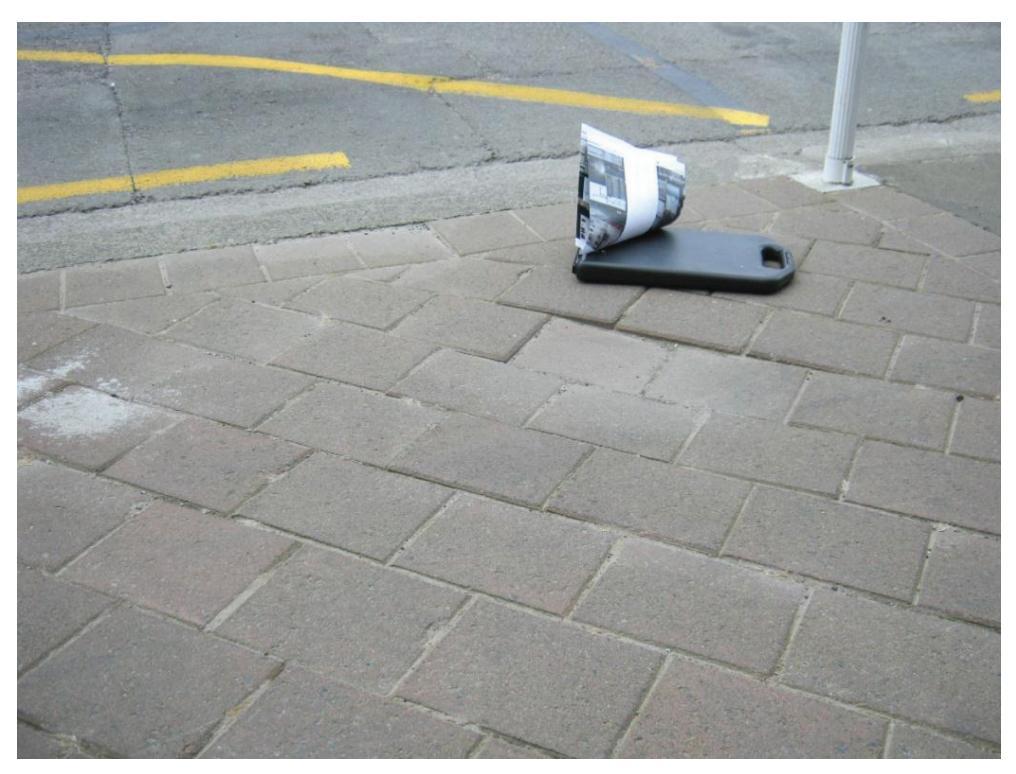
**Photograph 5** – Minor settlement in footpath flagstones on the North side of Lichfield Street across from Rohits restaurant (24 January 2012).

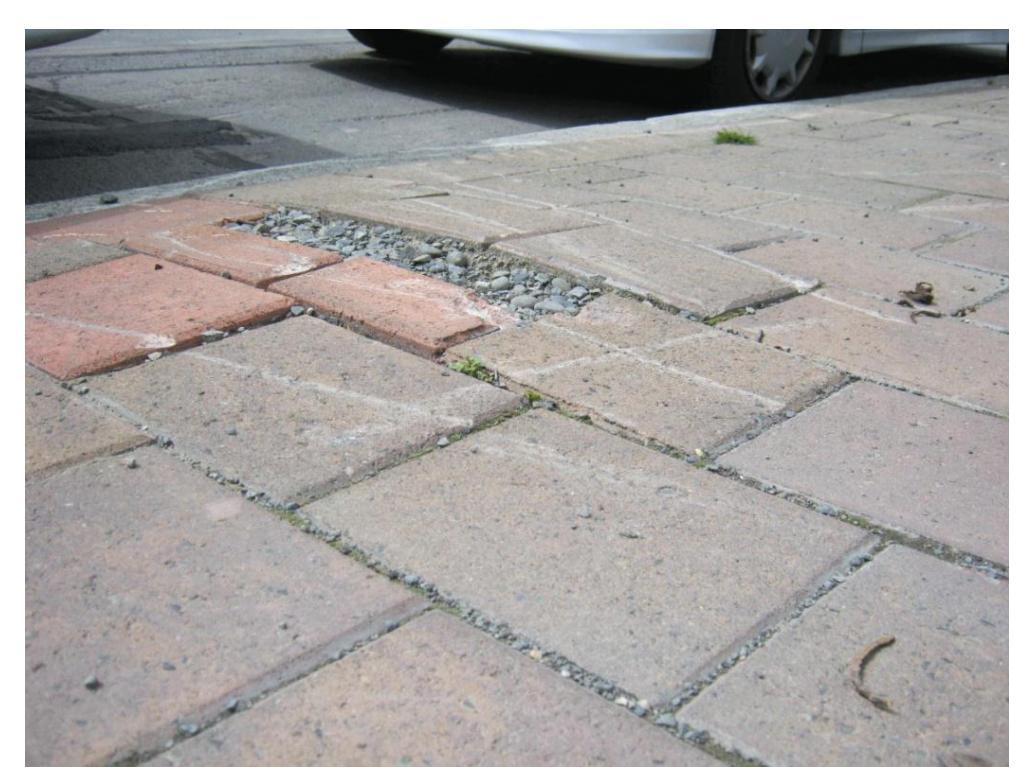
**Photograph 6** – Minor heave in footpath flagstones on the West side of Colombo Street (24 January 2012).

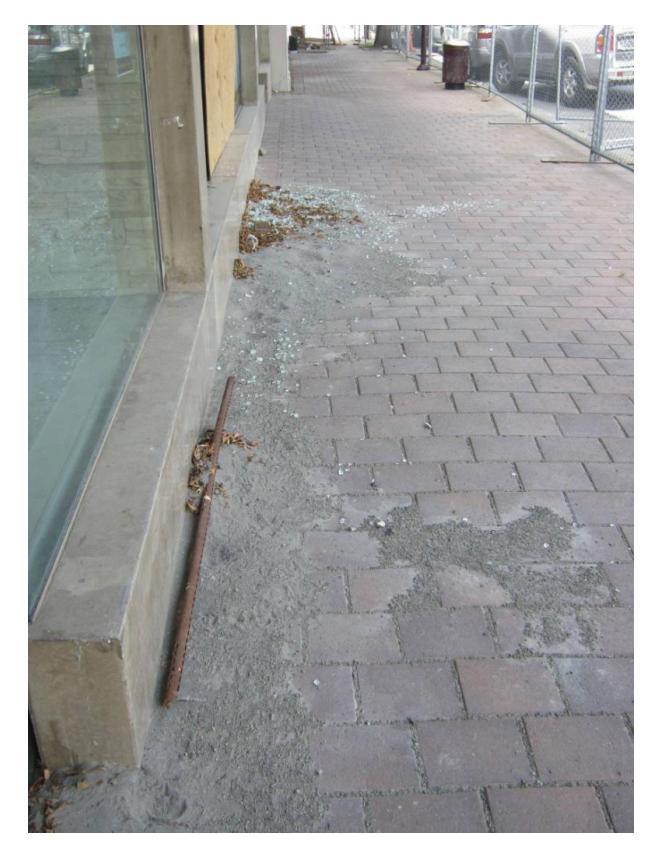
**Photograph 7** – Piling of sand ejected by minor liquefaction on the east side of Colombo Street across from R&R (24 January 2012).
