CONSERVATION PLAN

Barbadoes Street Cemetery,
Christchurch
July 2009

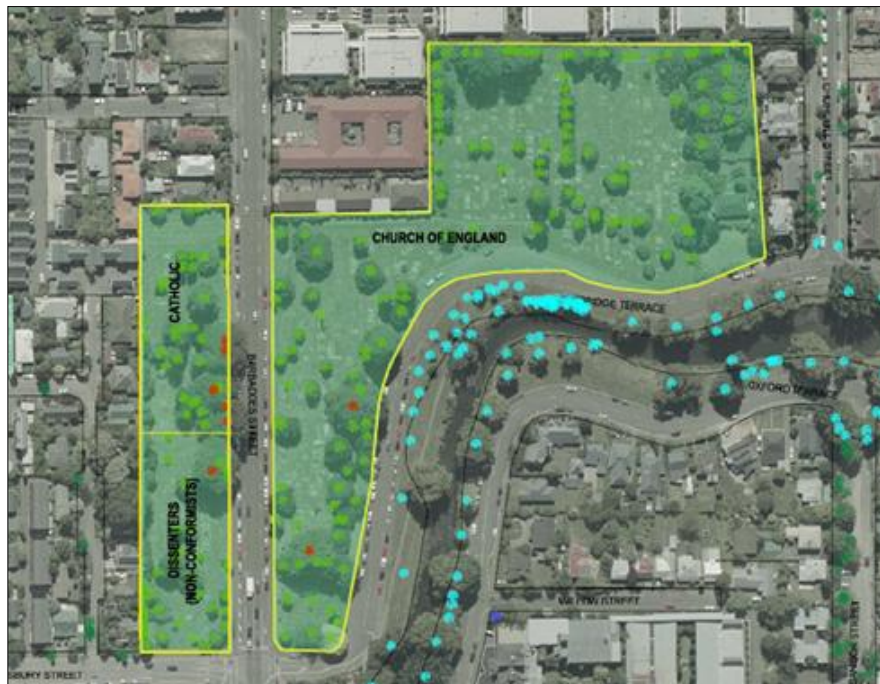
The location of the Barbadoes Street Cemetery. North is at the top of the picture. The Roman Catholic and Dissenters' cemeteries lie to the left (west) of Barbadoes Street and the Church of England cemetery lies to the right (east) of Barbadoes Street, with the Avon River defining its eastern and southern boundaries.
Source: CCC Aerial photography/Terralink International Ltd.

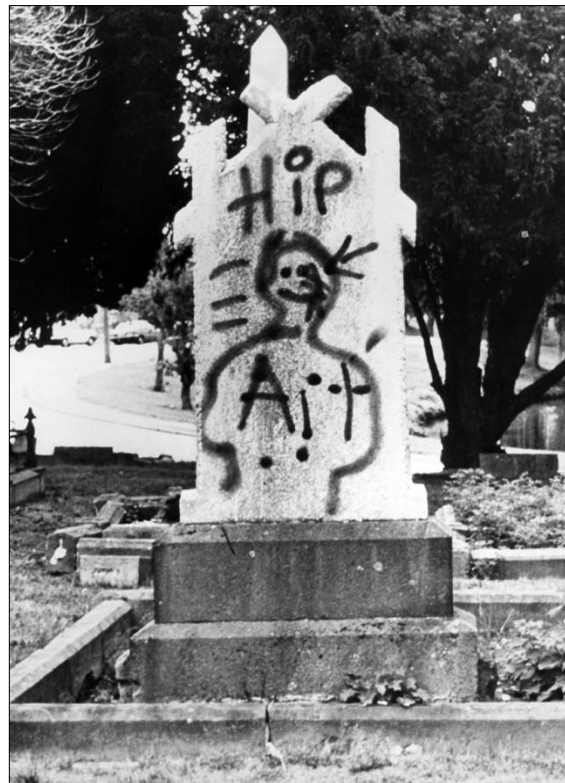
Graffiti on headstone, former Church of England cemetery, May 1989.

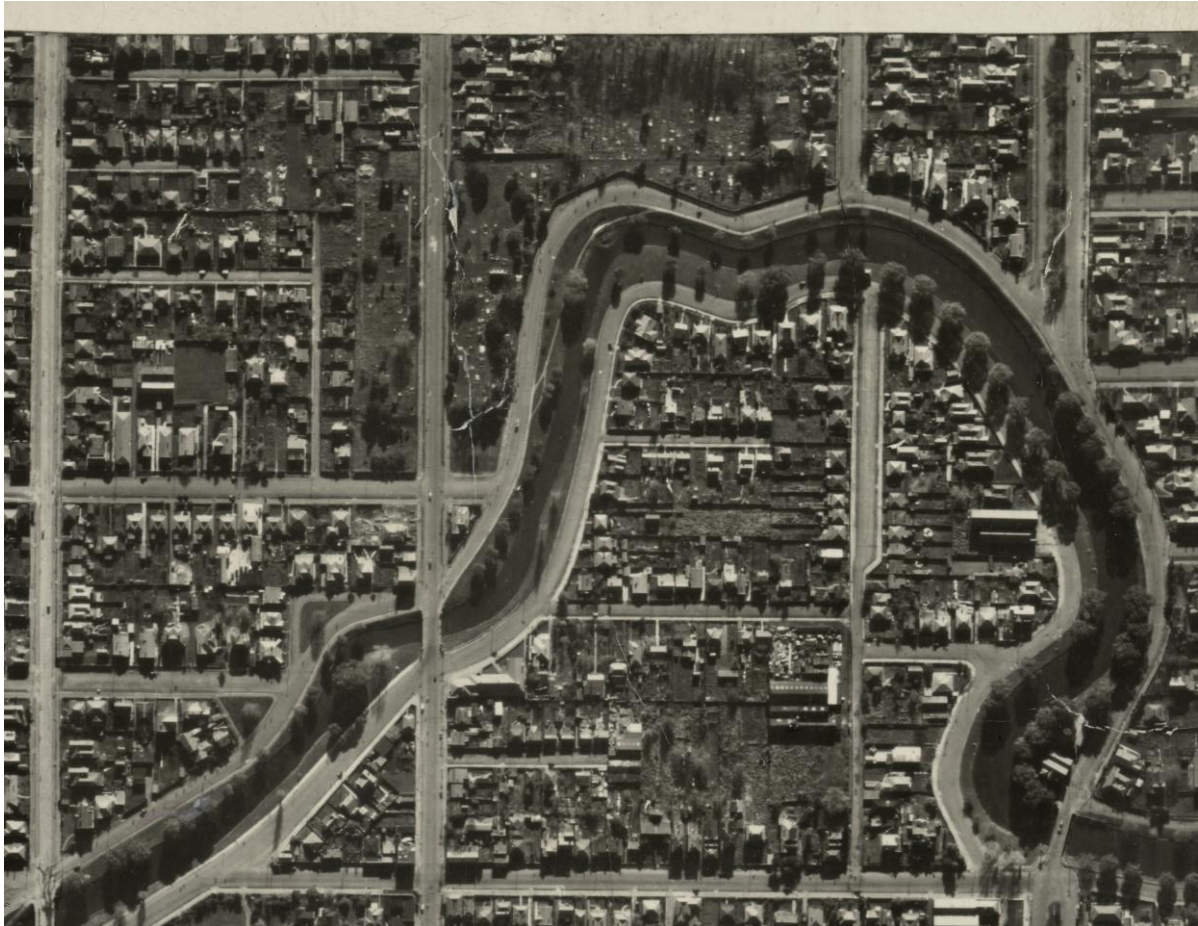
This 1946 aerial view shows the Barbadoes Street Cemetery in the upper centre of the photo, to the west and north of the prominent loop of the Avon River. The former Roman Catholic and Dissenters' cemeteries are to the left of Barbadoes Street (which runs vertically through the photo, just left of centre) and the oldest part of the former Church of England cemetery to the right of Barbadoes Street.

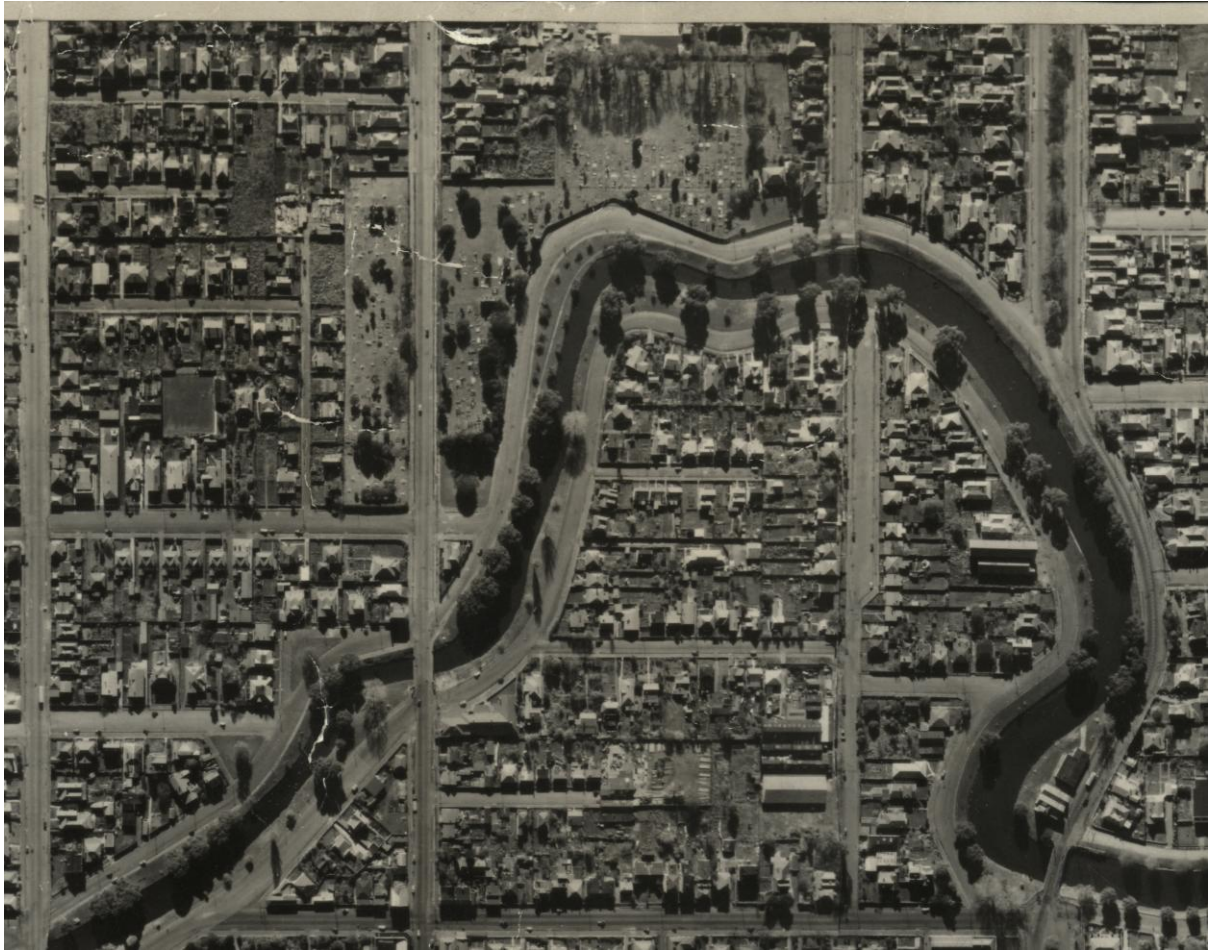
A 1955 aerial photograph of the area of Christchurch in which the Barbadoes Street Cemetery is located, similar to the 1946 photograph on the previous page. This photograph was taken just before the mortuary chapel in the older part of the former Church of England cemetery, visible in the area to the right of Barbadoes Street, was demolished. The cemetery as a whole is still less overgrown than it became later in the 20th century.

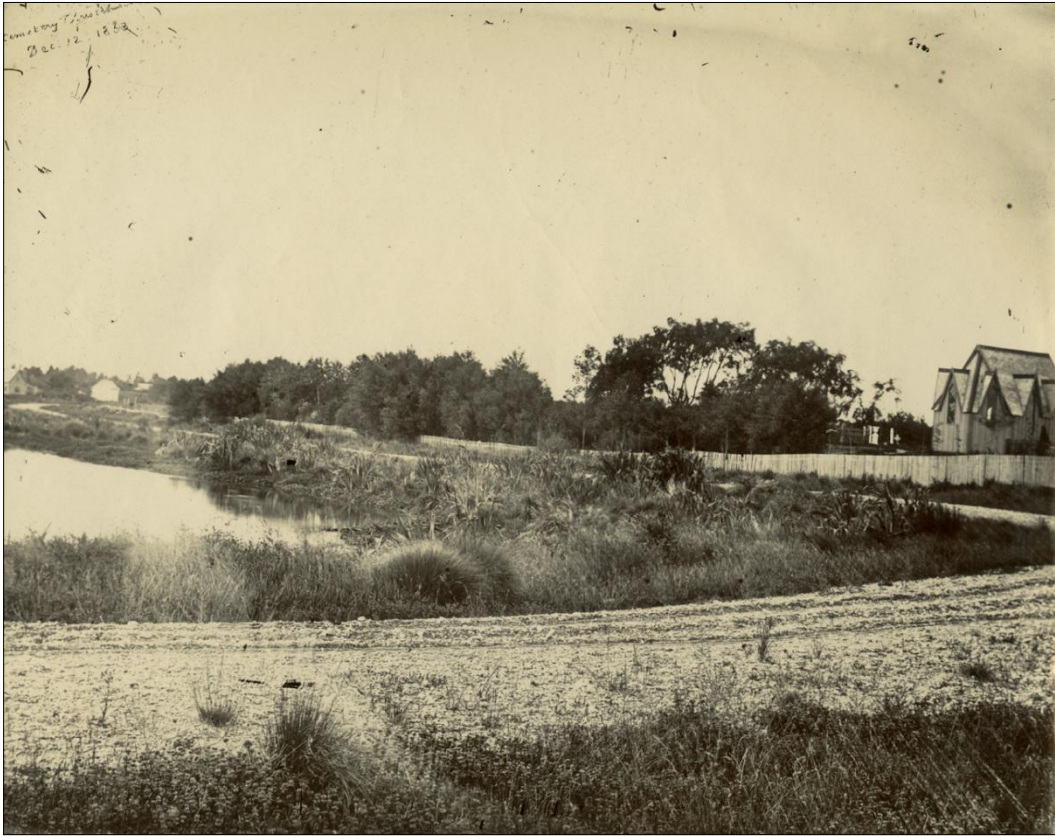
Above: Looking south-west towards the earliest part of the Church of England cemetery to be laid out from what is now Cambridge Terrace. The mortuary chapel, to the right of the photo, was built in 1863. To the left of the chapel can be seen the established ornamental plantation on the original part of the cemetery. In the detail (left) the established exotic plantation is contrasted with the native vegetation on the river margin.

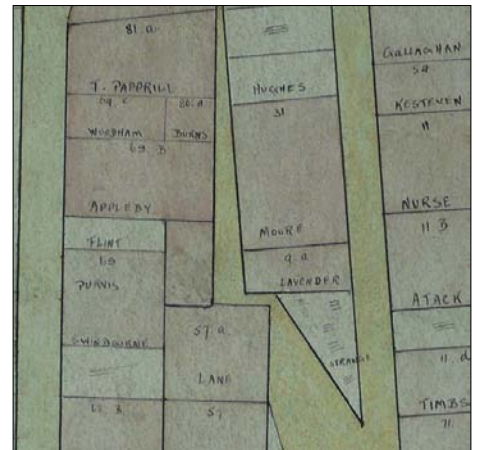
Top, left: An early working plan of the original cemetery which shows the serpentine path. Top, right: A 1906 plan of the same part of the cemetery which shows the revised layout. Above, left: A detail of the map showing the cemetery's original layout and, above, right a detail of the revised layout as it was drawn in 1906.
 Source: Cemetery Plan Collection, CADA

As in many early cemeteries, still-born babies were often buried in the small junctions between paths and in left over corners of plots. Historically unmarked on plans, many of these graves are likely to have been overwritten during this reconfiguration process.

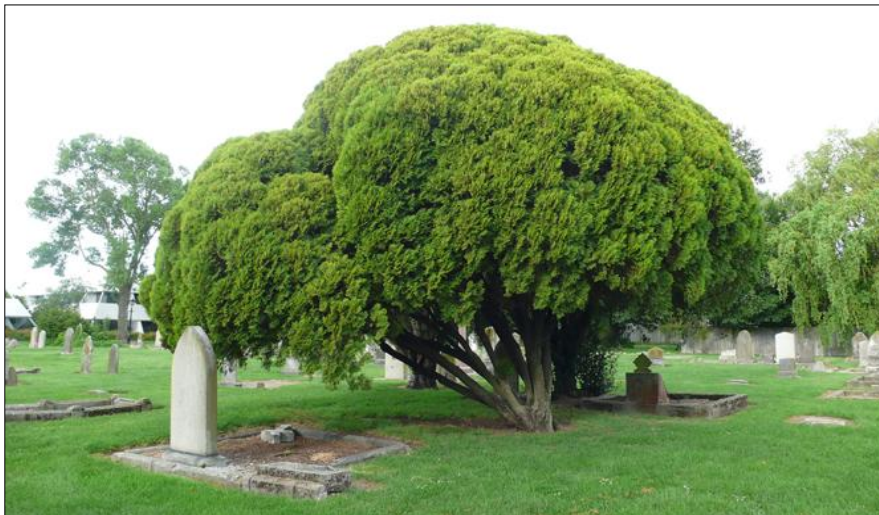
Left: *Platycladus orientalis* 'Elegantissima', syn *Thuja orientalis* (gold-tipped eastern arborvitae) which is likely to be one of the trees supplied for planting in the cemetery by William Wilson. Source: Louise Beaumont, November 2008

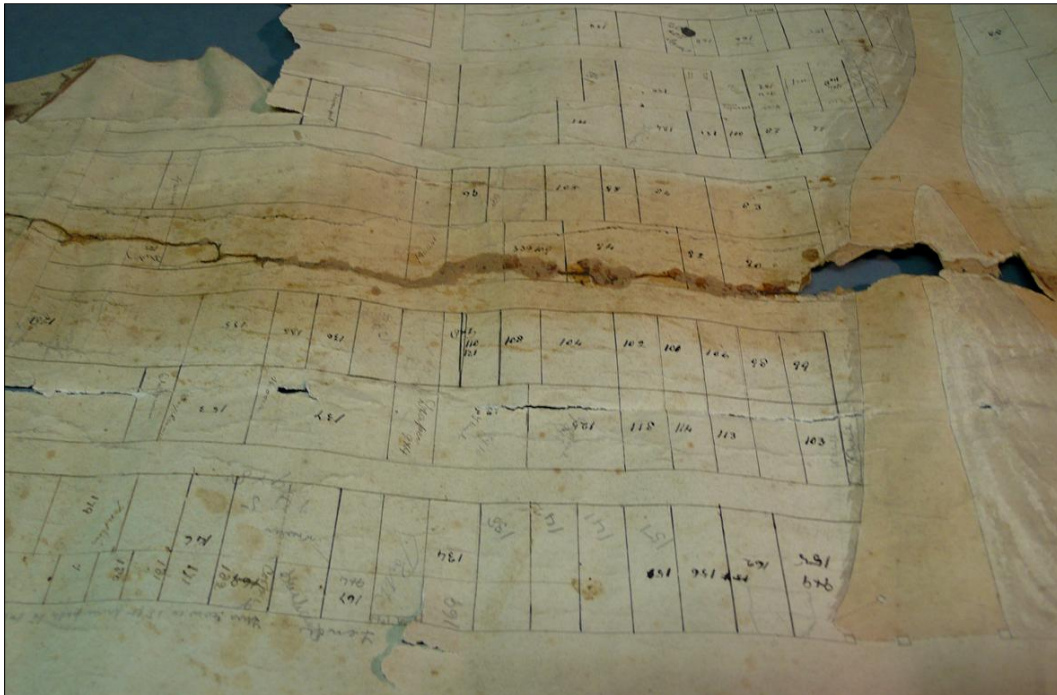
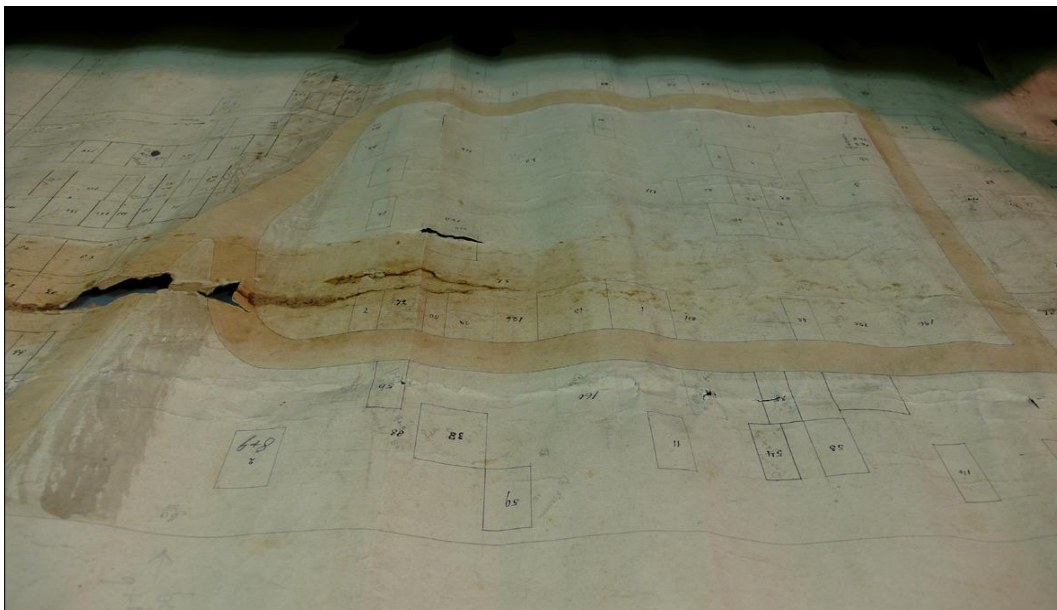
Both pictures above: In 1872, the Christchurch architect Samuel Farr prepared a plan for the layout of the Dissenters' cemetery. This is the only surviving plan which records details of the designed layout of the Dissenters' cemetery.

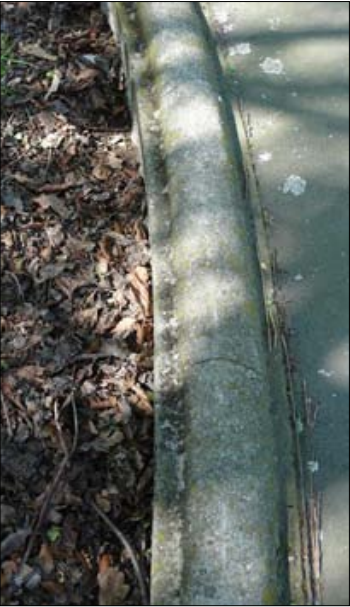
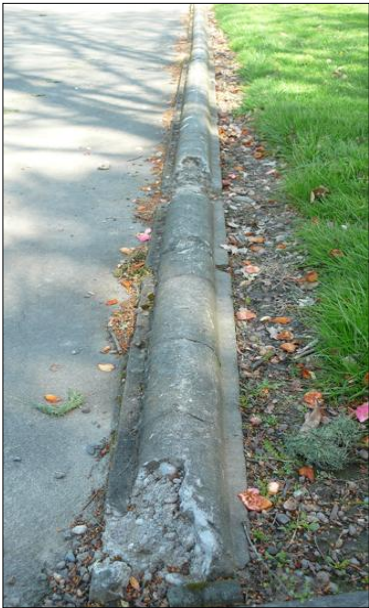
<p>Description: ca. 1880s sectional concrete curb partially encircling the reserve on the Cambridge Terrace boundary. Possibly the work of J. Sherriff, monumental mason who leased this portion of the reserve from the Church of England Property Trustees from 1870 until at least 1883.¹⁸⁵</p>		
<p>Comments: Curb is associated with the Church of England Cemetery and marks the 1880 boundary following transfer of a portion of this part of the cemetery reserve to Council for the Salisbury Street extension.</p>		
<p>Condition:</p> <p>For the most part the ornamental curb is in good condition with the exception of the end portion where a reasonable area has been damaged. Other smaller areas of damage appear to be concentrated around the sectional joints.</p>

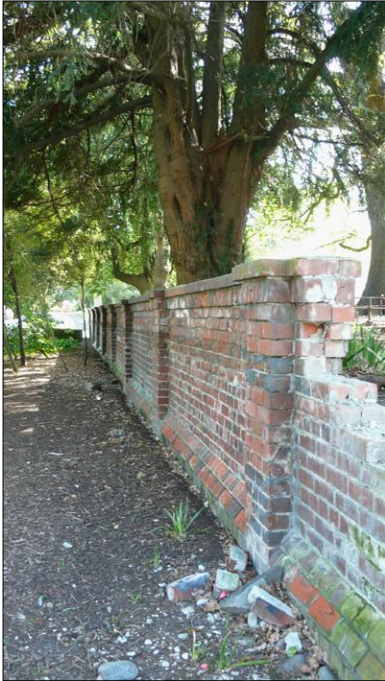
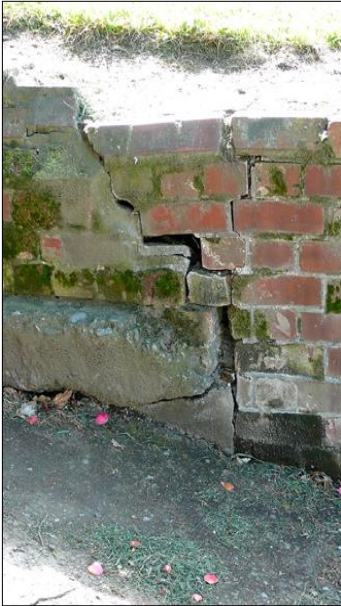
Description: ca. 1925 glazed brick retaining wall constructed using common bond or English garden wall pattern (1 course of headers to 3 rows of stretchers). Widened base detail with projecting courses and copping.		
Comments: Erected by the Council as part of the “gifting agreement” negotiated by the Anglican Church Property Trustees for the small reserve on the cemetery’s Salisbury Street/Cambridge Terrace boundary.		
Condition: The middle section of the wall appears to be in good condition. However, end piers and sections are cracked through mortar joints. Vandalism has contributed to brick loss on outer edges.

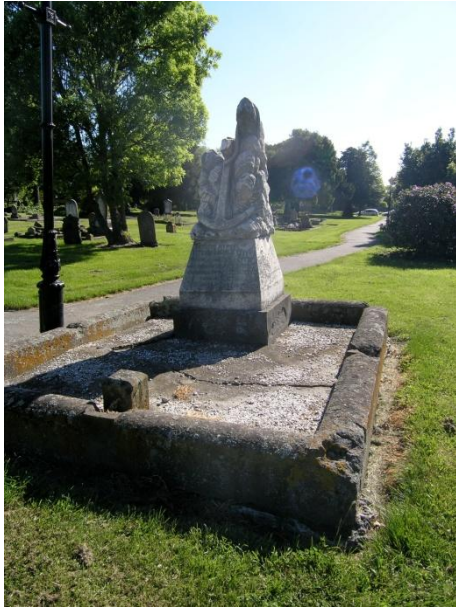
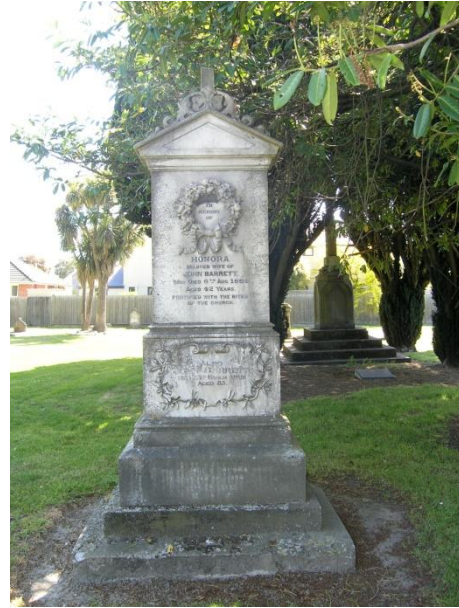
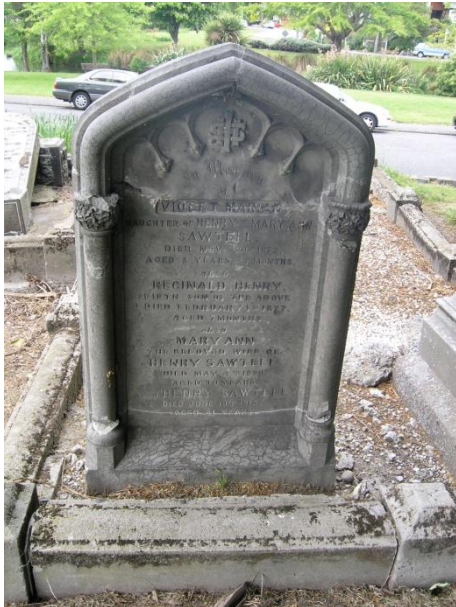
Representative examples of surviving Victorian gravestones in the Barbadoes Street Cemetery and, right: a typical footstone
 Source: Ian Bowman, various dates 2008

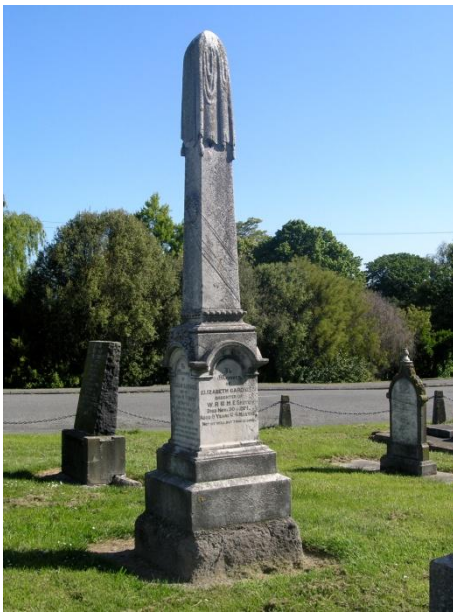
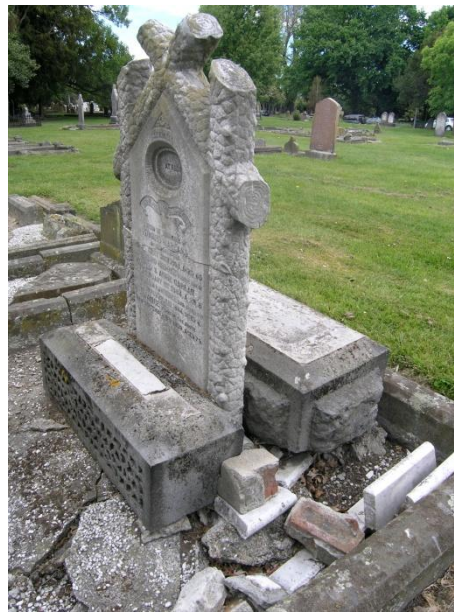
Above, left: a draped column. Above, right: an upright slab gravestone, with the stone carved to resemble branches.

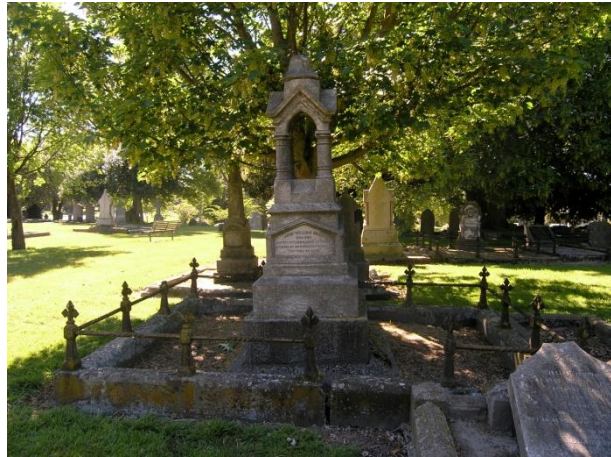
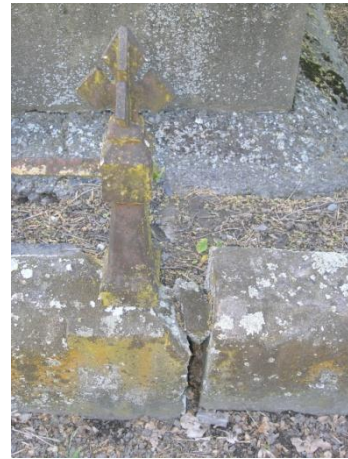
George and Matthew Oram

Black scab and skin damage to arch of cupola

Staining in centre of lettered section

Broken and missing sections of cast iron

Cast iron rusting

Slab undulating

Chipped "I" of "In Memoriam"

Remove painted graffiti - necessary/desirable

Poultice to remove to remove black scab, staining and exfoliation – necessary

Consolidate skin damage – necessary

Reinstate broken cast iron railings – desirable

Clean down and treat cast iron elements for rust, paint with appropriate coating – necessary

Consolidate base and slab – necessary

Cut out all pointing and re-point whole monument with lime mortar – necessary

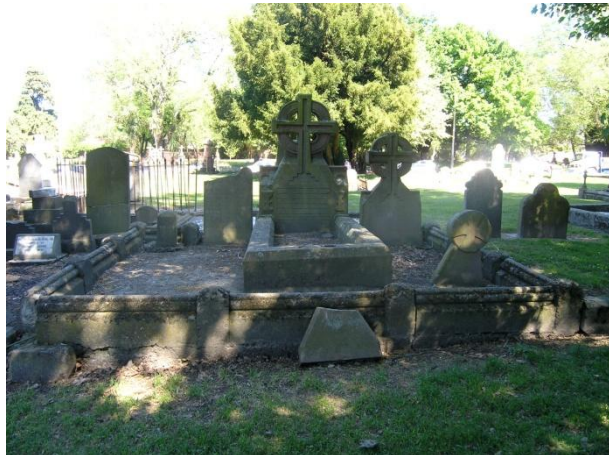
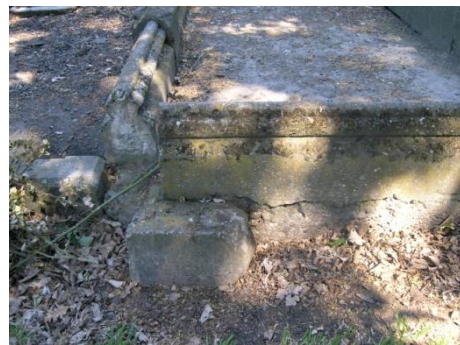
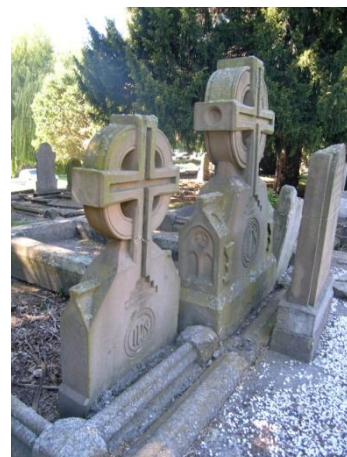
Henry Jacobs

Marble cross broken into pieces and lying beside edging

Edging loose and dislocated

Instigate maintenance regime, with cleaning of limestone every twenty years and re-pointing every hundred years, painting cast iron every 10 years; apply biocide when necessary.

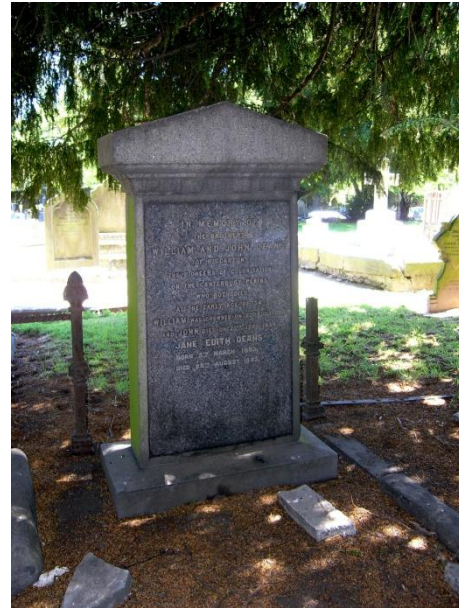
Jane Deans

Edging broken, discontinuous, missing parts

Missing broken and rusting railings

Lead lettering missing

Trachyte exfoliating

Reinstate edging – necessary

Clean down and treat cast iron elements for rust, paint with appropriate coating – necessary

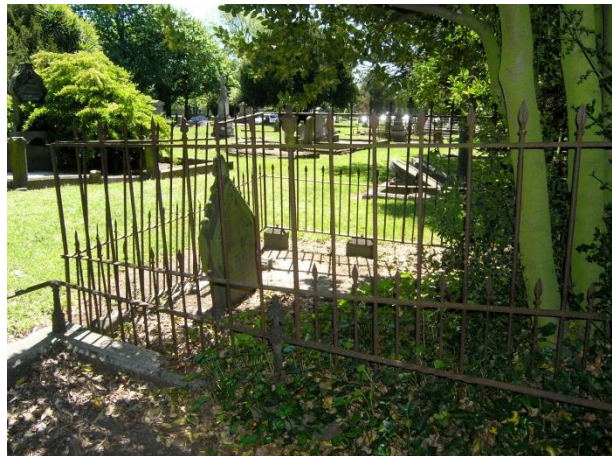
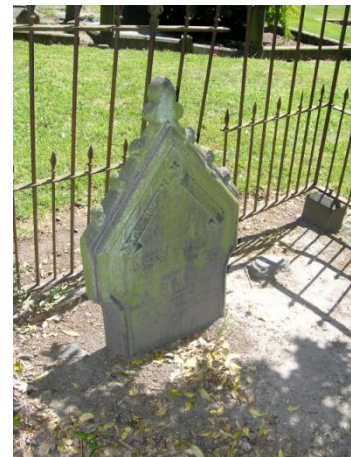
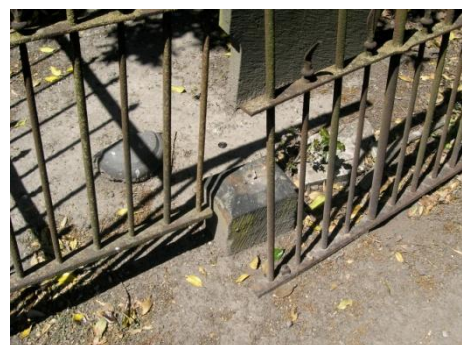
Railings rusting, missing sections, missing connections, dislocated, not level

Sandstone blocks have impact damage, splitting where bolt rusting

Repair railings and blocks, clean down and treat cast iron elements for rust, paint with appropriate coating – necessary

Instigate maintenance regime, with cleaning of basalt every twenty years and painting cast iron every 10 years; apply biocide when necessary.

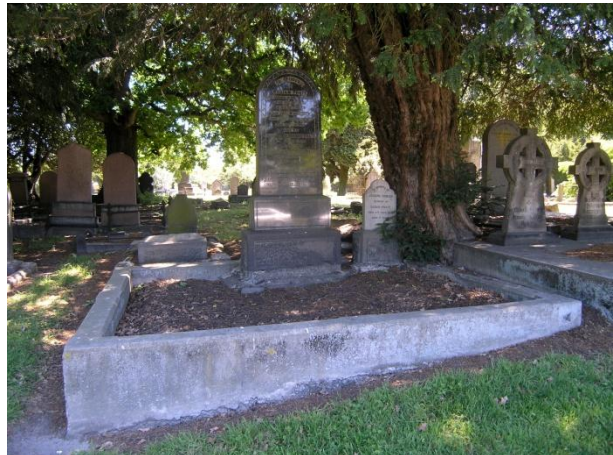
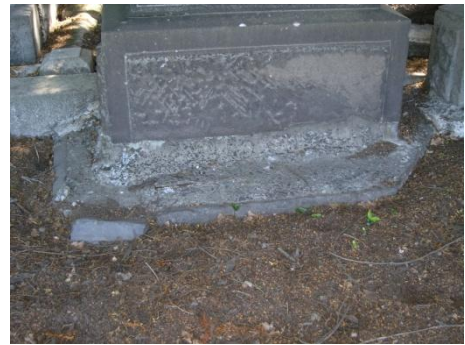
Pratt

Biological growth

Basalt base damaged/eroded exposing concrete base

Cracking at rear between edging and neighbouring memorial

Yew tree growing in corner

Remove graffiti - necessary

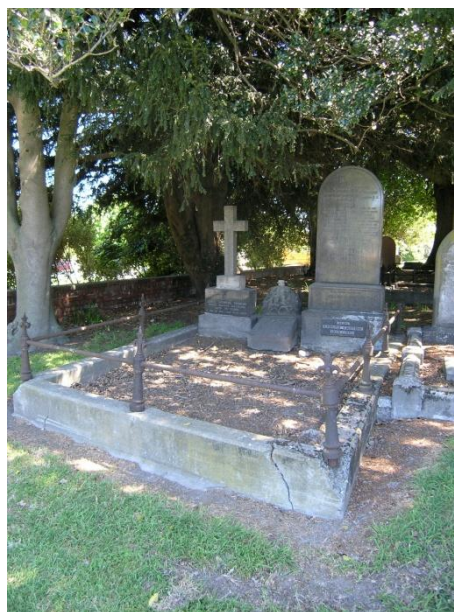
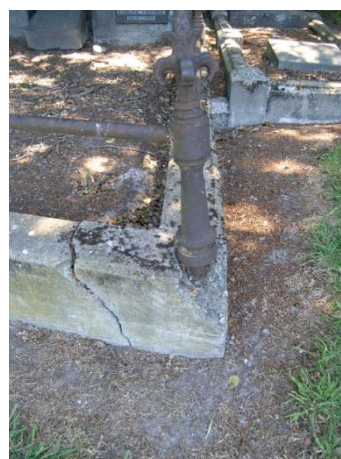
Cracking at rear between edging and neighbouring memorial

Cracked and spalled edging, especially at corners

Missing sections, rusting and cracked railings

Repair edges – necessary

Reinstate missing and repair damaged cast iron railings – desirable

Clean down and treat cast iron elements for rust, paint with appropriate coating – necessary

Instigate maintenance regime, with cleaning of granite every twenty years, painting cast iron every 10 years; apply biocide when necessary.

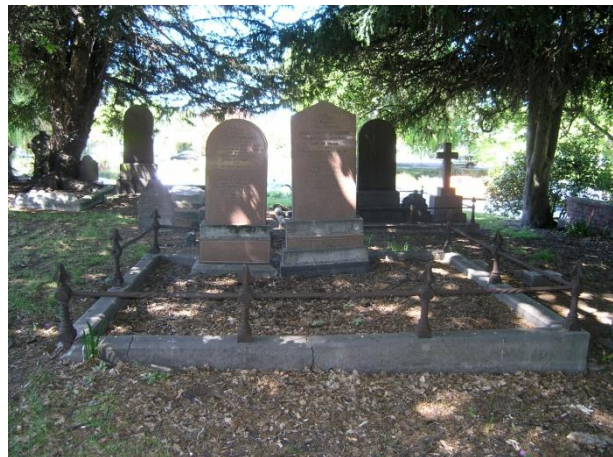
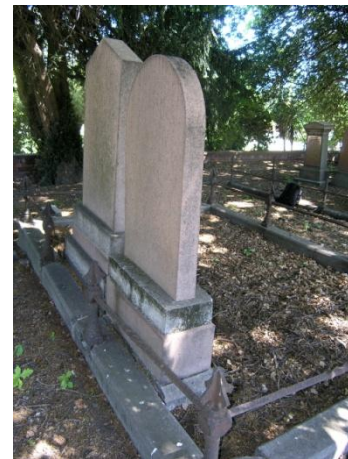
Stewart

Cracking and spalling of edging

Rusting and missing sections of railing

Reinstate missing cast iron railings – desirable

Clean down and treat cast iron elements for rust, paint with appropriate coating – necessary

Instigate maintenance regime, with cleaning of granite every twenty years, painting cast iron every 10 years; apply biocide when necessary.

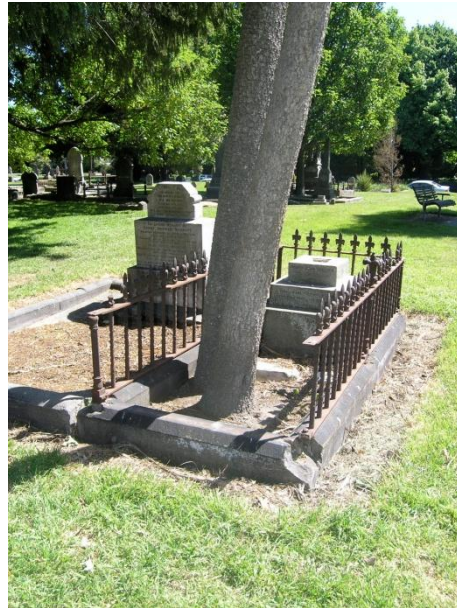
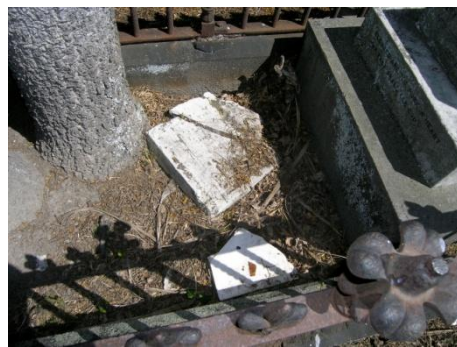
Henry John Tancred

Missing top section (possibly sections on slabs)

Cracking, dislocated and spalling edging

Rusting and missing sections of railing

Reinstate missing top section – desirable

Reinstate damaged and missing cast iron railings – desirable

Clean down and treat cast iron elements for rust, paint with appropriate coating – necessary

Repair damage to base - necessary

Instigate maintenance regime, with cleaning of limestone every twenty years, painting cast iron every 10 years; apply biocide when necessary.

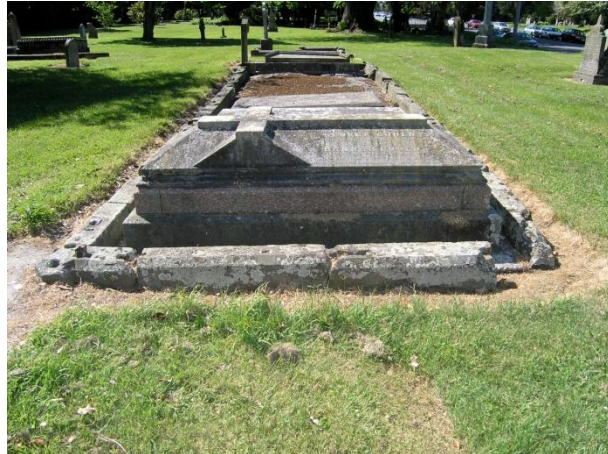
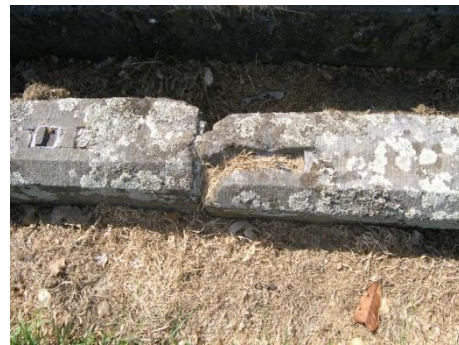
George Gould

Biological growth

Cracking, dislocated and spalling edging

Missing railing

Lettering standing proud

Reinstate edging – necessary

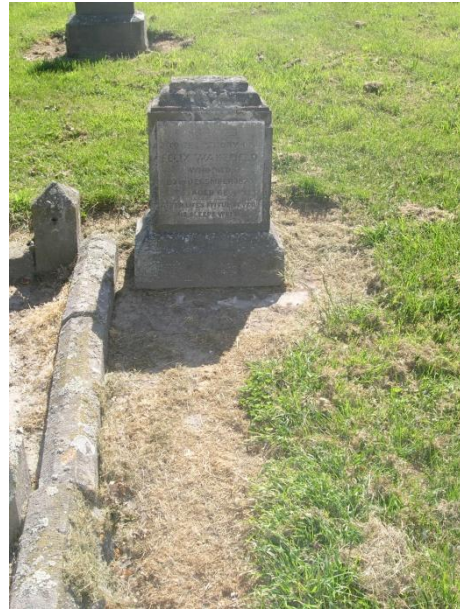
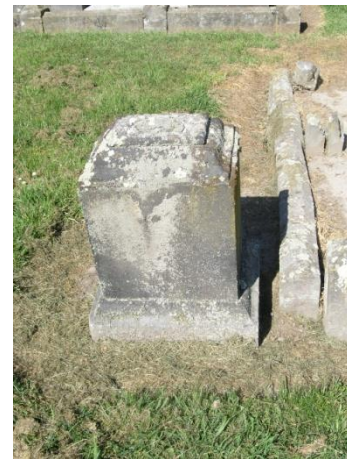
Missing top section

Dislocated base

Chipped corners

Reinstate top section if design can be determined - desirable

Instigate maintenance regime, with cleaning of limestone every twenty years and re-pointing every hundred years; apply biocide when necessary.

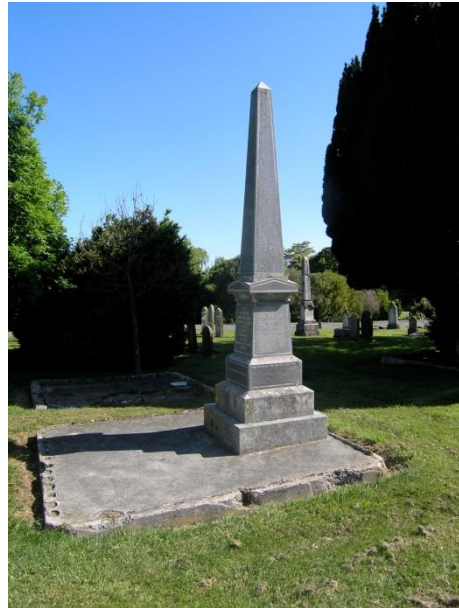
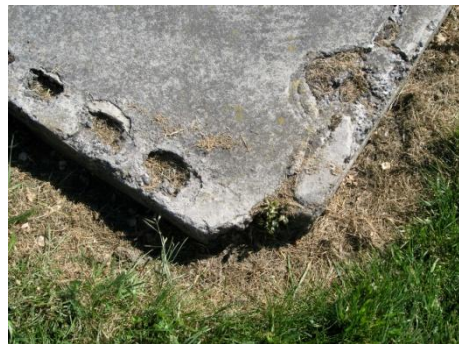
John Williams

Missing railings

Cracking, missing section of slab

Repair slab - necessary

Instigate maintenance regime, with cleaning of granite every twenty years and re-pointing every hundred years; apply biocide when necessary.

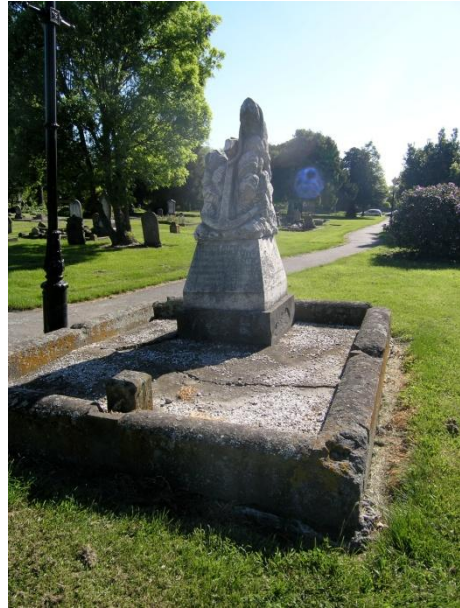
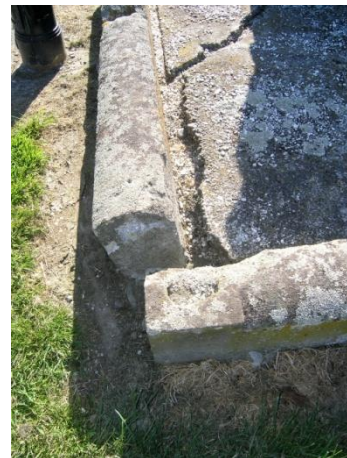
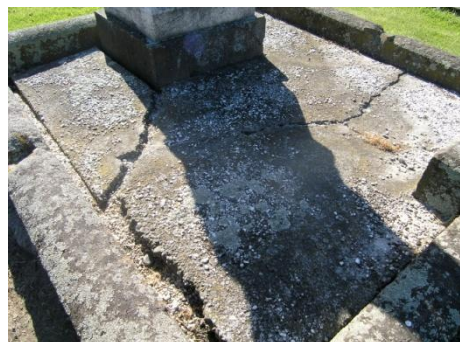
Francis George Garrard

Biological growth
Leaning
Skin damage to trachyte
Cracked concrete slab
Cracked, dislodged, undermined edging
Holes where railings were

Monitor leaning – necessary
Poultice to remove salts from trachyte and to consolidate skin damage – necessary
Apply biocide to remove biological growth - necessary
Reinstate cast iron railings following research to determine design – desirable
Repair slab - necessary
Reinstate damaged edging– necessary
Cut out all pointing and re-point whole monument with lime mortar – necessary

Instigate maintenance regime, with cleaning of limestone every twenty years and re-pointing every hundred years; apply biocide when necessary.

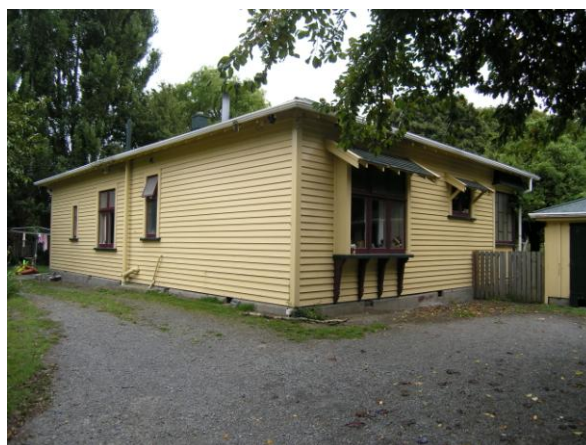
The cottage is designed in the early Californian bungalow style with a shallow pitched roof, exposed rafter ends, shingles in a splayed hood over the verandah, double casement windows with toplights, an upright panelled front door with toplight and sidelights, and Art Nouveau detailing. The house has typical shiplap weatherboards and is built on a concrete foundation wall with cast iron vents. The early version of the style, seen in the cottage, has a hipped rather than the gabled roofs, and late Edwardian Arts and Crafts detailing, such as the shallow arches to the verandah, corner coverboards and the projecting bay windows with ornate brackets.

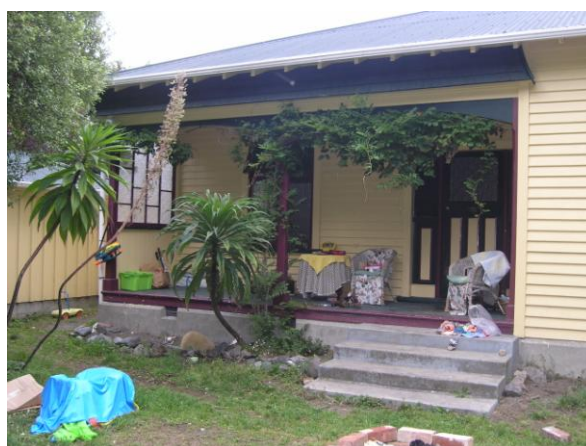
The sexton's house

The exterior of the cottage is largely authentic from the time of construction, likely to be early 1920s. This includes the original glazing with obscure glass at the verandah end and coloured glass in the sidelights of the front door.

The house is in generally good condition for a building of its age.

Routine maintenance is required to maintain the house in good condition. Any repairs or replacement of material should maintain the authentic period character of the house and be undertaken in accord with the ICOMOS New Zealand Charter (see Appendix 5).

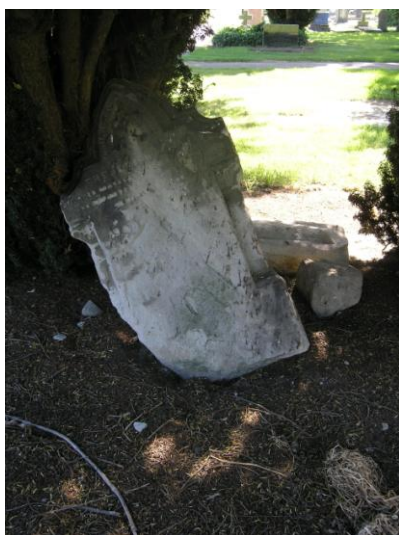
Issue – If the surface of a stone is lying against the earth this can accelerate deterioration of the stone. The pieces of a broken stone could become separated and eventually become disassociated from the grave.

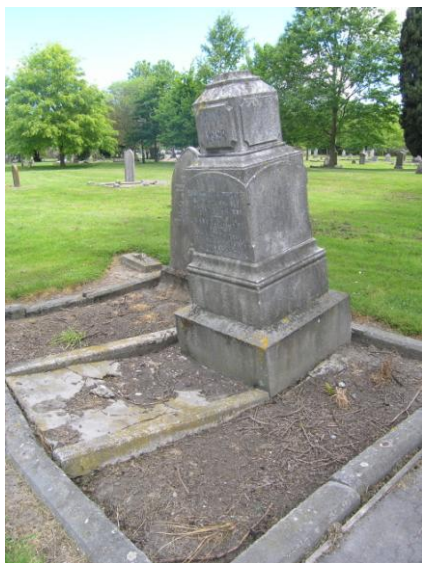
Issue – an unstable monument is likely to topple and break and is easier for vandals to push over. A toppling monument can damage other graves.

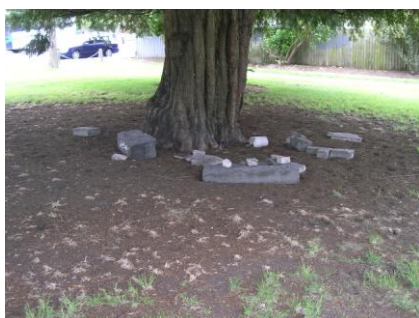
Issue – In many cases the shattering of a stone into many pieces is due to vandalism. There is a risk that the broken pieces could be removed and become disassociated from the grave.

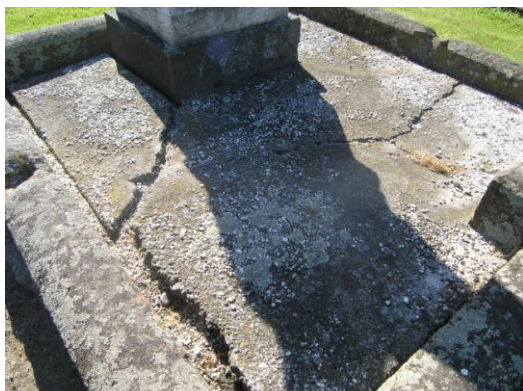
Issue – The cracking or breaking up of a concrete slab means the slab itself can become unstable, simultaneously making the headstones/monuments on the grave also unstable. Even where a cracked or broken slab is not itself unstable or contributing to the instability of a monument, it can appear unsightly.

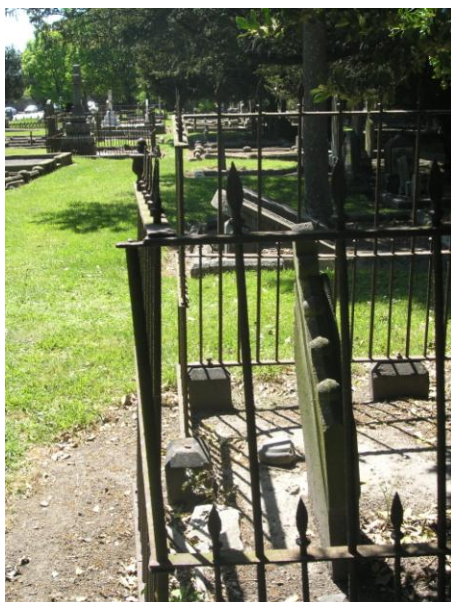
Issue – Broken or corroding railings look untidy. There is a risk that with corrosion, parts of the railings could become disassociated from the grave.

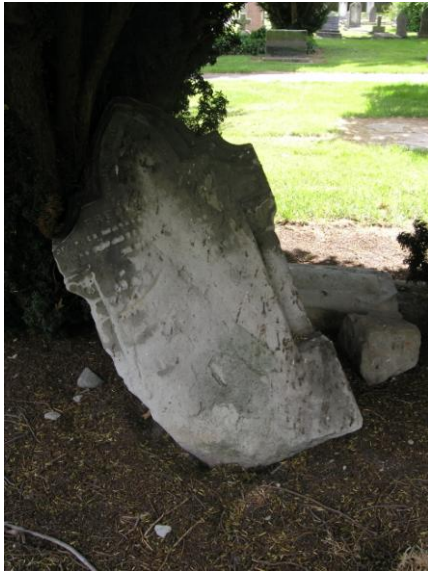
Issue – Parts of the original stone flaking or falling away, causing loss of historic inscriptions. Delamination occurs when a hard outer crust forms on the surface of the stone, which then comes away and eventually falls off.

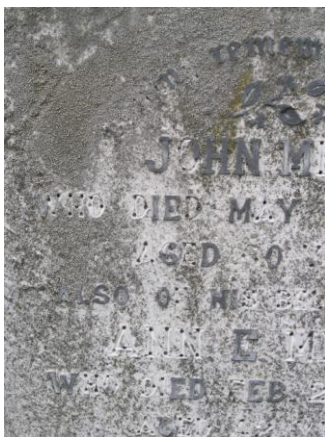
Issue – When lead letters become detached from the stones to which they are fixed, heritage fabric is broken or lost and inscriptions become hard or impossible to read.

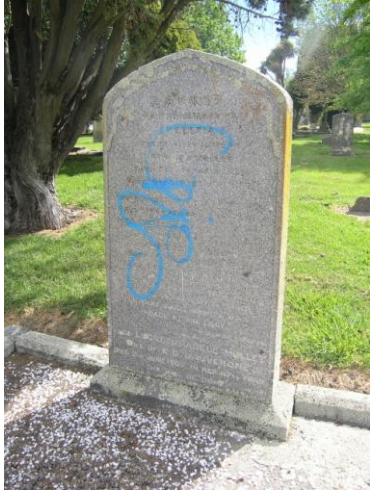
Issue – Potential damage to the surfaces of the monuments from the paint itself and from failed attempts to remove the graffiti using inappropriate techniques. The scratching of some graffiti causes permanent damage to monuments.

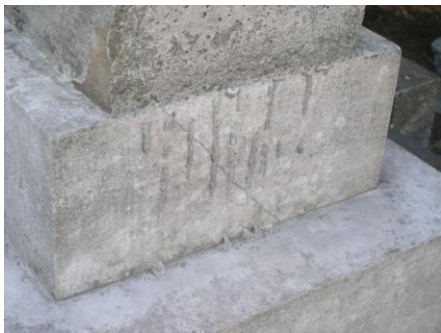
Issue – Potential damage and/or staining from the use of inappropriate methods and fixing agents. Attempts to repeat the repair using the same failed method usually result in further damage.

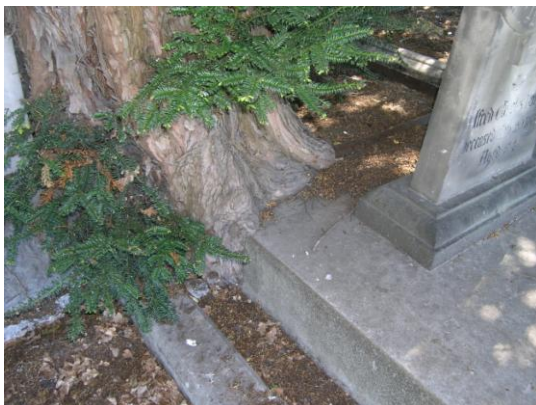
Issue – Invasive roots can damage graves. Often shade from the same trees whose roots are damaging graves encourages the growth of moss.

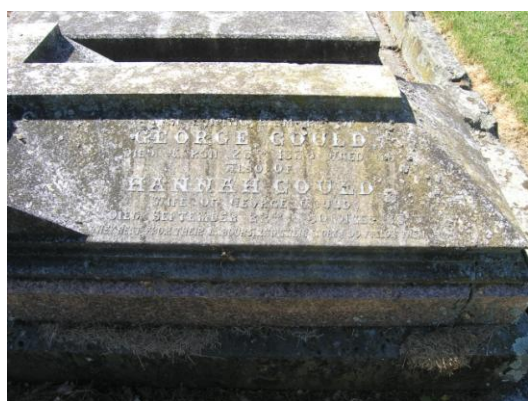
Issue – The growth of lichens or mosses can eat into stone, and obscure or obliterate inscriptions.

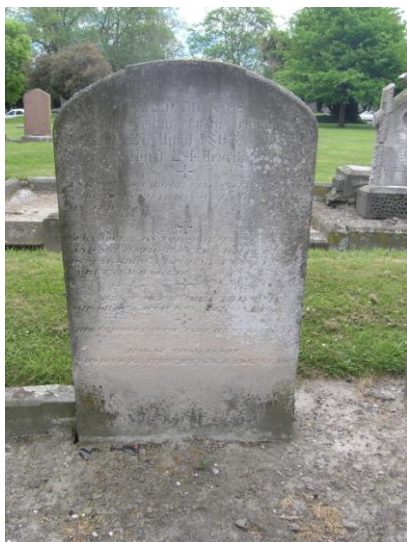
Issue – Accumulations of dirt on headstones can obscure historical inscriptions and cause damage to the surface of the stone.
