RESOURCE CONSENT RMA/2022/3611 – RFI RESPONSE LAND USE AND SUBDIVISION APPLICATION 320 AND 320A CUMNOR TERRACE, CHRISTCHURCH

APPENDIX 1 - LANDSCAPE RFI PORTLINK INDUSTRIAL SUBDIVISION

BRAEBURN PROPERTIES

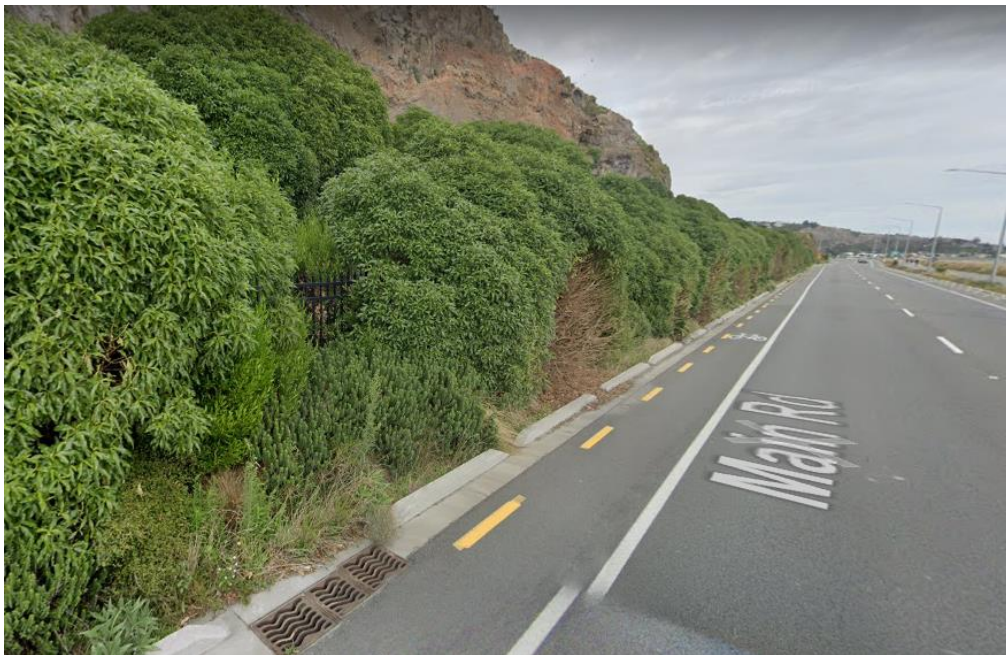
Image: Peacocks Gallop, Main Road, Sumner

Previous experience has proven the 5m vegetation buffer is adequate to achieve screening. As seen along Peacocks Gallop, Main Road, Sumner, a similar vegetation buffer of approximately 3m depth exists (see the image below). This vegetation is approximately 4-5 years old and planted with similar species, such as Ngiao, demonstrating a successful level of screening.

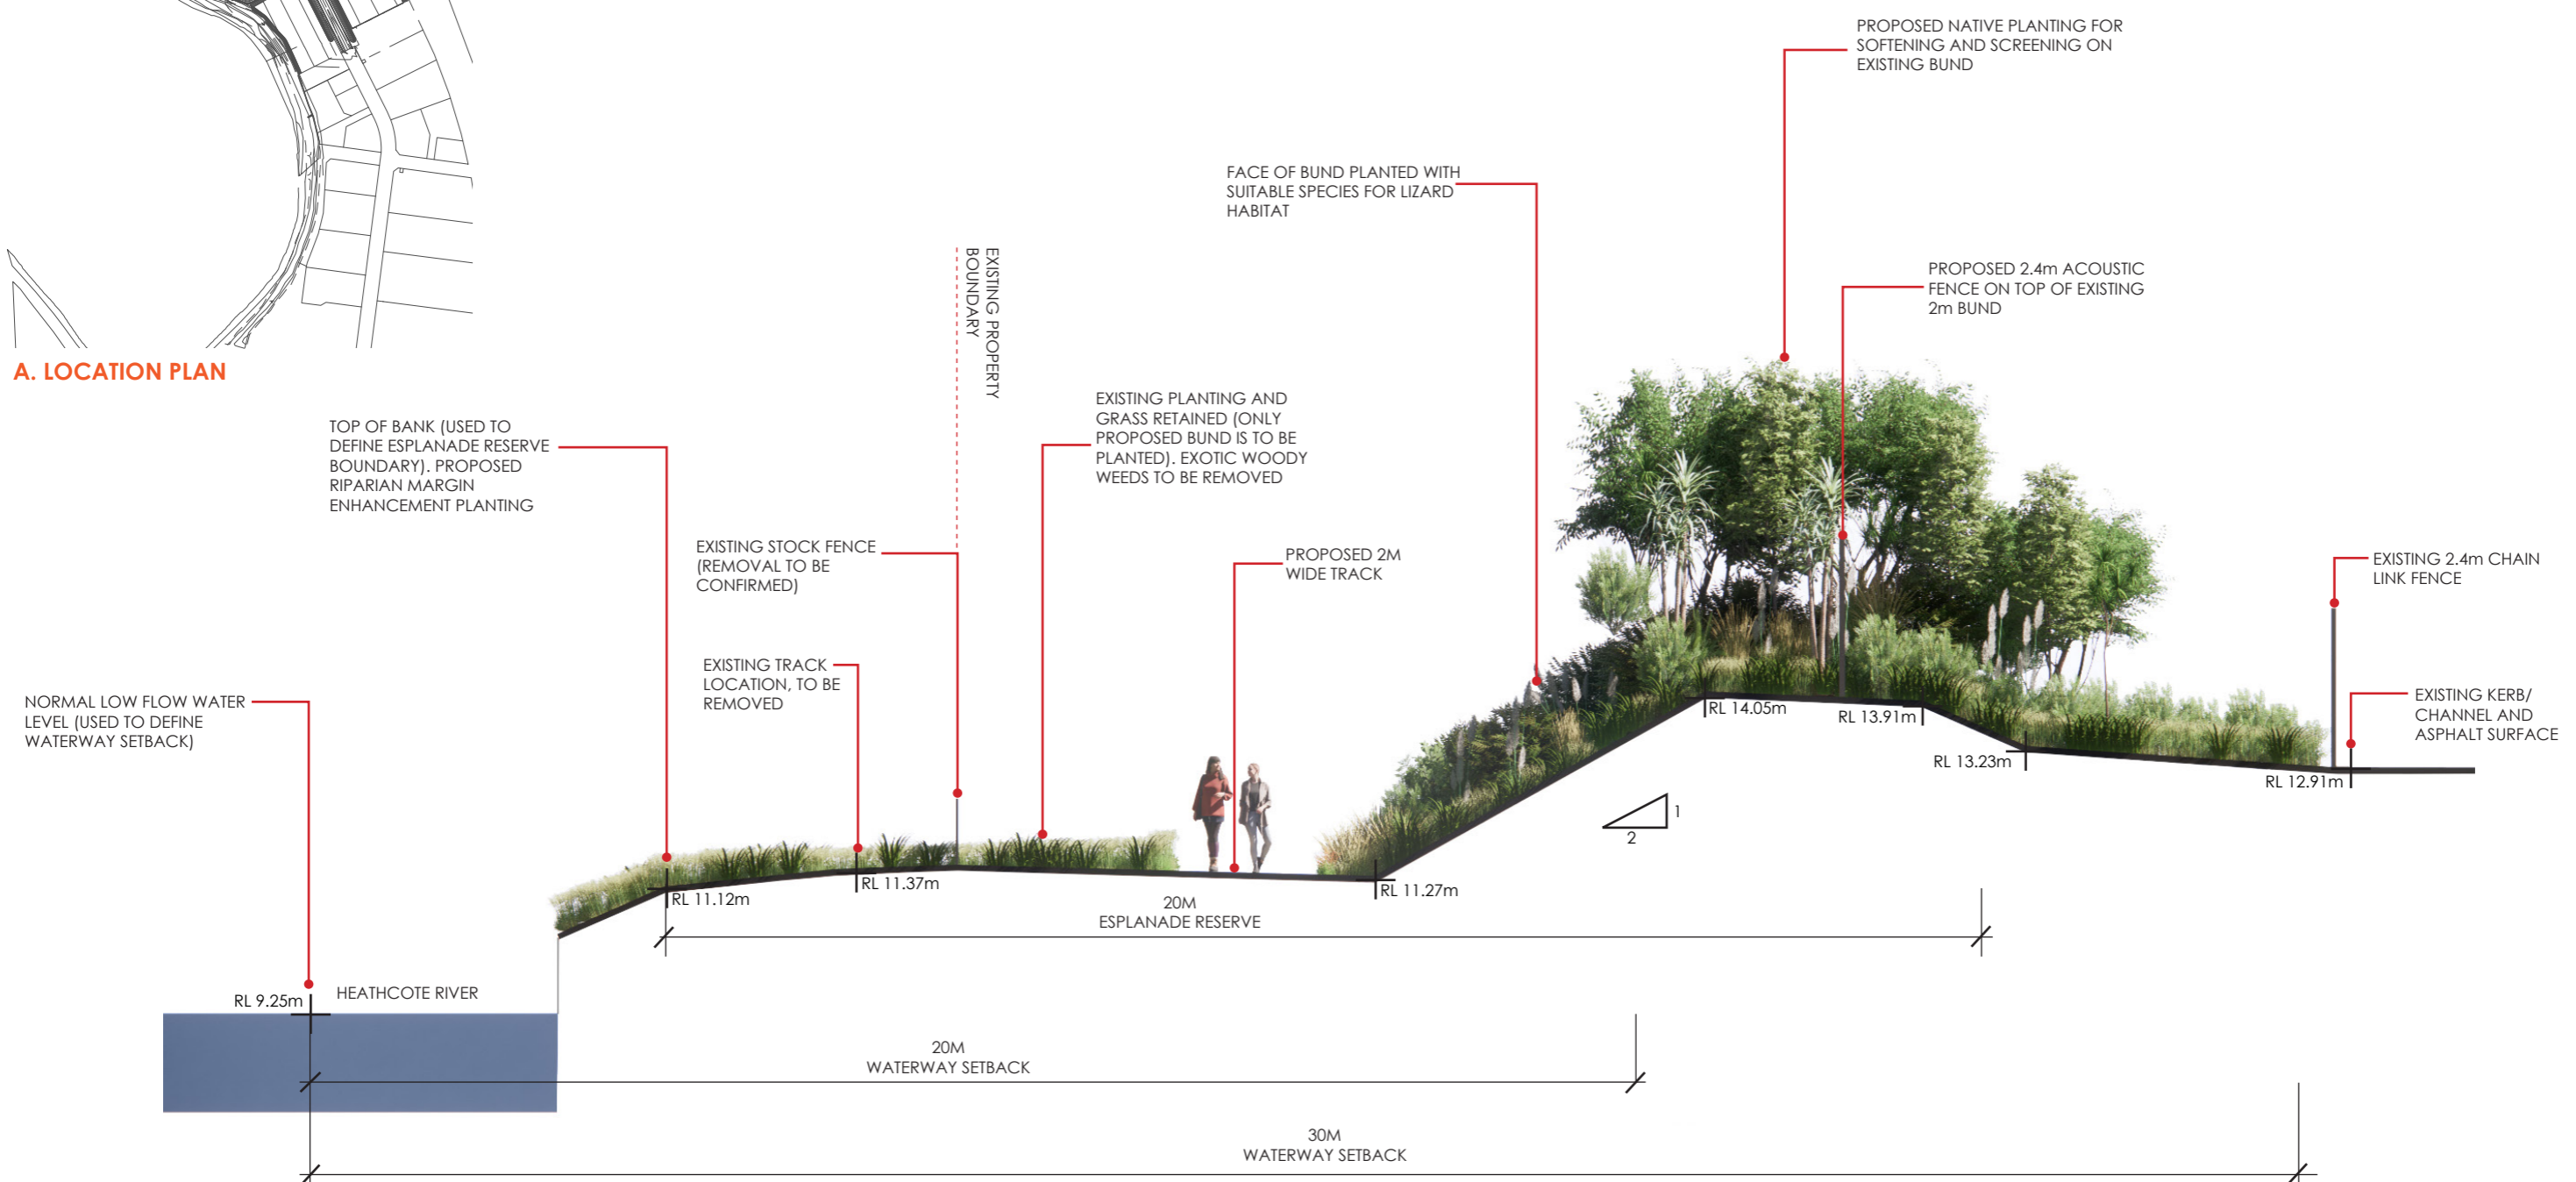
B. BUND CROSS SECTION B-B (SCALE 1:100)

NOTE: Survey levels provided by Woods

boundaries / setbacks and other key features. The cross-sections are consistent with updated survey data provided by the surveyor.

5. The north face of the northern bund has a gradient of 2H:1V and the western face of the southwest bund has a gradient of 2H:1V, as confirmed by survey data. In terms of its construction, the core has been formed using recycled concrete left over from site filling. The core is covered with a minimum 300mm layer of topsoil and was grass seeded for stabilisation prior to planting.

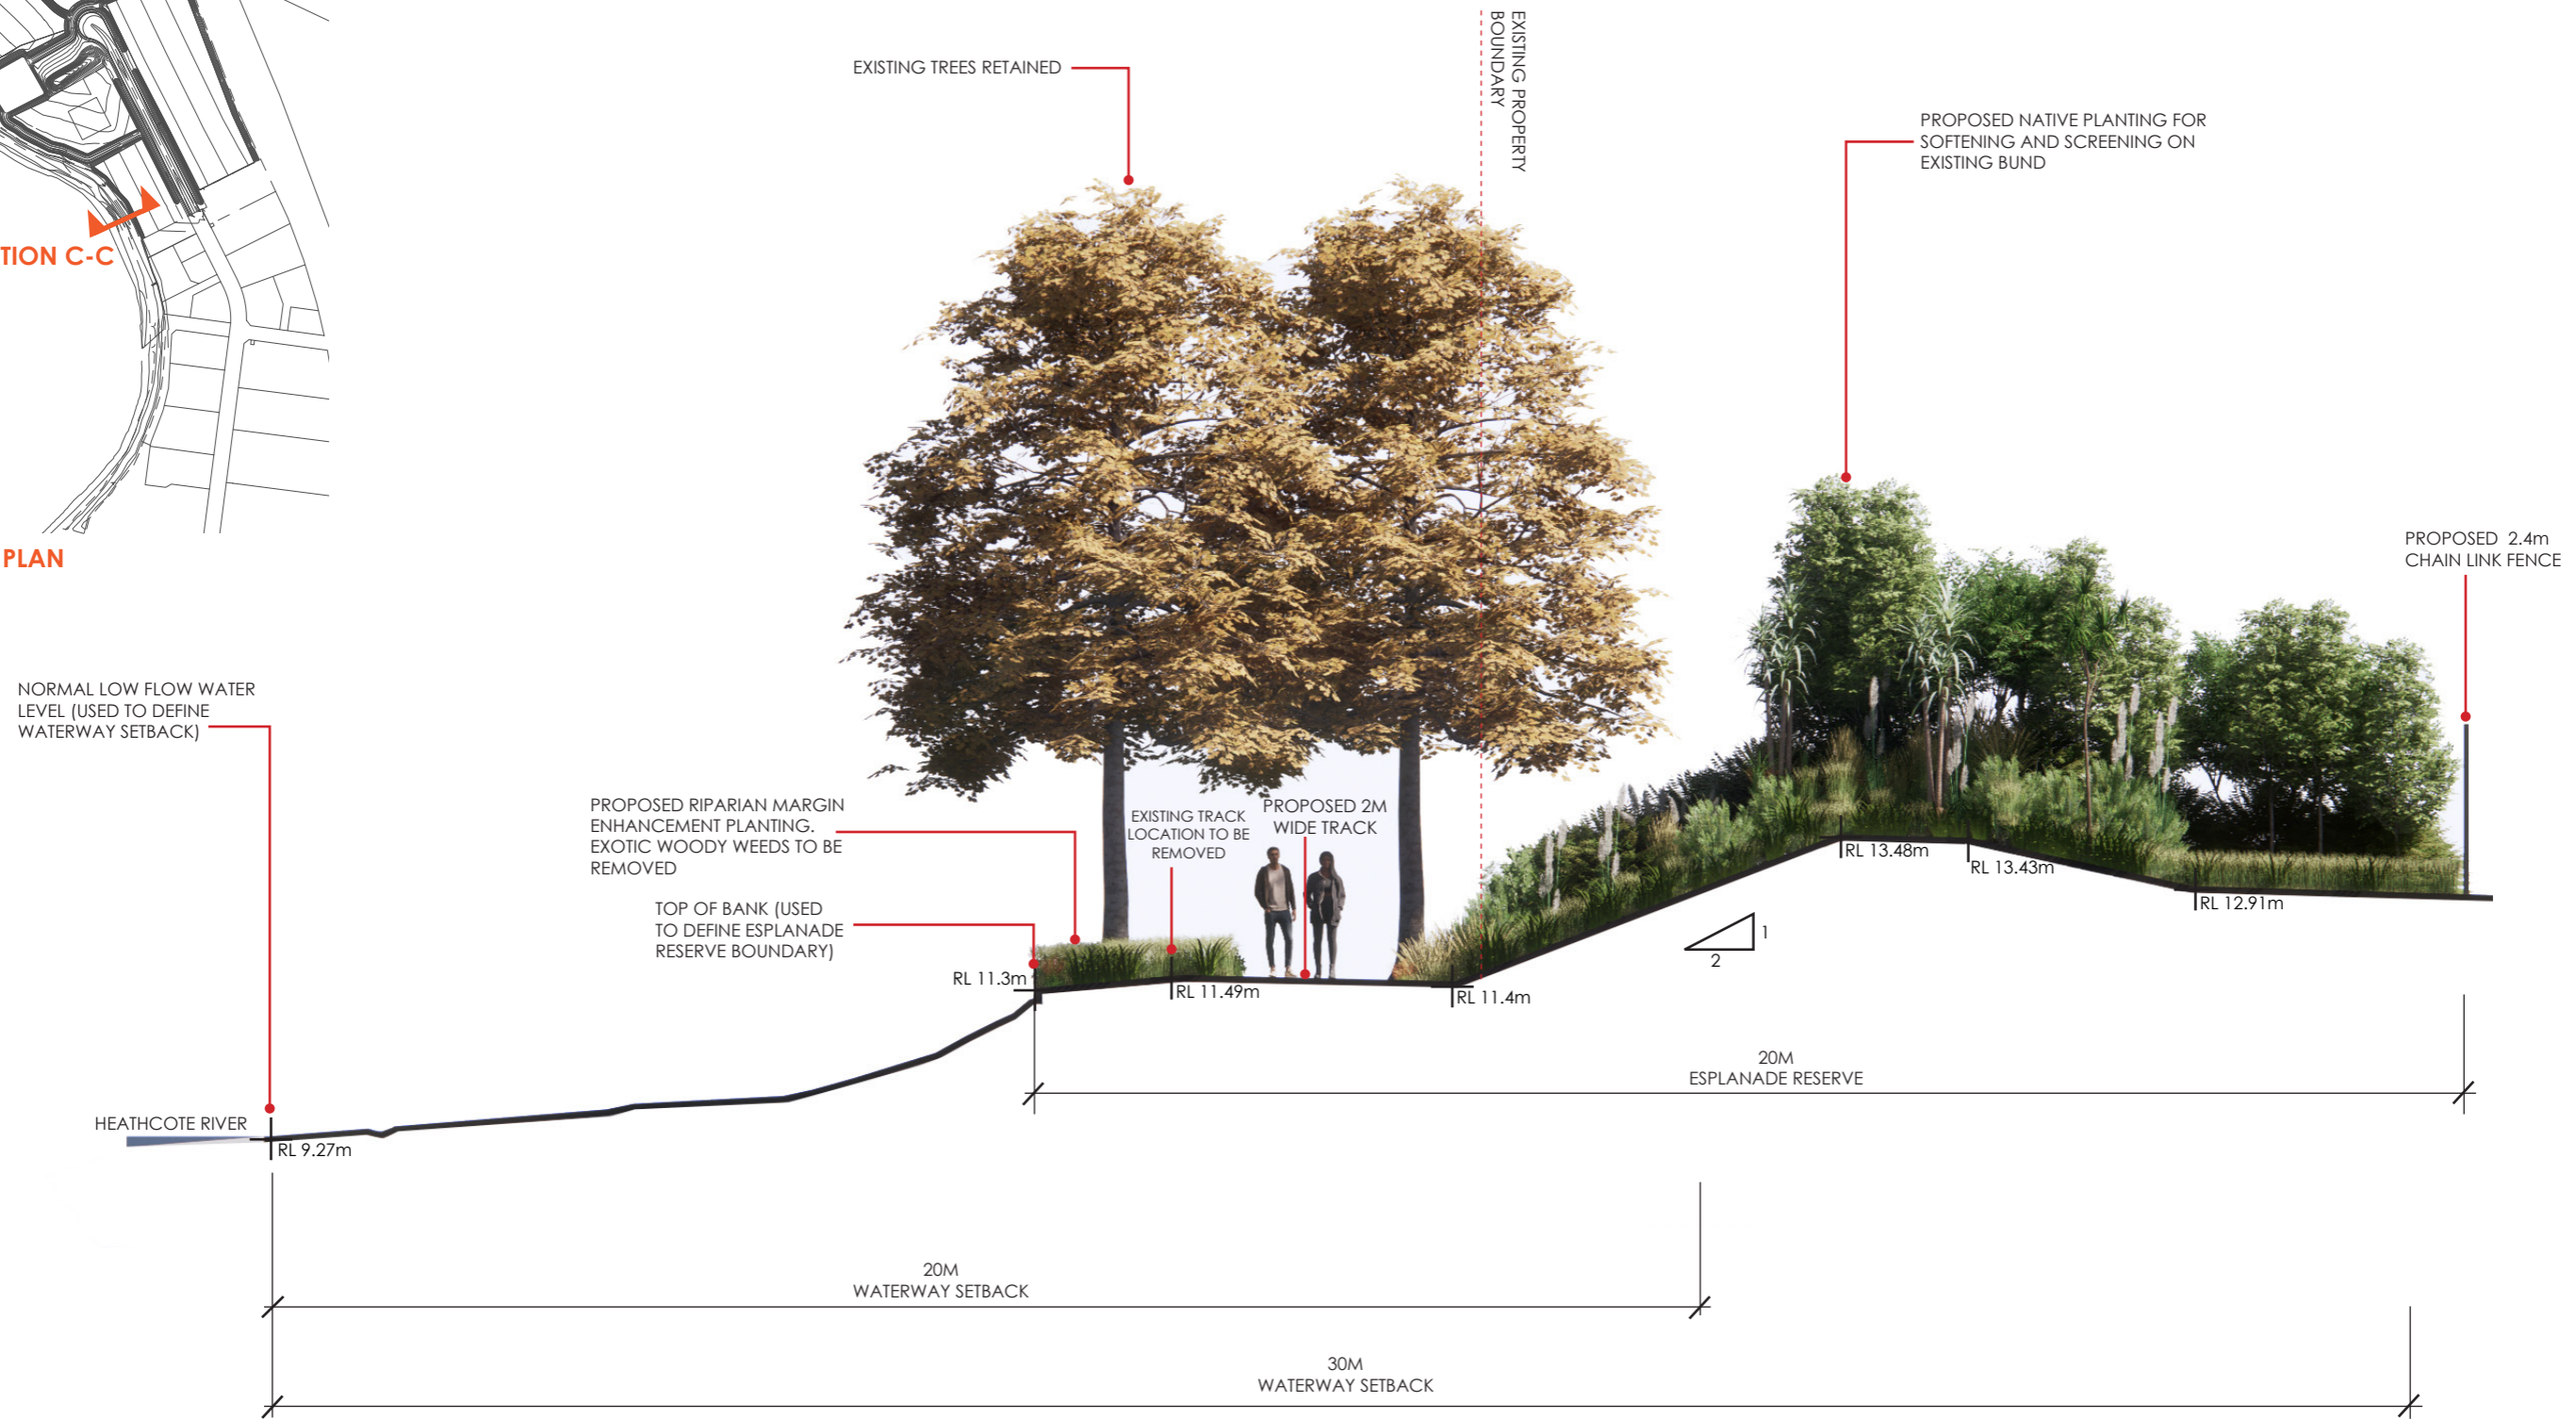
B. BUND CROSS SECTION C-C (SCALE 1:100)

NOTE: Survey levels provided by Woods

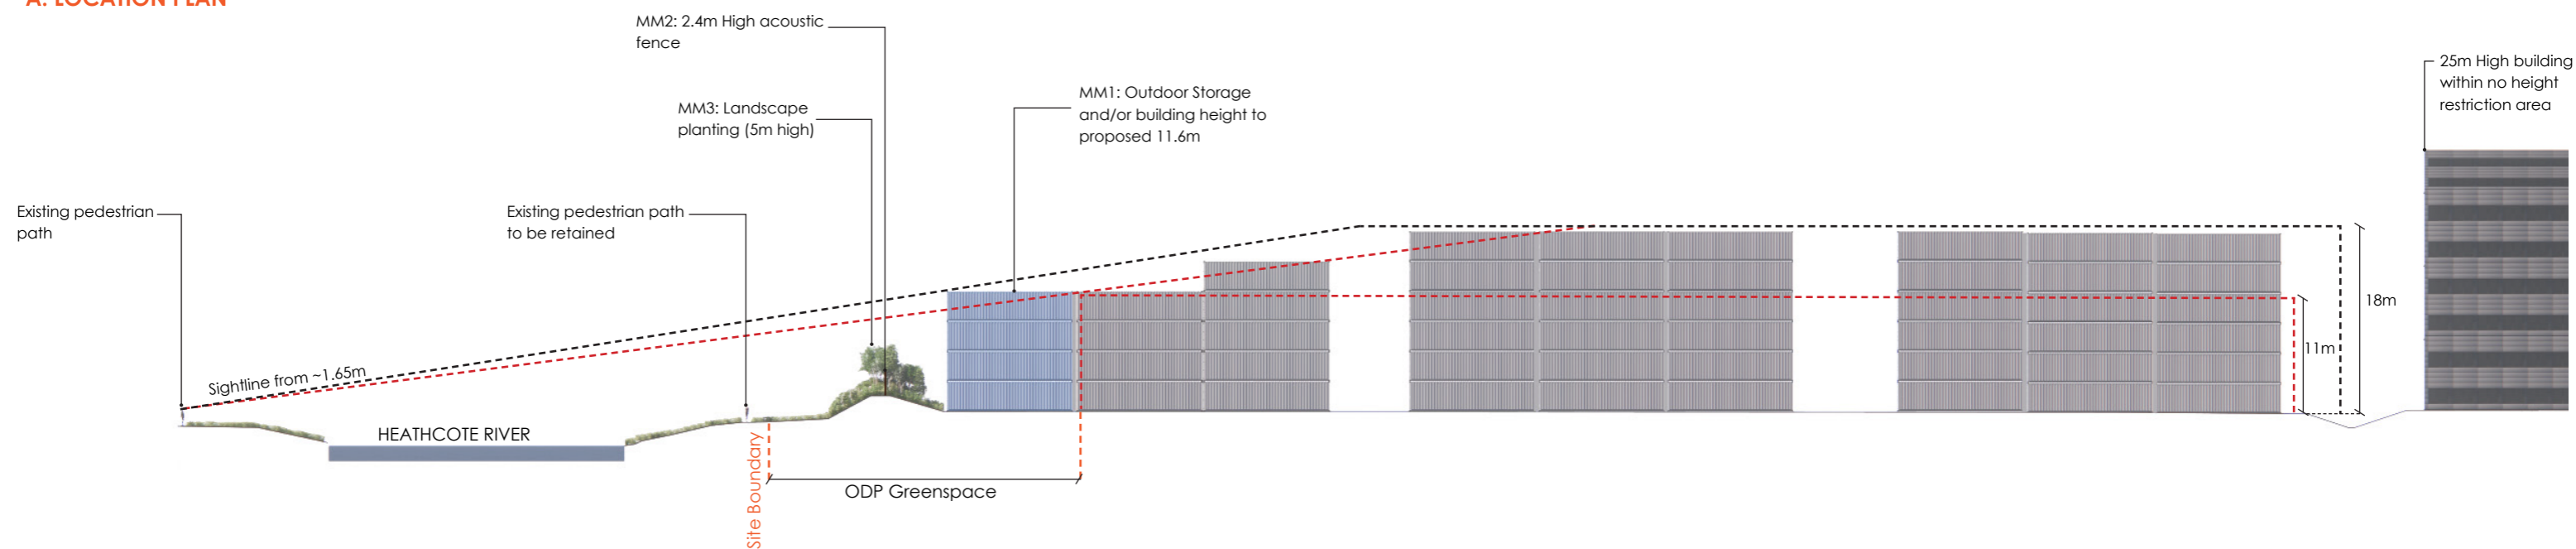
BASELINE/ PROPOSAL SECTION

- - - - Permitted baseline
- - - - Proposal

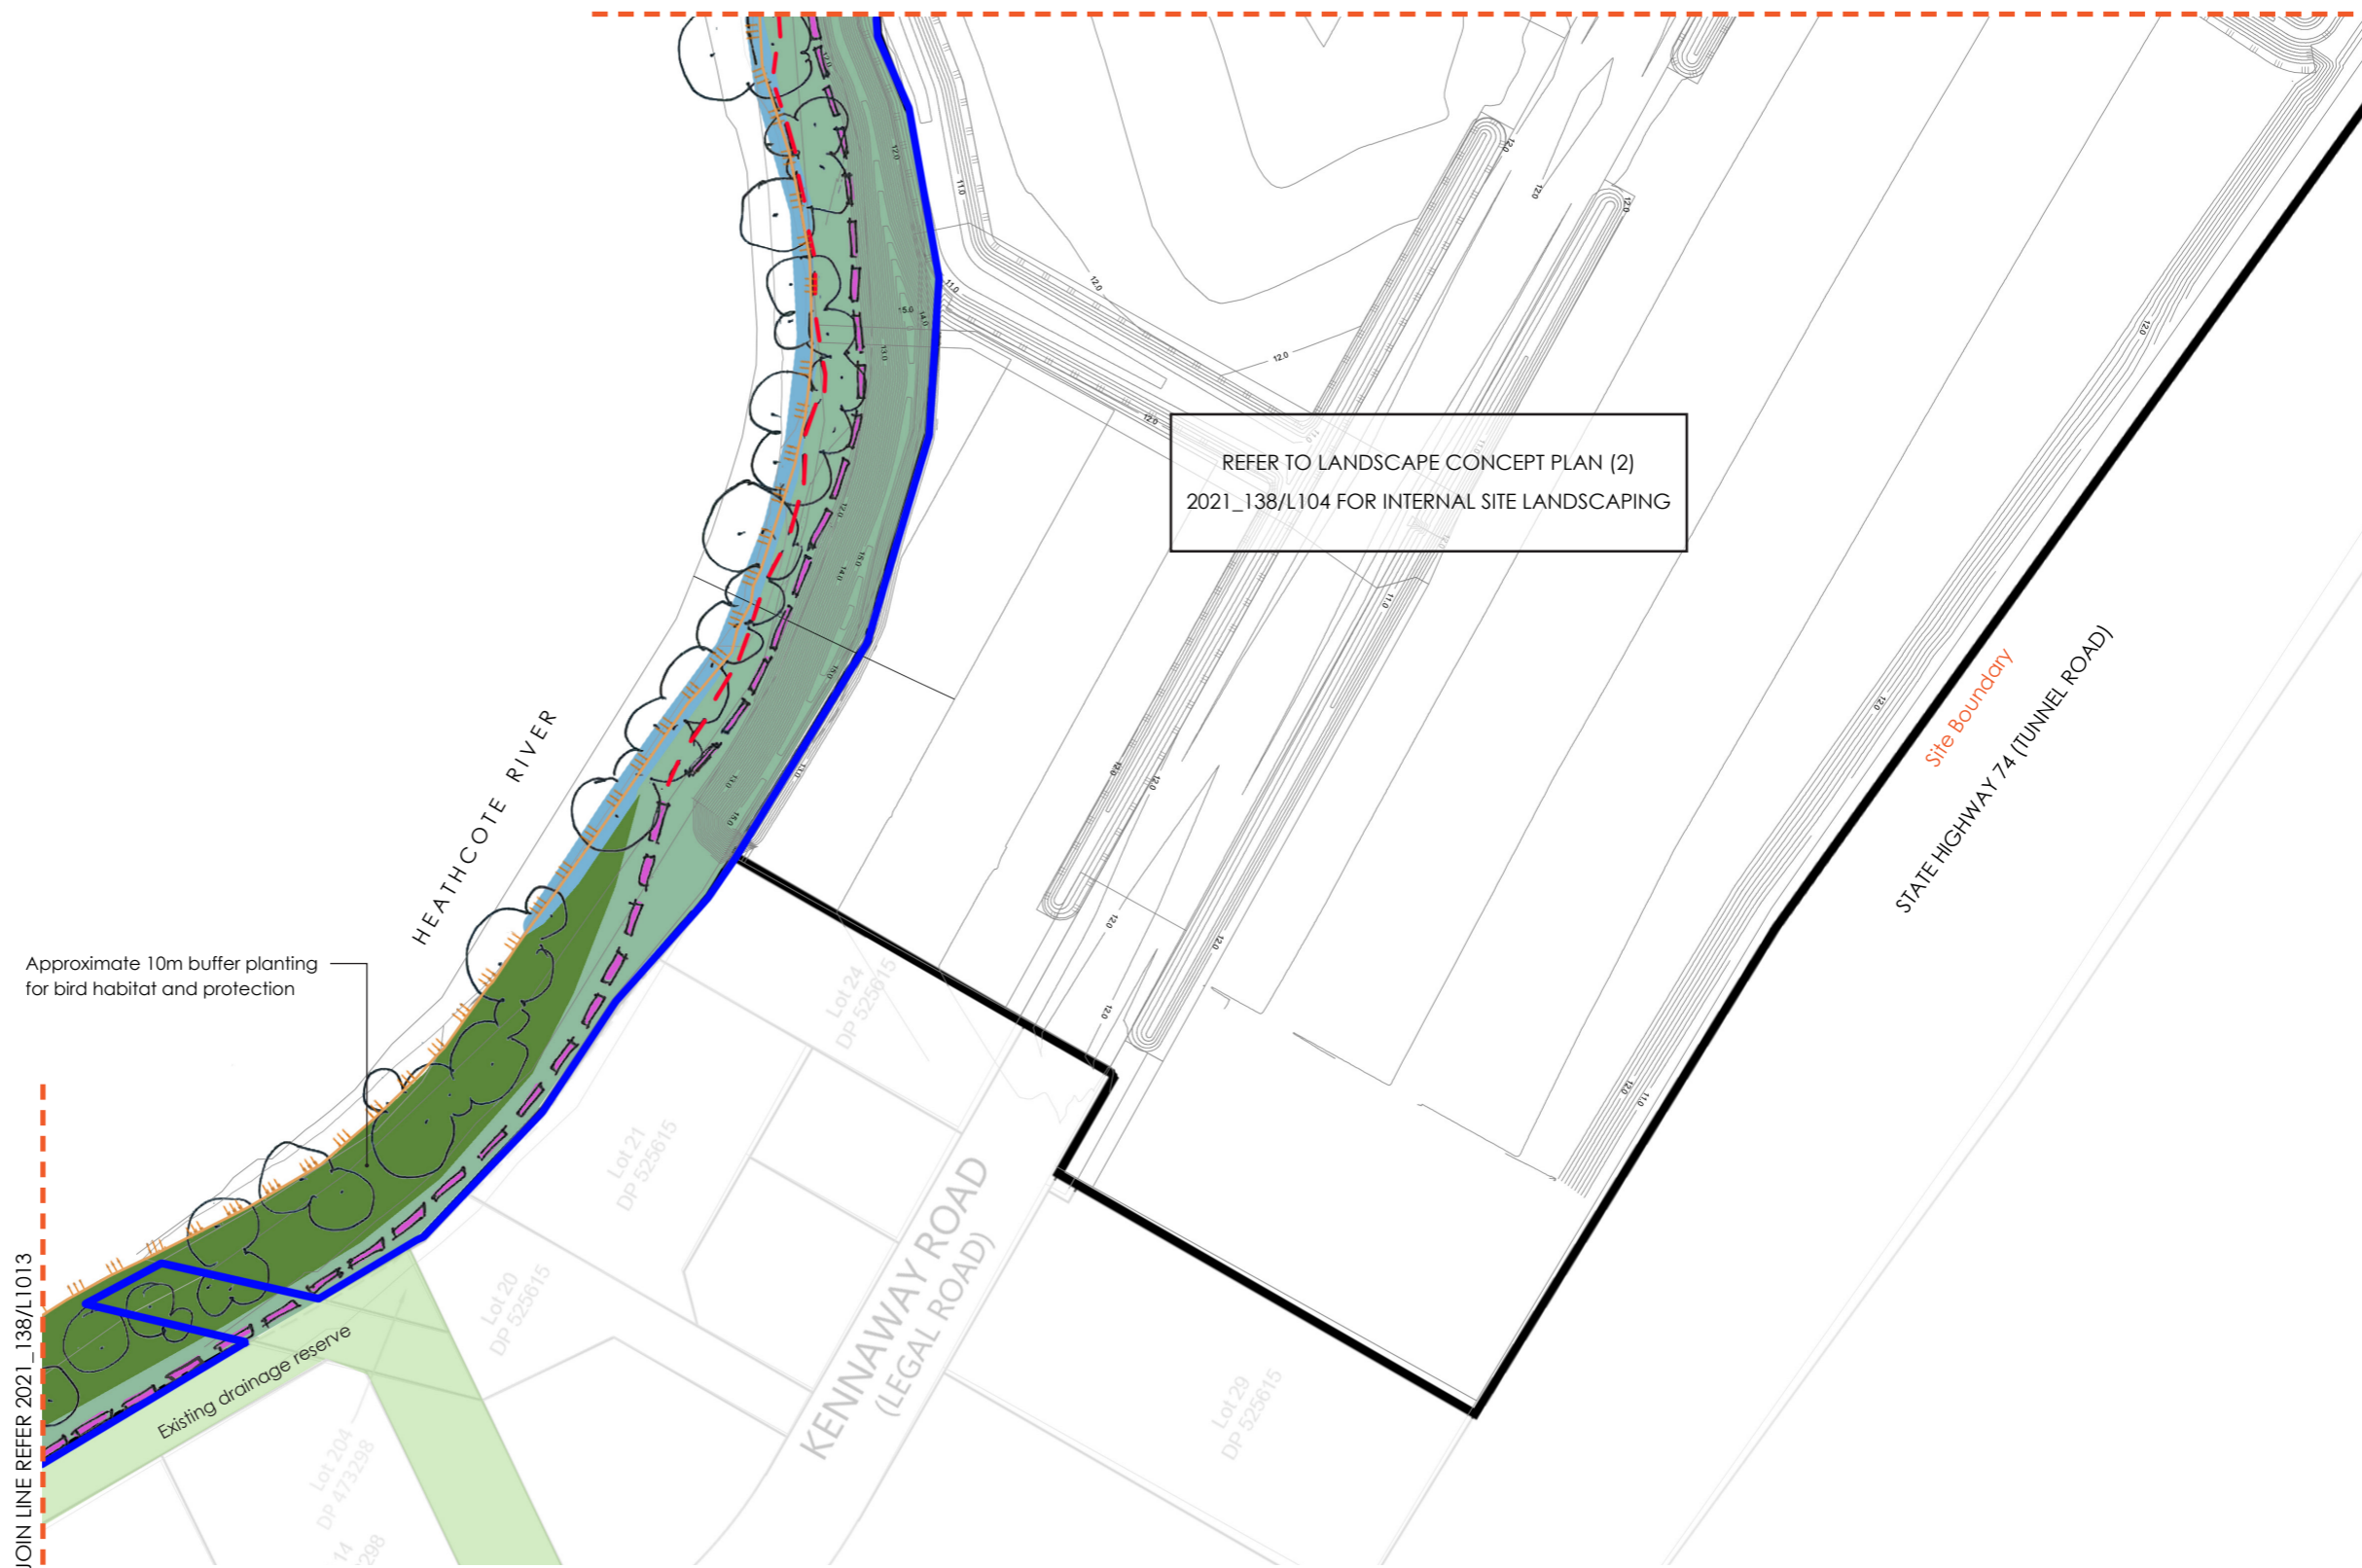
B. ESPLANADE ECOLOGICAL PRINCIPLES PLAN (2) (N.T.S)

*Plant species to be discuss and agreed with the various ecological experts to create suitable habitat.

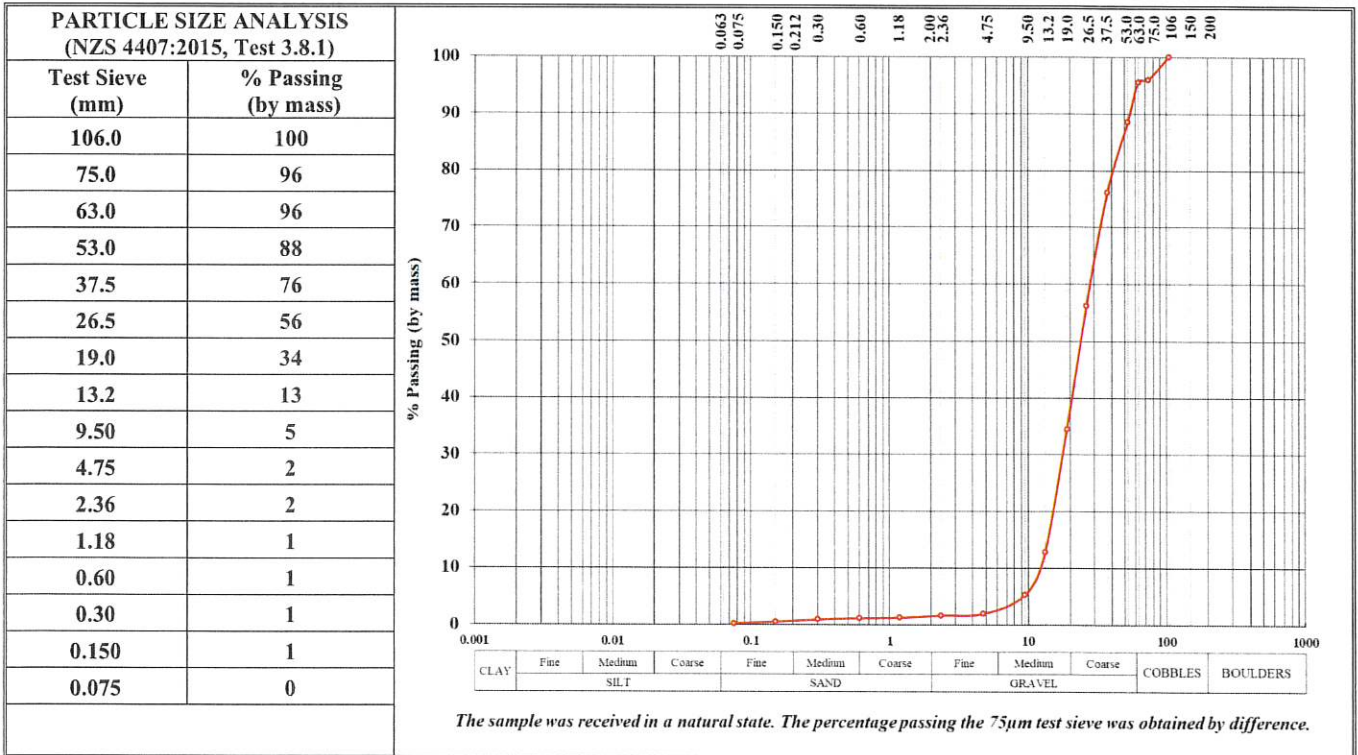
TEST REPORT – RECYCLED CRUSHED CONCRETE

PLASTICITY INDEX RESULTS (NZS 4402:1986, Test 2.2, 2.3 & 2.4)		FOREIGN MATERIALS - Not IANZ Accredited (NSW RTA T276)	
Test Description	Sample Result	Foreign Material Type	% Foreign Material
Liquid Limit: (LL)	Not Applicable	Type 1 - Metal, Glass, Asphalt, Ceramics and Slag (other than blast furnace slag):	0.1
Plastic Limit: (PL)	Non - Plastic	Type 2 - Plaster, Clay Lumps and other Friable Material:	0.0
Plasticity Index: (PI)	Non - Plastic	Type 3 - Rubber, Plastic, Bitumen, Paper, Cloth, Paint, Wood & other Vegetable Matter:	0.3
<i>Note: The sample was received in a natural state. The plasticity index material tested was the fraction passing the 425 µm test sieve.</i>		Total Foreign Material:	0.4
		<i>Note: The fraction tested was 4.75mm to 106.0mm</i>
