**APPLICATION FOR RESOURCE CONSENT RMA/2023/597
ADDRESS 130 BOWENVALE AVENUE**

Thank you for your application for resource consent for 35 lot fee simple subdivision on the above site, which we received on 11th April 2023.

BOWENVALE AVENUE SUBDIVISION
PRELIMINARY DESIGN ROAD SAFETY AUDIT

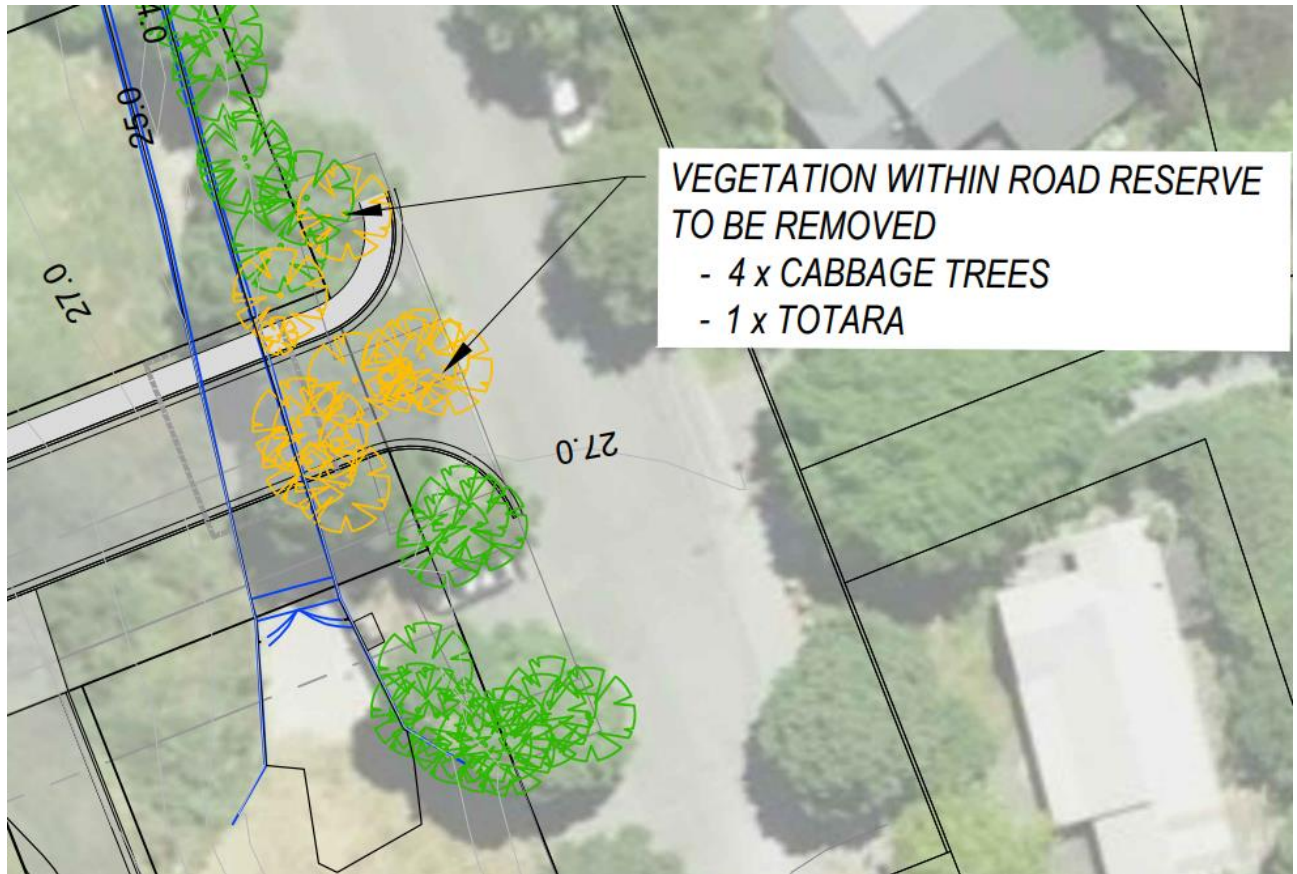
There are only 5 trees within the road reserve as shown on plan EN-110 and as per the Arboricultural report. The remaining trees to be removed are located within the applicant's property and therefore are not street trees. Refer to snippet below.

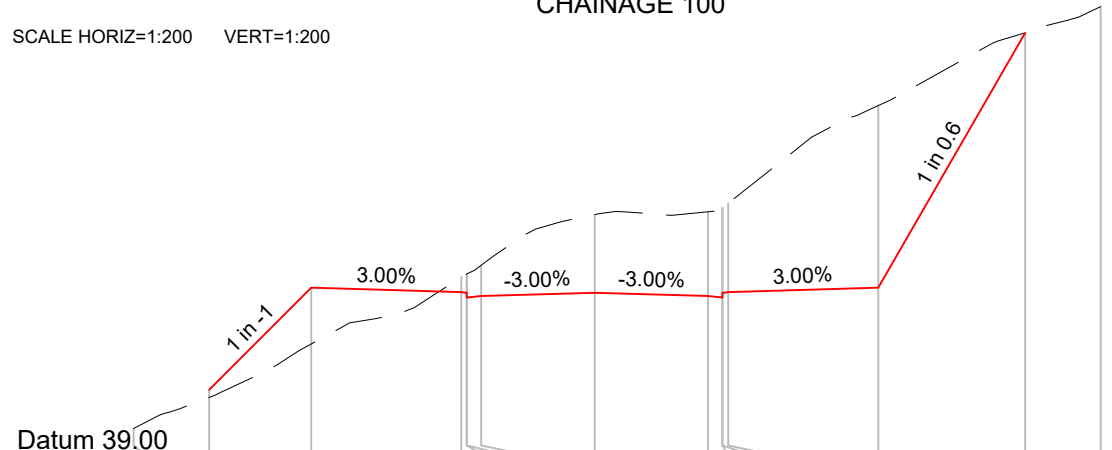
DESIGN	40.67	43.37	43.25	43.24	43.11	43.15	43.24	43.15	43.37	50.12	50.81
SURVEY	40.67	43.37	43.25	43.24	43.11	43.15	43.24	43.15	43.37	50.12	50.81
OFFSET	-12.20	-10.20	-7.50	-3.53	-3.38	-3.00	0.00	3.00	3.38	3.53	11.39

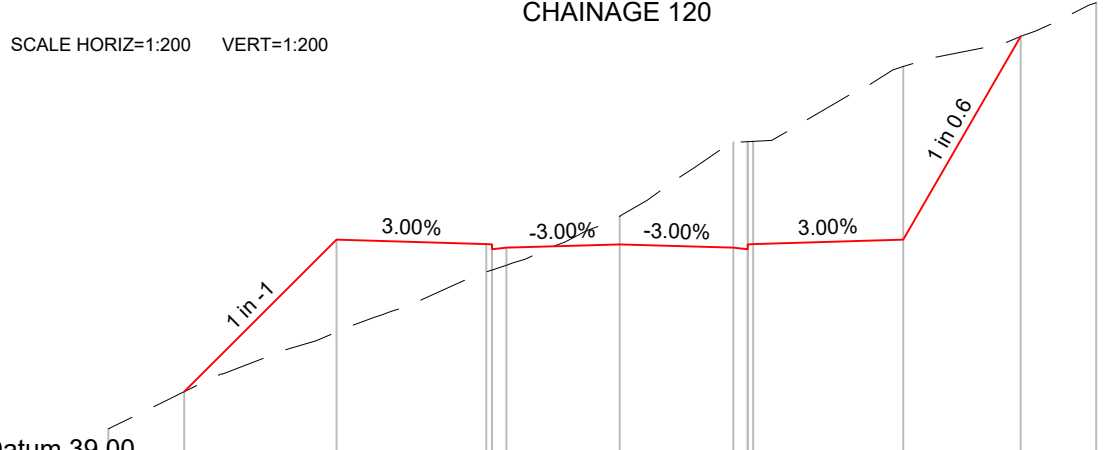
DESIGN	40.85	44.87	44.76	44.75	44.62	44.66	44.75	44.66	44.87	50.25	51.14
SURVEY	40.85	44.87	44.76	44.75	44.62	44.66	44.75	44.66	44.87	50.25	51.14
OFFSET	-13.53	-11.53	-7.50	-3.53	-3.38	-3.00	0.00	3.00	3.38	3.53	12.60

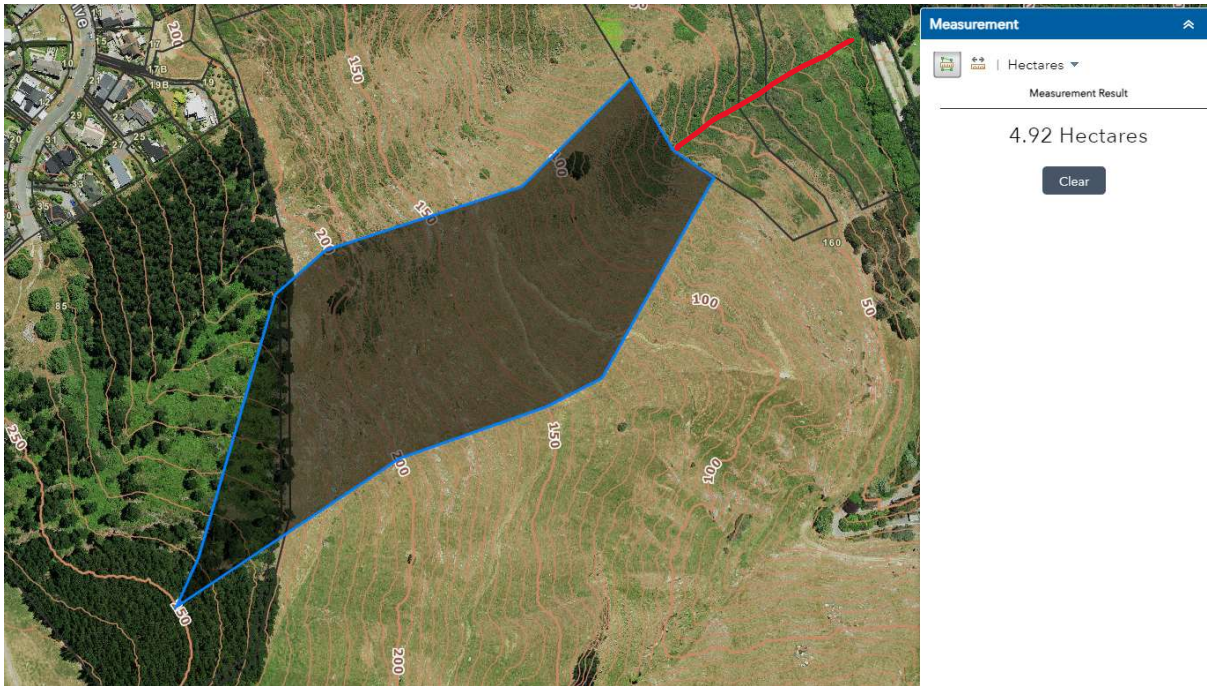
b) Waterway B - Hillside waterway (north)

- Area = 4.92ha
- Length = 460m
- Slope = 41%

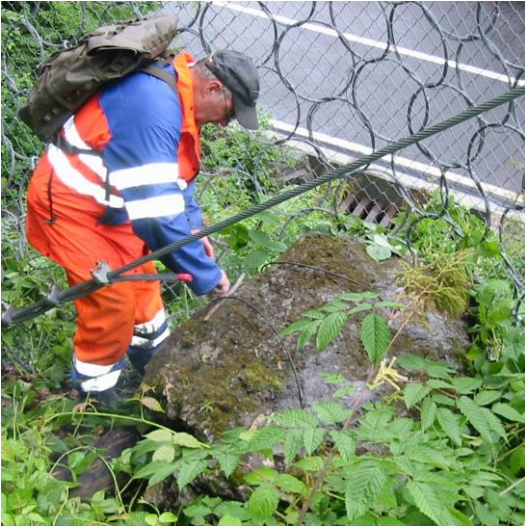
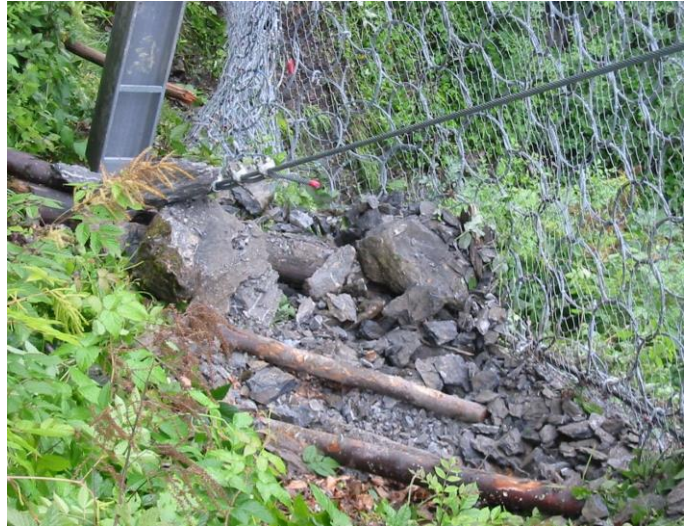
- Manual
- Explosives (see following illustration)
- Expanding cement (“cold explosives”). For this, the stones are drilled into and filled with the “propellant” (e.g. that manufactured by Betonamit) and water is added. After about one day, the stone is broken and can be cleared away.

Breaking a block down using explosives

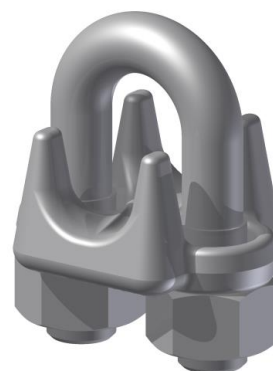
The clamping brackets (U-brackets) must always be fitted to the unstressed end of the rope, the clamping jaws (saddle) must always be fitted to the strained rope („never saddle a dead horse“).

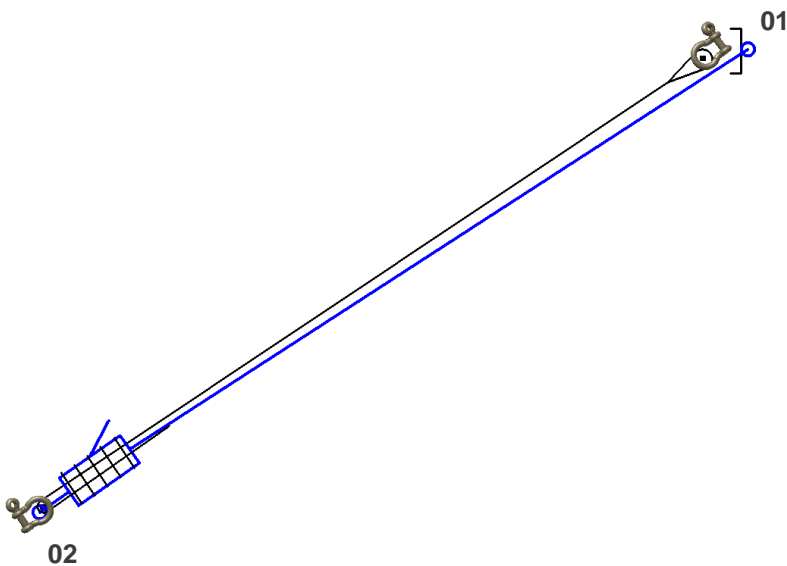
8.3 Replacing ropes

- Fit the clips of the cable pulley device to the post (e.g. with the auxiliary strap) **01** and to the fastening of the U-brake (e.g. rope anchor) **02**.

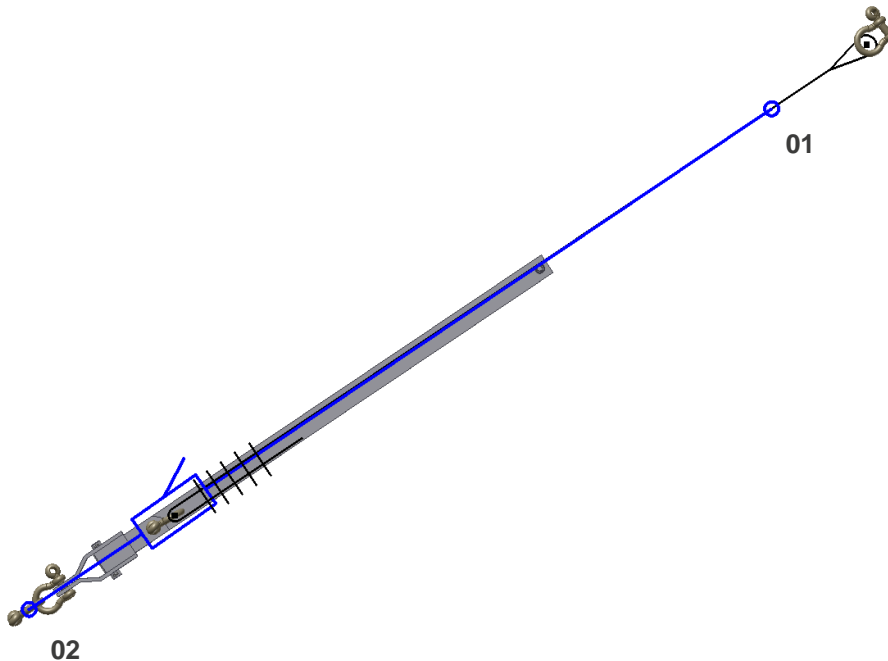
8.4 Replacing U-brakes

- Fit the clips of the cable pulley device to the rope of the U-brake 01 and the fastening of the U-brake (e.g. rope anchor) 02.

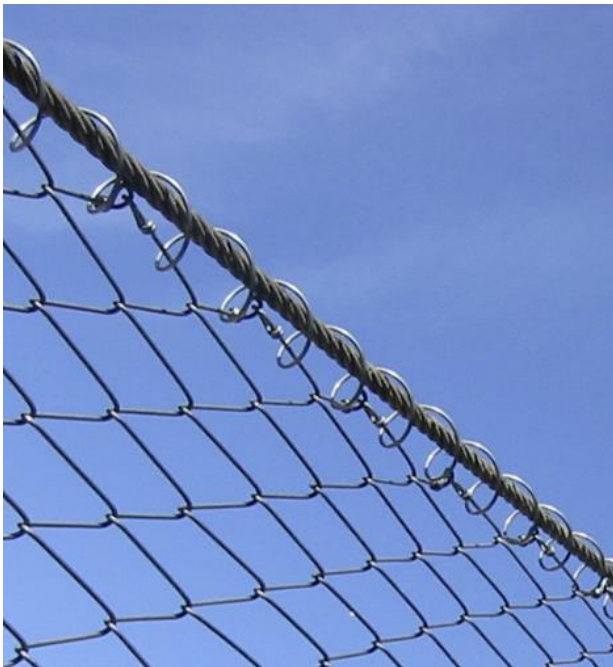
- a) Relieve the strain on the outermost spiral of the damaged area.
- b) Open up the eyelet connection of the outermost spiral.
- c) Unscrew the outermost spiral. ⇒ A separation is produced in the mesh area.
- d) Cut open the mesh loops of the damaged mesh along the support rope and remove the damaged mesh.

- e) Fasten the mesh loops of the new mesh to the support ropes with HELIX spirals (or shackles).
- f) Connect the new mesh to the intact adjacent meshes with a TECCO spiral (or with shackles).
- g) Connect the eyelets of the two TECCO spirals with a shackle and remove the strain relief.

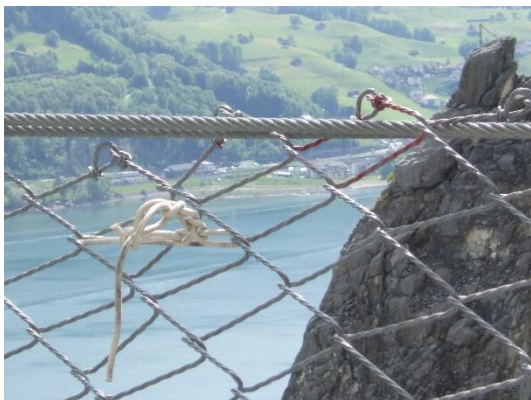
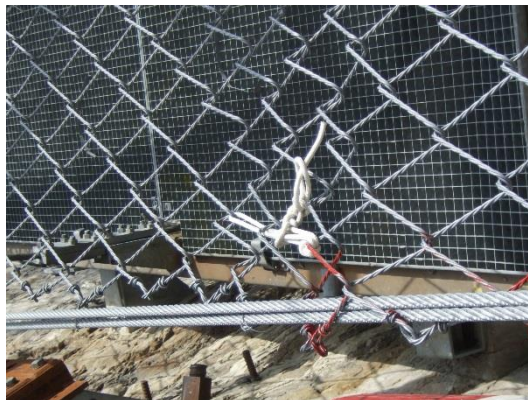
The SPIDER net is replaced by unscrewing the outermost spirals of the damaged area, inserting the new net, and joining this to the intact nets with two new spirals (or with shackles).

a) Relieve the strain on the outermost spiral of the damaged area

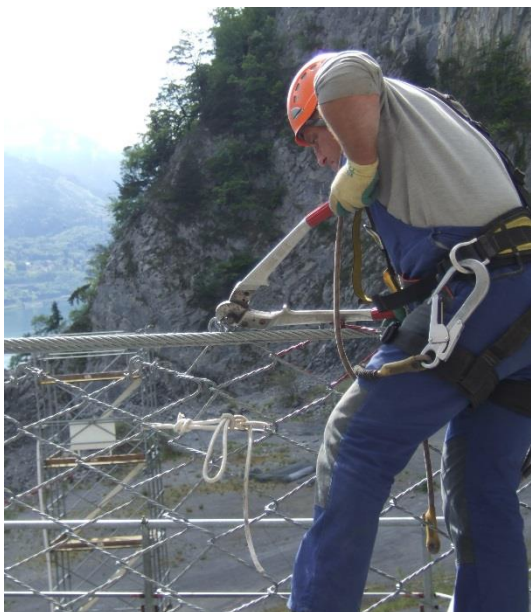
b) Cut open the eyelet connection of the outermost spiral

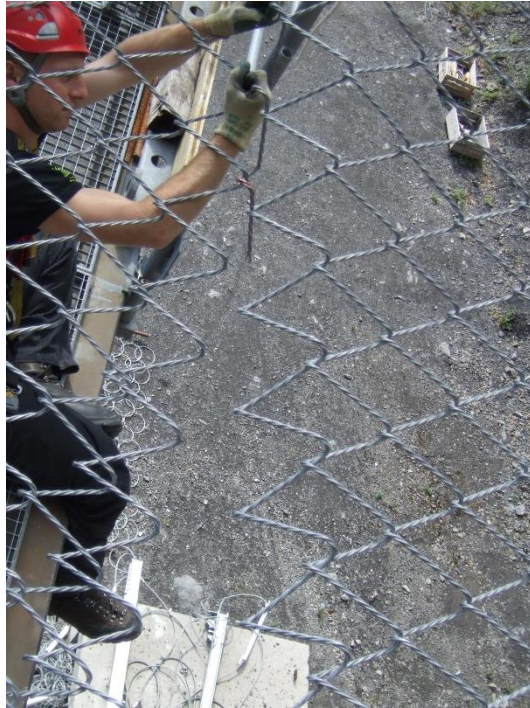
A separation is produced in the net area

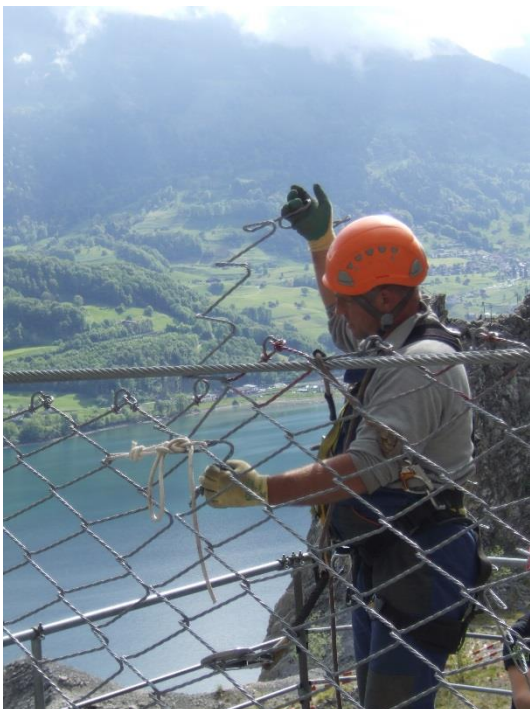
- d) Cut open the mesh loops of the damaged net along the support rope and remove the damaged net.
- e) Fasten the mesh loops of the new net to the support ropes with shackles.

f) Connect the new net to the intact adjacent nets with a spiral (or with shackles).

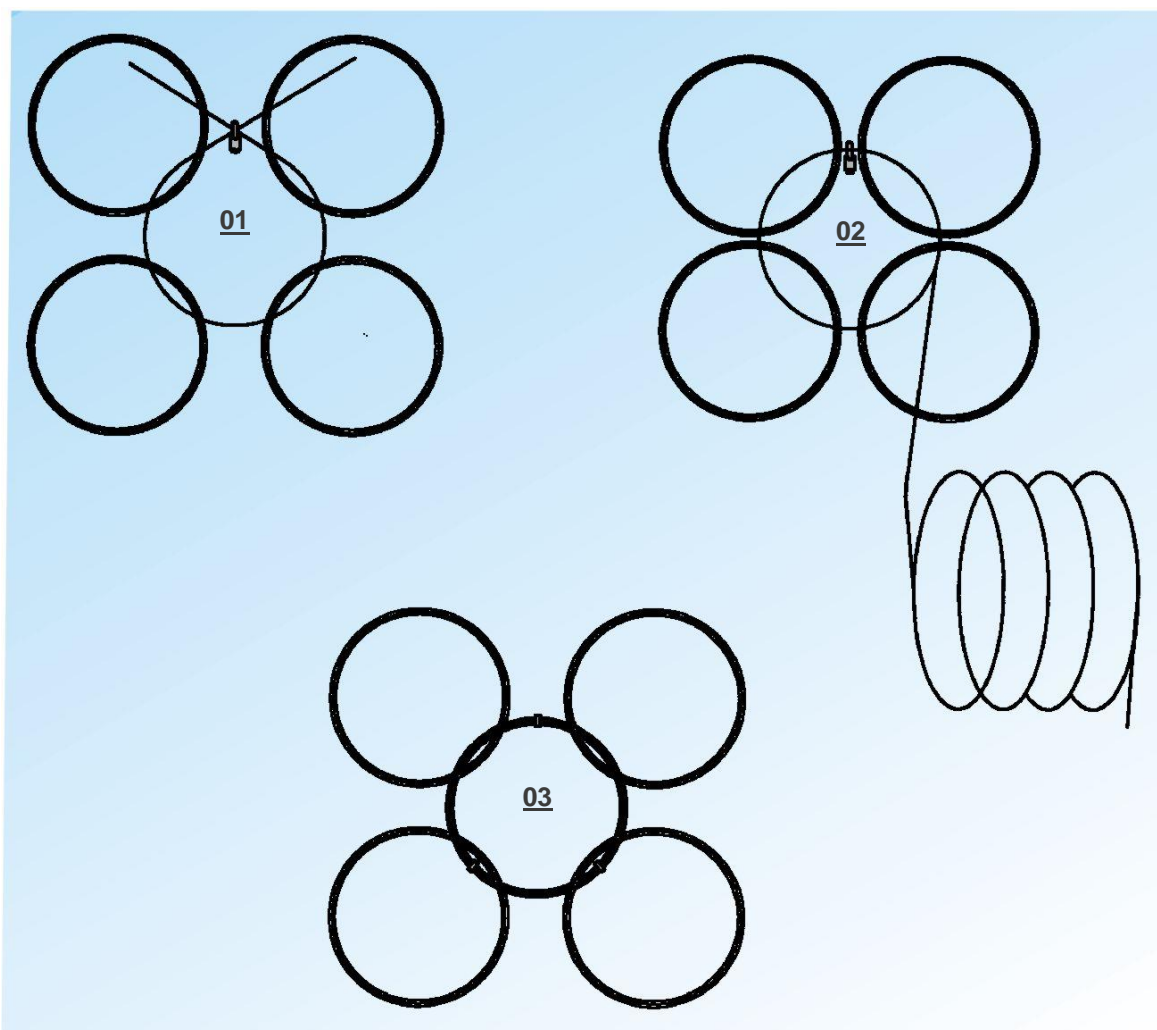
- a) Pull a piece of rope with a diameter of 4-8 mm through the 4 rings adjacent to the damaged ring and tighten it such that its diameter becomes smaller than that of the ring that is to be replaced.
- b) Secure the piece of rope that has been threaded through with a wire rope clip **01**.
- c) Guide a piece of wire with a diameter of 3 mm and a tensile strength of at least 1770 N/mm² along the piece of rope that was threaded through and through the four rings **02**.
- d) Repeat this until the number of turns of the adjacent rings has been reached.
- e) Fix the circular shape of the resulting ring bundle with three wire rope clips **03** (7 turns: WRC 1/4" / NG 6.5; 12 turns: WRC 5/16" / NG 8; 16 turns: WRC 7/16" / NG 13; 19 turns: WRC 9/16" / NG 16).
- f) Remove the piece of rope that was threaded through.

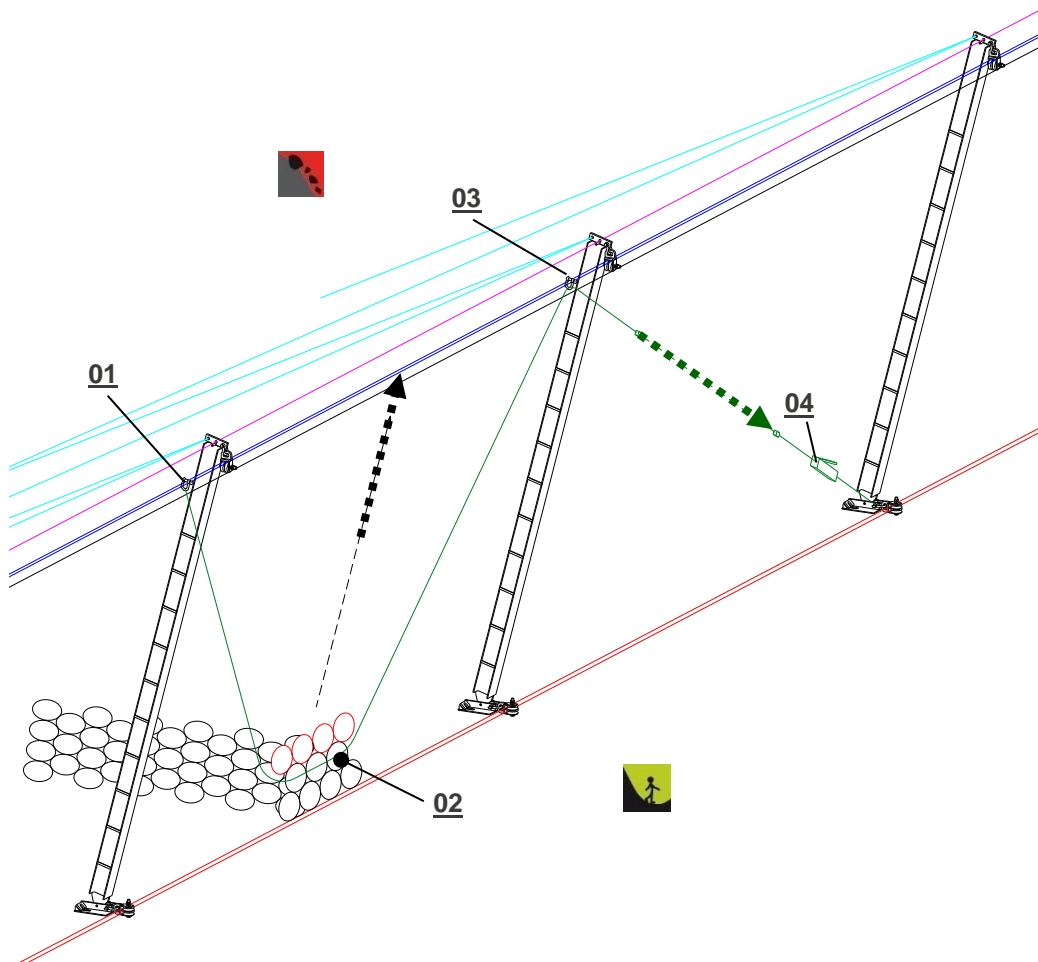
- f) Take care to ensure that the correct number of rings is fastened to the right and left of the post, not on the support ropes, but on the U-Ropes. Detailed information can be found in the corresponding product manual.

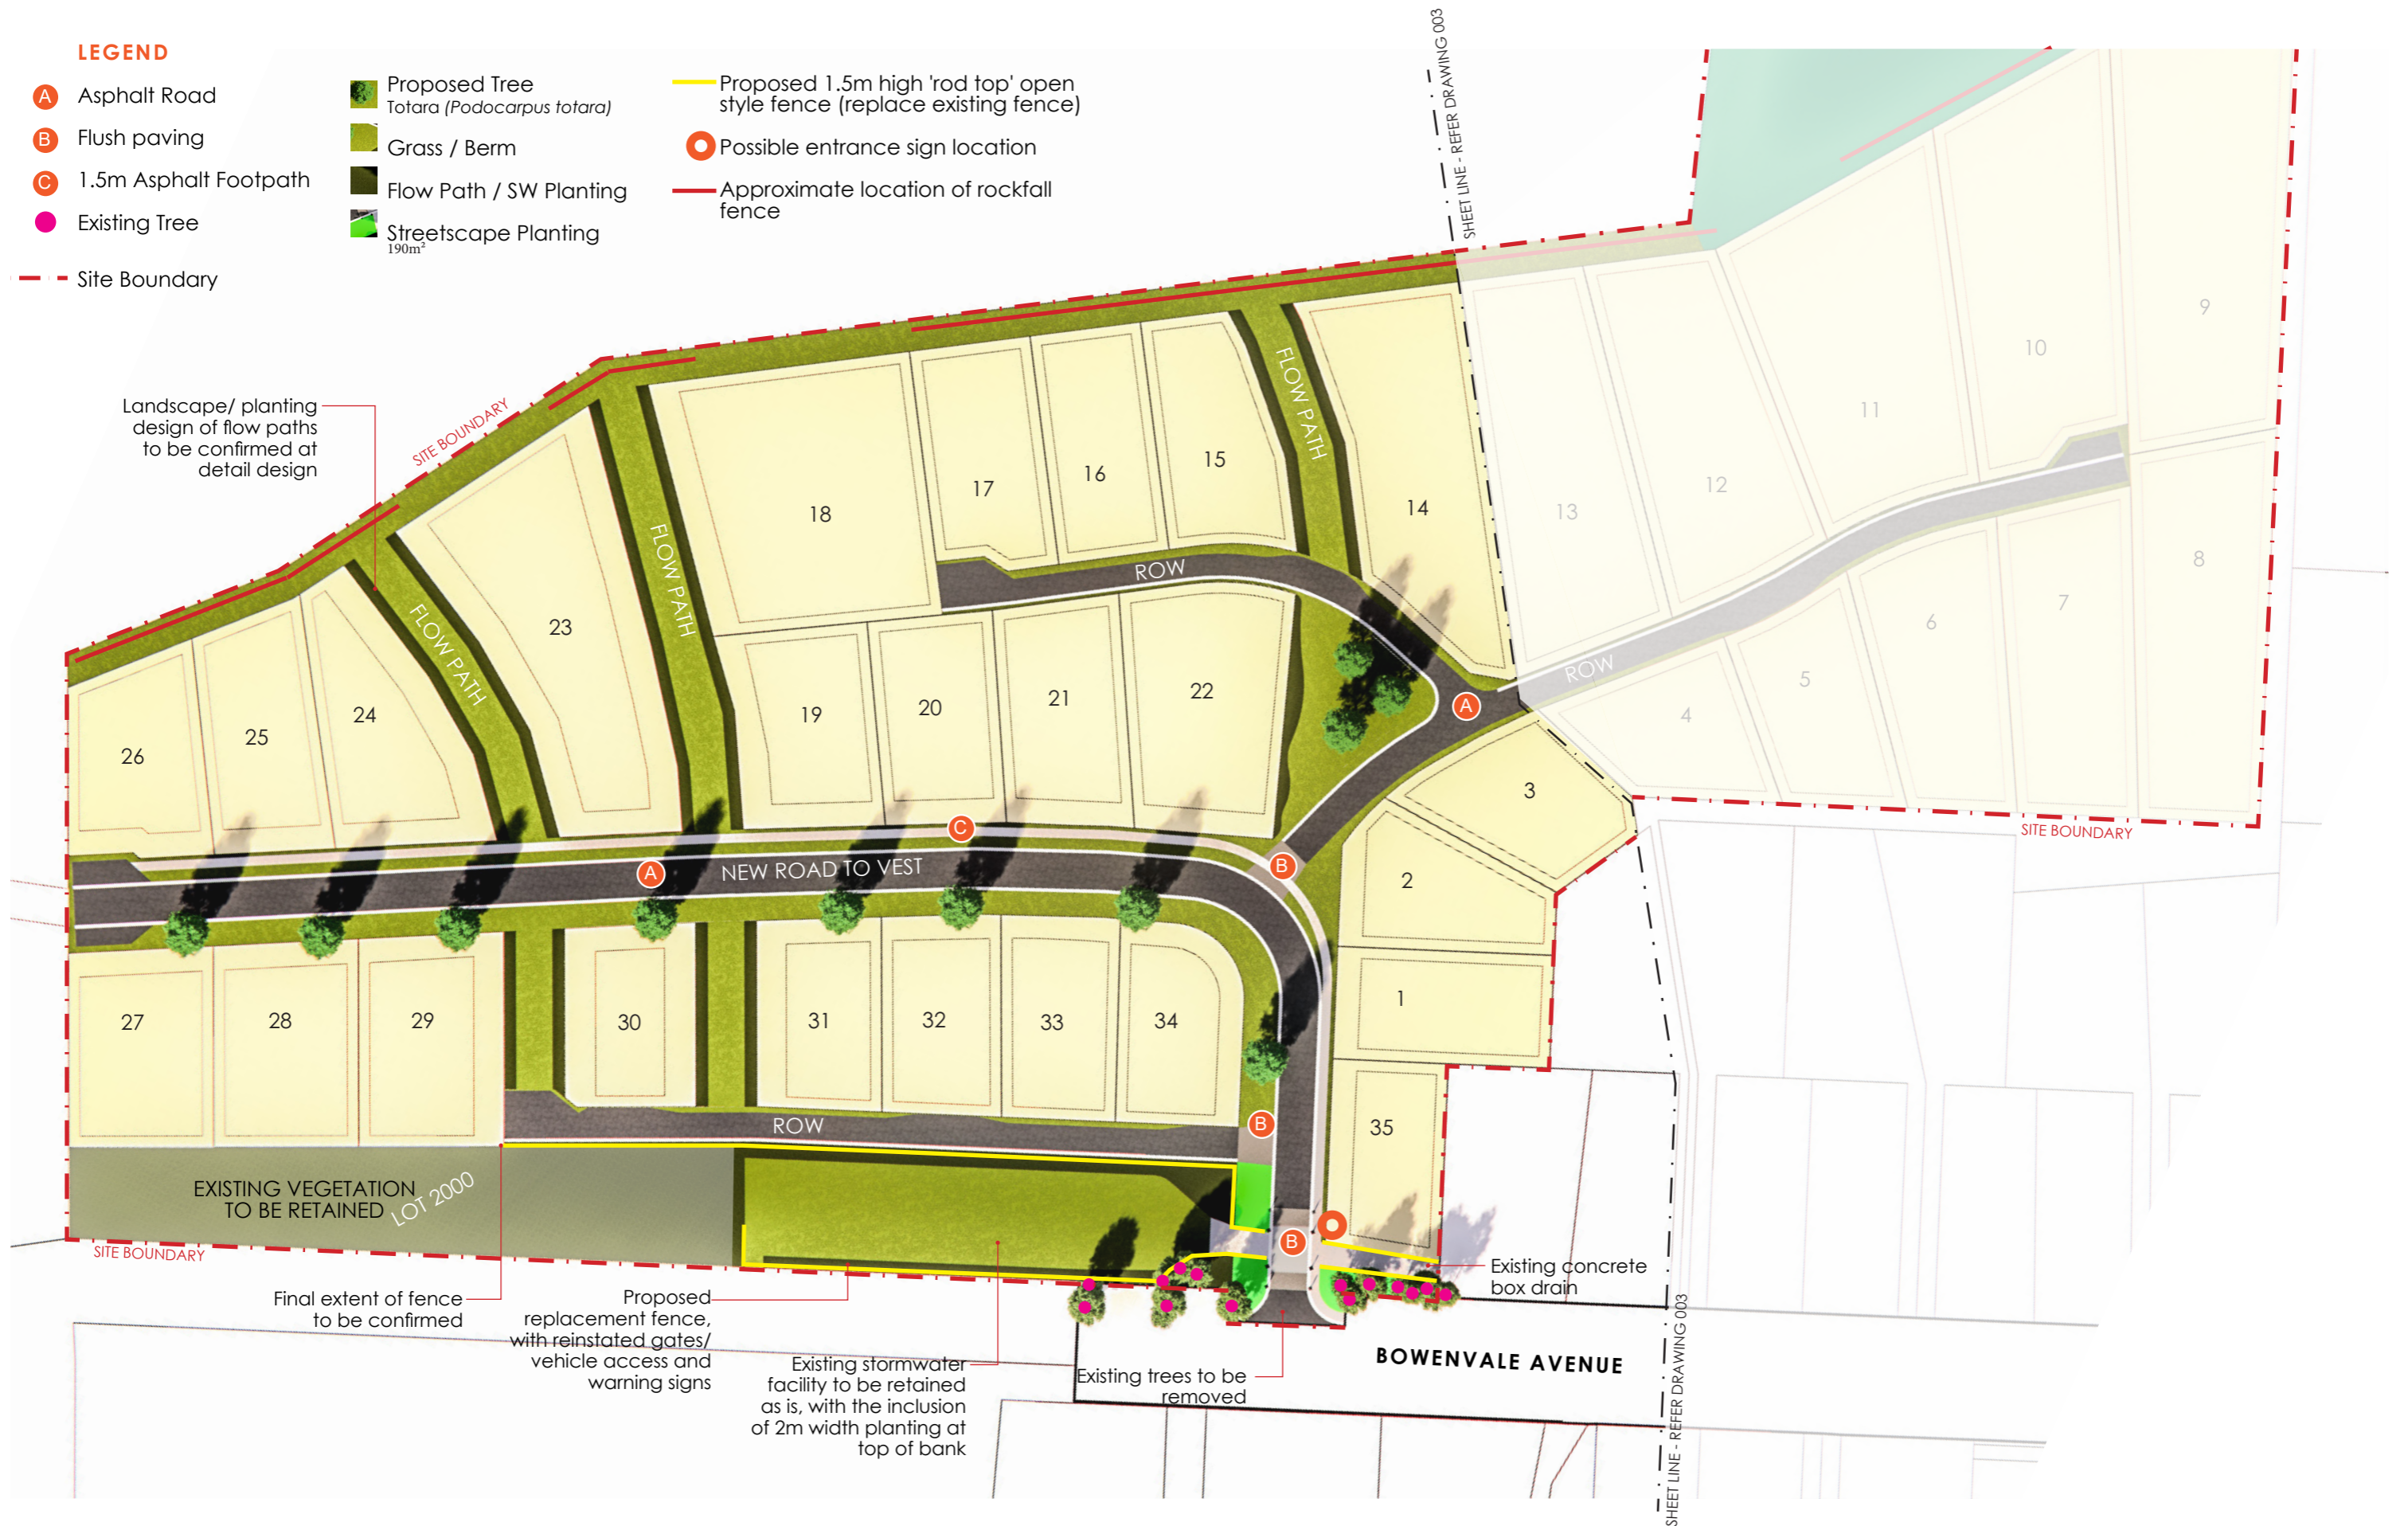
A. LANDSCAPE CONEPT PLAN

- A Asphalt Road
- B Flush paving
- C 1.5m Asphalt Footpath
- Existing Tree
- - - Site Boundary
- Proposed Tree
Totara (*Podocarpus totara*)
- Grass / Berm
- Flow Path / SW Planting
- Streetscape Planting
190m²
- Proposed 1.5m high 'rod top' open style fence (replace existing fence)
- Possible entrance sign location
- Approximate location of rockfall fence

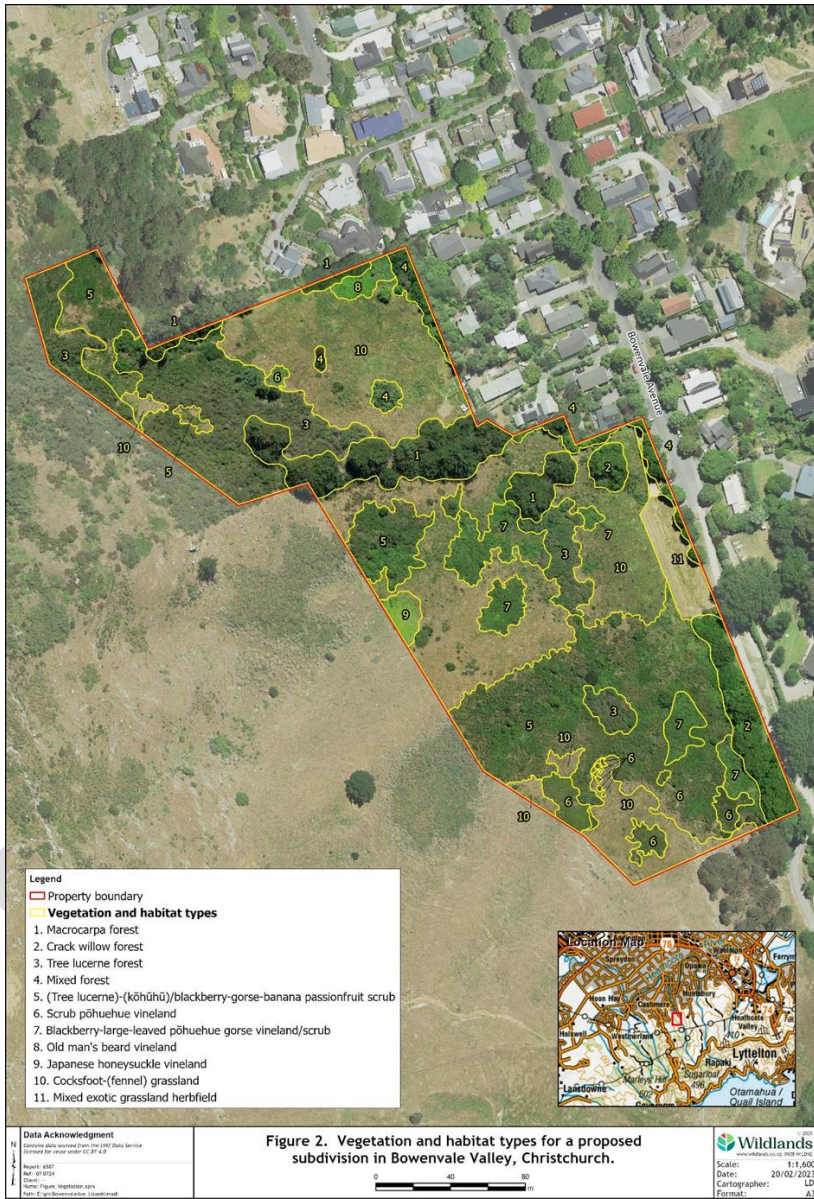
Figure 1. Vegetation and habitat types identified on site by Wildlands. Source: Wildland Consultants (2023).

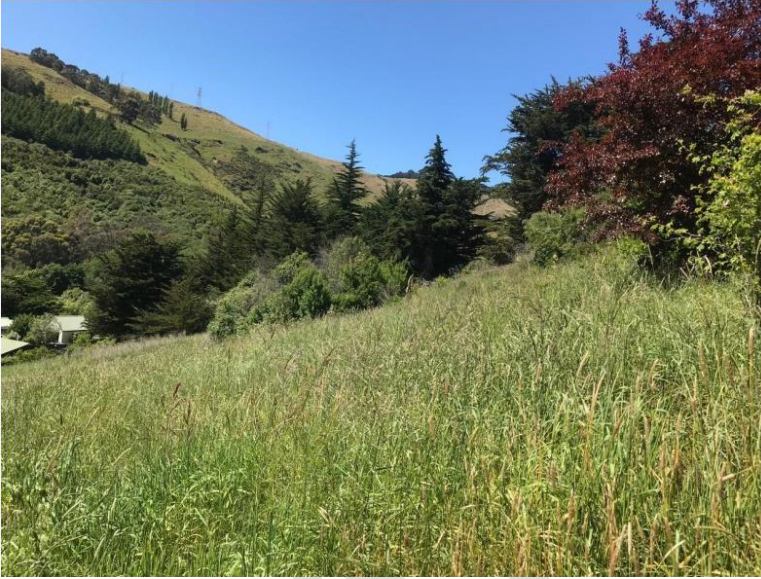
Figure 2. Rank exotic grassland at the northern end of the site at 130 Bowenvale Avenue (Source: Wildland Consultants, 2023)

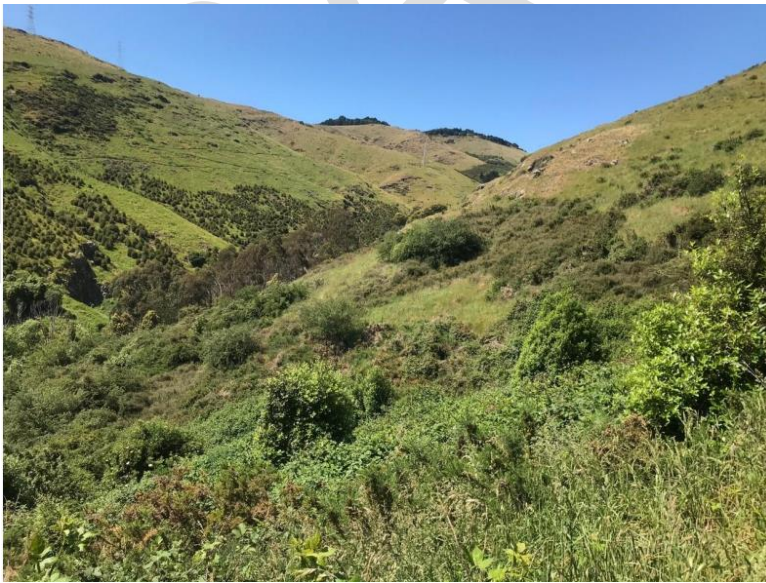
Figure 3. Mixed indigenous-exotic scrub with patches of rank grassland in the central area of the site at 130 Bowenvale Avenue (Source: Wildlands, 2023).

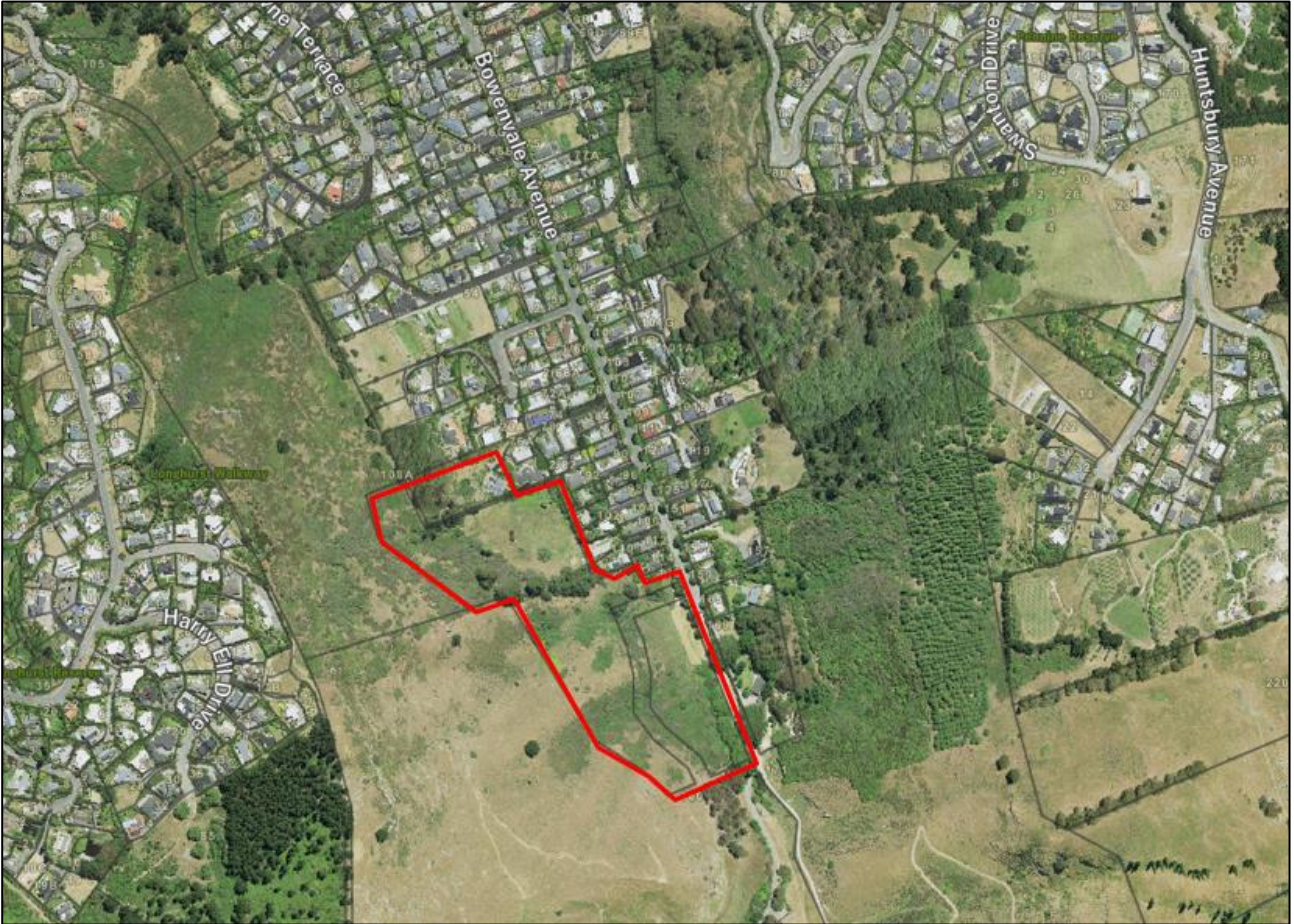
The project is a residential subdivision of land zoned 'Residential Hills' at the end of Bowenvale Avenue, as outlined in **Figure 1-1** below.

Figure 1-1. Site Outline

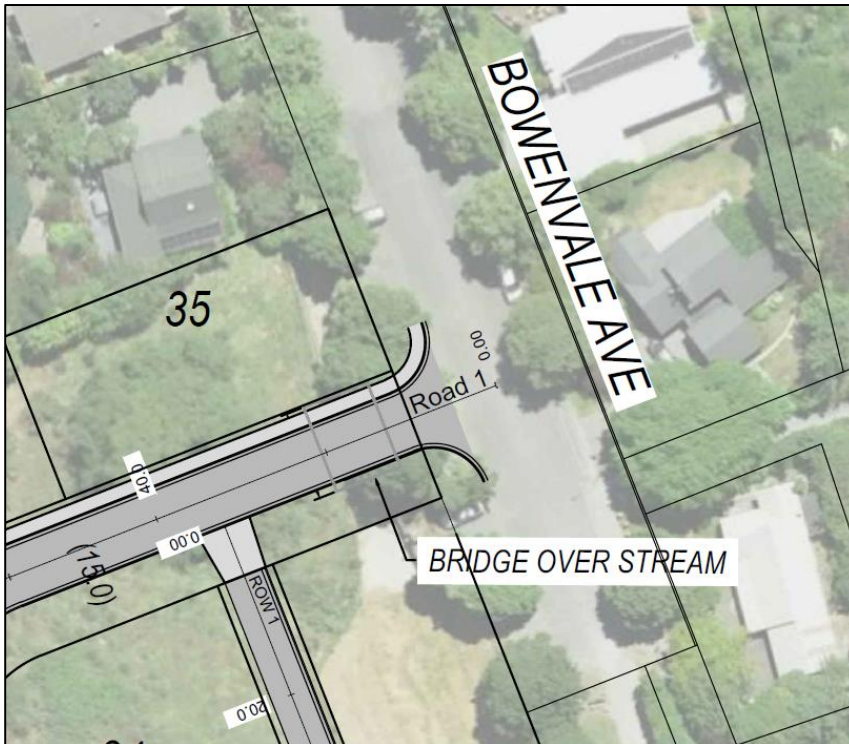
Road 1 is proposed to meet Bowenvale Avenue at a T-intersection (**Figure 2-1**). It is considered that a basic T-intersection will be appropriate however there will be several matters to be considered through the detailed design stage.

Figure 2-1: Bowenvale Avenue / Road 1 Intersection

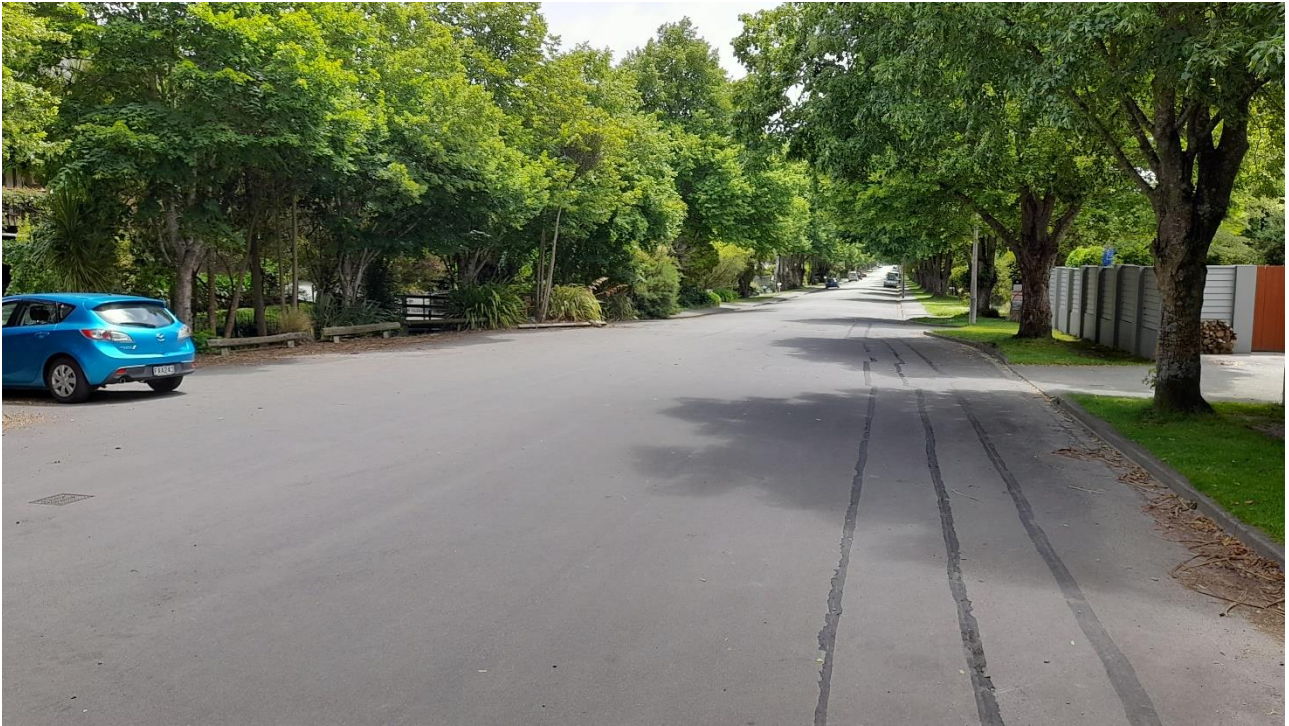
The intersection location is near the end of Bowenvale Avenue, where there is 90-degree car parking on the western side of the road and kerbside parking available on the eastern side of the road (**Photograph 2-1**).

Photograph 2-1: Bowenvale Avenue Looking North at Proposed Intersection Location

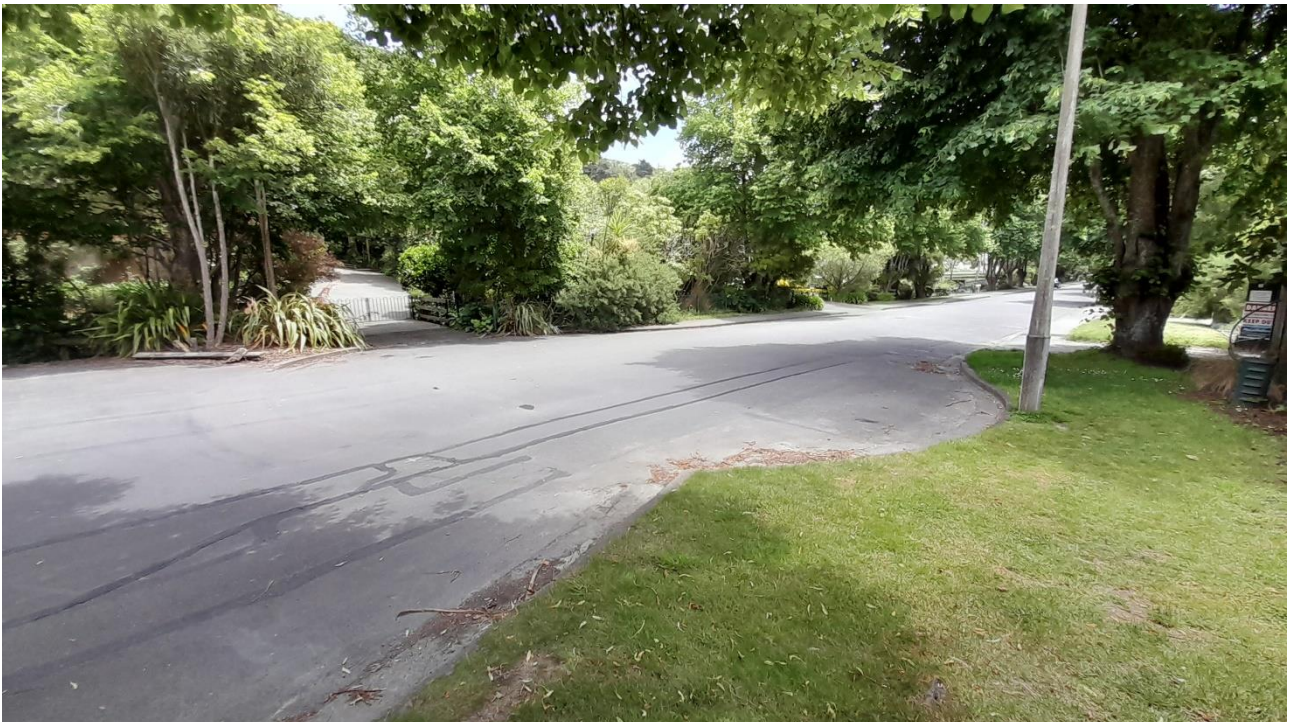
The footpaths on Bowenvale Avenue stop north of a turning head outside 114 Bowenvale Avenue (**Photograph 2-2**). It is considered that the existing footpath on the western side of the road should be extended to connect to the Road 1 footpath to provide a safe and convenient link for pedestrians.

Photograph 2-2: Existing Turning Head at 114 Bowenvale Avenue

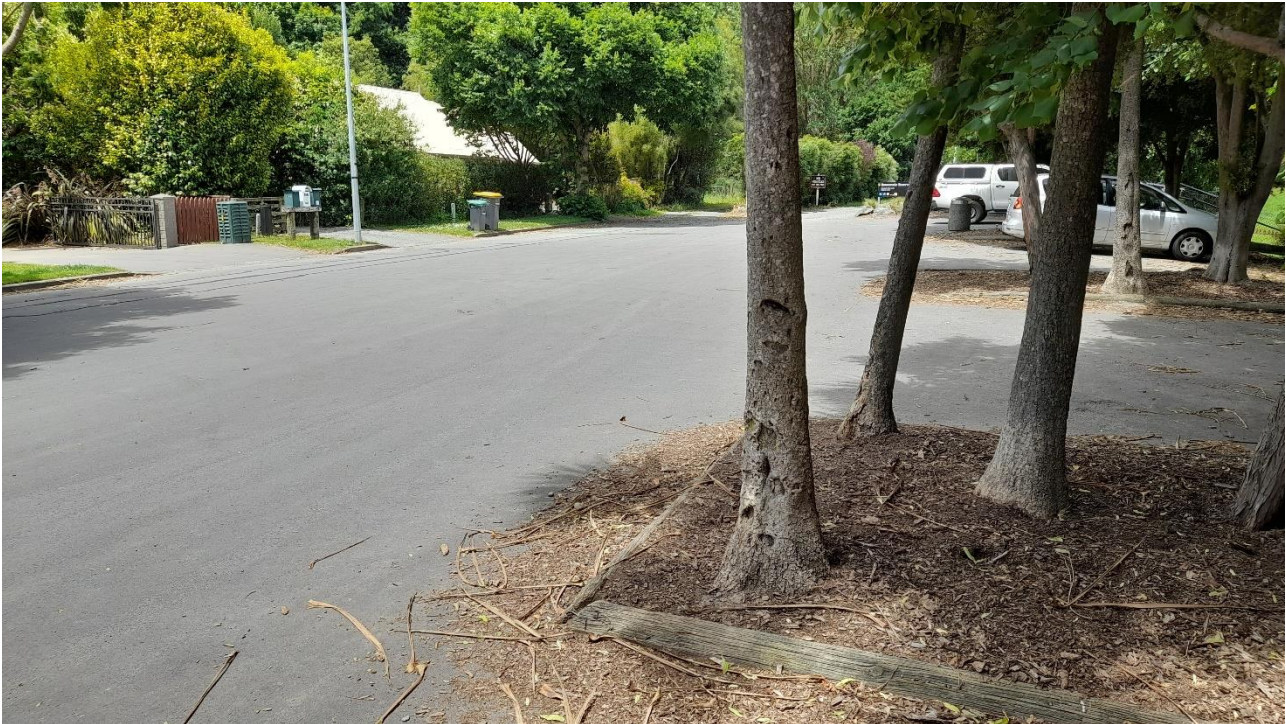
Photograph 2-3 shows the sightline to the right from the approximate intersection location. The trees visible could obstruct visibility to the right, particularly to a cyclist who has just ridden out of the park. It will be necessary through the intersection detailed design to ensure that suitable visibility is available to vehicles and cyclists. Narrowing Bowenvale Avenue at the intersection by having kerbs extend out into the existing carriageway can be considered to provide improved sightlines and traffic calming benefits.

Photograph 2-3: Trees to Right of Intersection

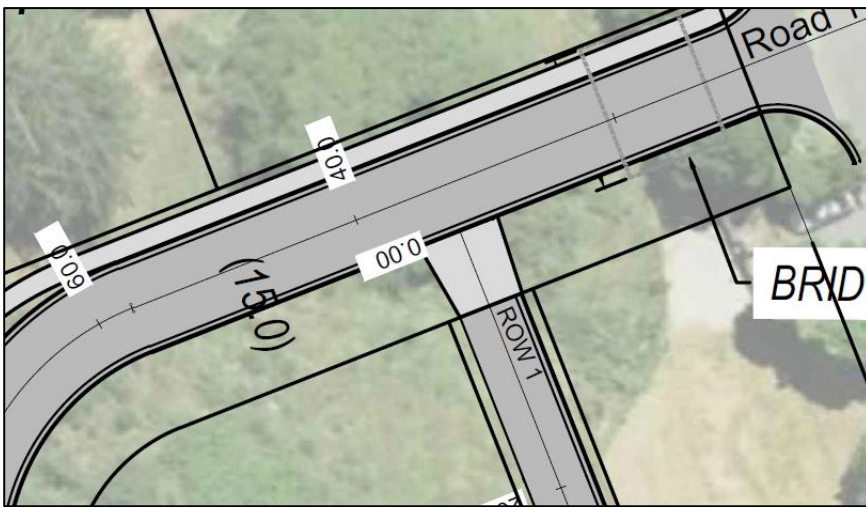
ROW 1 is proposed with a carriageway width suitable for one-way travel, and with two passing bays midway along it. There is a concern that if there are opposing drivers who meet over the initial length of the driveway (**Figure 2-2**), one may reverse back onto Road 1. It is acknowledged that vehicle speeds would be slow in this location given the proximity to the Bowenvale Avenue intersection and the narrow carriageway. However, reversing vehicles are hazards to all road users including vulnerable road users such as cyclists.

Figure 2-2: Initial Length of ROW 1

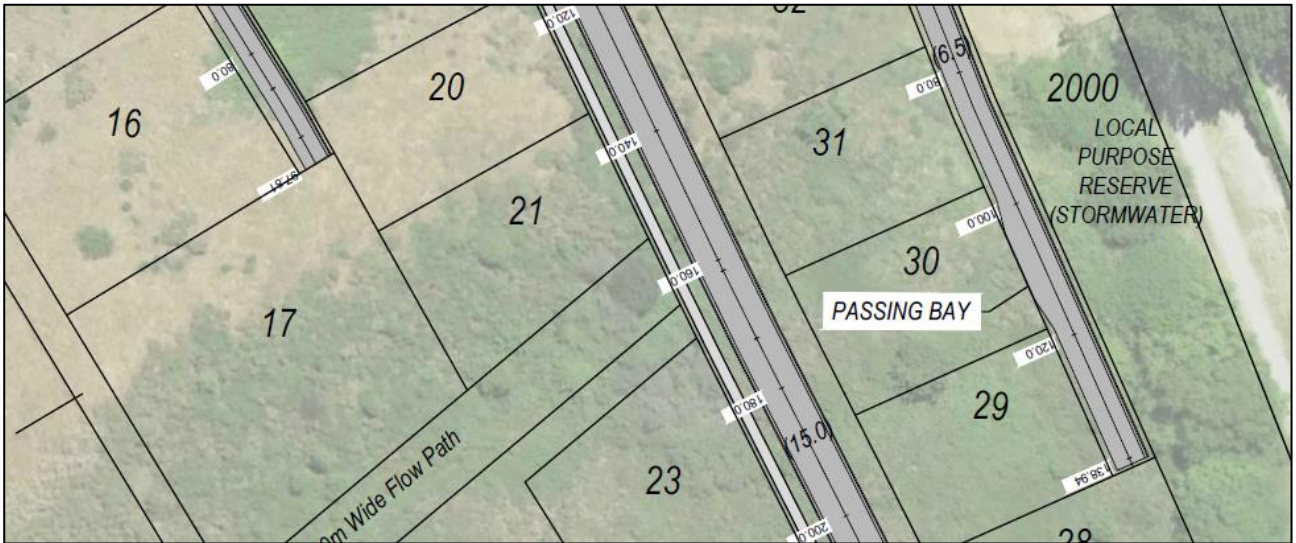
It is acknowledged that there would be a low demand for turning at the end of the ROWs since drivers would be expected to be able to turn at the properties they are visiting.

Figure 2-4: Ends of ROW 1 and ROW 3

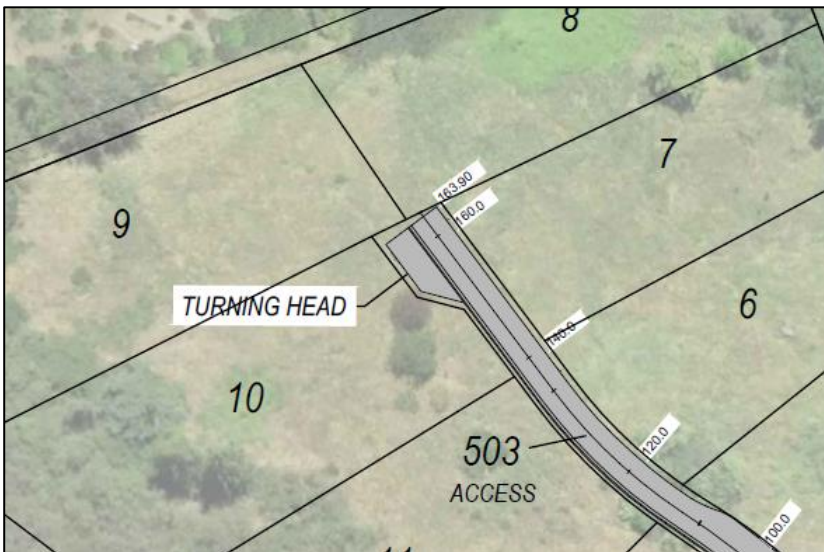
A turning head is indicated at the end of ROW 2 (Figure 2-5). Its size does not look standard and if a vehicle cannot use it to turnaround, the same safety concerns as raised for ROWs 1 and 3 would exist.

Figure 2-5: End of ROW 2
