**APPLICATION FOR RESOURCE CONSENT RMA/2023/597
ADDRESS 130 BOWENVALE AVENUE**

Thank you for your application for resource consent for 35 lot fee simple subdivision on the above site, which we received on 11th April 2023.

BOWENVALE AVENUE SUBDIVISION
PRELIMINARY DESIGN ROAD SAFETY AUDIT

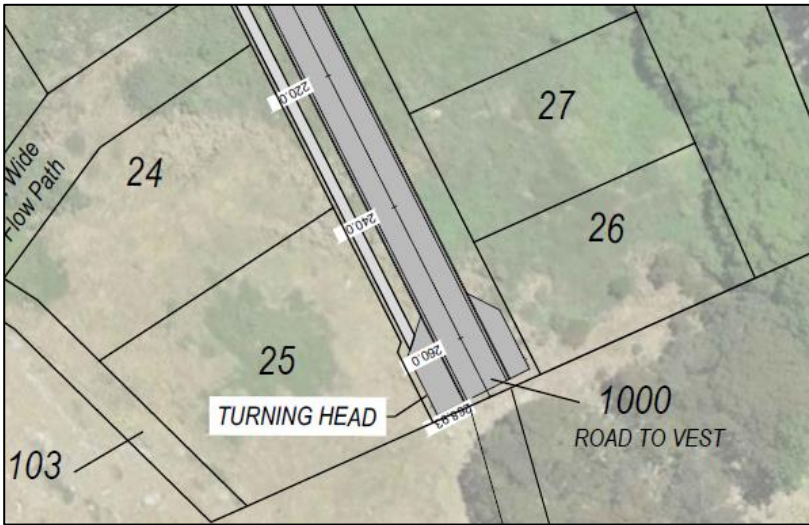
to reverse over a long distance. A reversing truck is a hazard to all road users and particularly vulnerable road users.

Figure 2-6: End of Road 1

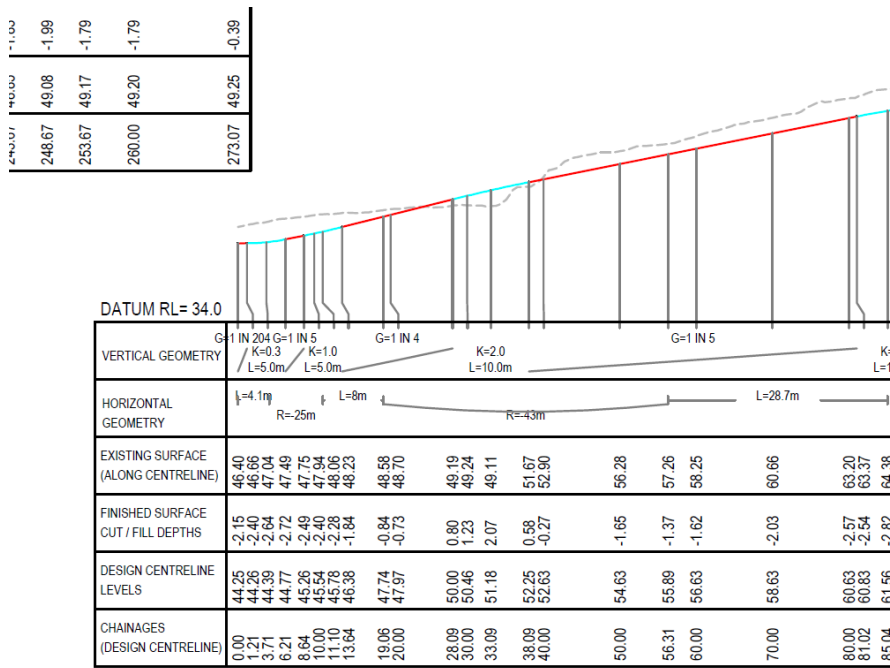
ROW 2 has a centreline gradient of 1 in 5 and ROW 3 has a section with a centreline gradient of 1 in 4 (Figure 2-7). These are steep gradients and the driveways may be difficult to access by vehicle or foot in icy conditions. Drivers could lose control of their vehicles or pedestrians could fall over.

ROW 3 LONGSECTION (CENTRELINE LEVEL)

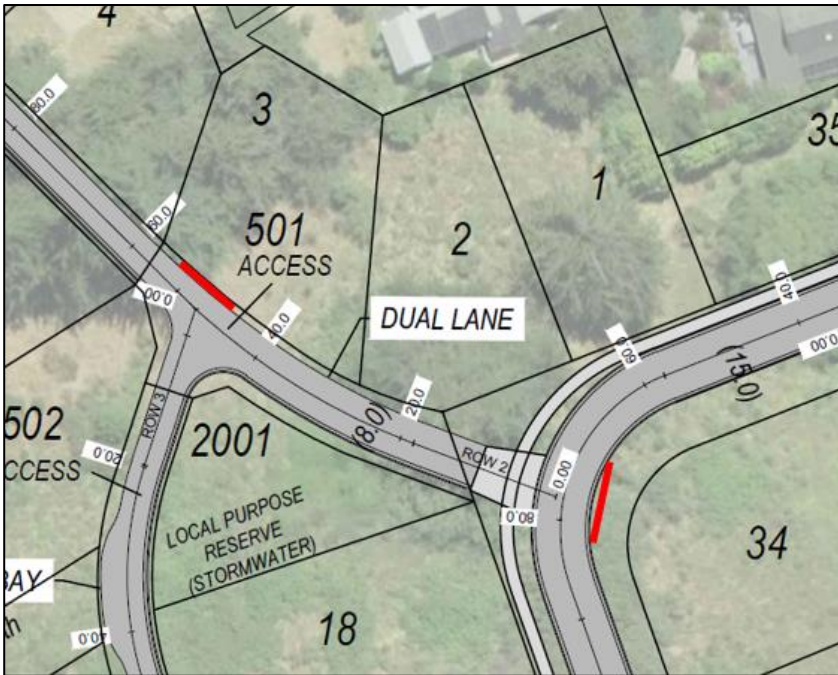
With the steep grades on ROW 2 and ROW 3, there is the potential for a driver to lose control of their vehicle in wet or icy conditions. There is a concern that an out-of-control vehicle could continue off the end of ROW 3 or ROW 2 into a property below. **Figure 2-8** indicates locations where vehicle barriers should be considered (noting these are indicative and a full design will be required to determine the length of need at these locations).

Figure 2-8: Indicative Edge Protection Opposite ROWs

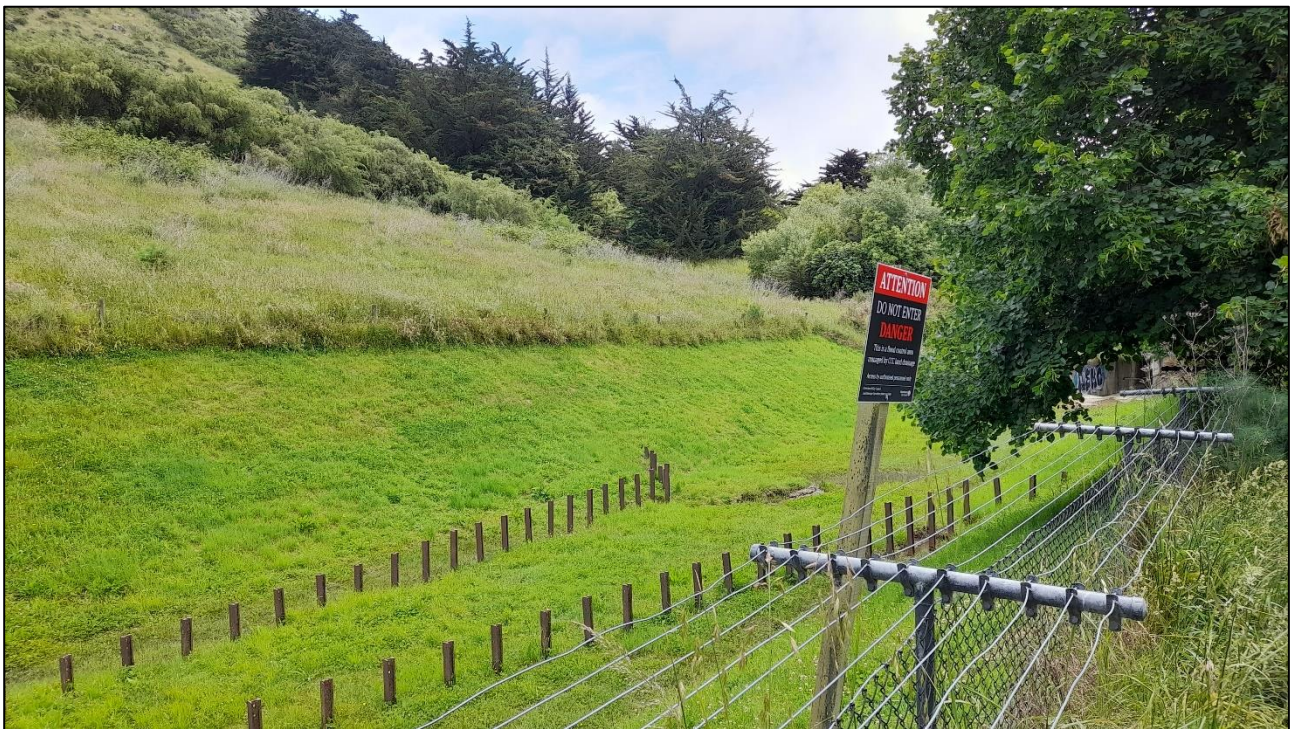
Photograph 2-4: Stormwater Area Adjacent to ROW 1

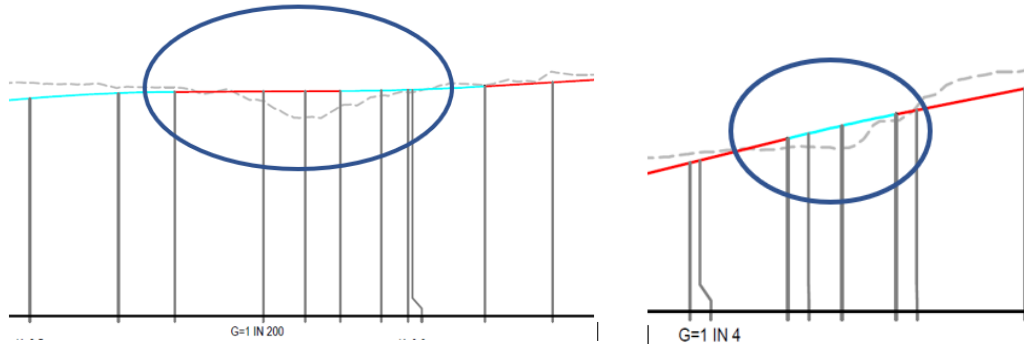
Figure 2-10: Instances of Road Level above Surrounding Ground Level- Road 1 Left, ROW 3 Right

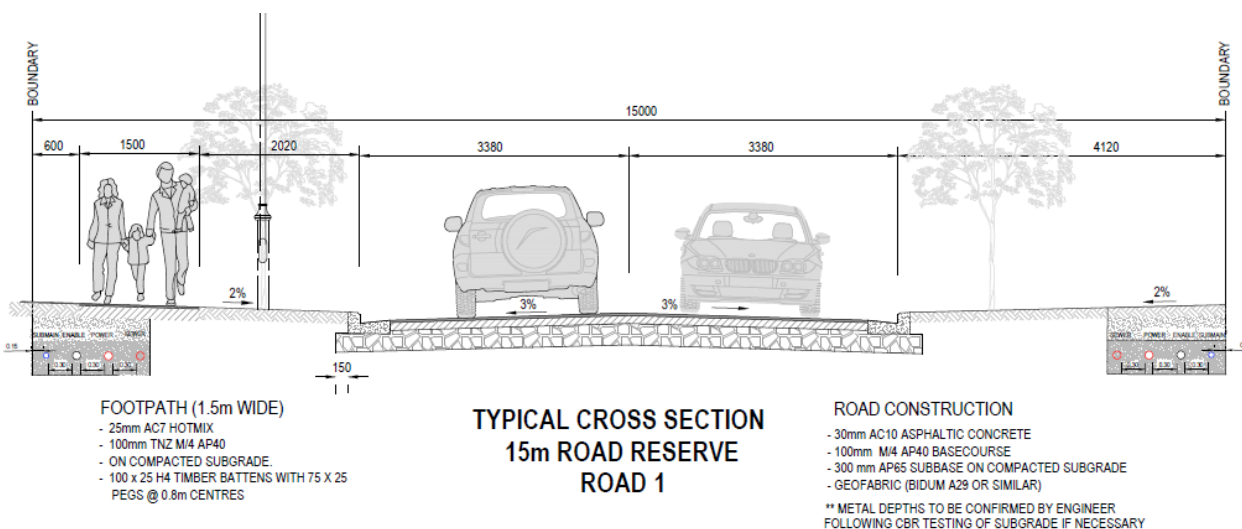
Figure 2-11: Proposed Road 1 Cross-Section
