Application for Resource Consent: Subdivision

Resource Management Act 1991 – Form 9

130 Bowenvale Avenue Cashmere

Part Lot 2 DP 33462

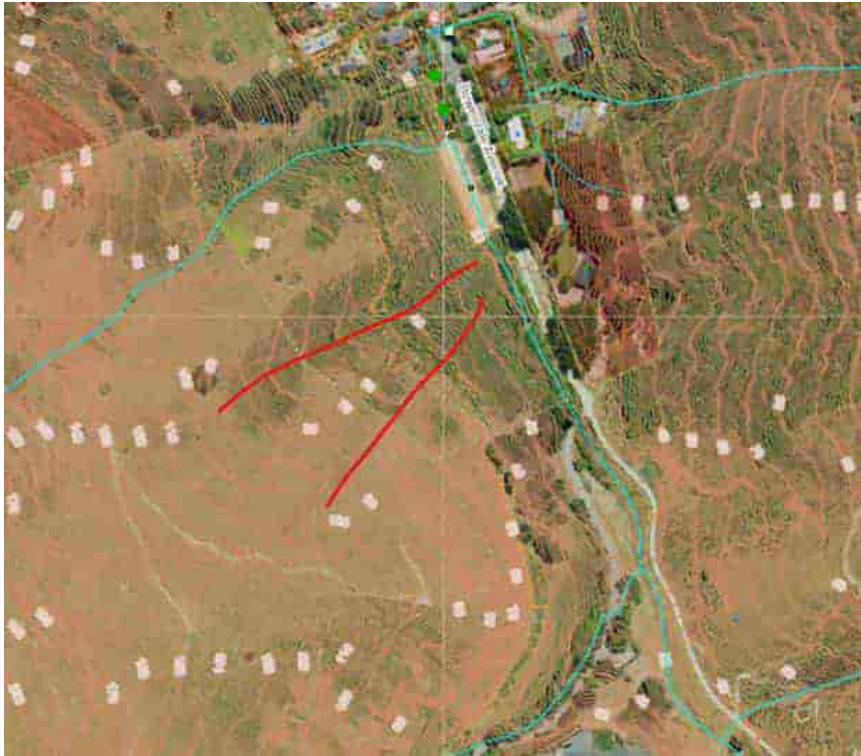
Figure 4: Environmental and Hill Waterways

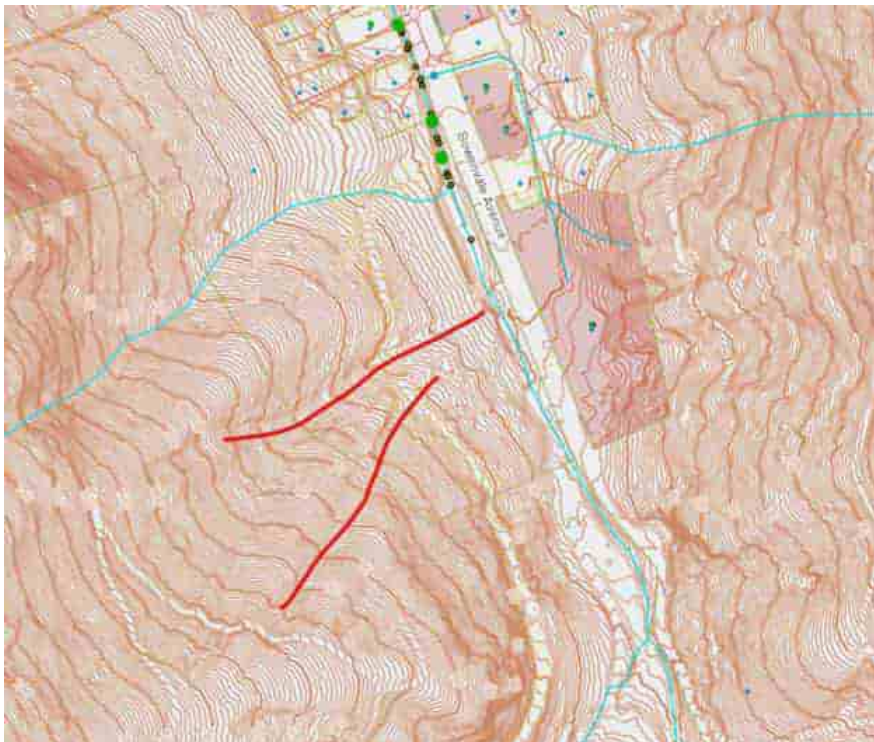
Figure 5: Environmental and Hill Waterways

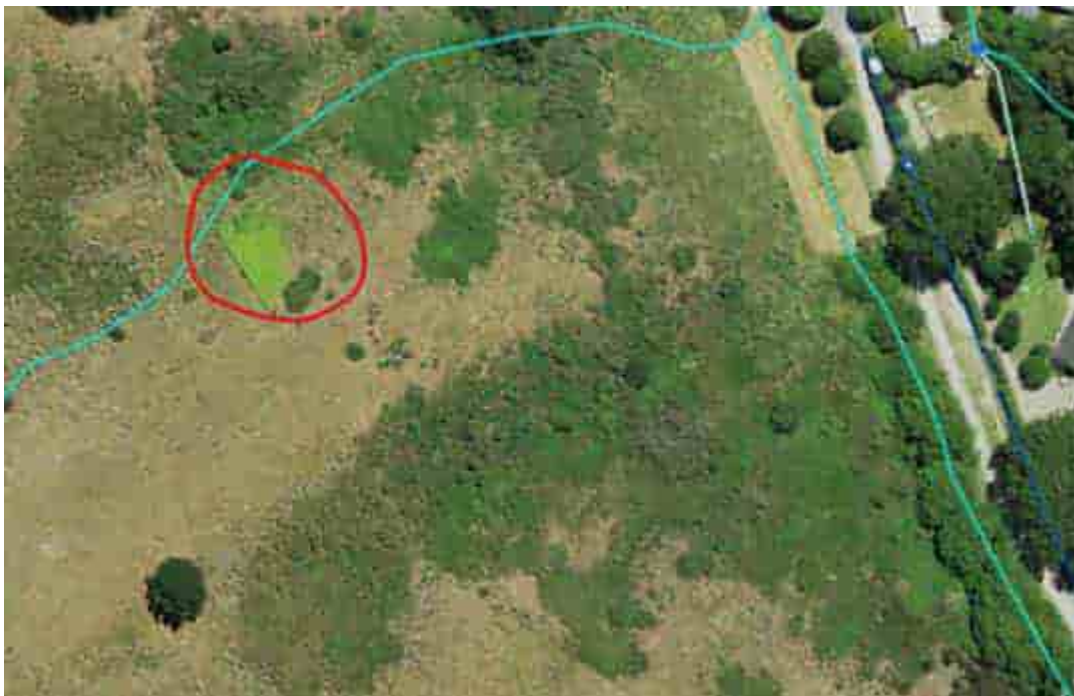
Council records show a potential wet area as shown below, but the aquatic ecology report confirms that there are no wetland areas/ponding within the site and the gradient of the site makes ponding highly unlikely.

Figure 8: Council records showing wet area

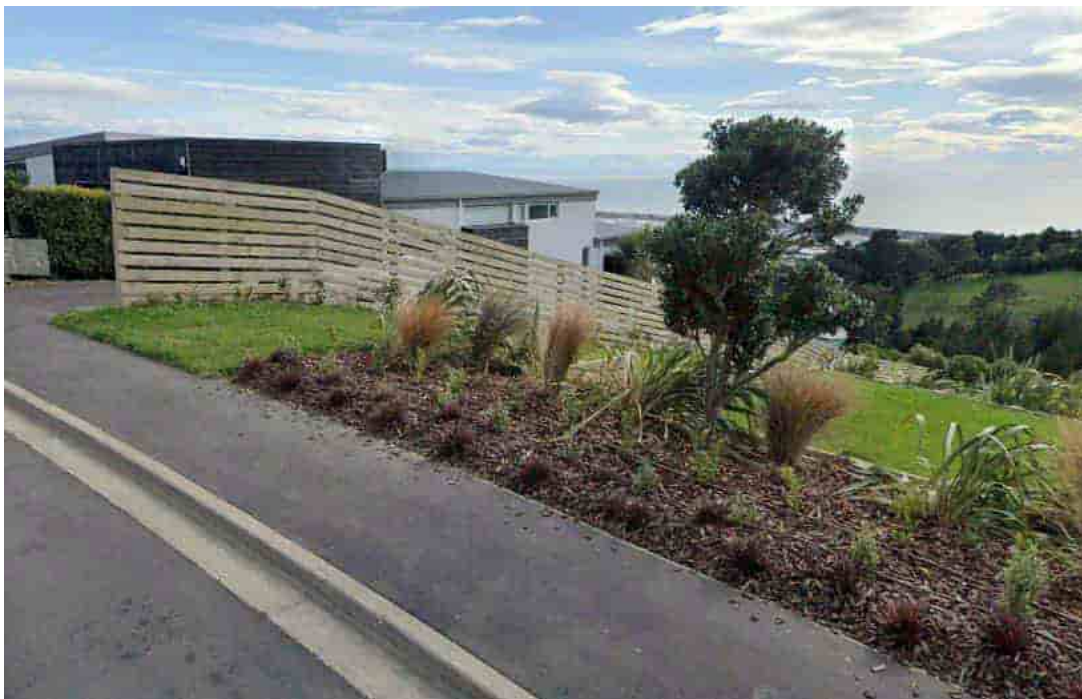
The below shows the internal fencing considered between lots, but with 1m height for 3m from the road/access lot boundary with an increase to 1.8m for the remainder of the boundary.

Figure 9: Possible internal boundary fencing between lots

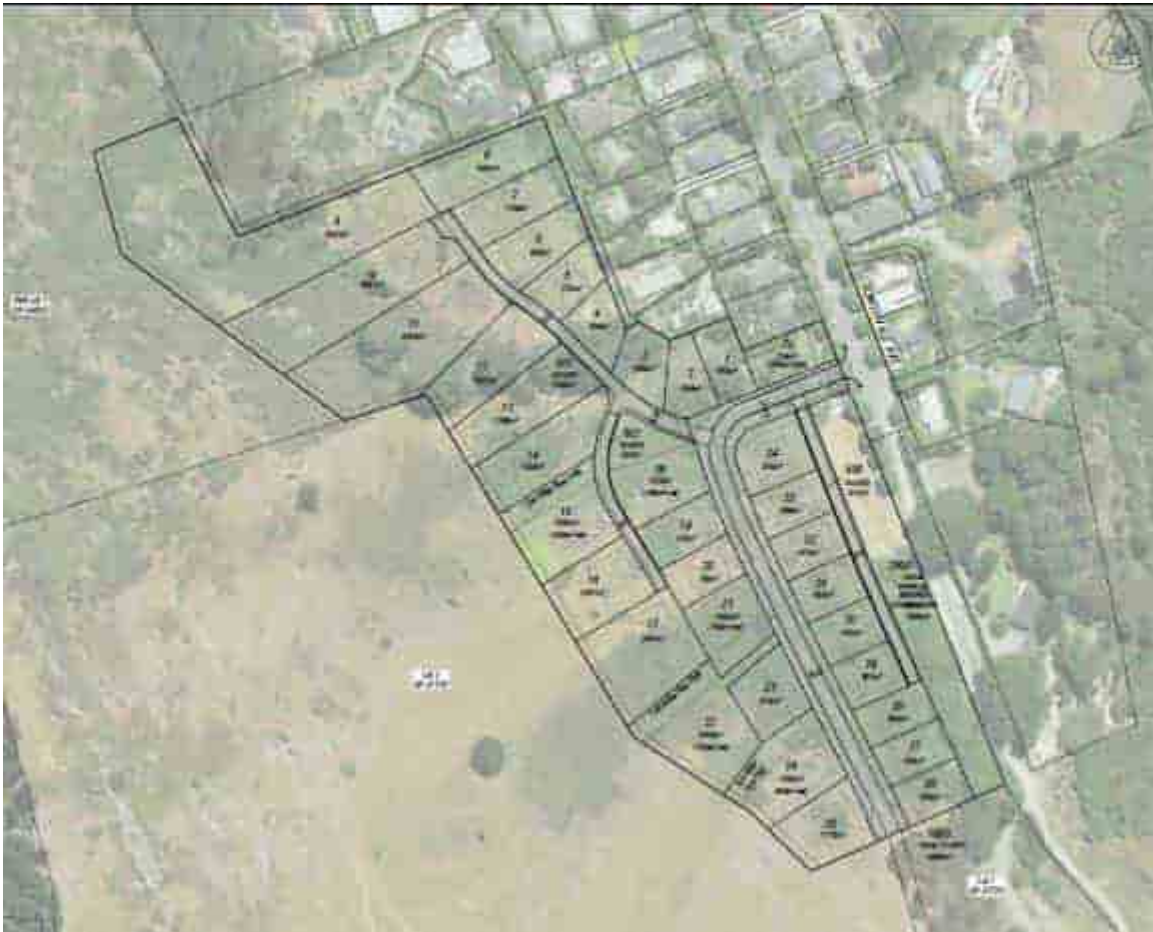
Figure 1: Proposed subdivision

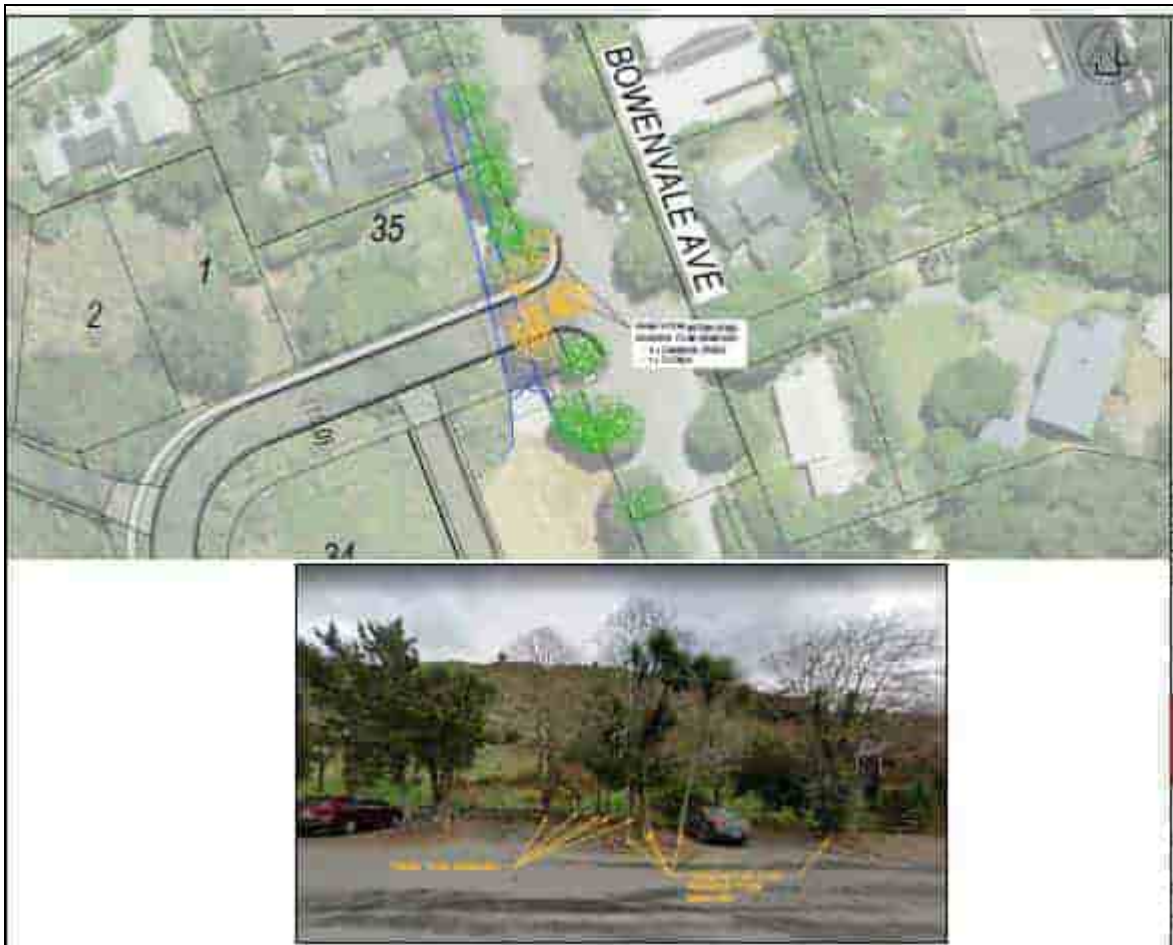
Cabbage tree - in very poor condition overall not a public realm tree (less than 6m in height)

Cabbage tree - in poor condition overall protected as public realm (greater than 6m in height)

Figure 2: Trees affected by the proposed access

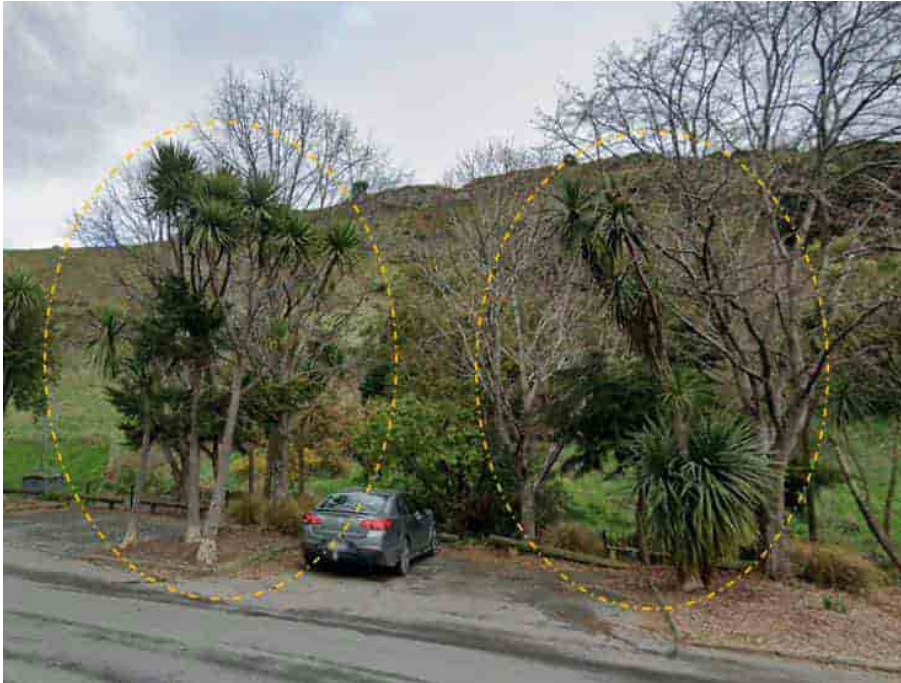
Figure 3: Trees to be removed - Winter

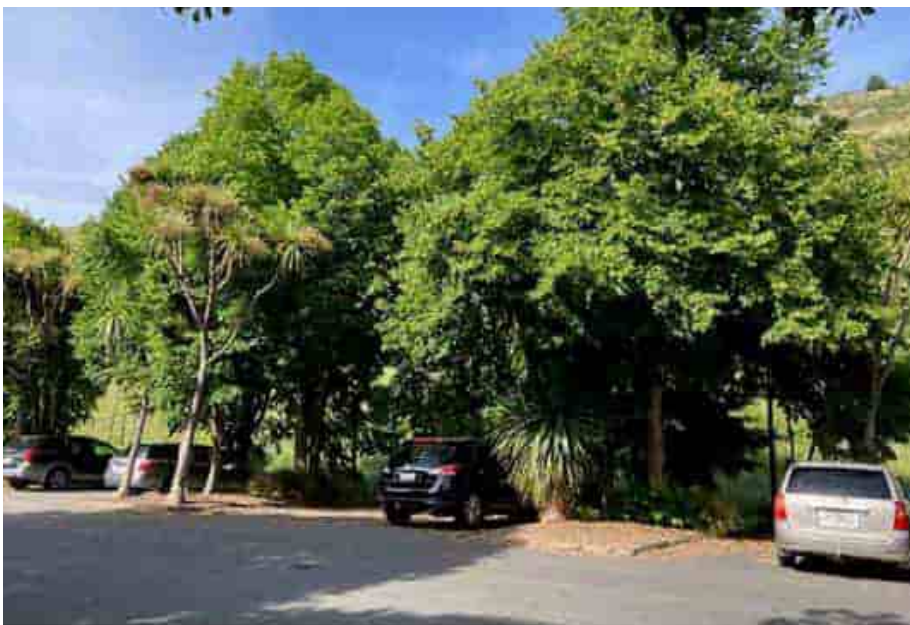
Figure 4: Trees to be removed - Summer

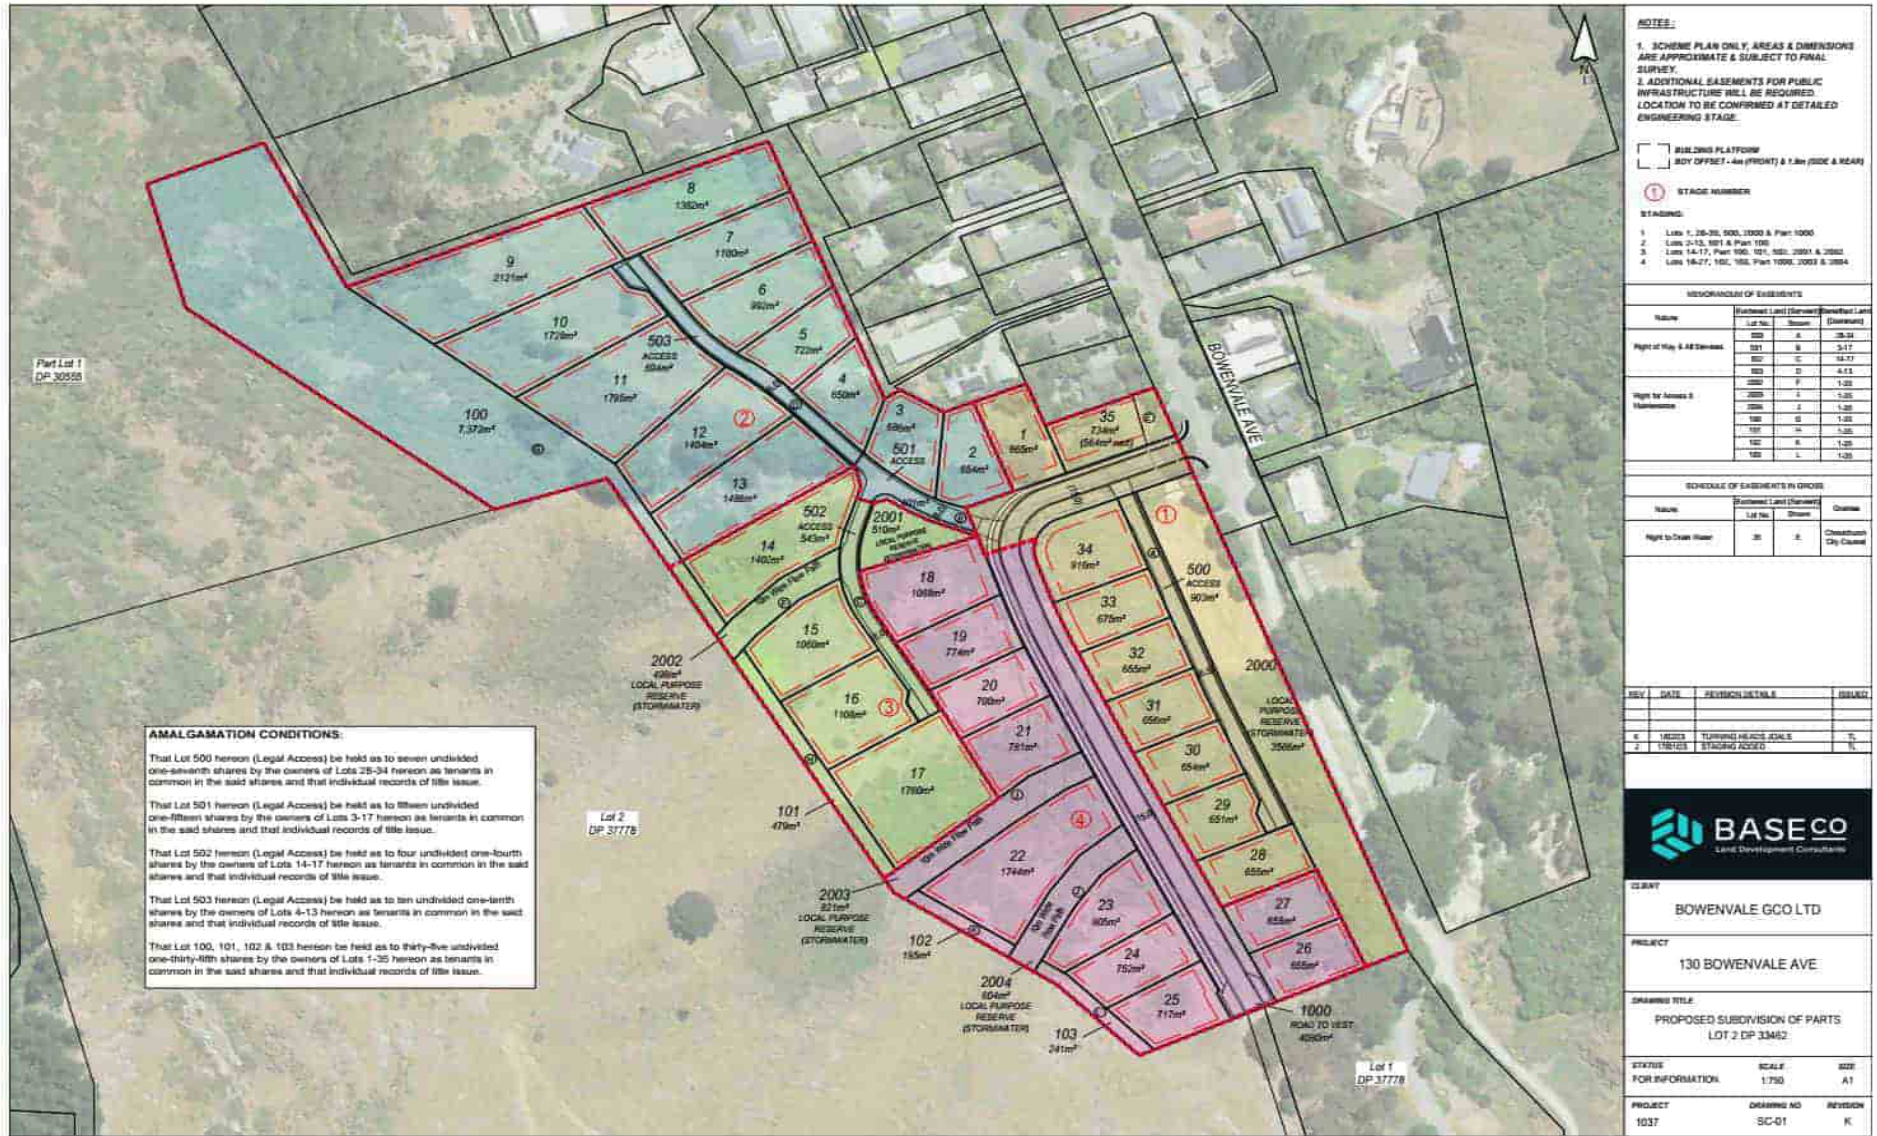
Figure 1: Project site and subdivision plan, provided by Base Co Ltd on behalf of Bowenvale GCO Ltd.

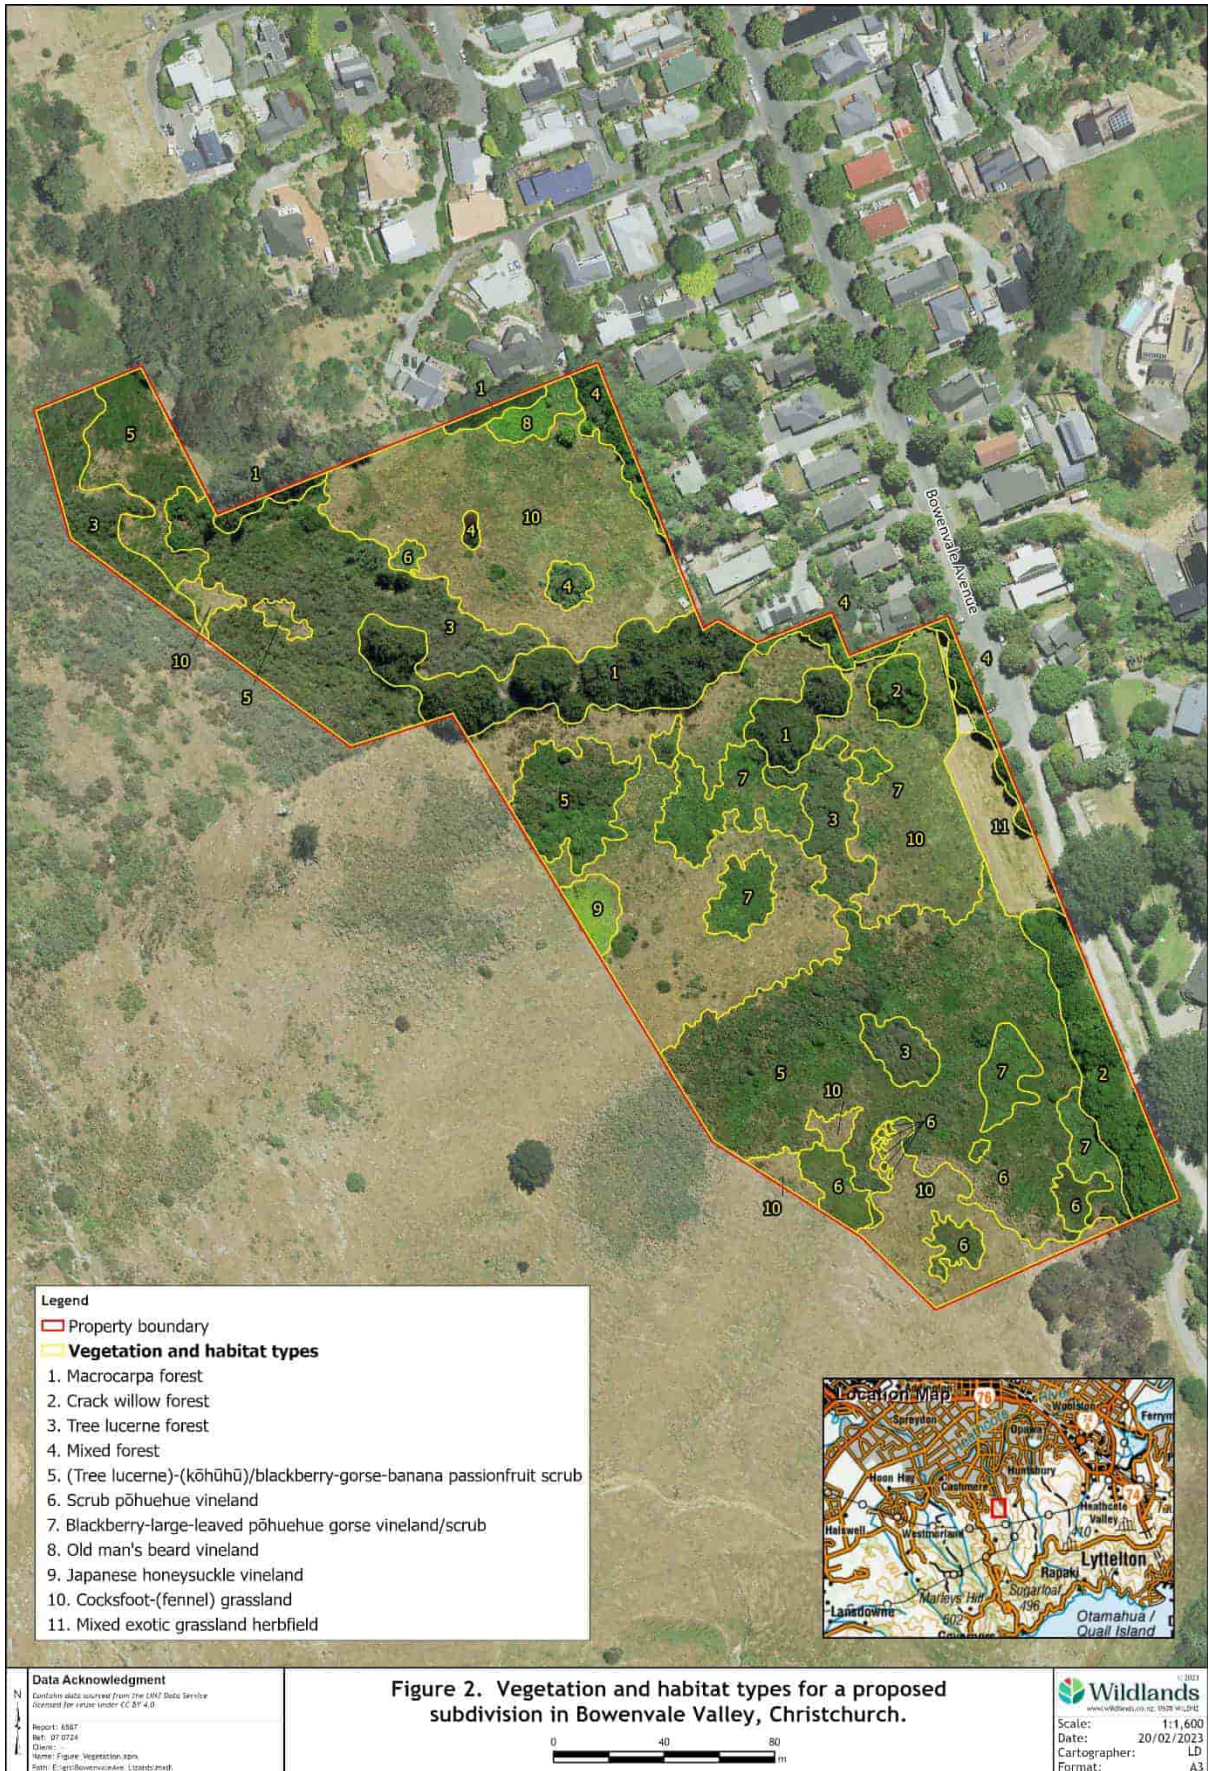
The field survey delineated 11 vegetation and habitats across the site (Figure 2):

1. Macrocarpa forest (c. 0.43 hectares)
2. Crack willow forest (c.0.23 hectares)
3. Tree lucerne forest (c.0.86 hectares)
4. Mixed forest (c. 0.14 hectares)
5. (Tree lucerne)-(kōhūhū)/blackberry-gorse-banana passionfruit scrub (c. 1.36 hectares)
6. Scrub pōhuehue vineland (c. 0.11 hectares)
7. Blackberry-large-leaved pōhuehue gorse vineland/scrub (c. 0.30 hectares)
8. Old man's beard vineland (c. 0.04 hectares)
9. Japanese honeysuckle vineland (c. 0.04 hectares)
10. Cocksfoot-(fennel) grassland (c. 1.97 hectares)
11. Mixed exotic grassland herbfield (c. 0.12 hectares)

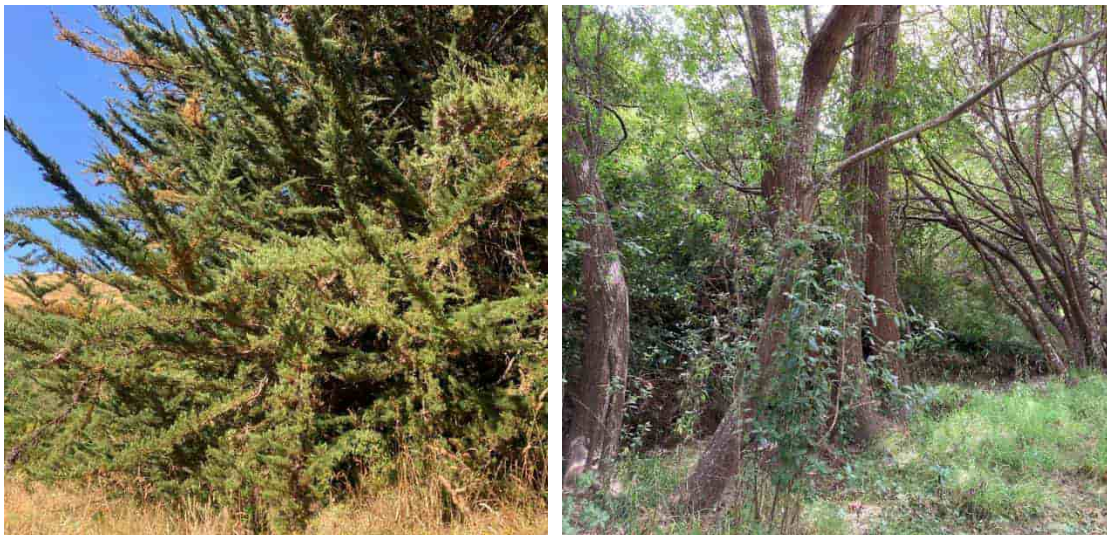
Crack willow (*Salix ×fragilis*) mostly occurs along the Bowenvale stream boundary of the site. The canopy is predominantly crack willow, with some indigenous subcanopy species including kōhūhū (*Pittosporum tenuifolium*), tarātā (*Pittosporum eugenioides*) and cabbage tree/tī kōuka (*Cordyline australis*). Grey willow (*Salix cinerea*) is also present and occasionally reaches the canopy. Indigenous understory species present include kāpuka (*Griselinia littoralis*), pigeonwood/porokaiwhiri (*Hedycarya arborea*), five-finger/whauwhaupaku (*Pseudopanax arboreus*) and lancewood/horoeka (*Pseudopanax crassifolius*). Ferns, including thousand-leaved fern (*Hypolepis millefolium*), prickly shield fern/pūniu (*Polystichum vestitum*), and sedges (*Carex diandra*, *C. species*), which are common along the line of the stream (Plate 1).

Plate 1: Macrocarpa forest (left) and understory of crack willow forest (right)

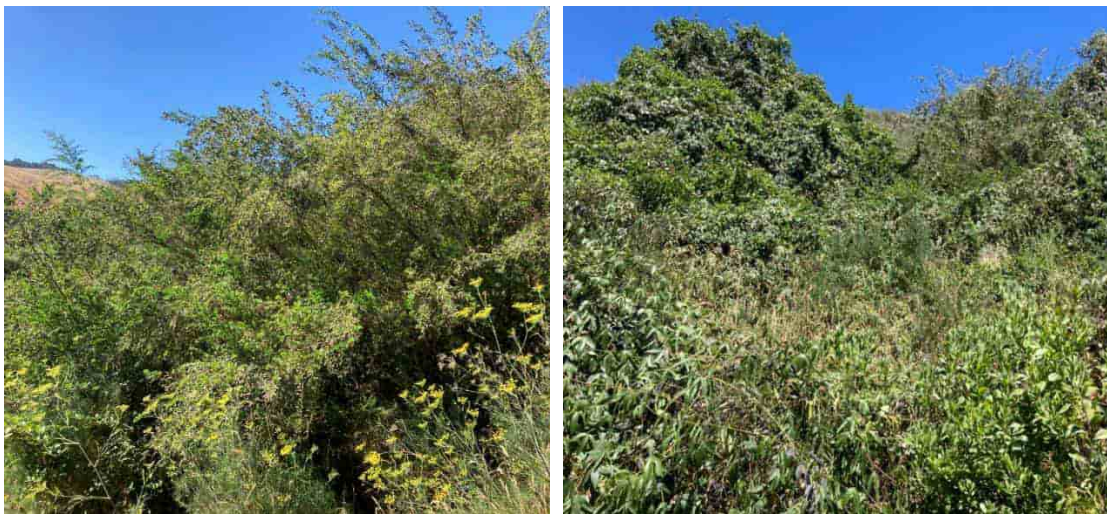
This scrub type is scattered across much of the site, and is most abundant towards the southern end. The canopy is variable, with scattered tree lucerne and kōhūhū, often draped in banana passionfruit or large-leaved pōhuehue, emergent above the lower stature gorse and blackberry (Plate 2). Occasional patches of the indigenous scrub pōhuehue (*Muehlenbeckia complexa*) are also present, as well as exotic shrubs including broom, sweet briar (*Rosa rubiginosa*) and cotoneaster (*Cotoneaster glaucophyllus*). The dense canopy mostly excludes understorey tiers, but rank cocksfoot (*Dactylis glomerata*) is common in canopy gaps.

Plate 2: Tree lucerne forest (left) and (tree lucerne)-(kōhūhū)/blackberry-gorse-banana passionfruit scrub (right).

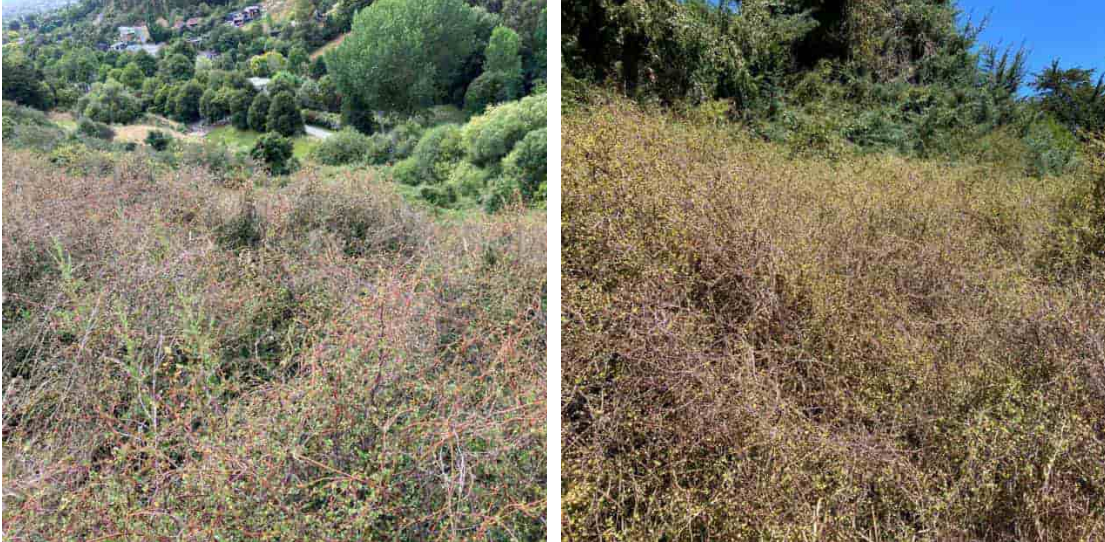
Small patches of indigenous scrub pōhuehue vineland are scattered across the site, although it is most common towards the southern boundary. The low (1-2 m) canopy is dominated by densely tangled scrub pōhuehue, which is interspersed with occasional gorse, blackberry and sweet briar (Plate 3).

Plate 3: scrub pōhuehue vineland in the south of the site (left), and the only patch in the north of the site (right).

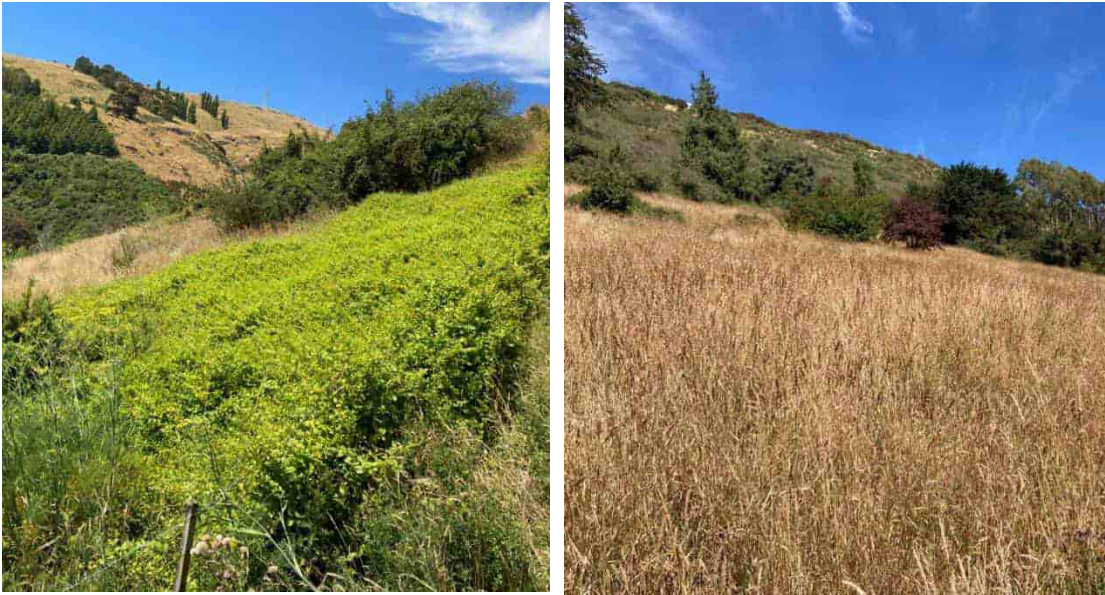
Plate 4: Japanese honeysuckle vineland (left), cocksfoot-(fennel) grassland (right).

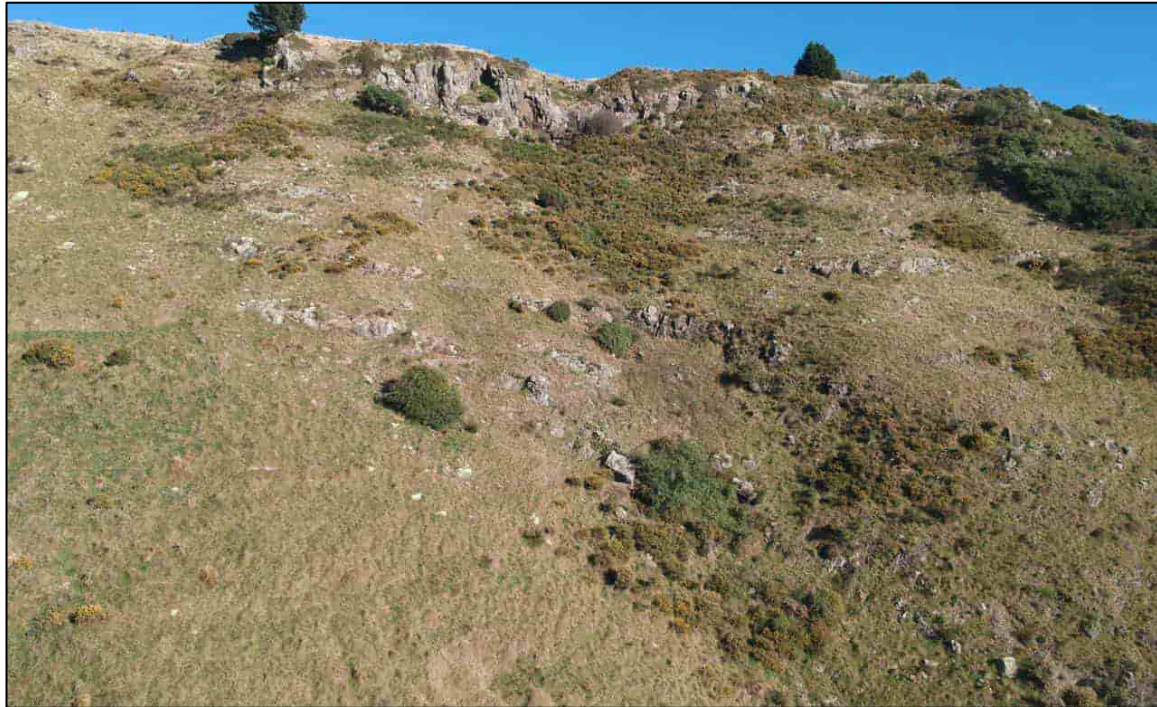
Photo 1: Ridgeline and boulder field below with blocks typically concentrated to the valleys.

Photo 2: Aerial view of the boulder field.

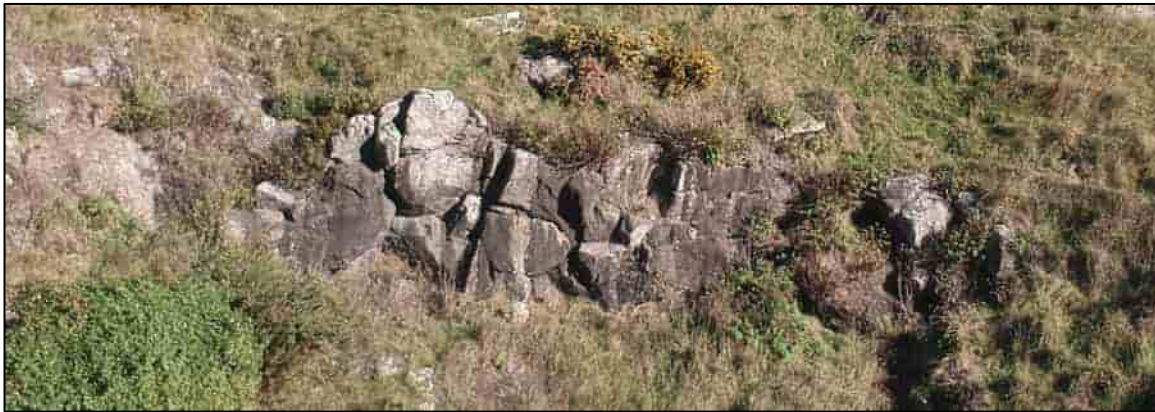
Photo 3: View of jointed basalt and what appears to be loose blocks in an outcrop source area.

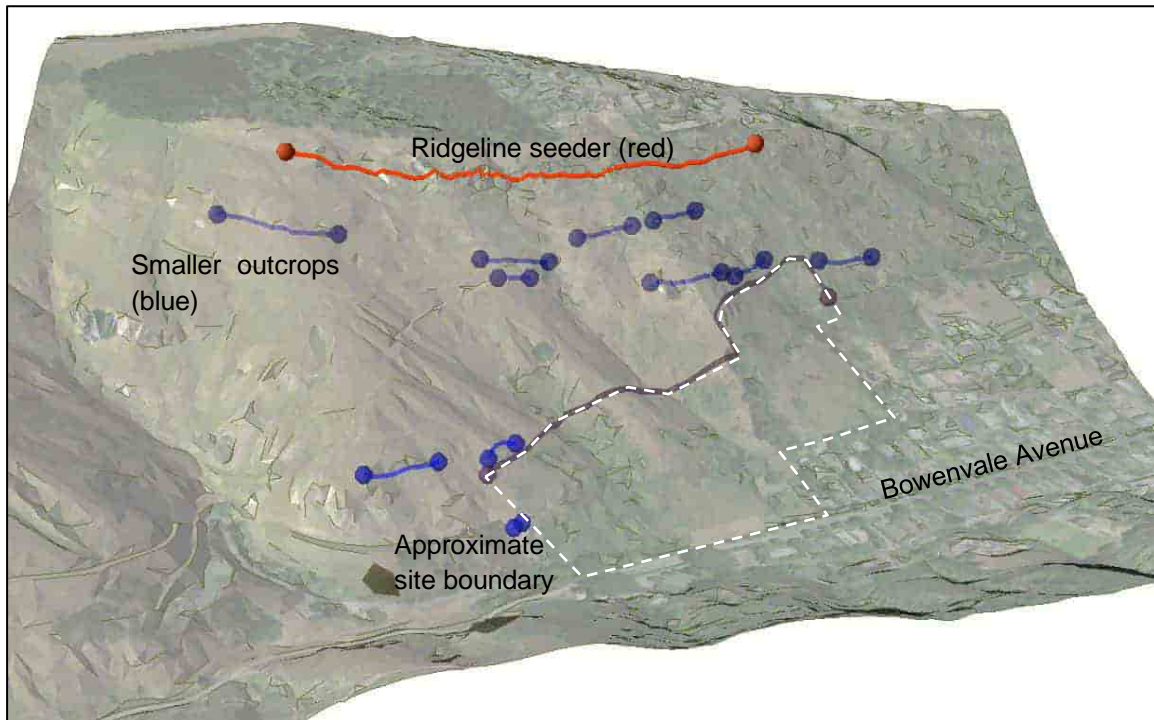
Figure 8: Line Seeders modelled on the site

Image taken from Rocfall3. Not to scale

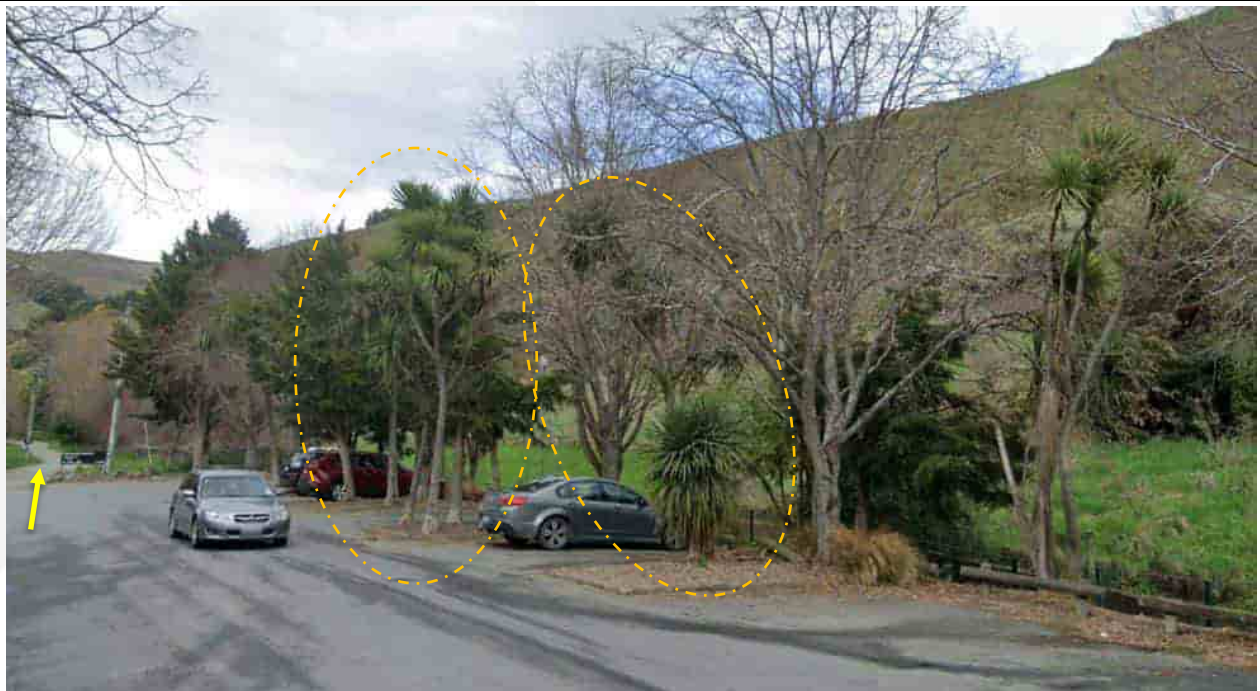
3.1.1 The section of Bowenvale Avenue and the CCC street trees with which this report relates are located at the southern end of Bowenvale Avenue where Bowenvale Avenue meets Bowenvale Valley Track. The trees are located with garden beds which separate car parking spaces for recreational users to access Bowenvale Valley Track (images 1/2).

Image 2: Southern end of Bowenvale Avenue where Bowenvale Avenue meets Bowenvale Valley Track (yellow arrow) and the CCC street trees (orange circles) with which this report relates located within the garden beds between car park spaces. *Images courtesy of Google Street View 2019.*

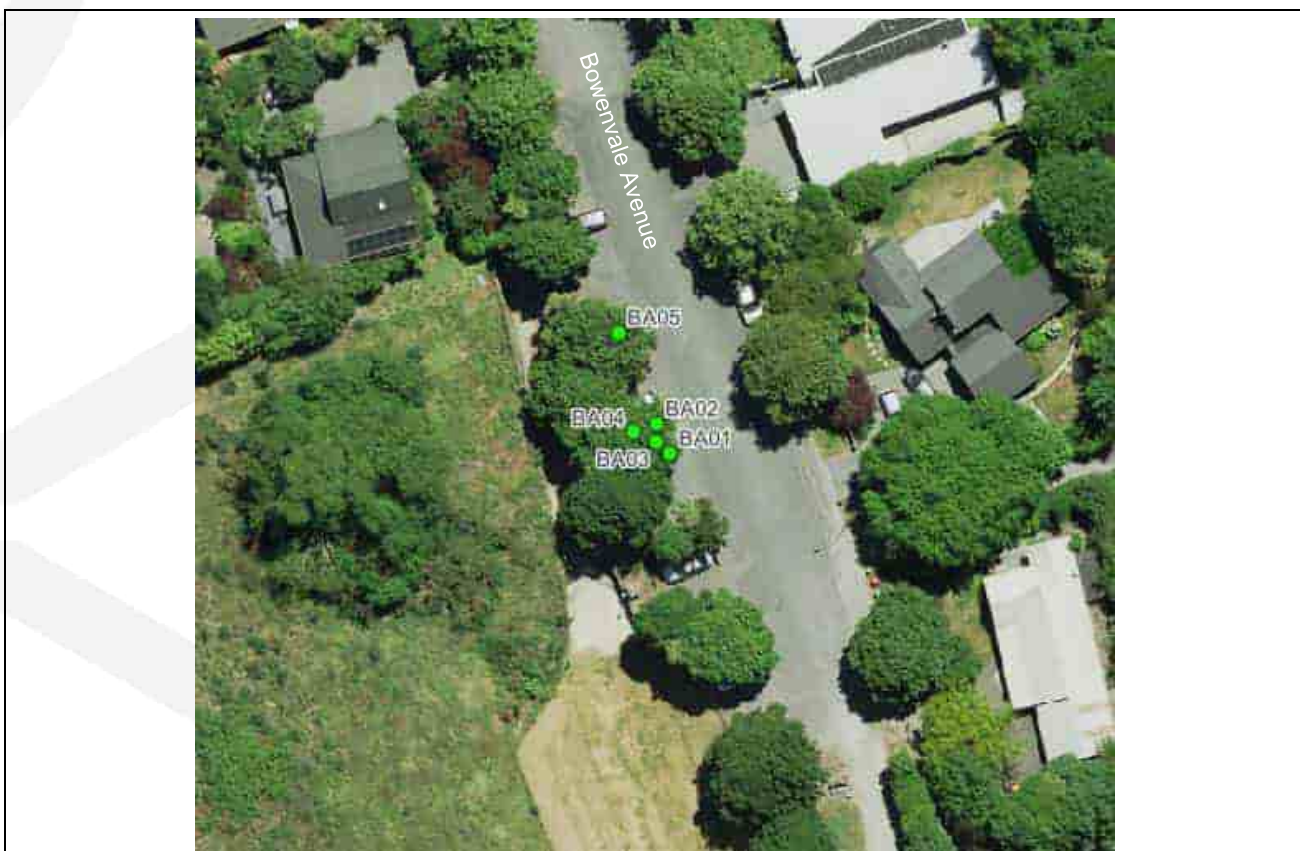
Image 3: Location of the five trees on Bowenvale Avenue.

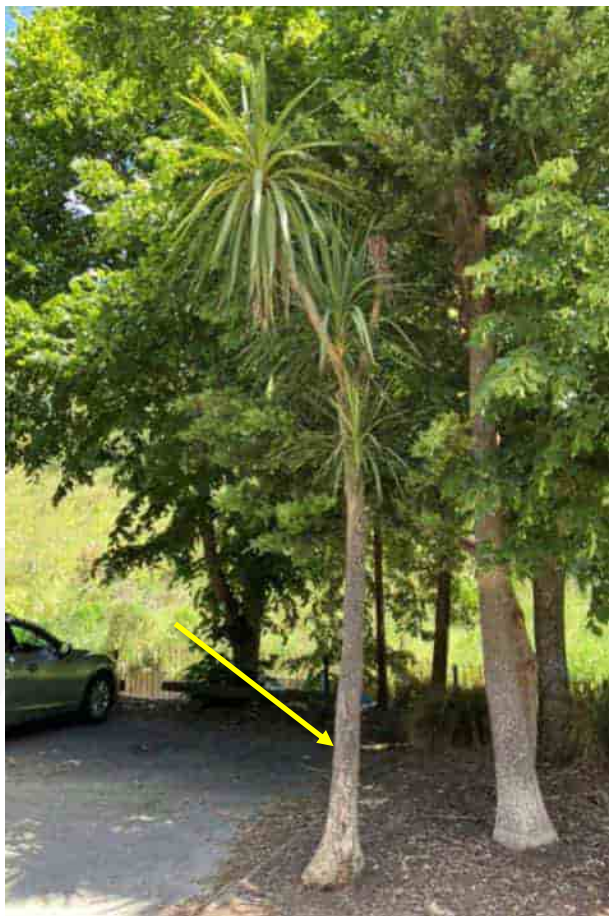
Tree ID:	BA01	
Protection status:	Non	
Native/Exotic:	Native	
Height:	4.0m	
Canopy:	0.75m	
Diameter at Breast Height:	0.150m	
¹ Health:	Poor	
¹ Structure:	Poor	
¹ Overall:	Poor

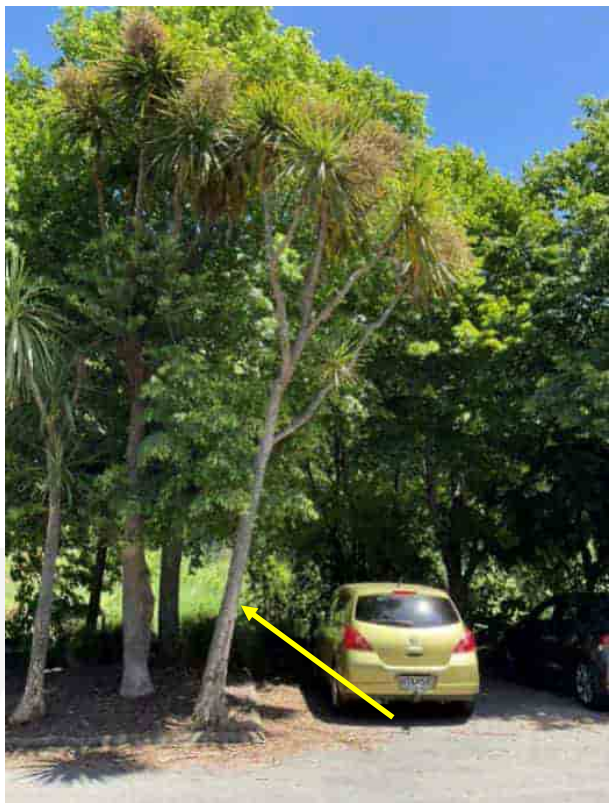
Tree ID:	BA02	
Protection status:	Public realm	
Native/Exotic:	Native	
Height:	6.2m	
Canopy:	1.5m	
Diameter at Breast Height:	0.150m	
¹ Health:	Good	
¹ Structure:	Fair	
¹ Overall:	Fair	
<p>Comments:</p> <p>¹Health - Tree is in good health with: <i>'Approximately 6-10% foliage density loss, discolouration or disease, below ideal leaf size or shoot growth, dieback, dead wood or other disorders'.</i></p> <p>¹Structure - Tree has fair structure where: <i>'Defects (including roots and trunk taper) present, but can be rectified in order to maintain the structural integrity and continued well-being of tree'.</i></p>

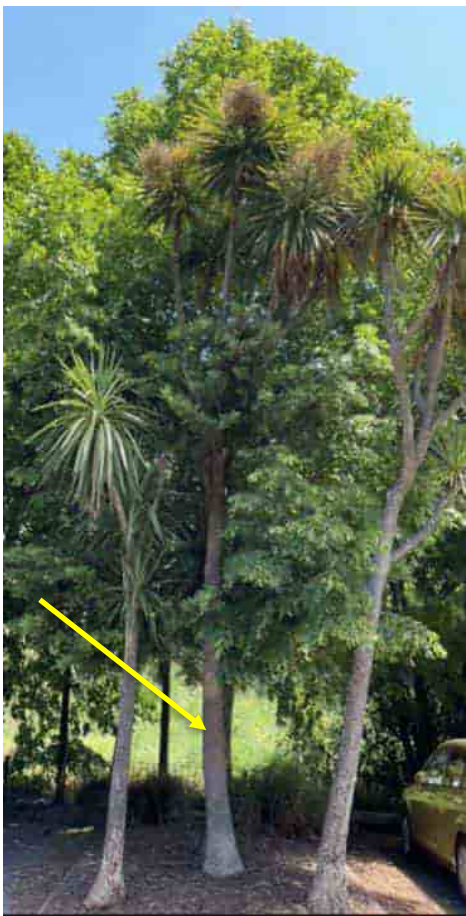
Tree ID:	BA03	
Protection status:	Public realm	
Native/Exotic:	Native	
Height:	7.1m	
Canopy:	2.0m	
Diameter at Breast Height:	0.2m	
¹ Health:	Good	
¹ Structure:	Fair	
¹ Overall:	Fair	
Comments: ¹ Health - Tree is in good health with: ‘... 6-10% foliage density loss, discoloration or disease.....’. ¹ Structure - Tree has fair structure where: ‘Defects (including roots and trunk taper) present, but can be rectified in order to maintain the structural integrity and continued well-being of tree’.

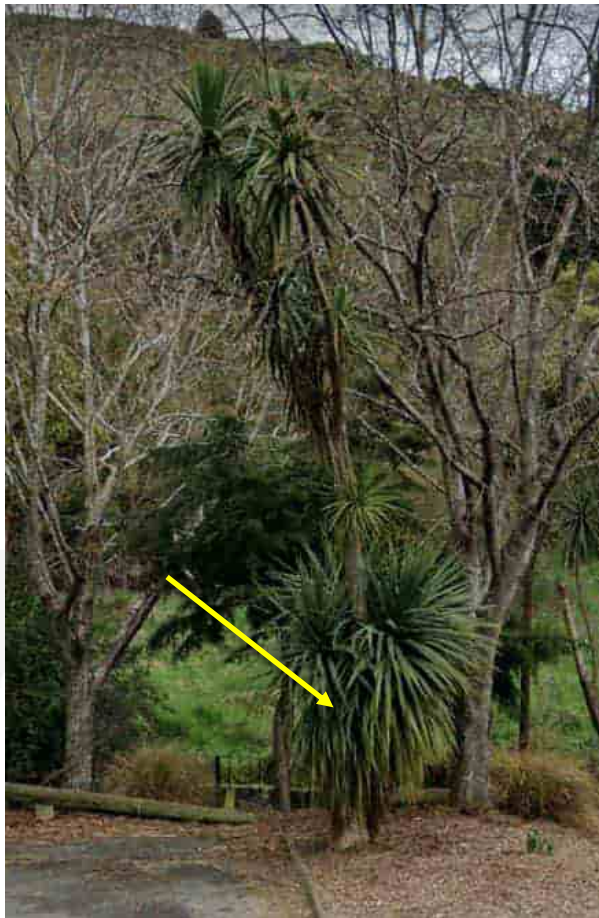
Tree species:	<i>Cordyline australis</i> (Cabbage Tree)

Tree ID:	BA05	
Protection status:	Public realm	
Native/Exotic:	Native	
Height:	6.8m	
Canopy:	2.0m	
Diameter at Breast Height:	0.2m	
¹ Health:	Good	
¹ Structure:	Fair	
¹ Overall:	Fair	
Comments: ¹ Health - Tree is in good health with: ‘... 6-10% foliage density loss, discoloration or disease.....’. ¹ Structure - Tree has fair structure where: ‘Defects (including roots and trunk taper) present, but can be rectified in order to maintain the structural integrity and continued well-being of tree’.

4.4 Four of the CCC street trees (BA02/BA03/BA04/BA05) are in fair condition with one CCC street tree in poor condition (BA01).
