Application for Resource Consent: Subdivision

Resource Management Act 1991 – Form 9

130 Bowenvale Avenue Cashmere

Part Lot 2 DP 33462

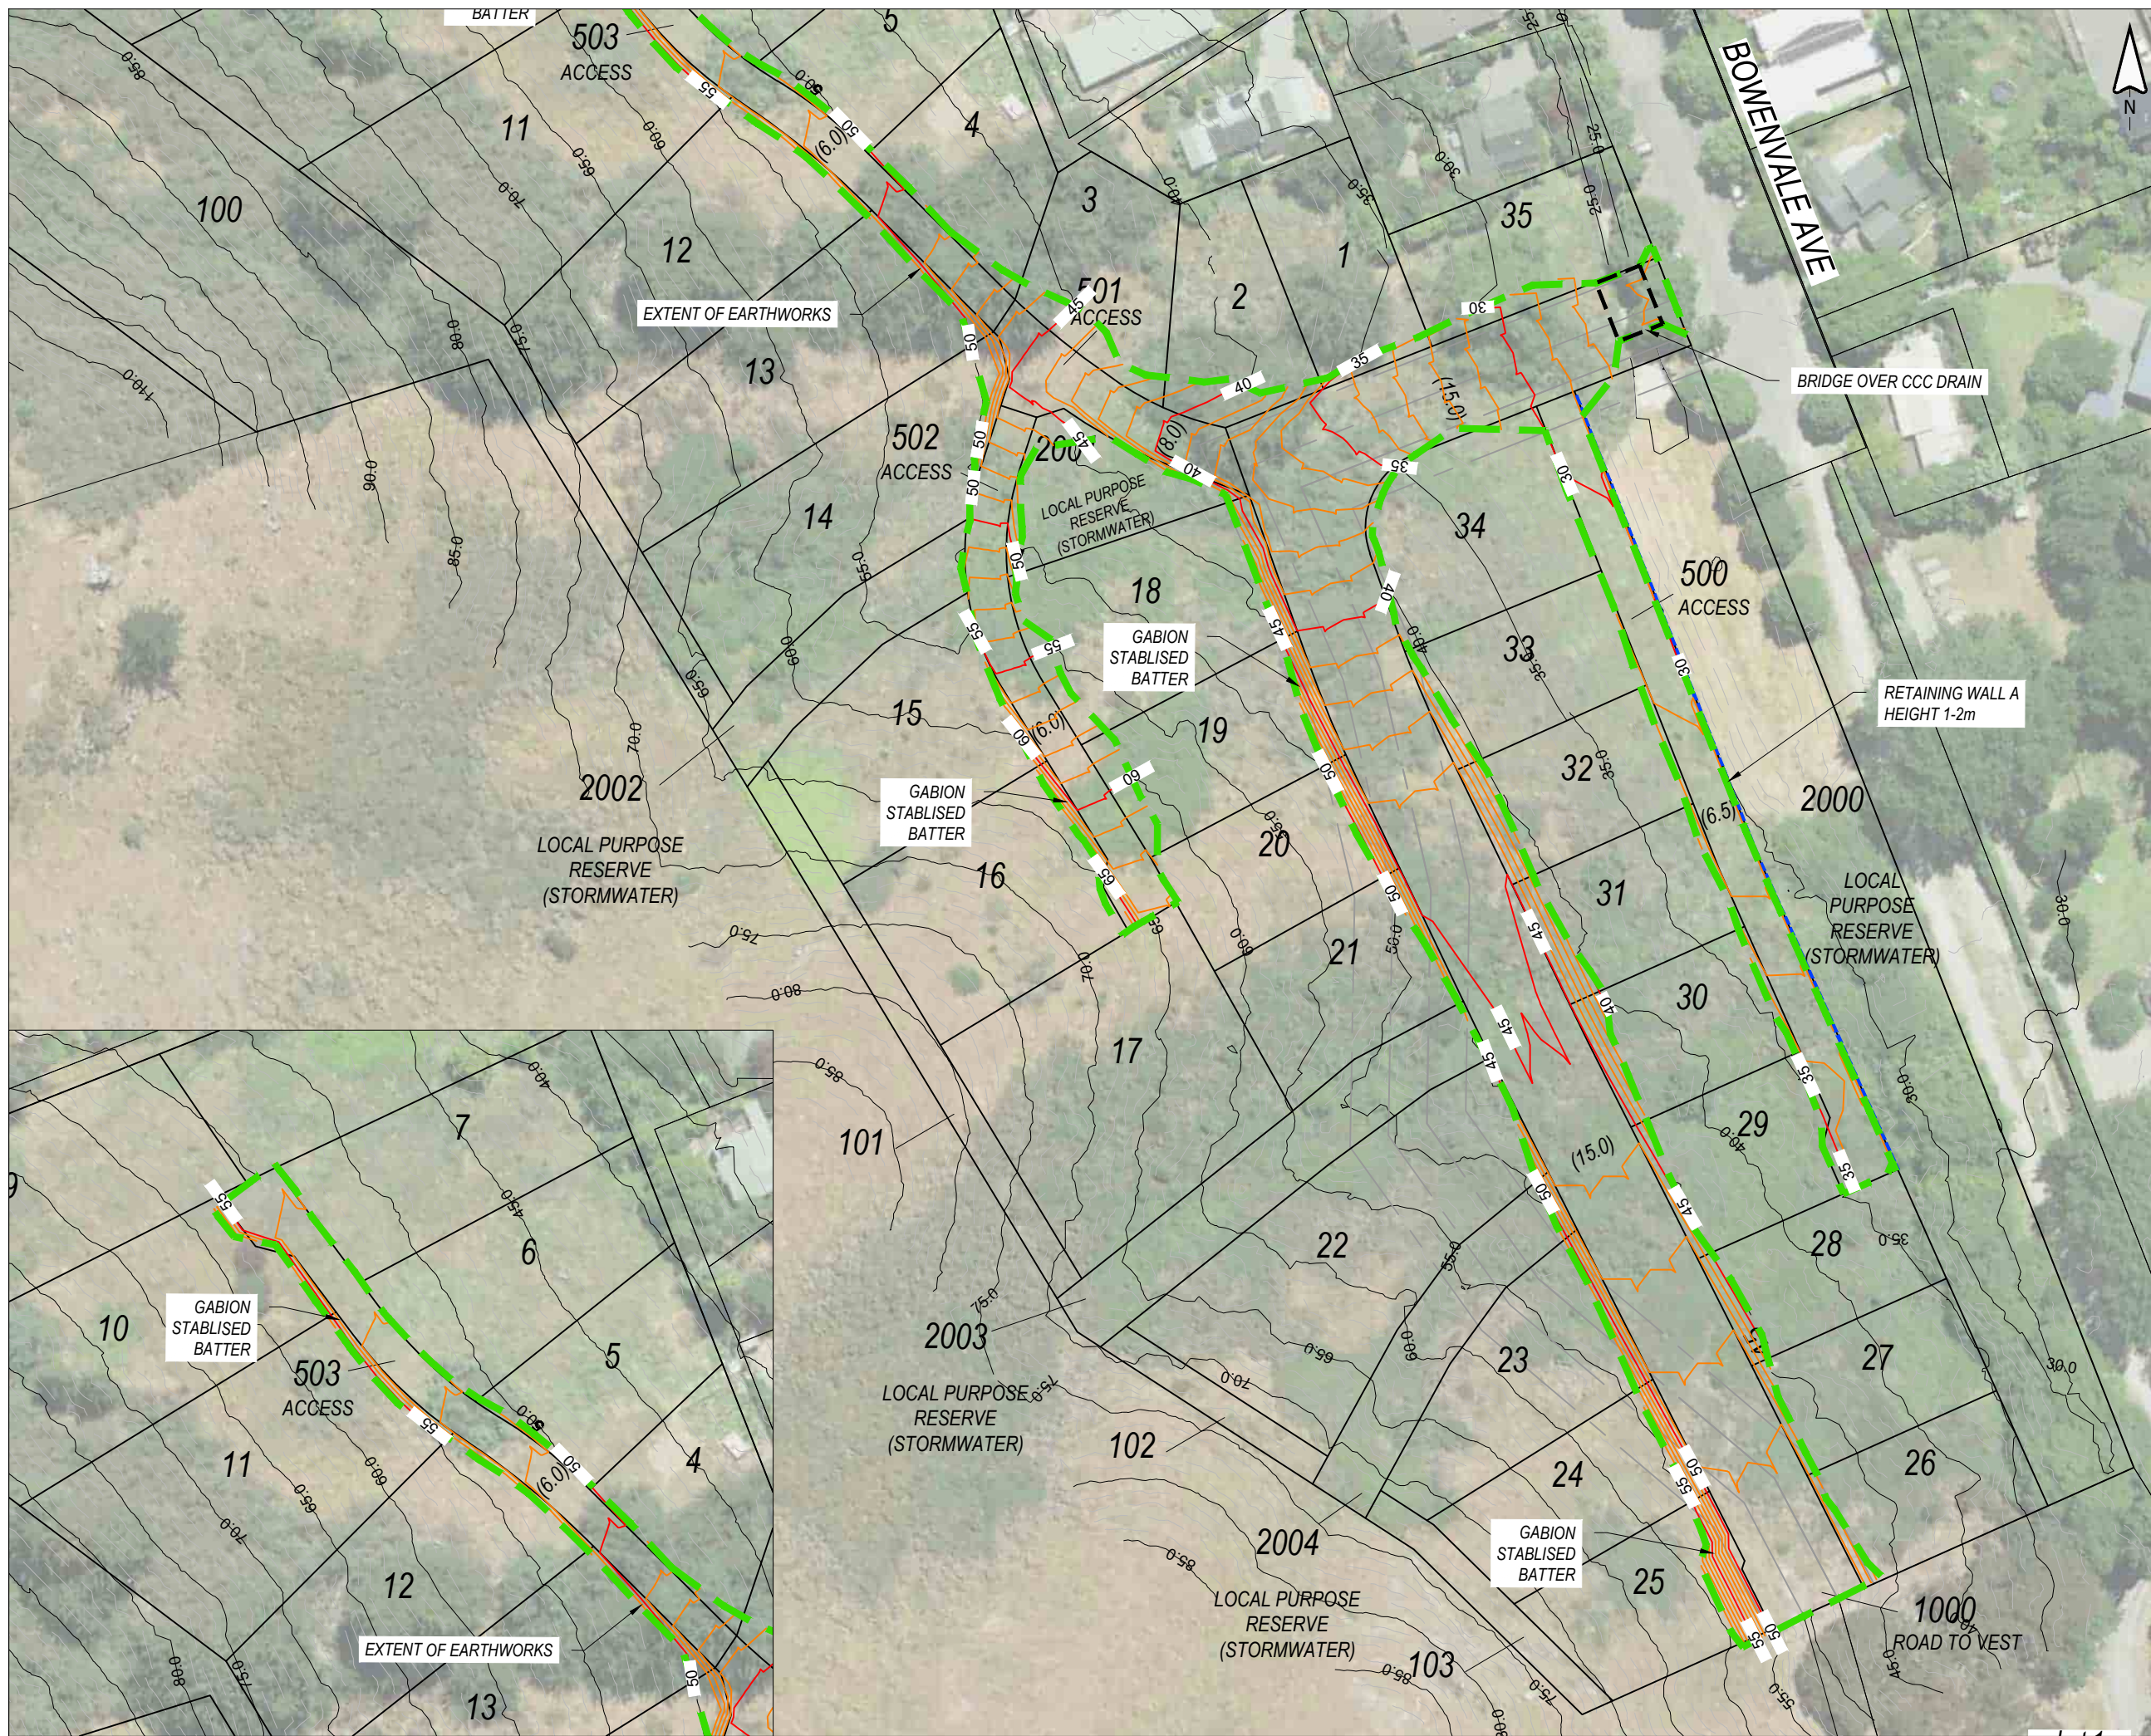
DRAWING TITLE
PROPOSED CONTOUR PLAN

- 24.0 - MAJOR CONTOUR - CCC LIDAR CONT
- MINOR CONTOUR - CCC LIDAR CONT
- EXTENT OF EARTHWORKS
- 24.0 - MAJOR CONTOUR - DESIGN CONT
- MINOR CONTOUR - DESIGN CONT (1.0m)
- RETAINING WALL - HEIGHT 1.0 - 2.0m

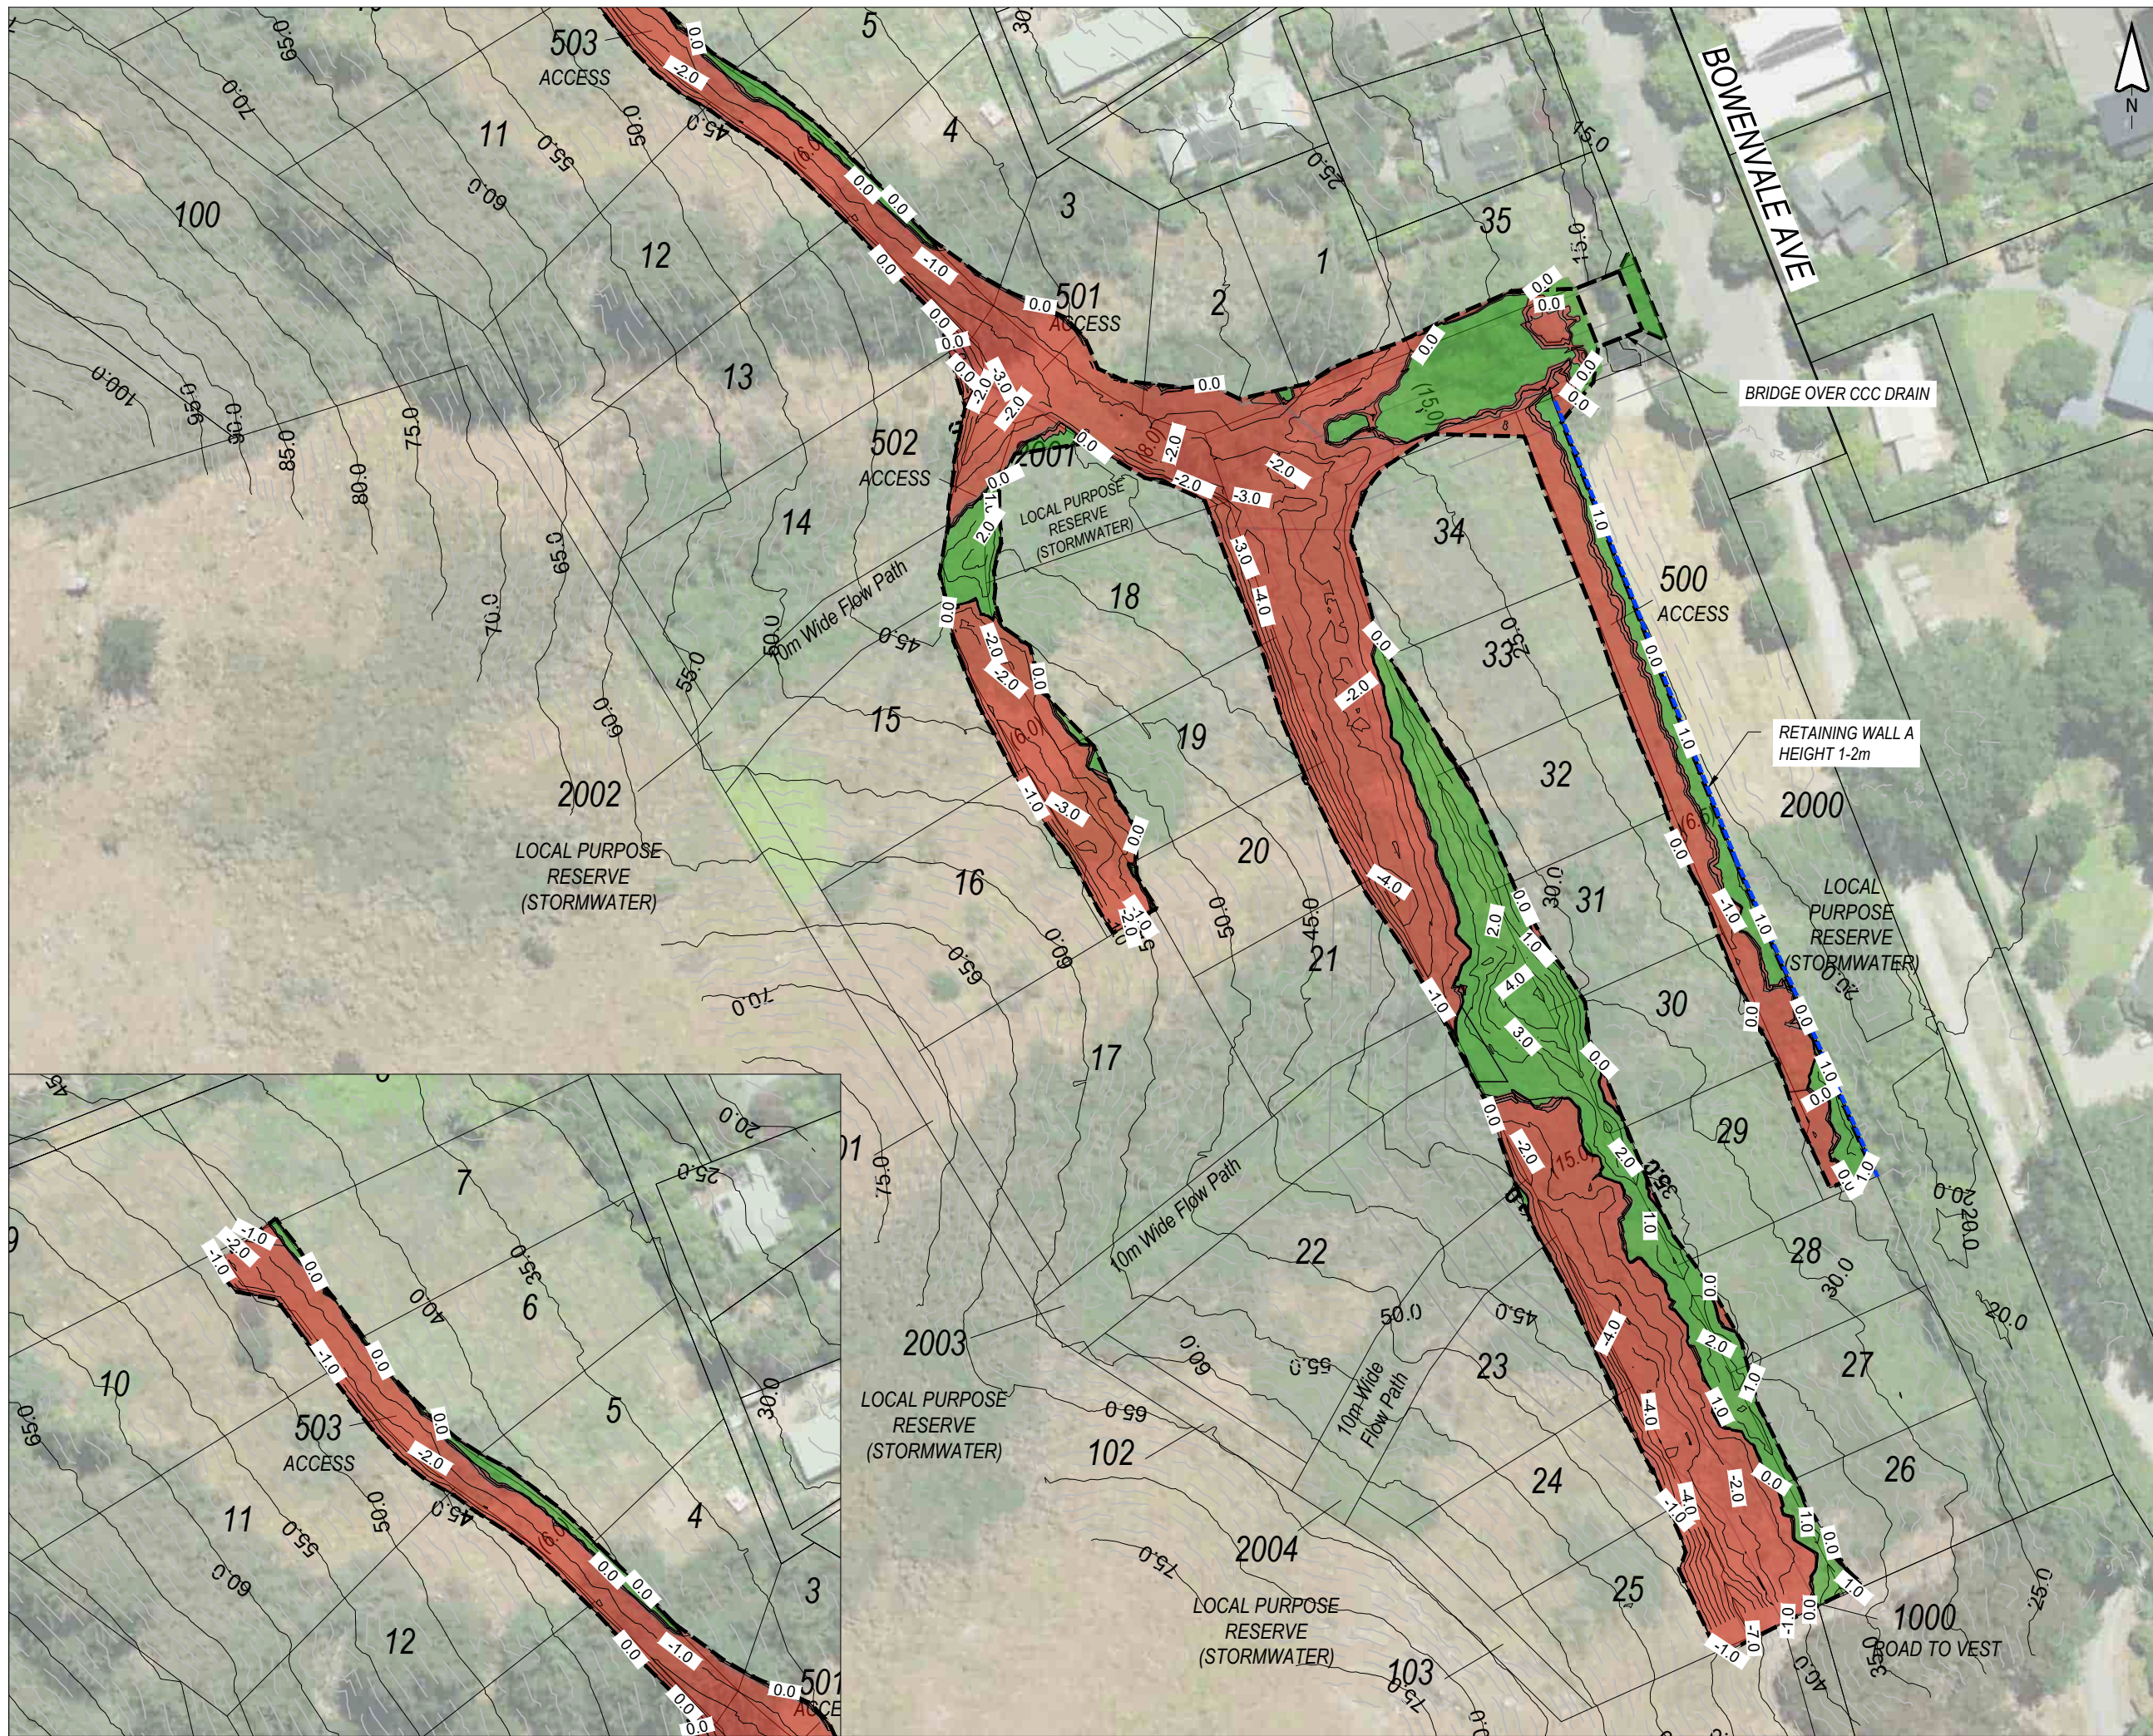
- 1.0 CUT AREA & DEPTH CONTOURS (1m INTERVAL)
- 1.0 FILL AREA & DEPTH CONTOURS (1m INTERVAL)

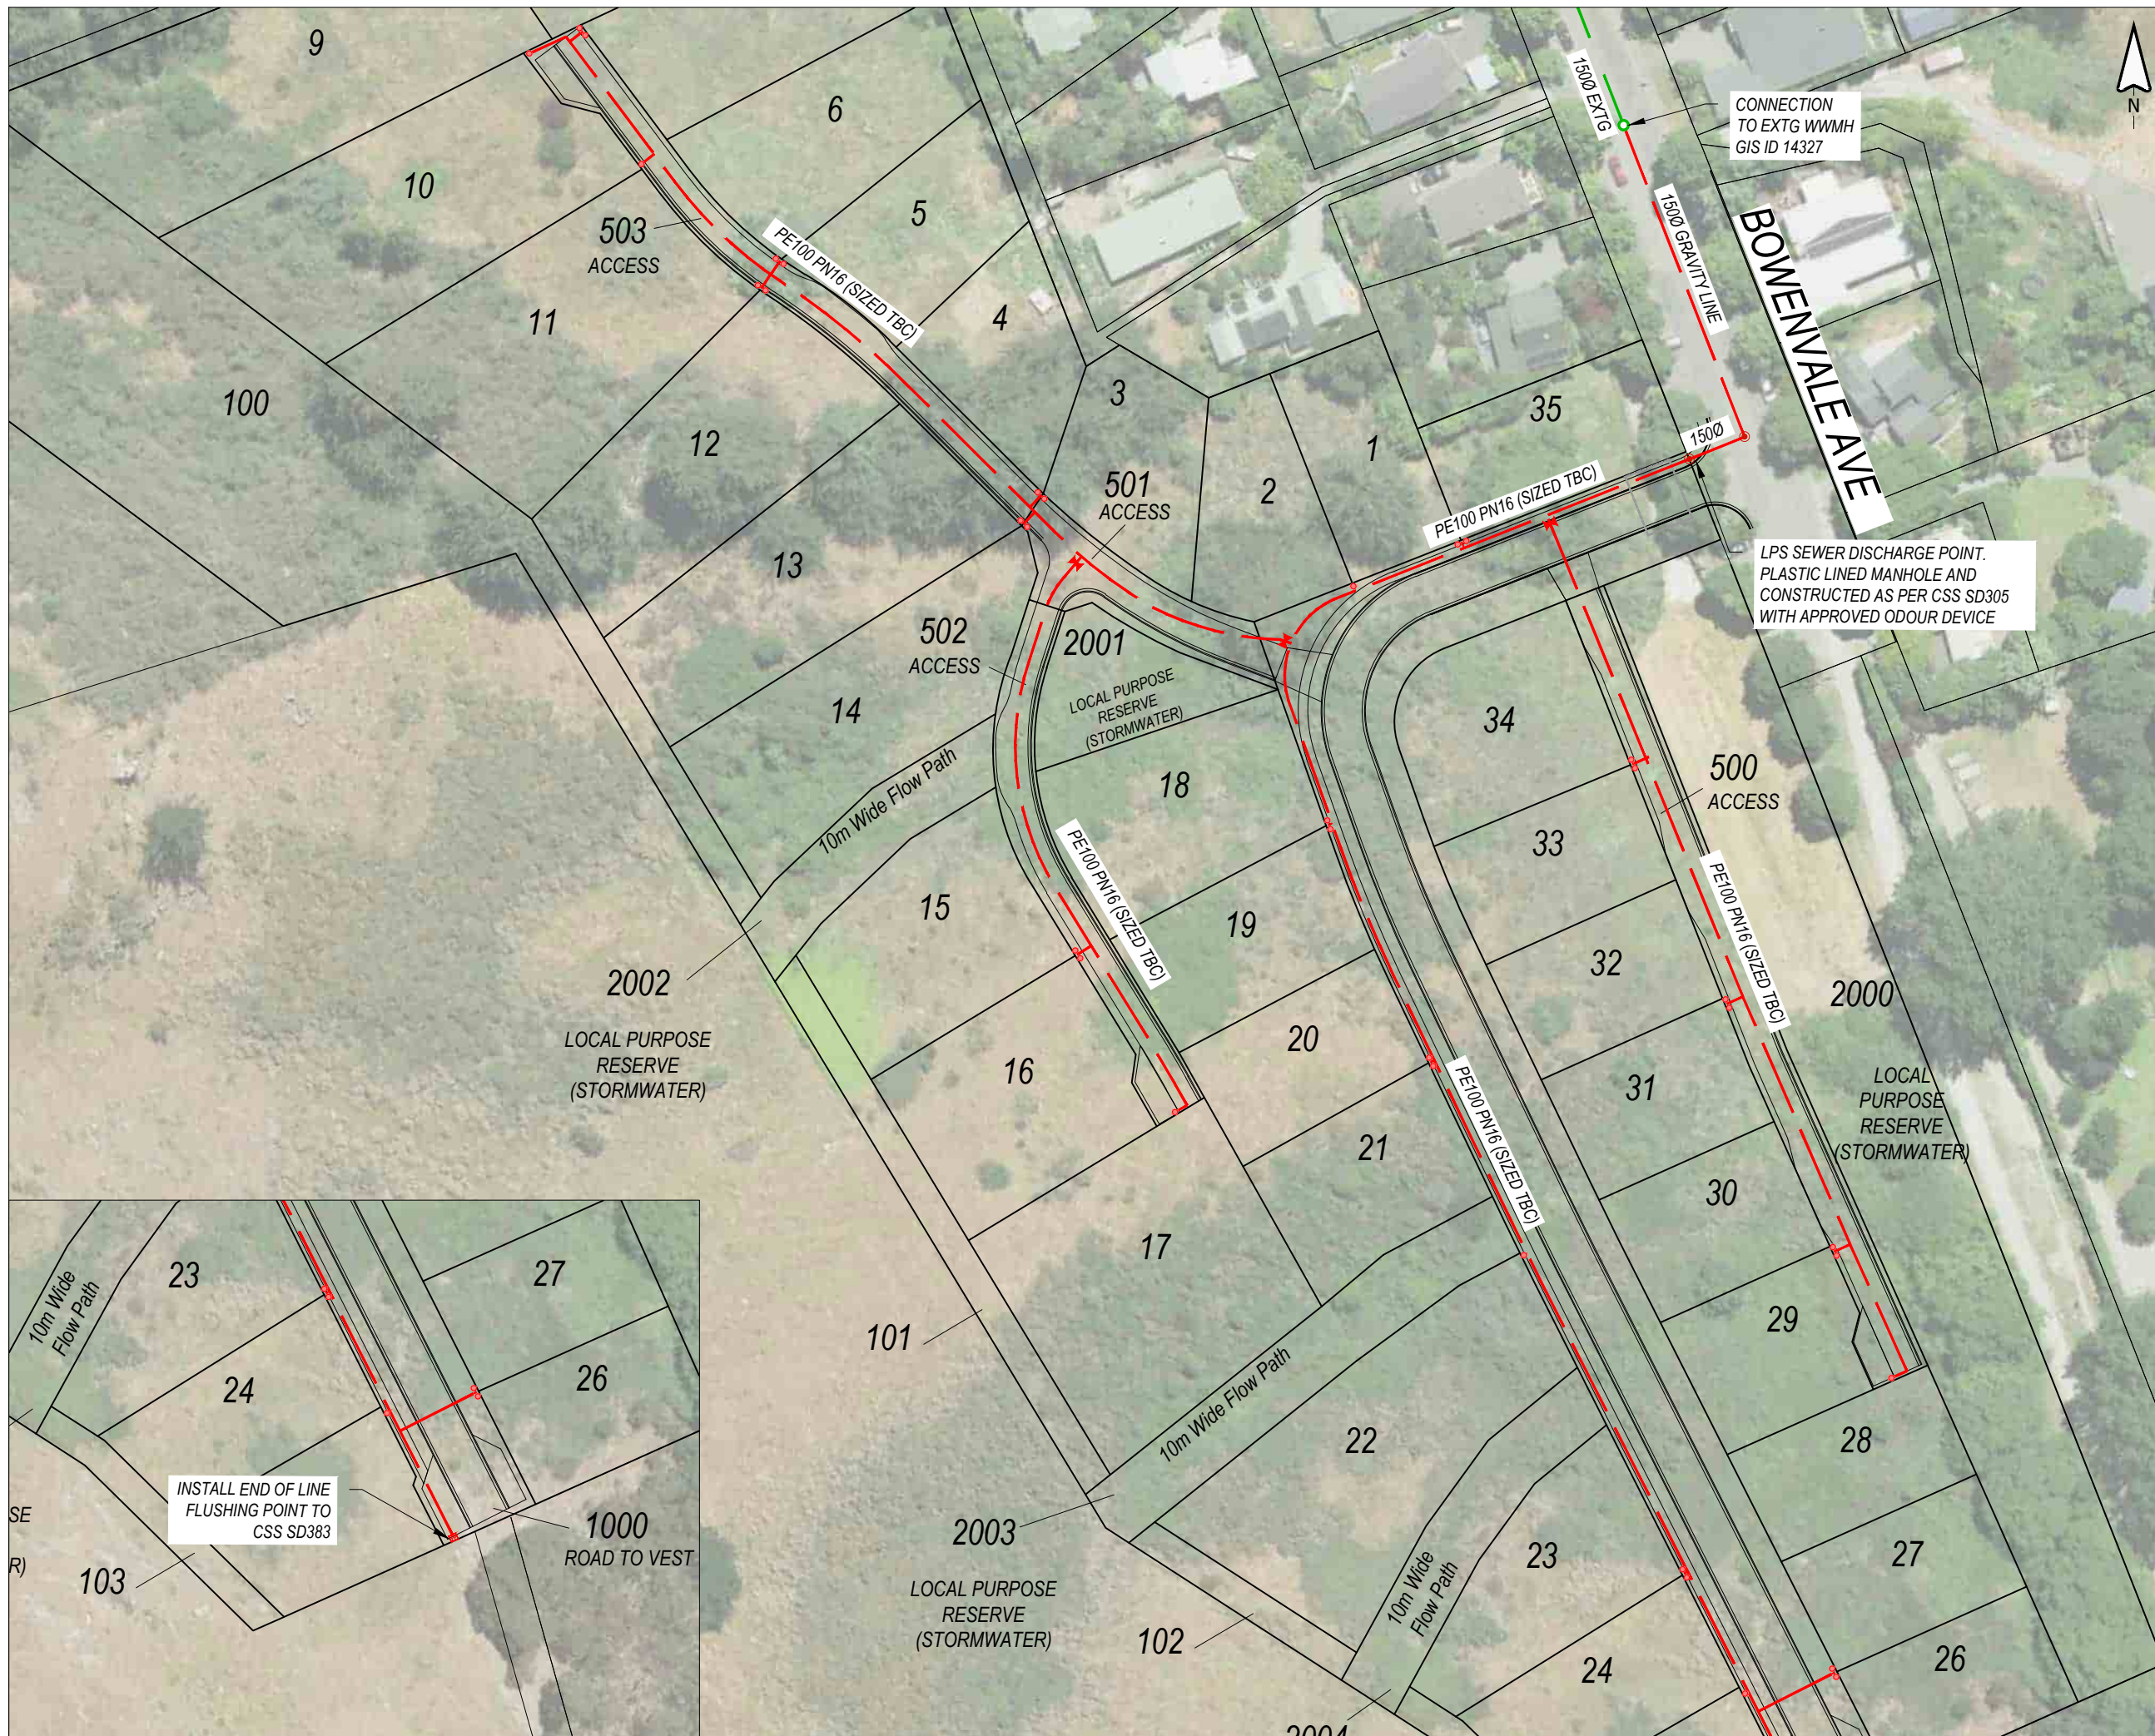
- PE 100 PN16 PRESSURE MAIN (SIZE TO BE DETERMINED AT DETAILED DESIGN)
- ✕ PROPOSED SLUIICE VALVE
- F PROPOSED FLUSHING POINT
- BOUNDARY KIT

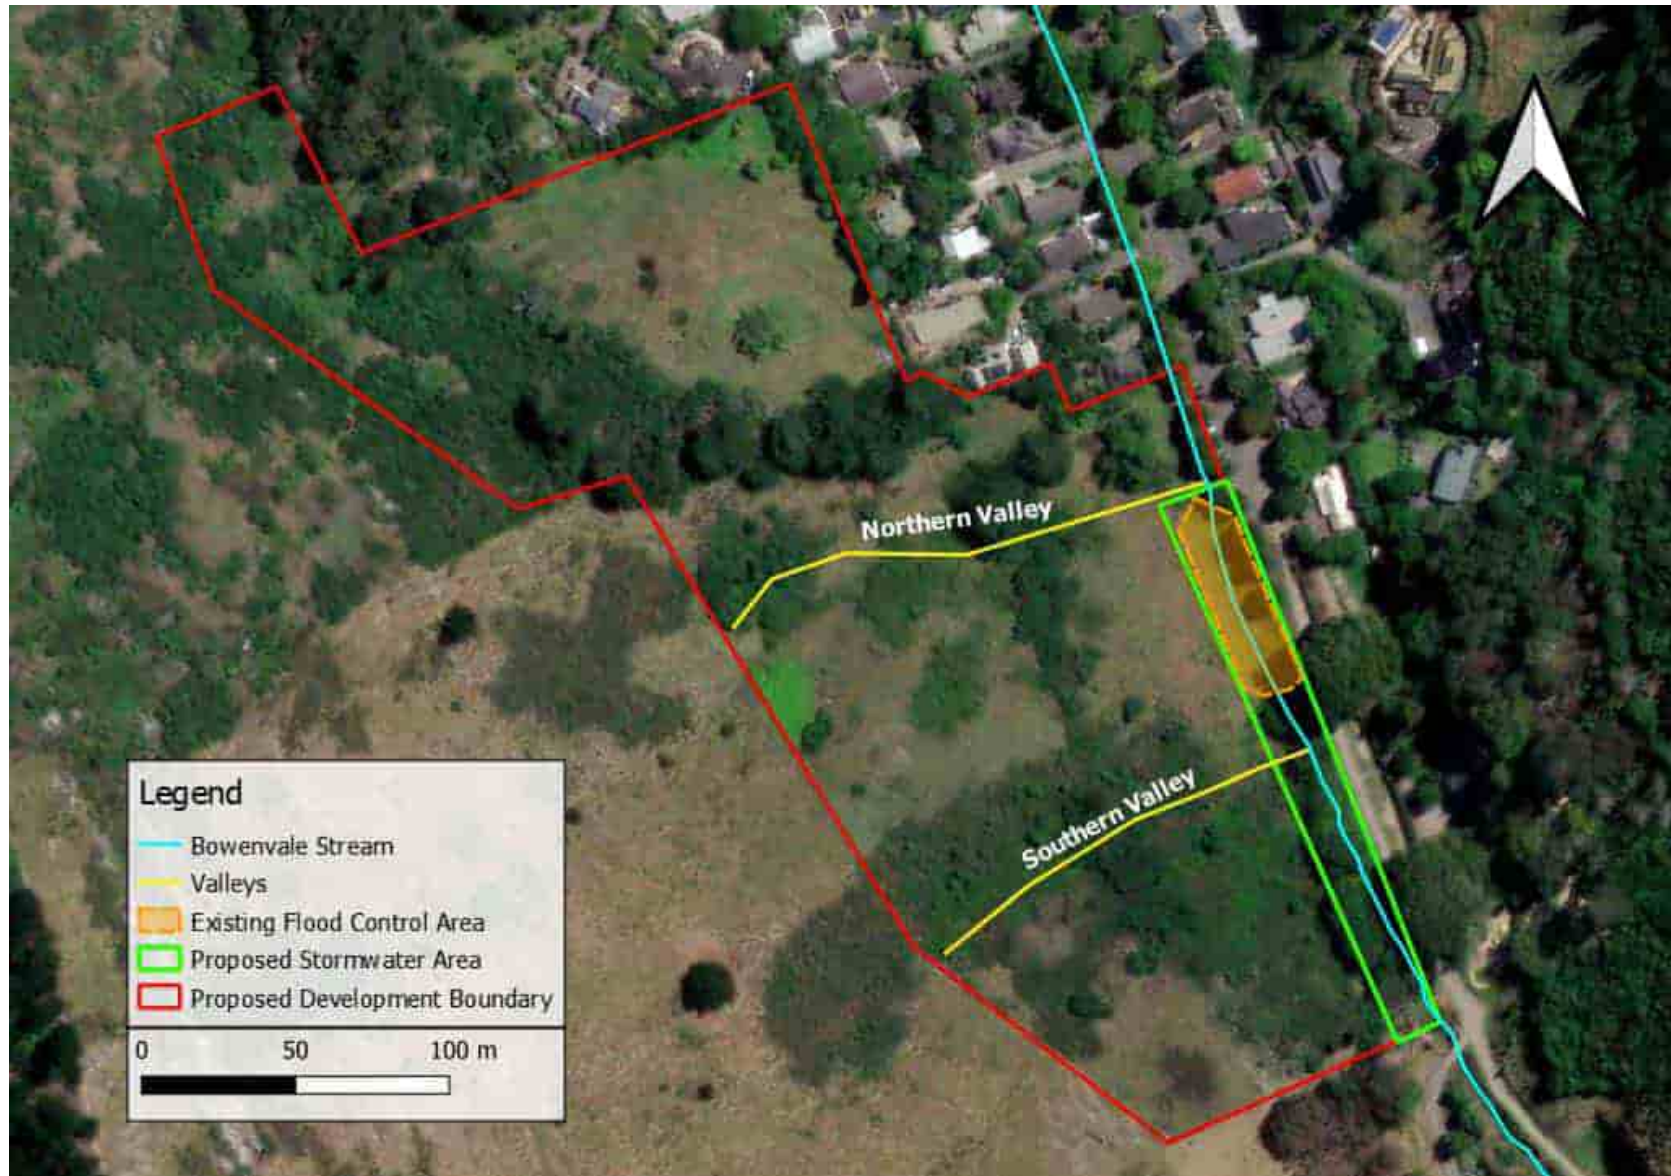
Figure 1. Map showing proposed development at 130 Bowenvale Avenue.

The northernmost gully (Fig. 1), terminated at the proposed subdivision road entry and was surveyed during a site visit on 08/04/2022. This gully contained geomorphological and ecological indicators of a small ephemeral channel. Specifically, tunnel and sheet erosion was observed in this channel, however no wetland plants or surface water were identified (App. I, Figs. i, ii). Due to the steep gradient and lack of wetland vegetation, it is likely that the channel in the north gully only flows during rainfall events, does not incorporate standing water, and therefore does not develop any freshwater ecological values. The ephemerality of the channel, it that no surface or sub-surface water is retained, means that no aquatic flora and fauna can survive.

The southern gully (Fig. 1) was not able to be surveyed on foot during the 08/04/2022 site visit, due to dense growth of gorse and other dryland shrubs (App. I, Fig. iii). All observed vegetation was exotic and dryland in nature. No flow was observed leaving this gully at the lower end.

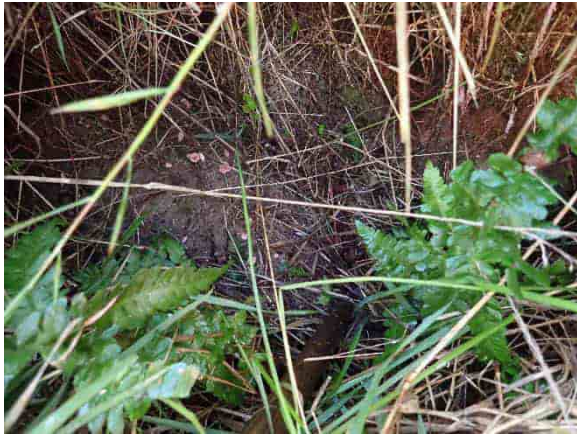
Figure i. Dry channel identified in the northern gully. No wetland vegetation present.

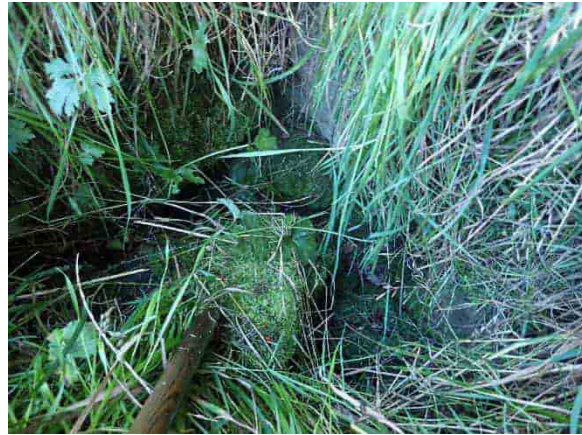
Figure ii. Evidence of underground tunnelling by rainfall in the northern gully.

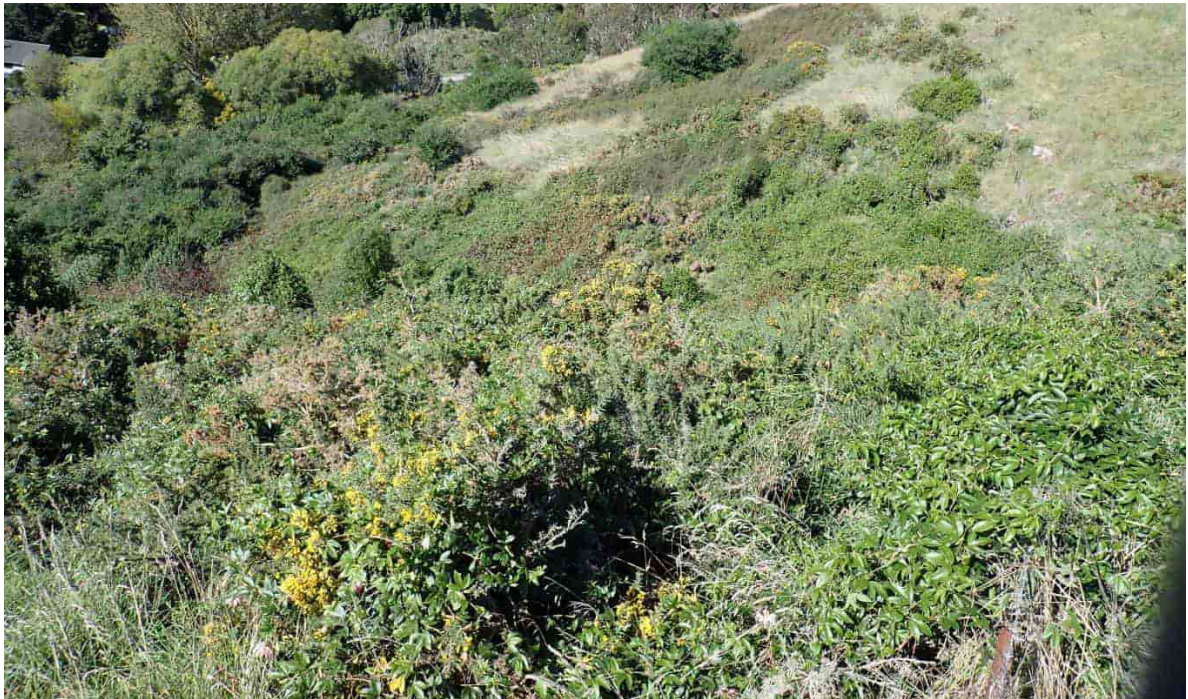
Figure iii. Showing the dense exotic vegetation in the southern gully. No foot access beyond this point.

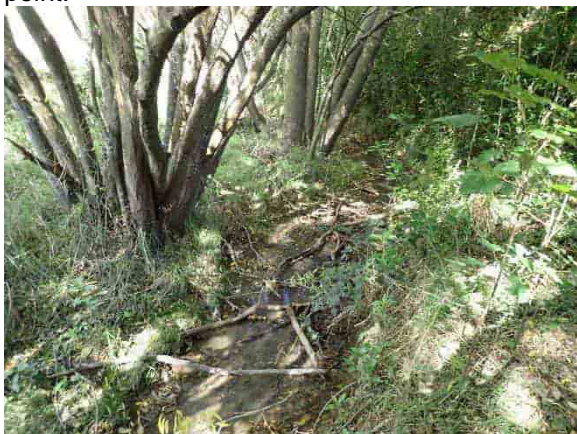
Figure iv. Looking upstream at the Bowenvale Stream, upstream of the flood protection area. Note the presence of woody debris.

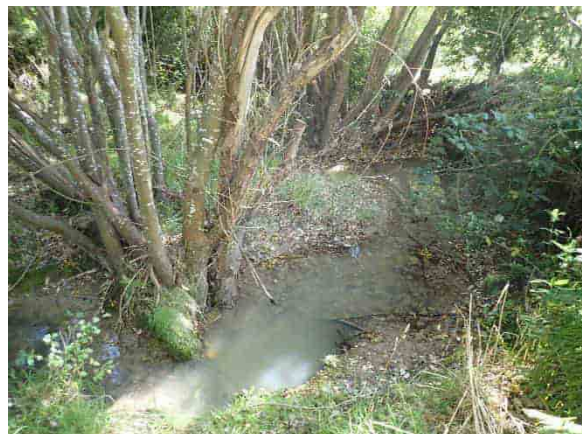
Figure v. Looking downstream at the upper reach of the Bowenvale Stream.

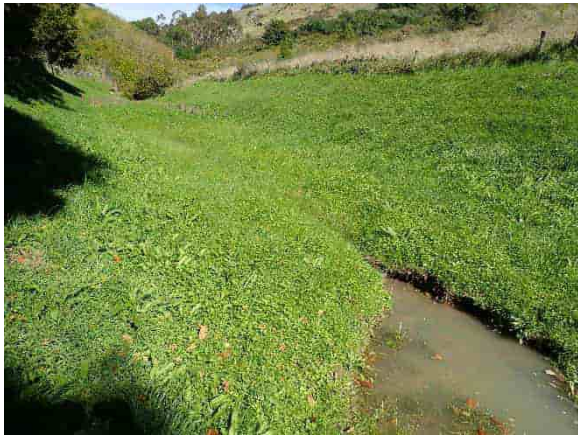
Figure vi. Looking upstream at the existing CCC flood control area.

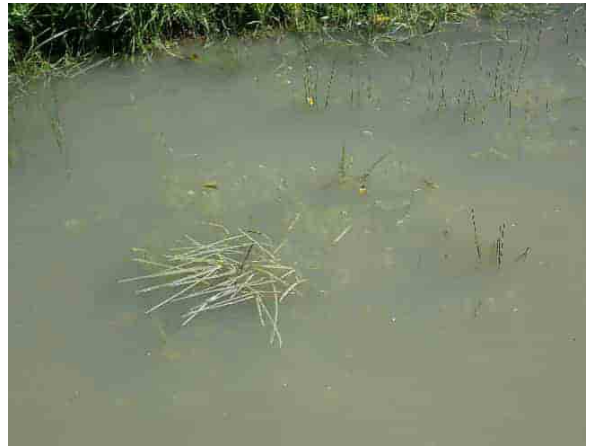
Figure vii. Macrophytes in the existing flood control area, indicating habitat permanence.

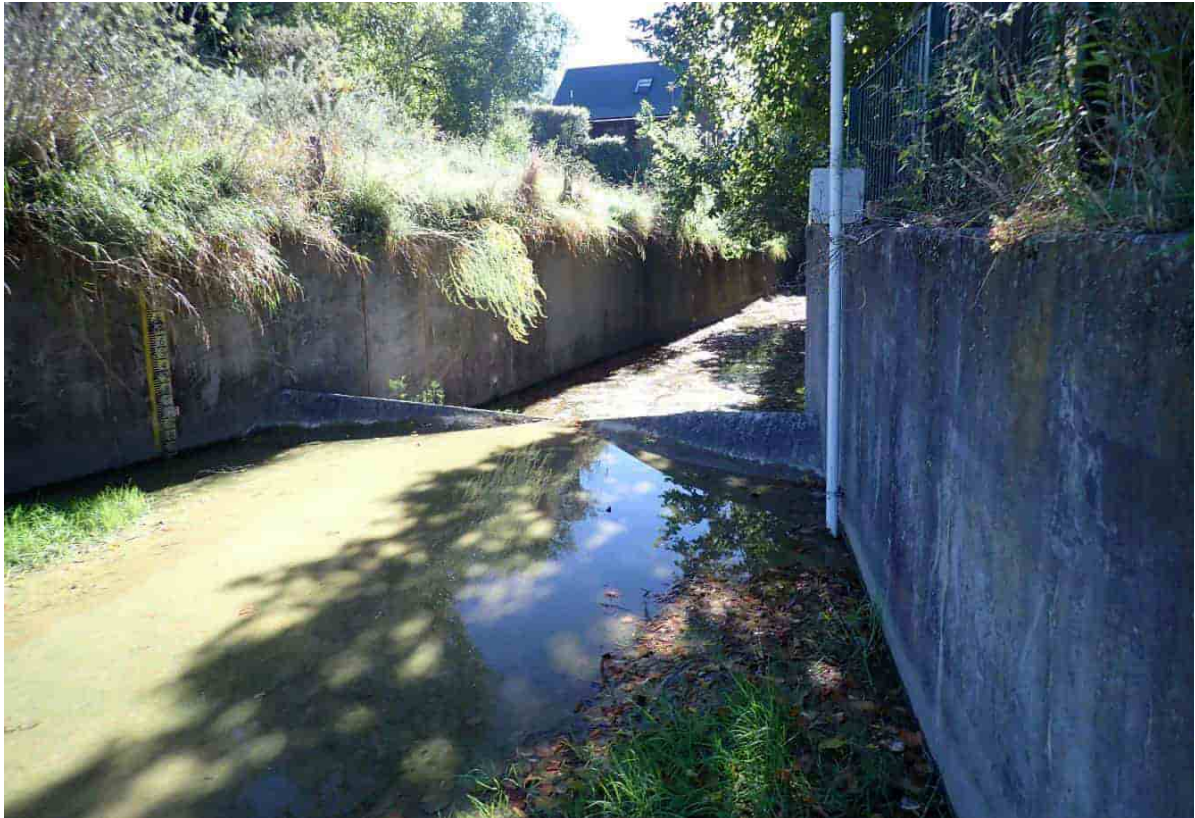
Figure viii. Looking downstream at Bowenvale Stream, downstream of the existing CCC flood control area. This waterway is concrete-lined to the Heathcote River, with no visible fish baffles.

Smooth concrete channels are difficult for fish to negotiate an upstream passage. There are no low-flow areas to rest in, and fish are exposed to predators (e.g., birds and cats). At low flow, the reach water is also likely to become warm due to its shallow depth and sun exposure. The reach of Bowenvale Stream between the Heathcote River and the CCC flood control area can therefore be considered a significant fish passage barrier. Because of difficult fish passage from the sea, only the adept climbing species (shortfin eel (*Anguilla australis*)) has been confirmed to be present. A survey by Environment Canterbury in 2019 recorded the presence of shortfin eels in the existing CCC flood control area (Card 115728 in NZFFDB). Therefore, this species is likely to be present in suitable downstream habitats.

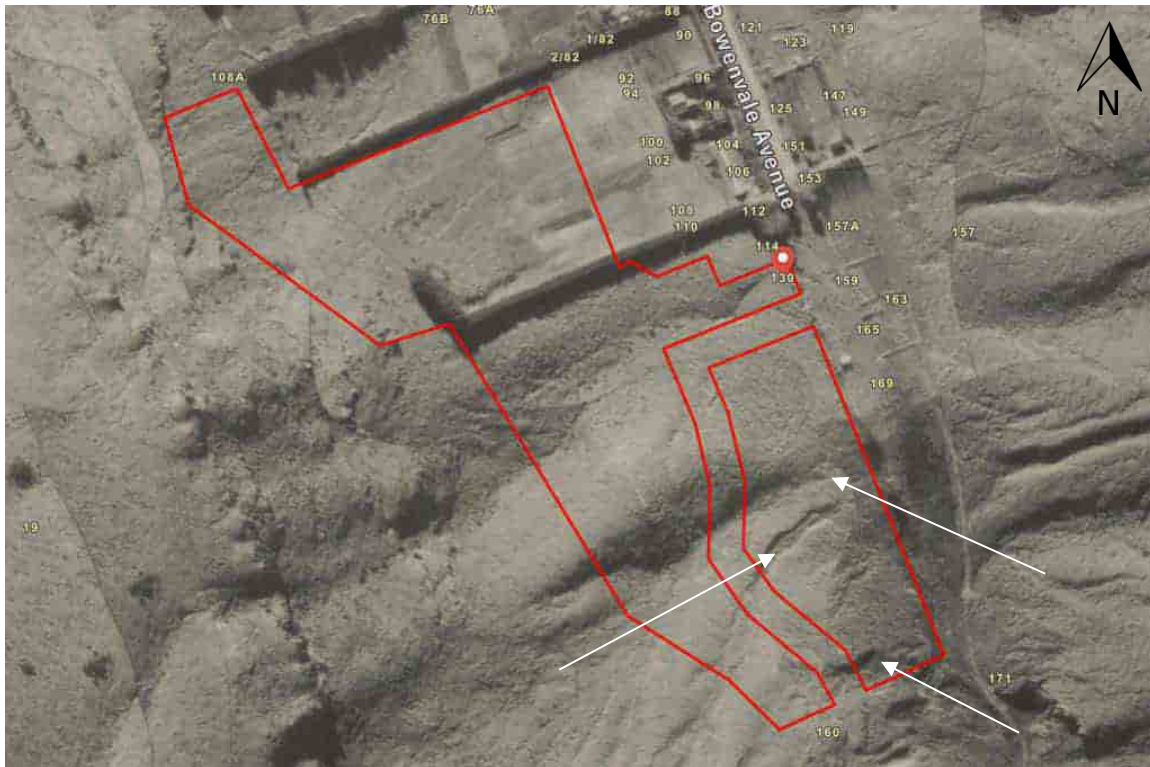
Figure 4: Historic Aerial 1955-1959

Note 1: Earthflow indicated by white arrows.

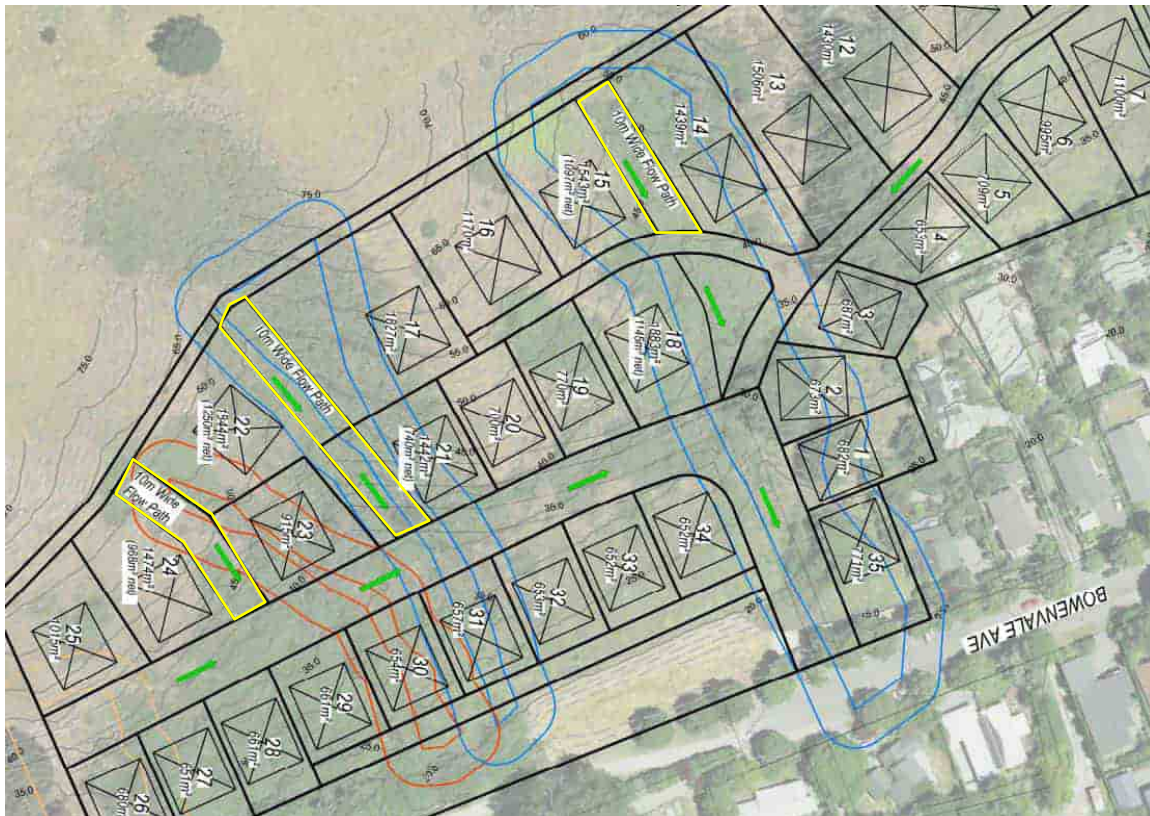
Figure 5: Proposed remediation in designed subdivision plan.

The water associated with the known drainage lines (shown in Figure 3 and Appendix 3) is recommended to be captured into a culvert system (designed by others). The drainage lines are indicated by the 10 m wide flow paths shown below in Figure 5 (highlighted in yellow). The purpose of the proposed system is to reduce the width of the flow paths, by entraining surface water runoff into a designed channel system. This will facilitate development of the proposed lots in close proximity to the designated flow paths. Our understanding is that the culvert and overland flow path system will be designed for the calculated 0.5% AEP peak flow while also providing 0.5 m freeboard.

The earthflow instabilities as described in Section 3.6 have the potential to impact the developments on Lots 22, 23 and 30. Based on the information available to us further movement of this landslide is likely triggered by rainfall events rather than seismic events. Therefore, we have recommended another engineered flow path be constructed at the head of the known landslide to divert water away from these areas and into an engineered culvert system. It should be noted however that the soil within the earthflows is likely to be significantly weakened and, depending on foundation solution, may need to be removed or stabilised prior to development of building platforms. We recommend further testing, assessment and remedial works design be completed at the building consent stage for these lots. This is covered further in Section 7.1 below.

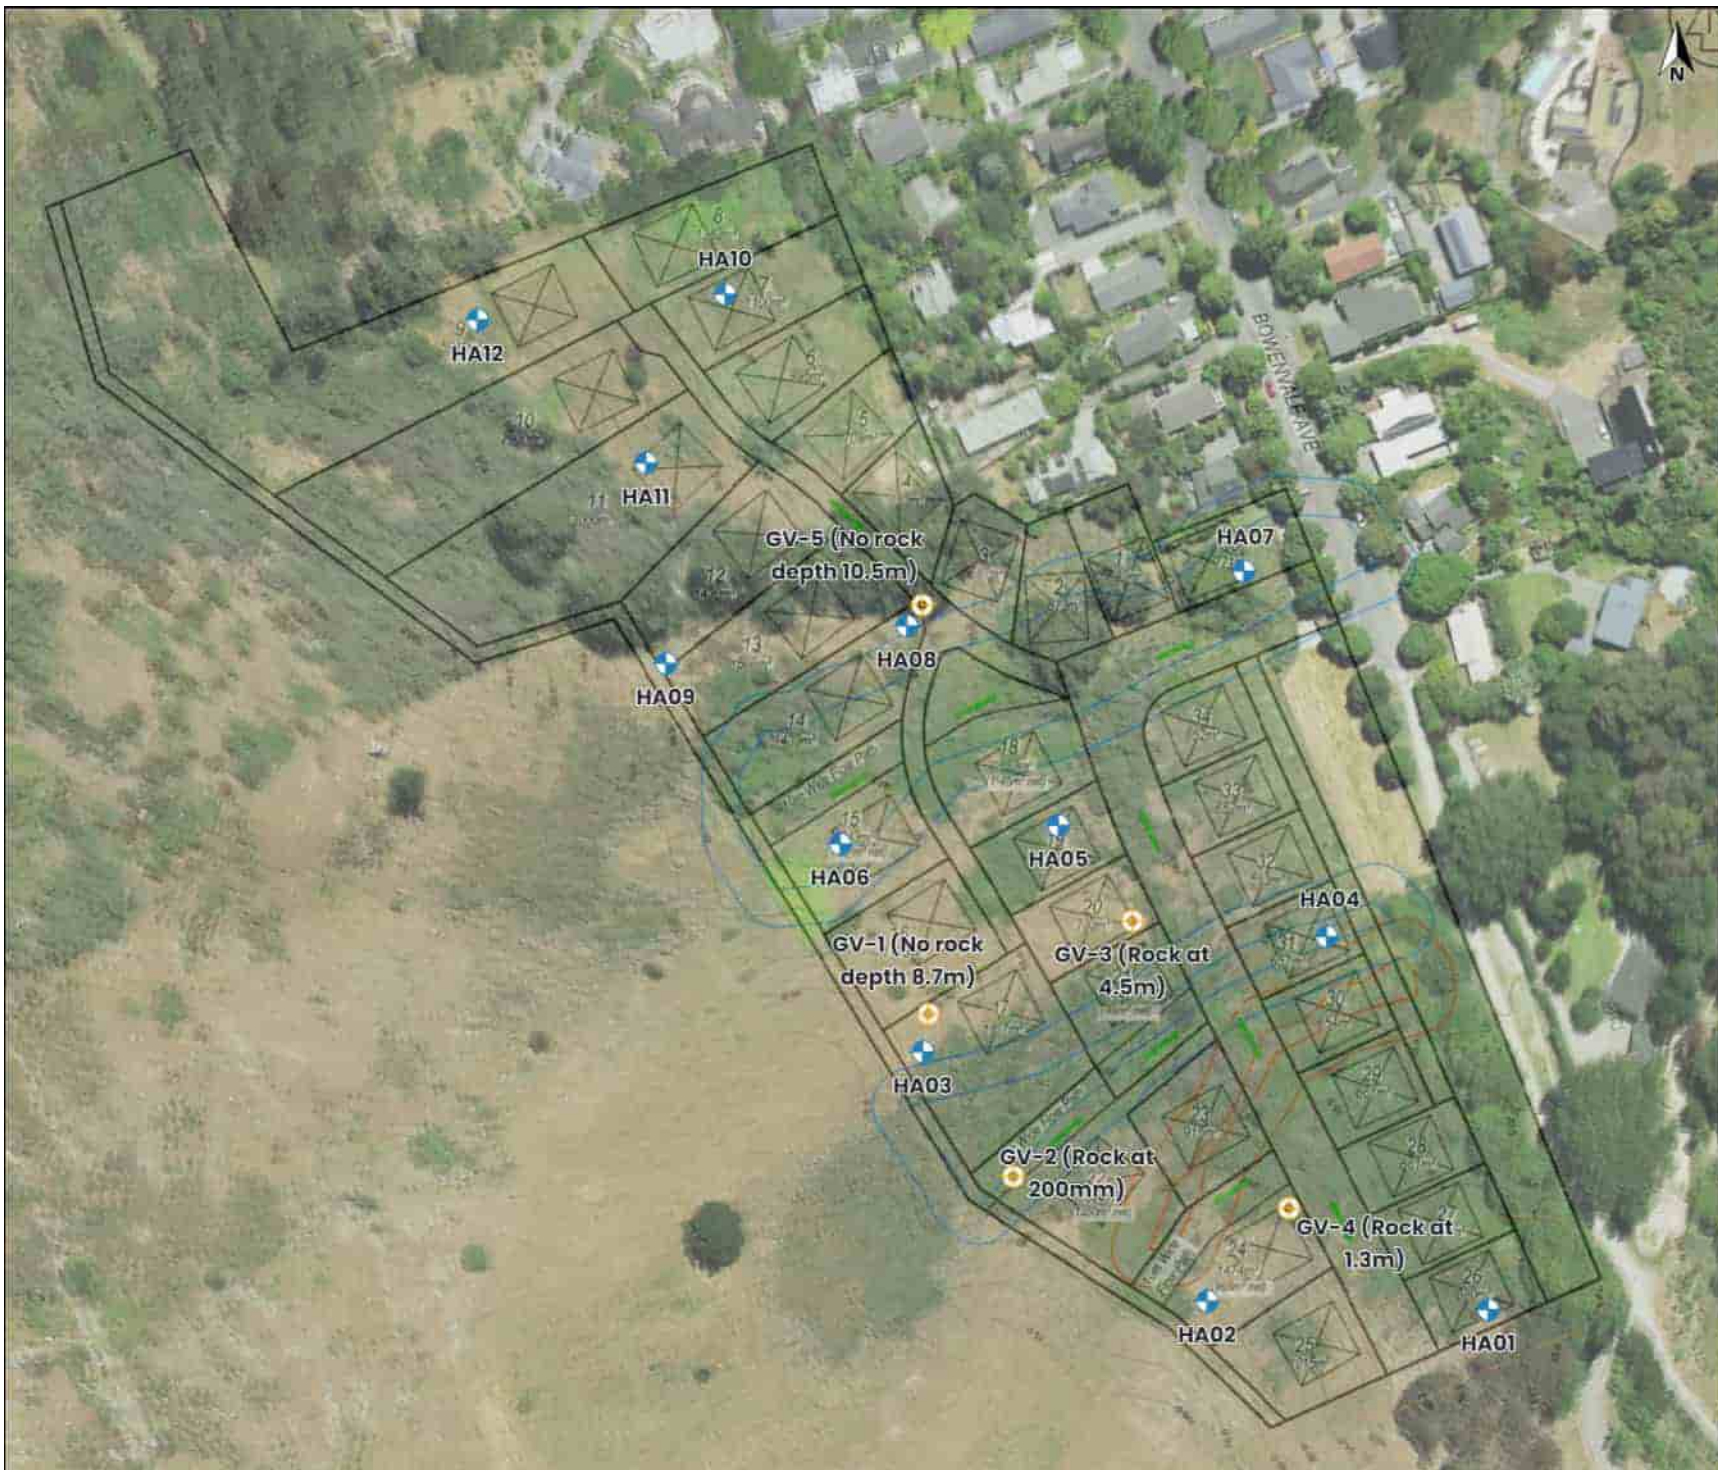
APPENDIX 1: Test Location Plan

- Hand Auger Locations
- Gevert Test Location
- Proposed Subdivision Layout Plan
