Application for Resource Consent: Subdivision

Resource Management Act 1991 – Form 9

130 Bowenvale Avenue Cashmere

Part Lot 2 DP 33462

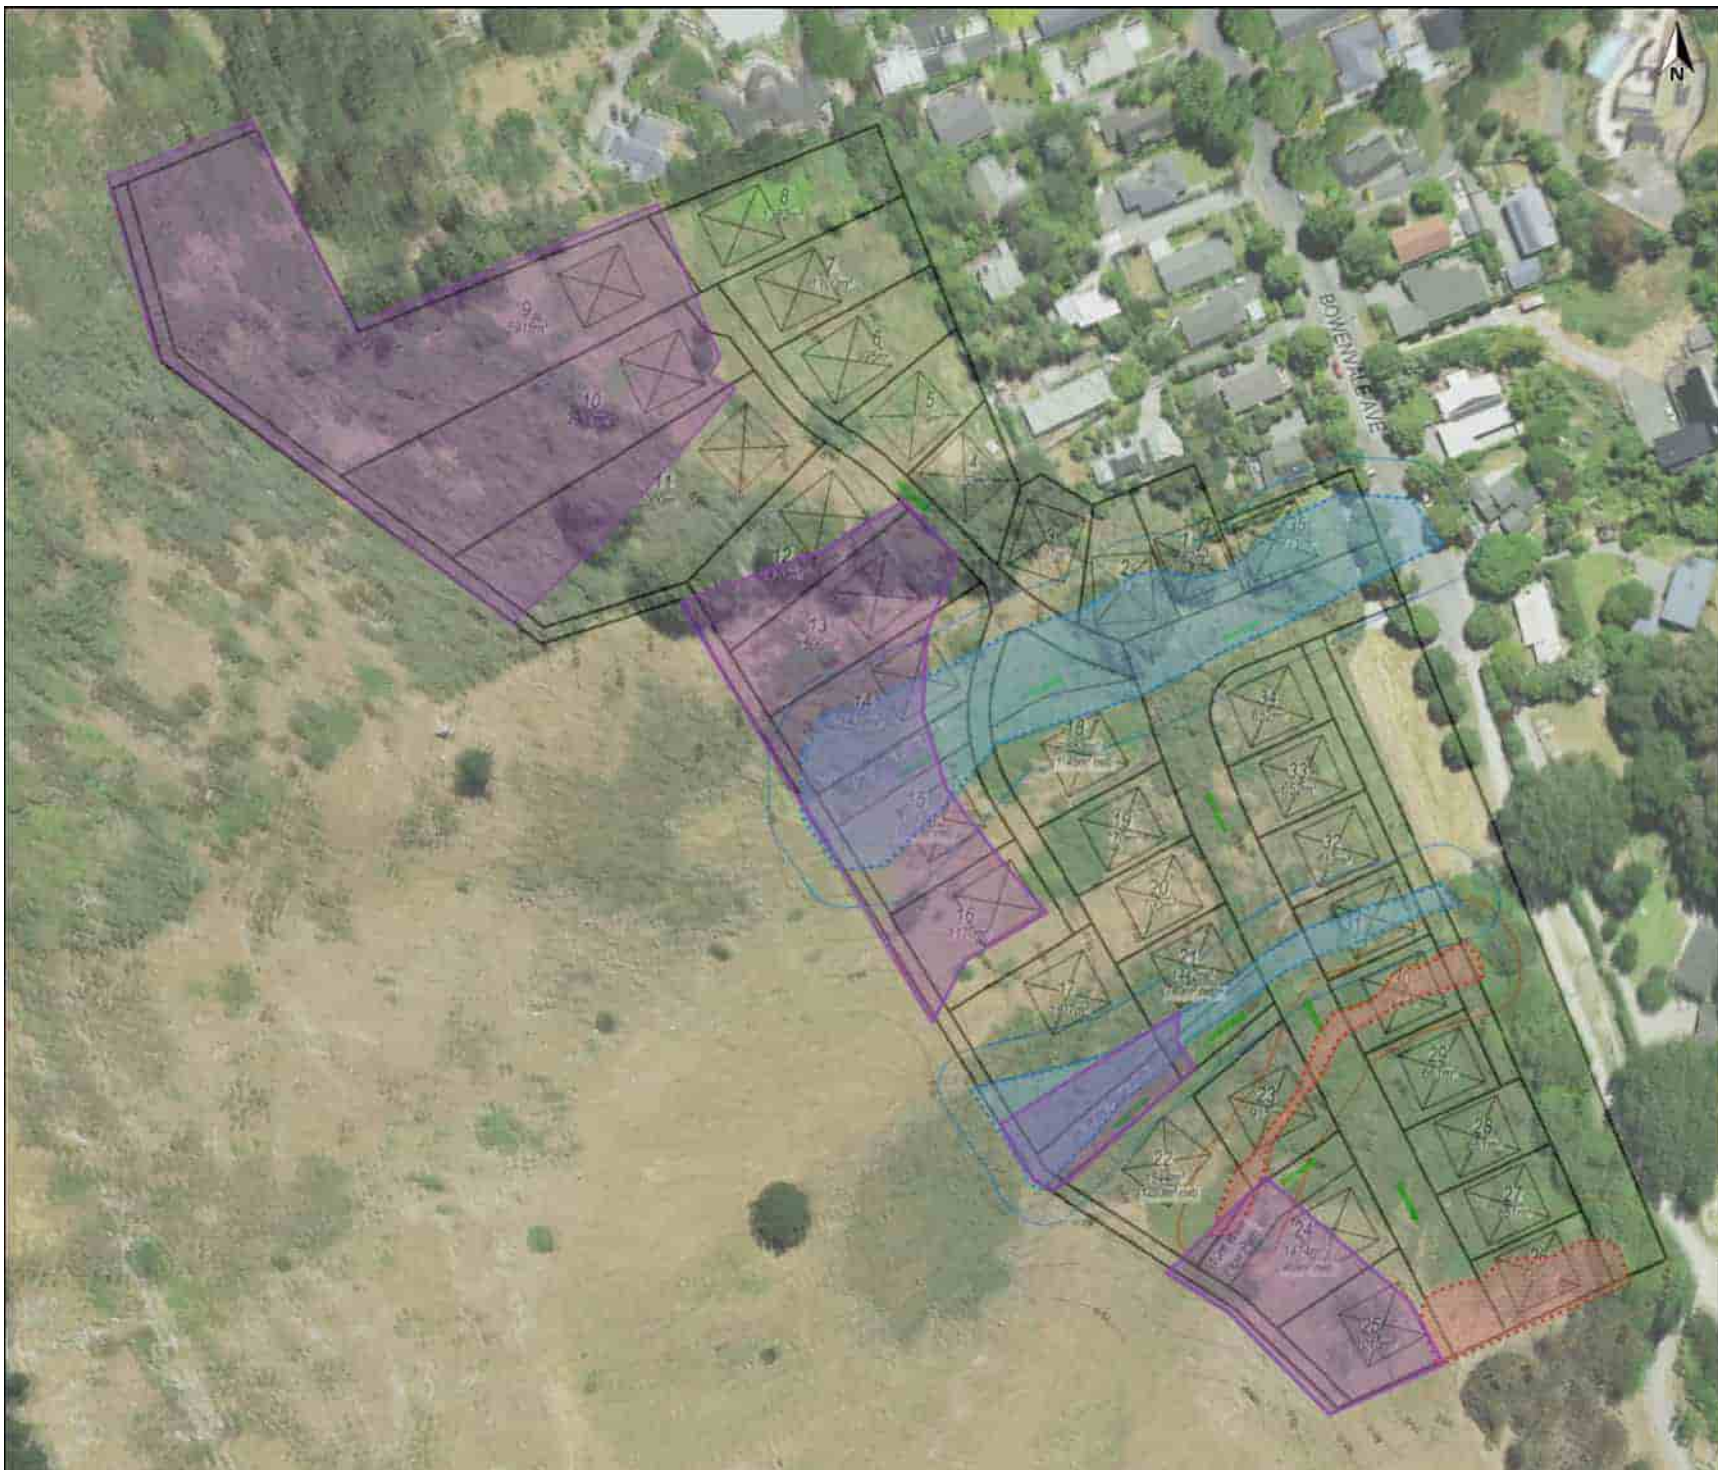
APPENDIX 3: Combined Hazard Map

- Rockfall Risk Zone 1 – Unacceptable Risk
- Inferred Earthflow Location
- Mapped Flow path
- Proposed Subdivision Layout Plan

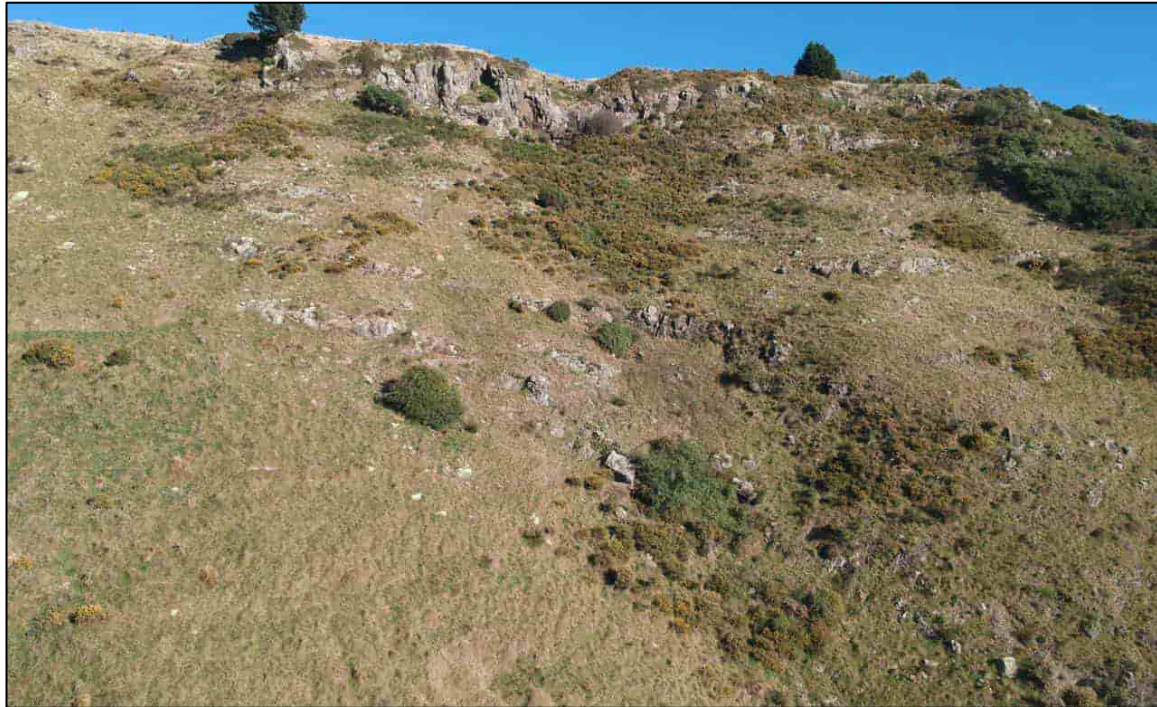
Photo 1: Ridgeline and boulder field below with blocks typically concentrated to the valleys.

Photo 2: Aerial view of the boulder field.

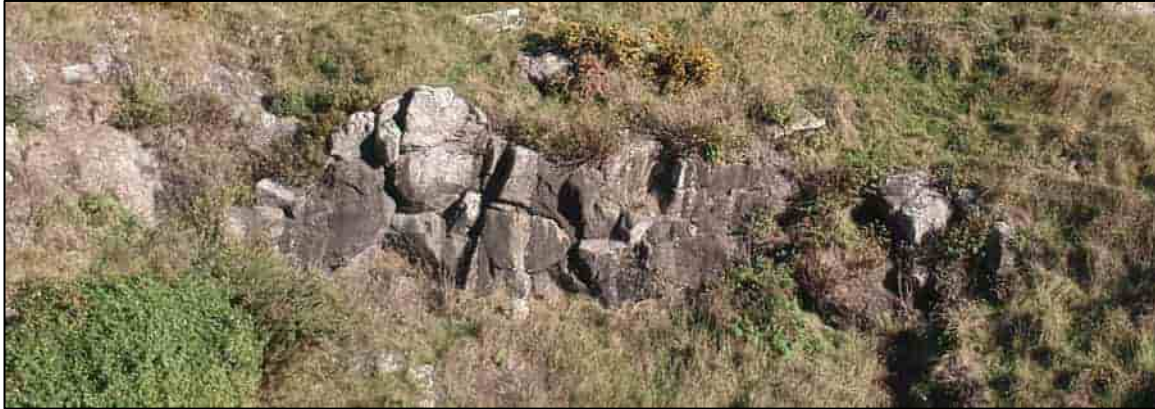
Photo 3: View of jointed basalt and what appears to be loose blocks in an outcrop source area.

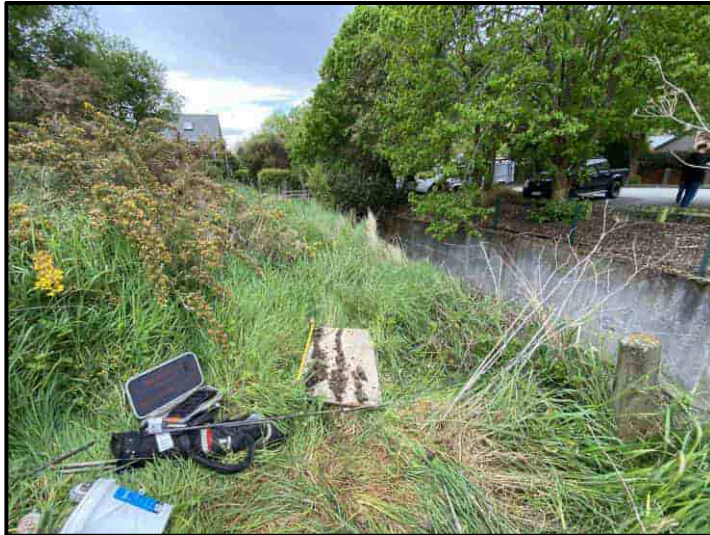
Photo 1: HA 03 location looking North

Site photos below looking both north and south from proposed stream crossing location (Figure 2). Existing stream infrastructure is a concrete lined channel approximately 3 m wide.

Figure 2: Site Photographs

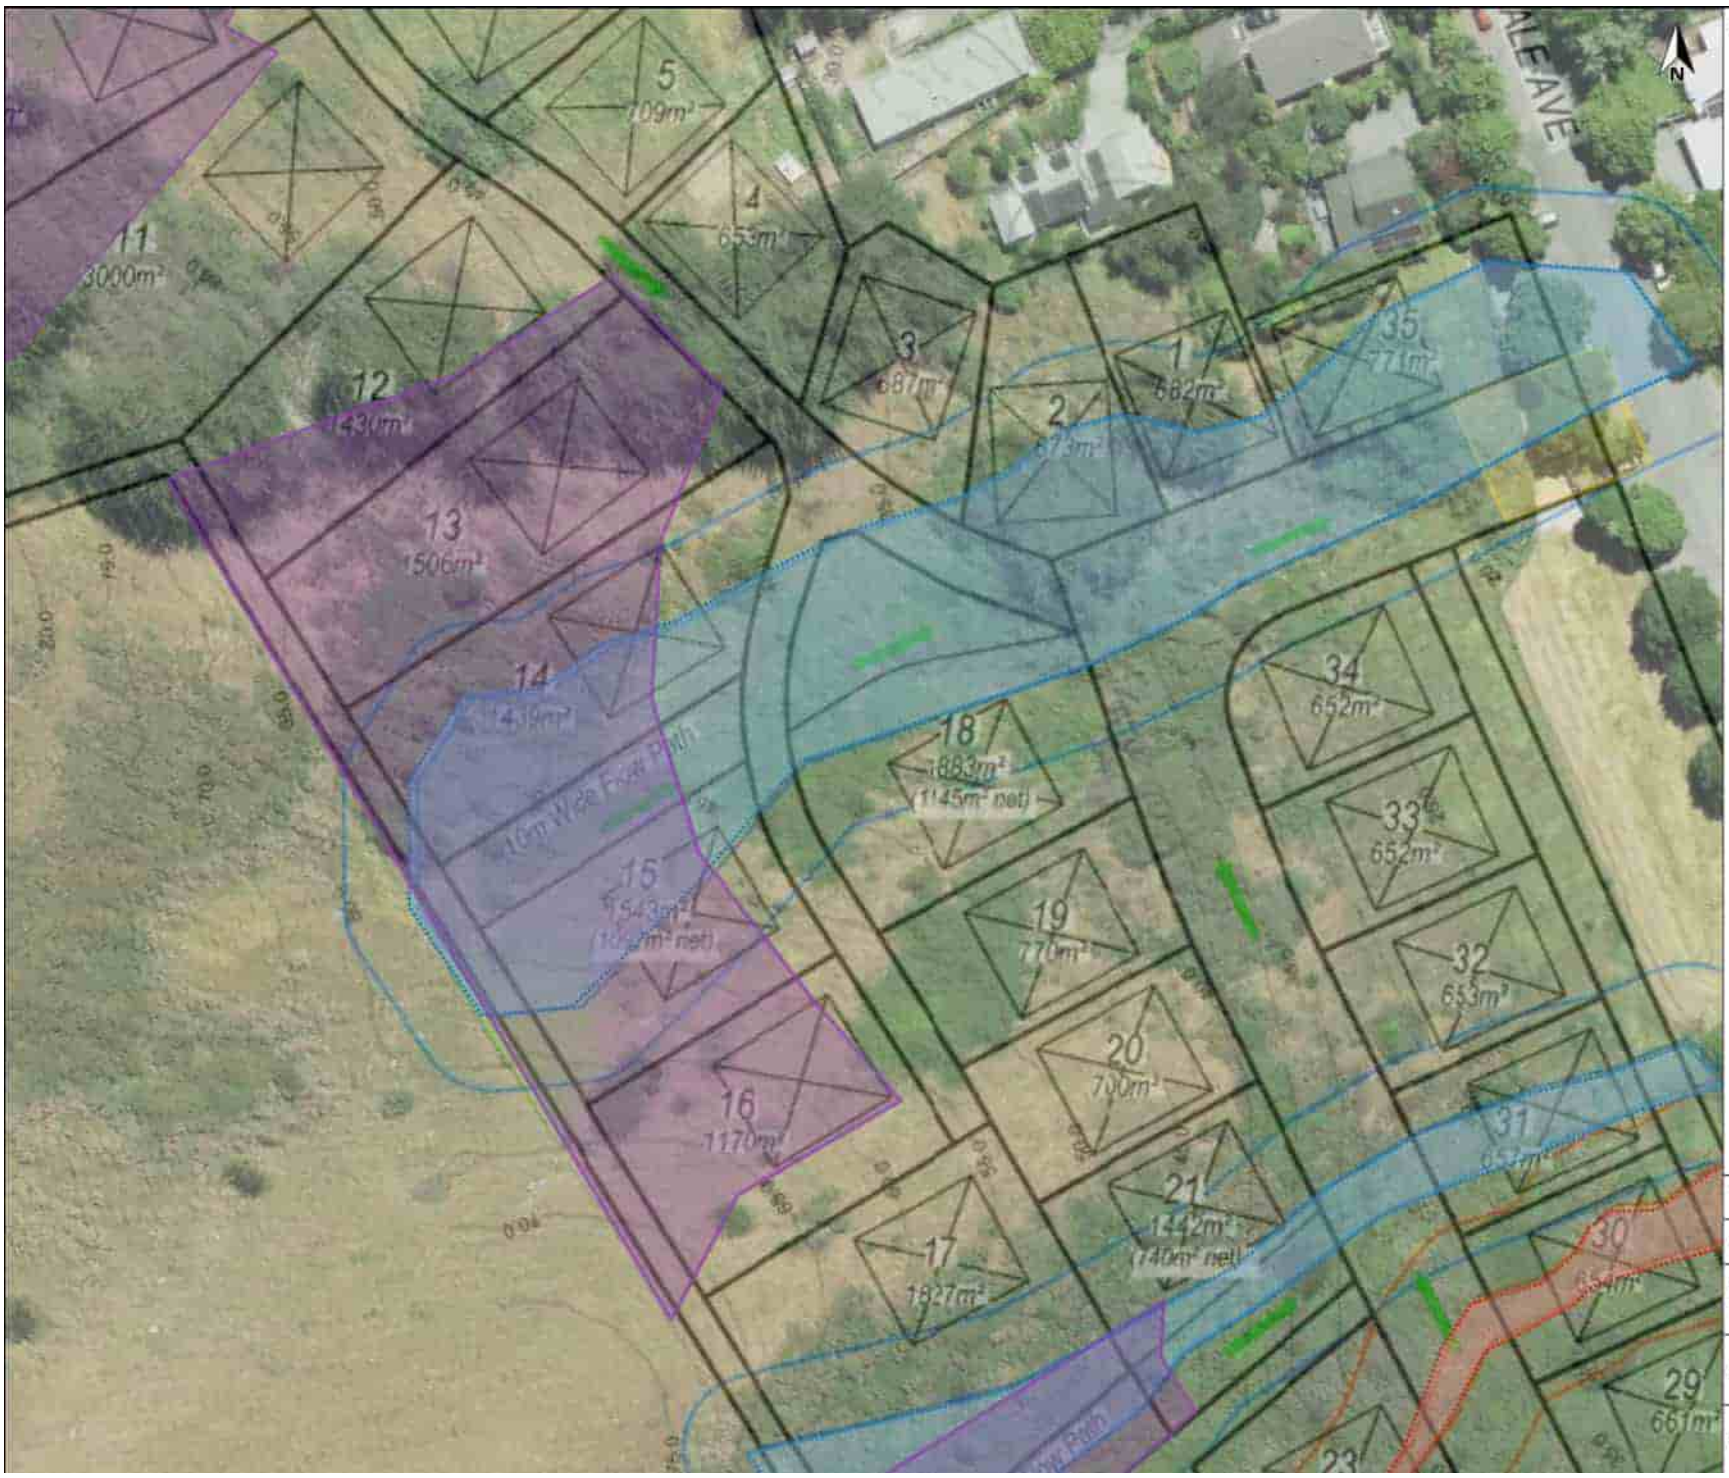
APPENDIX 3: Combined Hazard Map

- Legend**
- Rockfall Risk Zone 1 – Unacceptable Risk
 - - - Inferred Earthflow Location
 - Mapped Flow path
 - Proposed Subdivision Layout Plan
 - Proposed Stream Crossing Location

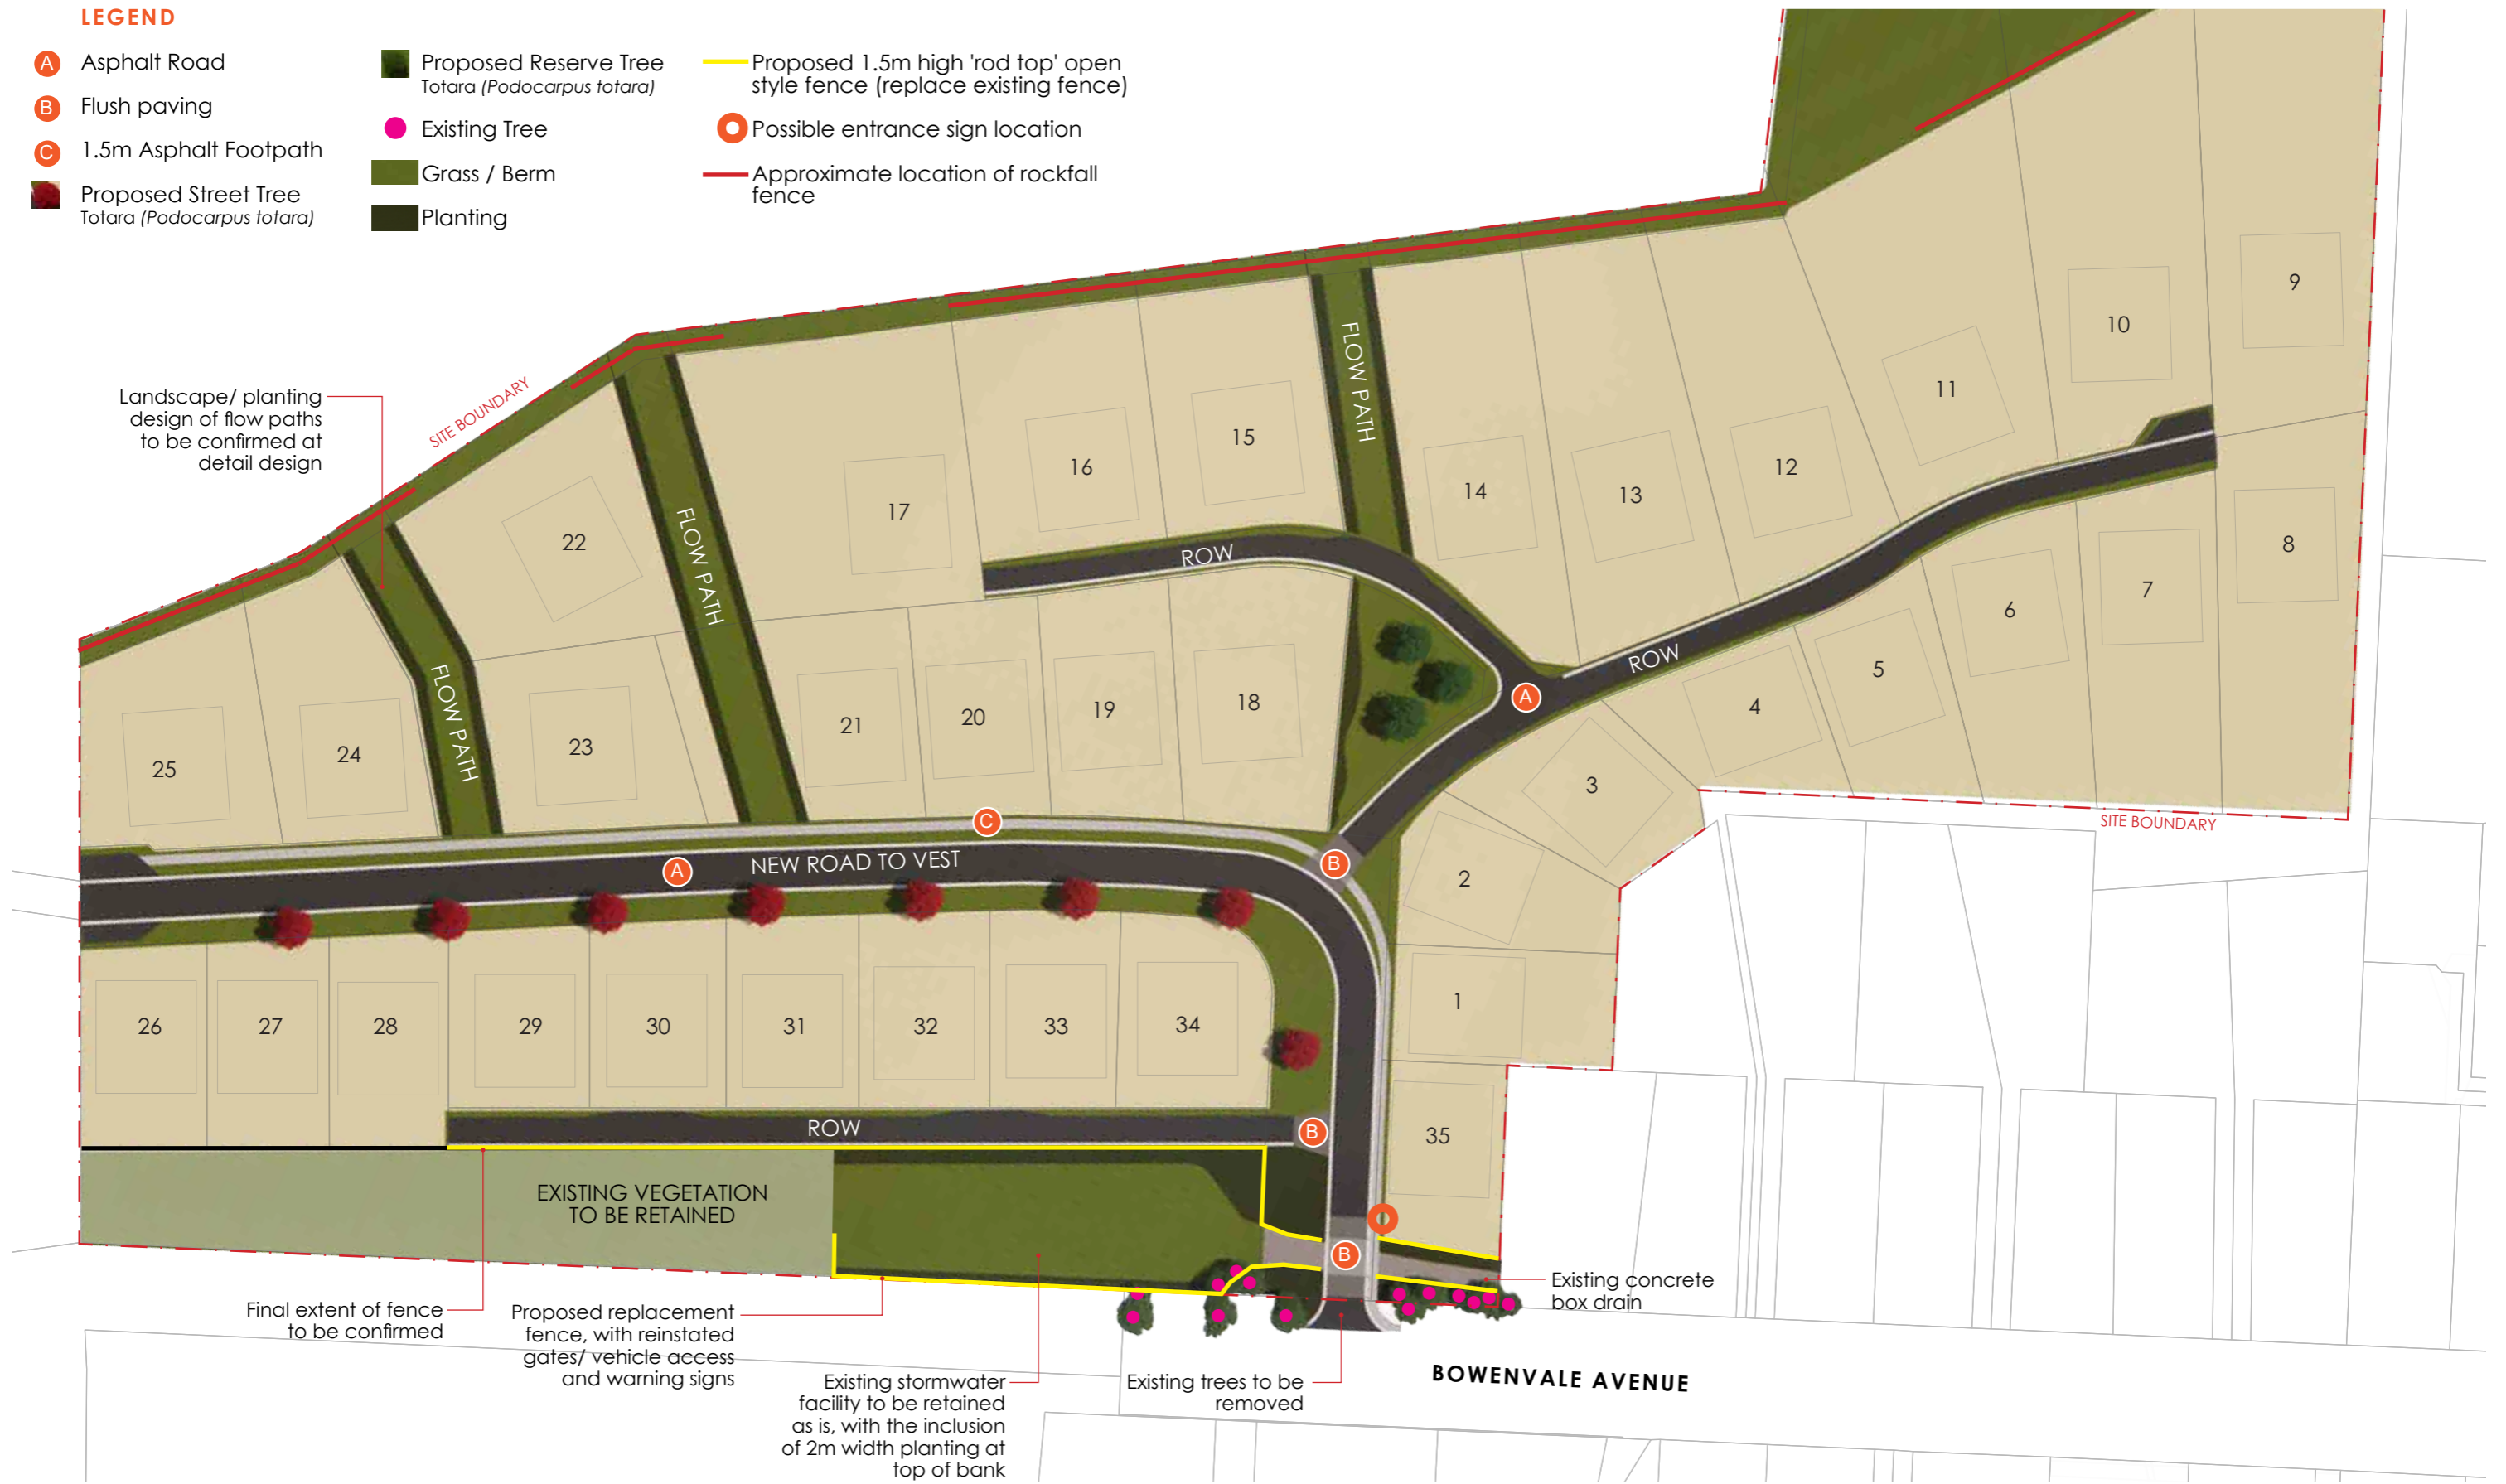
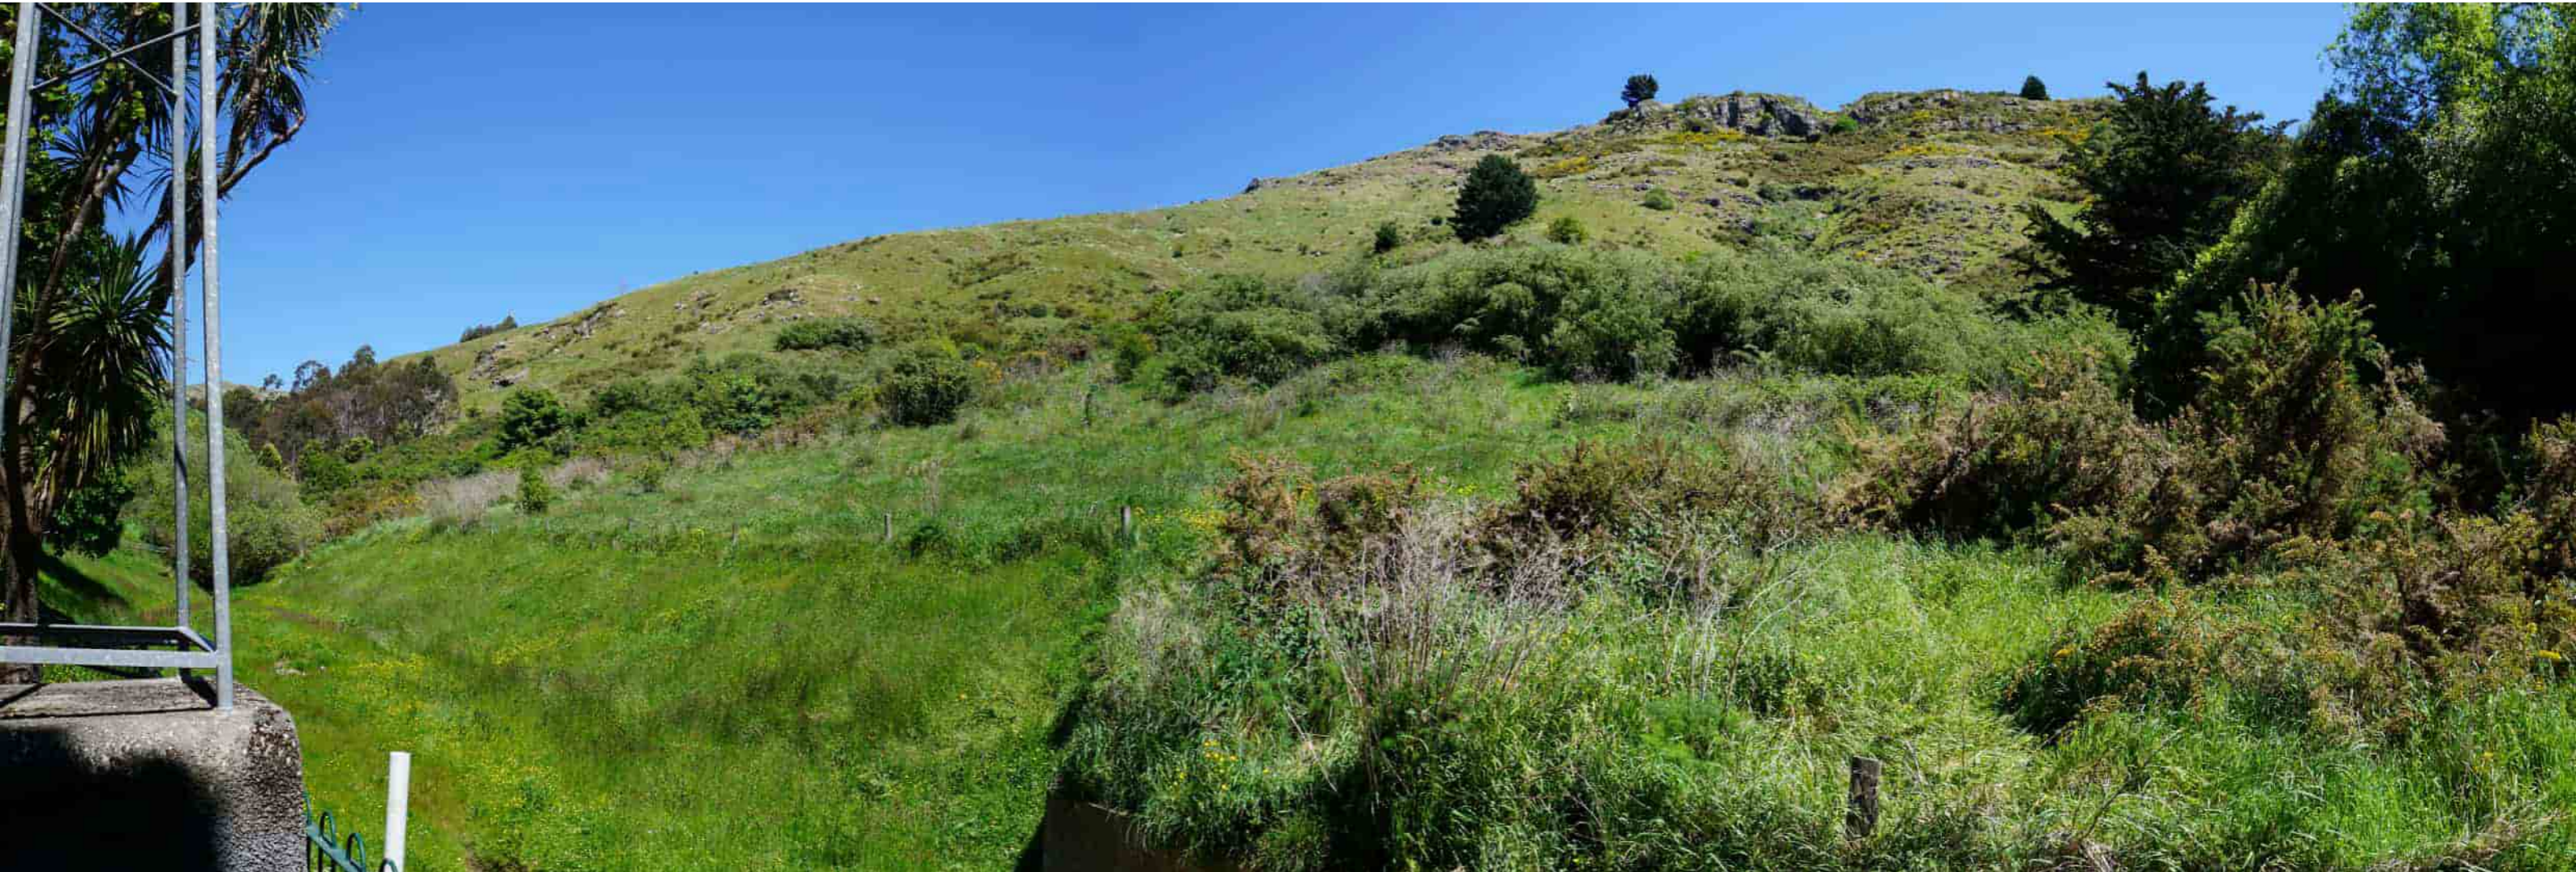
A. LANDSCAPE CONCEPT PLAN

LANDSCAPE CONCEPT PLAN

130 BOWENVALE AVENUE SUBDIVISION
FOR S5 CONSULTING GROUP

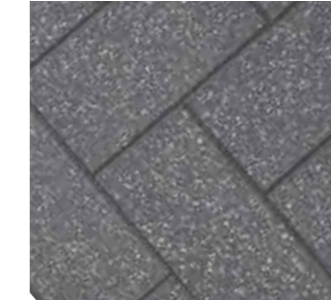
Holland Paving -
Hammered Finish, 45
degree herringbone
pattern, Colour -TBC
(Flush threshold in
carriageway)

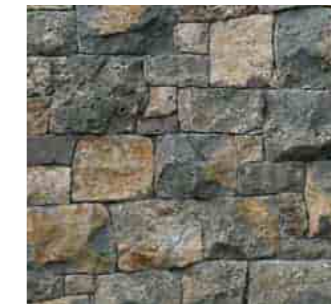
Split face basalt columns
(Bridge entrance)

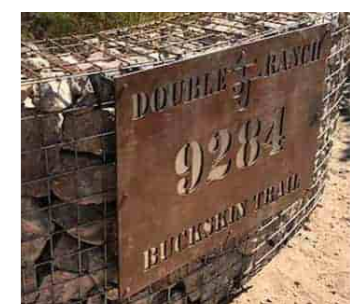
Corten Entrance Sign
(Fixed to gabion basket
retaining wall)

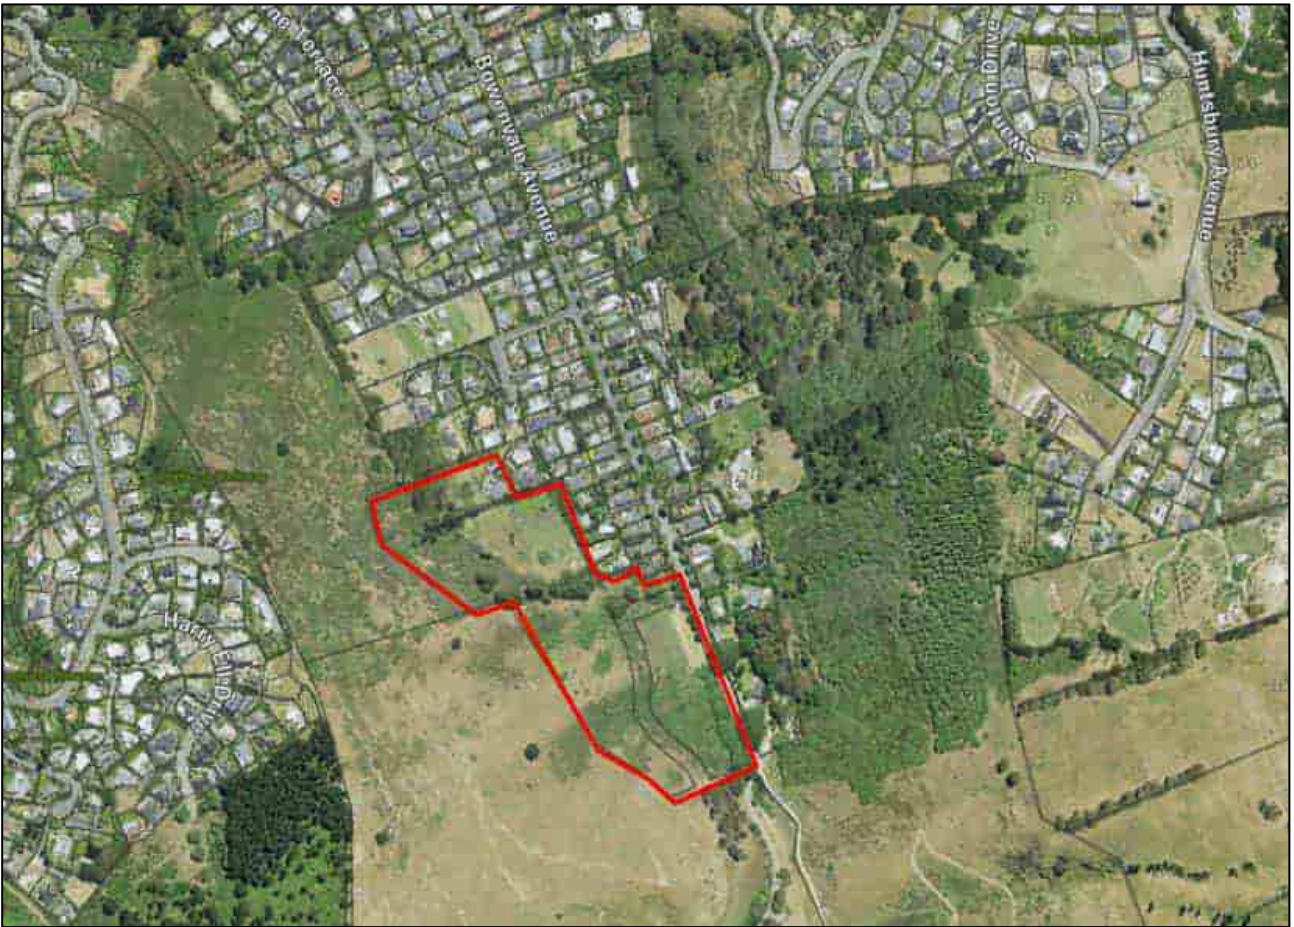
Figure 1-1. Site Outline

The project is a residential subdivision of land zoned 'Residential Hills' at the end of Bowenvale Avenue, as outlined in Figure 1-1 below.

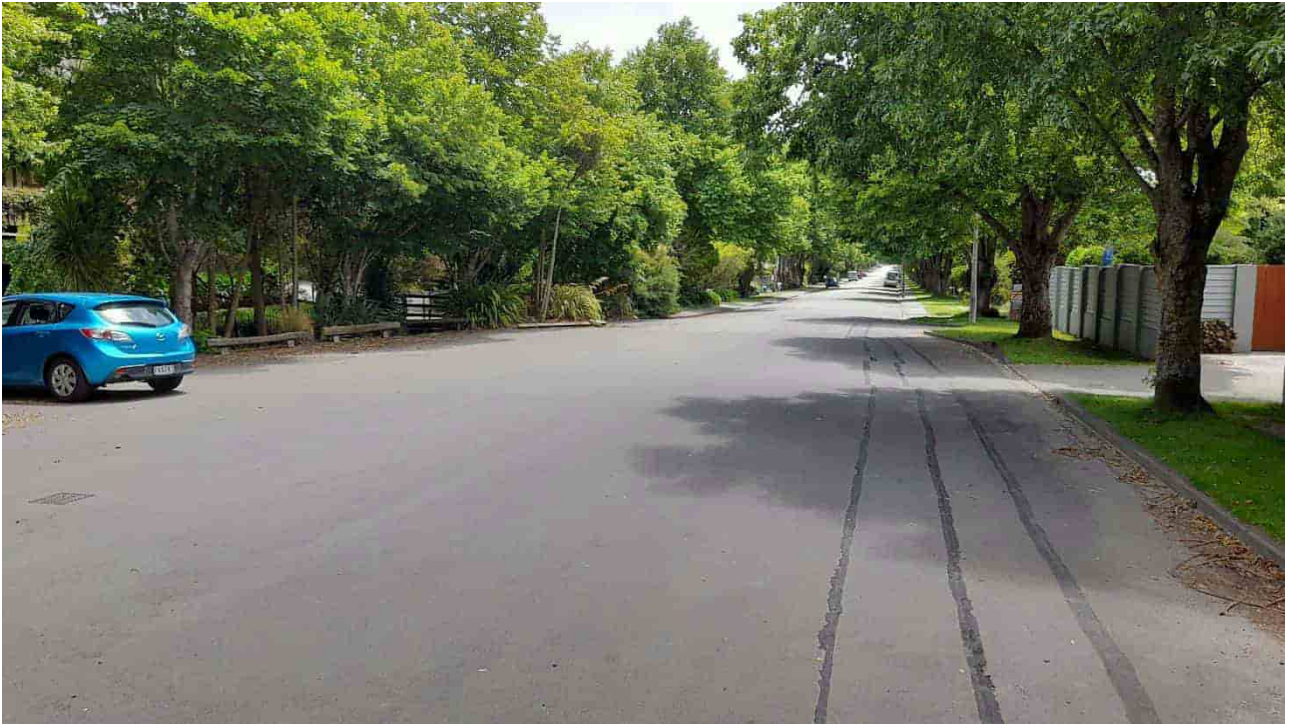
Photograph 2-1: Bowenvale Avenue Looking North at Proposed Intersection Location

The intersection location is near the end of Bowenvale Avenue, where there is 90-degree car parking on the western side of the road and kerbside parking available on the eastern side of the road (Photograph 2-1).

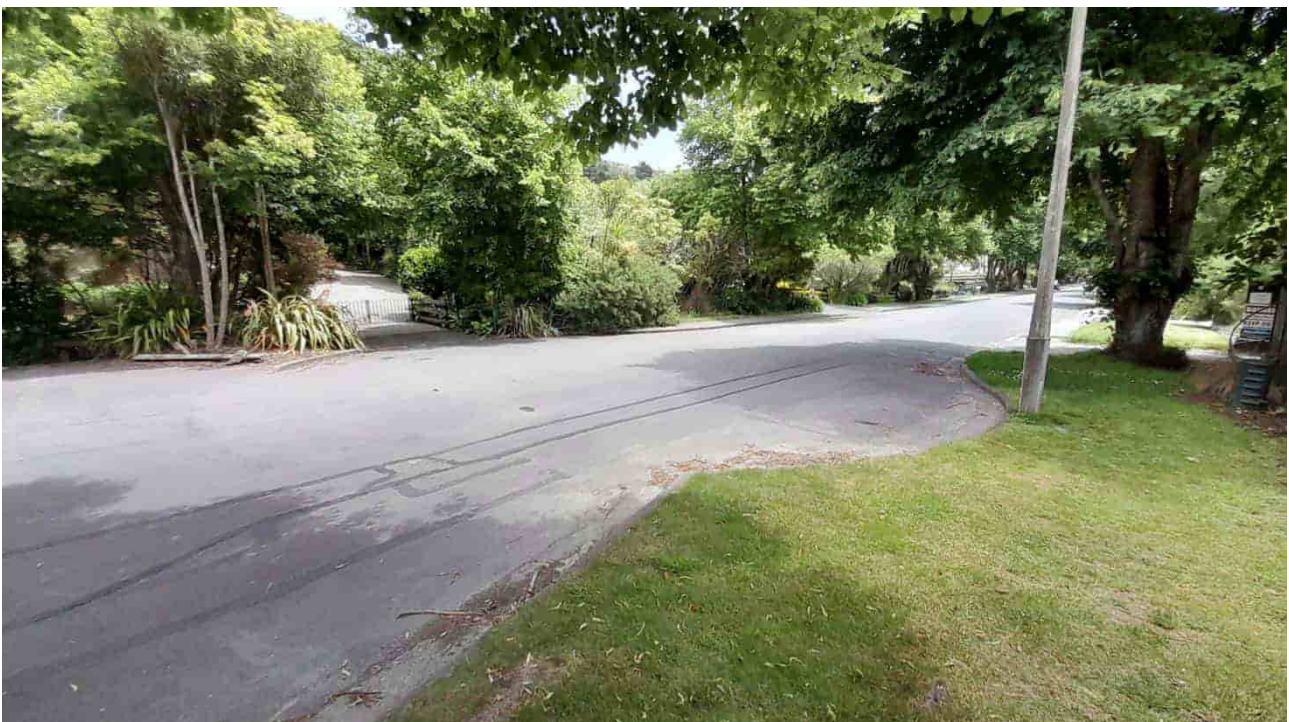
Photograph 2-2: Existing Turning Head at 114 Bowenvale Avenue

The footpaths on Bowenvale Avenue stop north of a turning head outside 114 Bowenvale Avenue (Photograph 2-2). It is considered that the existing footpath on the western side of the road should be extended to connect to the Road 1 footpath to provide a safe and convenient link for pedestrians.

It may be necessary to remove the turning head so that a footpath can be provided. The turning head may not be required once the subdivision road is constructed (as turning should be provided for on that road) however the need for a turning head and its location should be considered further.

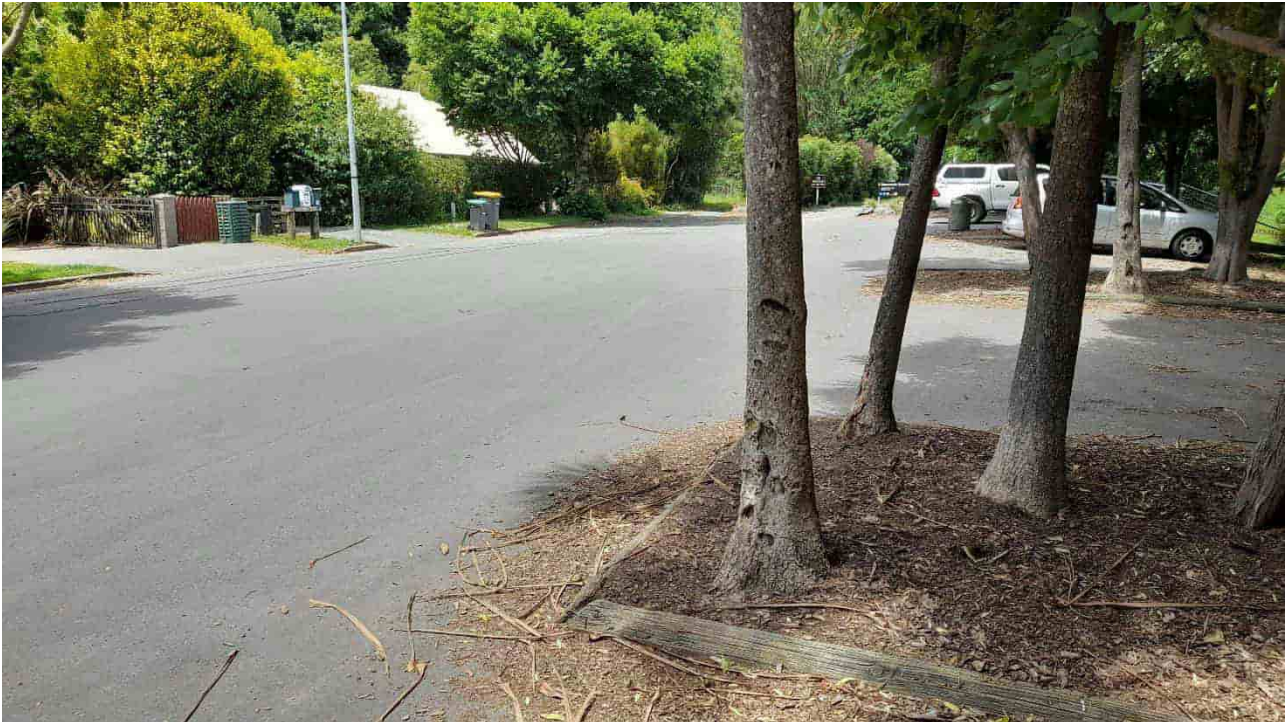
Photograph 2-3: Trees to Right of Intersection

Photograph 2-3 shows the sightline to the right from the approximate intersection location. The trees visible could obstruct visibility to the right, particularly to a cyclist who has just ridden out of the park. It will be necessary through the intersection detailed design to ensure that suitable visibility is available to vehicles and cyclists. Narrowing Bowenvale Avenue at the intersection by having kerbs extend out into the existing carriageway can be considered to provide improved sightlines and traffic calming benefits.

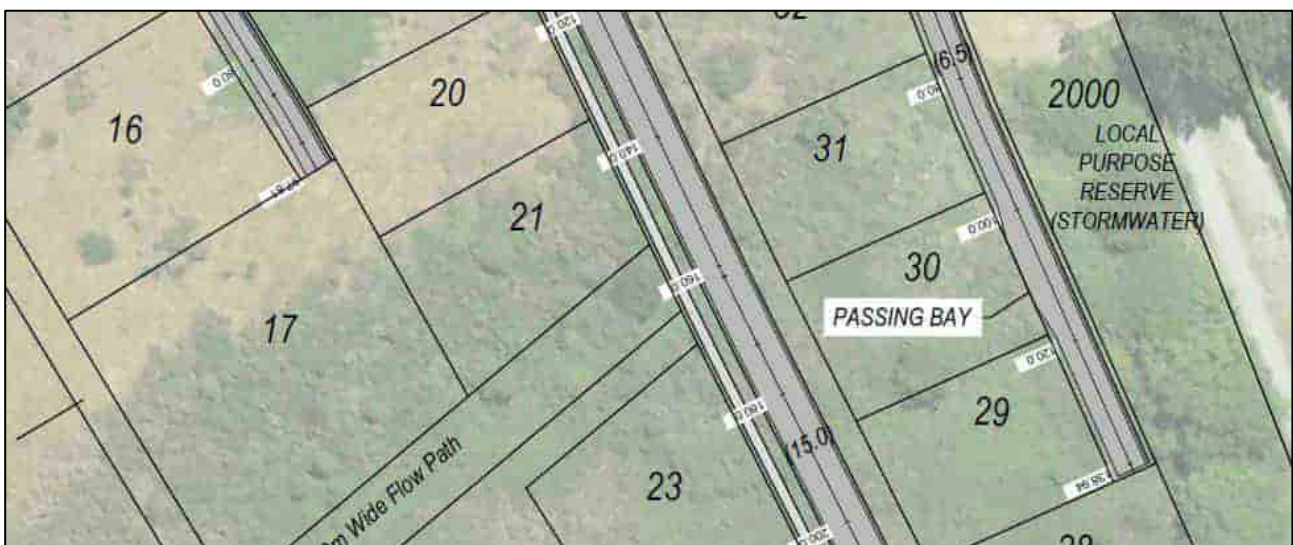
Figure 2-4: Ends of ROW 1 and ROW 3

It is acknowledged that there would be a low demand for turning at the end of the ROWs since drivers would be expected to be able to turn at the properties they are visiting.

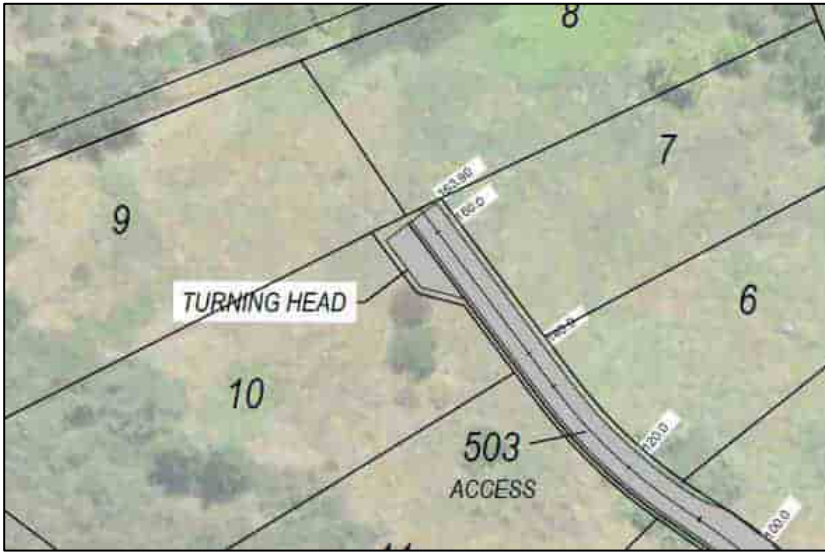
Figure 2-5: End of ROW 2

A turning head is indicated at the end of ROW 2 (Figure 2-5). Its size does not look standard and if a vehicle cannot use it to turnaround, the same safety concerns as raised for ROWs 1 and 3 would exist.

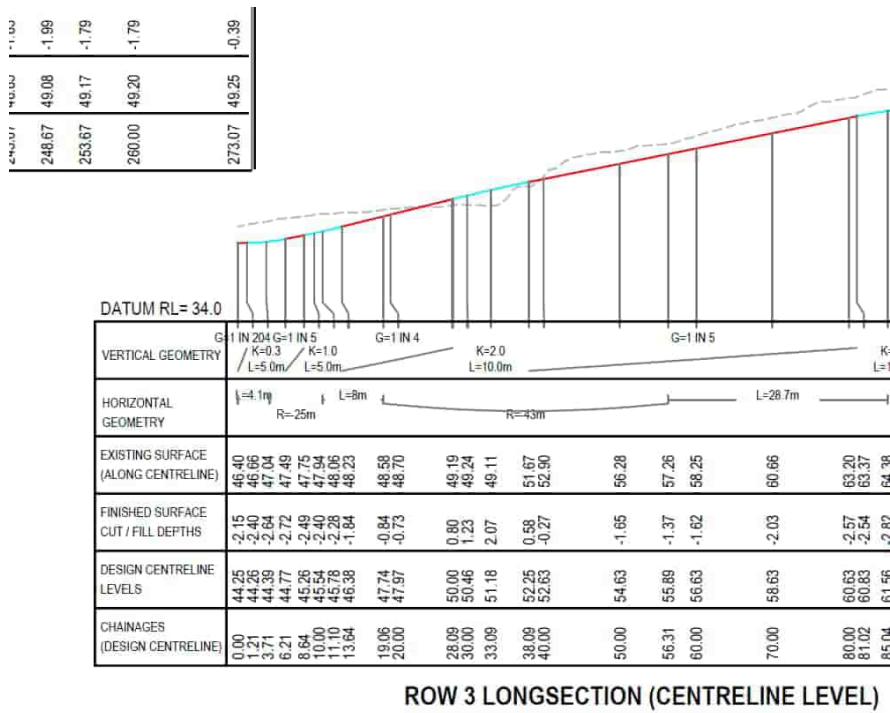
ROW 3 LONGSECTION (CENTRELINE LEVEL)

ROW 2 has a centreline gradient of 1 in 5 and ROW 3 has a section with a centreline gradient of 1 in 4 (Figure 2-7). These are steep gradients and the driveways may be difficult to access by vehicle or foot in icy conditions. Drivers could lose control of their vehicles or pedestrians could fall over.

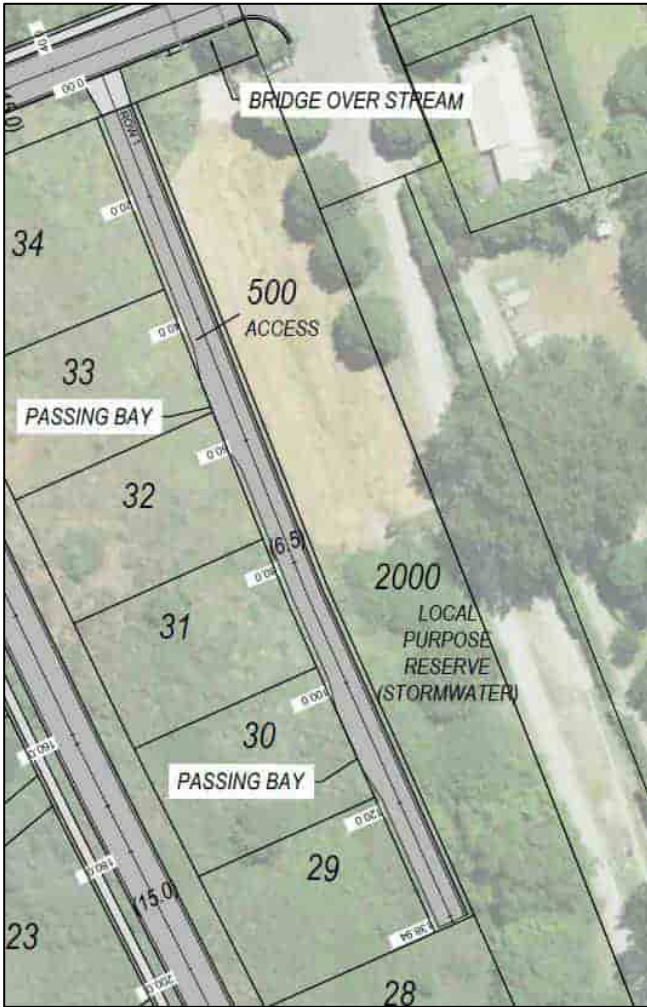
Figure 2-9: ROW 1

ROW 1 (Figure 2-9) is proposed to run along the ridge above the existing stormwater area shown in Photograph 2-4. This has steep sides and there are concerns that a vehicle, pedestrian or other road users could fall off the ROW. Also vehicles being manoeuvred out of Lots 29-34 could be mistakenly driven off the edge. The stormwater channel has steep, non-recoverable gradients and in the event that high levels of water are present, there is a risk of drowning. The form of edge protection and its purpose, i.e. to stop vehicles or to keep pedestrians out, should be considered.

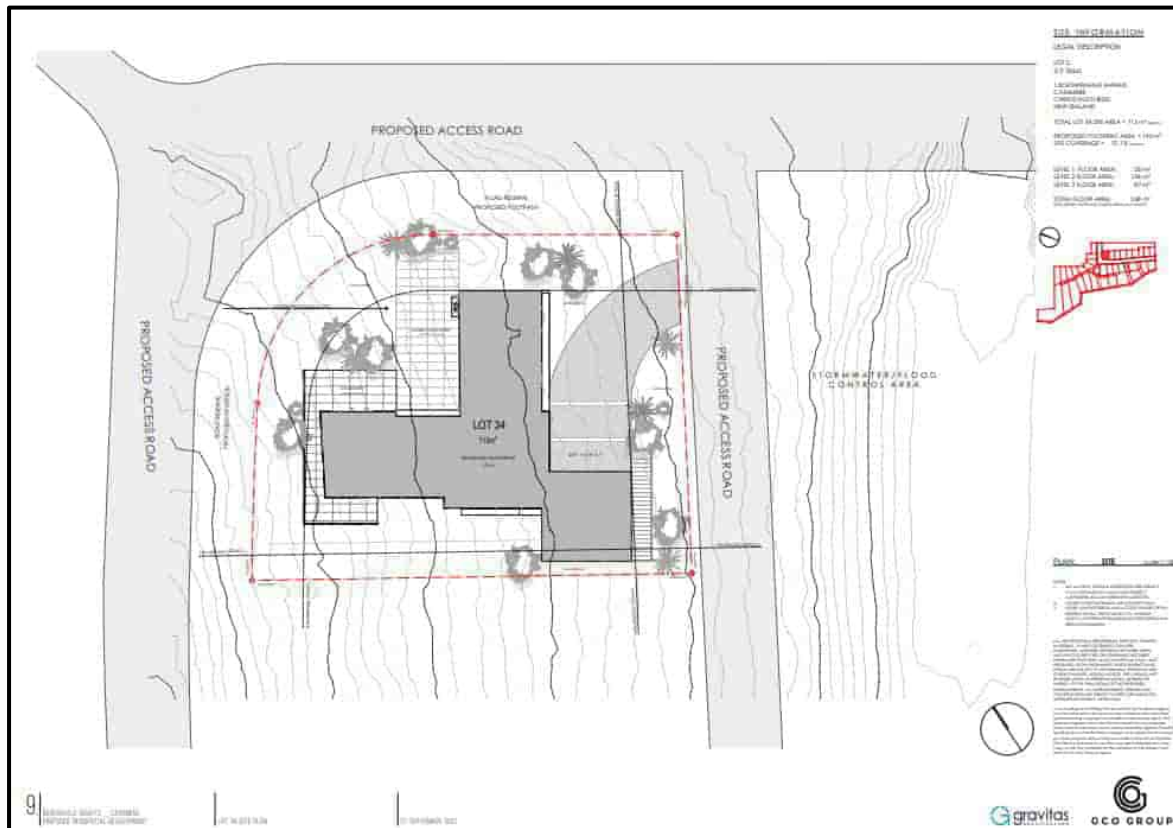
Figure 1: Site Development Plan (GCO Group)

The site at Lot 34, 130 Bowenvale Avenue is located on an east-facing section of that is moderately sloping (~20-22°) in Cashmere, Christchurch. The property will be accessed from Bowenvale Avenue via the access road to the east of the property. The proposed site development plan is displayed below in Figure 1.
