Application for Resource Consent: Subdivision

Resource Management Act 1991 – Form 9

130 Bowenvale Avenue Cashmere

Part Lot 2 DP 33462

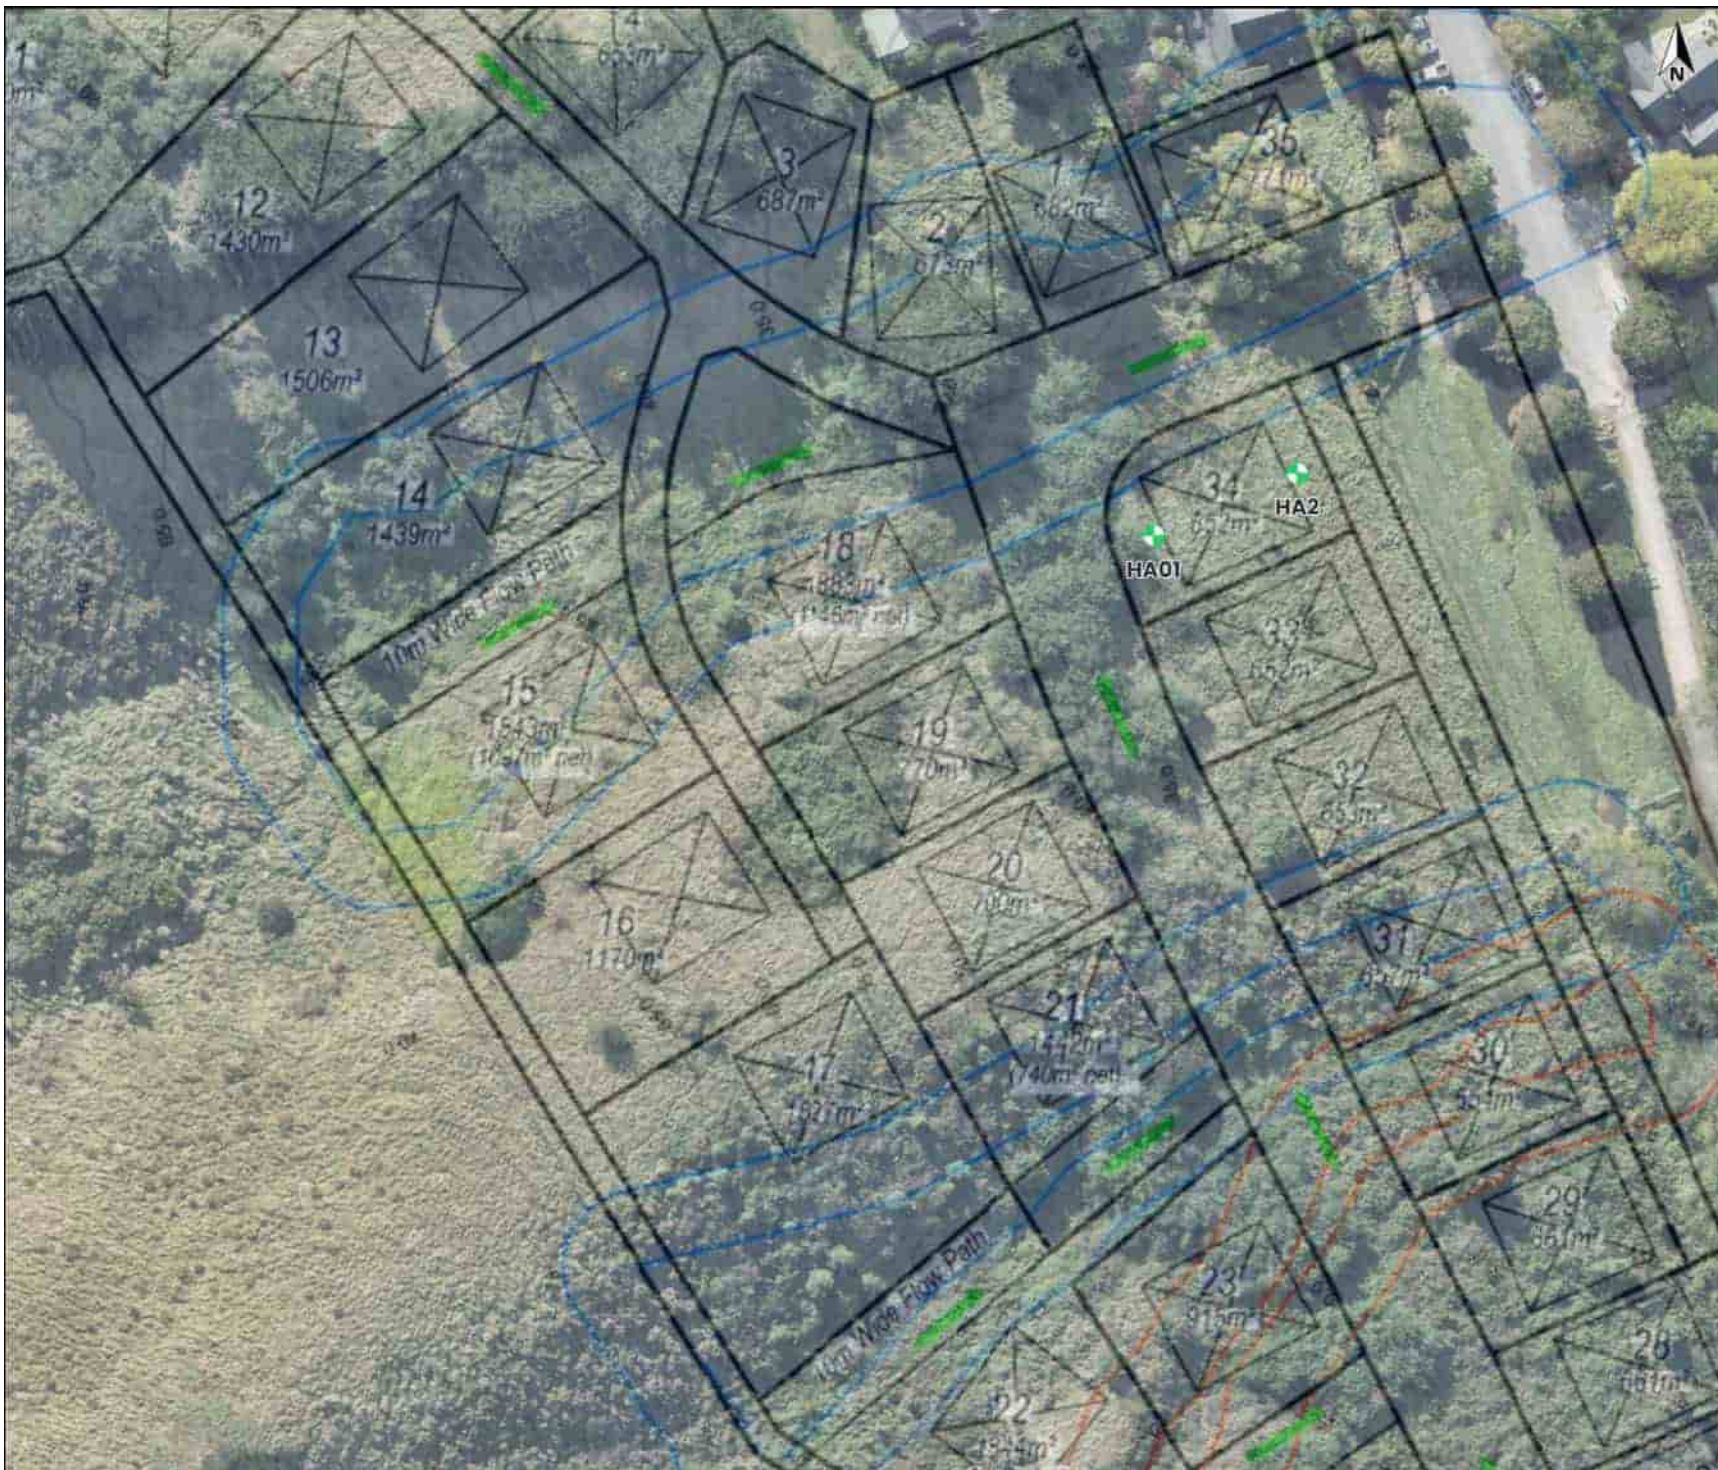
APPENDIX 1: Test Location Plan

- ★ ENGEO 2022 - Hand Auger Locations
- Proposed Subdivision Layout Plan
