A Conservation Plan for  
Hagley Park and the  
Christchurch Botanic Gardens  
Volume Two: Hagley Park

## Conservation plan: Hagley Park and the Christchurch Botanic Gardens

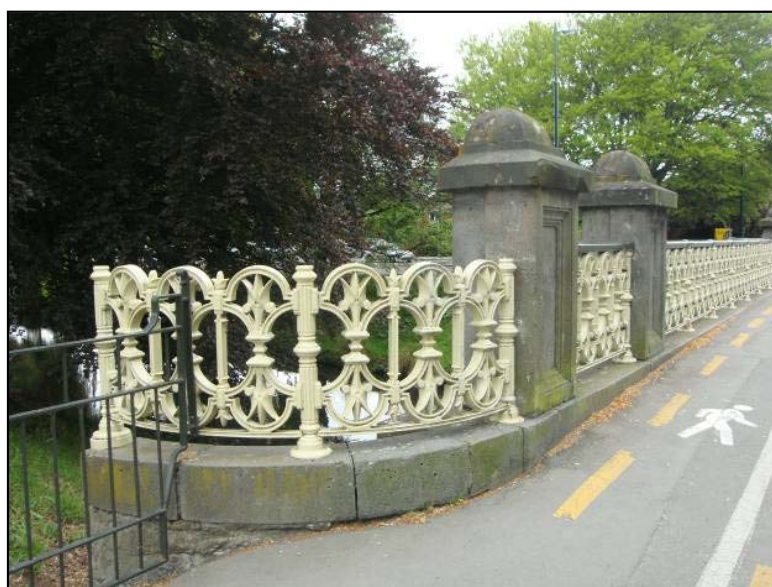
The brick arch spans 12.2 metres in length and is 12.6 metres wide. On the arch facing, stone voussoirs adorn the exterior along with moulded panels. An elaborate lace balustrade embellishes the bridge.

Figure 1.15. Cast iron balustrade on Armagh Street Bridge.  
Source: DPAL, 2012

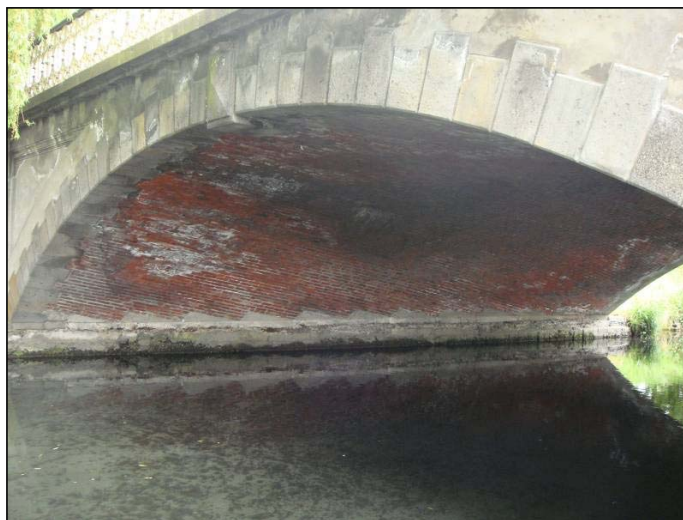
The bridge is constructed with a brick arch on concrete foundations. Basalt stone voussoirs feature on the arch exterior, the abutments and the posts anchoring the balustrades. The arch facings are plaster finished. Elaborate cast iron balustrades and handrails are another characteristic of the bridge.

Figure 1.18. Brick arch on concrete foundations with basalt stone voussoirs on the arch.

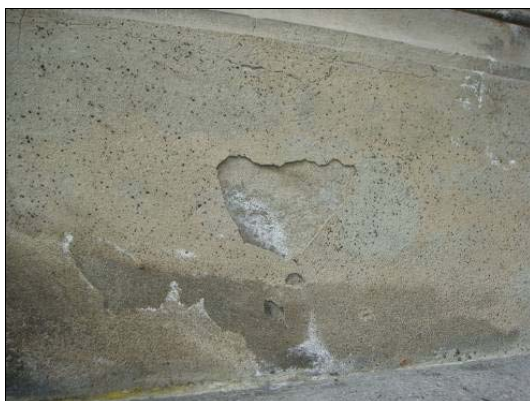
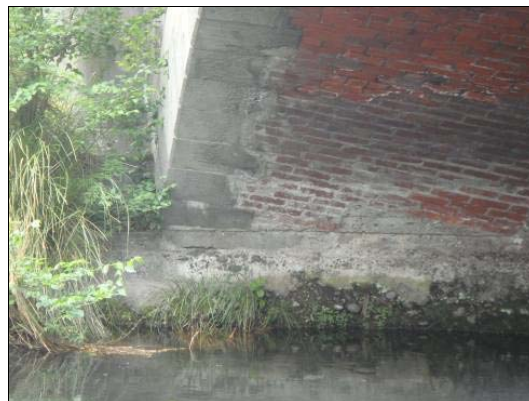
- Efflorescence is apparent in the brick arch, the voussoirs and the plaster facings.
- Spalling of plaster is visible on the south eastern side of the bridge.

Figure 1.19. (Left) Erosion of plaster on bridge face and (right) signs of efflorescence on brick arch

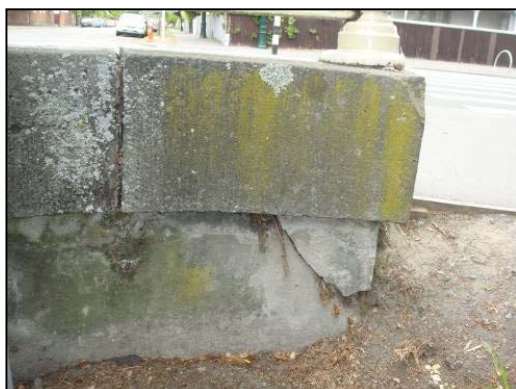
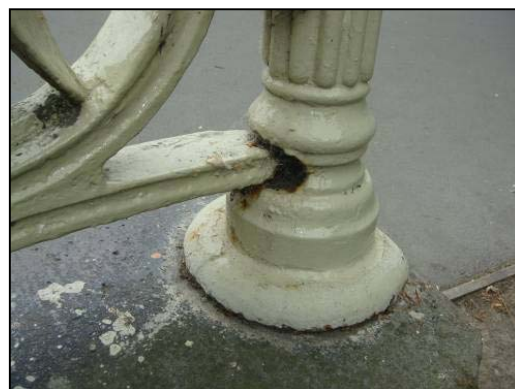
- On the basalt capping stones there is some loss of mortar causing some cappings to slump.
- One capping stone is cracked
- On the eastern corner spalling of the pillar has occurred.
- Rust is evident on the cast iron balustrade and the handrail.
- The rail of the balustrade is loose on the eastern corner.
- There is some settlement with a cracked footing.
- The south abutment is previously repaired.
- On the north western side of the bridge some erosion of the voussoirs has occurred.
- The concrete base has eroded in the southern and western corner.
- On the north western some of the stone voussoirs have eroded with fractures in the stone occurring naturally.
- There is a general loss of pointing between the stones. rail of the balustrade is loose on the eastern corner.
- Some sections of the railing are missing.
- Gap opened up below pillar.

Figure 1.20. Cracked footing (left) and rust on the balustrade (right).

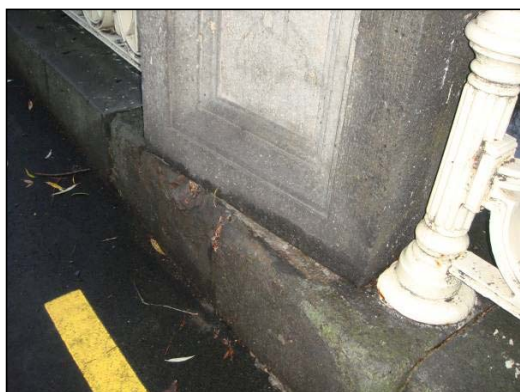
- Pillar on the west side of the bridge is inclined outwards.
- Movement in the stones on the north west abutment.
- Possible movement near the north east abutment.
- Crack on the north facing side of the bridge.
- The pillar near the south western corner has rotated.
- The pillar near the north western corner is displaced.
- Crack on the north facing side of the bridge.
- The pillar near the south western corner has rotated.
- The pillar near the north western corner is displaced

Figure 1.21. Rotation of pillar on bridge.  
Source: DPAL, 2012

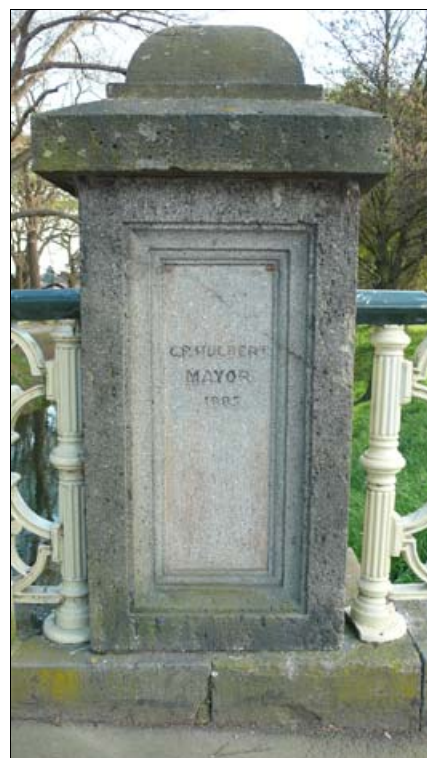
Figure 1.22. Diagonal cracking through abutment.  
Source: L. Beaumont, 2011

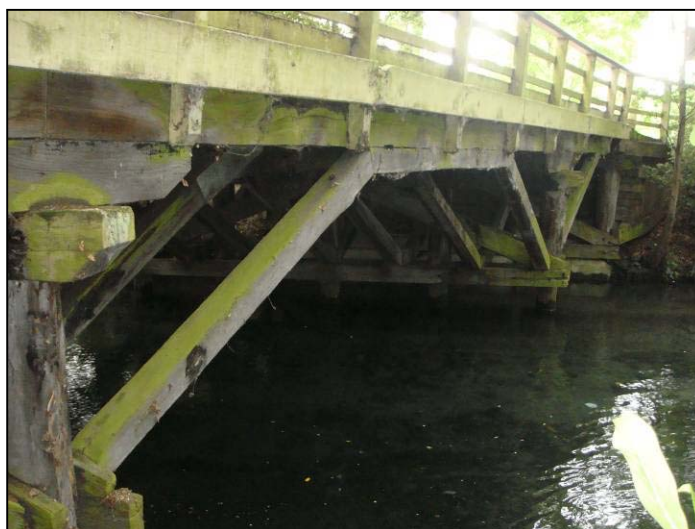
Figure 1.25. Timber elements supporting the bridge.  
Source: DPAL, 2012

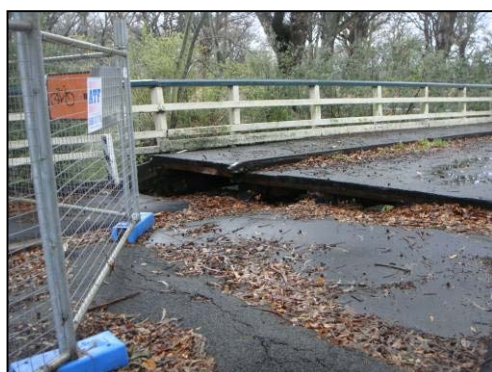
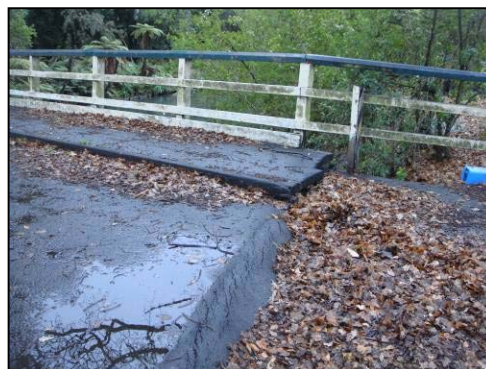
- Substantial subsidence of abutment and road on both sides of the bridge.
- Possible lateral movement in the piles.
- The pile supporting the north abutment is substantially decayed and possibly fractured below ground.
- There is decay in the cross head adjacent to bridge abutments
- Decay is apparent in the longitudinal beam.
- The handrail is generally in poor condition and decaying. A section of the handrail is loose and movement is apparent as a result of the earthquakes.
- There are cracks in some beams.
- There is decay in the runner at either side of the carriage way.
- On the carriage way the seal is cracking.

Figure 1.26. Subsidence of abutment beside road.

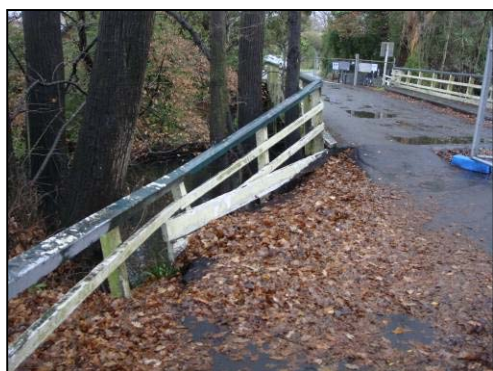
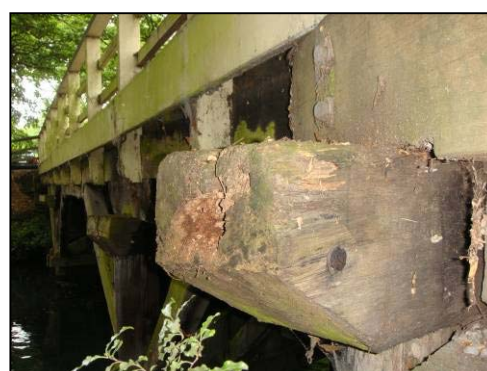
Figure 1.27. General deterioration and movement of handrail (left) and general decay in timber (right).
