Fabric: Magnetic Observatory Workshop/Museum	Also discussed in: Volume 1:3.6.1, 3.9.1, 3.14.1
Location plan reference: 5	Historical images: Volume 3:1.75
<p>Description: The former Magnetic Observatory site is located south of the former Tea Kiosk. The remaining building is the Workshop which now functions as an Observatory Museum. It has an entrance facing north. A climatological station operates within the small fenced area adjoining the building. The Observatory Museum is surrounded by grounds planted with shrubbery and trees. To the south east of the area is Cunningham House and its associated buildings.</p> <p>Provenance /Design:</p> <ul style="list-style-type: none"> • Unknown designer and builder. <p>Modifications:</p> <ul style="list-style-type: none"> • The current building was probably constructed around 1940. It was recorded as being on the site in 1941. • The site itself has undergone many changes since the Magnetic Observatory was first constructed in 1901 with the erection and destruction of various observatory buildings.

Fabric: Peacock Fountain	Also discussed in: Volume 1:3.6.1, 3.11.2
Location plan reference: 12	Historical images: Volume 1:3.47, 3.56
<p>Descriptio

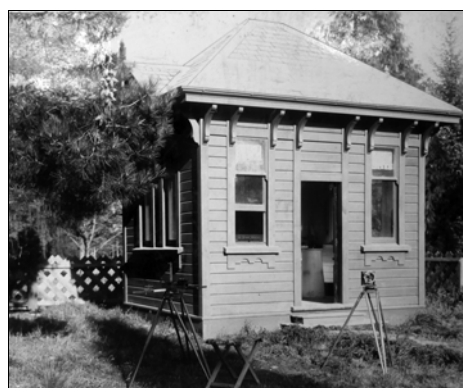
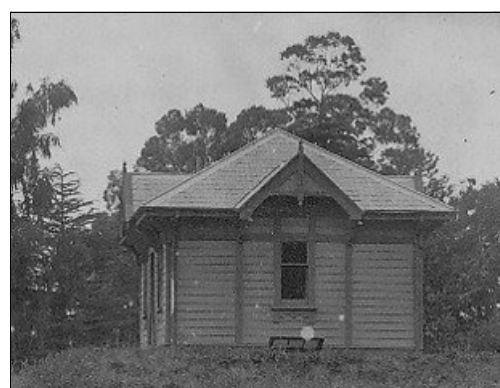
Figure 1.70. Absolute Magnetic House (left) and Magnetographic House and cellar (right).

Visitors were prevented from going near the magnetographic cellar because of the potential for the metal objects that they may have carried, such as keys, belt buckles and the like, to affect the delicate adjustments of the seismographs.¹²⁸

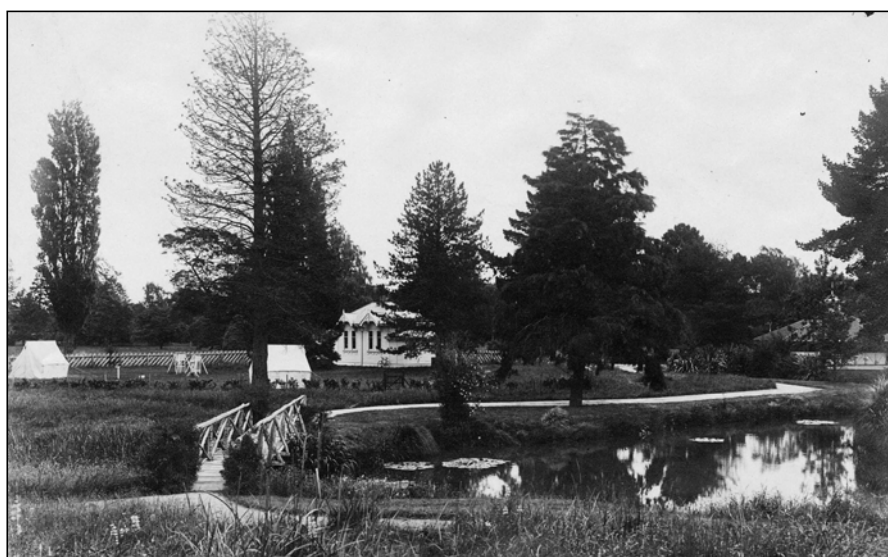
Figure 1.72. Jarrah Peg, Brass Pipe, Office and Kiosk(right), November 1915.
The tents belonged to visiting American scientists from the Carnegie Institution.
Source: C725, Carnegie Institution of Washington, Dept of Terrestrial Magnetism

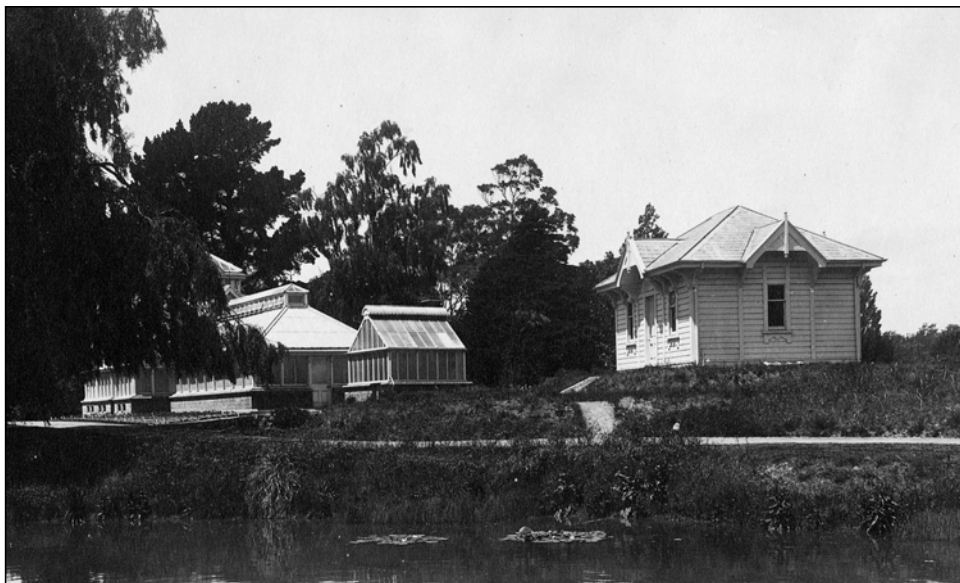
Figure 1.73. Magnetographic House, also called the Variation Observatory (right) and Orchid House (centre) Source: C722, Carnegie Institution of Washington,

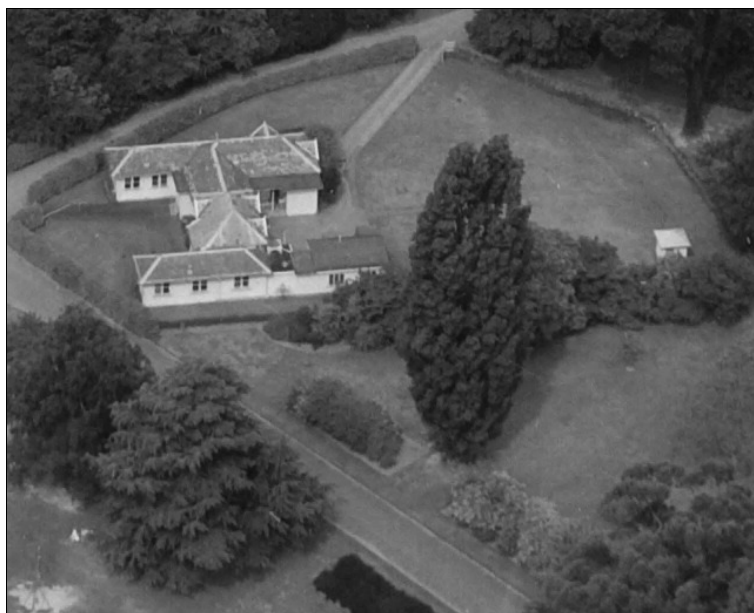
Figure 1.75. Aerial view of the Magnetic Observatory showing the extent of the operation and the setting in 1962. Source: Whites Aviation, WA-61184-F, ATL

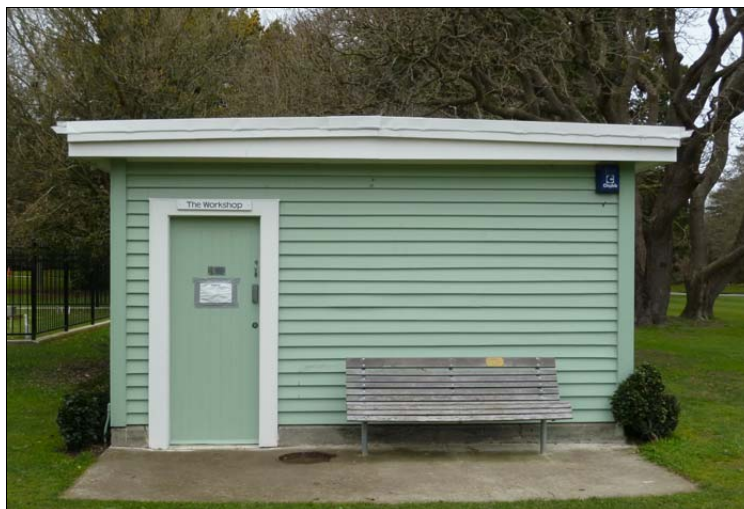
Figure 1.76 The Workshop, 2012.

Construction:***Foundations***

The building is founded on a concrete slab. A concrete foundation wall can be seen at the front of the building.

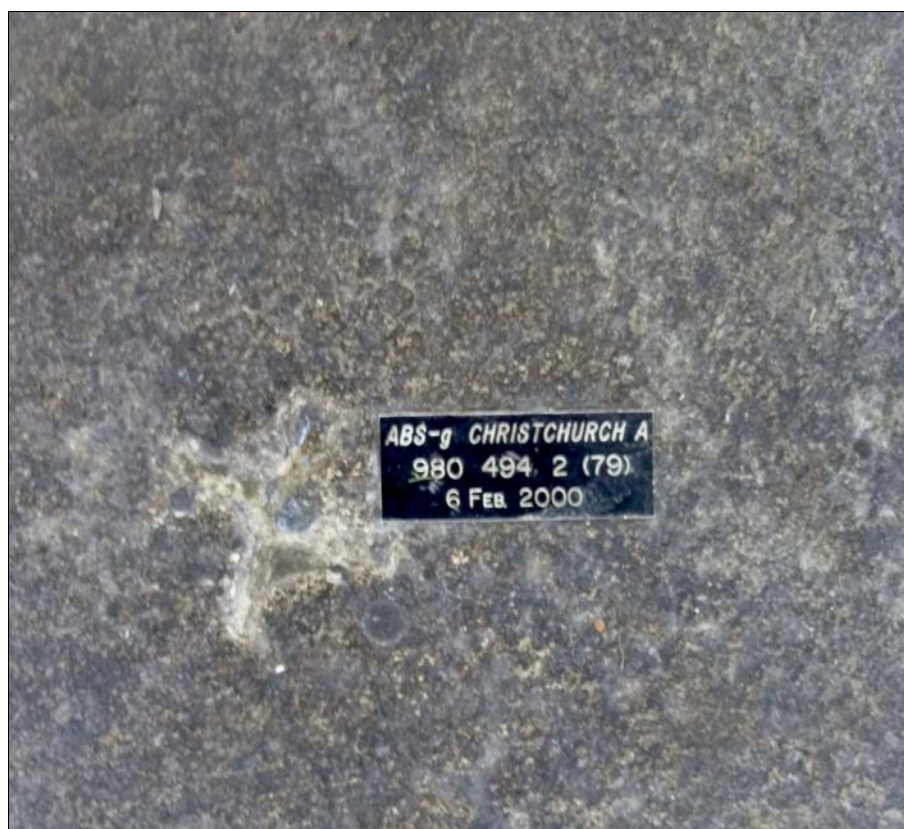
Figure 1.77. The cross in the floor of the Workshop marks the fundamental reference point. The small number plate on the floor was given to the Gardens by the Institute of Geophysical and Nuclear Sciences (GNS) - formally DSIR - to be glued next to the cross.

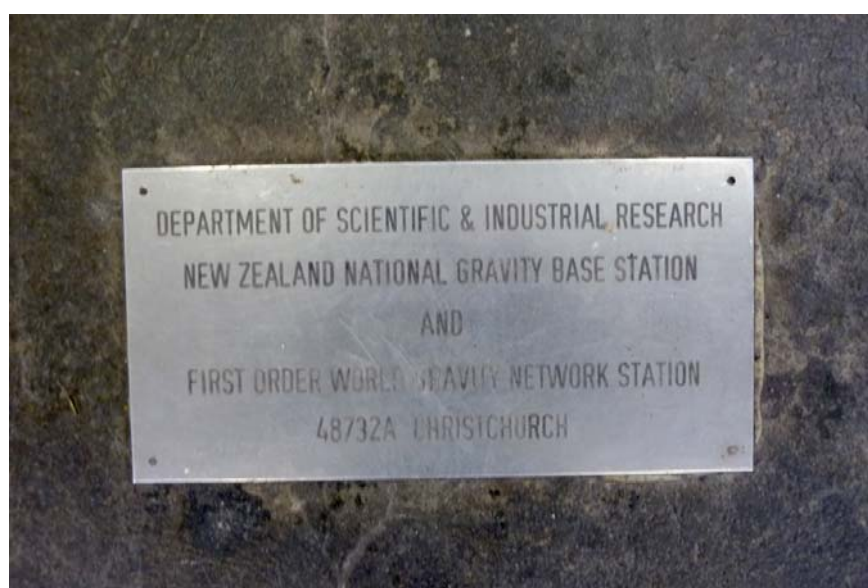
Figure 1.78. DSIR plaque mounted in the floor of the Workshop.

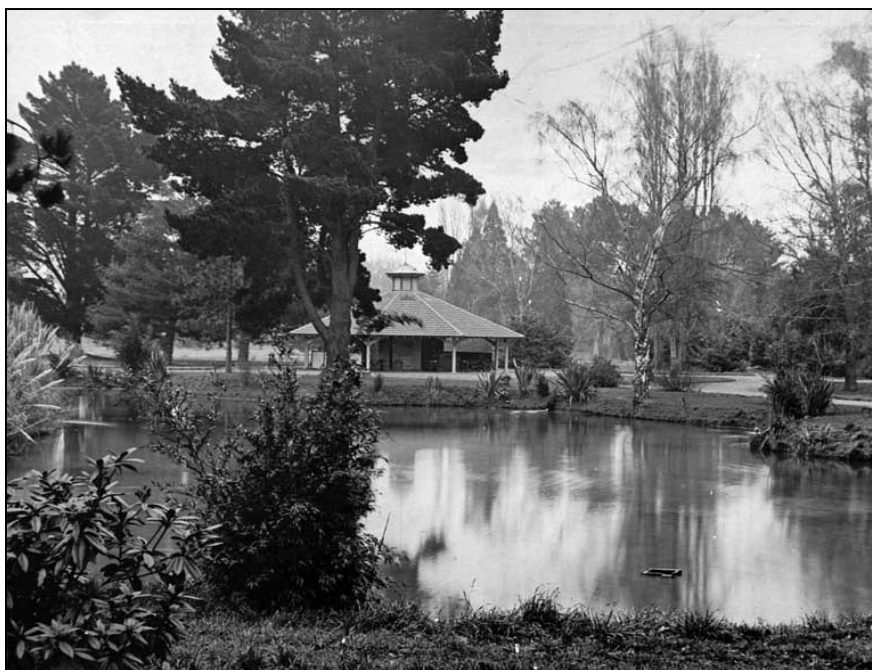
Figure 1.79. First Tea Kiosk ca. 1911.
Source: CCL Photo CD 22 IMG01427

Domain Board by-laws of 1888 prevented patrons from having bottles, glasses, crockery or paper, remnants of food and the like within the limits of the Domain of Hagley Park. A tea kiosk would compensate by providing light refreshments to the public. By 1910 a kiosk had been erected in the grounds near the lake. Built for £300 it was a partially enclosed building with a tiled roof.

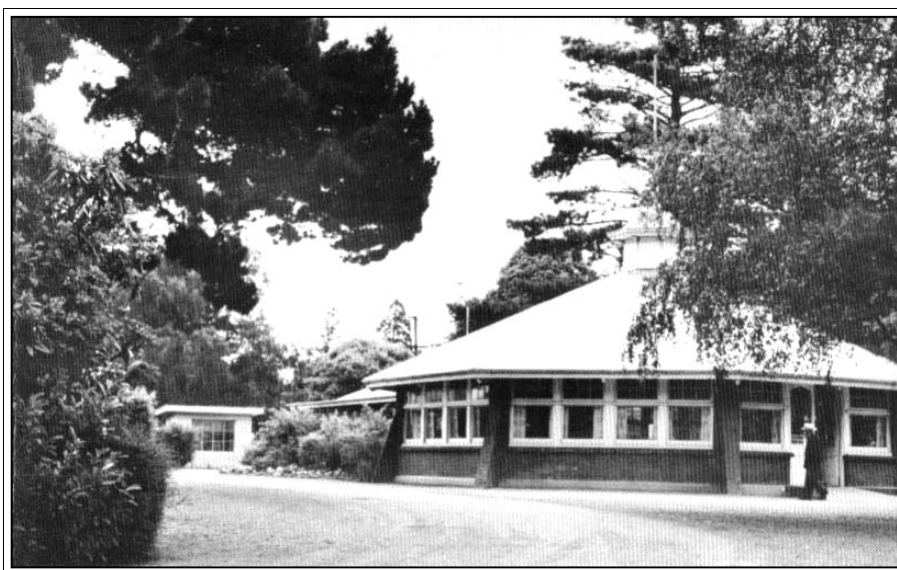
Figure 1.81. Second Tea Kiosk photographed in 1963.
Source: *A Garden Century*

In September 1922 the Tea Kiosk was destroyed by a fire thought to have been started by burglars. A temporary tea tent was set up as construction of a new kiosk began immediately on the same site. A local building company, Moore and Sons, completed the new kiosk for a fee of £1436. The replacement building was a larger octagonal fully enclosed brick structure which seated 100 patrons and was completed in 1923.

Originally the new Tea Kiosk was an open structure without windows. However draughty conditions eventually lead to windows being installed. In 1931 the kiosk was extended. This disturbed the original octagonal form of the building.¹³⁹

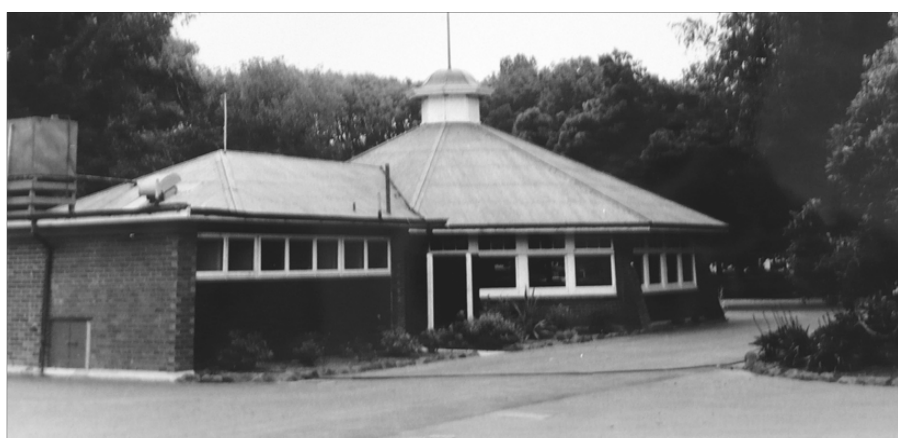
Figure 1.82. Second Kiosk with the rear addition ca.1973.
Source: CCC Heritage Files

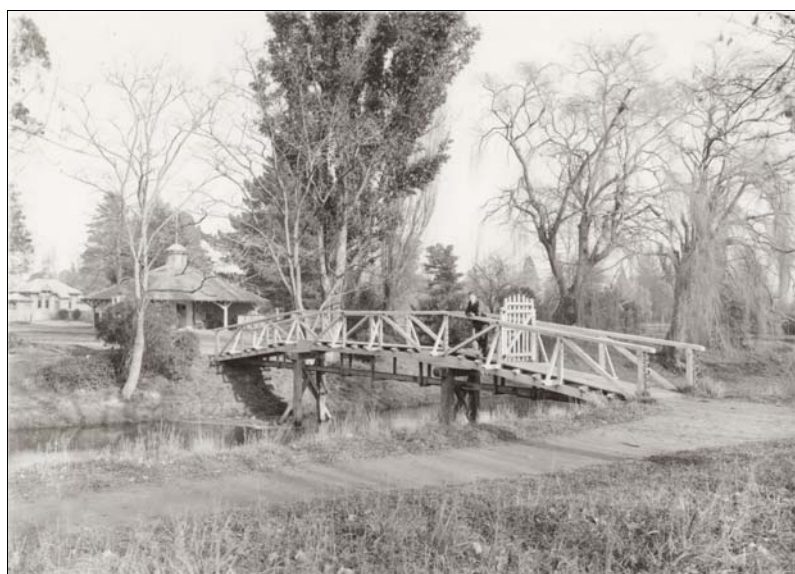
Figure 1.83 Tea Kiosk Footbridge at the time of the original Kiosk. Source: G- 40980-1/2 , ATL

On the northern side of the former Tea Kiosk is a footbridge crossing the Avon allowing direct access to the café from North Hagley Park. This footbridge is believed to have been in existence in 1881 as, at that time, records indicate the Domains Board agreed the river path be extended from this bridge to the Armagh Street Bridge.¹⁴⁰

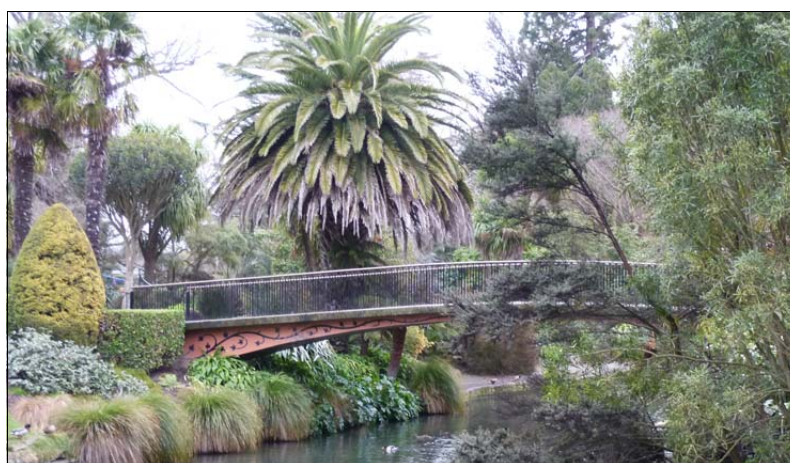
Figure 1.84 Extant bridge, now known as North Bridge, 2011
Source: L. Beaumont

The bridge is also known as North Bridge, Tearooms Bridge and Domain Bridge. In 1966 the bridge was replaced with a contemporary concrete bridge.¹⁴¹ This was replaced again in 2003 with the extant structure.

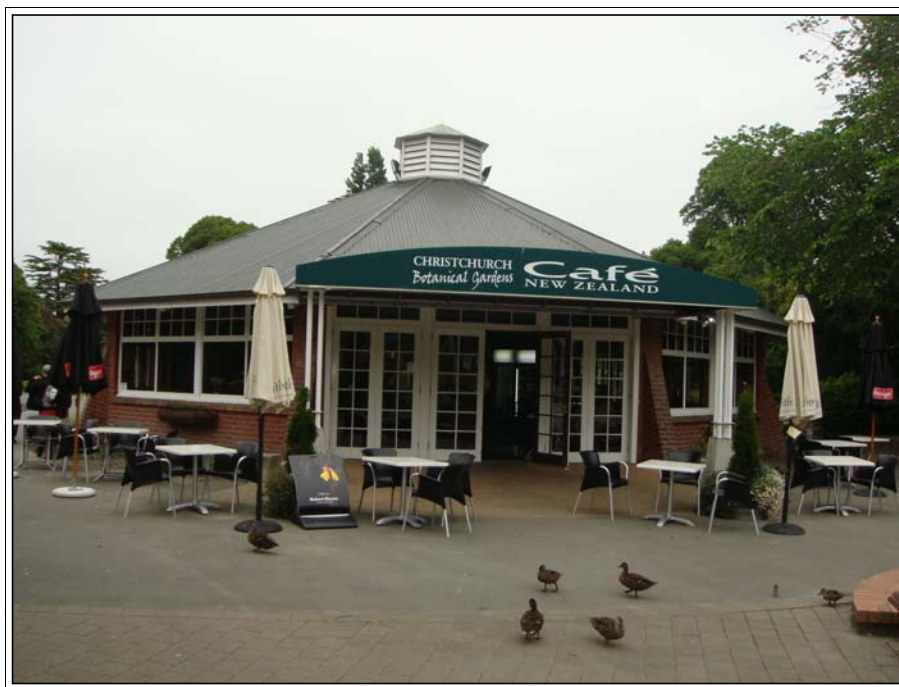
The front of the kiosk faces north east. On this side of the building, located beneath a canopy, are three sets of multi-panelled double doors, each with a fan light above. Four of the remaining sides of the octagonal section comprise a low wall of brickwork with windows above.

Figure 1.85. The front elevation to the café with multi-paned doors, 2011.

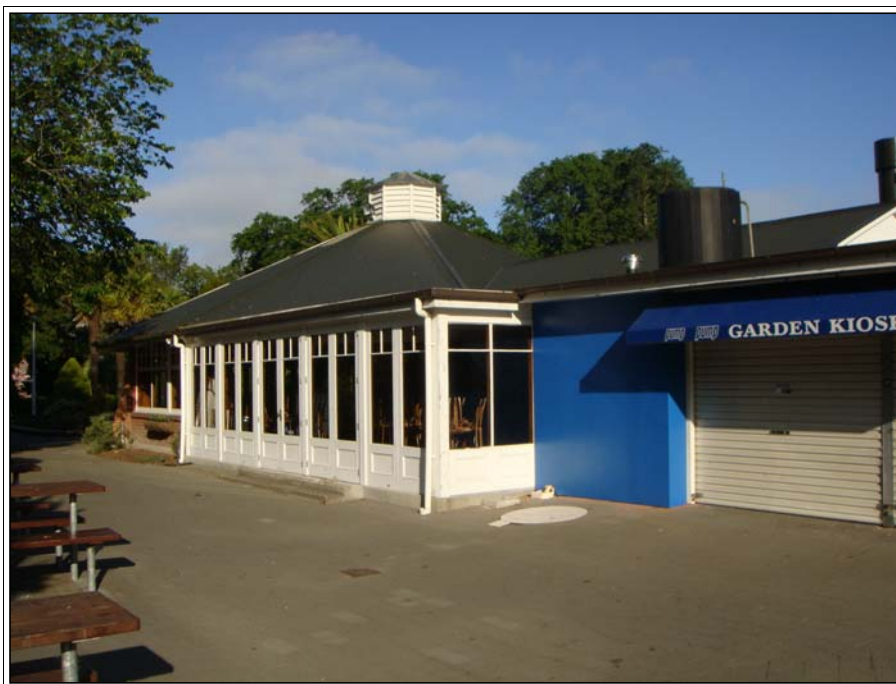
Figure 1.86. The conservatory and kiosk on the north western side of the building.
Source: DPAL, 2011

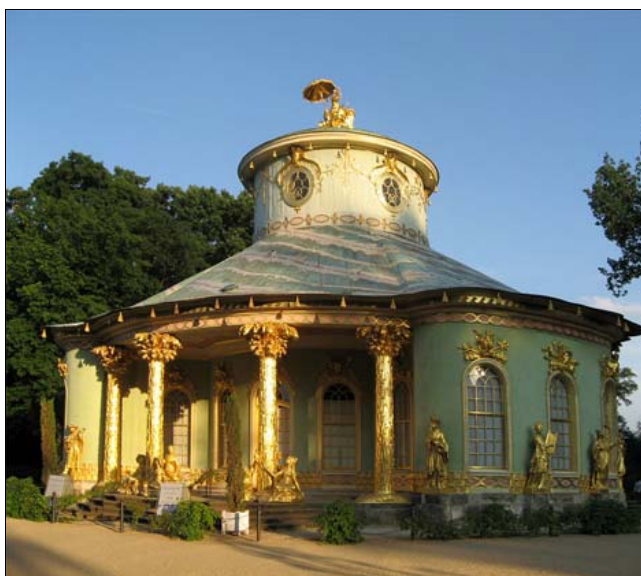
Figure 1.87. The Chinoiserie Tea Pavilion in Potsdam, Germany.

Like the Band Rotunda in South Hagley Park, the Tea Kiosk has been influenced by the design of follies that were often placed in gardens and parks frequented by the European aristocracy. Tea Kiosks became a common feature in parks at the turn of the 19th century in Europe and elsewhere and originated from earlier pavilions or follies that adorned large private gardens.

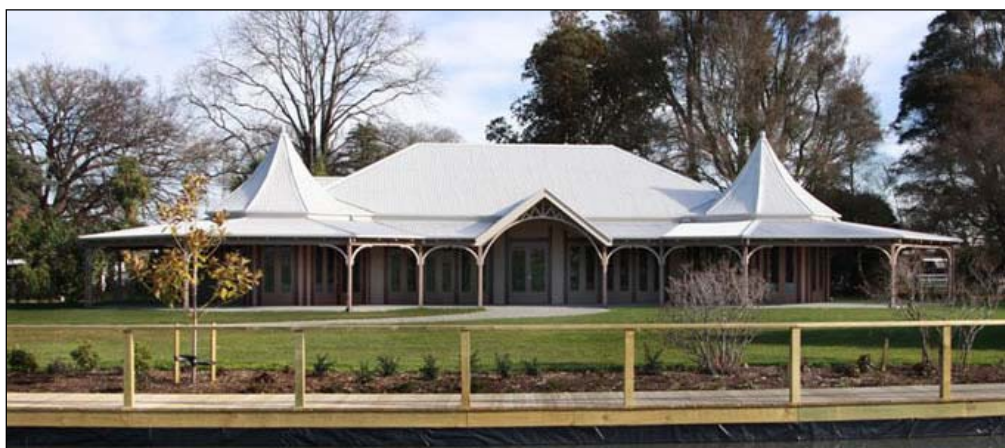
Figure 1.88. Riccarton Park Tea House, Riccarton. Source: www.teamarchitects.co.nz

A closer example is the Riccarton Park Tea House which was built in 1903 as part of a programme of improvements to mark the Golden Jubilee of the Canterbury Jockey Club in 1904. It was designed by local architects, the Luttrell Brothers, who also designed the Band Rotunda in the Botanic Gardens. This particular tea house is an Edwardian pavilion with wide verandahs. The octagonal plan shape can be seen in elements such as the turrets.

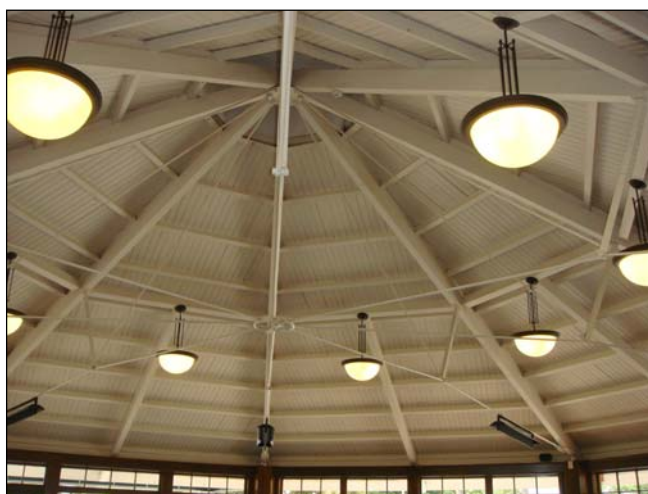
Within the café area, the roof is supported by eight exposed rafters which spring from the corners of the octagon and meet in the centre, below the lantern. Fixed to the rafters is a series of purlins which span horizontally across each section of the octagon from the walls to the centre of the roof. Fixed over the purlins is the sarking comprising painted tongue and groove boarding to form a ceiling.

Figure 1.89. Octagonal timber ceiling with timber rafters splayed to each corner supporting the roof.

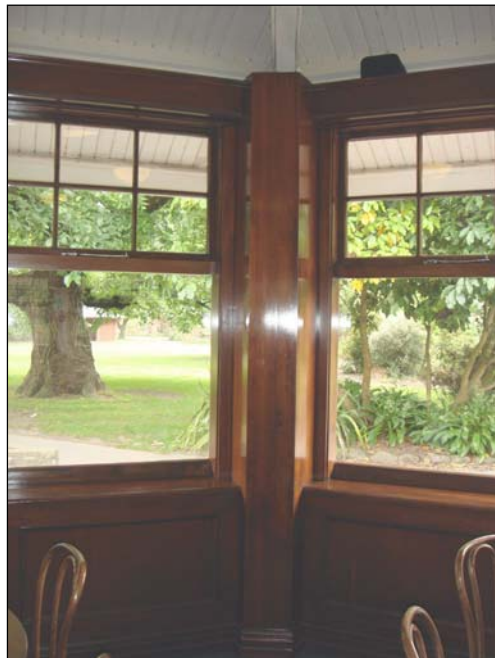
The walls below the windows consist of rimu wall panelling. The window sills, pelmets and moulded architraves are also made of rimu.

Figure 1.90. Rimu finish to interior of octagonal café
Source: DPAL

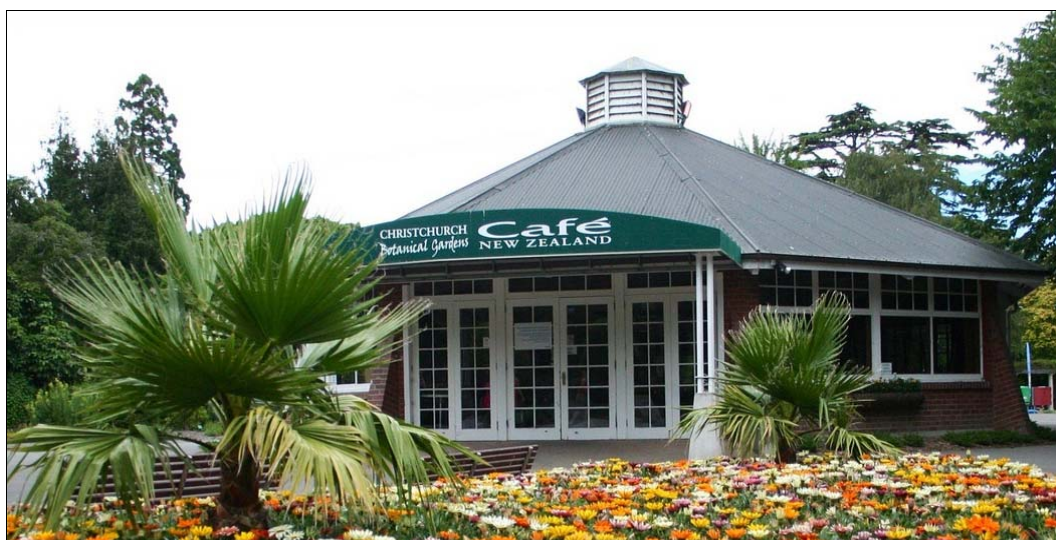
The former Tea Kiosk is generally in good condition. However the building suffered minor damage as a result of the 2010 and 2011 earthquakes.

- On the eastern wall a minor crack is apparent along the brick course and in the fascia.
- Cracking is evident in the brickwork buttresses.
- Cracking is apparent in the perimeter strip footing in several locations.
- Shear cracking can be seen in the brickwork walls in several locations.
- Minor movement has occurred between the bricks and the window joinery. Some holes are apparent where mortar has fallen out.
- Decay is evident in the timber facings to the windows. Some paintwork to the joinery is flaking.

- On the south wall of the café the cedar wall lining is stained.
- Some cracking has occurred to the internal masonry walls.
- Cracking is evident on the lintel above the door to the 1971 extension.
- The plasterboard is cracked in several locations.

Figure 1.91. Tea Kiosk and setting, 2013
Source: L. Beaumont

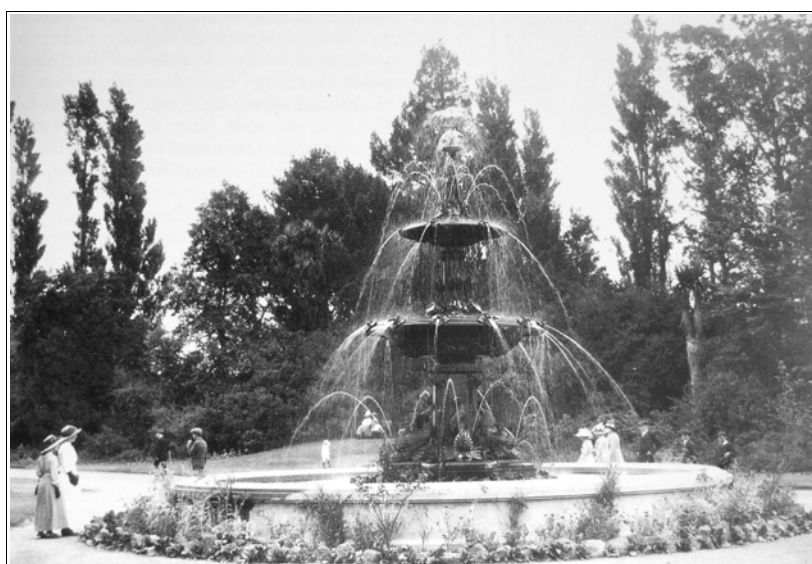
Figure 1.93. The Peacock Fountain, photograph published in June 1913.
Source: *Canterbury Times* photograph, Bishop Collection, Ref 1923.53.255, CMDRC

By mid-June 1911 the fountain had been erected by Andersons Ltd within a concrete bowl. This was sited at the junction of a path leading from the Museum entrance to the Gardens and the path branching from it towards the river (opposite the site of today's McDougall Art Gallery), where it could be seen from all entrances to the Garden from Rolleston Avenue. In this location the fountain was seen from “one point of view against a background of trees including a fine specimen of the Chilean Monkey Puzzle and pines from the Canary Islands and Australia, [and] from another view the background was the Archery Lawn”. This location had been jointly chosen by representatives of the Domains Board and the Beautifying Society soon after the order for the fountain had been placed with Coalbrookdale Foundry.¹⁴⁵

At their first inspection of the fountain in situ, members of the Domains Board were unanimous in their approval of the design and the working of the fountain. *The Press* was similarly complimentary, reporting “*The Peacock Memorial Fountain... has arrived from England and is being erected... The workmanship is perfect, and the design a fine one. The fountain was designed by Mr John Bell, R.A. The storks, dolphins, and leafage, etc., are made from models made by him, and the accessory parts were made under his personal direction by well-known modellers, Mr Bell frequently visiting the works for this purpose. Mr Bell is one of the best known sculptors of his time, and has produced some very important works. Among others, he was entrusted to design and execute one of the four groups representing Europe, Asia, Africa, and America, which are placed at the corners of the Albert Memorial erected in London... The fountain is about 20ft 4in high, consisting of a large four-way base, upon which are four dolphins (with water jets in each nostril, eight jets in all), water lilies, bullrushes, etc., from the centre of which rises an ornamental octagonal shaft, carrying a dish 10ft in diameter, around which are twelve water jets, and four storks are placed around a smaller octagonal shaft carrying another basin of 5ft 9in in diameter, having eight water jets. Above this is rockery, leaves, and bullrushes in a pyramid shape, and one large central jet, the whole forming a design of good proportions and effect, and the jets of water when in full play will be most effective.*”¹⁴⁶

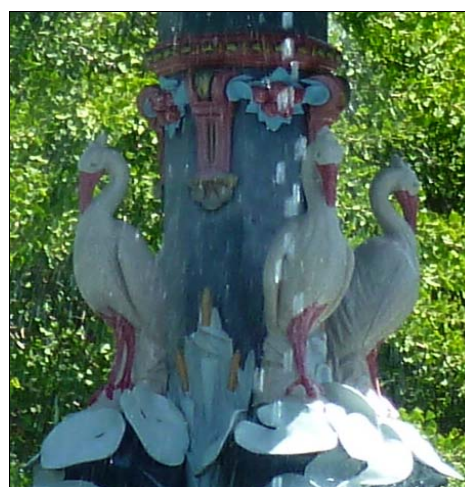
No structural damage sustained in Canterbury earthquakes and physical condition appears good.

Figure 1.94. Detail, Peacock Fountain 2010.

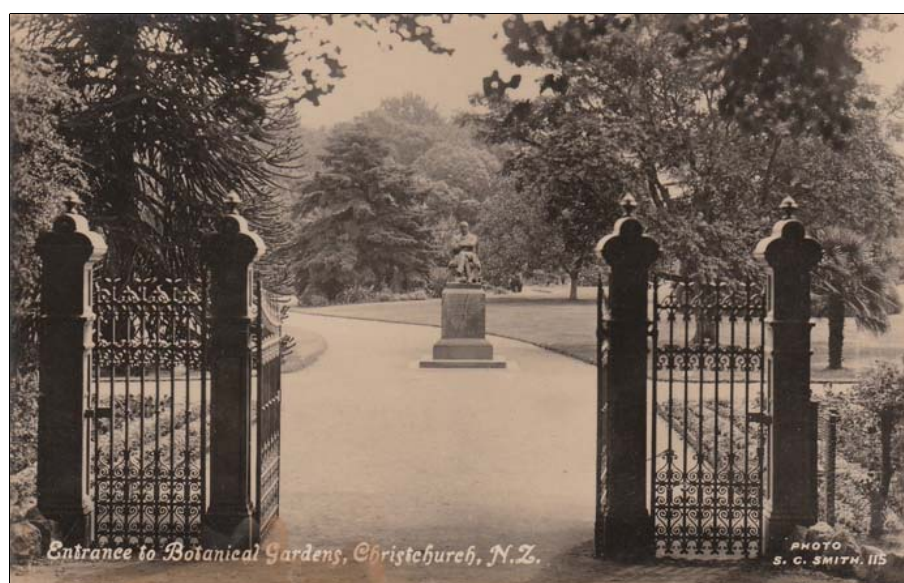
Figure 1.97. Postcard view of the Moorhouse Statue showing its location in relation to the Riccarton Avenue entrance gates and the (now erased path) to the west, undated
Source: Tanner Bros. Ltd postcard, Early New Zealand Photographers website

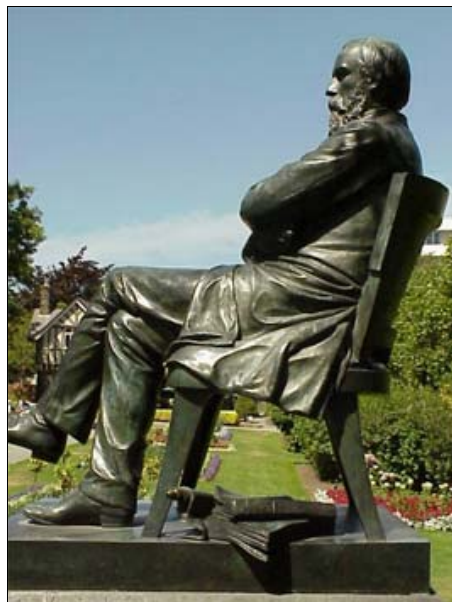
Pre-earthquake assessment noted surface cracking running the full height of stone pedestal from top to bottom on rear and front sections. The statue was also noted to have a fair degree of deterioration evident. These are predominantly streaks on the underside of the chair, the body of sculpture hand and legs but also include small scratches on the face.¹⁶⁵

Figure 1.98. Profile view of Moorhouse Statue, 2011.
Source: L. Beaumont
