*Akaroa Harbour Settlement Study Areas*

Historical Flooding  
Research and  
Mapping Project

*8 February 2008*

Prepared for  
Strategy and Planning Group  
Christchurch City Council

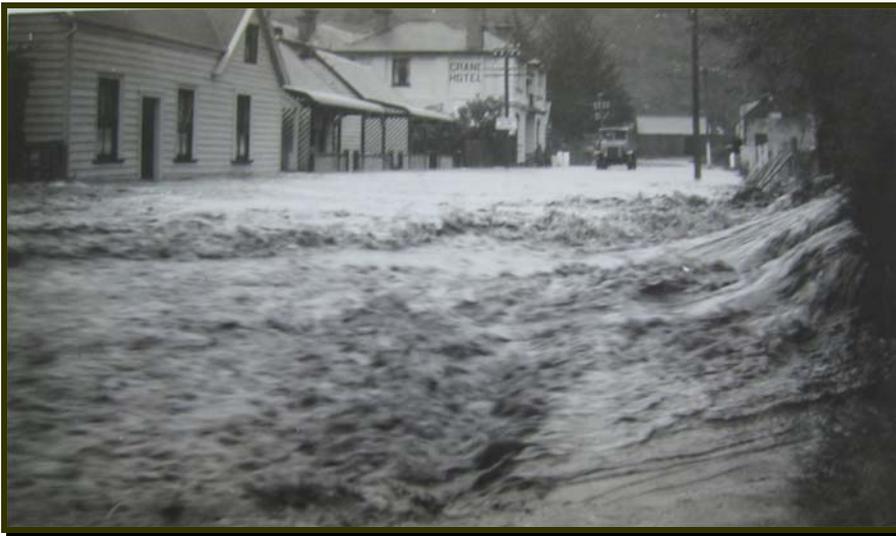
Figure 5 Photographs of North Akaroa February 1936

North Rue Lavaud with water pouring through Hennings Bridge (now known as the northern Waeckerle's bridge) The building opposite is Mon Desir. Mon Desir still exists, but has a very different façade. Further along one of the small cottages still stands, as does the Grand Hotel, the last building on the left.

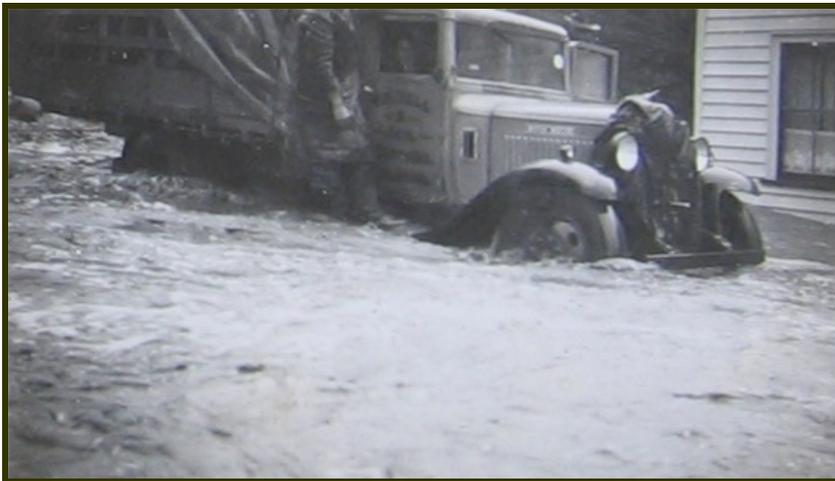
Bells Truck outside the Mon Desir window opposite Hennings bridge.

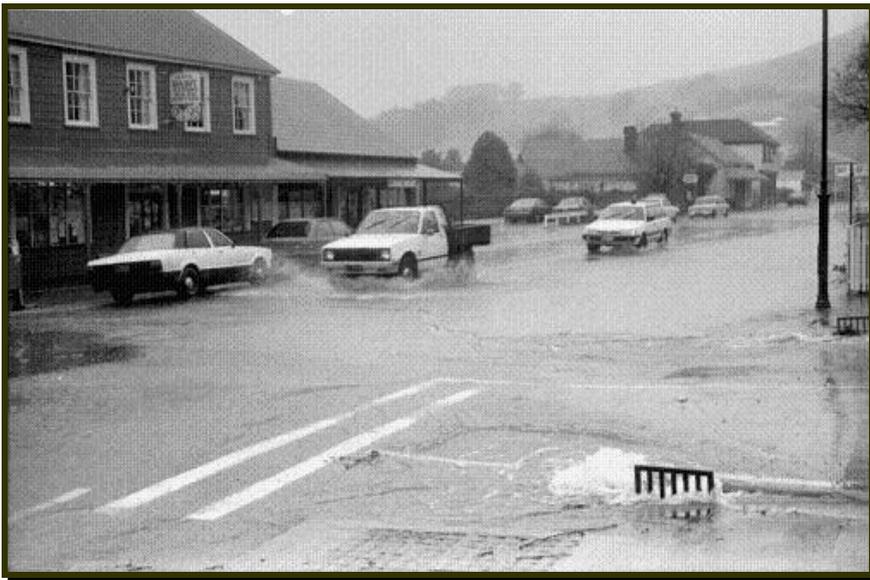
**Figure 9 Photograph of Rue Lavaud/Rue Balguerie corner 1994**

Water streaming down Rue Balguerie and flooding Rue Lavaud. It also ran into the back of the Museum.

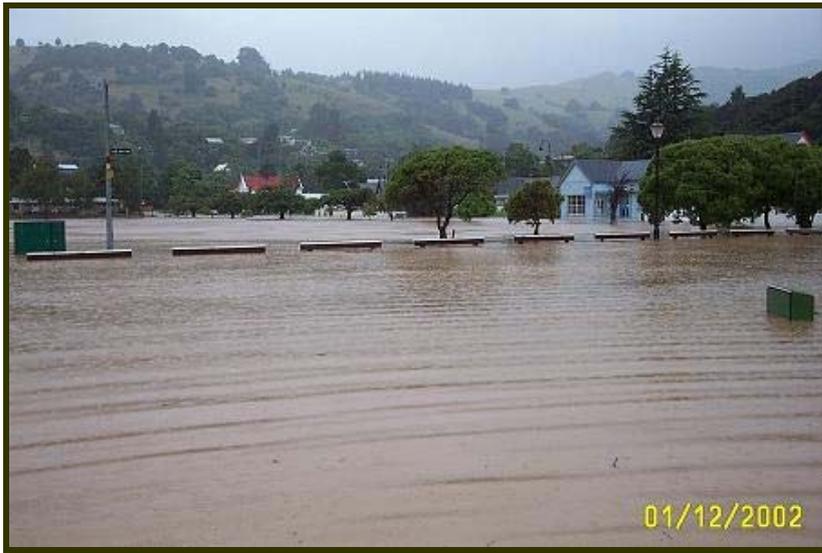
Figure 11 Photographs of North Akaroa January 2002

Looking across Rue Brittan and Recreation Ground to Rue Lavaud.

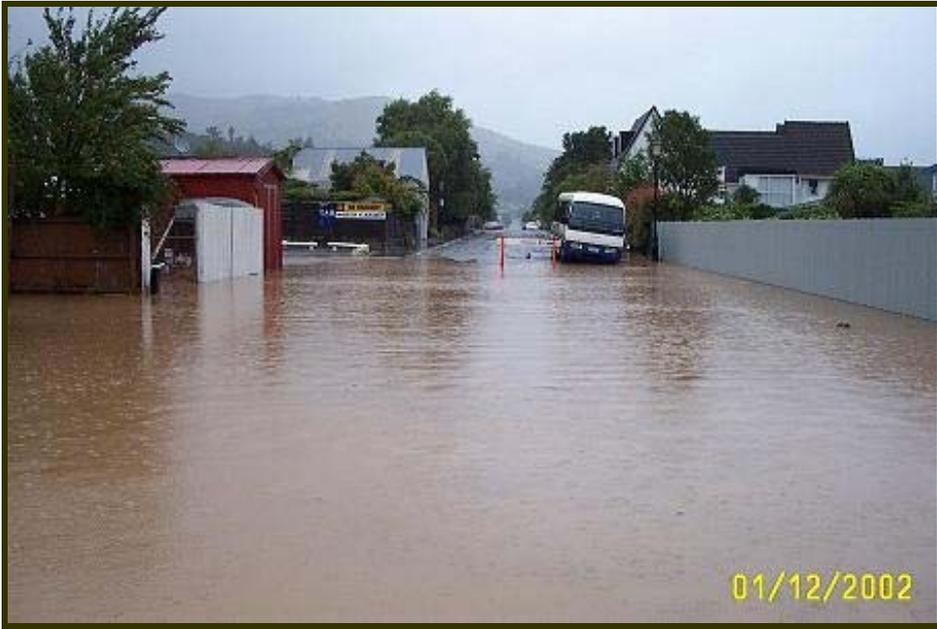
Rue Jolie North taken from Yew Cottage looking south. At the height of the flood the whole street back to Miller's bridge over the Balguerrie stream bridge was under water.

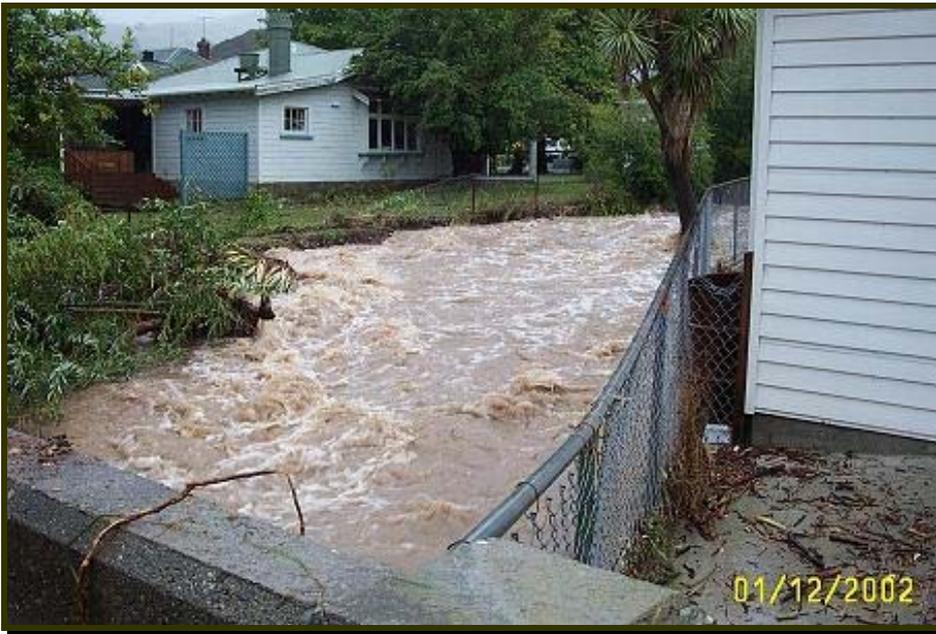
Balguerie stream from Miller's Bridge on Rue Jolie north looking to the Miller property on the north bank. Earlier when the bridge was blocked water was flooding over the bridge and into the garden of the Miller house shown. This picture is taken after the blockage was cleared and the stream had returned to its bed.

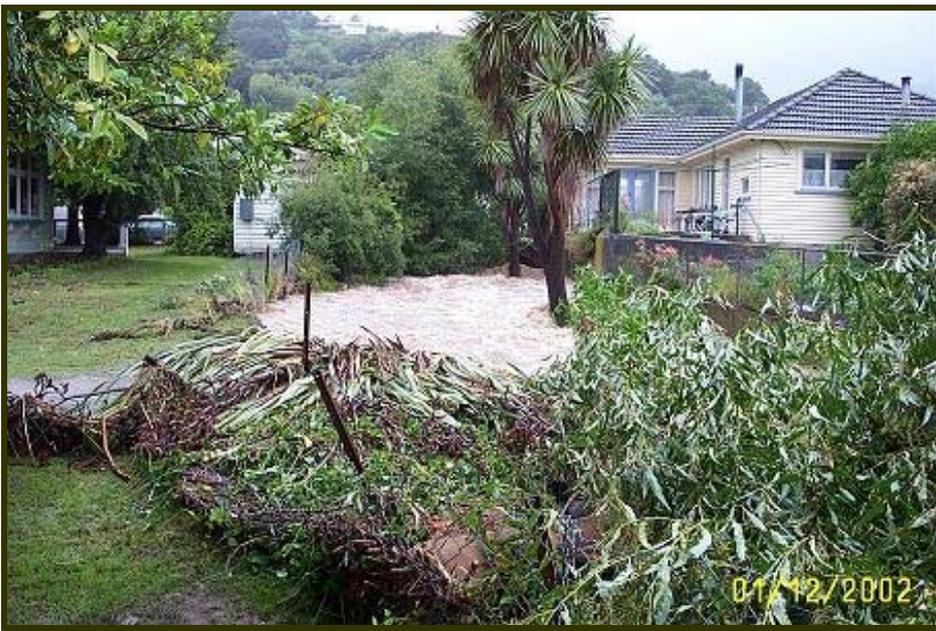
Balguerie stream from Miller's Bridge on Rue Jolie North looking to the Shepherd property on Rue Lavaud. Flattened plants show where the stream had broken its bank to flood onto Rue Jolie earlier and flooded Rue Jolie via Miller's garden and part of the fence cut by the Fire Brigade to release the water.

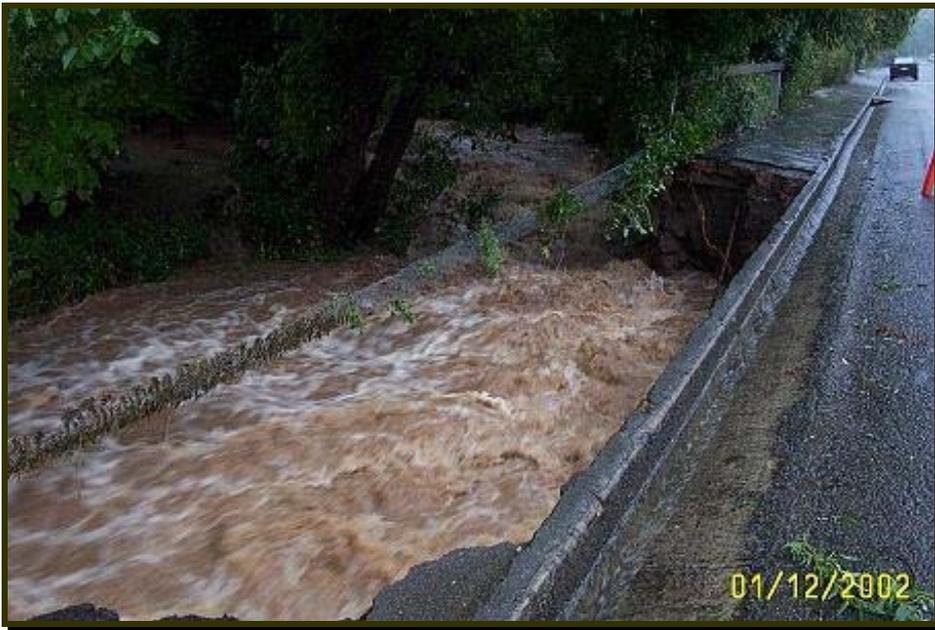
Balguerrie Stream along Rue Balguerrie opposite Muter Street showing footpath washed away. At the height of the flood water would have been flowing onto the street.

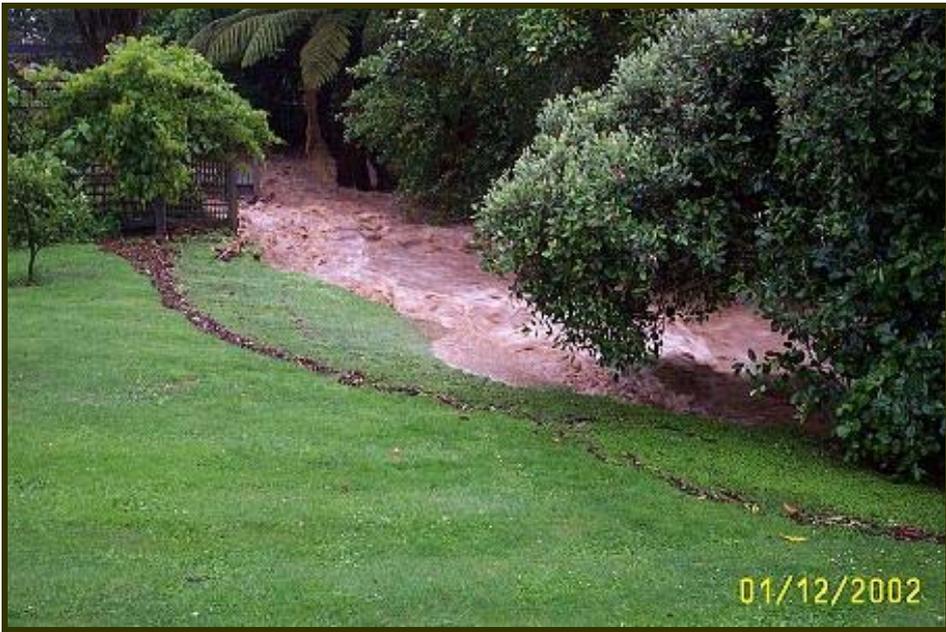
Balguerrie Stream in Blythcliffe garden, Feijoa tree beside stream bank and debris showing highest water mark.

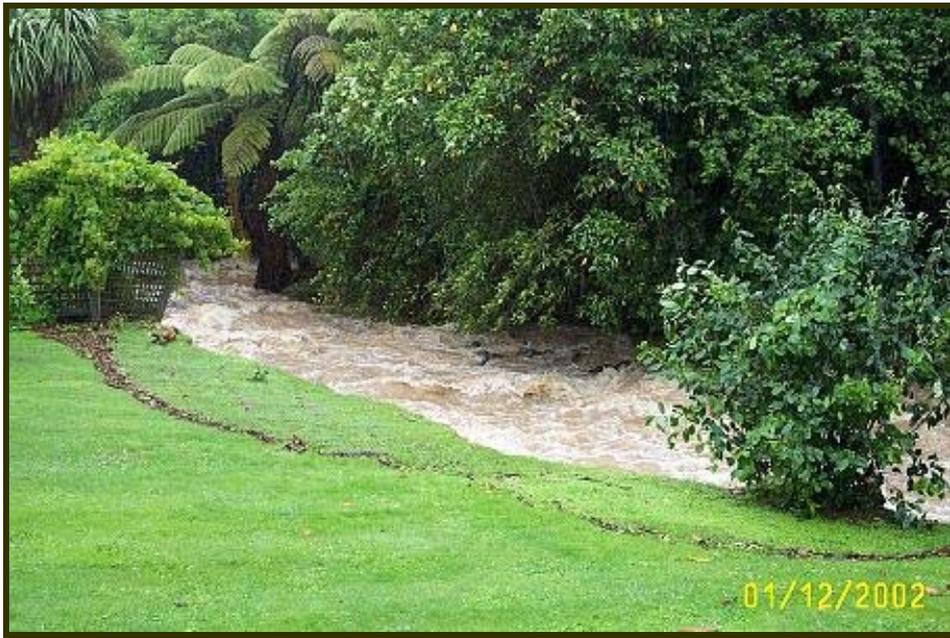
Balguerrie Stream in Blythcliffe garden. Feijoa tree has now washed away.

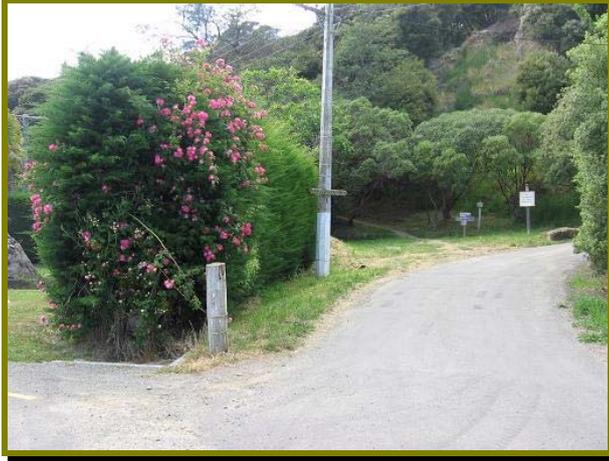
**Figure 13 Inadequate drainage in Rue Brittan**

Photograph shows the L'Aube Hill access road where it joins Rue Pompallier between the Recycling depot and the Gallery.

There is a drain below the rose bush of an adequate size, but during heavy rain the water flowing from L'Aube hill mainly comes down the L'Aube hill road, misses the drainage channel, fails to enter the drain and instead runs down Rue Brittan.

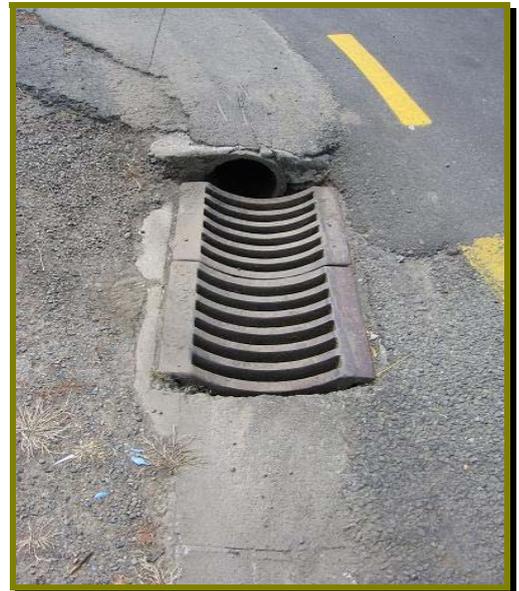
These two photographs show the drain on the corner of Rue Brittan and Rue Lavaud. The Recycling shed on Rue Pompallier can be seen in the background.

The grating on this drain blocks up with sticks and leaves during heavy rain, effectively reducing the total flow of the drain by about half, so more water pours onto lower Rue Brittan from here.

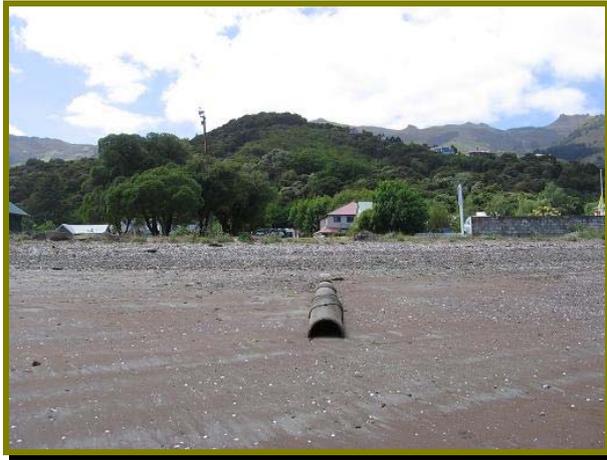
**Figure 14 Blocked outfalls**

The outfall from Rue Brittan follows the line of the beach and so fills up with sand, reducing the outflow.

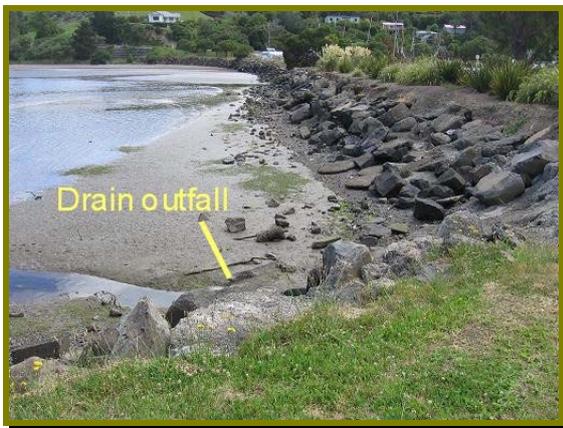
This picture and the following close-up show the outfall of a drain that runs from the Gallery (formerly the Power House) in Rue Pompallier across the Recreation Ground to the sea. The drain starts as a brick arch that used to drain the water from the Pelton Wheel at the Power House. Originally the Recreation Ground ended at the edge of what is now the grass area.

As it was extended over the years to create the present car park, the brick drain was extended with a concrete pipe, and the result is that the outfall to the sea is too low.

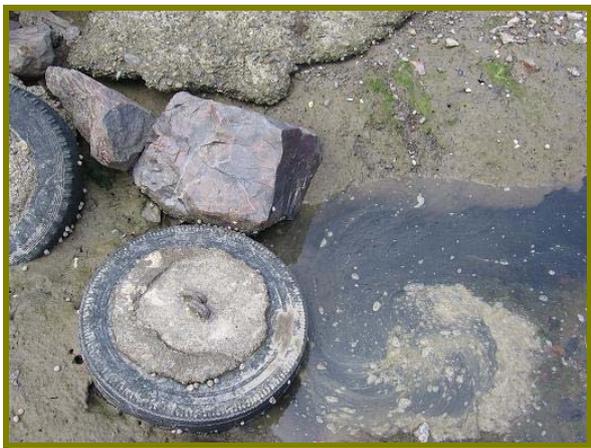
This is a close up of the drain outfall shown above. It was taken during dry weather and at low tide, but the slimy puddle shows that the drain does not flow well.

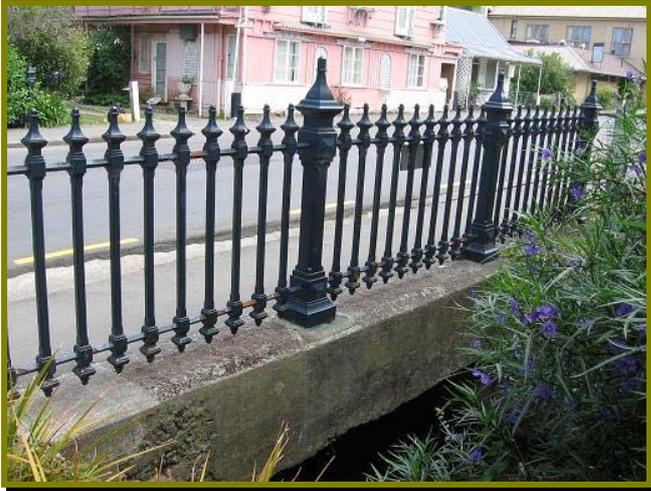
**Figure 15 Waeckerle bridge on Grehan Stream**

The upper side of the Northern Waeckerle bridge. The buildings across the street are Mon Desir (painted pink) and the historic cottage and Grand Hotel, which can also be seen in the 1936 flooding picture taken at this bridge.

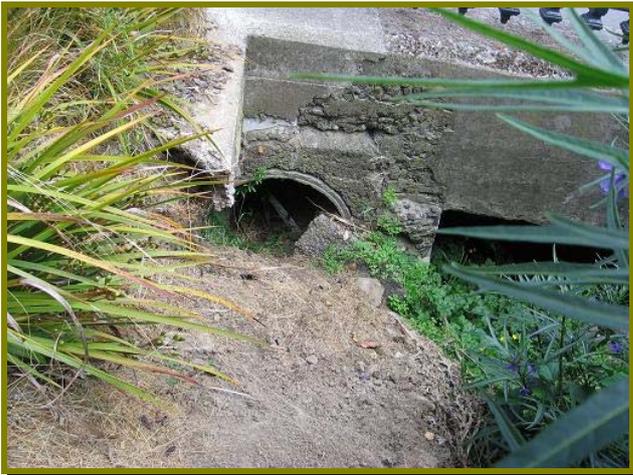
This pipe is an overflow drain for the stream at the bridge shown above and runs parallel to the stream bed to give the bridge extra capacity. It was probably constructed after the 1936 flood. As shown here, its effectiveness is limited because it is partially blocked.

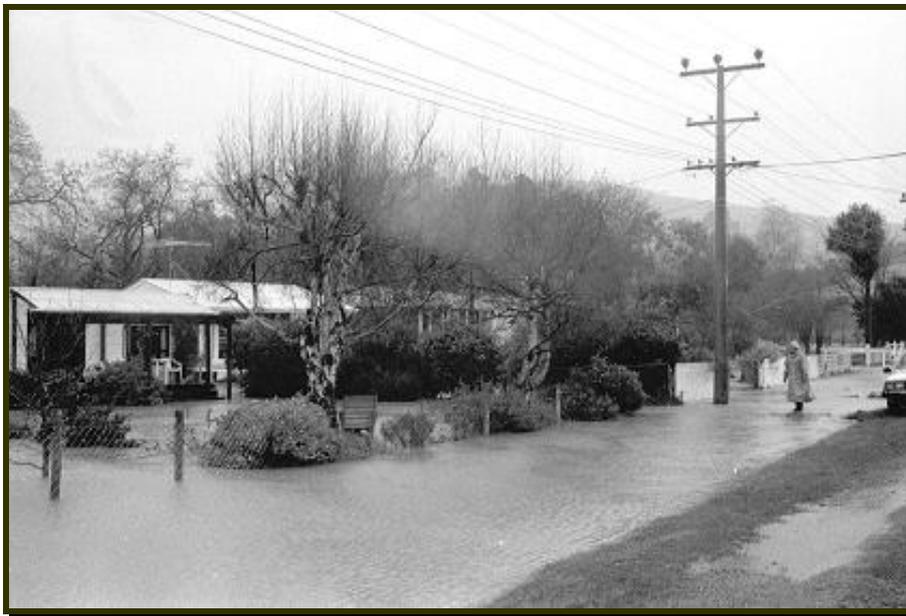
Figure 17 Photographs of Takamatua July 1994

Flooding around houses in Old French road,

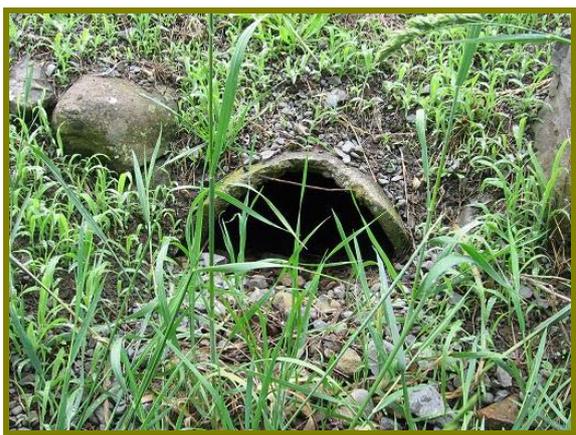
As identified by Ken Paulin and by local residents, Robinson's Bay has a constant problem with the culverts at the northern end that drain into the sea being blocked by debris. The drop from the valley into the sea is very shallow and these drains block with seaweed and other debris.

*Partially blocked culvert at beach opposite Old Post Office and houses.*

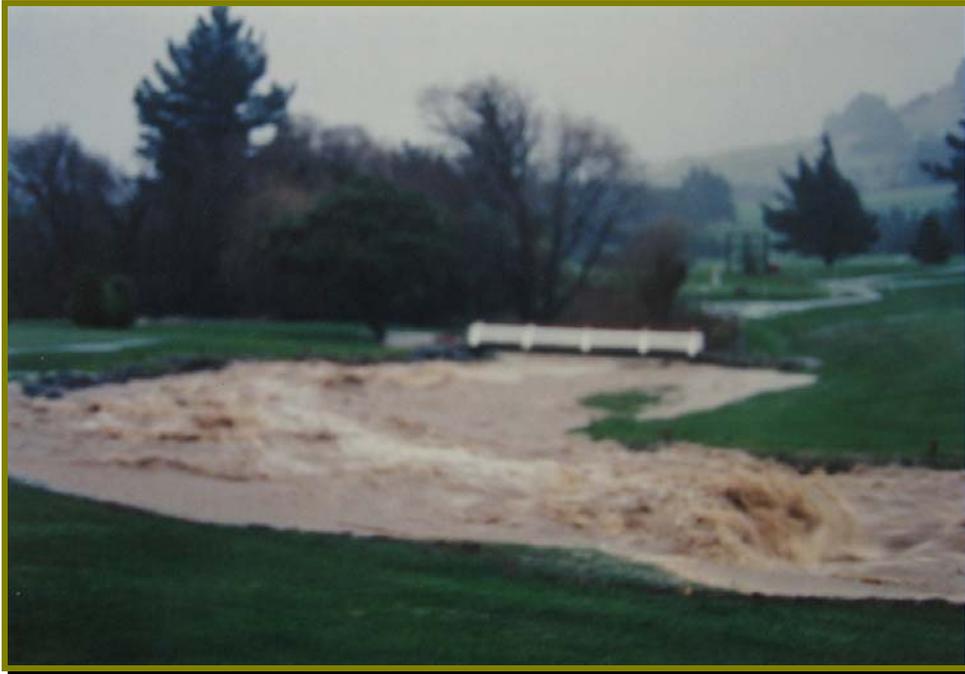
**Figure 23 Duvauchelle Golf Course March 1986**

Looking down the Golf Course, this shows the full torrent and the 17<sup>th</sup> bridge still intact.

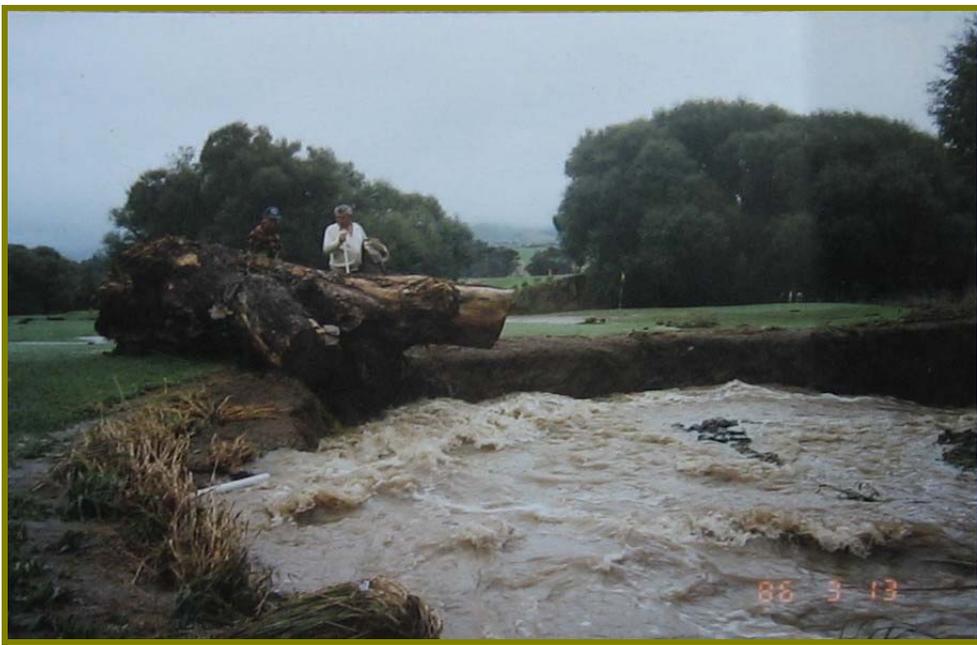
This is the log that broke the bridge, sitting where the stream in flood had deposited it a few hours earlier according to Barry Brownie. Photograph taken during the clean up a few hours later.

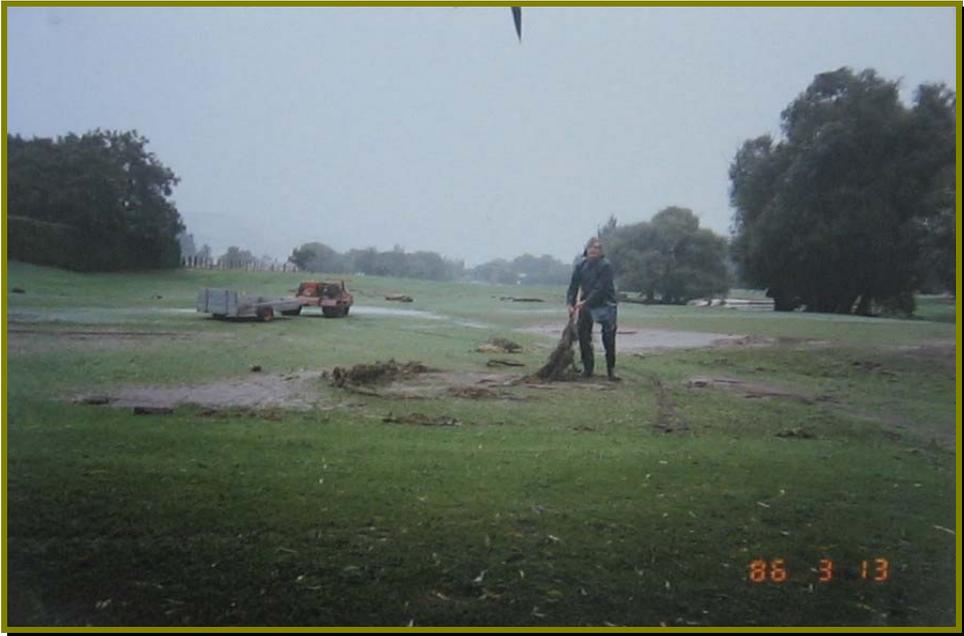
Looking from the 13<sup>th</sup> green down the fairway towards the sea. The extent of the flooding can be seen

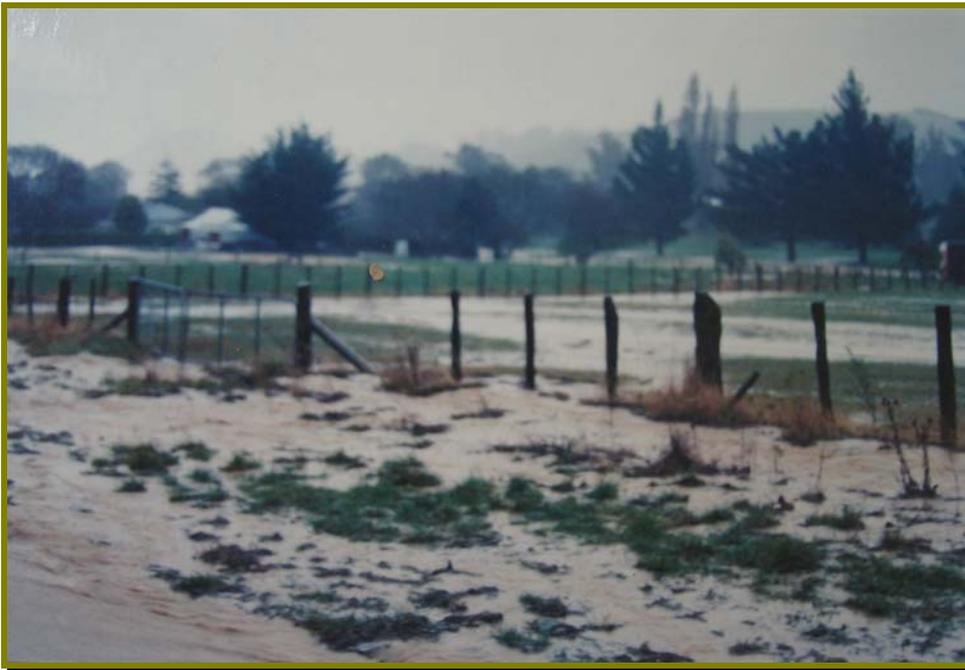
**Figure 24 Pawsons Road July 1986**

Looking down the Golf Course from Pawsons Valley Road. This picture was identified as taken in the late 1980s in the evening, and seems most likely to be in July 1986 when more problems were caused by the Pawsons Valley road culverts.

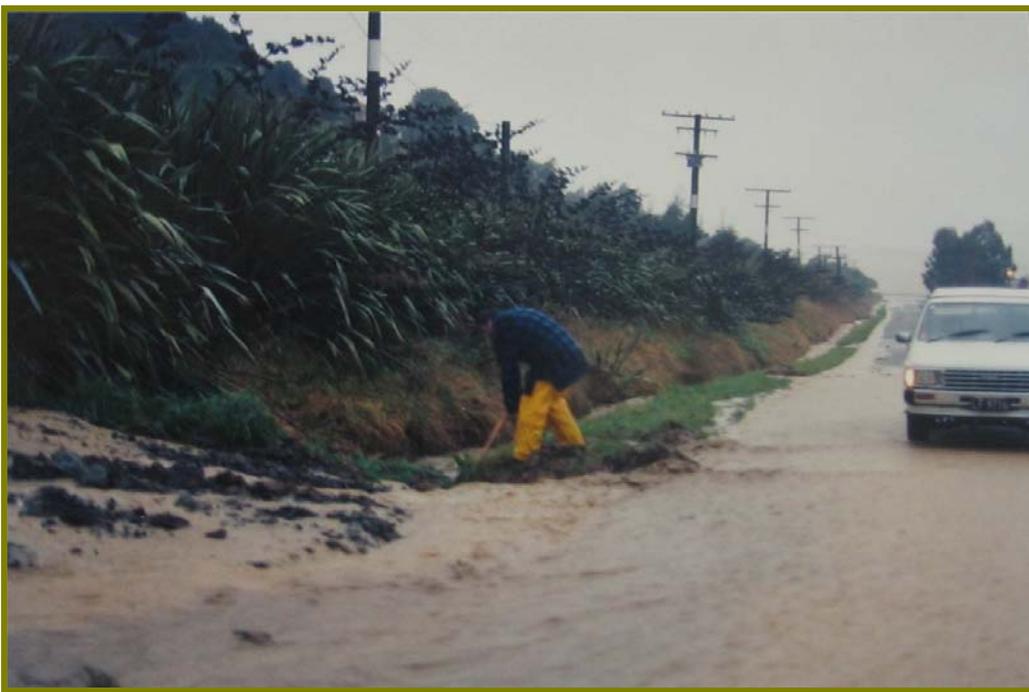
Pawsons Valley road opposite the Golf Club entrance and looking toward the sea. Water draining from the hillside is flooding across road towards Golf Course and down to sea. Also likely to be July 1986; photograph taken about 5:00pm and car lights are on.

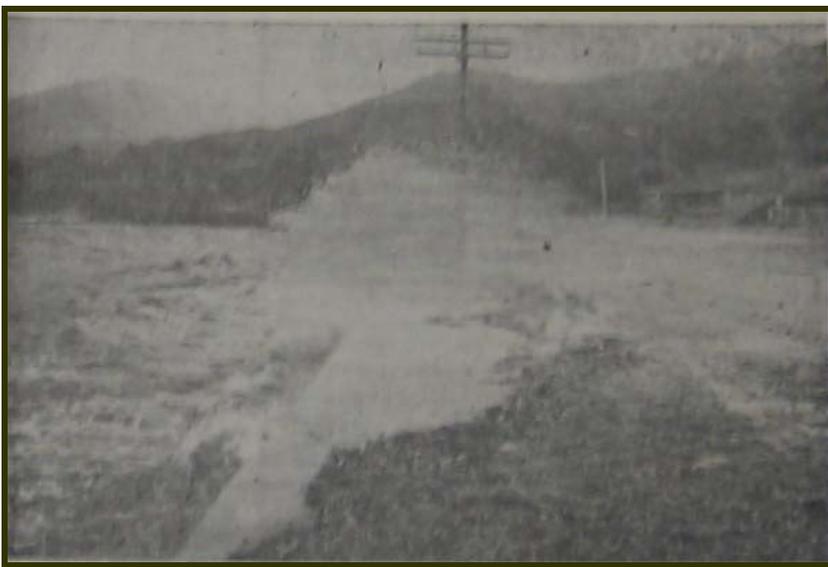
**Figure 28 Stock photograph of sea surge at Duvauchelle**

This photograph of a sea surge at Duvauchelle was reprinted in the Akaroa Mail several times when there was rain or storm news for the area during the Vine editorial years prior to Michael de Hamel taking over the paper. The first time it appeared is probably 22 August 1975. It is reprinted again here to show how the sea can behave.

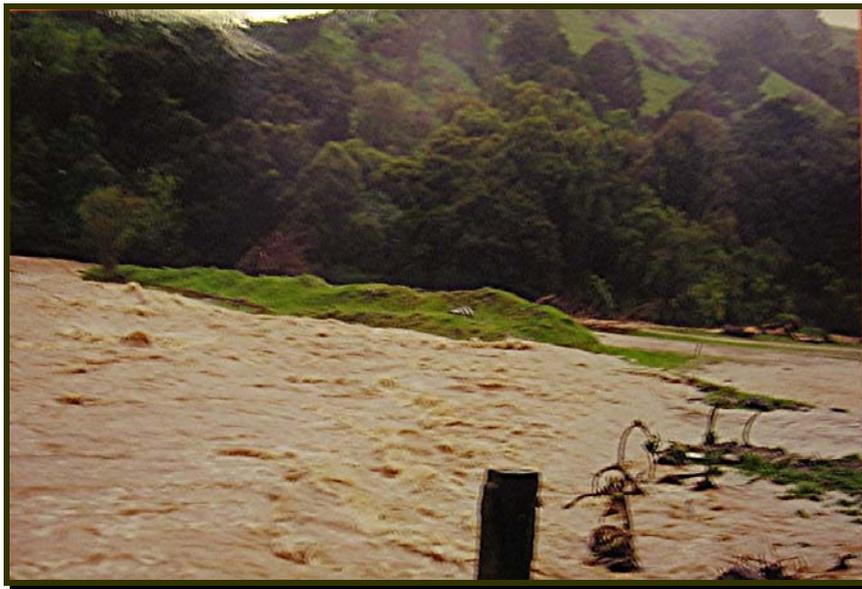
Figure 33 Photographs Barrys Bay October 2000

Stream torrent over stop bank. Fallen willows on far right.

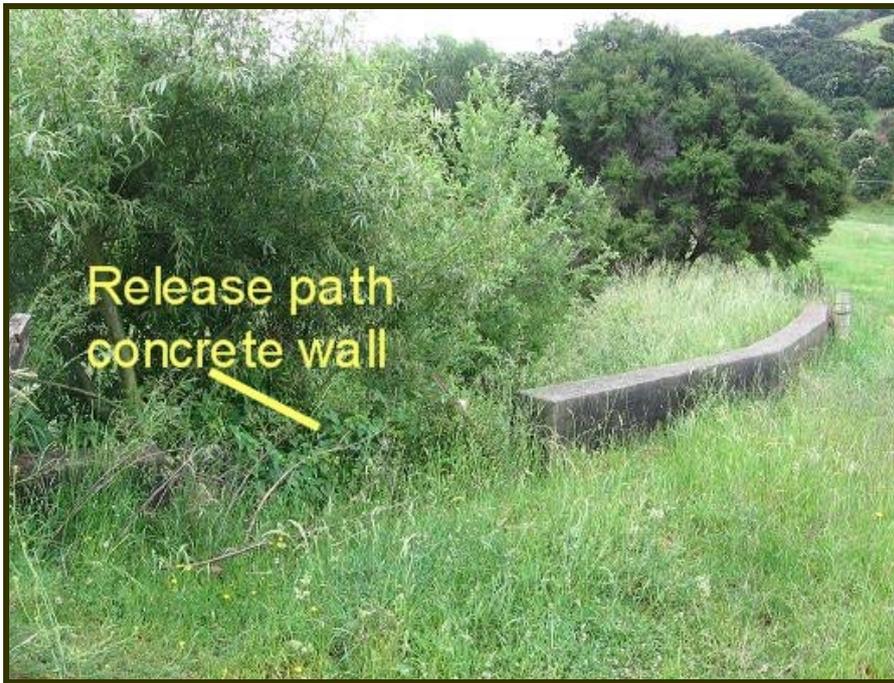
**Figure 34 Release path near Cheese Factory**

*Break in concrete wall by Cheese factory bridge appears to work in releasing excess water here rather than through the factory*

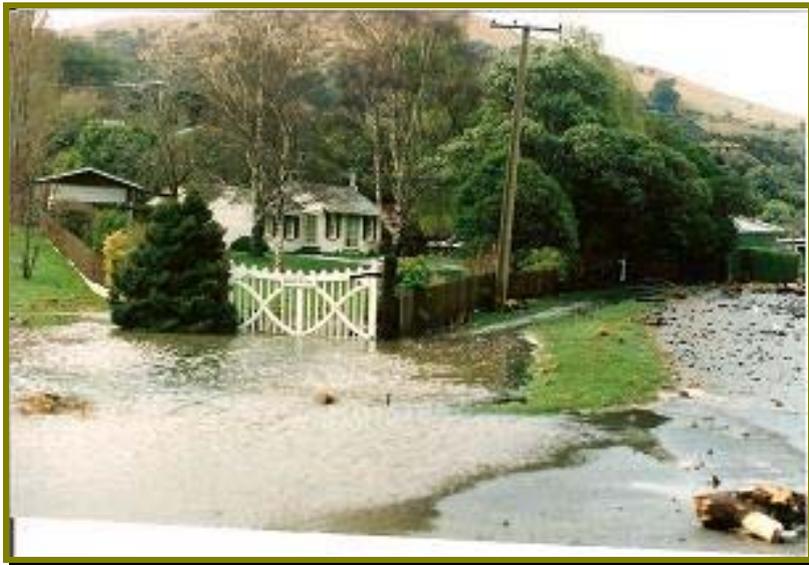
**Figure 39 Photographs of Wainui Big Snow August 1992**

This cottage on the corner of Cemetery Road is the worst affected by flooding.

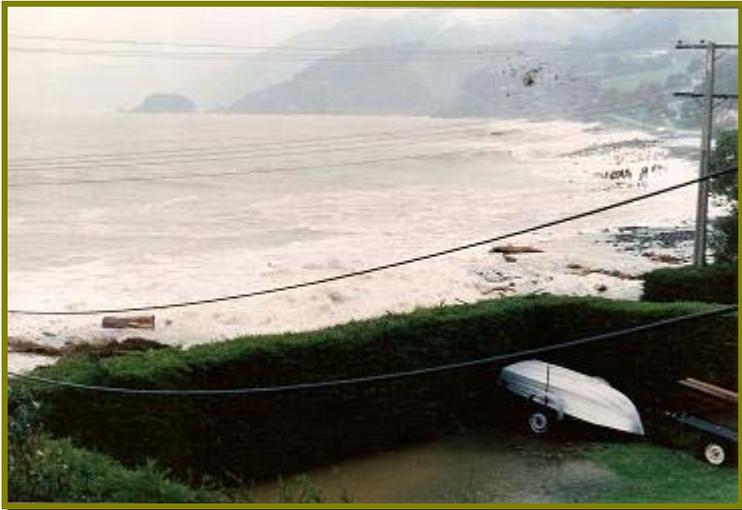
The sea coming right across the road.
