Number One Drain Restoration and Ecological Response

September 2020

Prepared for:
Christchurch City Council

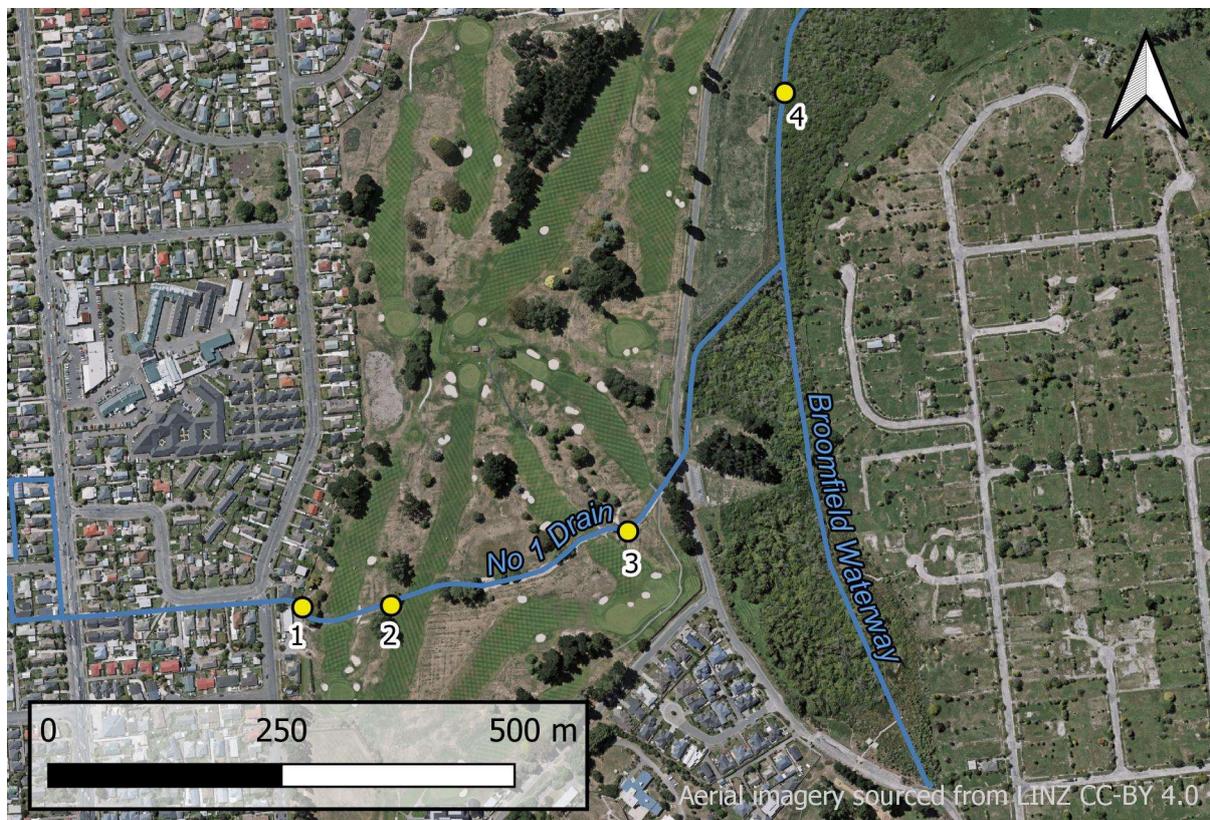
Figure 1: Locations of the flowing sampling sites (Sites 1–4) in No. 1 Drain. Note that aerial imagery is from 2015/16, so it does not show the realigned sections of the waterway or the ponds.

Four locations along the flowing section of No. 1 Drain were sampled before and after restoration work (Figure 1, Table 1). The site locations during the follow-up survey were within 8 m of the baseline survey locations, except for Site 3. The downstream extent of Site 3 was shifted approximated 30 m downstream from its previous location. This was done so that the entire reach was in flowing habitat, downstream of the second pond.

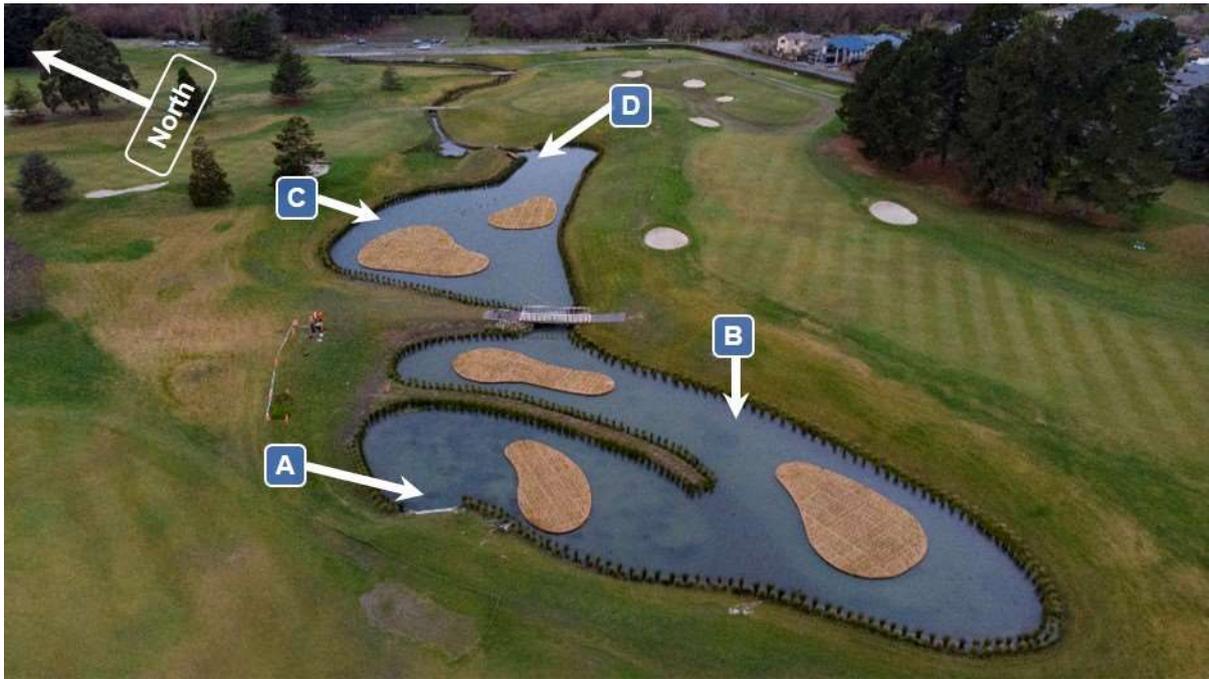
Figure 2: Pond sampling sites. Note that in this photograph the floating wetlands have just been planted and are still being moved into their final positions. Photograph taken 12 July 2019 (supplied by CCC).

Four additional sites were sampled in the new stormwater ponds. Sites A and D were sampled at the inlet and outlet of the ponds, respectively (Figure 2, Table 1). Site B was located alongside floating wetlands near the southeast bank of the first stormwater pond, while Site C was located along the northern bank of the second stormwater pond.

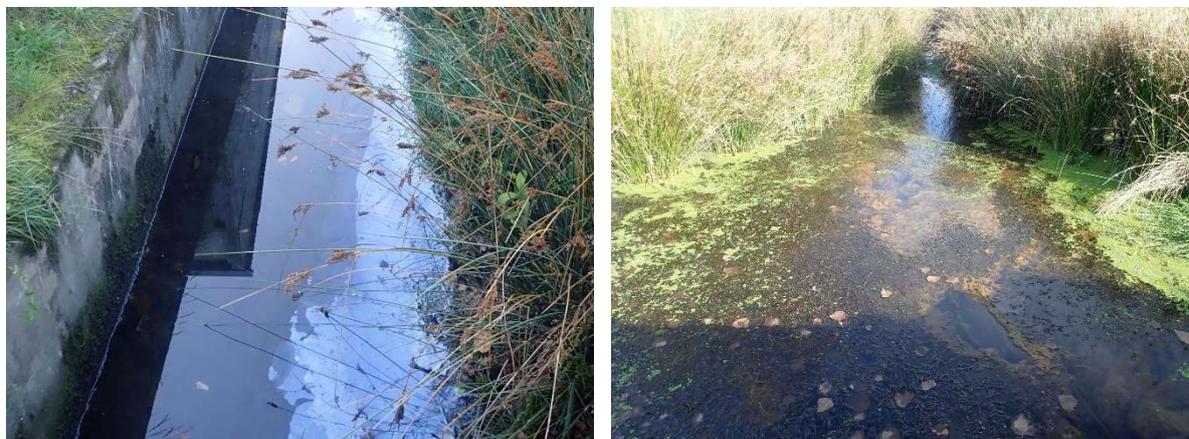
Figure 4: An oily sheen on the water surface at Site 1 (left) and iron floc at the downstream of Site 2 (right).

An oily sheen was observed on the water surface over much of the length of Site 1 (Figure 4). Such a sheen was noted during the baseline survey, over Sites 3 and 4. As discussed by Instream Consulting (2016b), oily sheens can be associated with natural seepage from wetland soils containing low DO, but can also be caused by other factors, such as hydrocarbon spills or landfill leachate. As the sheen has been observed during both survey rounds, and the drain is within area characterised by heavier soils that was covered in extensive wetland prior to land drainage, the source is most likely natural. Iron floc was also abundant through Sites

1 and 2, indicative of iron rich, low DO ground water (Figure 4). Iron floc and natural oily sheens often co-occur.

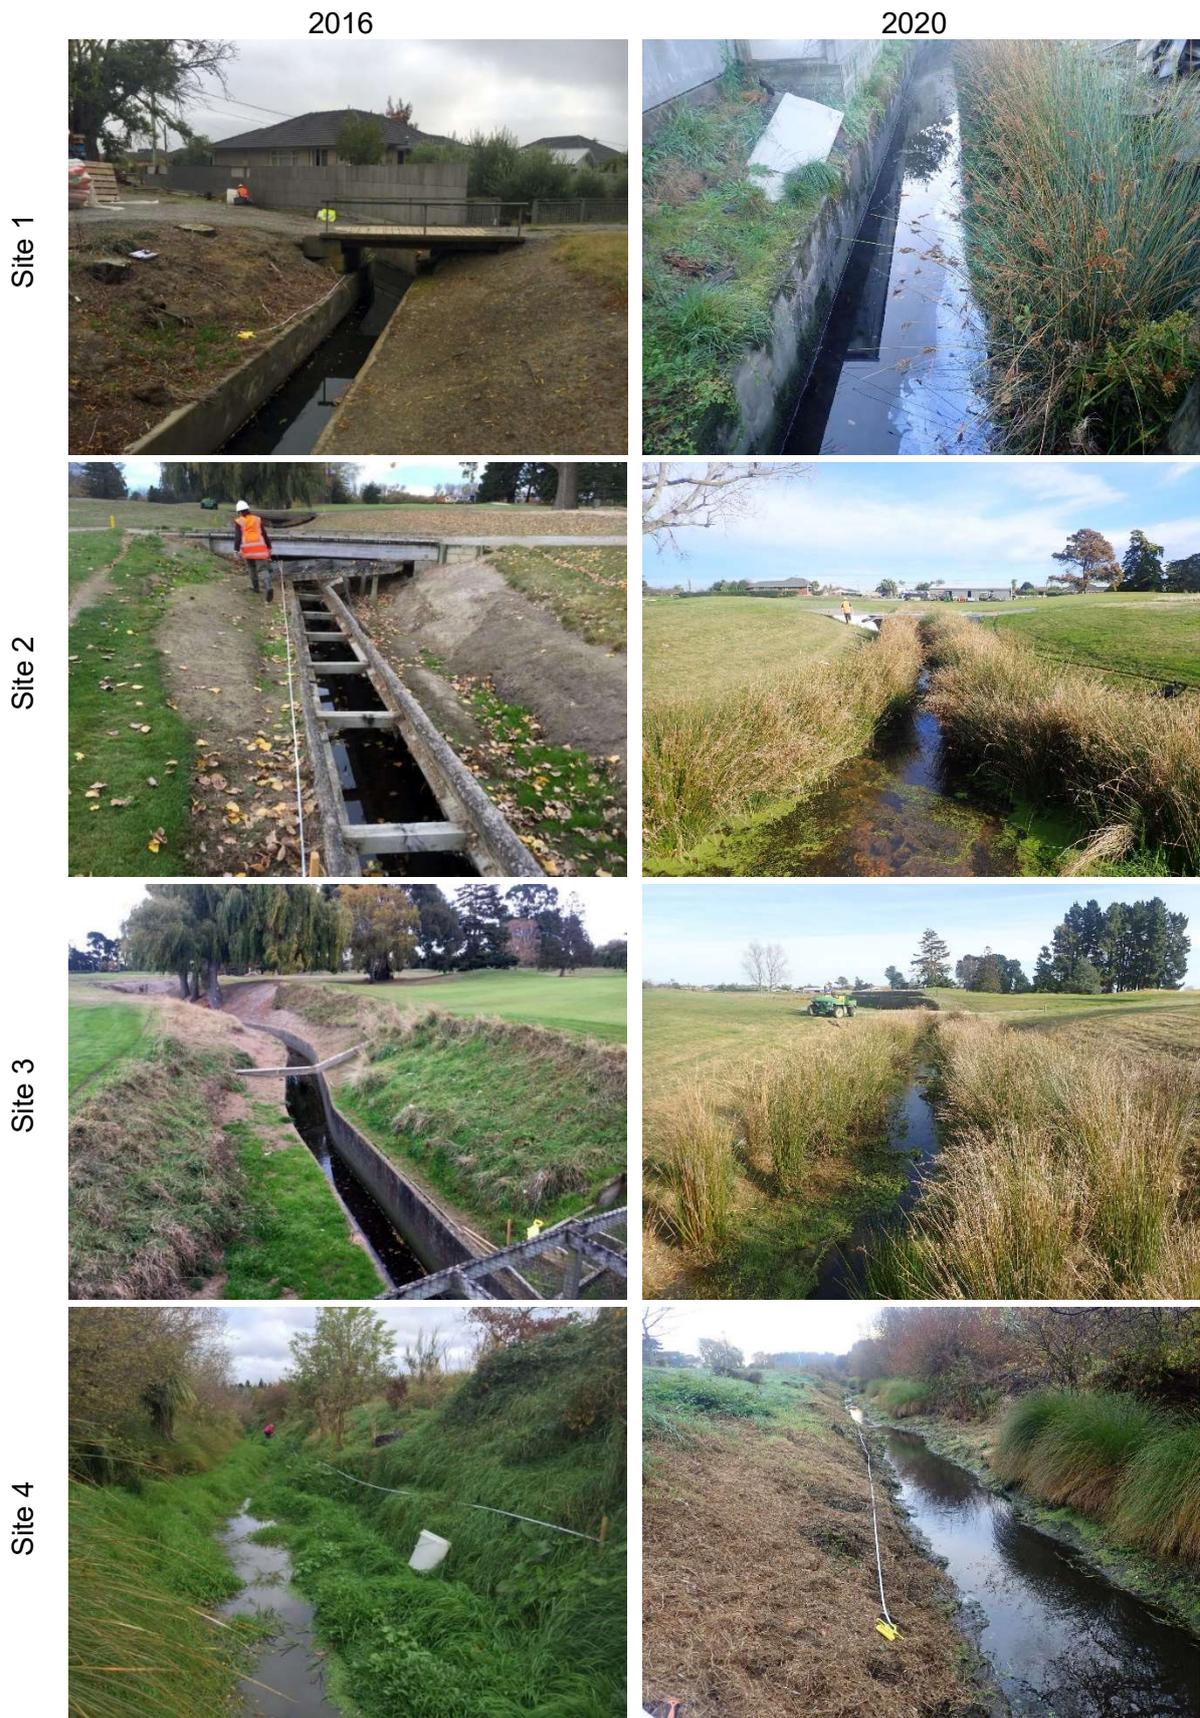
Figure 5: Representative photographs of the flowing sites during the baseline (2016) and follow-up (2020) surveys.

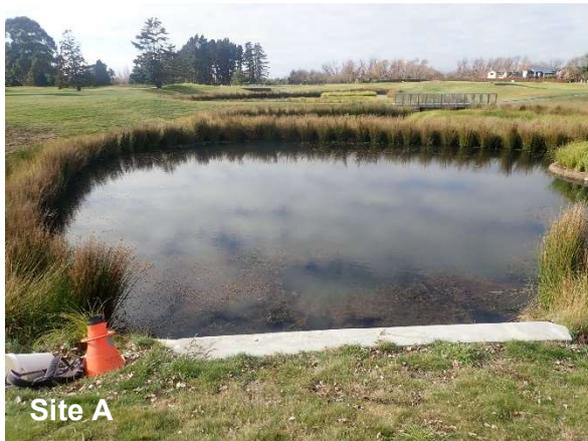
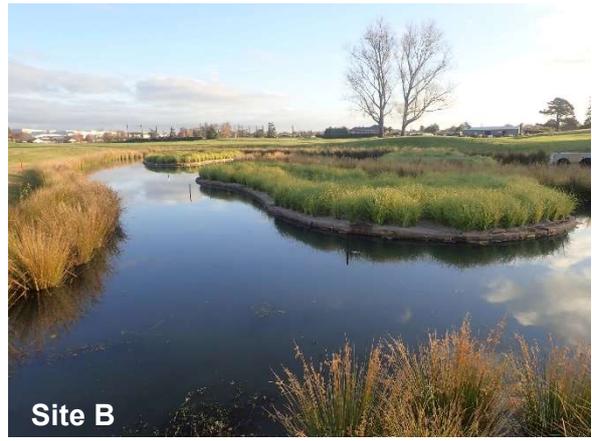
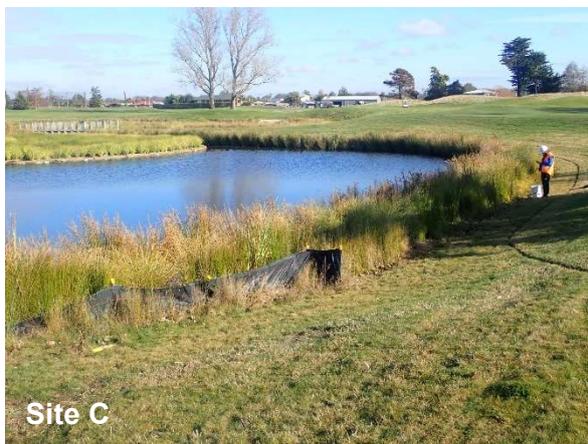
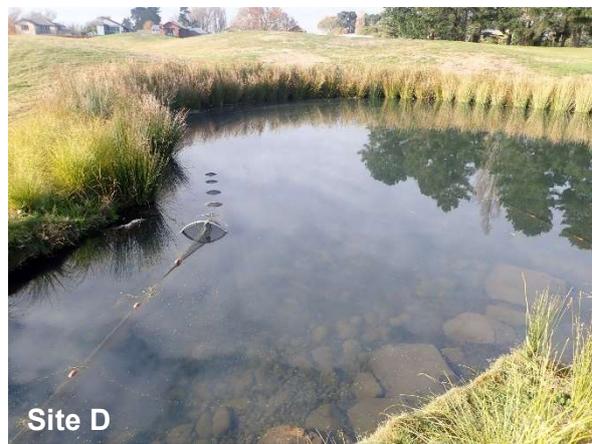
Figure 8: Representative photographs of each of the pond sampling sites: A) Inlet, B) Floating wetland, C) Bank, D) Outlet.

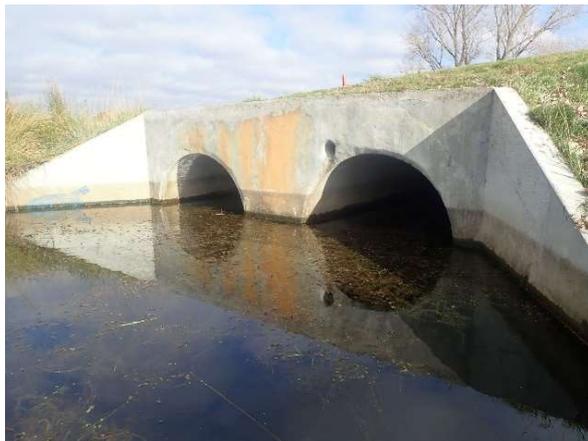
Figure 9: Inlet culverts to the pond system.

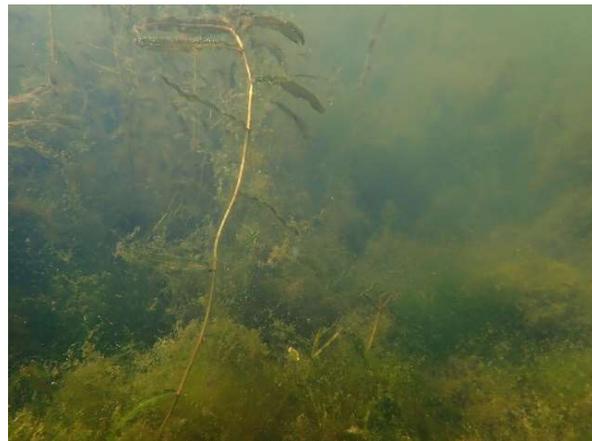
Figure 10: Long filamentous green algae and iron floc smothering macrophytes and substrate at site A.
