## **Appendix 1**

### **Implementation Examples**

Following are some examples of conservation issues at Linwood Cemetery. They include typical examples of common grave types, with recommended conservation interventions.

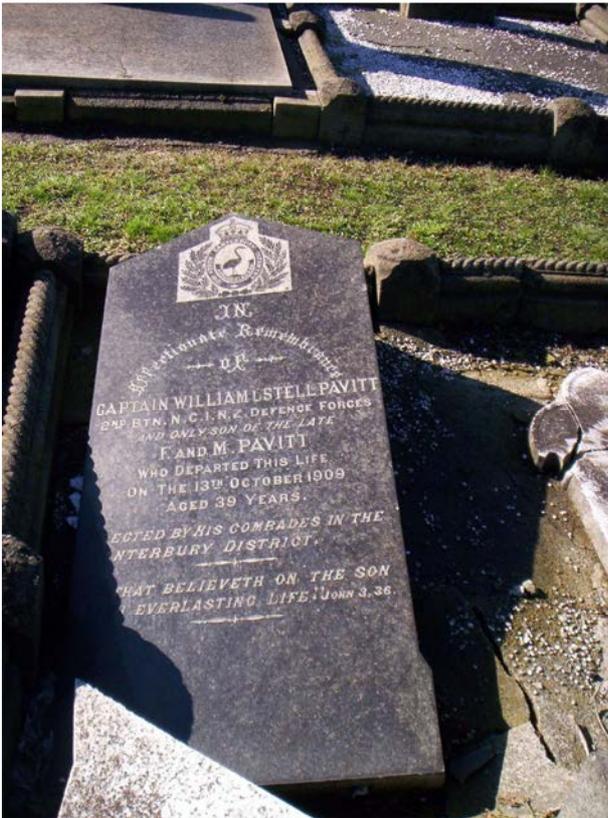
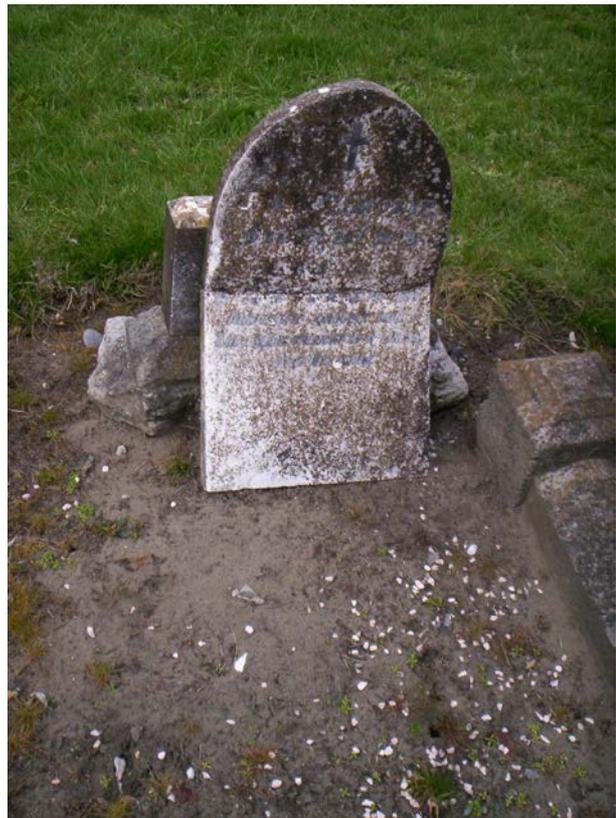
## Photograph 1 Broken Headstones

**Example** –headstone broken off base or broken itself

**Issue** – the stone surface lying against the earth can accelerate deterioration of the stone and the broken pieces could become separated and disassociated from the grave

**Recommendation** – Seek advice to have the broken pieces glued back together. If possible and practical, the headstone can also be pinned and returned to an upright position

**Priority** - Necessary

**Who to Undertake** – Stonemason or experienced Contractor

- Rejoining should only be carried out by suitably qualified professionals.
- Broken headstone pieces may be rejoined using bronze or other non-ferrous dowels and appropriate adhesives such as acrylic or epoxy resins.
- Do not use Portland cement or Plaster of Paris.
- Do not use iron as it is potentially corrosive.
- Wash from lime mortar causes problems especially with sandstone or polished black granite.

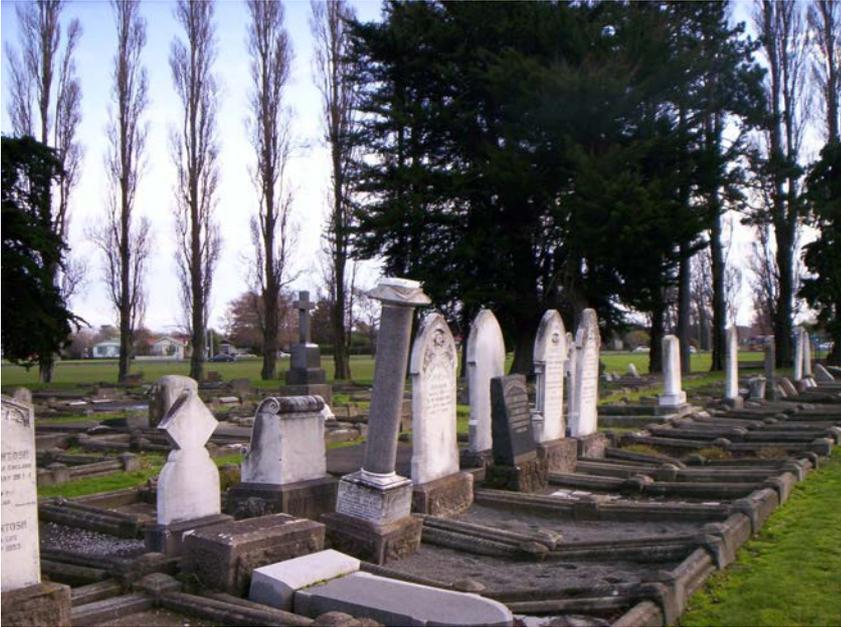
## Photograph 2 Unstable Memorial

**Example** – (centre of picture) unstable leaning monument (and broken and uneven concrete grave)

**Issue** – monument likely to topple and break (or encourage vandals to push over), possibly damaging other graves or people in the process

**Additional comments:** A slight lean in a headstone is not in itself an issue and can add to the character of the historic cemetery. The issue is when it may collapse. There are a number of headstones/memorials at Linwood Cemetery that are on a slight lean now and currently no intervention is required. They should be monitored however, and stabilised if the leans threaten their stability.

**Recommendation** – Seek professional advice for stabilising

**Priority** – Urgent to Necessary

**Who to Undertake** – Depending on the structure: Buildings Conservator, Engineer, Stonemason or experienced Contractor

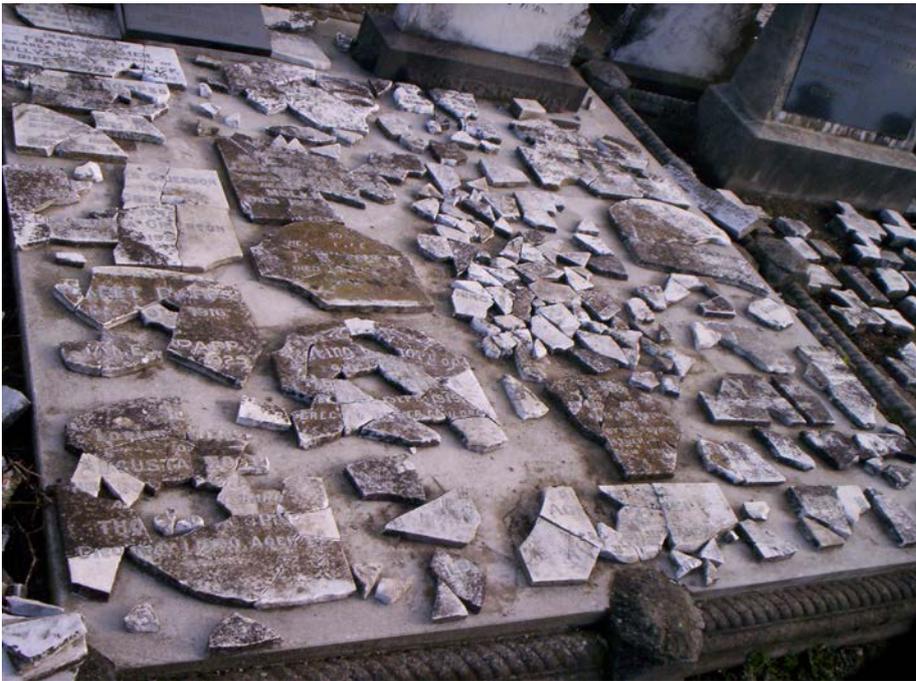
### Photograph 3 Multiple Breaks

#### **Example** – Multiple breaks

**Issue** – In many cases this is due to vandalism, and there is the risk that the broken pieces are removed and become disassociated from the grave.

**Recommendation** – glue pieces together and reinstate if possible. If not possible to reinstate, seek advice on resetting in a new concrete slab/desk. If original location is not known, secure in a designated area for ‘stray’ parts of monuments (reversible in case original location becomes known).

**Priority** – Urgent/Necessary

**Who to Undertake** – Conservator/Stonemason/Experienced Contractor or possibly others as long as best practice is followed

**Additional Comments:** Fragments of headstone could be set in concrete or some other way to present the fragments being removed. However, it is critical to ensure that if the fragments are set in concrete, they definitely belong to that burial/grave site. It is not acceptable to leave loose parts on the graves of others for anything other than the very short term. The joined fragments should be documented and cross-referenced to the Linwood Cemetery Working Group database where possible.

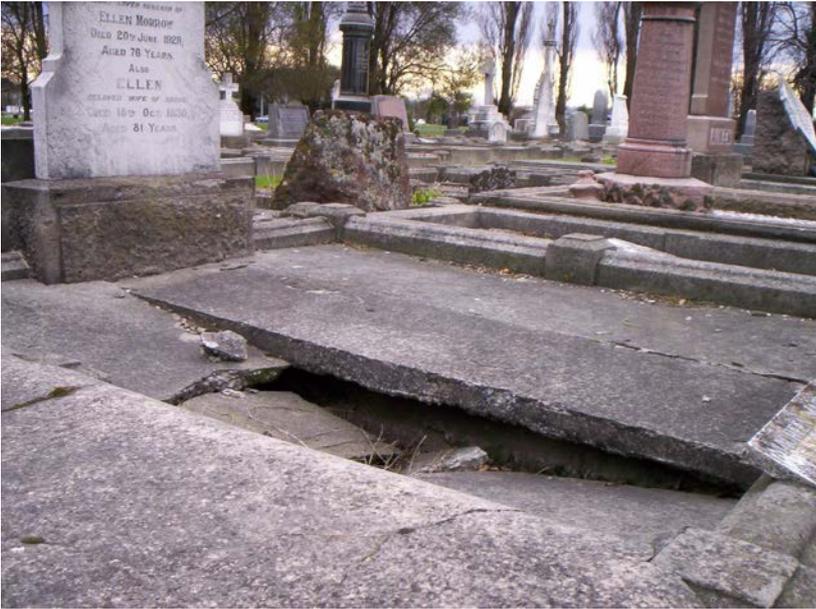
## Photograph 4 Concrete Slab Collapse

**Example** – concrete slab/vault distortion or collapse, due to compaction of grave fill and/or vandalism

**Issue** – potentially unstable (and can make the headstones/monuments unstable), and it can appear unsightly

**Recommendation** – One option is to cover the cracked concrete area with sand (which is particularly appropriate at Linwood Cemetery) or gravel. This is an affordable, minimum labour option which has been endorsed by the Historic Cemeteries Conservation Trust of New Zealand. It has the advantage of retaining the original concrete below the sand/gravel. In some cases, under professional guidance, it may be best to record then remove the broken stone, correct ground level and reset concrete

**Priority** – Immediate/Urgent where the stability of other elements of the grave (and safety of people) is being compromised. Generally the priority ranges from Necessary to Desirable.

**Who to Undertake** – Stonemason/Conservator/experienced Contractor for correcting ground level and replacing concrete, but for infilling with gravel/sand, Council staff or volunteers may undertake.

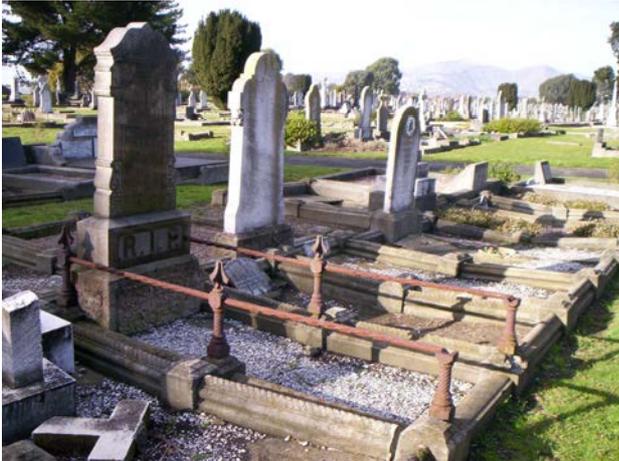
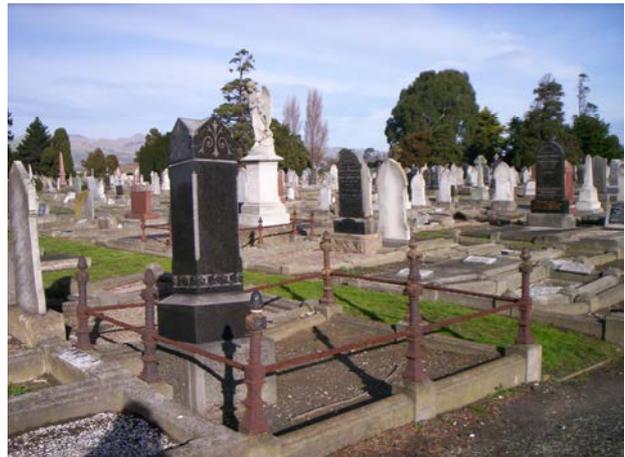
## Photographs 5 Railings

**Example** – bent wrought iron railing with some parts missing, rusting, broken, paint missing

**Issue** – looks untidy, iron corroding, parts could become disassociated with the grave

**Additional Comments:** Only paint where there is an indication of the original paint colour (often it was black). For the most part, rust on wrought and cast iron is not causing major problems at Linwood Cemetery. The area where the iron joins the concrete plinth or the earth is where most corrosion is occurring and this is the main reason to apply fisholene or paint. Common causes of failure are lack of maintenance of protective coating causing rusting, rusting of fixings, impact damage, vegetation growth, moss and lichen growth, inadequate cleaning of debris, galvanic corrosion, pollution, abrasion, fatigue, salts which act as electrolytes accelerating corrosion, inappropriate repairs and design.

**Recommendation** – For rusting iron, thoroughly hand clean to get loose rust off, then apply fisholene or if going to paint afterwards, apply anti-rusting guard and then paint with oil based paint. For broken, bent iron, parts of the concrete plinth of the rails could be reconstructed and rejoined. Where parts of the railing have been removed, they could be reinstated where original location is known.

**Priority** – Necessary to Desirable

**Who to Undertake** – Historic iron specialist

Note: Cast and wrought iron should be riveted, not welded.

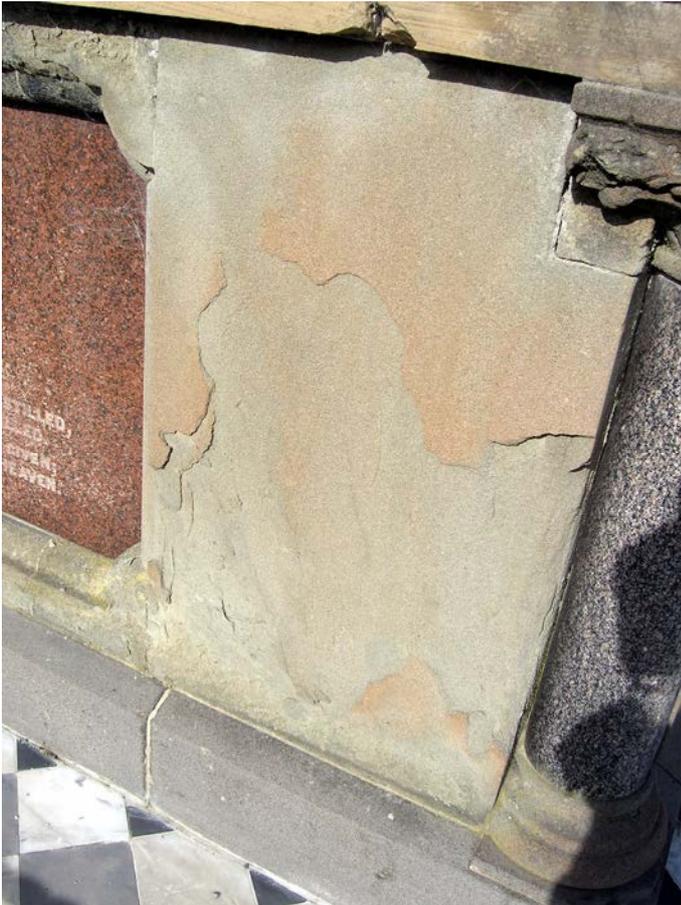
### Delamination of Stone

**Example** – Delamination of stone

**Issue** – Parts of original stone is falling away and historic inscriptions are disappearing

**Additional Comments:** Delamination is where a hard outer crust forms on the stone and causes it to come away and fall off. In many cases, there is very little that can be done to address it. While a poultice may be a solution to get rid of the salts causing the hard outer crust, it would need to be done every 5-10 years since salts will continue to enter the stone through the ground. Micro grouting is a technique developed by the International Centre for the Study of the Preservation and Restoration of Cultural Property (ICCROM) for reattaching or consolidating heritage fabric such as fresco and stonework. Micro grouting involves drilling tiny holes in the stonework, flushing the holes with alcohol to clean them and then very gently injecting lime fly ash grout.

**Recommendation** – Have assessed on a case by case basis. A possible solution is to clean off all moss/lichen/dirt, record the information inscribed, then apply a poultice over the entire stone to rid it of salts, then micro grout it solidify the loose bits.

**Priority** – Desirable, dependent on further information. For the most part addressing delamination is difficult.

**Who to Undertake** – Stone Conservator/Building Conservator

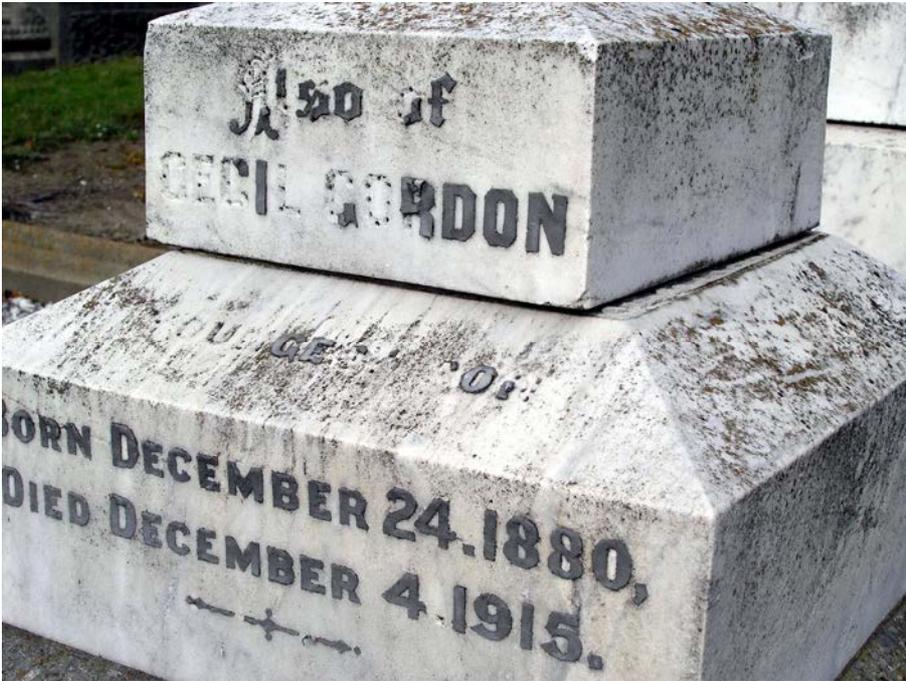
**Photograph 7**  
**Lead Lettering**

**Example** - Lead lettering falling off

**Issue** – Heritage fabric is broken or lost and inscriptions become hard or impossible to read

**Recommendation** – Record as much of the inscription as possible and photograph with the sun slanting across the face of the stone. While lettering can be re-leaded, it generally involves extensive work.

**Priority** – Recording Necessary; Re-leading Desirable where appropriate

**Who to Undertake** –. Systematic recording can be carried out by Council staff or volunteers. Re-leading only to be carried out by experienced professionals

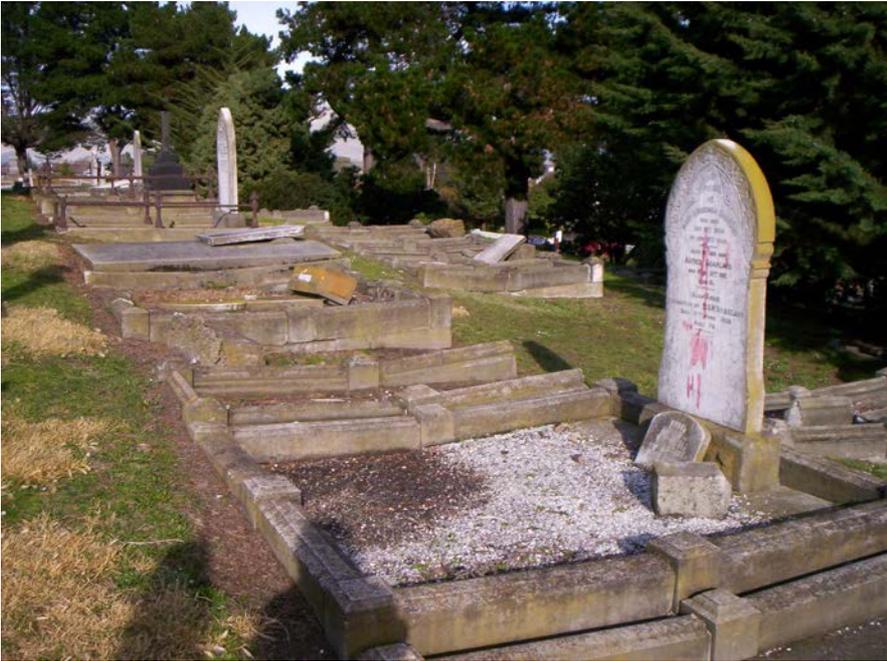
**Photograph 8**  
**Graffiti**

**Example** – Graffiti sprayed on and scratched

**Issue** – Potential damage from paint, and failed attempts to remove; permanent damage from scratching.

**Recommendation** – Poultice to remove paints, do not use acidic cleaners on limestone. Do not use mechanical grinders, sand or waterblasting to remove graffiti. Take appropriate safety precautions.

**Priority** – Necessary/Desirable

**Who to Undertake** – Stone Conservator or experienced Contractor

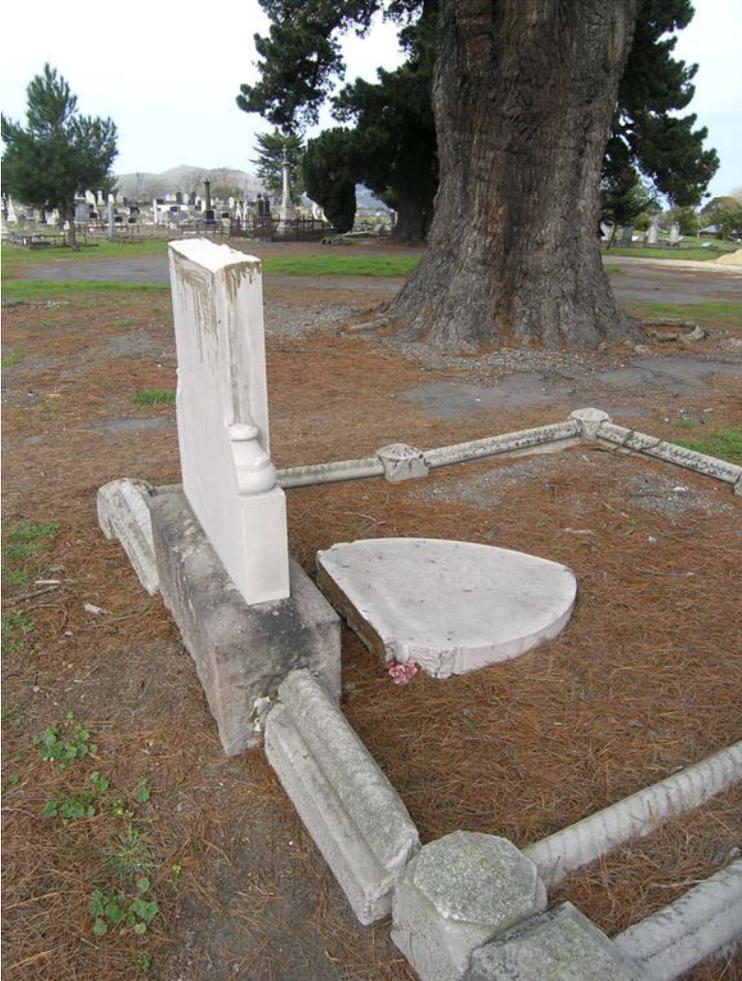
**Photograph 9**  
**Inappropriate and Failed Repairs**

**Example** – Failed glue, discoloured staining

**Issue** – Potential damage and/or staining from inappropriate methods and fixing agents, further damage if attempts to repeat failed method.

**Recommendation** – Poultice to remove stains, do not use acidic cleaners on limestone; do not use mechanical grinders, sand or waterblasting to remove glues or stains; take appropriate safety precautions.

**Priority** – Necessary/Desirable

**Who to Undertake** – Stone Conservator for complex repairs. Council staff/volunteers following best practice for basic repair.

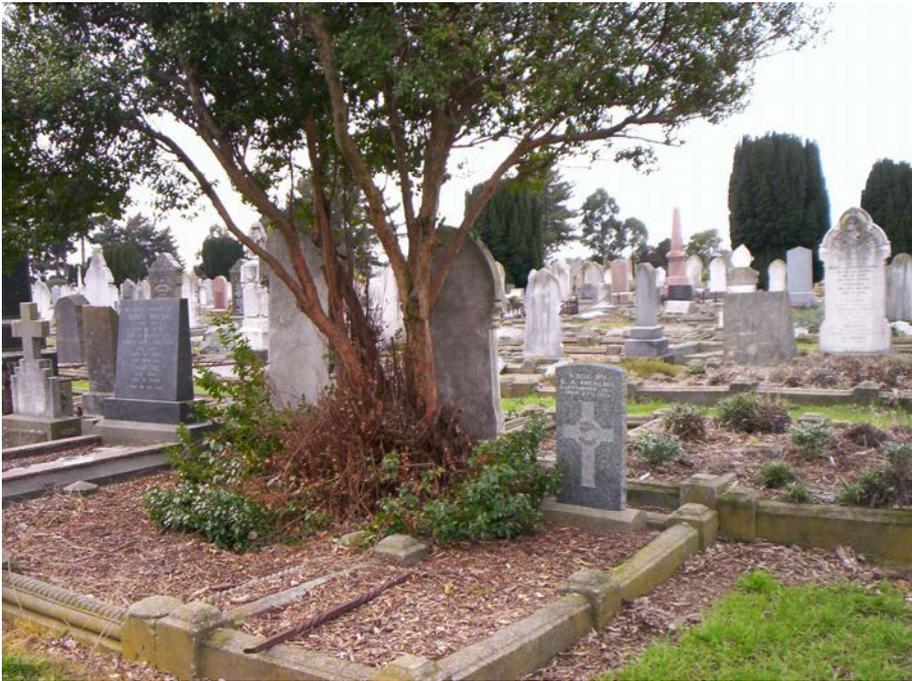
**Photograph 10**  
**Tree Roots**

**Example** – tree growth adjacent to graves

**Issue** – roots are damaging graves and shade encouraging moss growth

**Recommendation** – Seek advice from arboriculturalist. Where the tree does not have historic value, carefully remove at just above the ground level, taking care to protect graves. This may involve removing limbs and then poisoning the stump and roots. Stabilisation or repair of the grave can then be carried out.

**Priority** – Urgent to Necessary, on a case by case basis

**Who to Undertake** – Council staff under the guidance of arboriculturalist.

**Additional Comments:** Trees that have high heritage value for the cemetery need to be treated differently. Some yew trees are likely to be well over 100 years old and are themselves part of the grave/memorial. Under the guidance of an arboriculturalist, identified limbs of trees could be removed or pruned to lessen the impact on the graves. In some cases, it may be necessary to remove historic trees, but this should only be done weighing up all the considerations. It may be possible to take cuttings of some trees to replant where their lineage is important.

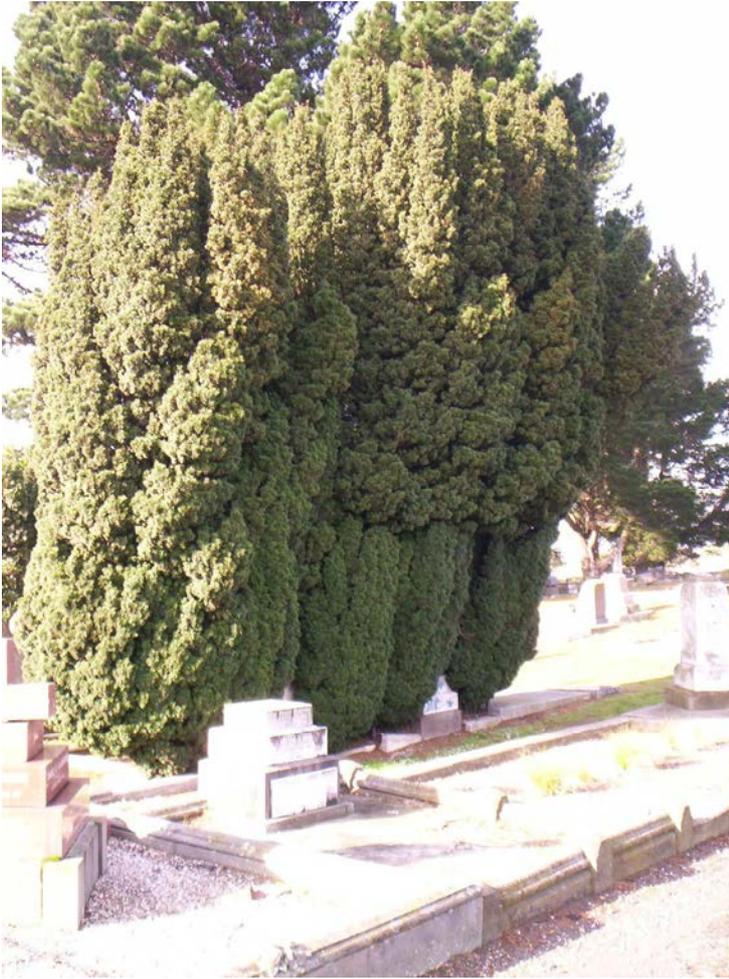
**Photograph 11**  
**Historic Grave Plantings**

**Example** – historic trees within grave sites

**Issue** – the trees themselves are part of the memorial and have heritage value, but as they grow, the trees over time are damaging other historic features such as railings, headstones, vaults.

**Recommendation** – seek the advice of an arboriculturalist. One solution may be to take out the inner limbs of the trees but retain the height and form of the tree.

**Priority** - Necessary

**Who to Undertake** – Seek advice from arboriculturalist.

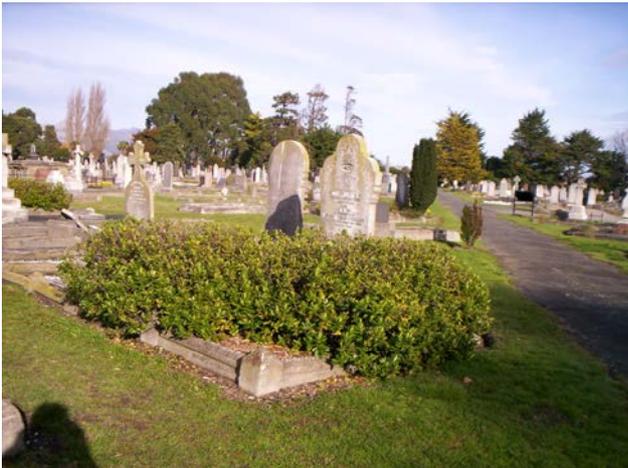
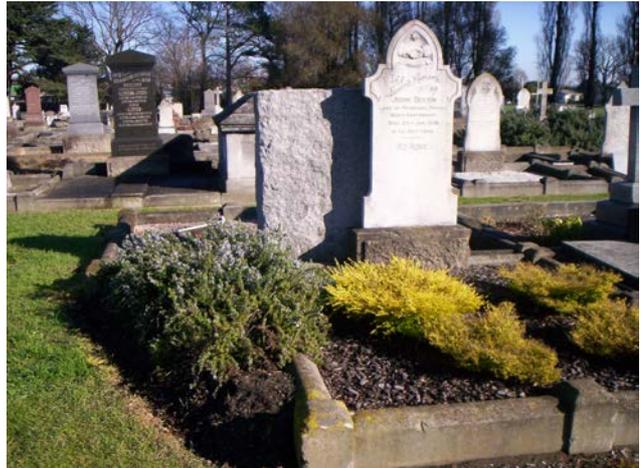
### Plantings on/beside Graves

**Example** – Recent plantings on graves

**Issue** – If not carefully maintained, will obscure headstones and potentially damage stone and ironwork over time.

**Recommendation** – Carefully maintain recent plantings. For example, agapanthus, hebes etc should be pruned and thinned regularly.

**Priority** – Necessary

**Who to Undertake** – Council staff/volunteers

**Additional Comments:** Avoid new plantings on or immediately adjacent to graves. New corner planting beside graves is not recommended. For the recent corner plantings, if possible the soil level needs to be lowered to be level with the grass since at present it is causing dampness to the sides of the graves

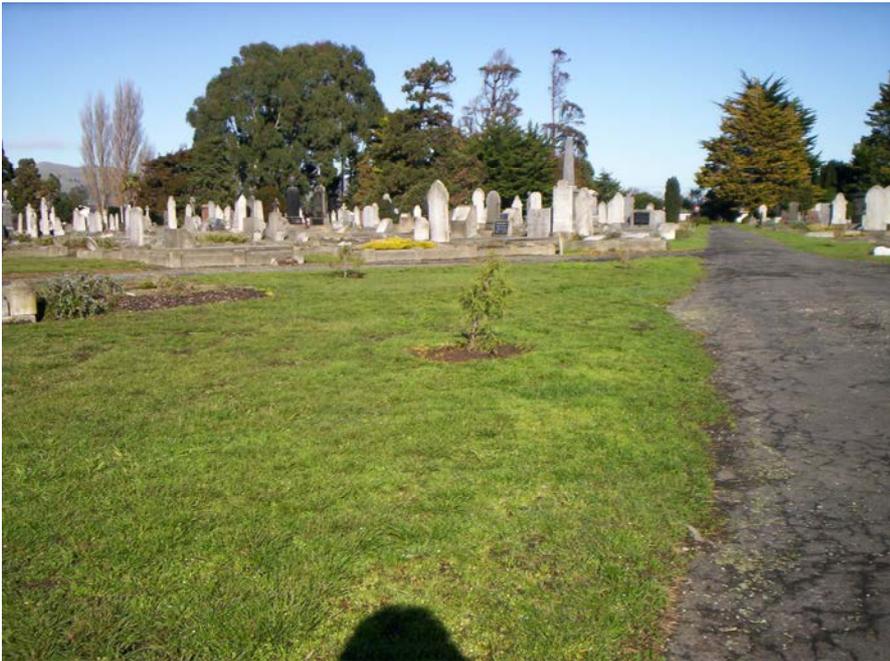
**Photograph 13**  
**Recent Plantings on Unmarked Burial Sites**

**Example** – Recent tree plantings in areas of known and likely burials

**Issue** – While recent plantings, such as in the photograph above, are not necessarily a fault or issue, careful consideration is required as to whether mature conifers are appropriate on a site of burials.

**Recommendation** – In the opinion of the authors, these conifers should be removed. However, before a final decision is made, the Council should consult with Roman Catholic Church (as area 38 was for Roman Catholic burials) and potentially the wider community to confirm if planting of conifers on this site is the agreed course of action.

**Priority** – Necessary/Desirable

**Who to Undertake** – Council staff

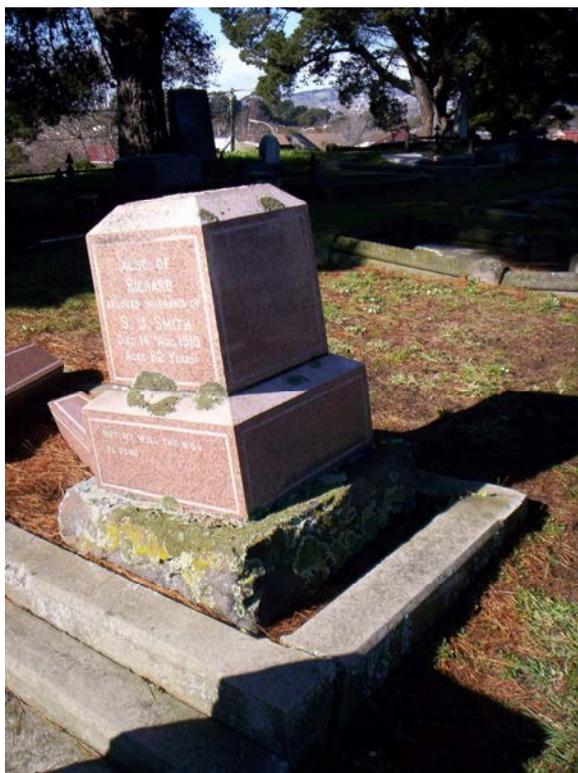
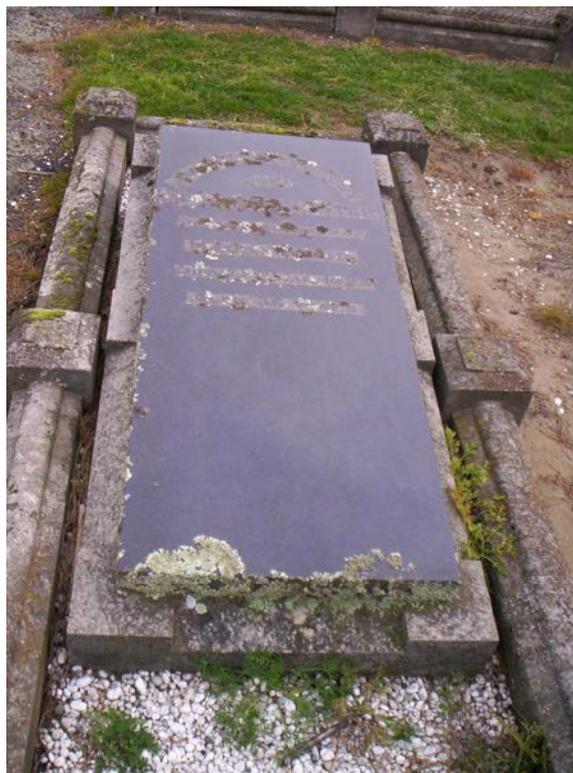
### Lichens and Mosses

**Example** – Biological Growth, notably mosses and lichens

**Issue** – Some growths are eating into stone, including obscuring inscriptions

**Recommendation** – Seek advice on a case by case basis as not all growth is causing damage. If removing biological growth, ensure this is done very carefully. In some cases, as with the photograph above, the main parts of the lichen can be scraped off carefully with a scalpel, then loose material gently brushed off the surface of the stone. In some cases it may be appropriate to use a biocide (see additional comments below).

**Priority** – Necessary/Desirable

**Who to Undertake** – Ideally a stone conservator, or an expert with experience in removing mosses/lichens on historic structures

**Additional Comments:** There is considerable discussion about the best way to deal with biological growth. English Heritage advises that most lichens, mosses and some wildflowers can be left on monuments so long as they do not obscure carved details, and do not recommend the use of chemicals. The National Trust of Australia's guide to conserving cemeteries cautions against removing biological growth and recommends expert advice if anything other than gentle brushing off is required. The HCCTNZ similarly cautions, but states that if it is necessary to remove biological growth, then use only preparations based on quarternary ammonium compounds eg benzylkonium chloride. For lichens, algae, fungi and moulds, the HCCTNZ recommends Kemsol "Mosskill". If a biocide is to be used, it is essential that it doesn't have soluble salts or bleach in it. The Council has received additional advice from HCCTNZ that "Wet and Forget" and "Simple Green" products are acceptable and are readily available. "30 Seconds" is not suitable.

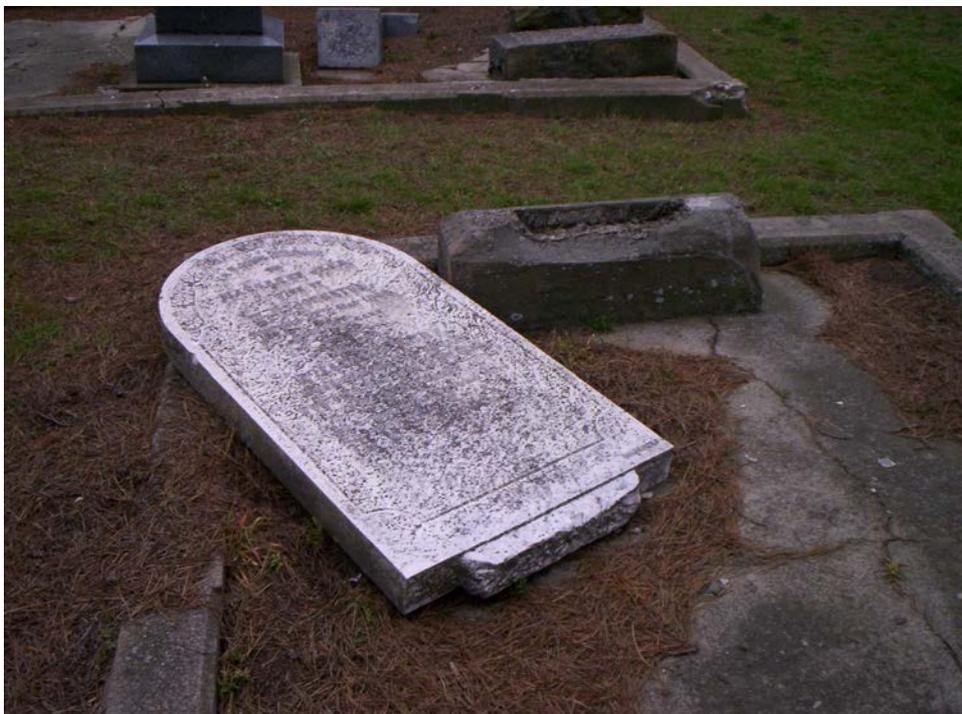
**Photograph 15**  
**Dirty Headstone**

**Example** – Dirty headstone

**Issue** – Obscures historical inscriptions and can cause damage

**Recommendation** – *In general, do not clean* unless not cleaning will result in information loss (text/pictorial inscriptions) or dirt is hiding faults that need to be assessed/addressed

**Priority** – Potentially desirable, although non-intervention may be most appropriate in most cases

**Who to Undertake** – Stone conservator/stone mason or Council staff/volunteers with appropriate training

**Additional Comments:** Do not clean headstones often, and do not clean unstable stones. Avoid acidic cleaners on marble or limestone. An effective gentle way to wash light soiling is washing with small quantities of water and natural fibre brushes. Never use wire brushes. Don't clean with water at a time when there is a risk of freezing temperatures before the stone dries out. Never sandblast or use high-pressure sprays on monuments.
