Bank Stabilisation

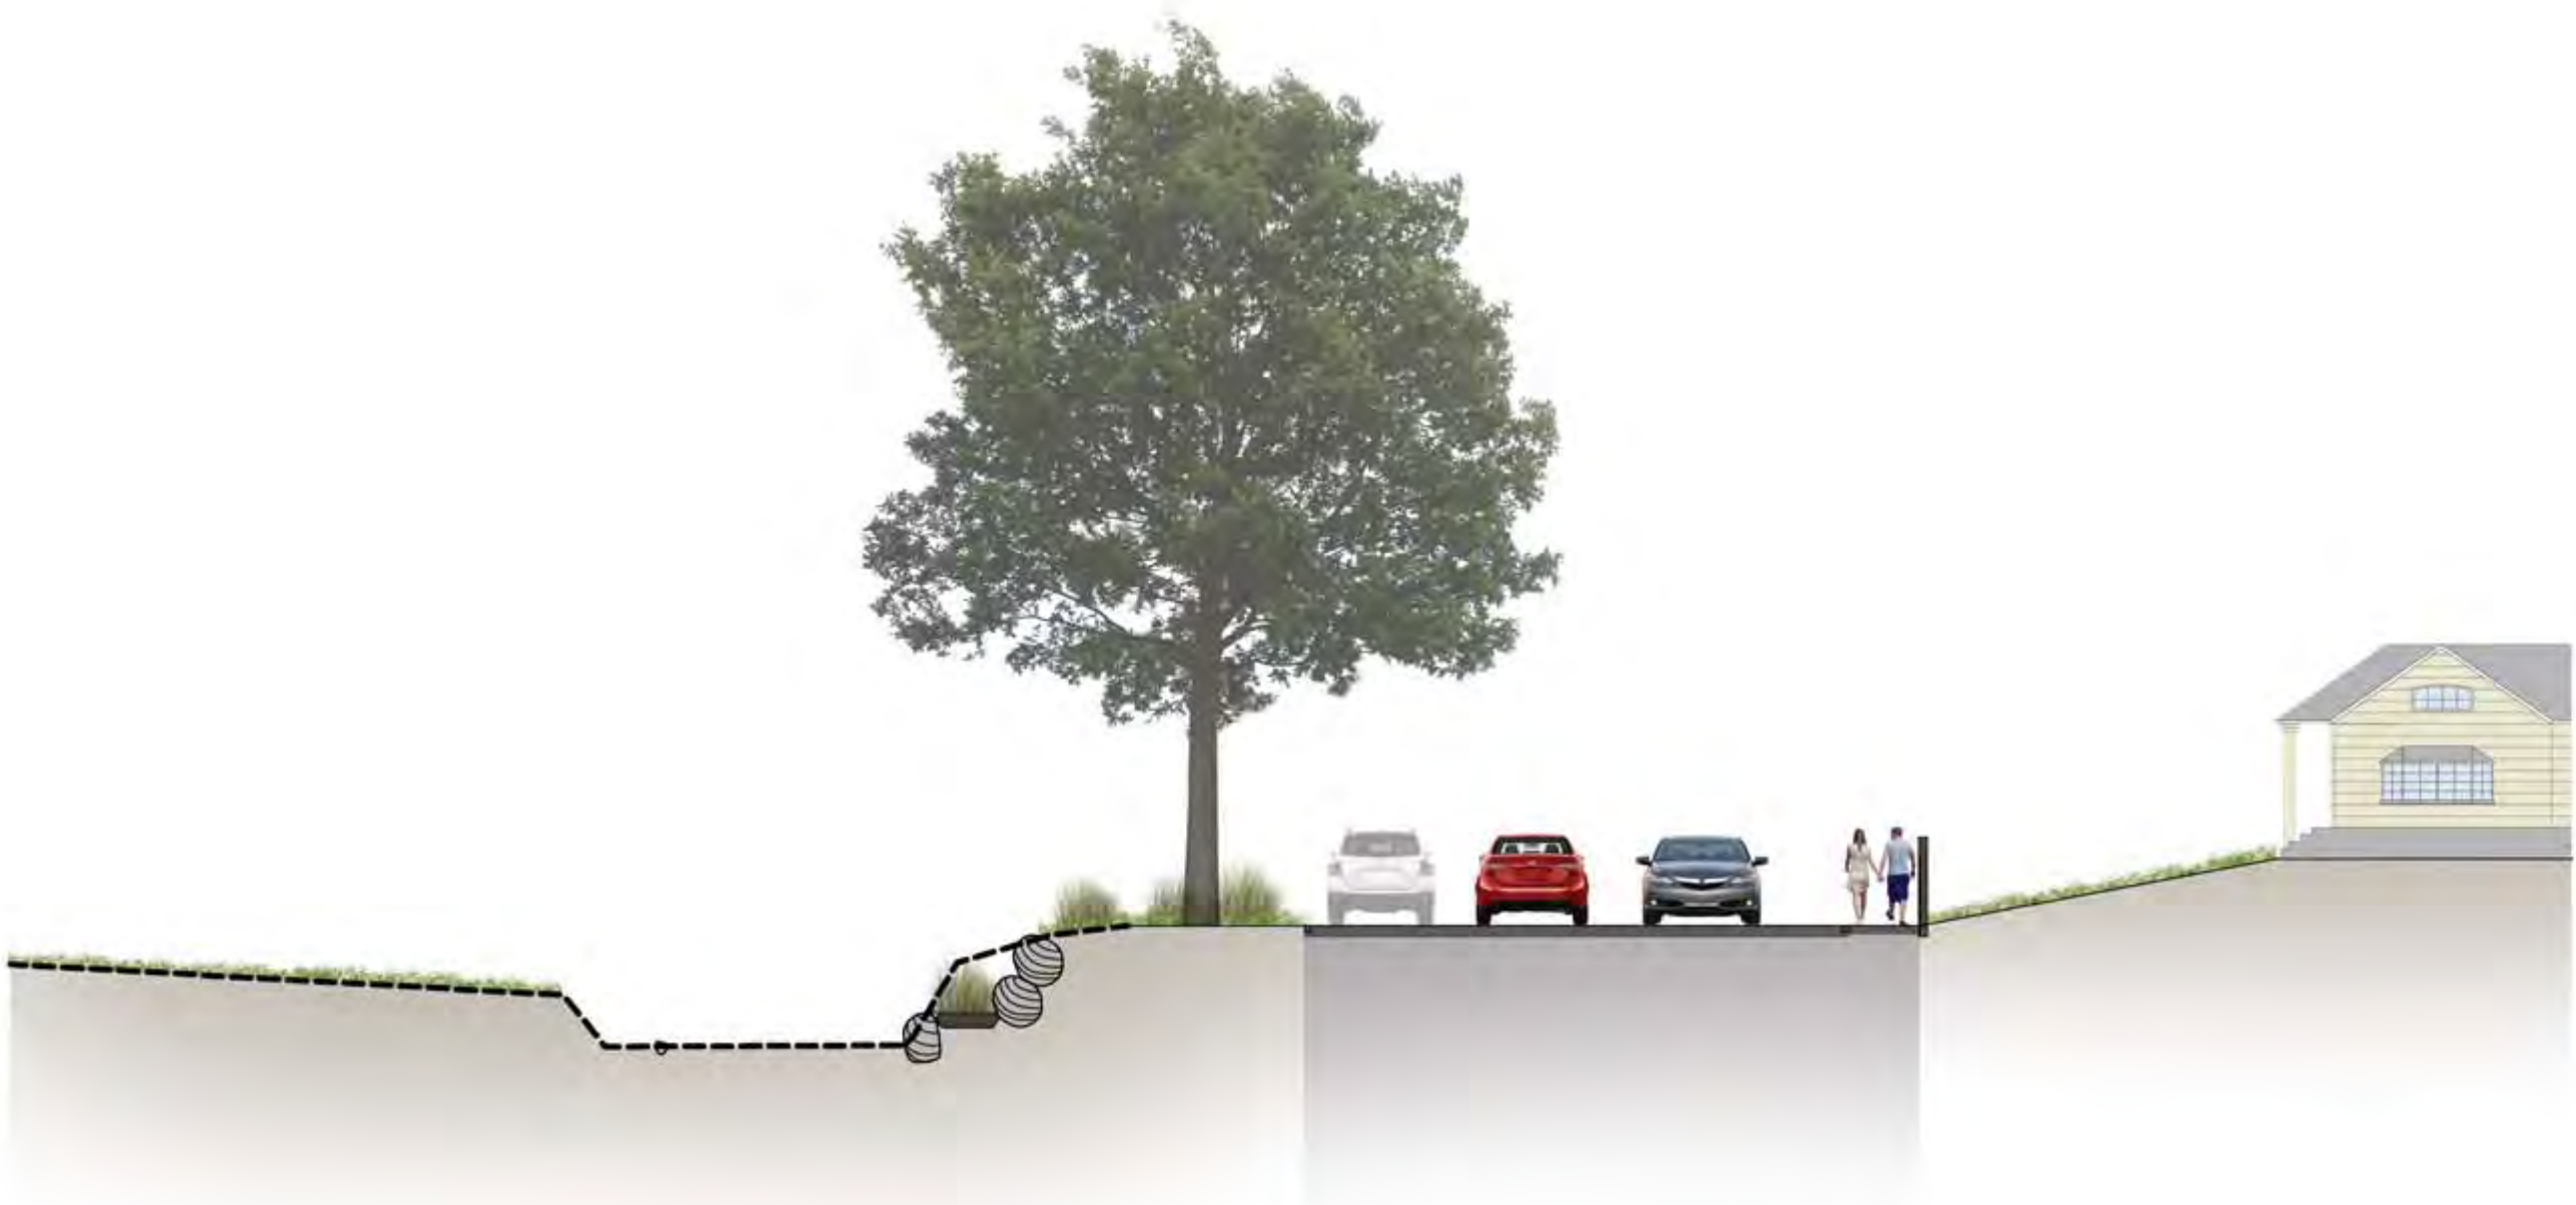
Typical cross-section with widening

- Where possible, waterway area has been increased by widening the channel. This enables bank stabilisation through a 'naturalised' bank profile (rather than hard engineering structures), and increases the capacity of the river.

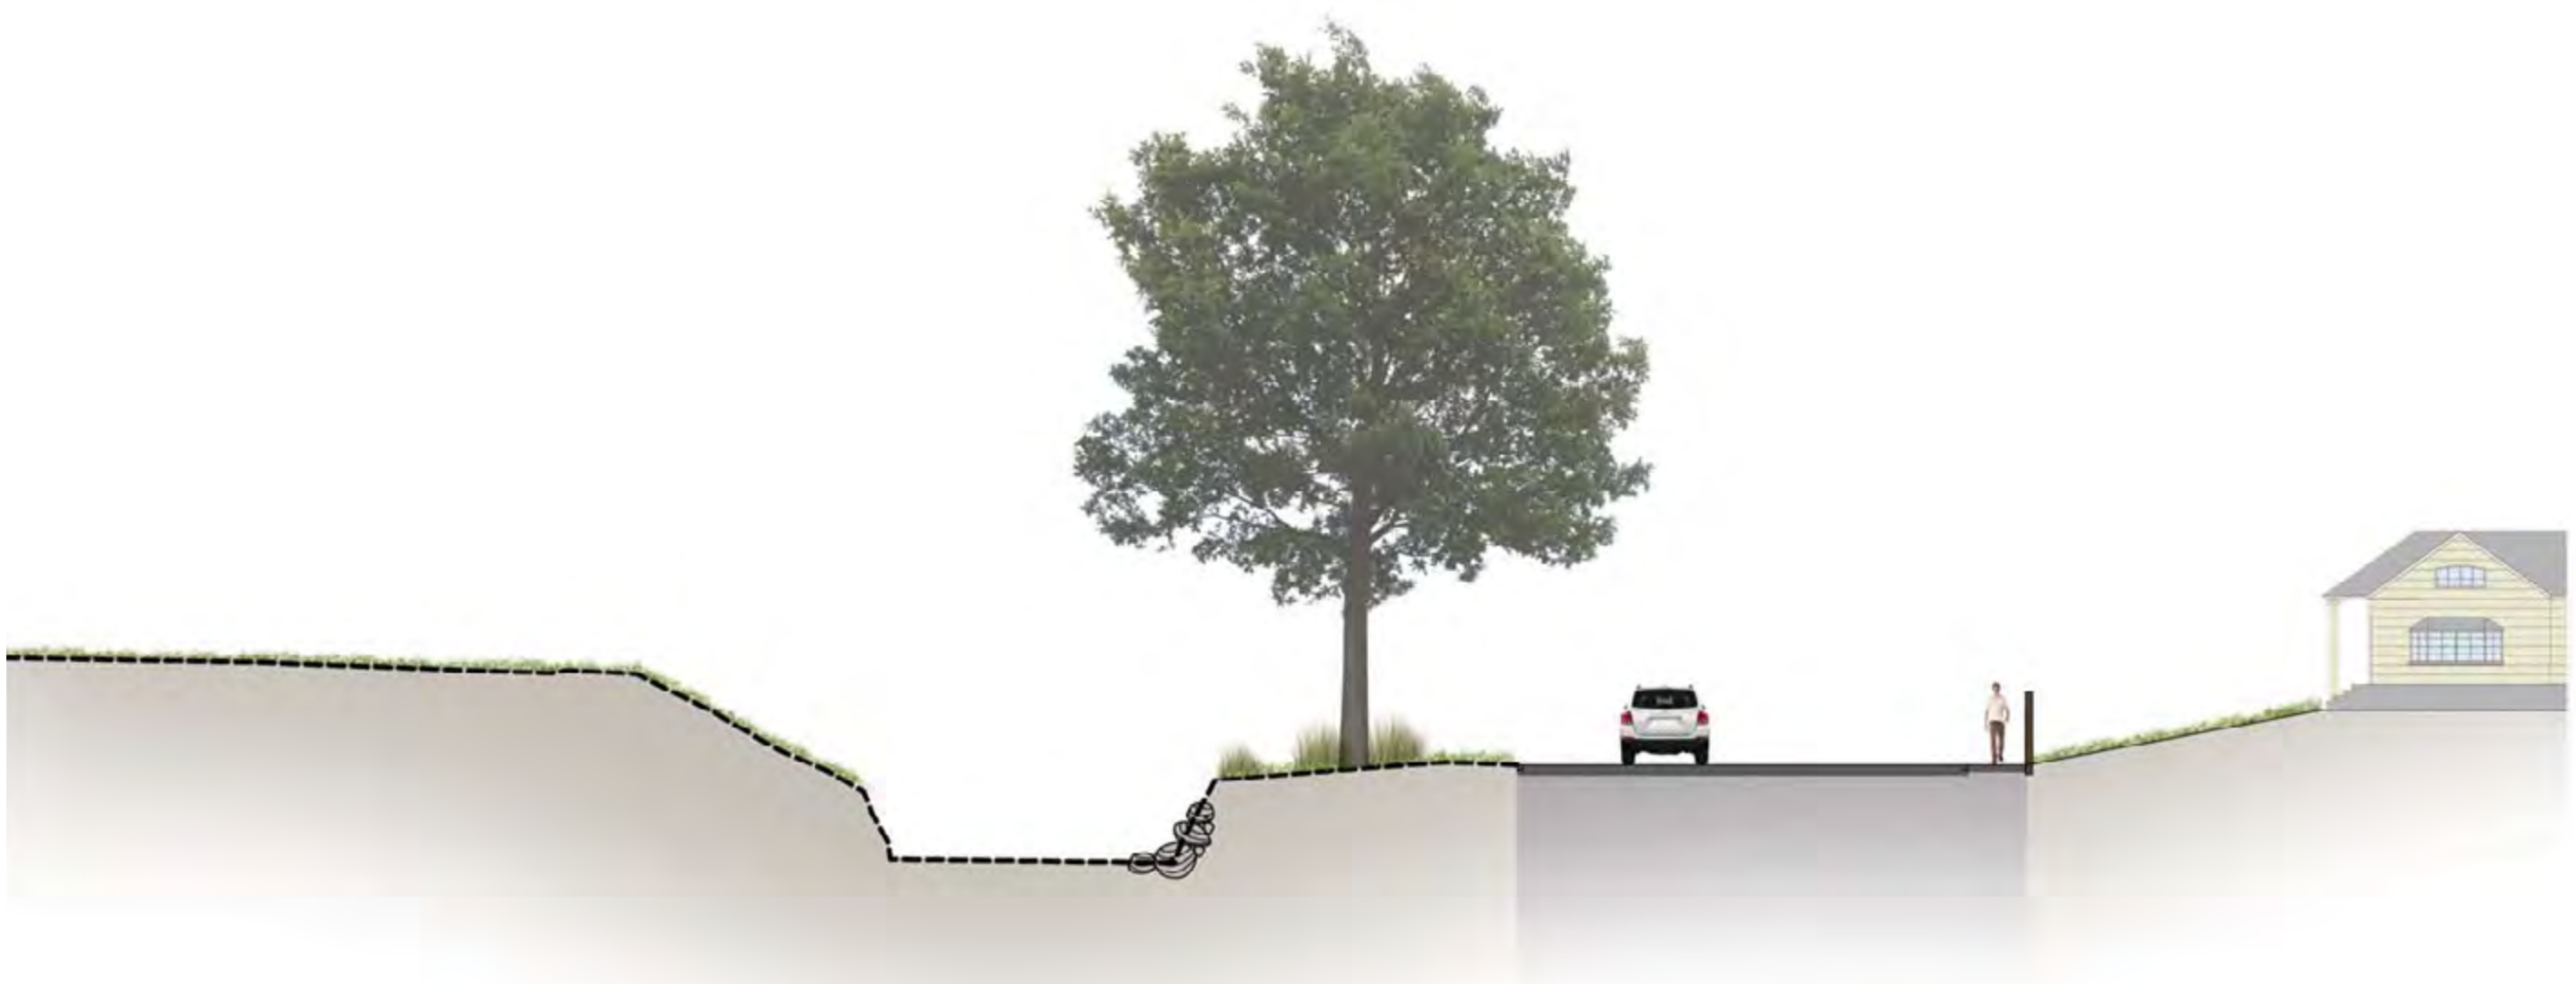
Typical cross-section protecting existing tree
