Aquatic Ecology Values of Western Cranford Basin

EOS Ecology Report No. CHR01-16129-01 | September 2016

Prepared for Christchurch City Council

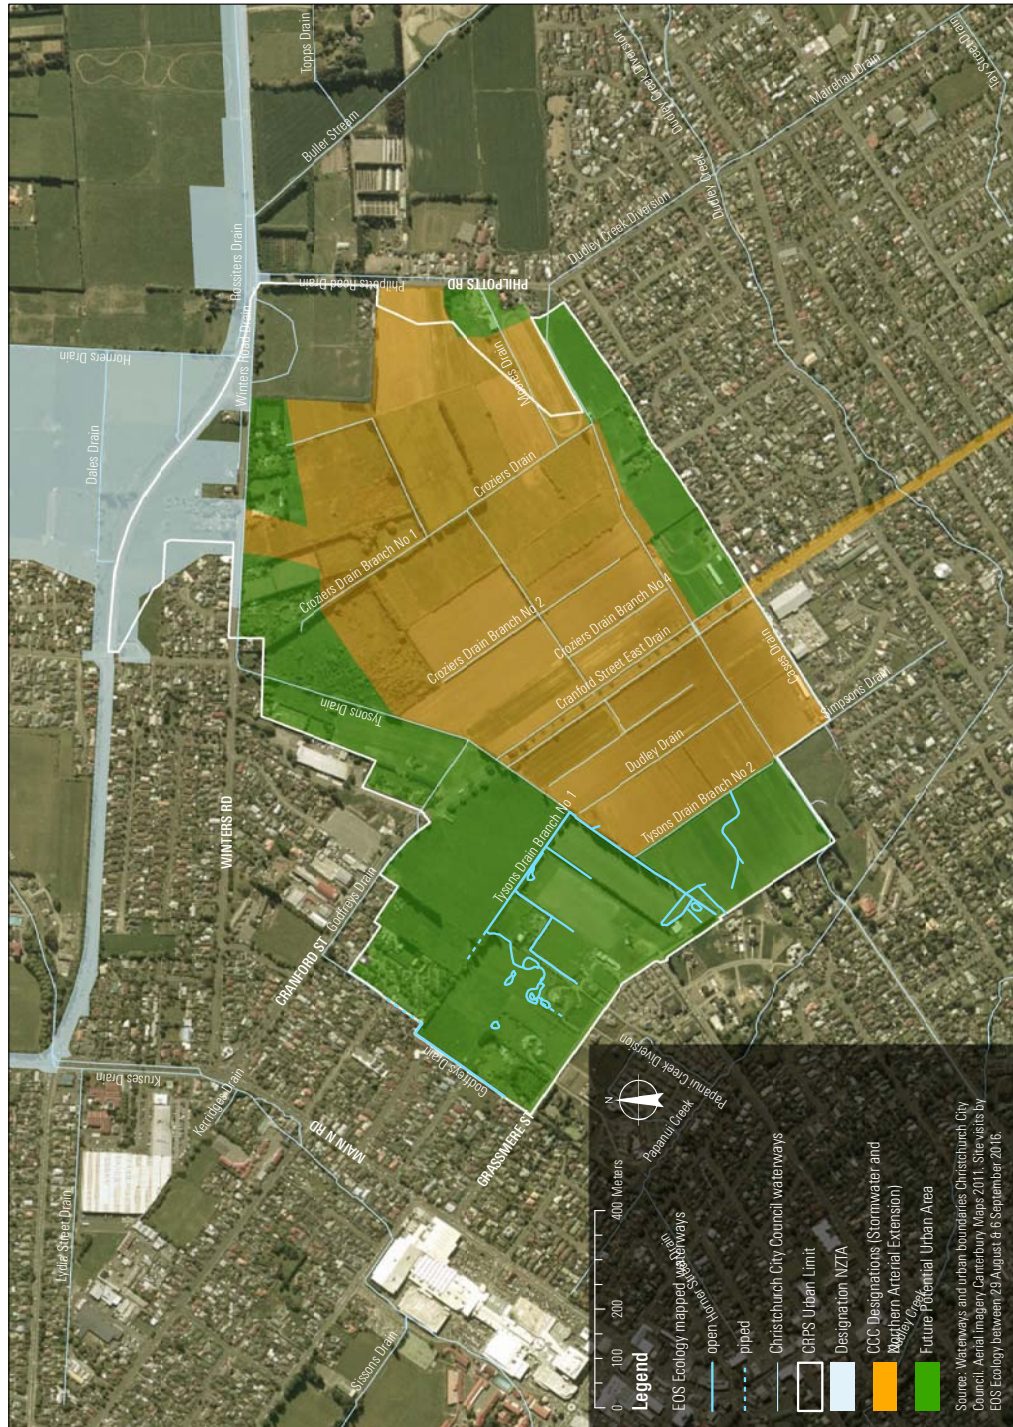
Figure 1 Cranford Basin and surrounds showing designations, waterways, and areas for proposed future urban development. The thick blue waterway lines in the western Cranford Basin are those mapped by EOS Ecology in the current study.

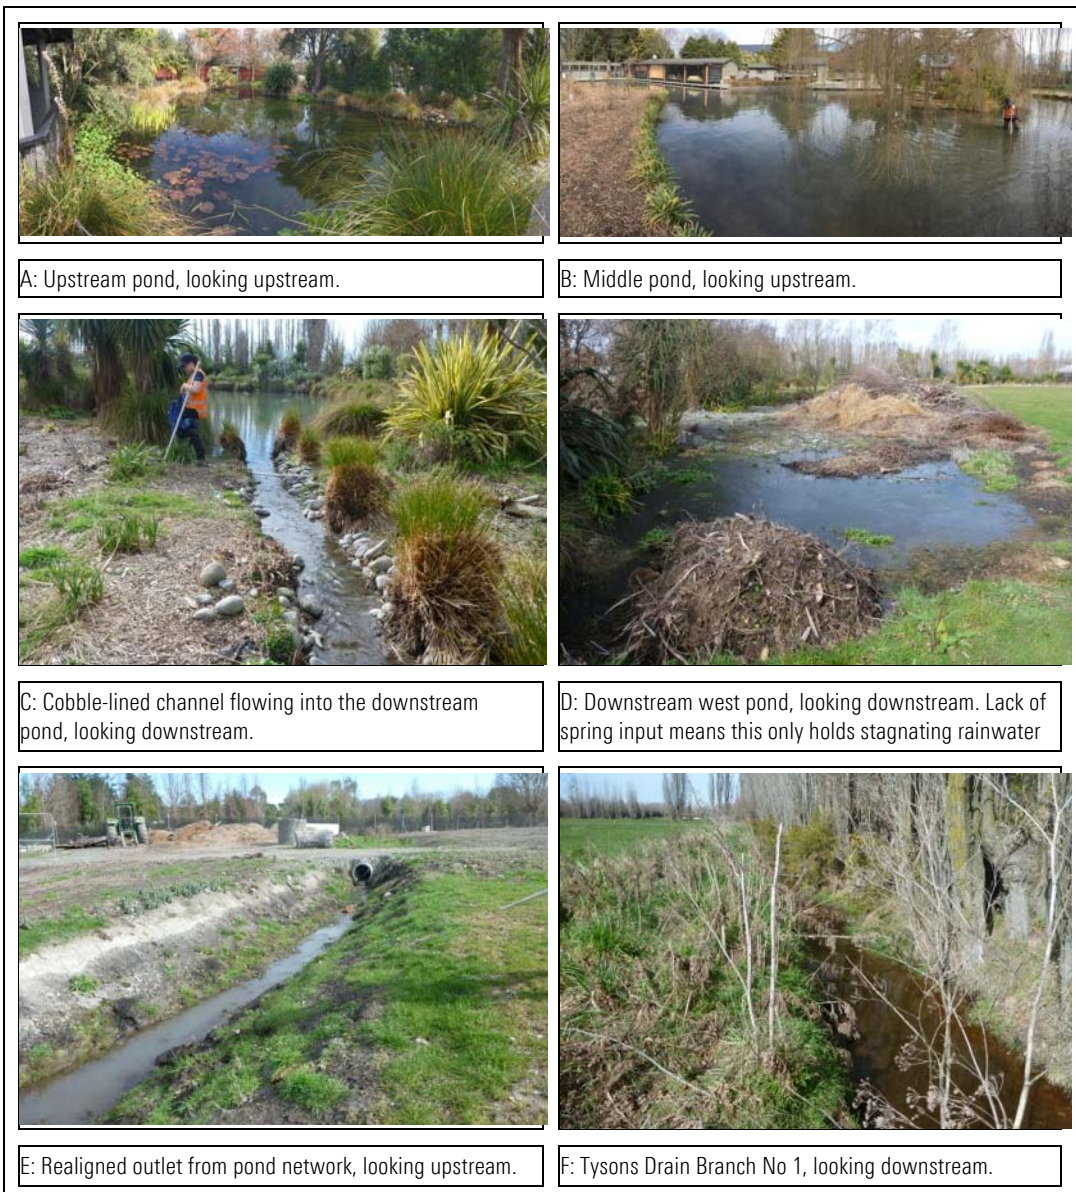
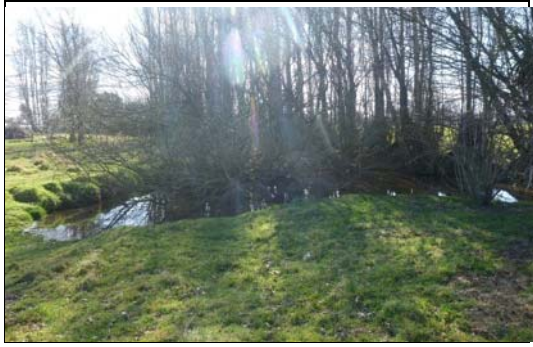
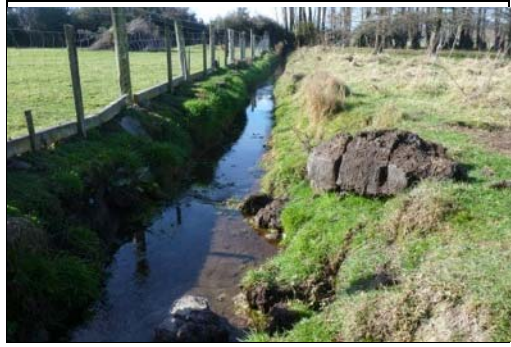
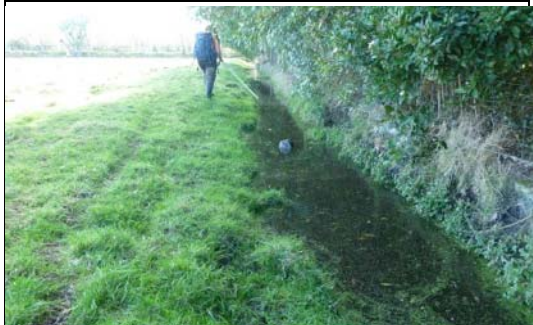
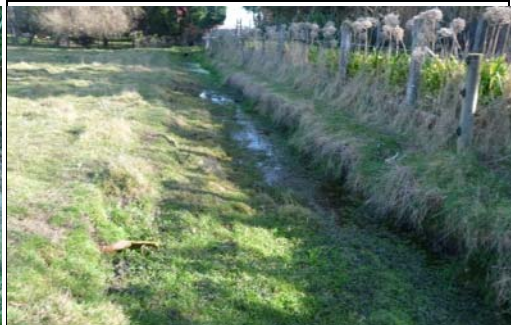
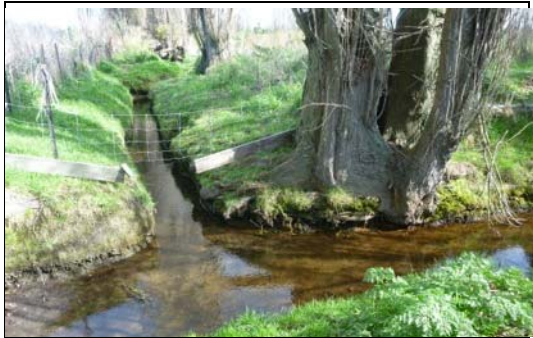
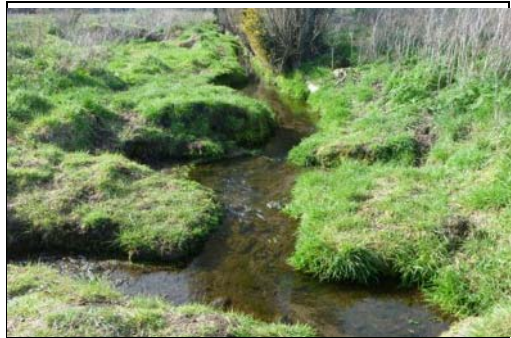
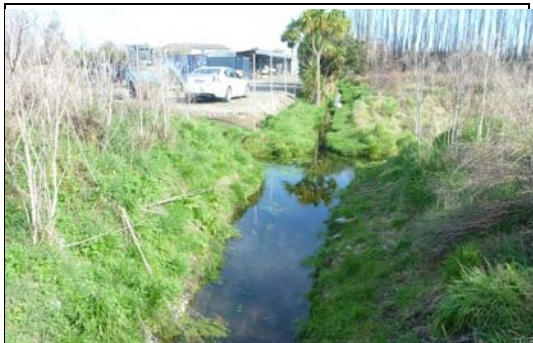
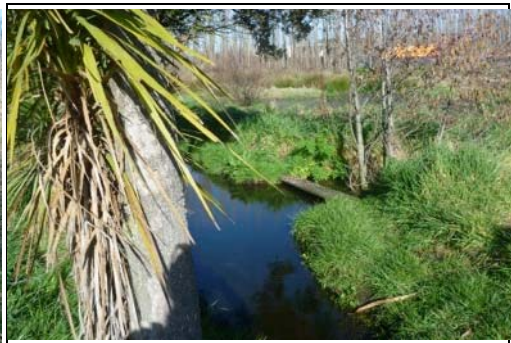
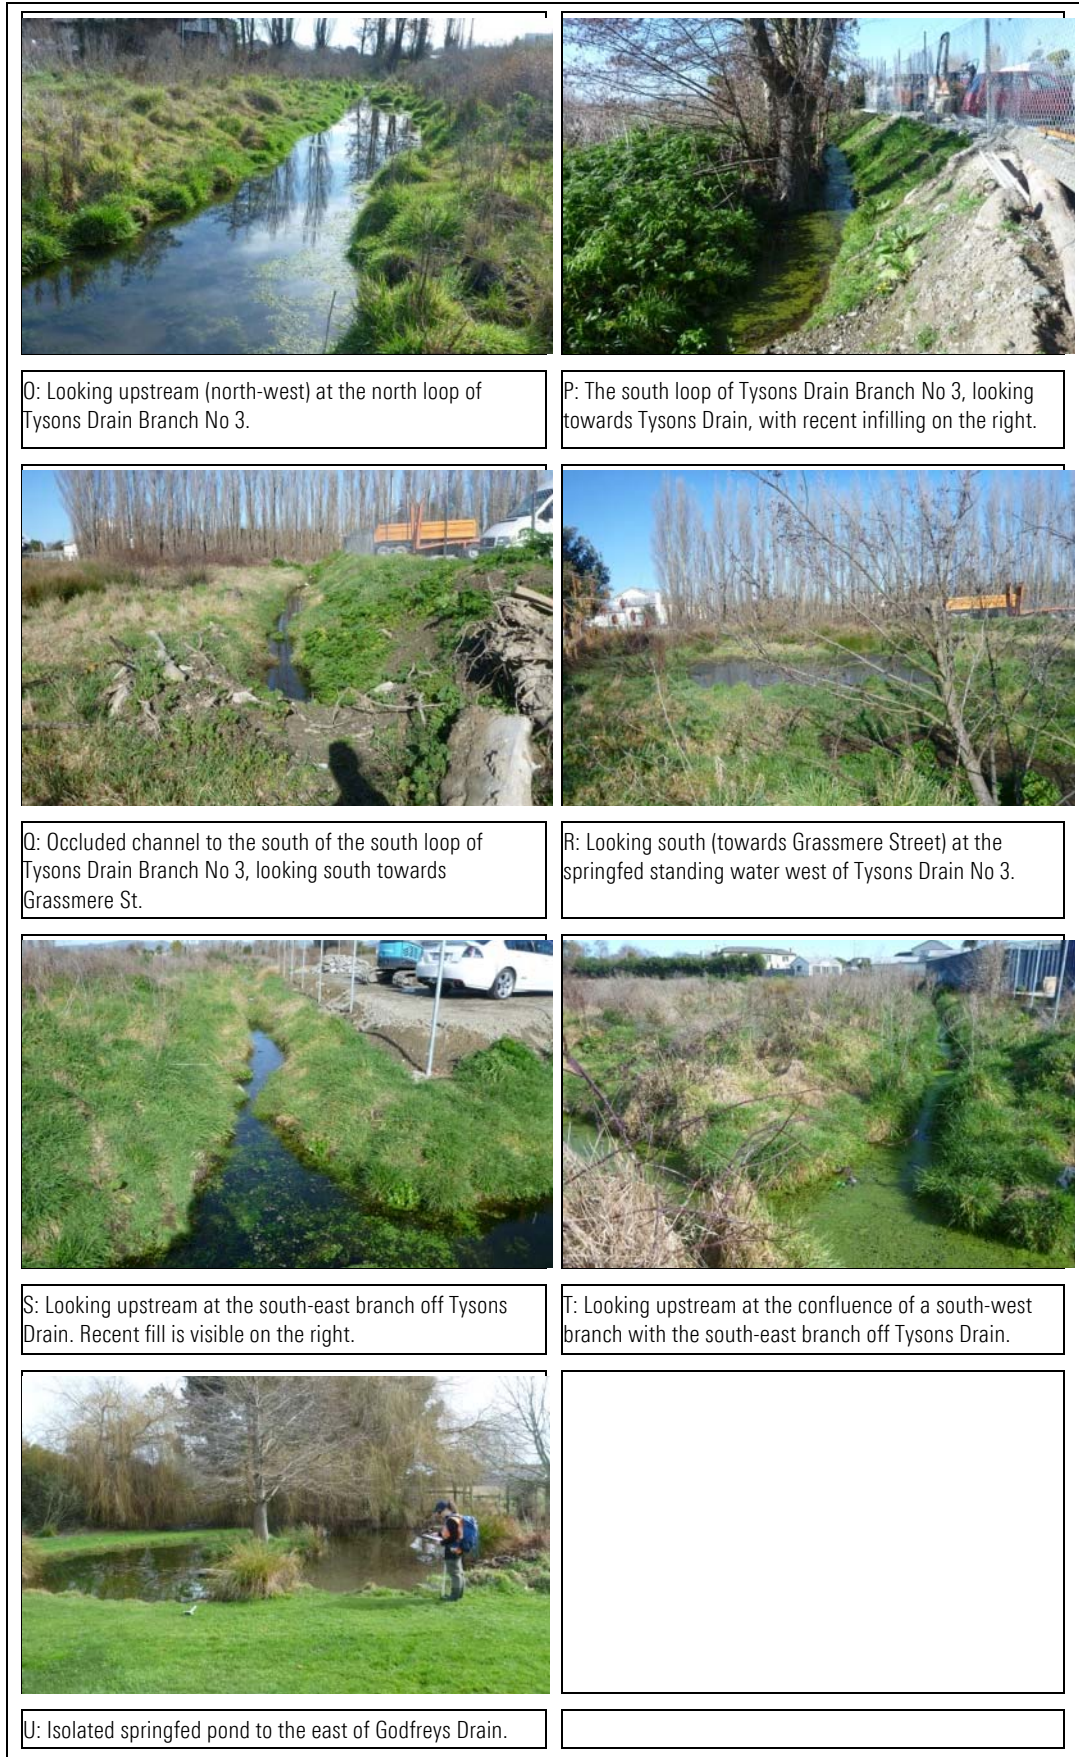
G: Pond (fed from a spring source) flowing into Tysons Drain Branch No 1.

H: Tysons Drain Branch No 1 South, looking downstream.

I: Tysons Drain Branch No 1 West, looking downstream.

J: Tysons Drain Branch No 1 West, looking upstream.

K: Confluence of Tysons Drain Branch No 1 (left) with Tysons Drain (centre and right), looking upstream into Tysons Drain.

L: Tysons Drain, looking downstream at faster flowing section and adjacent spring inputs.

M: Looking up stream at a cross intersection of Tysons Drain (centre) with Tysons Drain Branch No 3 (left) and a south-east side branch. Recent fill is visible on the left.

N: Looking upstream along Tysons Drain, with the confluence for the south loop of Tysons Drain Branch No 3 on the right.

Figure 4 Photos of streams and ponds in the Tysons Drain network west of Cranford Basin, as visited by EOS Ecology on 29 August and 8 September 2016.

In general all waterways were straight soft-bottomed channels with steep-sided earth banks typical of channels excavated for drainage. Riparian vegetation was dominated by exotic herbs and pasture grasses, and provided little in the way of overhanging cover for aquatic biota. Shading of channels was mainly provided by adjacent exotic shelterbelts, or were otherwise unshaded. A significant area of native trees (mainly *Pittosporum* species) were found along the west branch flowing into Tysons Drain branch No 1 South (Figure 4i). The channel substrate was usually a fine sediment of variable depth, with the exception of the channel feeding into and out of the downstream pond west of Tysons Drain Branch No 1 West (i.e., Site 4), which consisted of small cobbles (Figure 4c).

Five significant ponded areas were noted; an isolated pond east of Godfreys Drain (Figure 4u) which has no inflow or outflow channels but is presumably springfed; a network of four ponds west of Tysons Drain Branch No 1 West (Figure 4a-d) which were created by the realignment of a drainage channel fed by springs; a pond adjacent to Tysons Drain Branch No 1 (Figure 4g); and a large ponded area (albeit heavily silted) to the west of Tysons Drain Branch No 3 (Figure 4r). With the exception of the latter, these ponds appear to have been excavated to create a feature of the spring inputs. The habitat values were greatest for the upstream pond in the four-pond network immediately to the west of Tysons Drain Branch No 1 West. This pond had extensive plantings of vegetation (native sedges and other plants) around its margins and was reasonably well shaded by trees, with the flow supplemented by bore water. The second (middle) pond was substantially larger, but with little cover provided around the edge or within the pond itself. The shallower nature may make it more susceptible to turbid water by ducks disturbing settled sediment. Water for this pond and the downstream one was sourced from a spring source piped under the most upstream pond (Figure 2). The third pond was deeper and had a good overhanging cover provided by large *Carex secta* sedges, but there was little shade. The fourth pond no longer had a spring flow input so was occluded and held only stagnating rainwater and garden rubbish.

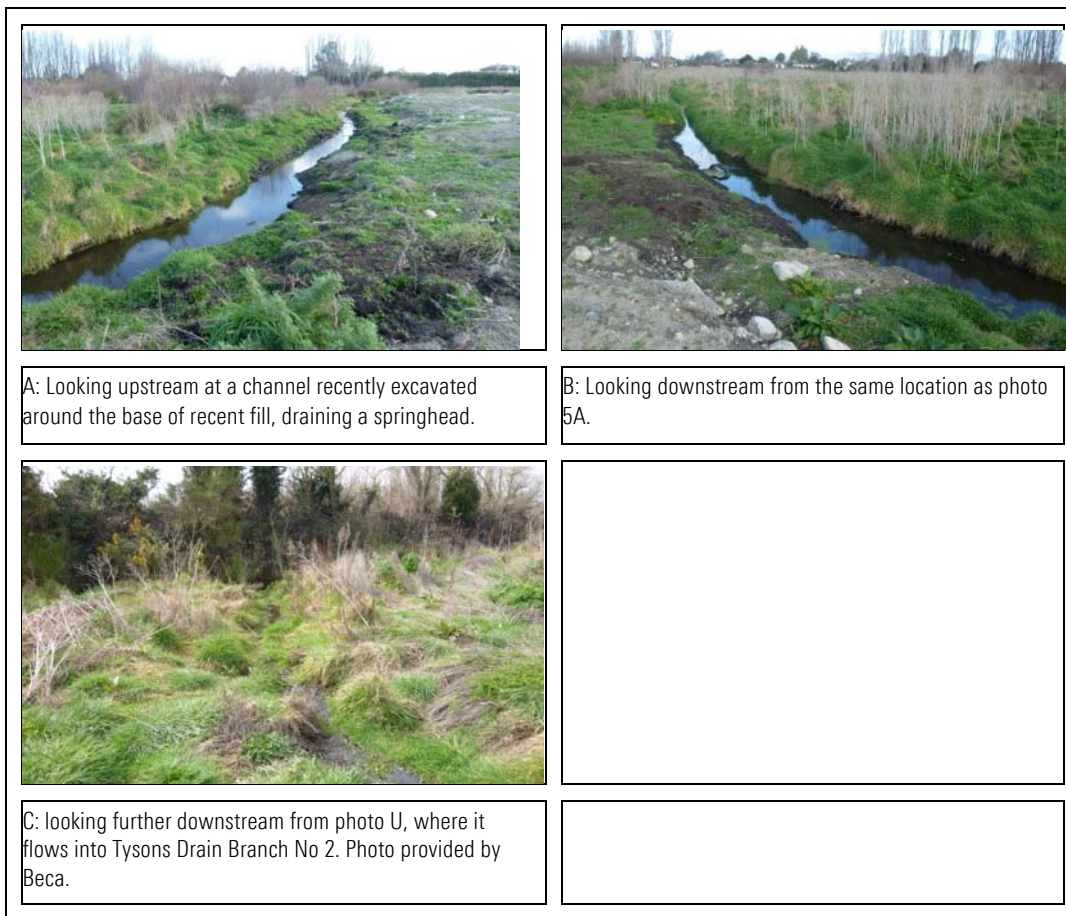
Figure 5 Photos of the unnamed drainage area in the south-east corner of the project area west of Cranford Basin, as visited by EOS Ecology on 29 August and 8 September 2016.

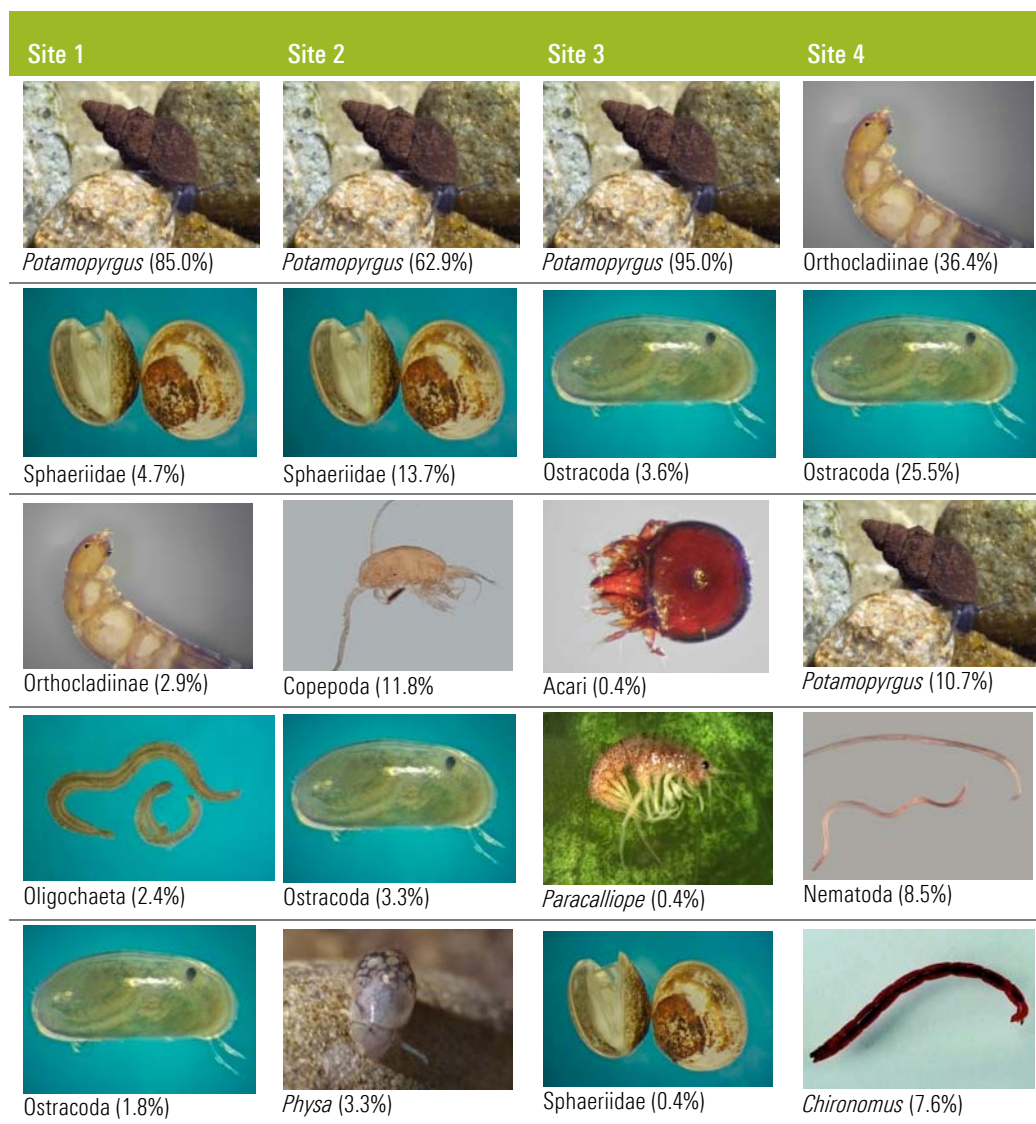
Figure 7 The five most abundant macroinvertebrate taxa at four western Cranford Basin sites sampled by EOS Ecology on 31 August 2016. The relative abundance of each taxon is given in parentheses. Photos © EOS Ecology.

Overall the freshwater snail *Potamopyrgus* (Figure 7) accounted for 83.6% of all invertebrates captured, dominated the community and was found at all four sites. The only other taxa with overall relative abundances greater than 1% were ostracod microcrustaceans (4.1%, found at all sites), Sphaeriidae pea clams (3.2%, found at Sites 1–3), orthoclad midge larvae (3.2%, found at Sites 1, 2, and 4), oligochaete worms (1.2%, found at all sites), and copepod microcrustaceans (1.2%, found at Sites 1 and 3) (Figure 7). The cleanwater EPT (Ephemera-Plecoptera-Trichoptera) group was represented by caddisflies (order Trichoptera), with both the mayfly (Ephemeroptera) and stonefly (Plecoptera) orders absent. Caddisflies accounted for only 0.5% of total invertebrate abundance, with only two taxa recorded. The most abundant of these was the more pollution-tolerant hydroptillid caddisfly *Oxyethira* (0.4%, found only at Sites 1 and 4), while *Hudsonema* was more uncommon (0.1%, found only at Site 1).

Considering the five most abundant taxa at each site, Sites 1–3 were all similar in being strongly dominated by the snail *Potamopyrgus* and including ostracod microcrustaceans and Sphaeriidae pea clams in the top five most abundant taxa (Figure 7). Site 4 differed in that *Potamopyrgus* did not dominate the community, with orthoclad midge larvae and ostracod microcrustaceans having higher relative abundances (Figure 7).

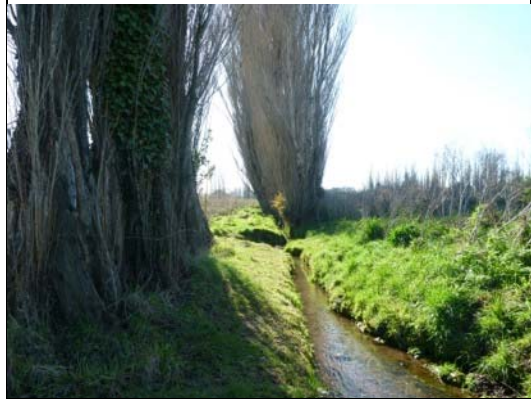
Site 1 (looking downstream from top of site)

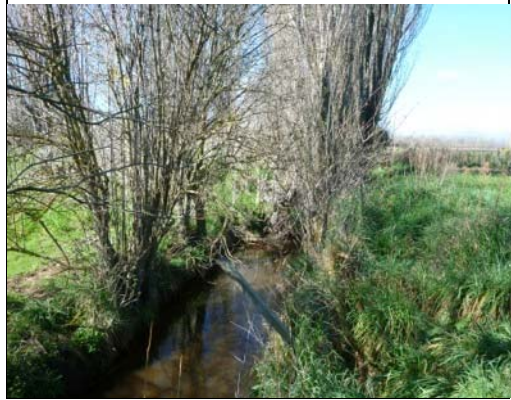
Site 2 (looking downstream from middle of site)

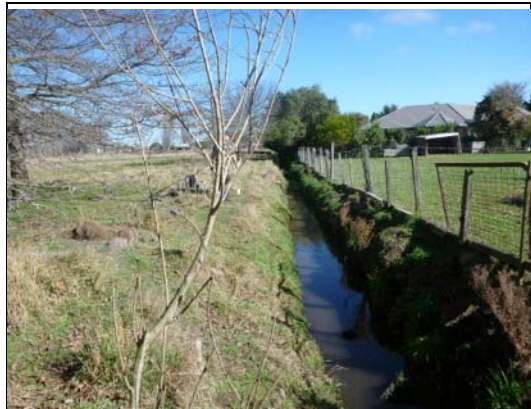
Site 3 (looking upstream from bottom of site)

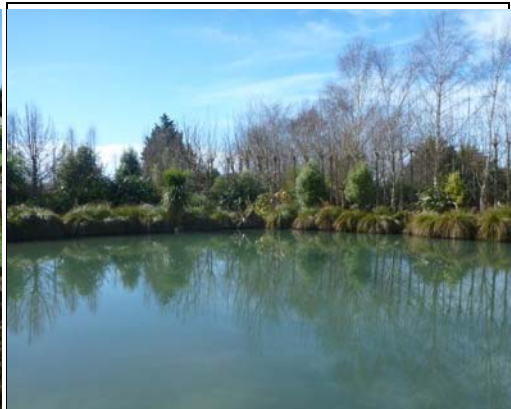
Site 4 (looking across pond)

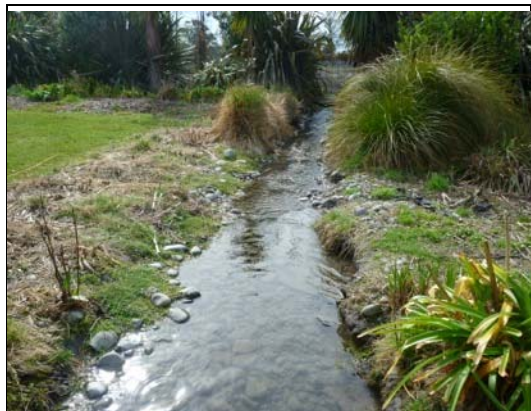
Site 4 (stony outlet stream from pond looking downstream)

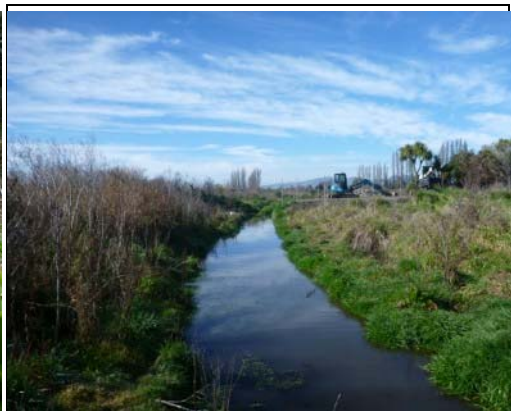
Site 5 (looking downstream from middle of site)

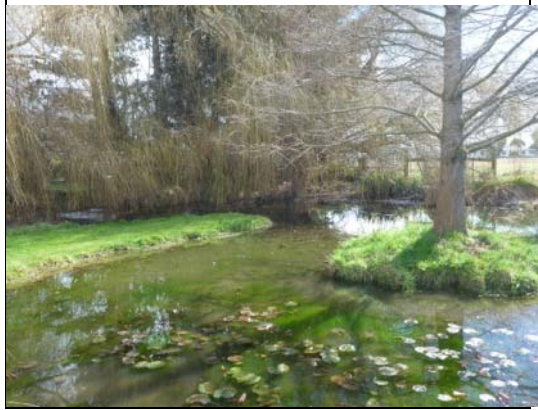
Site 6 (looking across pond)
